City of Rancho Palos Verdes
 Rancho Palos Verdes ADA Assessment
 Facility Report with Photos

Facility ID: # Area 5 Bus Stops

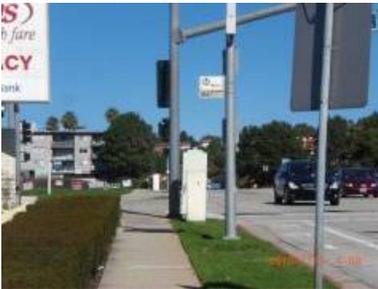
Location: Hawthorne Blvd./ Crest Rd. (SB)
Photo # 53

Field Condition	
02.12A - Bus Stop Pad Slope Parallel to Roadway - Bus stop pad is not at the same slope as the roadway in the direction parallel to the roadway.	1991 ADAAG 10.2.1
Existing Condition: 6.1% RS at bus pad, 6.2% RS at the road.	2004 ADAAG 810.2.4
	2007 CBC 1121B.2.1
	Other

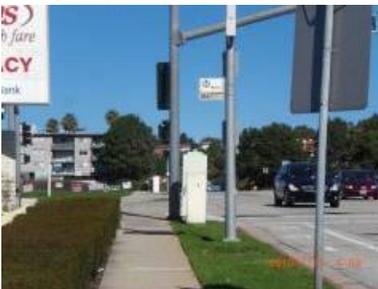
Location: Hawthorne Blvd./ Crest Rd. (SB)
Photo # 53

Field Condition	
02.12B - Bus Stop Pad Slope Perpendicular to Roadway - Bus stop pad slope perpendicular to the roadway exceeds 2%.	1991 ADAAG 10.2.1
Existing Condition: 2.4% CS.	2004 ADAAG 810.2.4
	2007 CBC 1121B.2.1
	Other

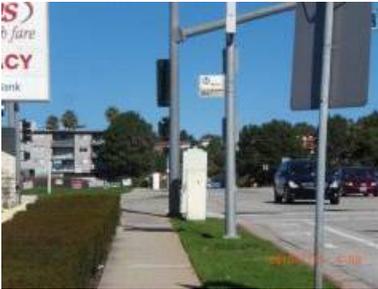
Location: Hawthorne Blvd./ Crest Rd. (SB) Photo # 53

Field Condition	
02.11A - Bus Stop Pad Size - Bus stop pad does not measure 8' long (measured from the curb or vehicle roadway edge) by 5' wide (measured parallel to the vehicle roadway).	1991 ADAAG 10.2.1
	2004 ADAAG 810.2.2
Existing Condition: Bus pad 4' long by 5' wide.	2007 CBC 1121B.1
	Other

Corrective Action
006 - Concrete Walk - Remove non-compliant pavement and replace with new concrete (area as shown on the drawings). The walkway slope shall not exceed 5% along the POT and cross slope shall not exceed 2%.
Additional Comments:

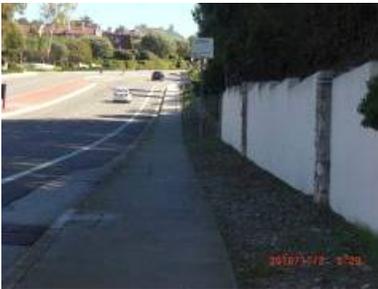
Location: Crest Rd./ Hawthorne Blvd. (EB) Photo # 56

Field Condition	
02.11A - Bus Stop Pad Size - Bus stop pad does not measure 8' long (measured from the curb or vehicle roadway edge) by 5' wide (measured parallel to the vehicle roadway).	1991 ADAAG 10.2.1
	2004 ADAAG 810.2.2
Existing Condition: Bus pad 5'-7" long by 5' wide.	2007 CBC 1121B.1
	Other
