THE CITY OF
RANCHO PALOS VERDES

Infrastructure Report Card

Revised May 14, 2014

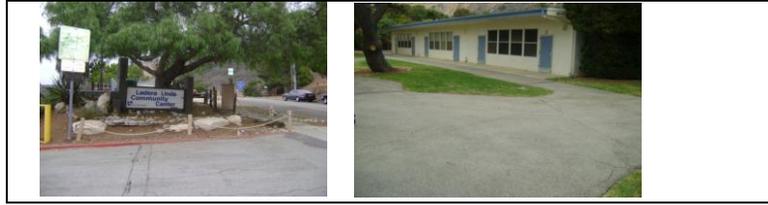
Facility No.: B8
Facility Name: Community Building
Location: Ladera Linda Community Center

Condition:

1	Background Info	Prefabricated, assembled on-site, interlocking metallic panel constructed school classroom type units.
	Year Built	1960's
	Last Renovation/Improvement	
2	Any Recent Work	
3	Any Scheduled Future Work	<p>The city is considering the rehabilitation of the of community center (CIP Plan for FY17/18)</p> <p>LADERA LINDA PARK & COMMUNITY CENTER BUILDINGS REPLACEMENT The initial stage of this project, <u>for which a budget is appropriated</u>, is to create a master plan which will lay the groundwork for the site's long-term redevelopment and phased implementation. This stage involves a study of community needs through public outreach along with contemplating the City's needs for public service facilities. This work will be followed by programming, quantifying the needs, planning and preparing a feasibility report to create a master plan which can be phased for design and construction.</p> <p>The cost calculation for Ladera Linda Buildings Replacement project is based on an estimated need for 12,000 square-feet of buildings to replace the existing 18,000 square-feet. The anticipated square footage can cover park restrooms, a staff building, multipurpose room, activity rooms, discovery room and a Park Ranger/Deputy Sheriff drop-in office. Other improvements include park grounds landscaping & irrigation, picnic tables, benches and an emergency generator. The project can be divided in three phases. The first phase will include Hazmat abatement, removal of all buildings, installation of all utility infrastructures, the construction of 6,000 SF of new building, park grounds, landscaping & improvements. The second and third phase will include 3,000 SF of new buildings each.</p> <p>For Phase 1: \$1.4 M is estimated for the park improvements and Infrastructure (20% of the \$7.2M), and \$2.6M for buildings. Phase 2 (\$3.2M) buildings only. Total for buildings is \$5.8. Not considered in investment needs.</p>

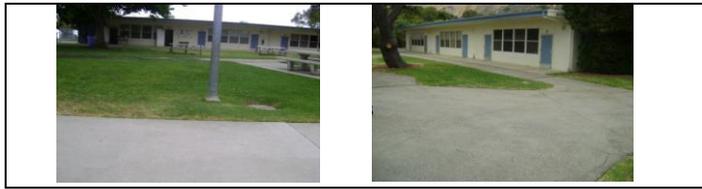
Facility No.: B10
Facility Name: Multi Purpose Room
Location: Ladera Linda Community Center

Condition:

1	Background Info	Prefabricated, assembled on-site, interlocking metallic panel constructed school classroom type units.
	Year Built	1960's
	Last Renovation/Improvement	
2	Any Recent Work	
3	Any Scheduled Future Work	
4	Identified Problems / Issues	Old buildings. Maintenance no longer effective. No ventilation, heating/cooling

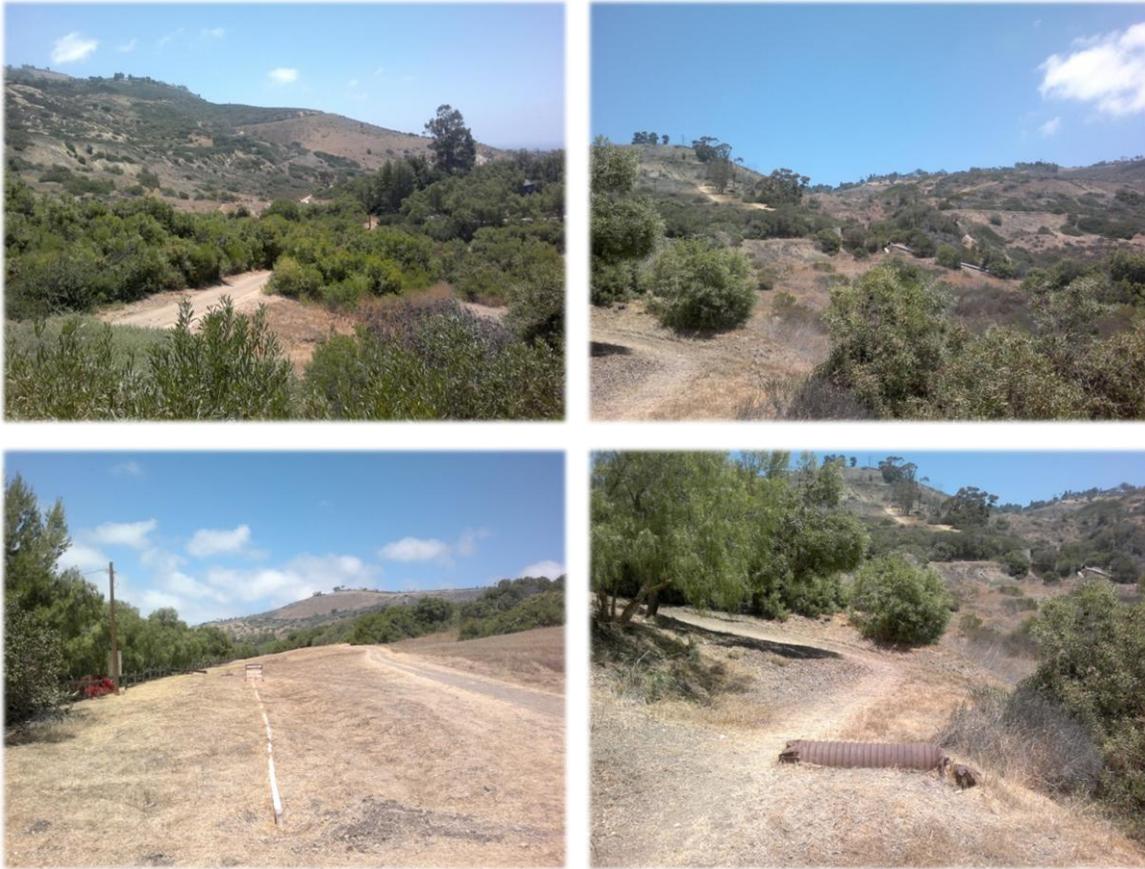
Abalone Cove Area:

Visited the Abalone Cove are of the overall Palos Verdes Drive South Landslide area. Inspected surface drainage systems, dewatering and monitoring wells, and surface conditions.
