**Re: Infrared Inspections for Planning Department and  
Ladera Linda Community Center Buildings J&K**

Certified Thermography Report  
for

**Planning Department Building**  
30940 Hawthorne Blvd.

**Ladera Linda Community Center**  
Recreation Room Building J & K  
32201 Forrestal Drive

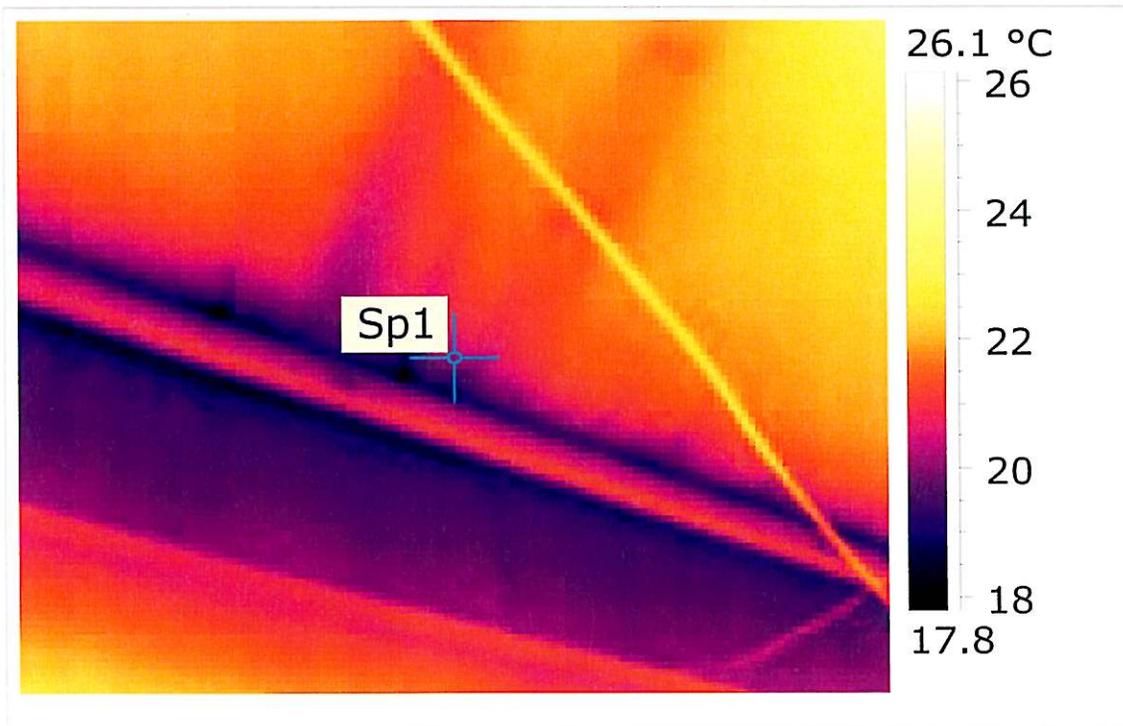
**Picture 8. (Inside Ceiling adjacent (west) to SW Corner office)**

**Comment:** Black line above and below wood baton indicates colder air-infiltration. Note: This infiltration is present without the use of blower door.

**Recommendation:** See same image below using blower door. Cable indicates potential phantom electrical issue.

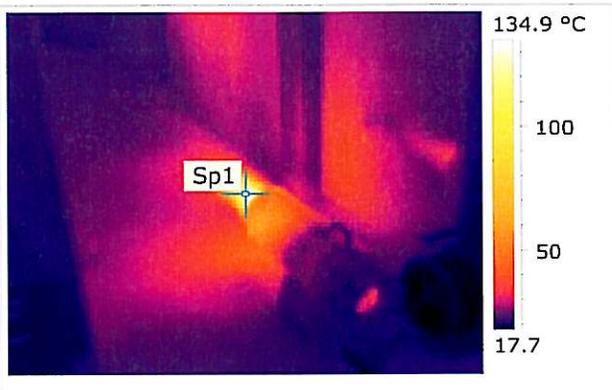
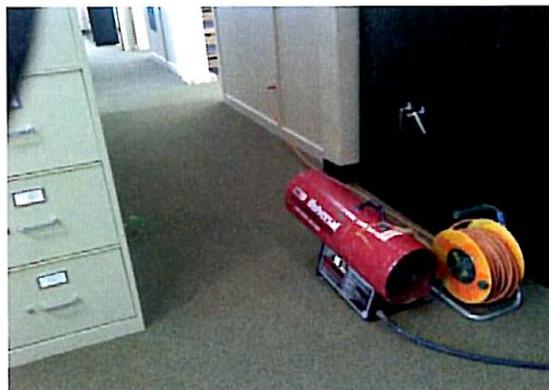
**Portable Propane 150,000 BTU Heater**

**Comment:** Used to achieve Delta T to optimize thermal imaging

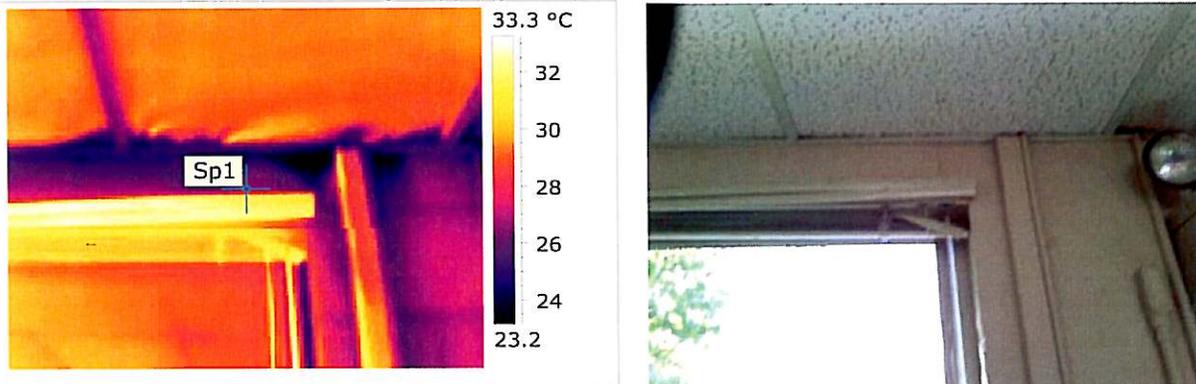
Picture 14. Captured at: (Various offices)

**Comment:** Lid line air-infiltration

**Recommendation:** Remove perimeter tile caulk and seal wood baton all sides. Further investigation required.

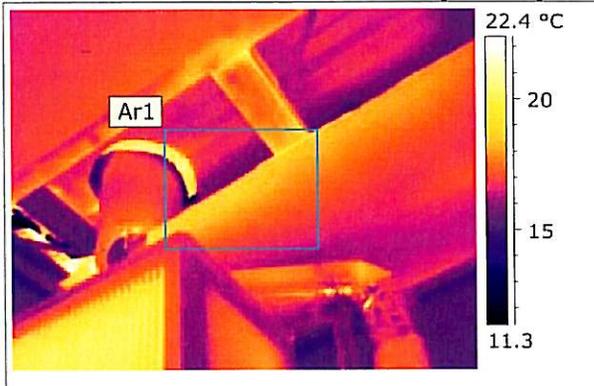
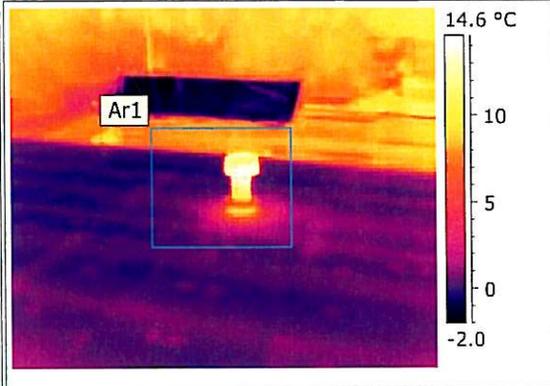
**View of 6" furnace vent inside primary 8" vent and 8" vent and cap on roof**
