Facility No.: B1
Facility Name: [City Hall \(Administration Building & Catalina Wing\) - Civic Center](#)
Location: [Point Vicente Park and Civic Center](#)

Facility No.: B2
Facility Name: [Planning Dept Building - Civic Center](#)
Location: Point Vicente Park and Civic Center

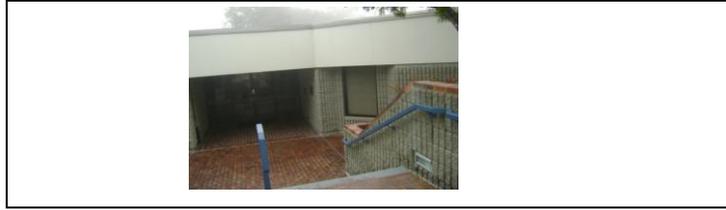
Facility No.: B13
Facility Name: Community Building
Location: Fred Hesse Jr. Park

Background Info		Building retrofitting performed around 1989
1	Year Built	
	Last Renovation/Improvement	Internal renovation performed recently. No documentation available.
2	Any Recent Work	
3	Any Scheduled Future Work	(1) JOHN MCTAGGART MEMORIAL HALL AND COUNCIL CHAMBERS IMPROVEMENTS \$250,000 (the hall where council meetings take place) Funding available in CIP Plan fro FY 13/14 (2) SOLAR POWER SYSTEM FOR HESSE PARK BUILDING to reduce power consumption with occasional opportunities to sell power to the grid \$350,000 (Funding not available. In CIP Plan)
4	Identified Problems / Issues

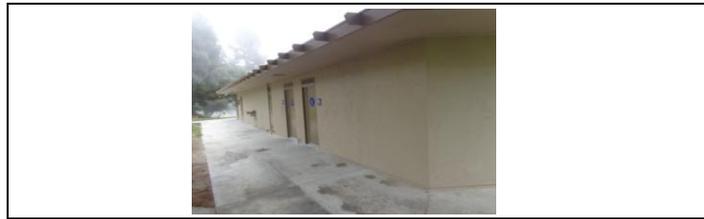
Facility No.: B14
 Facility Name: Community Building
 Location: Robert E. Ryan Community Park

Background Info	
1	Year Built: 1969
	Last Renovation/Improvement: 2011 Restrooms Renovation (ongoing)
2	Any Recent Work
3	Any Scheduled Future Work
4	Identified Problems / Issues

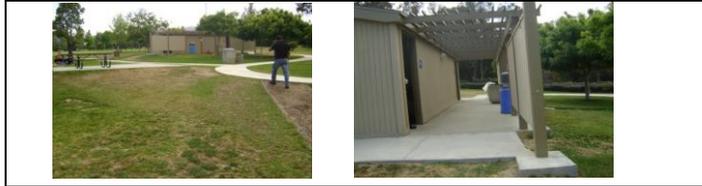
Facility No.: B16
Facility Name: Public Restrooms
Location: Eastview Park

Background Info		1/4 million project improvement for buildings??? Find source
1	Year Built	0
	Last Renovation/Improvement	2012
2	Any Recent Work	ADA Compliance
3	Any Scheduled Future Work	
4	Identified Problems / Issues

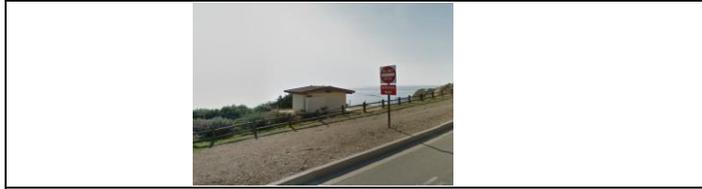
Facility No.: B17
Facility Name: Public Restrooms
Location: Pelican Cove Park (Previously Fisherman's Access)

Background Info	
1	Year Built
	Remodeled in 2008 to match adjacent hotel architecture
	Last Renovation/Improvement
	2008
2	Any Recent Work
3	Any Scheduled Future Work
4	Identified Problems / Issues
