## **2.0 Executive Summary**

### **2.2 Condition Assessment**

#### **2.2.1 CCTV Results**

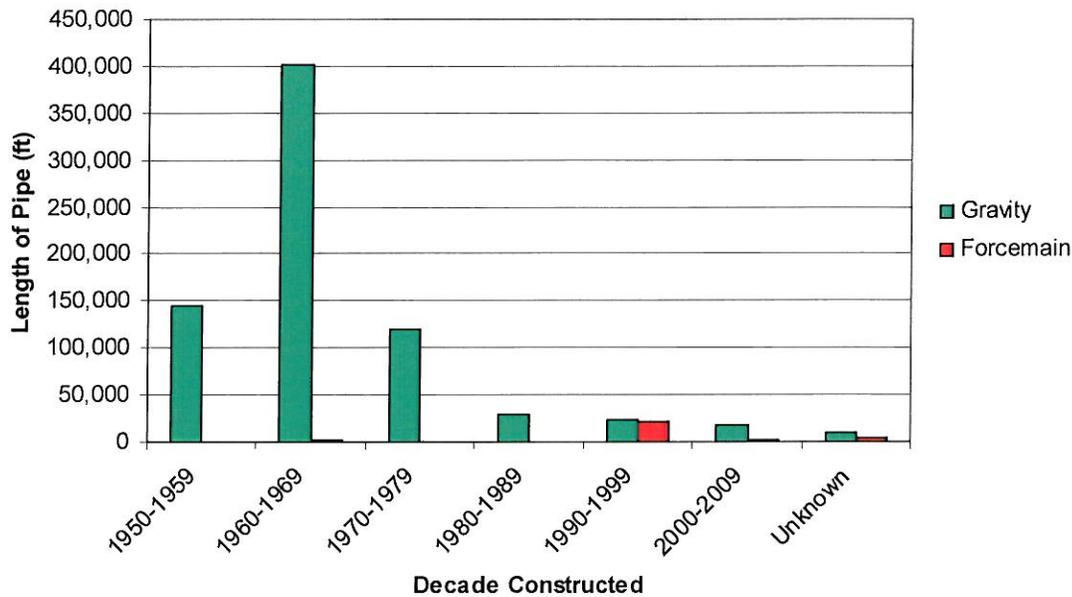
### Length of Pipe by Age

The majority of the system (over 73%) is now more than 40 years old and made of VCP. The average service life for VCP pipe is generally accepted as 100 years with breakage beginning at approximately 20 years. As a result there will be an increasing trend in pipe structural failures with time.

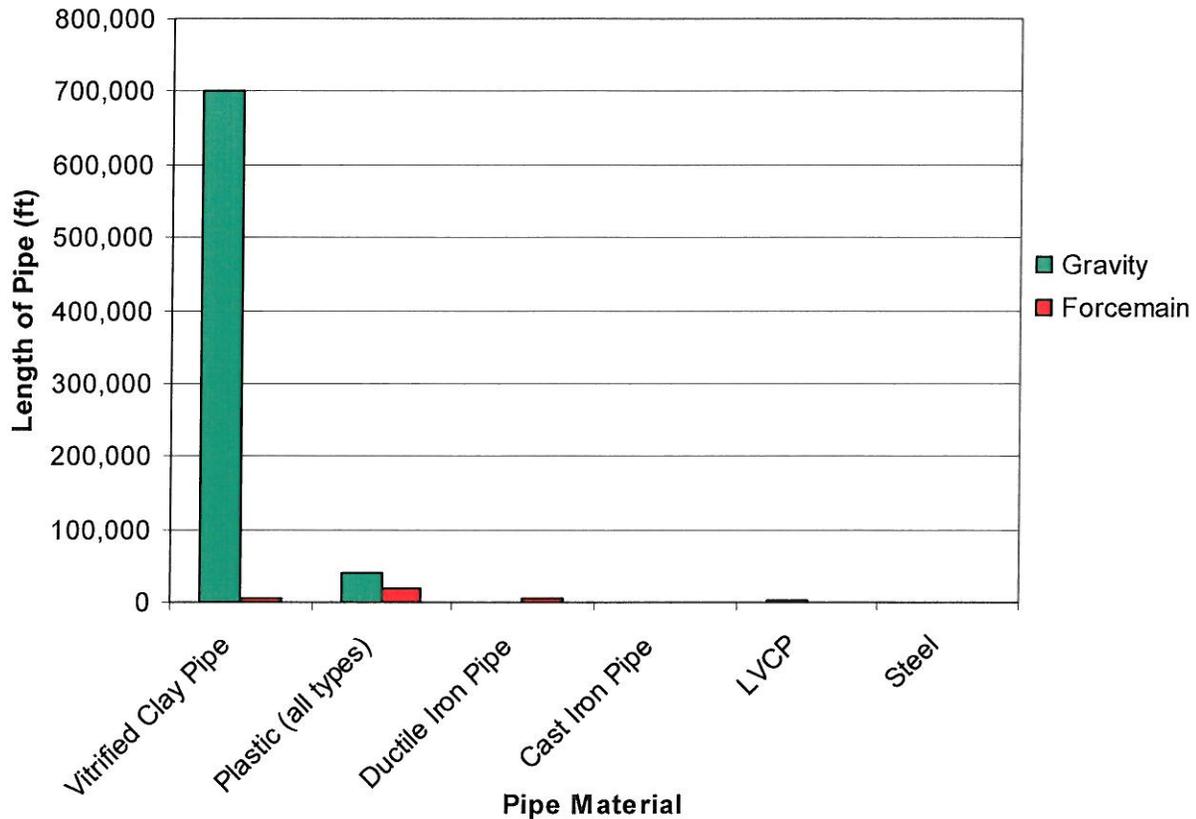
### Length of Pipe by Material

As shown in these tables the dominant material used in the system is Vitrified Clay Pipe (VCP) at just over 94%. Prior to the 1970s it was common practice to install VCP pipe sections without gaskets. This practice was based on the theory that additional groundwater flowing into the pipe was beneficial in cleaning and flushing the pipe. This practice resulted in easy entry of roots from surrounding trees and hedges into the pipes. In the mid 70's it became common practice to use mortar to "seal" the joints. This rigid seal would be easily cracked and would dissolve from hydrogen sulfide attack over time. Over 80% of the system was installed before gasketed joints became common.
