*City of Rancho Palos Verdes*  
**Rancho Palos Verdes ADA Assessment**  
**Facility Report with Photos**

**Reporting: 266 of 4367 Rcds**

**Facility ID: # 07 - Fred Hesse Jr. Community Park (Upper Part)**

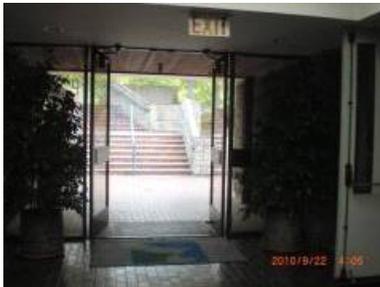
Location: Main Entrance Photo # 2

<b>Field Condition</b>	
10.13A - Required Exit Door Sign - At grade level exterior exit door, there is no tactile and CA Braille exit sign with the word "EXIT" mounted on the wall adjacent to the latch side of the door.	1991 ADAAG 4.1.3(16); 4.30.1
Existing Condition:	2004 ADAAG 216.4; 703.2; 703.3; 703.4
	2007 CBC 1011.3 item 1
	Other -

<b>Corrective Action</b>
414 - Exit Sign - Ground Floor - At ground floor door which exits to exterior, provide a tactile and CA Braille exit sign with the word "EXIT" mounted on the wall adjacent to the latch side of the door.
Additional Comments:

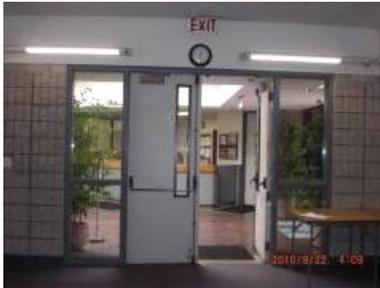
11.21A - Required Exit Route Sign - At exit access door from an interior room or area that is required to have a visual exit sign, there is no tactile and CA Braille exit sign with the words "EXIT ROUTE" mounted on the wall adjacent to the latch side of the door. (Visual exit signs are required when two or more exits are required. Generally, all occupants shall have access to two exits from a floor (CBC Table 1019.1). Exceptions: a) Single story building with maximum occupant load of 49 and less than 75 ft travel distance to exit (CBC Table 1019.2), and b) Two story building with maximum occupant load of 30 occupants per floor and maximum travel distance of 75 ft to exit. (CBC Table 1019.2). Two exit access doors are required from an office tenant space when the occupant load exceeds 49.)

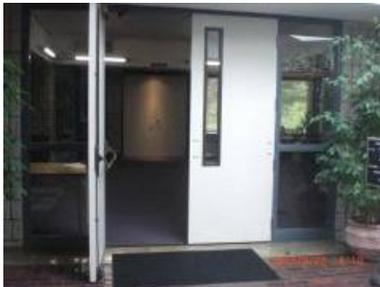
Field Condition	
11.07D - Floor Mat - Attachment to Floor - Floor mat used on a ground or floor surface is not securely attached.	1991 ADAAG 4.5.3
Existing Condition: Loose floor mat.	2004 ADAAG 303.2; Advisory 302.2
	2007 CBC 1124B.3
	Other -

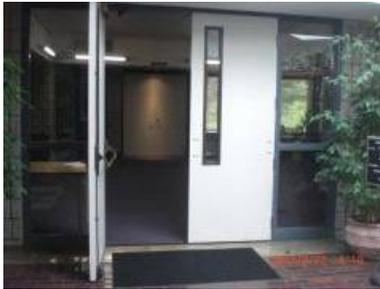
**Photo #**  
10

<b>Field Condition</b>	
11.17A - Recommendation: Providing Room/Space ID Sign - A sign designating the permanent room or space has not been provided.	<b>1991 ADAAG</b> 4.1.2(7)
Existing Condition:	<b>2004 ADAAG</b> 216.2; 703.1; 703.2; 703.5
	<b>2007 CBC</b> 1117B.5.1 item 1
	<b>Other</b> -

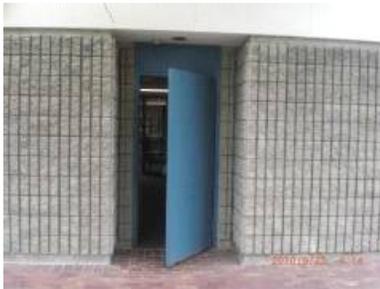
**Photo #**  
12

<b>Field Condition</b>	
10.07A - Landing - Level and Clear - Floor is not level (slope is greater than 2% in some or all directions). OR Floor is not clear within the required maneuvering space.	<b>1991 ADAAG</b> 4.13.6; Fig. 25
Existing Condition: 2.3% RS at door landing.	<b>2004 ADAAG</b> 305; 404.2.4.4
	<b>2007 CBC</b> 1133B.2.4
	<b>Other</b> -

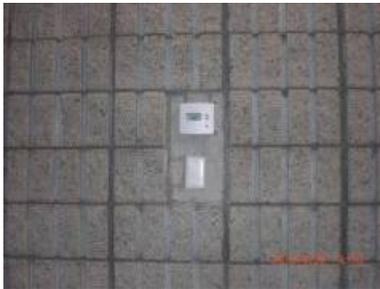
**Photo #**  
19

Existing Condition: 60" high thermostat.

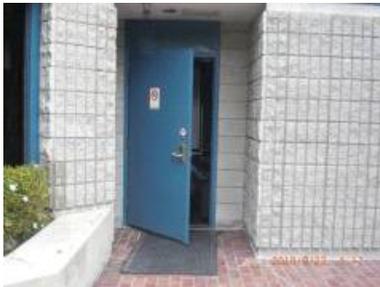
**Photo #**  
24

11.17A - Recommendation: Providing Room/Space ID Sign - A sign designating the permanent room or space has not been provided.

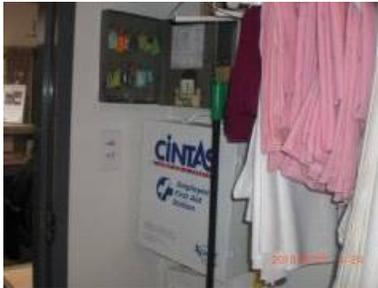
<b>Field Condition</b>	
14.32A - Reach Range - Controls - Controls, dispensers, and similar devices are not between 9" and 54" AFF when the clear floor space allows a parallel approach. OR They are not between 15" and 48" AFF when the clear floor space allows only a forward approach.	<b>1991 ADAAG</b> 4.1.3(13); 4.27.3; 4.2.5; 4.2.6 ; Fig. 5; Fig. 6 <b>2004 ADAAG</b> - <b>2007 CBC</b> 1117B.6(3); 1118.5; 1118.6; Fig. 11B-5C; Fig. 11B-5D <b>Other</b> -
Existing Condition: Key holder at 64" high.

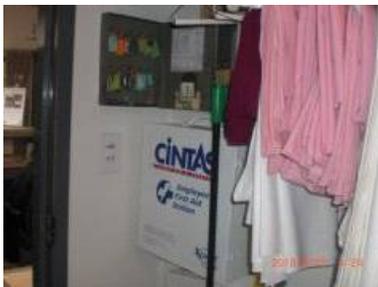
<b>Field Condition</b>	
14.32A - Reach Range - Controls - Controls, dispensers, and similar devices are not between 9" and 54" AFF when the clear floor space allows a parallel approach. OR They are not between 15" and 48" AFF when the clear floor space allows only a forward approach.	<b>1991 ADAAG</b> 4.1.3(13); 4.27.3; 4.2.5; 4.2.6 ; Fig. 5; Fig. 6 <b>2004 ADAAG</b> - <b>2007 CBC</b> 1117B.6(3); 1118.5; 1118.6; Fig. 11B-5C; Fig. 11B-5D <b>Other</b> -
Existing Condition: First aid kit at 50" high.

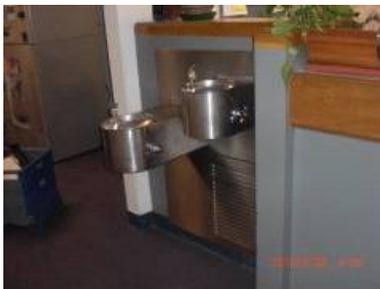
05.08A - Wall-Mounted Protruding Objects - Wall mounted drinking fountain with leading edges between 27" and 80" from the floor projects more than 4" into the circulation path.

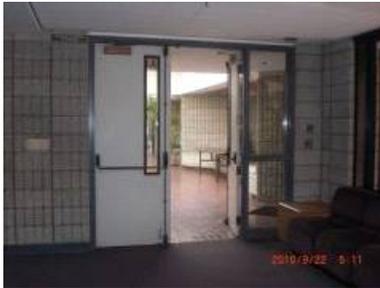
Field Condition	
11.13B - Hardware Operating Effort - The force required to activate handles, pulls, latches, locks, and other operable parts of door exceeds 5 lbs.	1991 ADAAG 4.27.4
Existing Condition: 10 LBF.	2004 ADAAG 309.4
	2007 CBC 1117B.6 item 4
	Other -

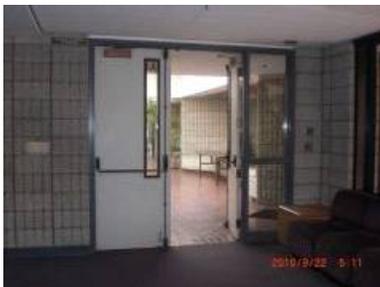
Field Condition	
11.13A - Door Operating Effort - The force required to operate door exceeds 5 lbs. (Fire doors may have up to 15 lbs to achieve positive latching).	1991 ADAAG 4.13.11
Existing Condition: 7 LBF.	2004 ADAAG 404.2.9
	2007 CBC 1133B.2.5
	Other -

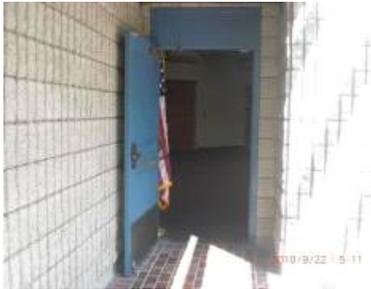
10.06A - Door Maneuvering Space - Door that is not automatic or power-assisted does not have compliant maneuvering space relative to the direction of approach as shown in CBC Fig. 11B-26. (Approach // Side // Width // Depth) (Front // Pull // D + 24" \* // 60") (Front // Push // D + 0" \*\* // 48") (Latch // Pull // D + 24" // 60") (Latch // Push // D + 24" // 44" \*\*\*) (Hinge // Pull // D + 36" // 60") (Hinge // Push // 54" \*\*\*\* // 44" \*\*\*\*\*) (\* D + 18" at interior doors.) (\*\* D + 12" if door has both a latch and a closer.) (\*\*\*) 48" if door has closer.) (\*\*\*\* Measured from latch toward hinge.) (\*\*\*\*\* 48" if door has both a latch and a closer.)

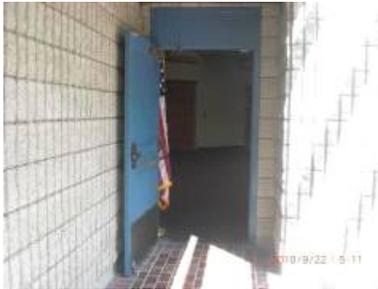
<b>Field Condition</b>	
10.08 - Kick Plate - Bottom 10" of door does not have a smooth, uninterrupted surface on the push side to allow the door to be opened by a wheelchair footrest without creating a trap or hazardous condition. (This requirement does not apply to automatic and sliding doors.)	<b>1991 ADAAG</b> -
Existing Condition: Door stop on kick plate.	<b>2004 ADAAG</b> 404.2.10
	<b>2007 CBC</b> 1133B.2.6
	<b>Other</b> -

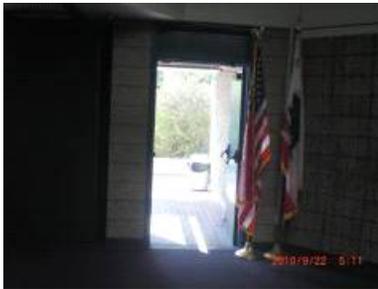
<b>Field Condition</b>	
10.13A - Required Exit Door Sign - At grade level exterior exit door, there is no tactile and CA Braille exit sign with the word "EXIT" mounted on the wall adjacent to the latch side of the door.	<b>1991 ADAAG</b> 4.1.3(16); 4.30.1
Existing Condition:	<b>2004 ADAAG</b> 216.4; 703.2; 703.3; 703.4
	<b>2007 CBC</b> 1011.3 item 1
	<b>Other</b> -

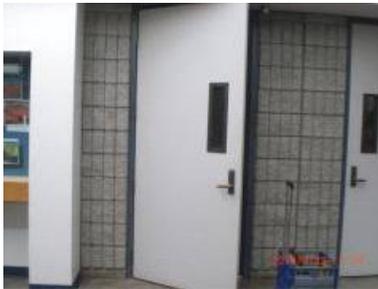
Field Condition	
11.15A - Kick Plate - Bottom 10" of door does not have a smooth, uninterrupted surface on the push side to allow the door to be opened by a wheelchair footrest without creating a trap or hazardous condition. (This requirement does not apply to automatic and sliding doors.)	1991 ADAAG -
Existing Condition: Door stop on kick plate.	2004 ADAAG 404.2.10
	2007 CBC 1133B.2.6
	Other -

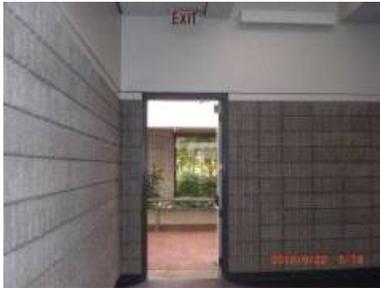
11.21A - Required Exit Route Sign - At exit access door from an interior room or area that is required to have a visual exit sign, there is no tactile and CA Braille exit sign with the words "EXIT ROUTE" mounted on the wall adjacent to the latch side of the door. (Visual exit signs are required when two or more exits are required. Generally, all occupants shall have access to two exits from a floor (CBC Table 1019.1). Exceptions: a) Single story building with maximum occupant load of 49 and less than 75 ft travel distance to exit (CBC Table 1019.2), and b) Two story building with maximum occupant load of 30 occupants per floor and maximum travel distance of 75 ft to exit. (CBC Table 1019.2). Two exit access doors are required from an office tenant space when the occupant load exceeds 49.)

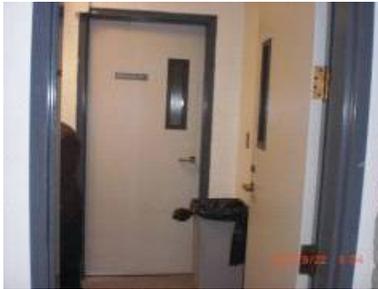
**Location:** Kitchen  
**Photo #** 81

Field Condition	
11.17A - Recommendation: Providing Room/Space ID Sign - A sign designating the permanent room or space has not been provided.	1991 ADAAG 4.1.2(7)
Existing Condition:	2004 ADAAG 216.2; 703.1; 703.2; 703.5
	2007 CBC 1117B.5.1 item 1
	Other -

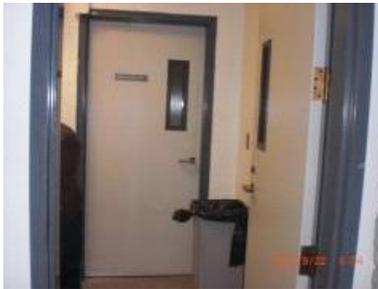
**Location:** Kitchen  
**Photo #** 81

Field Condition	
11.15A - Kick Plate - Bottom 10" of door does not have a smooth, uninterrupted surface on the push side to allow the door to be opened by a wheelchair footrest without creating a trap or hazardous condition. (This requirement does not apply to automatic and sliding doors.)	1991 ADAAG -
Existing Condition: Door stop on kick plate.	2004 ADAAG 404.2.10
	2007 CBC 1133B.2.6
	Other -

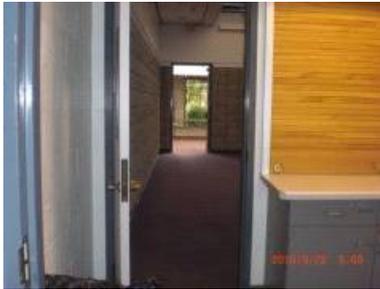
11.06A - Door Maneuvering Space - Door that is not automatic or power-assisted does not have compliant maneuvering space relative to the direction of approach as shown in CBC Fig. 11B-26. (Approach // Side // Width // Depth) (Front // Pull // D + 24" \* // 60") (Front // Push // D + 0" \*\* // 48") (Latch // Pull // D + 24" // 60") (Latch // Push // D + 24" // 44" \*\*\* ) (Hinge // Pull // D + 36" // 60") (Hinge // Push // 54" \*\*\*\* // 44" \*\*\*\*\* ) (\* D + 18" at interior doors.) (\*\* D + 12" if door has both a latch and a closer.) (\*\*\*) 48" if door has closer.) (\*\*\*\* Measured from latch toward hinge.) (\*\*\*\*\* 48" if door has both a latch and a closer.)

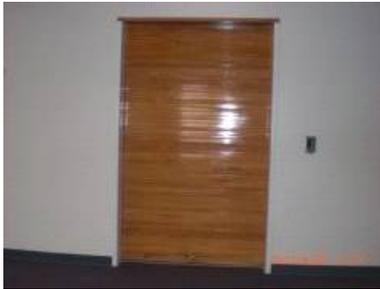
14.50 - Other - Rooms and Spaces - See Additional Comments

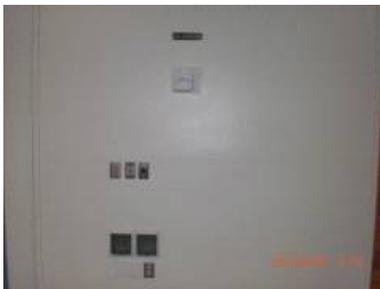
14.32A - Reach Range - Controls - Controls, dispensers, and similar devices are not between 9" and 54" AFF when the clear floor space allows a parallel approach. OR They are not between 15" and 48" AFF when the clear floor space allows only a forward approach.

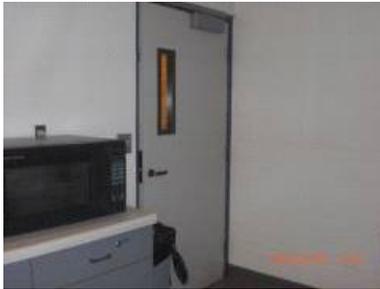
**Location:** Kitchen  
**Photo #** 92

<b>Field Condition</b>	11.15B_04AG - Vision Lights - Door, gate, or adjacent sidelight, containing one or more vision lights, does not include at least one vision light mounted with the bottom edge of the glazed panel at 43" max.. AFF. (Exception: Vision lights with the lowest part more than 66" AFF.)	<b>1991 ADAAG</b> -
	Existing Condition: 48 1/2" high Vision light.	<b>2004 ADAAG</b> 404.2.11
		<b>2007 CBC</b> -
		<b>Other</b> -

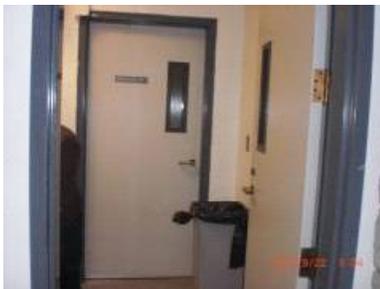
**Location:** Kitchen  
**Photo #** 81

<b>Field Condition</b>	11.17A - Recommendation: Providing Room/Space ID Sign - A sign designating the permanent room or space has not been provided.	<b>1991 ADAAG</b> 4.1.2(7)
	Existing Condition:	<b>2004 ADAAG</b> 216.2; 703.1; 703.2; 703.5
		<b>2007 CBC</b> 1117B.5.1 item 1
		<b>Other</b> -

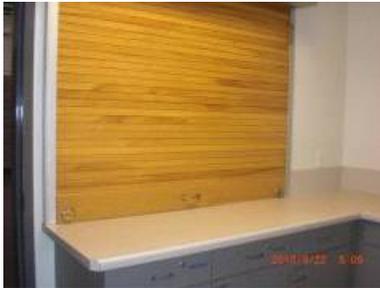
**Location:** Kitchen  
**Photo #** 99

<b>Field Condition</b>	
14.50 - Other - Rooms and Spaces - See Additional Comments	1991 ADAAG -
Existing Condition: Dead bolts at roll-up gate.	2004 ADAAG -
	2007 CBC -
	Other -

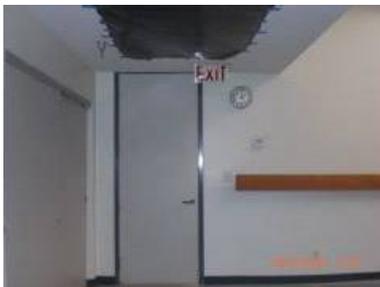
**Location:** Classroom  
**Photo #** 102

<b>Field Condition</b>	
11.13A - Door Operating Effort - The force required to operate door exceeds 5 lbs. (Fire doors may have up to 15 lbs to achieve positive latching).	1991 ADAAG 4.13.11
Existing Condition: 7 LBF Operating effort	2004 ADAAG 404.2.9
	2007 CBC 1133B.2.5
	Other -

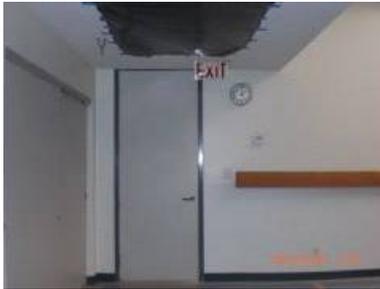
**Location:** Classroom  
**Photo #** 102

<b>Field Condition</b>	
11.11 - Single-Action Hardware - Handles, locks, and latches or other operative devices are not operable with one hand and without tight grasping, pinching, or twisting of the wrist. (U-shaped handles, levers, and push/pull type mechanisms are acceptable designs.)	<b>1991 ADAAG</b> 4.13.9  <b>2004 ADAAG</b> 309.4; 404.2.7; Advisory 404.2.7  <b>2007 CBC</b> 1133B.2.5.2  <b>Other</b> -
Existing Condition: Non-compliant hardware for closet doors.

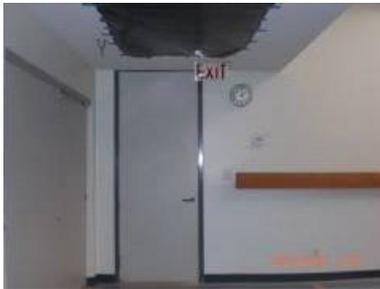
**Location:** Classroom  
**Photo #** 102

<b>Field Condition</b>	
14.32A - Reach Range - Controls - Controls, dispensers, and similar devices are not between 9" and 54" AFF when the clear floor space allows a parallel approach. OR They are not between 15" and 48" AFF when the clear floor space allows only a forward approach.	<b>1991 ADAAG</b> 4.1.3(13); 4.27.3; 4.2.5; 4.2.6 ; Fig. 5; Fig. 6  <b>2004 ADAAG</b> -  <b>2007 CBC</b> 1117B.6(3); 1118.5; 1118.6; Fig. 11B-5C; Fig. 11B-5D  <b>Other</b> -
Existing Condition: 64" high thermostat.

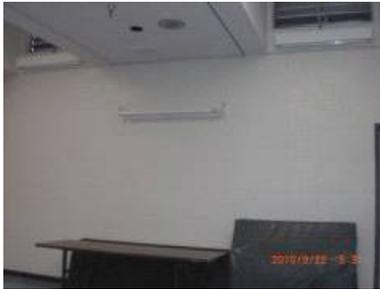
**Location:** Classroom **Photo #** 103

<b>Field Condition</b>	
14.32A - Reach Range - Controls - Controls, dispensers, and similar devices are not between 9" and 54" AFF when the clear floor space allows a parallel approach. OR They are not between 15" and 48" AFF when the clear floor space allows only a forward approach.	<b>1991 ADAAG</b> 4.1.3(13); 4.27.3; 4.2.5; 4.2.6 ; Fig. 5; Fig. 6 <b>2004 ADAAG</b> - <b>2007 CBC</b> 1117B.6(3); 1118.5; 1118.6; Fig. 11B-5C; Fig. 11B-5D <b>Other</b> -
Existing Condition: 102" to pull screen.

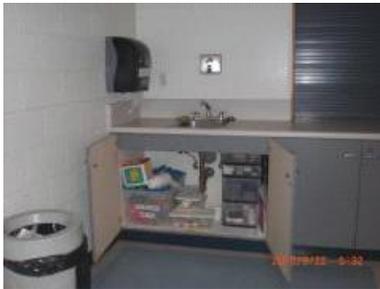
<b>Field Condition</b>	
16.84A - Paper Towel Dispenser - Operating Height - Mounting height of paper towel dispenser's highest operable part exceeds 40" AFF. (Where provided, ADA Standards require at least one paper towel dispenser to be accessible with the highest operable part placed within at least one of the reach ranges specified in 4.2.5 and 4.2.6; where provided, CBC Standards require at least one paper towel dispenser to be accessible with the highest operable part no higher than 40" AFF.)	<b>1991 ADAAG</b> 4.22.7; 4.27.3; 4.2.5; 4.2.6 <b>2004 ADAAG</b> 308; 309 <b>2007 CBC</b> 1115B.8.3 <b>Other</b> -
Existing Condition: 49" high.

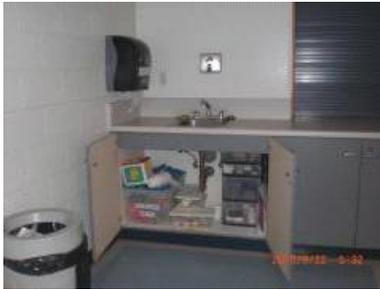
**Location:** Classroom **Photo #** 104

<b>Field Condition</b>	
14.36A - Counter Height - Where provided in public or common use areas, countertops are not between 28" - 34" high. (Common use areas are those interior and exterior rooms, spaces, or elements that are made available for the use of a restricted group of people (for example, the occupants of an office building, or the guests of such occupants).	<b>1991 ADAAG</b> 4.32.4  <b>2004 ADAAG</b> 902.3  <b>2007 CBC</b> 1122B.4  <b>Other</b> -
Existing Condition: 36" high.

<b>Corrective Action</b>
480A - New Counter Top and Sink - Remove existing cabinetry, and provide new counter at 34" above the finished floor. Remove and replace sink and faucet with new accessible sink and faucet. Provide accessible knee clearance (i.e. at least 27" high, 30" wide, and 19" deep) under the sink.
Additional Comments:

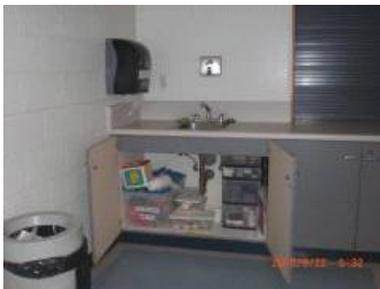
<b>Field Condition</b>	
14.29C - Counter - Knee Space Depth - Where seating for persons in wheelchairs is provided at table or counter, knee space is less than 19" deep.	<b>1991 ADAAG</b> 4.32.3  <b>2004 ADAAG</b> 306.3.2; Fig. 306.3  <b>2007 CBC</b> 1122B.3; Fig. 11B-13  <b>Other</b> -
Existing Condition: No knee space.

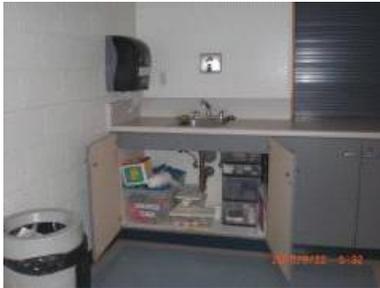
**Location:** Classroom      **Photo #** 104

<b>Field Condition</b>									
16.84C - Soap Dispenser - Operating Height - Mounting height of soap dispenser's highest operable part exceeds 40" AFF. (Where provided, ADA Standards require at least one soap dispenser to be accessible with the highest operable part placed within at least one of the reach ranges specified in 4.2.5 and 4.2.6; where provided, CBC Standards require at least one soap dispenser to be accessible with the highest operable part no higher than 40" AFF.)

<b>1991 ADAAG</b>	4.22.7; 4.27.3; 4.2.5; 4.2.6	<b>2004 ADAAG</b>	308; 309	<b>2007 CBC</b>	1115B.8.3	<b>Other</b>	-
<b>1991 ADAAG</b>	4.22.7; 4.27.3; 4.2.5; 4.2.6								
<b>2004 ADAAG</b>	308; 309								
<b>2007 CBC</b>	1115B.8.3								
<b>Other</b>	-								
Existing Condition: 52" high.

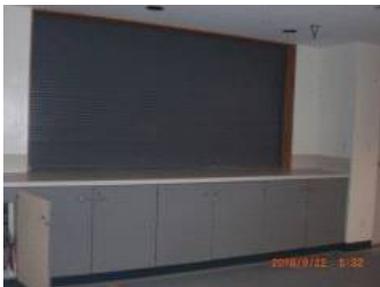
<b>Field Condition</b>									
14.28 - Fixed/Built-in Seating, Tables or Counters - At fixed or built-in seating, tables, or counters in public or common employee areas, less than 5% of the provided seating spaces are wheelchair accessible and have a 30" by 48" clear space which overlaps an accessible route of travel. (Wheelchair accessible seating spaces are between 28" - 34" high and with knee space measuring at least 27" high, 30" wide, and 19" deep.) (These elements include study carrels and student laboratory stations.)

<b>1991 ADAAG</b>	4.1.3(18); 4.32.1; 4.32.4	<b>2004 ADAAG</b>	226.1; Advisory 226.1; 305; 306; 902.2	<b>2007 CBC</b>	1122B.1	<b>Other</b>	-
<b>1991 ADAAG</b>	4.1.3(18); 4.32.1; 4.32.4								
<b>2004 ADAAG</b>	226.1; Advisory 226.1; 305; 306; 902.2								
<b>2007 CBC</b>	1122B.1								
<b>Other</b>	-								
Existing Condition: 36" high.

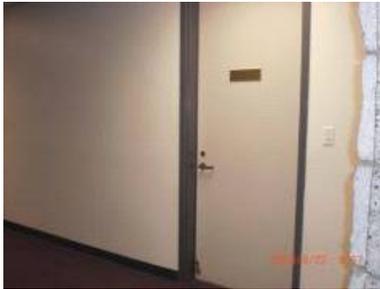
Location: Classroom Photo # 110

Field Condition	
11.15A - Kick Plate - Bottom 10" of door does not have a smooth, uninterrupted surface on the push side to allow the door to be opened by a wheelchair footrest without creating a trap or hazardous condition. (This requirement does not apply to automatic and sliding doors.)	1991 ADAAG -
Existing Condition: Door stop.	2004 ADAAG 404.2.10
	2007 CBC 1133B.2.6
	Other -

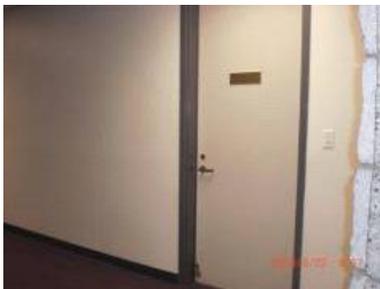
Location: Classroom Photo # 110

Field Condition	
11.17A - Recommendation: Providing Room/Space ID Sign - A sign designating the permanent room or space has not been provided.	1991 ADAAG 4.1.2(7)
Existing Condition:	2004 ADAAG 216.2; 703.1; 703.2; 703.5
	2007 CBC 1117B.5.1 item 1
	Other -

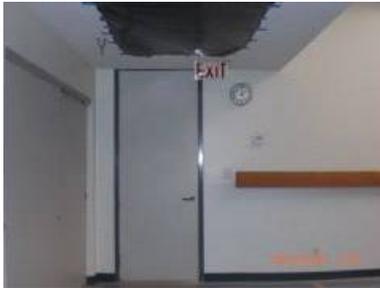
11.21A - Required Exit Route Sign - At exit access door from an interior room or area that is required to have a visual exit sign, there is no tactile and CA Braille exit sign with the words "EXIT ROUTE" mounted on the wall adjacent to the latch side of the door. (Visual exit signs are required when two or more exits are required. Generally, all occupants shall have access to two exits from a floor (CBC Table 1019.1). Exceptions: a) Single story building with maximum occupant load of 49 and less than 75 ft travel distance to exit (CBC Table 1019.2), and b) Two story building with maximum occupant load of 30 occupants per floor and maximum travel distance of 75 ft to exit. (CBC Table 1019.2). Two exit access doors are required from an office tenant space when the occupant load exceeds 49.)

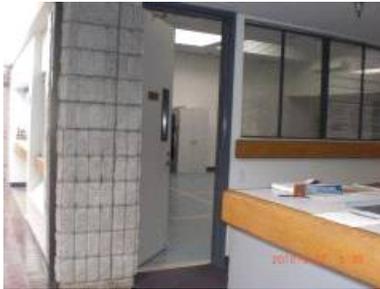
**Location:** Classroom  
**Photo #** 114

Field Condition	
11.13A - Door Operating Effort - The force required to operate door exceeds 5 lbs. (Fire doors may have up to 15 lbs to achieve positive latching).	1991 ADAAG 4.13.11
Existing Condition: 10 LBF.	2004 ADAAG 404.2.9
	2007 CBC 1133B.2.5
	Other -

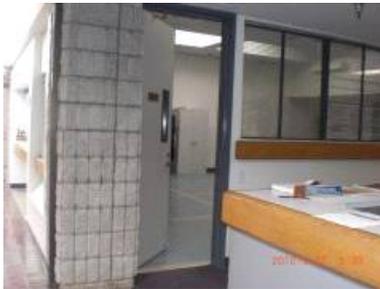
**Location:** Classroom  
**Photo #** 114

Field Condition	
11.15B_04AG - Vision Lights - Door, gate, or adjacent sidelight, containing one or more vision lights, does not include at least one vision light mounted with the bottom edge of the glazed panel at 43" max.. AFF. (Exception: Vision lights with the lowest part more than 66" AFF.)	1991 ADAAG -
Existing Condition: 48" high Vision light.	2004 ADAAG 404.2.11
	2007 CBC -
	Other -

Corrective Action
079 - Doors - Miscellaneous - See Additional Comments
Additional Comments: Replace door.

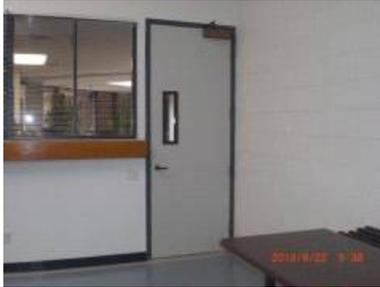
11.06A - Door Maneuvering Space - Door that is not automatic or power-assisted does not have compliant maneuvering space relative to the direction of approach as shown in CBC Fig. 11B-26. (Approach // Side // Width // Depth) (Front // Pull // D + 24" \* // 60") (Front // Push // D + 0" \*\* // 48") (Latch // Pull // D + 24" // 60") (Latch // Push // D + 24" // 44" \*\*\*\*) (Hinge // Pull // D + 36" // 60") (Hinge // Push // 54" \*\*\*\* // 44" \*\*\*\*\*) (\* D + 18" at interior doors.) (\*\* D + 12" if door has both a latch and a closer.) (\*\*\* 48" if door has closer.) (\*\*\*\* Measured from latch toward hinge.) (\*\*\*\*\* 48" if door has both a latch and a closer.)

Existing Condition: 2" pull side to wall board.

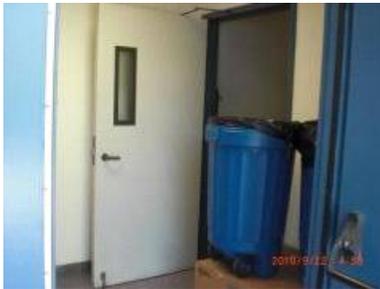
**Location:** Kitchen  
**Photo #** 119

Field Condition	
11.17A - Recommendation: Providing Room/Space ID Sign - A sign designating the permanent room or space has not been provided.	1991 ADAAG 4.1.2(7)
Existing Condition:	2004 ADAAG 216.2; 703.1; 703.2; 703.5
	2007 CBC 1117B.5.1 item 1
	Other -

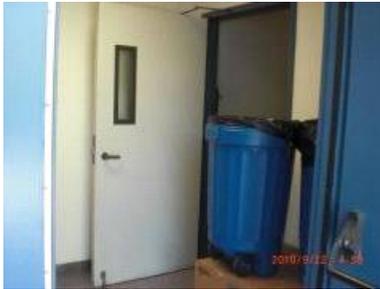
<b>Field Condition</b>	
11.15A - Kick Plate - Bottom 10" of door does not have a smooth, uninterrupted surface on the push side to allow the door to be opened by a wheelchair footrest without creating a trap or hazardous condition. (This requirement does not apply to automatic and sliding doors.)	<b>1991 ADAAG</b> -
Existing Condition: Door stop on kick plate.	<b>2004 ADAAG</b> 404.2.10
	<b>2007 CBC</b> 1133B.2.6
	<b>Other</b> -

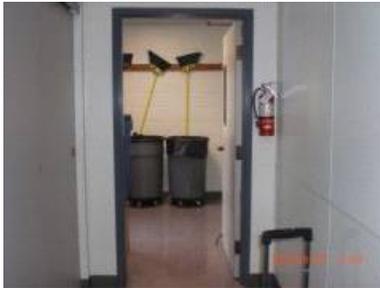
11.06A - Door Maneuvering Space - Door that is not automatic or power-assisted does not have compliant maneuvering space relative to the direction of approach as shown in CBC Fig. 11B-26. (Approach // Side // Width // Depth) (Front // Pull // D + 24" \* // 60") (Front // Push // D + 0" \*\* // 48") (Latch // Pull // D + 24" // 60") (Latch // Push // D + 24" // 44" \*\*\*) (Hinge // Pull // D + 36" // 60") (Hinge // Push // 54" \*\*\*\* // 44" \*\*\*\*\*) (\* D + 18" at interior doors.) (\*\* D + 12" if door has both a latch and a closer.) (\*\*\*) 48" if door has closer.) (\*\*\*\* Measured from latch toward hinge.) (\*\*\*\*\* 48" if door has both a latch and a closer.)

Existing Condition: 10" push side.

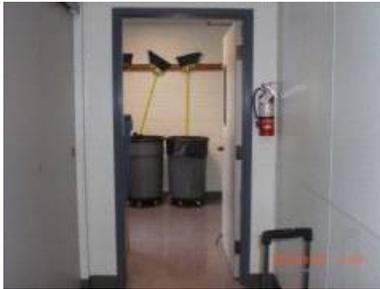
**Location:** Kitchen **Photo #** 124

20.16B - Surface-Mounted Fire Extinguisher - Mounting Height - Where fire extinguishers are surface-mounted, mounting height of the extinguisher is not compliant. (Compliant surface-mounted extinguisher is 48" AFF maximum, as measured to the highest operable part, or in existing buildings, when the extinguisher is 54" AFF and parallel approach is provided)

Existing Condition: 60" high.

388D - Relocate Fire Extinguisher - Relocate existing fire extinguisher. Repair and refinish.

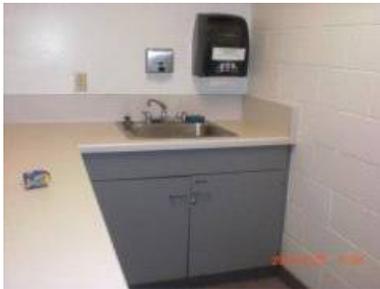
14.36B - Kitchen Counter/Sink Height - Where provided in public or common use areas, countertops and sinks are not mounted at 34" AFF. max..(Common use areas are those interior and exterior rooms, spaces, or elements that are made available for the use of a restricted group of people (for example, the occupants of an office building, or the guests of such occupants).

Existing Condition: No knee space.

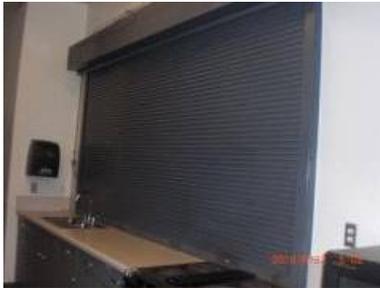
Location: Kitchen Photo # 125

<b>Field Condition</b>									
14.36A - Counter Height - Where provided in public or common use areas, countertops are not between 28" - 34" high. (Common use areas are those interior and exterior rooms, spaces, or elements that are made available for the use of a restricted group of people (for example, the occupants of an office building, or the guests of such occupants).  Existing Condition: 36" high Counter.

<b>Corrective Action</b>
480A - New Counter Top and Sink - Remove existing cabinetry, and provide new counter at 34" above the finished floor. Remove and replace sink and faucet with new accessible sink and faucet. Provide accessible knee clearance (i.e. at least 27" high, 30" wide, and 19" deep) under the sink.  Additional Comments:

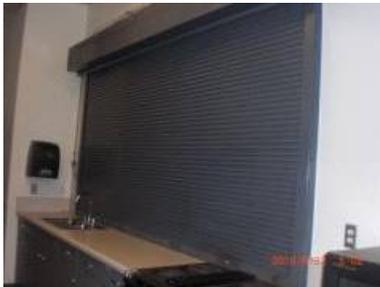
Location: Kitchen Photo # 125

<b>Field Condition</b>									
16.84A - Paper Towel Dispenser - Operating Height - Mounting height of paper towel dispenser's highest operable part exceeds 40" AFF. (Where provided, ADA Standards require at least one paper towel dispenser to be accessible with the highest operable part placed within at least one of the reach ranges specified in 4.2.5 and 4.2.6; where provided, CBC Standards require at least one paper towel dispenser to be accessible with the highest operable part no higher than 40" AFF.)  Existing Condition: 55" high.

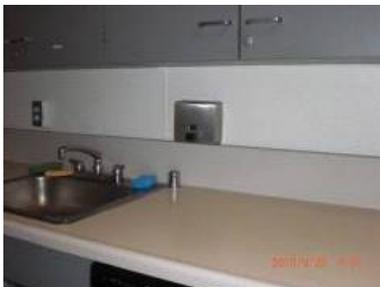
<b>Field Condition</b>									
16.84C - Soap Dispenser - Operating Height - Mounting height of soap dispenser's highest operable part exceeds 40" AFF. (Where provided, ADA Standards require at least one soap dispenser to be accessible with the highest operable part placed within at least one of the reach ranges specified in 4.2.5 and 4.2.6; where provided, CBC Standards require at least one soap dispenser to be accessible with the highest operable part no higher than 40" AFF.)

1991 ADAAG	4.22.7; 4.27.3; 4.2.5; 4.2.6	2004 ADAAG	308; 309	2007 CBC	1115B.8.3	Other	-
1991 ADAAG	4.22.7; 4.27.3; 4.2.5; 4.2.6								
2004 ADAAG	308; 309								
2007 CBC	1115B.8.3								
Other	-								
Existing Condition: 42" high.

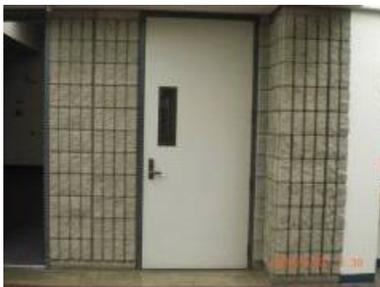
**Location:** Classroom  
**Photo #** 131

<b>Field Condition</b>	
11.13A - Door Operating Effort - The force required to operate door exceeds 5 lbs. (Fire doors may have up to 15 lbs to achieve positive latching).	1991 ADAAG 4.13.11
Existing Condition: 10 LBF.	2004 ADAAG 404.2.9
	2007 CBC 1133B.2.5
	Other -

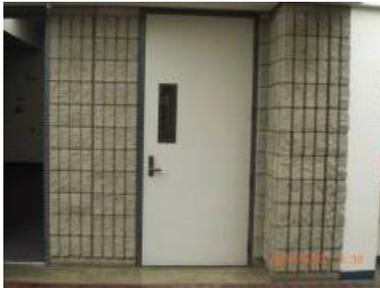
**Location:** Classroom  
**Photo #** 131

11.17A - Recommendation: Providing Room/Space ID Sign - A sign designating the permanent room or space has not been provided.

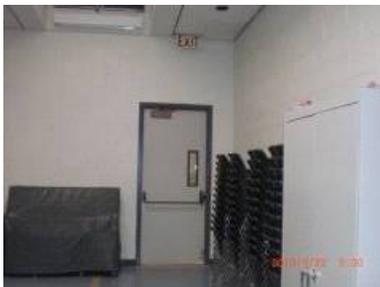
**Location:** Classroom  
**Photo #** 133

11.15A - Kick Plate - Bottom 10" of door does not have a smooth, uninterrupted surface on the push side to allow the door to be opened by a wheelchair footrest without creating a trap or hazardous condition. (This requirement does not apply to automatic and sliding doors.)

Existing Condition: Door stop.

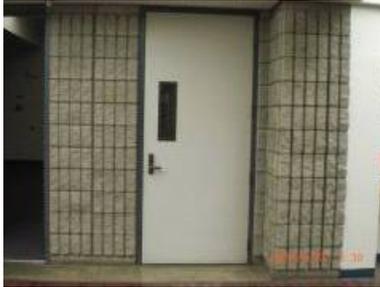
Field Condition	
11.15B_04AG - Vision Lights - Door, gate, or adjacent sidelight, containing one or more vision lights, does not include at least one vision light mounted with the bottom edge of the glazed panel at 43" max.. AFF. (Exception: Vision lights with the lowest part more than 66" AFF.)	1991 ADAAG -
Existing Condition: 48" high Vision light.	2004 ADAAG 404.2.11
	2007 CBC -
	Other -

Corrective Action
079 - Doors - Miscellaneous - See Additional Comments
Additional Comments: Replace door.

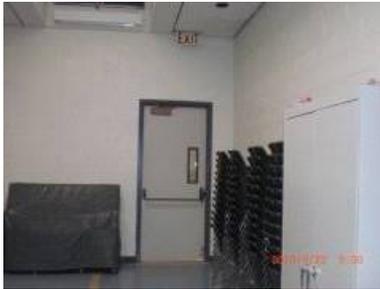
11.21A - Required Exit Route Sign - At exit access door from an interior room or area that is required to have a visual exit sign, there is no tactile and CA Braille exit sign with the words "EXIT ROUTE" mounted on the wall adjacent to the latch side of the door. (Visual exit signs are required when two or more exits are required. Generally, all occupants shall have access to two exits from a floor (CBC Table 1019.1). Exceptions: a) Single story building with maximum occupant load of 49 and less than 75 ft travel distance to exit (CBC Table 1019.2), and b) Two story building with maximum occupant load of 30 occupants per floor and maximum travel distance of 75 ft to exit. (CBC Table 1019.2). Two exit access doors are required from an office tenant space when the occupant load exceeds 49.)

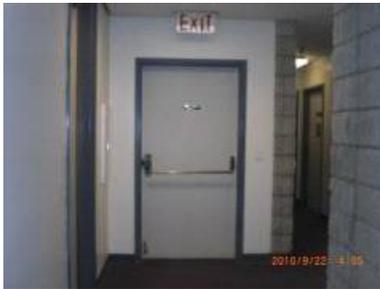
**Location:** Hallway  
**Photo #** 137

Field Condition	
11.13A - Door Operating Effort - The force required to operate door exceeds 5 lbs. (Fire doors may have up to 15 lbs to achieve positive latching).	1991 ADAAG 4.13.11
Existing Condition: 7 LBF.	2004 ADAAG 404.2.9
	2007 CBC 1133B.2.5
	Other -

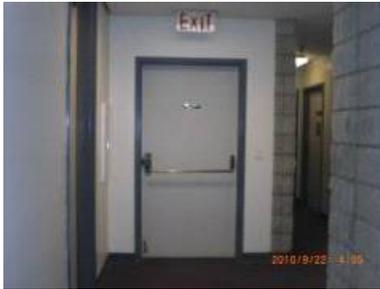
**Location:** Hallway  
**Photo #** 137

Field Condition	
11.13B - Hardware Operating Effort - The force required to activate handles, pulls, latches, locks, and other operable parts of door exceeds 5 lbs.	1991 ADAAG 4.27.4
Existing Condition: 7 LBF.	2004 ADAAG 309.4
	2007 CBC 1117B.6 item 4
	Other -

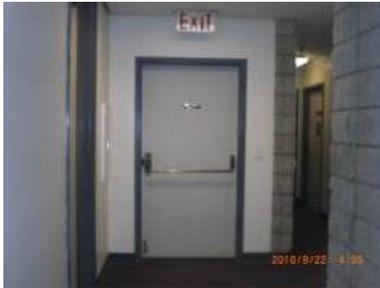
11.21A - Required Exit Route Sign - At exit access door from an interior room or area that is required to have a visual exit sign, there is no tactile and CA Braille exit sign with the words "EXIT ROUTE" mounted on the wall adjacent to the latch side of the door. (Visual exit signs are required when two or more exits are required. Generally, all occupants shall have access to two exits from a floor (CBC Table 1019.1). Exceptions: a) Single story building with maximum occupant load of 49 and less than 75 ft travel distance to exit (CBC Table 1019.2), and b) Two story building with maximum occupant load of 30 occupants per floor and maximum travel distance of 75 ft to exit. (CBC Table 1019.2). Two exit access doors are required from an office tenant space when the occupant load exceeds 49.)

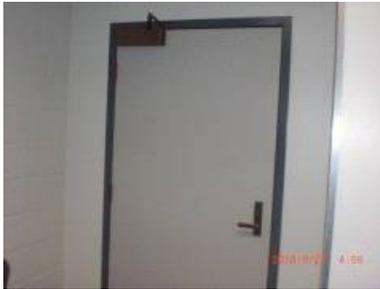
11.06A - Door Maneuvering Space - Door that is not automatic or power-assisted does not have compliant maneuvering space relative to the direction of approach as shown in CBC Fig. 11B-26. (Approach // Side // Width // Depth) (Front // Pull // D + 24" \* // 60") (Front // Push // D + 0" \*\* // 48") (Latch // Pull // D + 24" // 60") (Latch // Push // D + 24" // 44" \*\*\*) (Hinge // Pull // D + 36" // 60") (Hinge // Push // 54" \*\*\*\* // 44" \*\*\*\*\*) (\* D + 18" at interior doors.) (\*\* D + 12" if door has both a latch and a closer.) (\*\*\*) 48" if door has closer.) (\*\*\*\* Measured from latch toward hinge.) (\*\*\*\*\* 48" if door has both a latch and a closer.)

Existing Condition: 12 1/4" pull side.

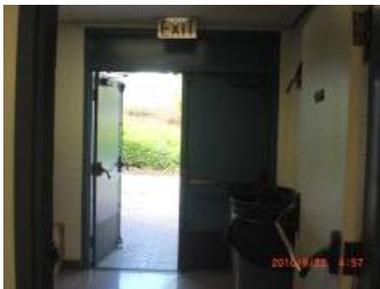
**Location:** Hallway  
**Photo #** 143

<b>Field Condition</b>	
10.11A - Door Operating Effort - The force required to operate door exceeds 5 lbs. (Fire doors may have up to 15 lbs to achieve positive latching).	<b>1991 ADAAG</b> 4.13.11
Existing Condition: 12 LBF.	<b>2004 ADAAG</b> 404.2.9
	<b>2007 CBC</b> 1133B.2.5
	<b>Other</b> -

<b>Corrective Action</b>
072B - Replace Closer - Replace door closer.
Additional Comments:

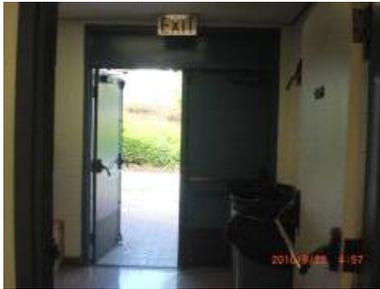
**Location:** Hallway  
**Photo #** 143

Field Condition	
10.11B - Hardware Operating Effort - The force required to activate handles, pulls, latches, locks, and other operable parts of door exceeds 5 lbs.	1991 ADAAG 4.27.4
Existing Condition: 10 LBF.	2004 ADAAG 309.4
	2007 CBC 1117B.6 item 4
	Other -

Corrective Action
072D - Replace Hardware with Panic Device - Replace door hardware with panic device.
Additional Comments:

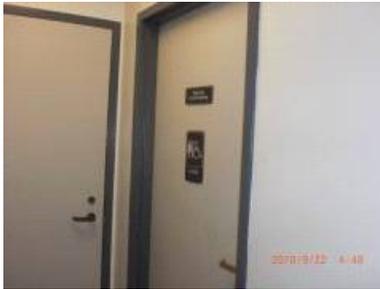
Location: Women's Restroom      Photo # 148

Field Condition	
16.11A - Door Operating Effort - The force required to operate door exceeds 5 lbs. (Fire doors may have up to 15 lbs to achieve positive latching).	1991 ADAAG 4.13.11
Existing Condition: 9 LBF.	2004 ADAAG 404.2.9
	2007 CBC 1133B.2.5
	Other -

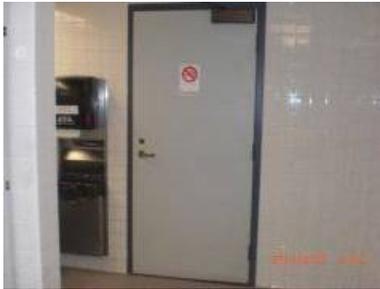
16.09A - Door Maneuvering Space - Door that is not automatic or power-assisted does not have compliant maneuvering space relative to the direction of approach as shown in CBC Fig. 11B-26. (Approach // Side // Width // Depth) (Front // Pull // D + 24" \* // 60") (Front // Push // D + 0" \*\* // 48") (Latch // Pull // D + 24" // 60") (Latch // Push // D + 24" // 44" \*\*\*) (Hinge // Pull // D + 36" // 60") (Hinge // Push // 54" \*\*\*\* // 44" \*\*\*\*\*) (\* D + 18" at interior doors.) (\*\* D + 12" if door has both a latch and a closer.) (\*\*\*) 48" if door has closer.) (\*\*\*\* Measured from latch toward hinge.) (\*\*\*\*\* 48" if door has both a latch and a closer.)

Existing Condition: 42" landing on push/pull side, PTD encroaches.

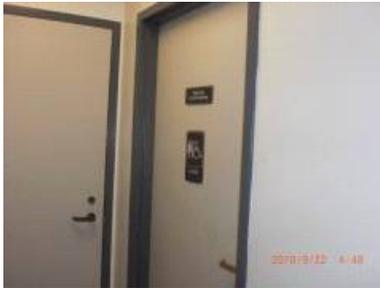
Location: Women's Restroom  
Photo #: 148

16.13B - Women's RR Geometric Symbol Signage - Circle - Doorway leading to a women's toilet room is not identified by a circle, 1/4" thick and 12" in diameter. OR Circle is provided, however it is accompanied by words in raised characters and Braille. (ADA and CBC Standards require a separate sign with raised characters and Braille mounted on the wall adjacent to the latch side of the door.)

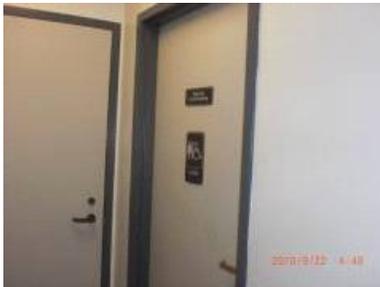
Location: Women's Restroom  
Photo #: 148

16.15B - Room/Space Identification Signs (Visual/Tactile Signs) - Sign designating the permanent room or space does not comply with ADAAG and CBC requirements for tactile signs.

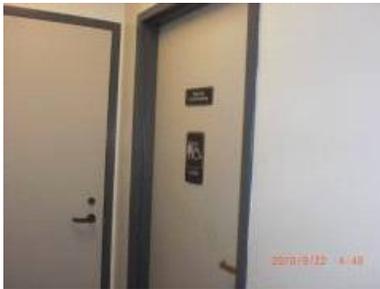
Location: Women's Restroom Photo #: 148

16.19B - Mounting Height (Visual/Tactile Signs) - Sign is not mounted at 60" o.c. AFF to the centerline of the sign. (If the sign contains pictorial symbols (pictograms) or other non-tactile information, mounting height is measured to the centerline of the tactile characters / Braille portion of the sign.)

Existing Condition: 50" high.

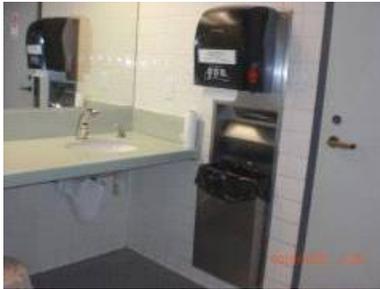
Location: Women's Restroom Photo # 154

<b>Field Condition</b>	
16.84A - Paper Towel Dispenser - Operating Height - Mounting height of paper towel dispenser's highest operable part exceeds 40" AFF. (Where provided, ADA Standards require at least one paper towel dispenser to be accessible with the highest operable part placed within at least one of the reach ranges specified in 4.2.5 and 4.2.6; where provided, CBC Standards require at least one paper towel dispenser to be accessible with the highest operable part no higher than 40" AFF.)	1991 ADAAG 4.22.7; 4.27.3; 4.2.5; 4.2.6
Existing Condition: 48" high.	2004 ADAAG 308; 309
	2007 CBC 1115B.8.3
	Other -

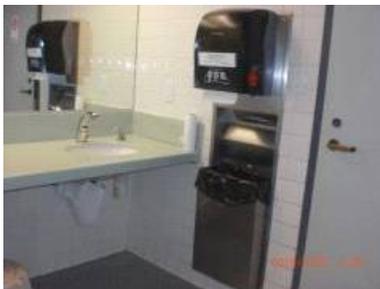
Location: Women's Restroom Photo # 154

<b>Field Condition</b>	
16.73 - Lavatory Knee Clearance - Lavatory does not provide accessible knee clearance (i.e. at least 27" clearance from the floor to the underside of the lavatory, extending 8" min.. measured from the front edge underneath the lavatory back towards the wall).	1991 ADAAG 4.19.2; Fig. 31
Existing Condition: 25 1/2" high.	2004 ADAAG 306.3; Fig. 306.3
	2007 CBC 1115B.4.3(2); Fig 11B-1D
	Other -

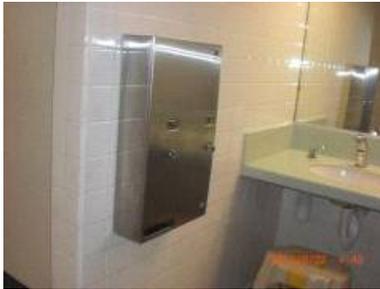
**Location:** Women's Restroom  
**Photo #** 157

<b>Field Condition</b>	
16.86A - Dispenser or Control - Single-Action Operation - The dispenser or control cannot be operated with one hand or without tight grasping, pinching, or twisting of the wrist. (Where provided, at least one dispenser or control of each type shall be accessible.)	1991 ADAAG 4.27.4
Existing Condition: Non-compliant control for SND.	2004 ADAAG 309.4
	2007 CBC 1117B.6 item 4
	Other -

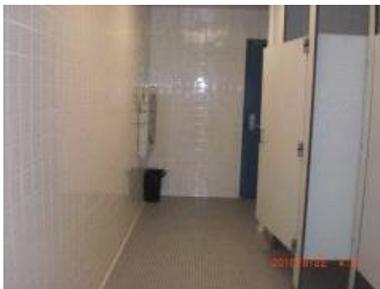
<b>Field Condition</b>	
20.02 - Toilet, Bathroom, or Shower Room - Visual Alarms - Visual alarms are not provided at public or common use toilet, bathroom, or shower room.	1991 ADAAG 4.28.1
Existing Condition:	2004 ADAAG 215.1; Advisory 215.1; 702.1
	2007 CBC 907.9.1.1
	Other -

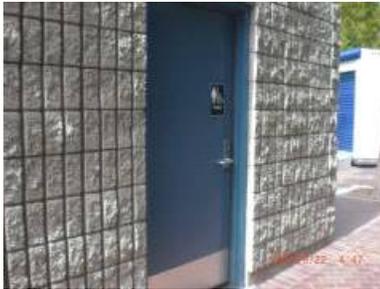
**Location:** Women's Restroom  
**Photo #** 160

Field Condition	
16.11A - Door Operating Effort - The force required to operate door exceeds 5 lbs. (Fire doors may have up to 15 lbs to achieve positive latching).	1991 ADAAG 4.13.11
Existing Condition: 15 LBF.	2004 ADAAG 404.2.9
	2007 CBC 1133B.2.5
	Other -

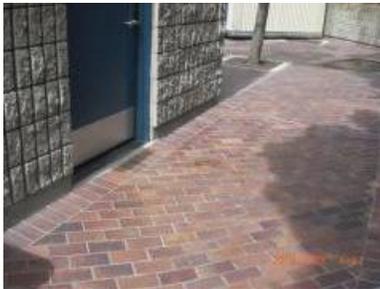
**Location:** Women's Restroom  
**Photo #** 161

Field Condition	
16.12 - Other Door Requirements - Door does not comply with all applicable ADAAG and CBC accessibility requirements.	1991 ADAAG 4.13
Existing Condition: 7.2% RS at door landing.	2004 ADAAG 404.1; Advisory 404.1
	2007 CBC 1133B.2
	Other -

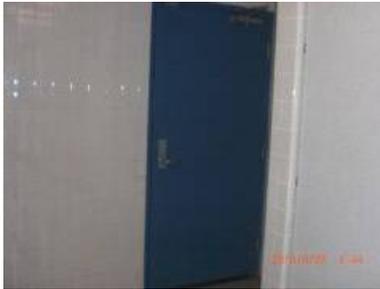
16.09A - Door Maneuvering Space - Door that is not automatic or power-assisted does not have compliant maneuvering space relative to the direction of approach as shown in CBC Fig. 11B-26. (Approach // Side // Width // Depth) (Front // Pull // D + 24" \* // 60") (Front // Push // D + 0" \*\* // 48") (Latch // Pull // D + 24" // 60") (Latch // Push // D + 24" // 44" \*\*\*) (Hinge // Pull // D + 36" // 60") (Hinge // Push // 54" \*\*\*\* // 44" \*\*\*\*\*) (\* D + 18" at interior doors.) (\*\* D + 12" if door has both a latch and a closer.) (\*\*\*) 48" if door has closer.) (\*\*\*\* Measured from latch toward hinge.) (\*\*\*\*\* 48" if door has both a latch and a closer.)

Existing Condition: 49" landing on pull side.

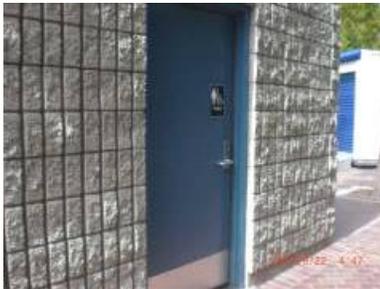
<b>Field Condition</b>									
16.13B - Women's RR Geometric Symbol Signage - Circle - Doorway leading to a women's toilet room is not identified by a circle, 1/4" thick and 12" in diameter. OR Circle is provided, however it is accompanied by words in raised characters and Braille. (ADA and CBC Standards require a separate sign with raised characters and Braille mounted on the wall adjacent to the latch side of the door.)

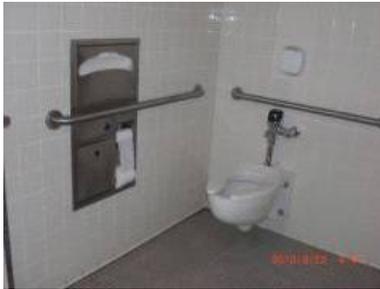
**Location:** Women's Restroom  
**Photo #** 167

<b>Field Condition</b>	
16.55A - Side Grab Bar Height - Side grab bar is not centered at 33" AFF. (ADA Standards require side grab bars to be centered from 33" to 36" AFF; CBC Standards require side grab bars to be centered at 33" AFF.)	<b>1991 ADAAG</b> 4.17.6; Figs. 29 & 30  <b>2004 ADAAG</b> 604.5; Advisory 604.5; 604.5.2; Fig. 604.5.2; 609.4  <b>2007 CBC</b> 1115B.4.1(3.1); Fig. 11B-1A  <b>Other</b> -
Existing Condition: 33 1/4" high to center line of both grab bars.

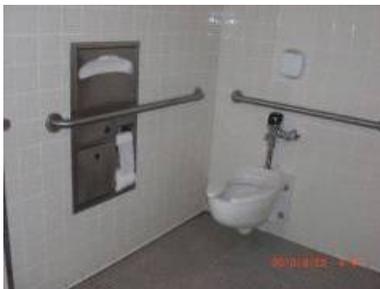
**Location:** Women's Restroom  
**Photo #** 167

<b>Field Condition</b>	
16.47A - WC Location from Sidewall - The centerline of the WC is not 18" absolute from a wall or partition.	<b>1991 ADAAG</b> 4.22.4  <b>2004 ADAAG</b> -  <b>2007 CBC</b> 1115B.4.1(1)  <b>Other</b> -
Existing Condition: 18 1/4" from sidewall.

<b>Corrective Action</b>
319C - Water Closet - New Location - Replace existing water closet with compliant model in new location.
Additional Comments:

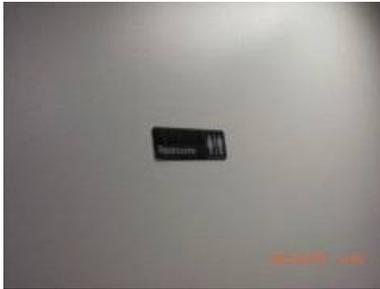
**Location:** Women's Restroom  
**Photo #** 171

<b>Field Condition</b>	
19.14A - Raised Characters and Braille (Visual/Tactile Signs) - The raised characters on this sign are not accompanied by California Grade 2 Braille (i.e., the dots within each cell are domed and spaced 1/10" o.c.)	1991 ADAAG 4.30.4
Existing Condition: None provided.	2004 ADAAG 703.3.1; Fig. 703.3.1
	2007 CBC 1117B.5.5 item 1; 1117B.5.6
	Other -

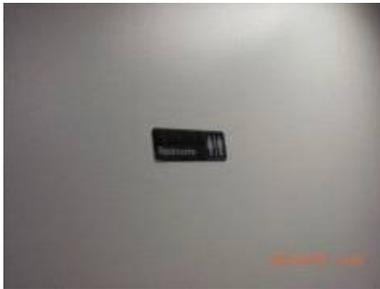
<b>Field Condition</b>	
19.20 - Other - Signage - See Additional Comments	1991 ADAAG -
Existing Condition: Non-compliant restroom sign provided.	2004 ADAAG -
	2007 CBC -
	Other -

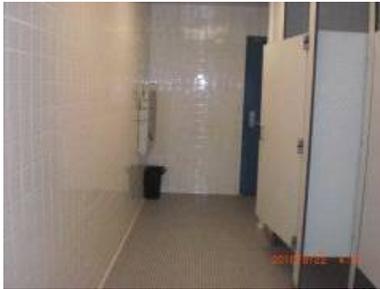
16.88 - Other - Toilet Facilities - See Additional Comments

Existing Condition: No exit sign provided.

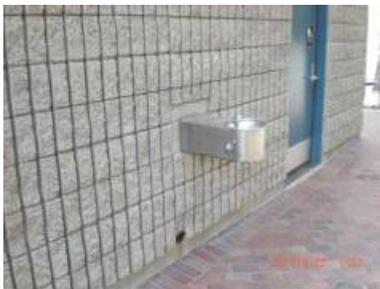
<b>Field Condition</b>	
05.01A - "Hi" Drinking Fountain Requirement - Where there is only one drinking fountain area on a floor (e.g., an area with a drinking fountain or separate drinking fountains), it is accessible to wheelchair users and not to persons who have difficulty bending or stooping (i.e., the required accessibility for persons who have difficulty bending or stooping on each floor has not been provided).	<b>1991 ADAAG</b> 4.1.3(10)(a); 4.15.1
Existing Condition:	<b>2004 ADAAG</b> 211.1; 211.2
	<b>2007 CBC</b> 1115B.4.6 item 1
	<b>Other</b> -

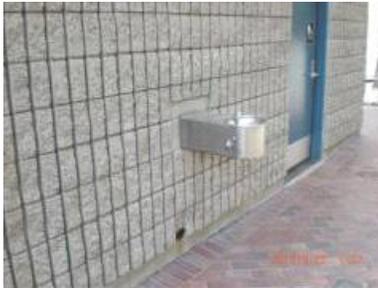
**Location:** Drinking Fountain **Photo #** 176

<b>Field Condition</b>	
05.08A - Wall-Mounted Protruding Objects - Wall mounted drinking fountain with leading edges between 27" and 80" from the floor projects more than 4" into the circulation path.	<b>1991 ADAAG</b> 4.4.1
Existing Condition:	<b>2004 ADAAG</b> 204; 307.2; Advisory 307.2; Fig.
	<b>2007 CBC</b> 1133B.8.6.1
	<b>Other</b> -

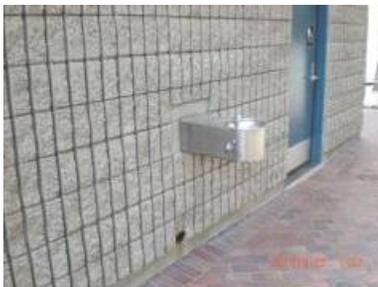
<b>Field Condition</b>	
05.09A - Spout Height for Wheelchair Users - The spout outlet is higher than 36" from the floor.	<b>1991 ADAAG</b> 4.15.2
Existing Condition: 40" high.	<b>2004 ADAAG</b> 602.4; 602.6; Advisory 602.6
	<b>2007 CBC</b> 1115B.4.6 item 4
	<b>Other</b> -

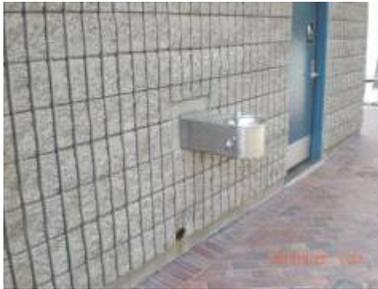
**Location:** Drinking Fountain  
**Photo #** 176

<b>Field Condition</b>	05.13 - Operation - The controls are not compliant.(Accessible controls shall be operable with one hand, and without tight grasping, pinching, or twisting of the wrist, and the force to operate the controls shall be no greater than 5 lbs.)	<b>1991 ADAAG</b> 4.27.4
	Existing Condition: 7 LBF.	<b>2004 ADAAG</b> 602.3; 309.4
		<b>2007 CBC</b> 1115B.4.6 item 4
		<b>Other</b> -

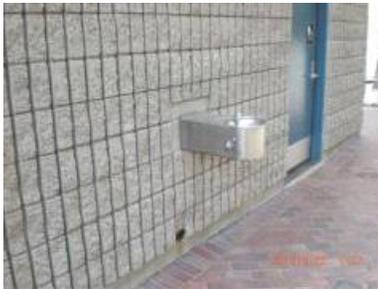
**Location:** Drinking Fountain  
**Photo #** 176

<b>Field Condition</b>	05.16 - Other - Drinking Fountains - See Additional Comments	<b>1991 ADAAG</b> -
	Existing Condition: 9.6% RS at drinking fountain.	<b>2004 ADAAG</b> -
		<b>2007 CBC</b> -
		<b>Other</b> -

<b>Corrective Action</b>	006 - Concrete Walk - Remove non-compliant pavement and replace with new concrete (area as shown on the drawings). The walkway slope shall not exceed 5% along the POT and cross slope shall not exceed 2%.
	Additional Comments:

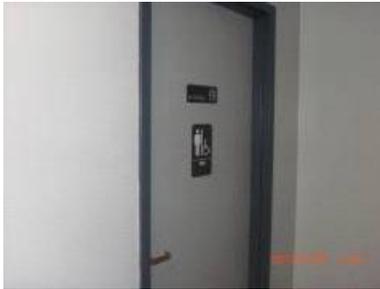
Field Condition	
16.11A - Door Operating Effort - The force required to operate door exceeds 5 lbs. (Fire doors may have up to 15 lbs to achieve positive latching).	1991 ADAAG 4.13.11
Existing Condition: 10 LBF.	2004 ADAAG 404.2.9
	2007 CBC 1133B.2.5
	Other -

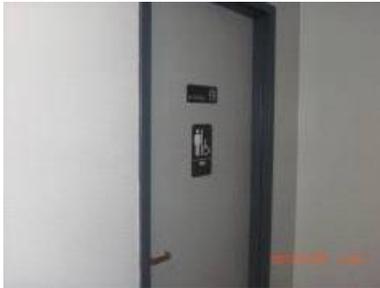
16.09A - Door Maneuvering Space - Door that is not automatic or power-assisted does not have compliant maneuvering space relative to the direction of approach as shown in CBC Fig. 11B-26. (Approach // Side // Width // Depth) (Front // Pull // D + 24" \* // 60") (Front // Push // D + 0" \*\* // 48") (Latch // Pull // D + 24" // 60") (Latch // Push // D + 24" // 44" \*\*\*) (Hinge // Pull // D + 36" // 60") (Hinge // Push // 54" \*\*\*\* // 44" \*\*\*\*\*) (\* D + 18" at interior doors.) (\*\* D + 12" if door has both a latch and a closer.) (\*\*\*) 48" if door has closer.) (\*\*\*\* Measured from latch toward hinge.) (\*\*\*\*\* 48" if door has both a latch and a closer.)

Existing Condition: 42" door landing on push side.

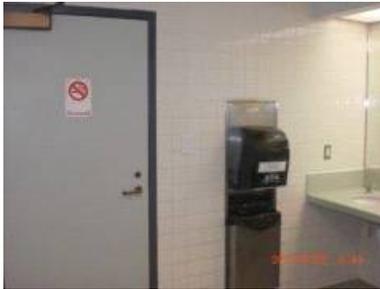
**Location:** Men's Restroom  
**Photo #** 183

Field Condition	
16.86A - Dispenser or Control - Single-Action Operation - The dispenser or control cannot be operated with one hand or without tight grasping, pinching, or twisting of the wrist. (Where provided, at least one dispenser or control of each type shall be accessible.)	1991 ADAAG 4.27.4
Existing Condition: Twist type control for PTD.	2004 ADAAG 309.4
	2007 CBC 1117B.6 item 4
	Other -

Corrective Action	
337 - Toilet and Bathing Rooms - Miscellaneous - See Additional Comments	
Additional Comments: Replace PTD.

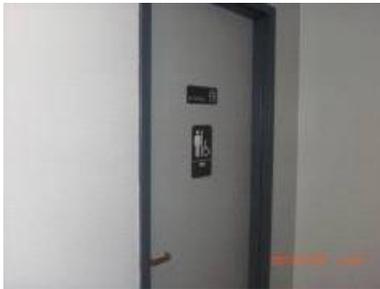
**Location:** Men's Restroom  
**Photo #** 181

Field Condition	
16.13A - Men's RR Geometric Symbol Signage - Triangle - Doorway leading to a men's toilet room is not identified by an equilateral triangle 1/4" thick with edges 12" long. OR Equilateral triangle is provided, however it is accompanied by words in raised characters and Braille. (ADA and CBC Standards require a separate sign with raised characters and Braille mounted on the wall adjacent to the latch side of the door.)	1991 ADAAG -
Existing Condition:	2004 ADAAG -
	2007 CBC 1115B.6
	Other -

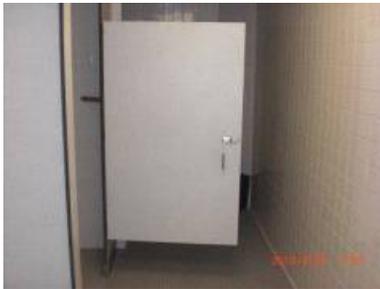
16.35C - Out-Swinging Stall Door - Approach - Where the stall door swings out, the aisle approaching the stall is less than 60" deep.

Existing Condition: 52" deep door landing at stall door.

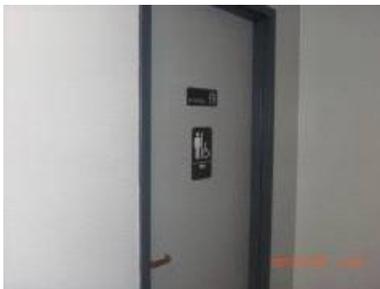
16.19B - Mounting Height (Visual/Tactile Signs) - Sign is not mounted at 60" o.c. AFF to the centerline of the sign. (If the sign contains pictorial symbols (pictograms) or other non-tactile information, mounting height is measured to the centerline of the tactile characters / Braille portion of the sign.)

Existing Condition: 50" high.

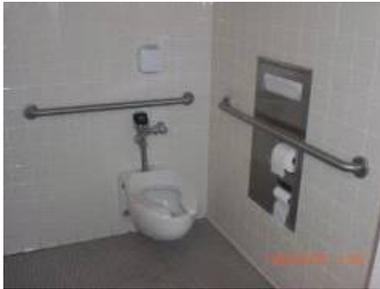
**Location:** Men's Restroom  
**Photo #** 189

Existing Condition: 33 1/4" high to center line of grab bars.

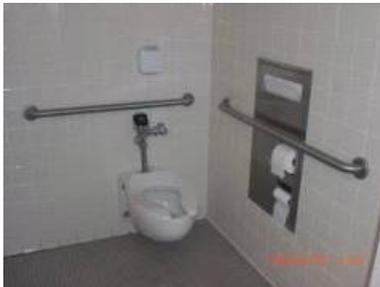
**Location:** Men's Restroom  
**Photo #** 189

Existing Condition: 41" high.

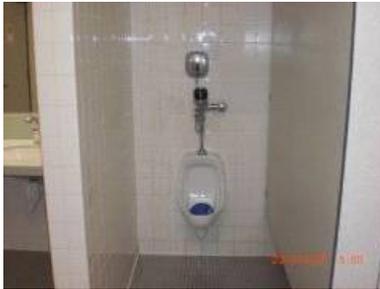
**Location:** Men's Restroom  
**Photo #** 191

Existing Condition: 34" wide.

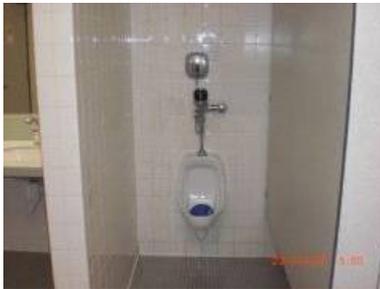
**Location:** Men's Restroom  
**Photo #** 191

Existing Condition: 17 1/4" high.

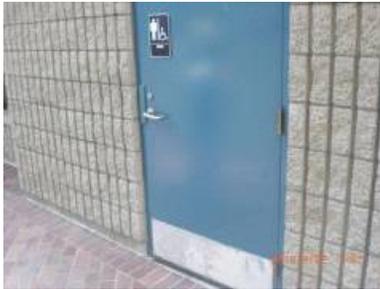
**Location:** Men's Restroom **Photo #** 193

<b>Field Condition</b>	
16.12 - Other Door Requirements - Door does not comply with all applicable ADAAG and CBC accessibility requirements.	<b>1991 ADAAG</b> 4.13
Existing Condition: 5.5% RS at door landing.	<b>2004 ADAAG</b> 404.1; Advisory 404.1
	<b>2007 CBC</b> 1133B.2
	<b>Other</b> -

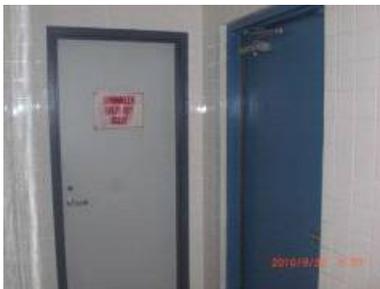
<b>Field Condition</b>	
16.11A - Door Operating Effort - The force required to operate door exceeds 5 lbs. (Fire doors may have up to 15 lbs to achieve positive latching).	<b>1991 ADAAG</b> 4.13.11
Existing Condition: 11 LBF.	<b>2004 ADAAG</b> 404.2.9
	<b>2007 CBC</b> 1133B.2.5
	<b>Other</b> -

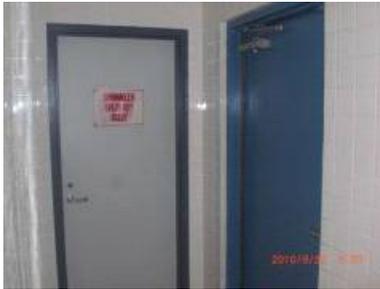
16.88 - Other - Toilet Facilities - See Additional Comments
