*City of Rancho Palos Verdes*  
**Rancho Palos Verdes ADA Assessment**  
**Facility Report with Photos**

**Reporting: 266 of 4367 Rcds**

**Facility ID: # 07 - Fred Hesse Jr. Community Park (Upper Part)**

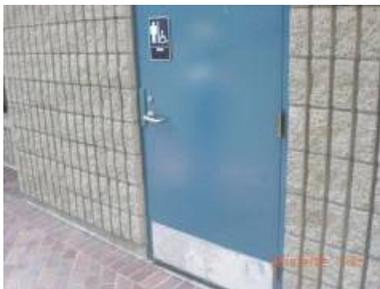
16.10 - Single-Action Hardware - Handles, locks, and latches or other operative devices are not operable with one hand. OR They are not operable without tight grasping, pinching, or twisting of the wrist. (U-shaped handles, levers, and push/pull type mechanisms are acceptable designs.)

Existing Condition: Twist type lock.

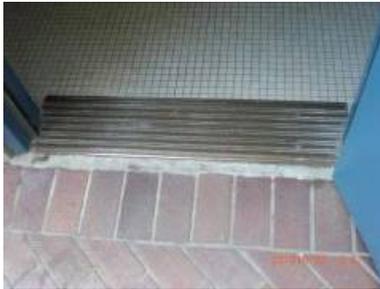
**Location:** Men's Restroom  
**Photo #** 197

<b>Field Condition</b>	
16.12 - Other Door Requirements - Door does not comply with all applicable ADAAG and CBC accessibility requirements.	1991 ADAAG 4.13
Existing Condition: 3/8" threshold.	2004 ADAAG 404.1; Advisory 404.1
	2007 CBC 1133B.2
	Other -

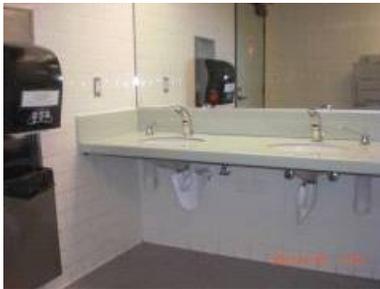
<b>Field Condition</b>	
16.73 - Lavatory Knee Clearance - Lavatory does not provide accessible knee clearance (i.e. at least 27" clearance from the floor to the underside of the lavatory, extending 8" min.. measured from the front edge underneath the lavatory back towards the wall).	1991 ADAAG 4.19.2; Fig. 31
Existing Condition: 25 1/2" high.	2004 ADAAG 306.3; Fig. 306.3
	2007 CBC 1115B.4.3(2); Fig 11B-1D
	Other -

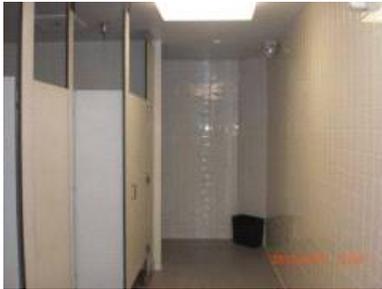
**Location:** Men's Restroom  
**Photo #** 199

Field Condition	
20.02 - Toilet, Bathroom, or Shower Room - Visual Alarms - Visual alarms are not provided at public or common use toilet, bathroom, or shower room.	1991 ADAAG 4.28.1
Existing Condition:	2004 ADAAG 215.1; Advisory 215.1; 702.1
	2007 CBC 907.9.1.1
	Other -

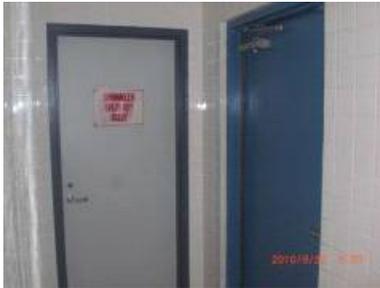
16.09A - Door Maneuvering Space - Door that is not automatic or power-assisted does not have compliant maneuvering space relative to the direction of approach as shown in CBC Fig. 11B-26. (Approach // Side // Width // Depth) (Front // Pull // D + 24" \* // 60") (Front // Push // D + 0" \*\* // 48") (Latch // Pull // D + 24" // 60") (Latch // Push // D + 24" // 44" \*\*\*) (Hinge // Pull // D + 36" // 60") (Hinge // Push // 54" \*\*\*\* // 44" \*\*\*\*\*) (\* D + 18" at interior doors.) (\*\* D + 12" if door has both a latch and a closer.) (\*\*\*) 48" if door has closer.) (\*\*\*\* Measured from latch toward hinge.) (\*\*\*\*\* 48" if door has both a latch and a closer.)

Existing Condition: 48" door landing on pull side.

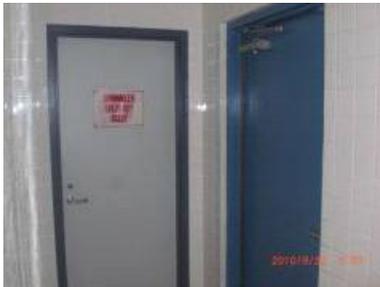
11.05A - Clear Opening - Single-Leaf Door - When the door is open 90 degrees, clear opening width is not at least 32" measured between the face of the door and the doorstop on the latch side.

Existing Condition: 30 1/2" wide.

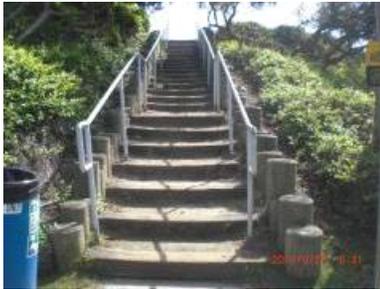
08.01B - Exterior Stairs - Public or common use exterior stair does not comply with accessibility requirements. (Stairs to floors or portions of floors not customarily occupied, including non-occupiable or employee spaces accessed only by ladders, catwalks, crawl spaces, very narrow passageways, and frequented only by service personnel for repair or maintenance purposes: such spaces as elevator pits and elevator penthouses, piping and equipment catwalks and machinery rooms need not be accessible with the exception of stair striping.)

Existing Condition: Handrail 1 3/4" in diameter and 39" high with no top/ bottom extensions. 2.7% CS at bottom landing. Uneven surface at treads, uneven riser height and tread depth, no color strip.

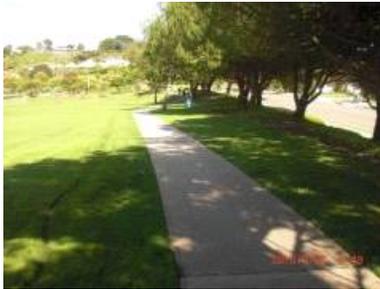
**Location:** Park Area      **Photo #** 207

<b>Field Condition</b>	
03B.09 - Cross Slope - Cross slope of the accessible route of travel exceeds 1:50. Existing Condition: 2.2% to 5.6% CS at concrete path.	<b>1991 ADAAG</b> 4.3.7  <b>2004 ADAAG</b> 403.3  <b>2007 CBC</b> 1133B.7.1.3  <b>Other</b> -

<b>Corrective Action</b>	
006 - Concrete Walk - Remove non-compliant pavement and replace with new concrete (area as shown on the drawings). The walkway slope shall not exceed 5% along the POT and cross slope shall not exceed 2%.	
Additional Comments:

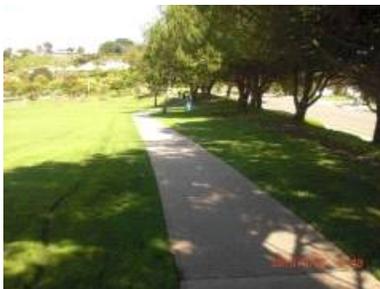
<b>Field Condition</b>	
03B.10 - Running Slope - Slope of the accessible route of travel exceeds 1:20. Existing Condition: 5.4% to 10.7% RS.	<b>1991 ADAAG</b> 4.3.7  <b>2004 ADAAG</b> 403.3  <b>2007 CBC</b> 1133B.7.3  <b>Other</b> -

<b>Corrective Action</b>	
006 - Concrete Walk - Remove non-compliant pavement and replace with new concrete (area as shown on the drawings). The walkway slope shall not exceed 5% along the POT and cross slope shall not exceed 2%.	
Additional Comments:

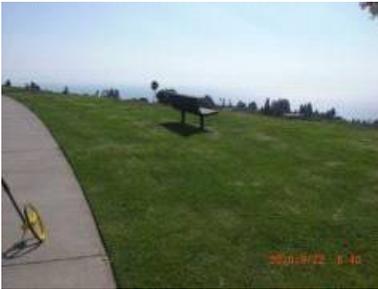
Field Condition	
30.12 - Fixed Bench - Fixed bench is not accessible for users with various types of disabilities.	1991 ADAAG -
Existing Condition: 3 benches, 0 accessible and not connecting path.	2004 ADAAG 903.1
	2007 CBC -
	Other 1999 ADAAG-16.12.2.1

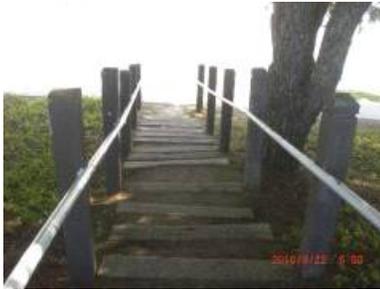
08.01B - Exterior Stairs - Public or common use exterior stair does not comply with accessibility requirements. (Stairs to floors or portions of floors not customarily occupied, including non-occupiable or employee spaces accessed only by ladders, catwalks, crawl spaces, very narrow passageways, and frequented only by service personnel for repair or maintenance purposes: such spaces as elevator pits and elevator penthouses, piping and equipment catwalks and machinery rooms need not be accessible with the exception of stair striping.)

Existing Condition: Handrail 2" in diameter and 26" high with no top/ bottom extensions. 4.6% CS at intermediate landing. Uneven surface at treads, uneven riser height and tread depth, no color strip.

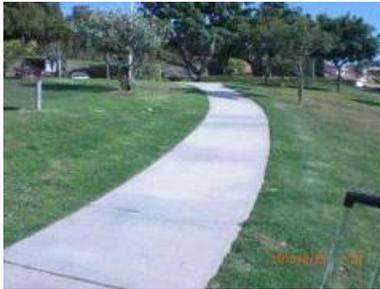
Location: Park Area Photo # 211

Field Condition	
07.16 - Handrails - Slope of the ramp exceeds 5%, and handrails are not provided on each side. (Per CBC 1133B.5.5.1, at exterior door landings, handrails are not required on ramps less than 6" high or 72" long. Handrails are not required on curb ramps or adjacent to fixed seating in assembly areas.)	1991 ADAAG 4.8.5
Existing Condition: None provided.	2004 ADAAG 405.8; 505.2
	2007 CBC 1133B.5.5.1
	Other -

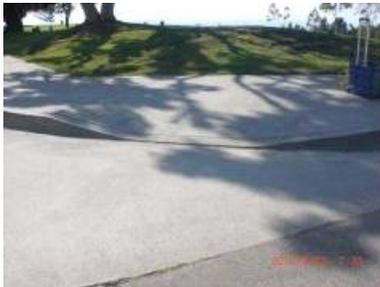
Field Condition	
04.01B - Curb Ramp Compliance - Where accessible route crosses a curb, a curb ramp has not been provided.	1991 ADAAG 4.7.1
Existing Condition: No domes provided, no grooved border, 1/2" lip, flare slopes varies from 10.4% - 14.2%, ramp slope at 10.6%, curb ramp top landing 7.0%, 9.0% CS at curb ramp bottom landing.	2004 ADAAG 406.1
	2007 CBC 1127B.5 item 1
	Other 2005 PROWAG-R303

Corrective Action
120D - Replace Curb Ramp - Remove existing curb ramp, provide new.
Additional Comments:

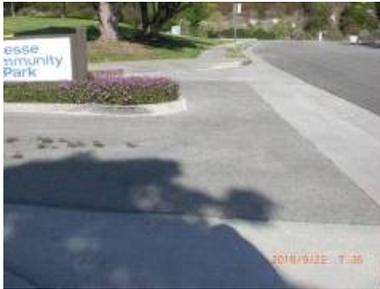
**Location:** Park Area **Photo #** 213

<b>Field Condition</b>	
04.01B - Curb Ramp Compliance - Where accessible route crosses a curb, a curb ramp has not been provided.	<b>1991 ADAAG</b> 4.7.1
Existing Condition: No domes provided, no grooved border, 1/2" lip, flare slopes varies from 10.4% - 14.2%, ramp slope at 10.6%, curb ramp top landing 7.0%, 9.0% CS at curb ramp bottom landing.	<b>2004 ADAAG</b> 406.1
	<b>2007 CBC</b> 1127B.5 item 1
	<b>Other</b> 2005 PROWAG-R303

<b>Corrective Action</b>	
120D - Replace Curb Ramp - Remove existing curb ramp, provide new.	
Additional Comments:

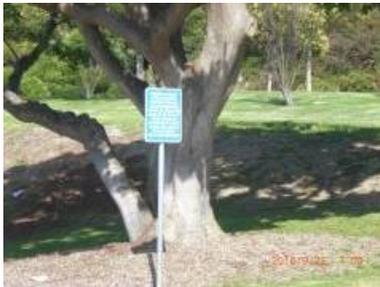
<b>Field Condition</b>	
01.19C - Tow-away Sign - Contact Information - California tow-away sign does not include contact information.	<b>1991 ADAAG</b> -
Existing Condition: No phone number provided.	<b>2004 ADAAG</b> -
	<b>2007 CBC</b> 1129B.4
	<b>Other</b>

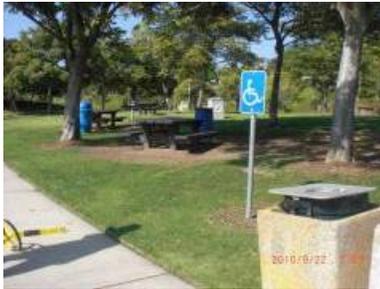
Location: Park Area Photo # 215

<b>Field Condition</b>	
30.25 - Number - Accessible Picnic Tables - Where fixed picnic tables are provided in a picnic area, the required number of fixed picnic tables is not provided. (1999 ADAAG: Where two or more fixed picnic tables are provided in a picnic area, at least 50%, but never less than two, shall comply with 16.5.4 through 16.5.6. In addition, at least 40%, but never less than two, of the accessible picnic tables shall be connected to an outdoor recreation access route complying with 16.3.)	1991 ADAAG -
Existing Condition: 7 picnic tables, 0 accessible.	2004 ADAAG -
	2007 CBC -
	Other 1999 ADAAG-16.5.1.2

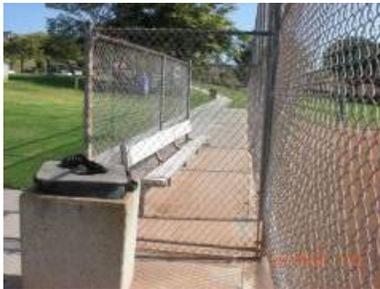
<b>Field Condition</b>	
30.68 - Other - Parks - See Additional Comments	1991 ADAAG -
Existing Condition: Bleachers do not provide wheelchair/ semi-ambulant seating space.	2004 ADAAG -
	2007 CBC -
	Other -

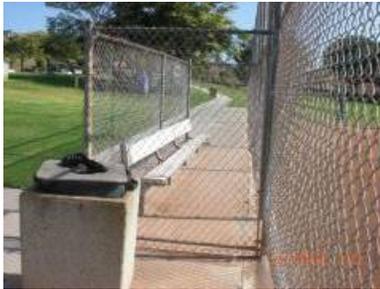
**Location:** Park Area      **Photo #** 217

<b>Field Condition</b>	
30.68 - Other - Parks - See Additional Comments	1991 ADAAG -
Existing Condition: No compliant access provided to dugout area.	2004 ADAAG -
	2007 CBC -
	Other -

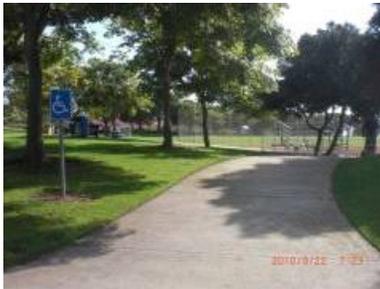
<b>Field Condition</b>	
03B.09 - Cross Slope - Cross slope of the accessible route of travel exceeds 1:50.	1991 ADAAG 4.3.7
Existing Condition: 2.3% to 3.2% CS.	2004 ADAAG 403.3
	2007 CBC 1133B.7.1.3
	Other -

<b>Corrective Action</b>	
006 - Concrete Walk - Remove non-compliant pavement and replace with new concrete (area as shown on the drawings). The walkway slope shall not exceed 5% along the POT and cross slope shall not exceed 2%.	
Additional Comments:

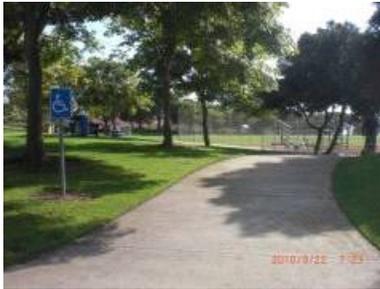
Field Condition									
03B.10 - Running Slope - Slope of the accessible route of travel exceeds 1:20. Existing Condition: 7.65 to 13.2% RS.

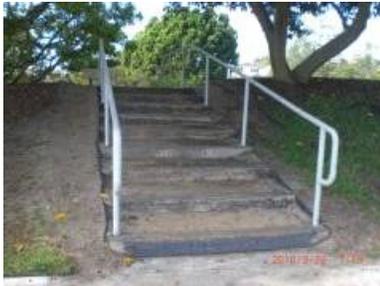
08.01B - Exterior Stairs - Public or common use exterior stair does not comply with accessibility requirements. (Stairs to floors or portions of floors not customarily occupied, including non-occupiable or employee spaces accessed only by ladders, catwalks, crawl spaces, very narrow passageways, and frequented only by service personnel for repair or maintenance purposes: such spaces as elevator pits and elevator penthouses, piping and equipment catwalks and machinery rooms need not be accessible with the exception of stair striping.)

Existing Condition: Handrail 2" in diameter and 26" high with no top/ bottom extensions. 4.6% CS at intermediate landing. Uneven surface at treads, uneven riser height and tread depth, no color strip.

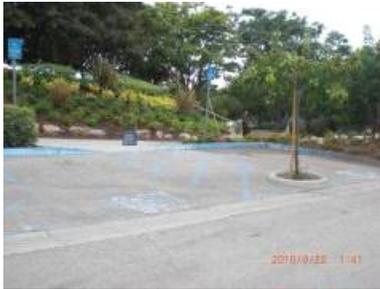
**Location:** Park Area  
**Photo #** 221

<b>Field Condition</b>	
01.19A - Lettering - The words "NO PARKING" is not provided in each access aisle, painted in white, 12" high letters.	1991 ADAAG -
Existing Condition:	2004 ADAAG -
	2007 CBC 1129B.3 items 1 & 2
	Other

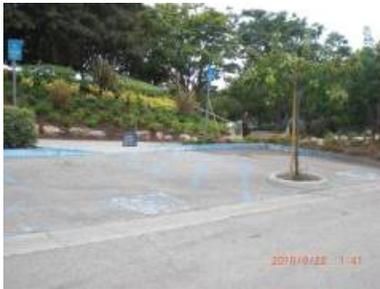
**Location:** Park Area  
**Photo #** 221

<b>Field Condition</b>	
01.15B - Parking Space Sign - Accessible parking space has no reflectorized sign visible from the stall, showing an ISA in white on a blue background.	1991 ADAAG 4.6.4
Existing Condition: No Van sign provided.	2004 ADAAG 502.6
	2007 CBC 1129B.4
	Other

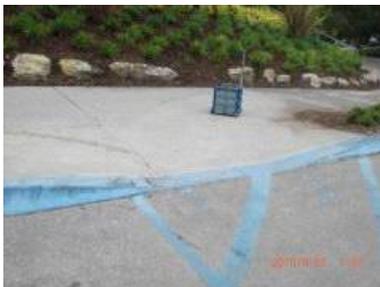
<b>Field Condition</b>	
01.23 - Other - Parking - See Additional Comments	1991 ADAAG -
Existing Condition: No truncated domes provided.	2004 ADAAG -
	2007 CBC -
	Other

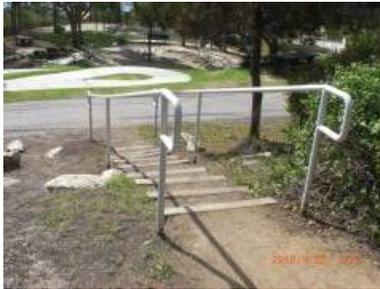
Field Condition	
08.01B - Exterior Stairs - Public or common use exterior stair does not comply with accessibility requirements. (Stairs to floors or portions of floors not customarily occupied, including non-occupiable or employee spaces accessed only by ladders, catwalks, crawl spaces, very narrow passageways, and frequented only by service personnel for repair or maintenance purposes: such spaces as elevator pits and elevator penthouses, piping and equipment catwalks and machinery rooms need not be accessible with the exception of stair striping.)	<b>1991 ADAAG</b> 4.1.3(4)  <b>2004 ADAAG</b> 210.1; Advisory 210.1; 504  <b>2007 CBC</b> 1114B.1.1; 1133B.4  <b>Other</b> -
Existing Condition: Handrail 1 3/4" in diameter. Uneven surface at treads, uneven riser height and tread depth, no color strip.

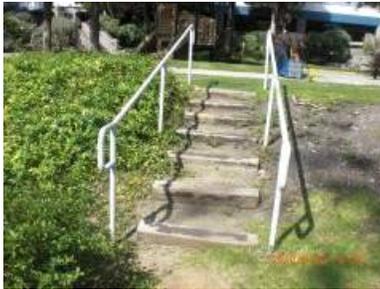
08.01B - Exterior Stairs - Public or common use exterior stair does not comply with accessibility requirements. (Stairs to floors or portions of floors not customarily occupied, including non-occupiable or employee spaces accessed only by ladders, catwalks, crawl spaces, very narrow passageways, and frequented only by service personnel for repair or maintenance purposes: such spaces as elevator pits and elevator penthouses, piping and equipment catwalks and machinery rooms need not be accessible with the exception of stair striping.)

Existing Condition: Handrail 1 3/4" in diameter, 31" high. Uneven surface at treads, uneven riser height and tread depth, no color strip.

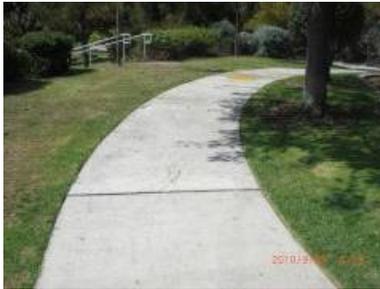
Location: Park Area Photo # 230

<b>Field Condition</b>									
03B.09 - Cross Slope - Cross slope of the accessible route of travel exceeds 1:50. Existing Condition: 2.5% to 6.5% CS.

<b>Corrective Action</b>	
006 - Concrete Walk - Remove non-compliant pavement and replace with new concrete (area as shown on the drawings). The walkway slope shall not exceed 5% along the POT and cross slope shall not exceed 2%.	
Additional Comments:

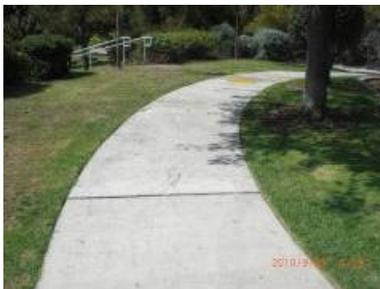
Location: Park Area Photo # 230

<b>Field Condition</b>									
03B.13 - > 1/2" Changes in Level - Curb ramps, ramps, or elevators are not used for changes in level greater than 1/2 inch. (Lifts may only be used in certain limited situations.) Existing Condition: 3/4" high.

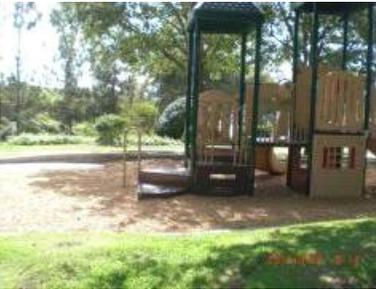
**Location:** Park Area **Photo #** 232

<b>Field Condition</b>	
31.34 - Play Areas - Ground Surfaces - Ground surfaces along accessible routes, clear floor or ground spaces, or turning spaces are not compliant.	<b>1991 ADAAG</b> -
Existing Condition: Mulch.	<b>2004 ADAAG</b> 1008.2.6
	<b>2007 CBC</b> -
	<b>Other</b> 2000 ADAAG-15.6.7; PRC 5410-5411; H&SC 115725

<b>Corrective Action</b>	
006 - Concrete Walk - Remove non-compliant pavement and replace with new concrete (area as shown on the drawings). The walkway slope shall not exceed 5% along the POT and cross slope shall not exceed 2%.	
Additional Comments: Provide path to play area.

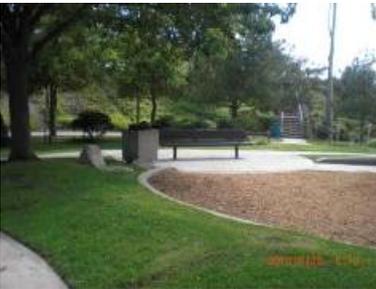
<b>Field Condition</b>	
30.12 - Fixed Bench - Fixed bench is not accessible for users with various types of disabilities.	<b>1991 ADAAG</b> -
Existing Condition: 3 benches provided, 1 accessible (non-compliant).	<b>2004 ADAAG</b> 903.1
	<b>2007 CBC</b> -
	<b>Other</b> 1999 ADAAG-16.12.2.1

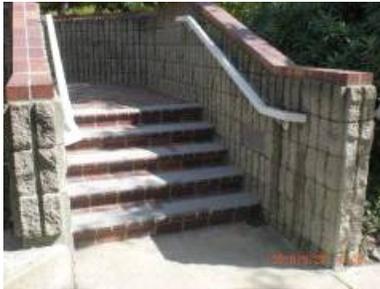
08.09A - Handrail Extensions - Top Landing - At ends of handrails, less than 12" of handrail extends beyond the top nosing. (Top and bottom handrail extensions are important safety features for persons with balance problems and must extend in the direction of the stair run to permit the intended use.) (Per ADA/CBC Standards, in existing buildings and facilities, full extension of handrails at stairs shall not be required in alterations where such extensions would be hazardous or impossible due to plan configuration.)

Existing Condition: 3" top extensions, 12"-20" bottom extensions, 2" clear from wall, 2" square profile.

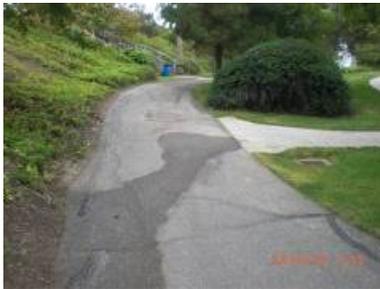
**Location:** Park Area  
**Photo #** 236

<b>Field Condition</b>	
03B.09 - Cross Slope - Cross slope of the accessible route of travel exceeds 1:50.	1991 ADAAG 4.3.7
Existing Condition: 2.9% to 7.4% CS.	2004 ADAAG 403.3
	2007 CBC 1133B.7.1.3
	Other -

<b>Corrective Action</b>	
004A - Asphalt Paving - Remove non-compliant pavement and replace with new asphalt paving (area as shown on the drawings). The walkway slope shall not exceed 5% along the POT and cross slope shall not exceed 2%.	
Additional Comments:

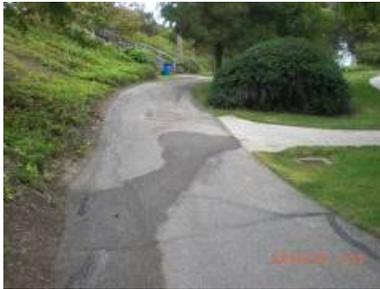
Location: Park Area Photo # 236

<b>Field Condition</b>									
03B.10 - Running Slope - Slope of the accessible route of travel exceeds 1:20. Existing Condition: 6.7% to 12.1% RS.

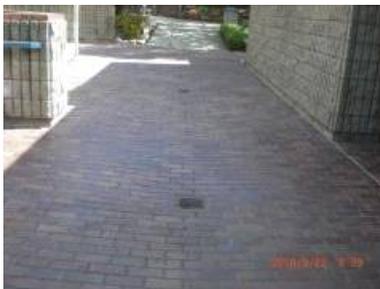
<b>Field Condition</b>									
03B.09 - Cross Slope - Cross slope of the accessible route of travel exceeds 1:50. Existing Condition: Bad slope at floor drains.

<b>Corrective Action</b>	
006 - Concrete Walk - Remove non-compliant pavement and replace with new concrete (area as shown on the drawings). The walkway slope shall not exceed 5% along the POT and cross slope shall not exceed 2%.	
Additional Comments:

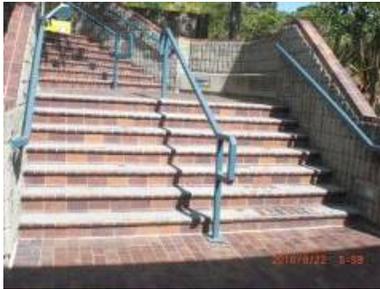
Location: Park Area Photo # 239

08.09B - Handrail Extensions - Bottom Landing - At ends of handrails, less than 12" plus the tread width extends beyond the bottom nosing. (Top and bottom handrail extensions are important safety features for persons with balance problems and must extend in the direction of the stair run to permit the intended use.) (Per ADA/CBC Standards, in existing buildings and facilities, full extension of handrails at stairs shall not be required in alterations where such extensions would be hazardous or impossible due to plan configuration.)

Existing Condition: 2" square profile, 17" bottom extension, top extension not parallel to stair run.

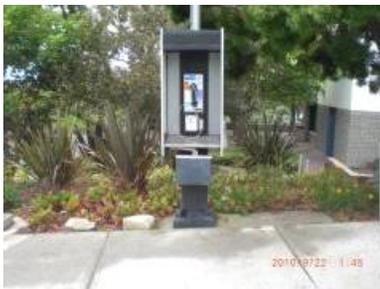
<b>Field Condition</b>	
03B.09 - Cross Slope - Cross slope of the accessible route of travel exceeds 1:50.	1991 ADAAG 4.3.7
Existing Condition: 8.1% CS at telephone.	2004 ADAAG 403.3
	2007 CBC 1133B.7.1.3
	Other -

<b>Corrective Action</b>	
006 - Concrete Walk - Remove non-compliant pavement and replace with new concrete (area as shown on the drawings). The walkway slope shall not exceed 5% along the POT and cross slope shall not exceed 2%.	
Additional Comments:

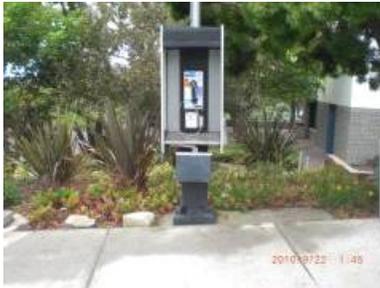
**Location:** Park Area **Photo #** 241

<b>Field Condition</b>	06.04 - Volume Control - The telephone(s) required to be accessible has not been equipped with a volume control. OR Less than 25% of all other public telephones are equipped with volume controls. (If banks of public telephones are provided, at least one in each bank shall be equipped with a volume control.)	<b>1991 ADAAG</b>	4.1.3(17)(b)
		<b>2004 ADAAG</b>	-
<b>Existing Condition:</b>		<b>2007 CBC</b>	1117B.2.8
		<b>Other</b>	-

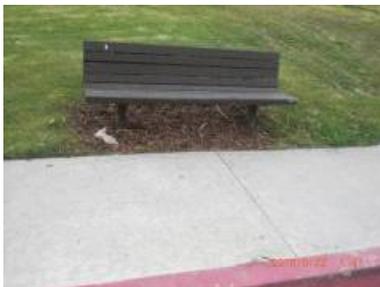
<b>Field Condition</b>	30.12 - Fixed Bench - Fixed bench is not accessible for users with various types of disabilities.	<b>1991 ADAAG</b>	-
		<b>2004 ADAAG</b>	903.1
<b>Existing Condition:</b>		<b>2007 CBC</b>	-
		<b>Other</b>	1999 ADAAG-16.12.2.1

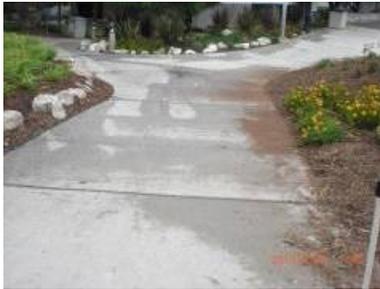
Location: Park Area      Photo # 244

<b>Field Condition</b>									
03B.10 - Running Slope - Slope of the accessible route of travel exceeds 1:20.  Existing Condition: 8.5% to 9.1% RS.

<b>Corrective Action</b>	
006 - Concrete Walk - Remove non-compliant pavement and replace with new concrete (area as shown on the drawings). The walkway slope shall not exceed 5% along the POT and cross slope shall not exceed 2%.	
Additional Comments:

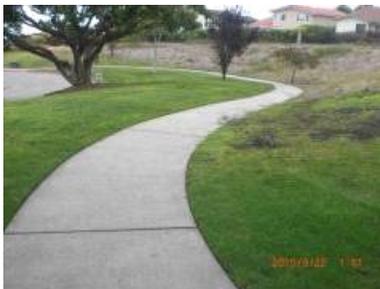
<b>Field Condition</b>									
03B.10 - Running Slope - Slope of the accessible route of travel exceeds 1:20.  Existing Condition: 7.3% to 11.1% RS.

<b>Corrective Action</b>	
006 - Concrete Walk - Remove non-compliant pavement and replace with new concrete (area as shown on the drawings). The walkway slope shall not exceed 5% along the POT and cross slope shall not exceed 2%.	
Additional Comments:

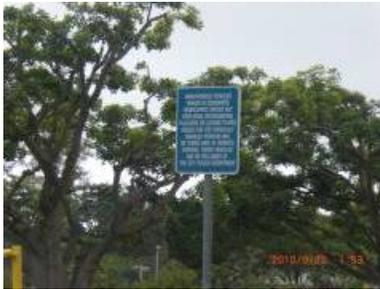
Location: Park Area Photo # 246

<b>Field Condition</b>	
01.19C - Tow-away Sign - Contact Information - California tow-away sign does not include contact information.	1991 ADAAG -
Existing Condition:	2004 ADAAG -
	2007 CBC 1129B.4
	Other

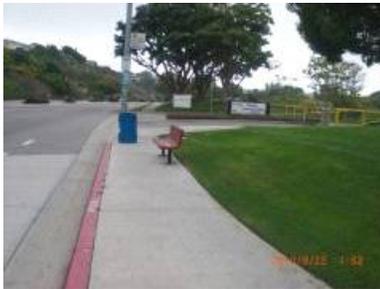
Location: Park Area Photo # 247

<b>Field Condition</b>	
30.12 - Fixed Bench - Fixed bench is not accessible for users with various types of disabilities.	1991 ADAAG -
Existing Condition:	2004 ADAAG 903.1
	2007 CBC -
	Other 1999 ADAAG-16.12.2.1

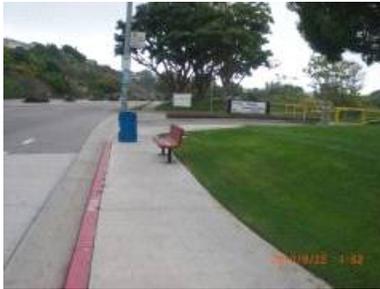
<b>Field Condition</b>	
30.68 - Other - Parks - See Additional Comments	1991 ADAAG -
Existing Condition: No wheelchair seating provided.	2004 ADAAG -
	2007 CBC -
	Other -

<b>Corrective Action</b>	
006 - Concrete Walk - Remove non-compliant pavement and replace with new concrete (area as shown on the drawings). The walkway slope shall not exceed 5% along the POT and cross slope shall not exceed 2%.	
Additional Comments:

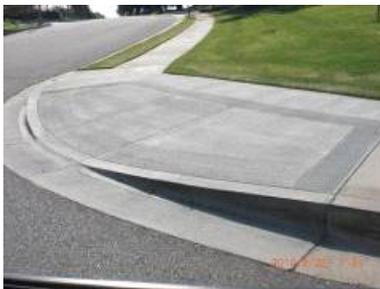
<b>Field Condition</b>	
04.10 - Detectable Warning Requirement - Regardless of slope, the curb ramp does not have a detectable warning.	1991 ADAAG 4.7.7; 4.29.2
Existing Condition: No domes provided at three different locations.	2004 ADAAG 705.1; Fig. 705.1
	2007 CBC 1127B.5 item 7
	Other 2005 PROWAG-R303.3.2

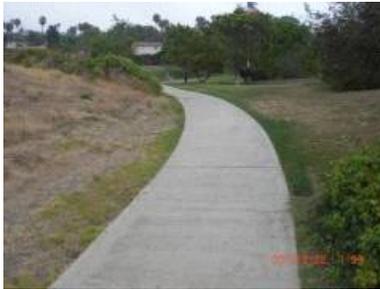
Location: Park Area      Photo # 250

<b>Field Condition</b>									
03B.10 - Running Slope - Slope of the accessible route of travel exceeds 1:20.  Existing Condition: 5.5% to 14% RS.

<b>Corrective Action</b>	
004A - Asphalt Paving - Remove non-compliant pavement and replace with new asphalt paving (area as shown on the drawings). The walkway slope shall not exceed 5% along the POT and cross slope shall not exceed 2%.	
Additional Comments:

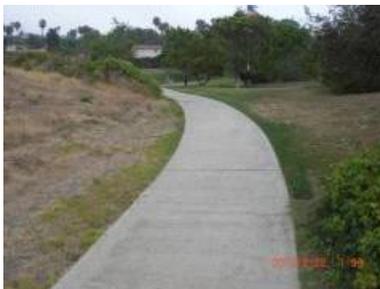
<b>Field Condition</b>									
03B.09 - Cross Slope - Cross slope of the accessible route of travel exceeds 1:50.  Existing Condition: 2.7% to 3.6% CS.

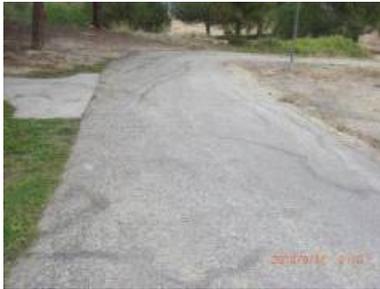
**Location:** Park Area  
**Photo #** 252

<b>Field Condition</b>	
03B.10 - Running Slope - Slope of the accessible route of travel exceeds 1:20.	<b>1991 ADAAG</b> 4.3.7
Existing Condition: Asphalt path 7.0%, 10.8% RS at transition point - asphalt to concrete.	<b>2004 ADAAG</b> 403.3
	<b>2007 CBC</b> 1133B.7.3
	<b>Other</b> -

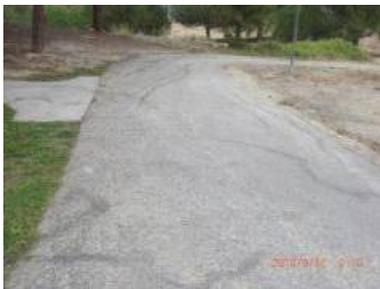
<b>Field Condition</b>	
03B.09 - Cross Slope - Cross slope of the accessible route of travel exceeds 1:50.	<b>1991 ADAAG</b> 4.3.7
Existing Condition: Asphalt path 7.4%.	<b>2004 ADAAG</b> 403.3
	<b>2007 CBC</b> 1133B.7.1.3
	<b>Other</b> -

<b>Corrective Action</b>	
004A - Asphalt Paving - Remove non-compliant pavement and replace with new asphalt paving (area as shown on the drawings). The walkway slope shall not exceed 5% along the POT and cross slope shall not exceed 2%.	
Additional Comments:

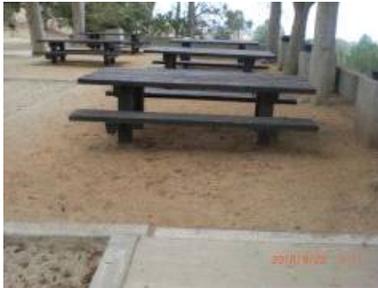
Location: Park Area Photo # 254

30.25 - Number - Accessible Picnic Tables - Where fixed picnic tables are provided in a picnic area, the required number of fixed picnic tables is not provided. (1999 ADAAG: Where two or more fixed picnic tables are provided in a picnic area, at least 50%, but never less than two, shall comply with 16.5.4 through 16.5.6. In addition, at least 40%, but never less than two, of the accessible picnic tables shall be connected to an outdoor recreation access route complying with 16.3.)

Existing Condition: 6 picnic tables provided at playground area, non-accessible, surface at picnic table area not firm and stable,

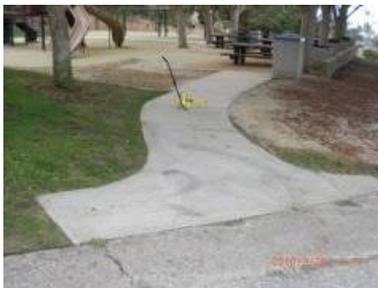
Location: Park Area Photo # 255

30.68 - Other - Parks - See Additional Comments

Existing Condition: No directional sign provided to playground.

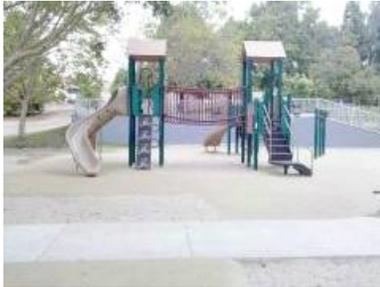
Location: Park Area Photo # 256

<b>Field Condition</b>	
31.38 - Other - Play Areas - See Additional Comments	1991 ADAAG -
Existing Condition: Monkey bars at 67" and 76" high.	2004 ADAAG -
	2007 CBC -
	Other -

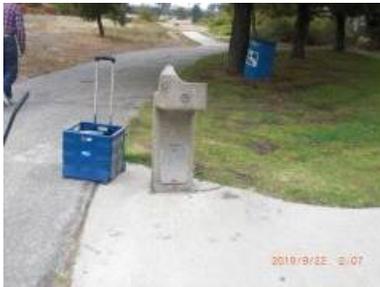
Location: Park Area Photo # 257

<b>Field Condition</b>	
05.09A - Spout Height for Wheelchair Users - The spout outlet is higher than 36" from the floor.	1991 ADAAG 4.15.2
Existing Condition: 38" high.	2004 ADAAG 602.4; 602.6; Advisory 602.6
	2007 CBC 1115B.4.6 item 4
	Other -

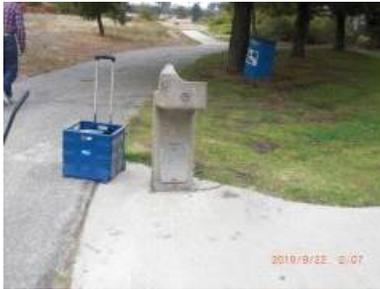
<b>Field Condition</b>	
05.03 - Accessible Route - The accessible drinking fountain is not located on an accessible route.	1991 ADAAG 4.1.3(10)(b)
Existing Condition: 10% slope at drinking fountain clear floor space.	2004 ADAAG 206.2.4
	2007 CBC 1115B.4.6 item 1
	Other -

<b>Corrective Action</b>	
006 - Concrete Walk - Remove non-compliant pavement and replace with new concrete (area as shown on the drawings). The walkway slope shall not exceed 5% along the POT and cross slope shall not exceed 2%.	
Additional Comments:

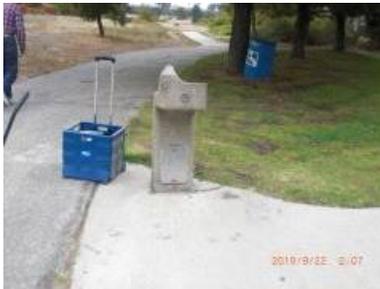
<b>Field Condition</b>	
05.01A - "Hi" Drinking Fountain Requirement - Where there is only one drinking fountain area on a floor (e.g., an area with a drinking fountain or separate drinking fountains), it is accessible to wheelchair users and not to persons who have difficulty bending or stooping (i.e., the required accessibility for persons who have difficulty bending or stooping on each floor has not been provided).	1991 ADAAG 4.1.3(10)(a); 4.15.1
Existing Condition: No "Hi" drinking fountain provided.	2004 ADAAG 211.1; 211.2
	2007 CBC 1115B.4.6 item 1
	Other -

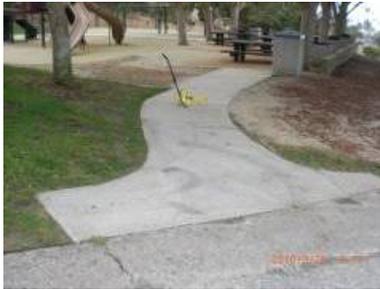
<b>Field Condition</b>									
03B.09 - Cross Slope - Cross slope of the accessible route of travel exceeds 1:50. Existing Condition: 7.5%.

<b>Corrective Action</b>	
006 - Concrete Walk - Remove non-compliant pavement and replace with new concrete (area as shown on the drawings). The walkway slope shall not exceed 5% along the POT and cross slope shall not exceed 2%.	
Additional Comments:

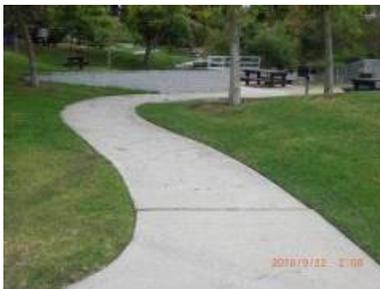
<b>Field Condition</b>									
03B.09 - Cross Slope - Cross slope of the accessible route of travel exceeds 1:50. Existing Condition: 4.6% CS.

<b>Corrective Action</b>	
006 - Concrete Walk - Remove non-compliant pavement and replace with new concrete (area as shown on the drawings). The walkway slope shall not exceed 5% along the POT and cross slope shall not exceed 2%.	
Additional Comments:

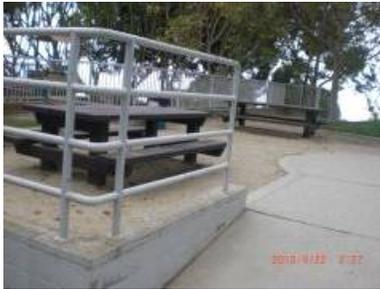
**Location:** Park Area  
**Photo #** 262

Existing Condition: 6 picnic tables provided, 0 accessible.

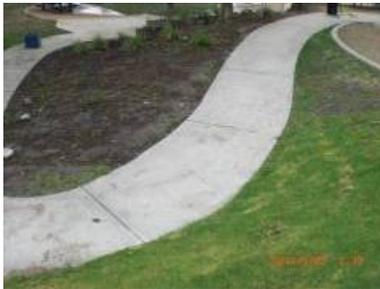
**Location:** Park Area  
**Photo #** 263

Existing Condition: 5.3% to 13.6% RS.

006 - Concrete Walk - Remove non-compliant pavement and replace with new concrete (area as shown on the drawings). The walkway slope shall not exceed 5% along the POT and cross slope shall not exceed 2%.

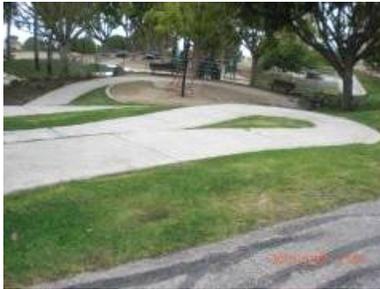
<b>Field Condition</b>	
03B.09 - Cross Slope - Cross slope of the accessible route of travel exceeds 1:50. Existing Condition: 2.3% to 7.6% CS.	<b>1991 ADAAG</b> 4.3.7  <b>2004 ADAAG</b> 403.3  <b>2007 CBC</b> 1133B.7.1.3  <b>Other</b> -

<b>Corrective Action</b>	
006 - Concrete Walk - Remove non-compliant pavement and replace with new concrete (area as shown on the drawings). The walkway slope shall not exceed 5% along the POT and cross slope shall not exceed 2%.	
Additional Comments:

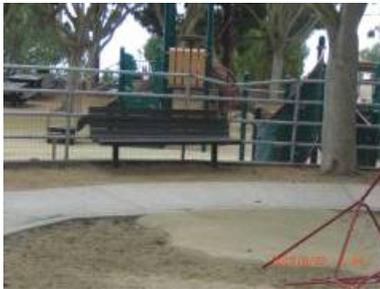
**Keynote 265**

<b>Field Condition</b>	
30.12 - Fixed Bench - Fixed bench is not accessible for users with various types of disabilities. Existing Condition: No accessible bench provided.	<b>1991 ADAAG</b> -  <b>2004 ADAAG</b> 903.1  <b>2007 CBC</b> -  <b>Other</b> 1999 ADAAG-16.12.2.1

<b>Classification</b>	
<b>DOJ Location Type:</b>	1
<b>Use:</b>	PV
<b>Severity:</b>	C
<b>Level of Difficulty</b>	Moderate
