*City of Rancho Palos Verdes*  
**Rancho Palos Verdes ADA Assessment**  
**Facility Report with Photos**

**Facility ID: # 08 - Ladera Linda Park & Community Center**

**Author: Vaish, B**

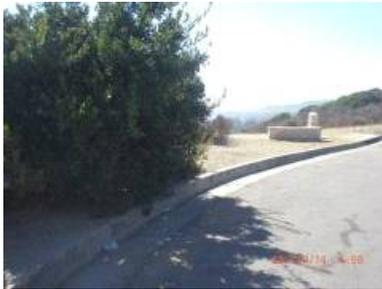
Location: View Point      Photo # 1

Field Condition	
03A.01A - Accessible Route of Travel (Public ROW) - Accessible route of travel linking an accessible site entrance with accessible feature(s) adjacent to the property line of the site (e.g., public transportation stops; passenger loading zones; accessible parking, and public sidewalks) is not accessible.	1991 ADAAG -
Existing Condition:	2004 ADAAG -
	2007 CBC -
	Other 2005 PROWAG-R204

Corrective Action	
001A - Accessible Route - Provide new accessible route.	
Additional Comments:

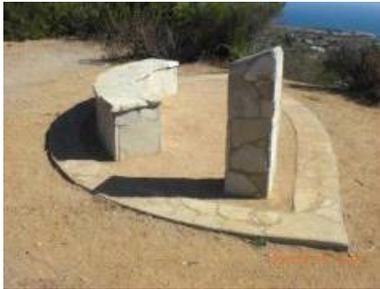
**Location:** View Point      **Photo #** 2

Field Condition	
30.21 - Fixed Bench Size - Accessible bench does not have seats that are 20" to 24" in depth and 42" min. in length. OR The back support does not extend from a point 2" maximum above the bench to 18" min. above the bench.	1991 ADAAG -
Existing Condition:	2004 ADAAG 903.3
	903.4
	903.4
	2007 CBC -
	Other -

Corrective Action
027 - Site Work - Miscellaneous - See Additional Comments
Additional Comments: Provide compliant bench with clear WC seating space.

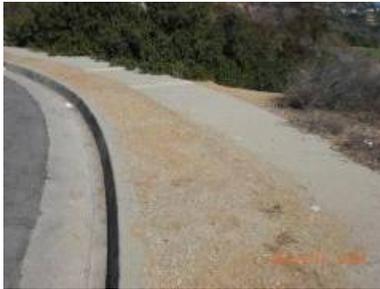
Location: Sidewalk Photo # 3

<b>Field Condition</b>	
03A.07A - Cross Slope (PAR) - Cross slope of the pedestrian access route exceeds 1:50.	1991 ADAAG 4.3.7
Existing Condition: 2.4% to 3.5% CS.	2004 ADAAG 403.3
	2007 CBC 1133B.7.1.3
	Other 2005 PROWAG-R301.4.1

<b>Corrective Action</b>	
006 - Concrete Walk - Remove non-compliant pavement and replace with new concrete (area as shown on the drawings). The walkway slope shall not exceed 5% along the POT and cross slope shall not exceed 2%.	
Additional Comments:

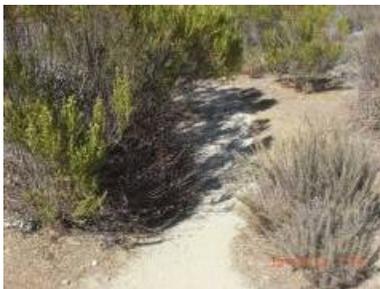
<b>Field Condition</b>	
03A.15 - Other - Pedestrian Accessible Route (Public Right of Way) - See Additional Comments	1991 ADAAG -
Existing Condition: Shrubs obstruct sidewalk.	2004 ADAAG -
	2007 CBC -
	Other -

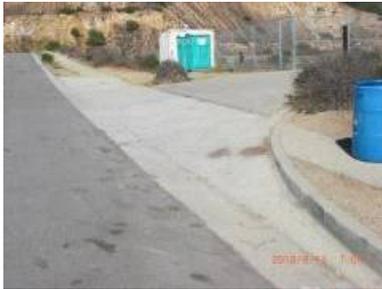
Field Condition	
03A.07B - Cross Slope - Driveway (PAR) - Cross slope of the pedestrian access route in a driveway exceeds 1:50.	1991 ADAAG 4.3.7
Existing Condition: 10%.	2004 ADAAG 403.3
	2007 CBC 1133B.7.1.3
	Other 2005 PROWAG-R301.4.1

Corrective Action	
006 - Concrete Walk - Remove non-compliant pavement and replace with new concrete (area as shown on the drawings). The walkway slope shall not exceed 5% along the POT and cross slope shall not exceed 2%.	
Additional Comments:

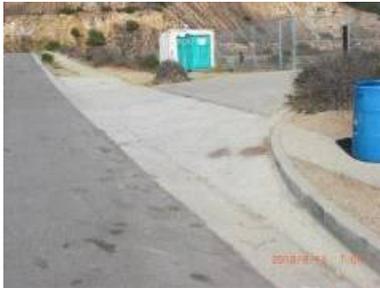
03A.14A - Walk Bordering Vehicular Way - Detectable Warnings - Where a walk crosses or adjoins the vehicular way and the walking surface is not separated by curbs, railings, or other elements between the pedestrian areas and vehicular areas, the boundary between the areas is not defined by a continuous detectable warning at least 36" wide complying with CBC 1121B.3.1 item 8(a). (i.e., the warning surface shall contrast visually with adjoining surfaces, either light on dark or dark on light, and shall differ from adjoining walking surfaces in resiliency or sound on cane contact. Color: yellow conforming to Federal Color No. 33538, Table IV/ Standard No. 595B. Where the color value contrast between the yellow warning and the main walking surface is less than 70 percent, a 1" wide black strip shall separate the yellow warning from the main walking surface.)

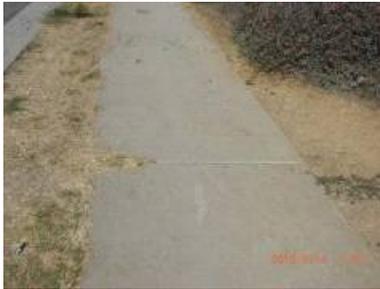
Location: Sidewalk Photo # 7

<b>Field Condition</b>	
03A.15 - Other - Pedestrian Accessible Route (Public Right of Way) - See Additional Comments	1991 ADAAG -
Existing Condition: 1" gap.	2004 ADAAG -
	2007 CBC -
	Other -

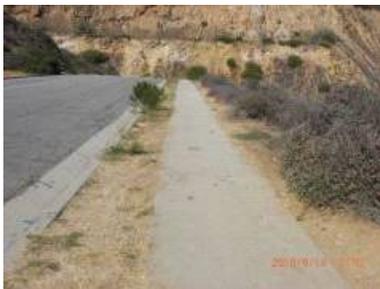
<b>Field Condition</b>	
03A.07A - Cross Slope (PAR) - Cross slope of the pedestrian access route exceeds 1:50.	1991 ADAAG 4.3.7
Existing Condition: 2.2% to 5.0% CS.	2004 ADAAG 403.3
	2007 CBC 1133B.7.1.3
	Other 2005 PROWAG-R301.4.1

<b>Corrective Action</b>	
006 - Concrete Walk - Remove non-compliant pavement and replace with new concrete (area as shown on the drawings). The walkway slope shall not exceed 5% along the POT and cross slope shall not exceed 2%.	
Additional Comments:

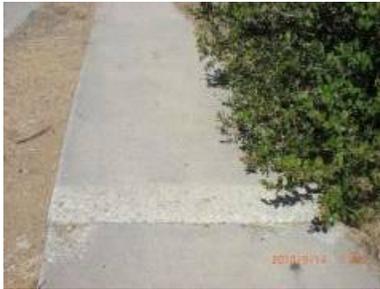
<b>Field Condition</b>	
03A.09 - > 1/4" Changes in Level - Where walkway levels change abruptly, the vertical difference between them exceed 1/4 inch. OR Changes in level between 1/4 inch and 1/2 inch are beveled with a slope greater than 1:2.	1991 ADAAG 4.5.2
Existing Condition: 1/2" level change.	2004 ADAAG 303.2; 303.3
	2007 CBC 1124B.2
	Other 2005 PROWAG-R301.5.2

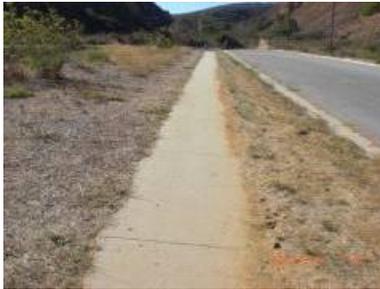
**Location:** Sidewalk      **Photo #** 11

<b>Field Condition</b>	
03A.07A - Cross Slope (PAR) - Cross slope of the pedestrian access route exceeds 1:50.	<b>1991 ADAAG</b> 4.3.7
Existing Condition: 2.2% to 4.5% CS.	<b>2004 ADAAG</b> 403.3
	<b>2007 CBC</b> 1133B.7.1.3
	<b>Other</b> 2005 PROWAG-R301.4.1

<b>Corrective Action</b>	
006 - Concrete Walk - Remove non-compliant pavement and replace with new concrete (area as shown on the drawings). The walkway slope shall not exceed 5% along the POT and cross slope shall not exceed 2%.	
Additional Comments:

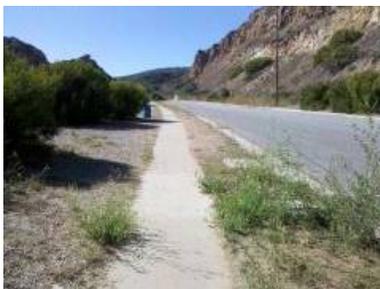
<b>Field Condition</b>	
03A.07A - Cross Slope (PAR) - Cross slope of the pedestrian access route exceeds 1:50.	<b>1991 ADAAG</b> 4.3.7
Existing Condition: 2.2% to 4.6% CS.	<b>2004 ADAAG</b> 403.3
	<b>2007 CBC</b> 1133B.7.1.3
	<b>Other</b> 2005 PROWAG-R301.4.1

<b>Corrective Action</b>	
006 - Concrete Walk - Remove non-compliant pavement and replace with new concrete (area as shown on the drawings). The walkway slope shall not exceed 5% along the POT and cross slope shall not exceed 2%.	
Additional Comments:

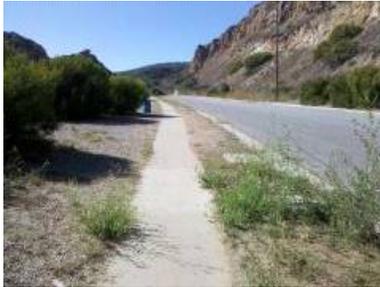
**Location:** Sidewalk **Photo #** 12

<b>Field Condition</b>									
03A.08 - Running Slope (PAR) - Slope of the pedestrian access route exceeds 1:20. Or slope of the pedestrian access route contained within a street or highway border exceeds the grade of the adjacent roadway. (1:20 requirement does not apply to compliant ramps or where slope of the pedestrian access route contained within a street or highway border does not exceed the grade of the adjacent roadway.)

<b>1991 ADAAG</b>	4.3.7	<b>2004 ADAAG</b>	403.3	<b>2007 CBC</b>	1133B.7.3	<b>Other</b>	2005 PROWAG-R301.4.2
<b>1991 ADAAG</b>	4.3.7								
<b>2004 ADAAG</b>	403.3								
<b>2007 CBC</b>	1133B.7.3								
<b>Other</b>	2005 PROWAG-R301.4.2								
Existing Condition: 11.3%.

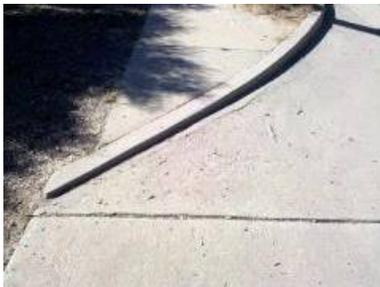
<b>Field Condition</b>									
03A.09 - > 1/4" Changes in Level - Where walkway levels change abruptly, the vertical difference between them exceed 1/4 inch. OR Changes in level between 1/4 inch and 1/2 inch are beveled with a slope greater than 1:2.

<b>1991 ADAAG</b>	4.5.2	<b>2004 ADAAG</b>	303.2; 303.3	<b>2007 CBC</b>	1124B.2	<b>Other</b>	2005 PROWAG-R301.5.2
<b>1991 ADAAG</b>	4.5.2								
<b>2004 ADAAG</b>	303.2; 303.3								
<b>2007 CBC</b>	1124B.2								
<b>Other</b>	2005 PROWAG-R301.5.2								
Existing Condition: Greater than 1 1/2" level change at transition from driveway to sidewalk at both side of driveway.

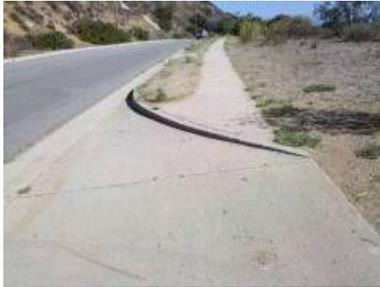
Location: Sidewalk Photo # 15

Field Condition	
03A.07B - Cross Slope - Driveway (PAR) - Cross slope of the pedestrian access route in a driveway exceeds 1:50.	1991 ADAAG 4.3.7
Existing Condition: 6.3% to 8.1% CS.	2004 ADAAG 403.3
	2007 CBC 1133B.7.1.3
	Other 2005 PROWAG-R301.4.1

Corrective Action	
006 - Concrete Walk - Remove non-compliant pavement and replace with new concrete (area as shown on the drawings). The walkway slope shall not exceed 5% along the POT and cross slope shall not exceed 2%.	
Additional Comments:

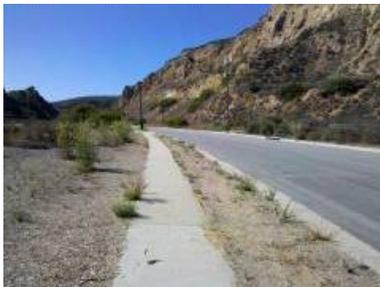
Field Condition	
03A.07A - Cross Slope (PAR) - Cross slope of the pedestrian access route exceeds 1:50.	1991 ADAAG 4.3.7
Existing Condition: 2.3% to 4.4% CS.	2004 ADAAG 403.3
	2007 CBC 1133B.7.1.3
	Other 2005 PROWAG-R301.4.1

Corrective Action	
006 - Concrete Walk - Remove non-compliant pavement and replace with new concrete (area as shown on the drawings). The walkway slope shall not exceed 5% along the POT and cross slope shall not exceed 2%.	
Additional Comments:

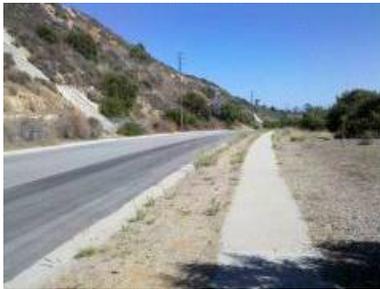
Location: Sidewalk Photo # 17

Field Condition									
03A.09 - > 1/4" Changes in Level - Where walkway levels change abruptly, the vertical difference between them exceed 1/4 inch. OR Changes in level between 1/4 inch and 1/2 inch are beveled with a slope greater than 1:2.

1991 ADAAG	4.5.2	2004 ADAAG	303.2; 303.3	2007 CBC	1124B.2	Other	2005 PROWAG-R301.5.2
1991 ADAAG	4.5.2								
2004 ADAAG	303.2; 303.3								
2007 CBC	1124B.2								
Other	2005 PROWAG-R301.5.2								
Existing Condition: 1/2" level change.

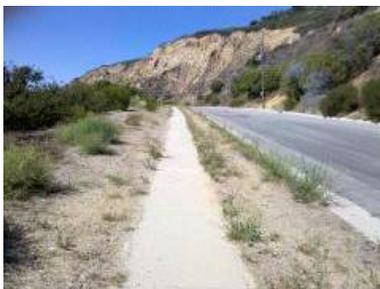
Field Condition									
03A.07A - Cross Slope (PAR) - Cross slope of the pedestrian access route exceeds 1:50.

1991 ADAAG	4.3.7	2004 ADAAG	403.3	2007 CBC	1133B.7.1.3	Other	2005 PROWAG-R301.4.1
1991 ADAAG	4.3.7								
2004 ADAAG	403.3								
2007 CBC	1133B.7.1.3								
Other	2005 PROWAG-R301.4.1								
Existing Condition: 2.2% to 5.9% CS.

Corrective Action
006 - Concrete Walk - Remove non-compliant pavement and replace with new concrete (area as shown on the drawings). The walkway slope shall not exceed 5% along the POT and cross slope shall not exceed 2%.
Additional Comments:

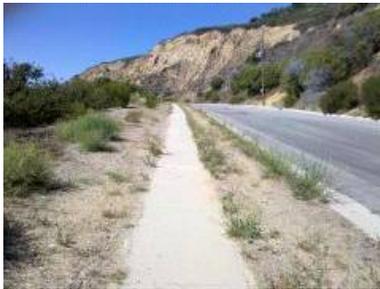
**Location:** Sidewalk  
**Photo #** 18

<b>Field Condition</b>	03A.02B - Passing Spaces - Where the accessible route of travel is less than 60" wide, passing spaces at least 60" by 60" or intersecting walks, allowing passing at reasonable intervals not exceeding 200', is not provided.	<b>1991 ADAAG</b> 4.3.4
Existing Condition:		<b>2004 ADAAG</b> 403.5.3
		<b>2007 CBC</b> 1133B.7.1
		<b>Other</b> 2005 PROWAG-R301.3.2

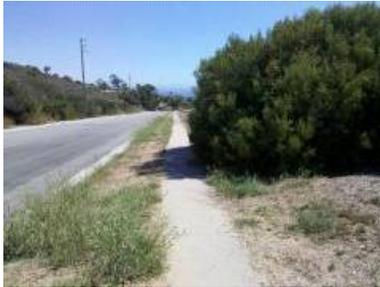
Location: Sidewalk      Photo # 21

Field Condition									
03A.06B - Clear Width - Free Standing Protruding Objects - Free standing object(s) mounted on posts with leading edges between 27" and 80" high (such as a sign or telephone) projects into the circulation path and does not maintains the required clear width of the accessible route.

1991 ADAAG	4.4.1	2004 ADAAG	307.3	2007 CBC	1133B.8.6.1	Other	2005 PROWAG-R401.1
1991 ADAAG	4.4.1								
2004 ADAAG	307.3								
2007 CBC	1133B.8.6.1								
Other	2005 PROWAG-R401.1								
Existing Condition: Shrubs obstruct clear width of sidewalk.

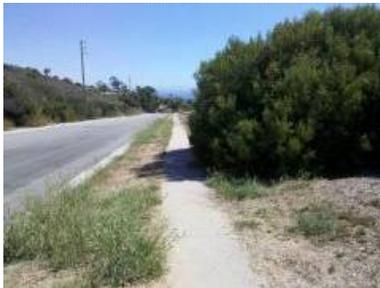
Location: Sidewalk      Photo # 21

Field Condition									
03A.07A - Cross Slope (PAR) - Cross slope of the pedestrian access route exceeds 1:50.

1991 ADAAG	4.3.7	2004 ADAAG	403.3	2007 CBC	1133B.7.1.3	Other	2005 PROWAG-R301.4.1
1991 ADAAG	4.3.7								
2004 ADAAG	403.3								
2007 CBC	1133B.7.1.3								
Other	2005 PROWAG-R301.4.1								
Existing Condition: 2.1% to 3.9% CS.

Corrective Action
006 - Concrete Walk - Remove non-compliant pavement and replace with new concrete (area as shown on the drawings). The walkway slope shall not exceed 5% along the POT and cross slope shall not exceed 2%.
Additional Comments:

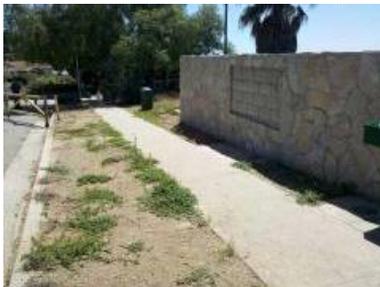
<b>Field Condition</b>									
03A.07A - Cross Slope (PAR) - Cross slope of the pedestrian access route exceeds 1:50.

<b>1991 ADAAG</b>	4.3.7	<b>2004 ADAAG</b>	403.3	<b>2007 CBC</b>	1133B.7.1.3	<b>Other</b>	2005 PROWAG-R301.4.1
<b>1991 ADAAG</b>	4.3.7								
<b>2004 ADAAG</b>	403.3								
<b>2007 CBC</b>	1133B.7.1.3								
<b>Other</b>	2005 PROWAG-R301.4.1								
Existing Condition: 2.4% to 4.5% CS.

<b>Corrective Action</b>
006 - Concrete Walk - Remove non-compliant pavement and replace with new concrete (area as shown on the drawings). The walkway slope shall not exceed 5% along the POT and cross slope shall not exceed 2%.
Additional Comments:

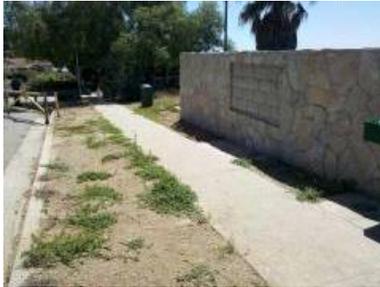
**Location:** Sidewalk      **Photo #** 24

<b>Field Condition</b>									
03A.08 - Running Slope (PAR) - Slope of the pedestrian access route exceeds 1:20. Or slope of the pedestrian access route contained within a street or highway border exceeds the grade of the adjacent roadway. (1:20 requirement does not apply to compliant ramps or where slope of the pedestrian access route contained within a street or highway border does not exceed the grade of the adjacent roadway.)

<b>1991 ADAAG</b>	4.3.7	<b>2004 ADAAG</b>	403.3	<b>2007 CBC</b>	1133B.7.3	<b>Other</b>	2005 PROWAG-R301.4.2
<b>1991 ADAAG</b>	4.3.7								
<b>2004 ADAAG</b>	403.3								
<b>2007 CBC</b>	1133B.7.3								
<b>Other</b>	2005 PROWAG-R301.4.2								
Existing Condition: 5.6% to 9.4% RS.

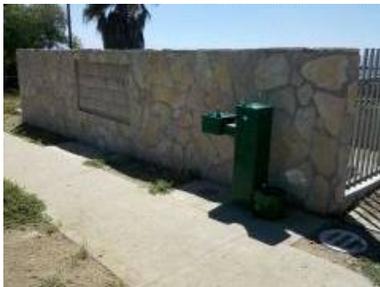
<b>Field Condition</b>									
05.07 - Clear Floor Space - Drinking fountain does not have a 30" x 48" clear floor space that adjoins or overlaps an accessible route of travel and that allows a forward approach by wheelchair users. (A side approach is not acceptable.)

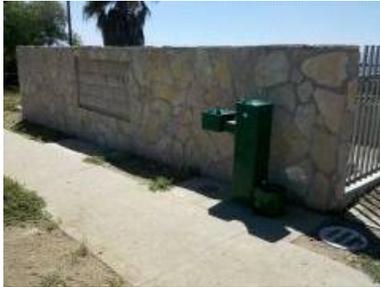
**Location:** Sidewalk  
**Photo #** 26

Field Condition	
05.09A - Spout Height for Wheelchair Users - The spout outlet is higher than 36" from the floor.	1991 ADAAG 4.15.2
Existing Condition: 38" high.	2004 ADAAG 602.4; 602.6; Advisory 602.6
	2007 CBC 1115B.4.6 item 4
	Other -

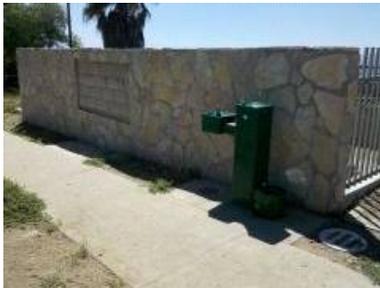
**Location:** Sidewalk  
**Photo #** 26

Field Condition	
05.09B - Water Flow Height - The water flow is less than 4" high and does not allow the insertion of a cup under the flow.	1991 ADAAG 4.15.3
Existing Condition: 1" high.	2004 ADAAG 602.6; Advisory 602.6
	2007 CBC 1115B.4.6 item 5
	Other -

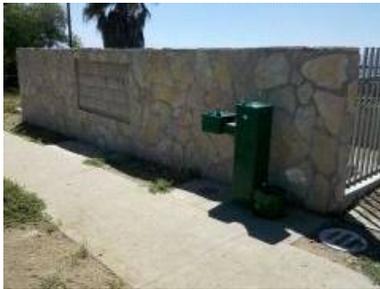
**Location:** Sidewalk  
**Photo #** 26

Field Condition	
05.10A - Bubbler Location - The bubbler outlet is not within 6" of the front edge of the unit.	1991 ADAAG 4.15.3
Existing Condition:	2004 ADAAG -
	2007 CBC 1115B.4.6 item 4
	Other -

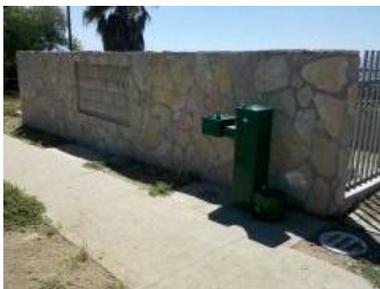
**Location:** Sidewalk  
**Photo #** 26

Field Condition	
05.10B - Water Flow Trajectory - The water flow trajectory is not parallel or nearly parallel to the front edge.	1991 ADAAG 4.15.3
Existing Condition:	2004 ADAAG 602.6; Advisory 602.6
	2007 CBC 1115B.4.6 item 4
	Other -

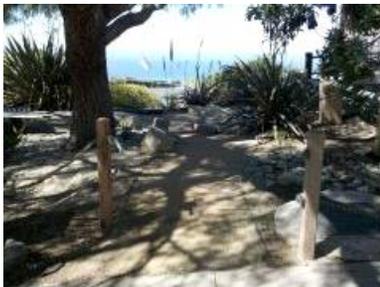
**Location:** Rest Area  
**Photo #** 32

<b>Field Condition</b>		
30.06E - Outdoor Recreation Access Route (ORAR) Segment - Cross Slope - Cross slope of the access route segment exceeds 3.33%. Exception: Cross slopes of 5% maximum are permitted to ensure proper drainage.	1991 ADAAG	-
Existing Condition: 4.0% to 7.8% CS.	2004 ADAAG	-
	2007 CBC	-
	Other	1999 ADAAG-16.3.7.1

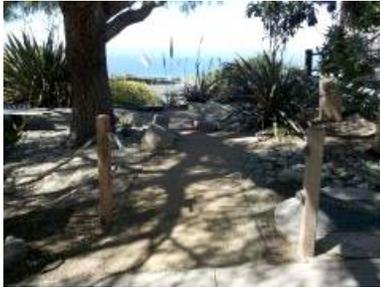
**Location:** Rest Area  
**Photo #** 32

Field Condition	
30.05 - Accessible Route - Width - Accessible route of travel is less than 48" wide (note: 48" wide requirement does not apply to doorways or gates).	1991 ADAAG 4.3.3
Existing Condition: 44" clear width.	2004 ADAAG 403.5.1
	2007 CBC 1133B.7.1
	Other -

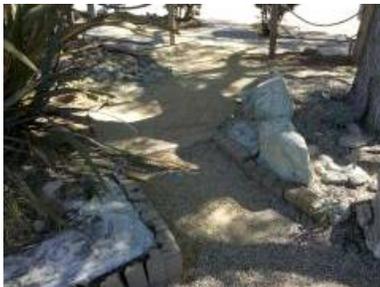
**Location:** Rest Area  
**Photo #** 34

Field Condition	
30.68 - Other - Parks - See Additional Comments	1991 ADAAG -
Existing Condition: 3" step at end of POT.	2004 ADAAG -
	2007 CBC -
	Other -

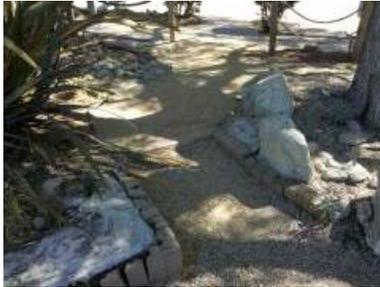
Location: Rest Area Photo # 34

Field Condition	
30.05 - Accessible Route - Width - Accessible route of travel is less than 48" wide (note: 48" wide requirement does not apply to doorways or gates).	1991 ADAAG 4.3.3
Existing Condition: 30" clear width at step.	2004 ADAAG 403.5.1
	2007 CBC 1133B.7.1
	Other -

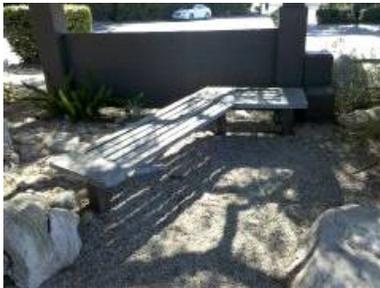
Field Condition	
30.06C - Outdoor Recreation Access Route (ORAR) Surface - The surface of the access route is not firm or stable.	1991 ADAAG -
Existing Condition: Loose gravel.	2004 ADAAG -
	2007 CBC -
	Other 1999 ADAAG-16.3.1

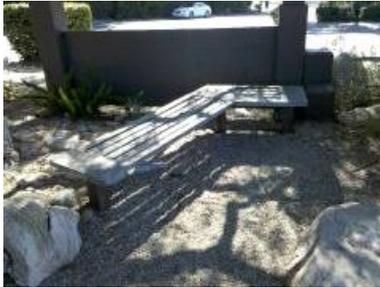
<b>Field Condition</b>	30.16 - Fixed Bench / Wheelchair Seating Space - Shoulder Alignment - A clear space at least 30" x 48" in size has not been provided at one end of the fixed bench so that a wheelchair user may be seated shoulder-to-shoulder with an individual seated on the bench.	1991 ADAAG -
Existing Condition:		2004 ADAAG -
		2007 CBC -
		Other 1999 ADAAG-16.12.4

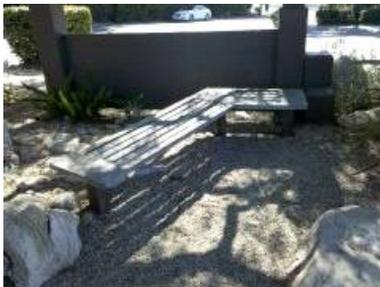
**Keynote 38**

<b>Field Condition</b>	30.12 - Fixed Bench - Fixed bench is not accessible for users with various types of disabilities.	1991 ADAAG -
Existing Condition:		2004 ADAAG 903.1
		2007 CBC -
		Other 1999 ADAAG-16.12.2.1

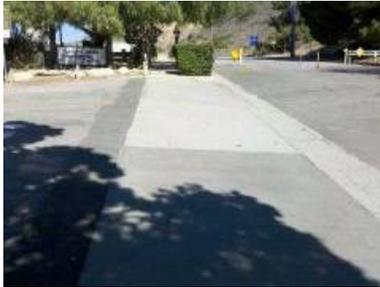
**Keynote 39**

Field Condition	
03A.07B - Cross Slope - Driveway (PAR) - Cross slope of the pedestrian access route in a driveway exceeds 1:50.	1991 ADAAG 4.3.7
Existing Condition: 6.5% to 7.3% CS.	2004 ADAAG 403.3
	2007 CBC 1133B.7.1.3
	Other 2005 PROWAG-R301.4.1

Corrective Action	
006 - Concrete Walk - Remove non-compliant pavement and replace with new concrete (area as shown on the drawings). The walkway slope shall not exceed 5% along the POT and cross slope shall not exceed 2%.	
Additional Comments:

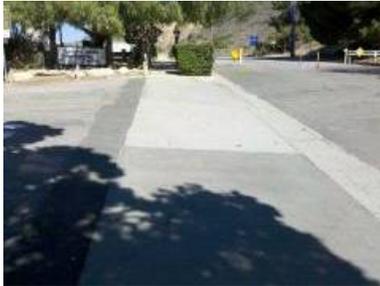
**Keynote 40**

03A.14A - Walk Bordering Vehicular Way - Detectable Warnings - Where a walk crosses or adjoins the vehicular way and the walking surface is not separated by curbs, railings, or other elements between the pedestrian areas and vehicular areas, the boundary between the areas is not defined by a continuous detectable warning at least 36" wide complying with CBC 1121B.3.1 item 8(a). (i.e., the warning surface shall contrast visually with adjoining surfaces, either light on dark or dark on light, and shall differ from adjoining walking surfaces in resiliency or sound on cane contact. Color: yellow conforming to Federal Color No. 33538, Table IV/ Standard No. 595B. Where the color value contrast between the yellow warning and the main walking surface is less than 70 percent, a 1" wide black strip shall separate the yellow warning from the main walking surface.)

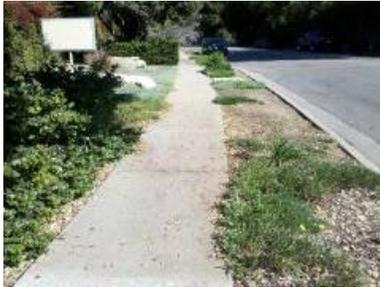
**Keynote 41**

Field Condition	
03A.07A - Cross Slope (PAR) - Cross slope of the pedestrian access route exceeds 1:50.	1991 ADAAG 4.3.7
Existing Condition: 2.2% to 6.1% CS.	2004 ADAAG 403.3
	2007 CBC 1133B.7.1.3
	Other 2005 PROWAG-R301.4.1

Corrective Action	
006 - Concrete Walk - Remove non-compliant pavement and replace with new concrete (area as shown on the drawings). The walkway slope shall not exceed 5% along the POT and cross slope shall not exceed 2%.	
Additional Comments:

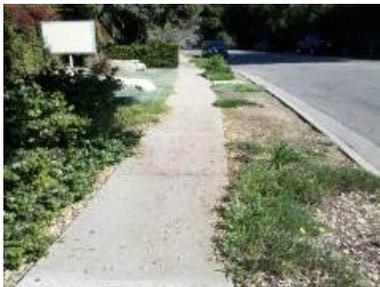
**Keynote 42**

Field Condition	
03A.08 - Running Slope (PAR) - Slope of the pedestrian access route exceeds 1:20. Or slope of the pedestrian access route contained within a street or highway border exceeds the grade of the adjacent roadway. (1:20 requirement does not apply to compliant ramps or where slope of the pedestrian access route contained within a street or highway border does not exceed the grade of the adjacent roadway.)	1991 ADAAG 4.3.7
Existing Condition: 8.8% at transition point.	2004 ADAAG 403.3
	2007 CBC 1133B.7.3
	Other 2005 PROWAG-R301.4.2

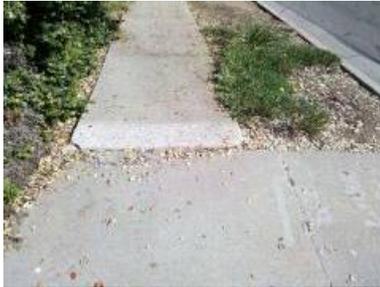
**Keynote 43**

Field Condition	
03A.10 - Changes in Level (Curb Ramps or Ramps) - Curb ramp(s) and ramp(s) are not compliant.	1991 ADAAG 4.7.1; 4.8.1
Existing Condition: 1 1/2" level change and ramp condition with 21.4% RS for 16" long segment.	2004 ADAAG 405; 406
	2007 CBC 1127B.5 item 1; 1133B.5.1
	Other 2005 PROWAG-R303.1; R406.1

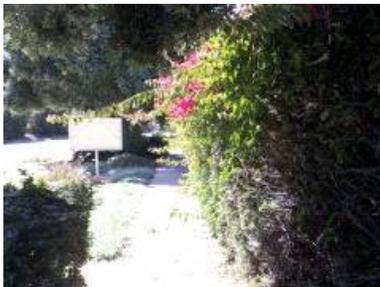
**Keynote 44**

Field Condition	
03A.05A - Wall-Mounted Protruding Objects - Wall-mounted object(s) with leading edges between 27" and 80" from the floor projects more than 4" into the pathway. (Wall mounted objects with leading edges at or below 27" may project any amount as long as the required clear width of the accessible route of travel is maintained).	1991 ADAAG 4.4.1
Existing Condition: Shrub maintenance.	2004 ADAAG 307.2
	2007 CBC 1133B.8.6.1
	Other 2005 PROWAG-R401.2

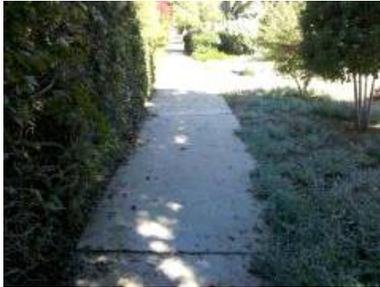
**Keynote 45**

<b>Field Condition</b>	
03A.09 - > 1/4" Changes in Level - Where walkway levels change abruptly, the vertical difference between them exceed 1/4 inch. OR Changes in level between 1/4 inch and 1/2 inch are beveled with a slope greater than 1:2.	1991 ADAAG 4.5.2
Existing Condition: 1/2" level change.	2004 ADAAG 303.2; 303.3
	2007 CBC 1124B.2
	Other 2005 PROWAG-R301.5.2

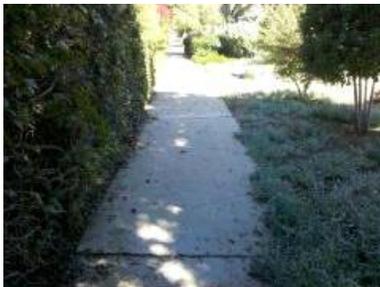
**Keynote 46**

<b>Field Condition</b>	
03A.07A - Cross Slope (PAR) - Cross slope of the pedestrian access route exceeds 1:50.	1991 ADAAG 4.3.7
Existing Condition: 2.2% to 3.6% CS.	2004 ADAAG 403.3
	2007 CBC 1133B.7.1.3
	Other 2005 PROWAG-R301.4.1

<b>Corrective Action</b>	
006 - Concrete Walk - Remove non-compliant pavement and replace with new concrete (area as shown on the drawings). The walkway slope shall not exceed 5% along the POT and cross slope shall not exceed 2%.	
Additional Comments:

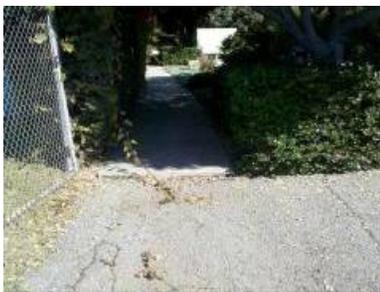
**Keynote 48**

<b>Field Condition</b>	03A.09 - > 1/4" Changes in Level - Where walkway levels change abruptly, the vertical difference between them exceed 1/4 inch. OR Changes in level between 1/4 inch and 1/2 inch are beveled with a slope greater than 1:2.	<b>1991 ADAAG</b> 4.5.2
	Existing Condition: 2" level change at transition point from sidewalk to driveway.	<b>2004 ADAAG</b> 303.2; 303.3
		<b>2007 CBC</b> 1124B.2
		<b>Other</b> 2005 PROWAG-R301.5.2

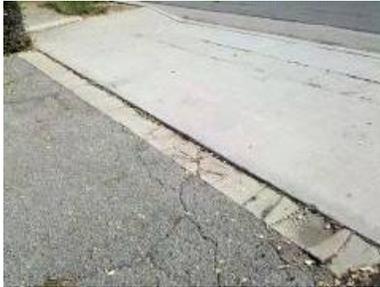
**Keynote 49**

Field Condition									
03A.09 - > 1/4" Changes in Level - Where walkway levels change abruptly, the vertical difference between them exceed 1/4 inch. OR Changes in level between 1/4 inch and 1/2 inch are beveled with a slope greater than 1:2.

1991 ADAAG	4.5.2	2004 ADAAG	303.2; 303.3	2007 CBC	1124B.2	Other	2005 PROWAG-R301.5.2
1991 ADAAG	4.5.2								
2004 ADAAG	303.2; 303.3								
2007 CBC	1124B.2								
Other	2005 PROWAG-R301.5.2								
Existing Condition: 1/2" to 1 1/2" level change.

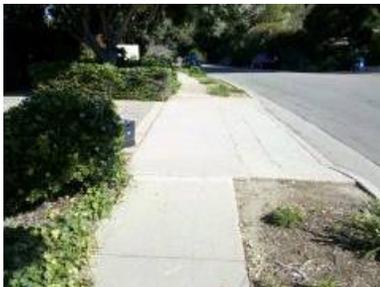
**Keynote 50**

Field Condition									
03A.07A - Cross Slope (PAR) - Cross slope of the pedestrian access route exceeds 1:50.

1991 ADAAG	4.3.7	2004 ADAAG	403.3	2007 CBC	1133B.7.1.3	Other	2005 PROWAG-R301.4.1
1991 ADAAG	4.3.7								
2004 ADAAG	403.3								
2007 CBC	1133B.7.1.3								
Other	2005 PROWAG-R301.4.1								
Existing Condition: 2.2% to 7.9% CS.

Corrective Action
006 - Concrete Walk - Remove non-compliant pavement and replace with new concrete (area as shown on the drawings). The walkway slope shall not exceed 5% along the POT and cross slope shall not exceed 2%.
Additional Comments:

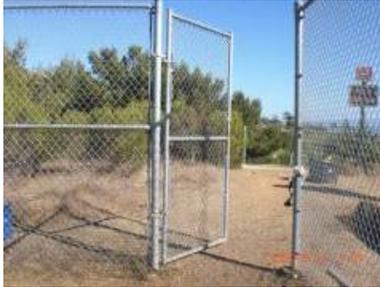
**Keynote 51**

<b>Field Condition</b>	
10.08 - Kick Plate - Bottom 10" of door does not have a smooth, uninterrupted surface on the push side to allow the door to be opened by a wheelchair footrest without creating a trap or hazardous condition. (This requirement does not apply to automatic and sliding doors.)	<b>1991 ADAAG</b> -
Existing Condition:	<b>2004 ADAAG</b> 404.2.10
	<b>2007 CBC</b> 1133B.2.6
	<b>Other</b> -

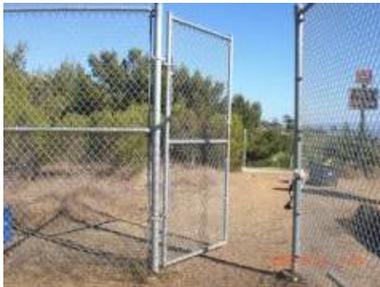
**Keynote 52**

<b>Field Condition</b>	
10.02 - Entrance Sign - Accessible entrance is not identified by an ISA.	<b>1991 ADAAG</b> 28 CFR 35.163(b)1
Existing Condition:	<b>2004 ADAAG</b> 216.6
	<b>2007 CBC</b> 1117B.5.8.1.2
	<b>Other</b> -

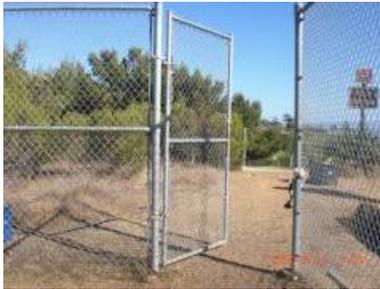
**Keynote 53**

<b>Field Condition</b>									
10.10 - Single-Action Hardware - Handles, locks, and latches or other operative devices are not operable with one hand and without tight grasping, pinching, or twisting of the wrist. (U-shaped handles, levers, and push/pull type mechanisms are acceptable designs.)

<b>1991 ADAAG</b>	4.13.9	<b>2004 ADAAG</b>	309.4; 404.2.7; Advisory 404.2.7	<b>2007 CBC</b>	1133B.2.5.2	<b>Other</b>	-
<b>1991 ADAAG</b>	4.13.9								
<b>2004 ADAAG</b>	309.4; 404.2.7; Advisory 404.2.7								
<b>2007 CBC</b>	1133B.2.5.2								
<b>Other</b>	-								
Existing Condition:

<b>Corrective Action</b>
067B - Lever Hardware - Replace door hardware with lever-type handset.
Additional Comments:

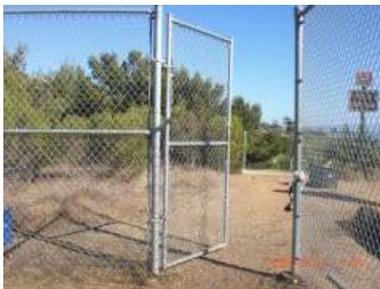
**Keynote 54**

<b>Field Condition</b>									
11.12 - Hardware Mounting Height - Mounting height of all operating hardware is not 30" min.. or 44" max., as measured to the highest operable part. (1994 ADA Standards permit a max.. height of 48"; CBC Standards permit a range of 30" min.. to 44" max..)

<b>1991 ADAAG</b>	4.13.9	<b>2004 ADAAG</b>	-	<b>2007 CBC</b>	1133B.2.5.2	<b>Other</b>	-
<b>1991 ADAAG</b>	4.13.9								
<b>2004 ADAAG</b>	-								
<b>2007 CBC</b>	1133B.2.5.2								
<b>Other</b>	-								
Existing Condition: Hardware at 48" and 57" high.

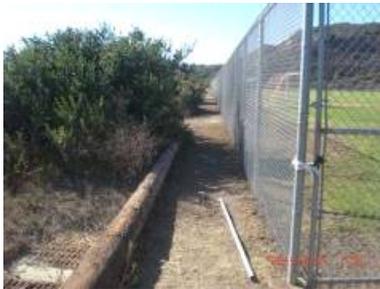
**Keynote 56**

Existing Condition: Uneven and not stable surface provided.

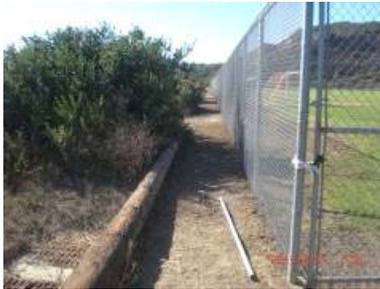
**Keynote 57**

<b>Field Condition</b>	
03B.09 - Cross Slope - Cross slope of the accessible route of travel exceeds 1:50.  Existing Condition: 3.1% to 6.2% CS.	<b>1991 ADAAG</b> 4.3.7  <b>2004 ADAAG</b> 403.3  <b>2007 CBC</b> 1133B.7.1.3  <b>Other</b> -

<b>Corrective Action</b>	
006 - Concrete Walk - Remove non-compliant pavement and replace with new concrete (area as shown on the drawings). The walkway slope shall not exceed 5% along the POT and cross slope shall not exceed 2%.	
Additional Comments:

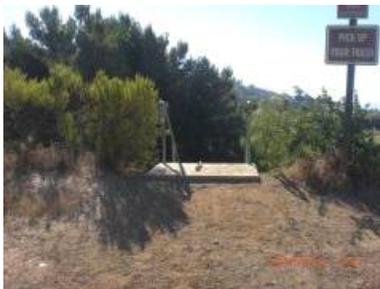
**Keynote 58**

<b>Field Condition</b>	
03B.11 - Ramps - This portion of an accessible route with a slope greater than 5% does not comply with the requirements for compliant ramps.  Existing Condition: 2.4% CS, & 7.8% RS.	<b>1991 ADAAG</b> 4.8.1  <b>2004 ADAAG</b> 405  <b>2007 CBC</b> 1133B.5  <b>Other</b> -

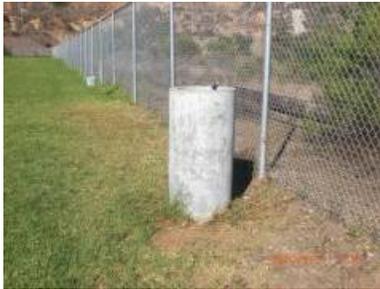
**Keynote 59**

<b>Field Condition</b>	
05.01A - "Hi" Drinking Fountain Requirement - Where there is only one drinking fountain area on a floor (e.g., an area with a drinking fountain or separate drinking fountains), it is accessible to wheelchair users and not to persons who have difficulty bending or stooping (i.e., the required accessibility for persons who have difficulty bending or stooping on each floor has not been provided).	<b>1991 ADAAG</b> 4.1.3(10)(a); 4.15.1 <b>2004 ADAAG</b> 211.1; 211.2 <b>2007 CBC</b> 1115B.4.6 item 1 <b>Other</b> -
Existing Condition:

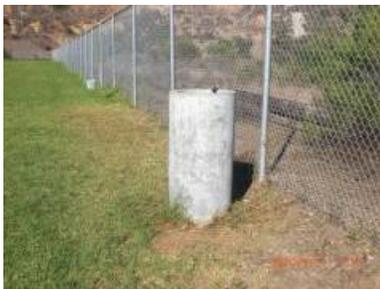
**Keynote 60**

<b>Field Condition</b>	
05.03 - Accessible Route - The accessible drinking fountain is not located on an accessible route.	<b>1991 ADAAG</b> 4.1.3(10)(b) <b>2004 ADAAG</b> 206.2.4 <b>2007 CBC</b> 1115B.4.6 item 1 <b>Other</b> -
Existing Condition: No POT to DF.

<b>Corrective Action</b>	
006 - Concrete Walk - Remove non-compliant pavement and replace with new concrete (area as shown on the drawings). The walkway slope shall not exceed 5% along the POT and cross slope shall not exceed 2%.	
Additional Comments:

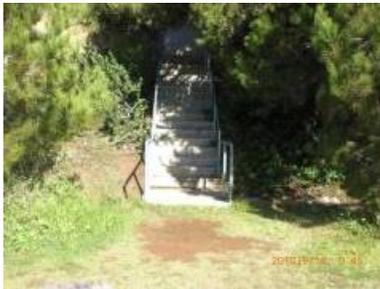
**Keynote 62**

Field Condition	
08.15 - Landing Size - Landing depth in the direction of travel is not at least equal to the width of the stairway.	1991 ADAAG -
Existing Condition: Top and bottom landings 4'-10" x 48". Intermediate landings 4'-10" x 44".	2004 ADAAG -
	2007 CBC 1009.4
	Other -

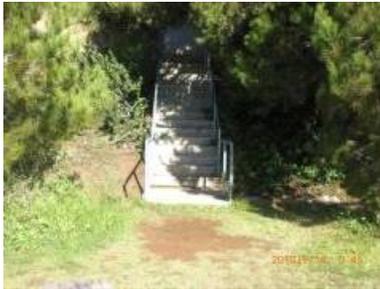
**Keynote 63**

<b>Field Condition</b>	
08.03D - Level Landing - Landing is not level (slope is greater than 2% in some or all directions).	1991 ADAAG -
Existing Condition: 3.3% RS.	2004 ADAAG -
	2007 CBC 1009.5.1
	Other -

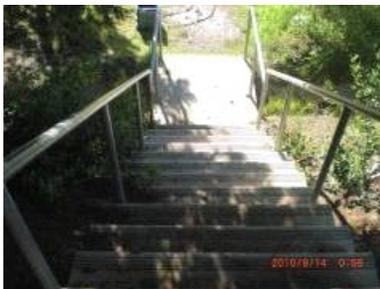
**Keynote 64**

<b>Field Condition</b>	
08.05A - Exterior Stairs - Color Strip - Contrasting color strips have not been provided.	1991 ADAAG -
Existing Condition: No stripes.	2004 ADAAG -
	2007 CBC 1133B.4.4
	Other -

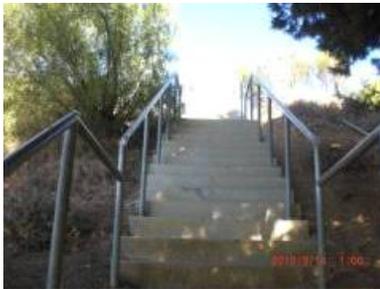
**Keynote 68**

<b>Field Condition</b>	
08.07A - Continuous Handrails - Continuous handrails are not provided along both sides.  Existing Condition:	1991 ADAAG 4.9.4  2004 ADAAG 504.6; 505.2  2007 CBC 1133B.4.1.1  Other -

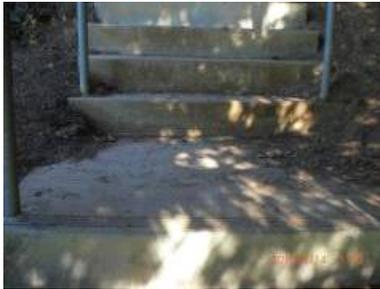
**Keynote 69**

<b>Field Condition</b>	
08.03D - Level Landing - Landing is not level (slope is greater than 2% in some or all directions).	1991 ADAAG -
Existing Condition: Intermediate landings - 3.7% RS.	2004 ADAAG -
	2007 CBC 1009.5.1
	Other -

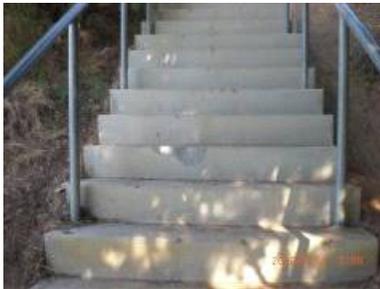
**Keynote 70**

<b>Field Condition</b>	
08.18 - Other - Stairs - See Additional Comments	1991 ADAAG -
Existing Condition: Damaged stair surface.	2004 ADAAG -
	2007 CBC -
	Other -

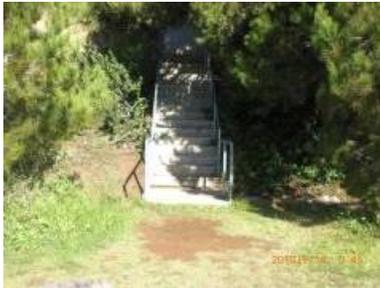
**Keynote 71**

<b>Field Condition</b>	
08.09B - Handrail Extensions - Bottom Landing - At ends of handrails, less than 12" plus the tread width extends beyond the bottom nosing. (Top and bottom handrail extensions are important safety features for persons with balance problems and must extend in the direction of the stair run to permit the intended use.) (Per ADA/CBC Standards, in existing buildings and facilities, full extension of handrails at stairs shall not be required in alterations where such extensions would be hazardous or impossible due to plan configuration.)	<b>1991 ADAAG</b> 4.9.4(2)  <b>2004 ADAAG</b> 505.10; 505.10.3; Fig. 505.10.3  <b>2007 CBC</b> 1133B.4.2.2  <b>Other</b> -
Existing Condition: None provided.

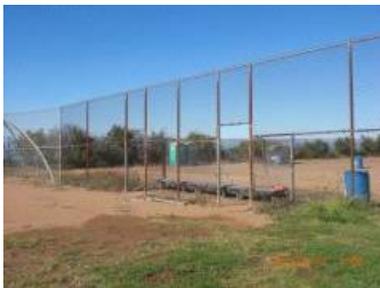
**Keynote 72**

<b>Field Condition</b>	
30.04 - Accessible Route - Facilities Connected - Accessible routes of travel do not connect all accessible buildings, facilities, elements and spaces on the same site with one another.	<b>1991 ADAAG</b> 4.1.2(2)(a)  <b>2004 ADAAG</b> 206.2.2; Advisory 206.2.2  <b>2007 CBC</b> 1114B.1.2; 1127B.1  <b>Other</b> -
Existing Condition: No POT connecting to dugout.

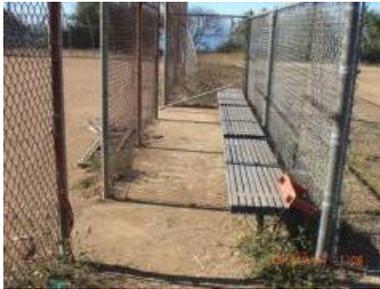
**Keynote 73**

Field Condition	
30.19 - Fixed Bench Height - The height of the front edge of the seating surface is not between 17" and 19" above the adjacent grade or floor space.	1991 ADAAG -
Existing Condition: 16 1/4" high.	2004 ADAAG 903.5
	2007 CBC -
	Other 1999 ADAAG-16.12.3

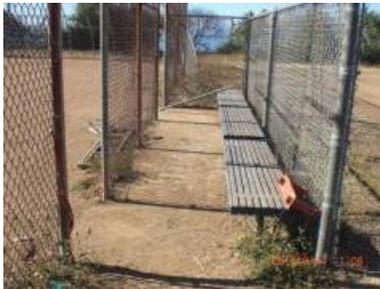
**Location:** Baseball Field  
**Photo #** 73

Field Condition	
30.16 - Fixed Bench / Wheelchair Seating Space - Shoulder Alignment - A clear space at least 30" x 48" in size has not been provided at one end of the fixed bench so that a wheelchair user may be seated shoulder-to-shoulder with an individual seated on the bench.	1991 ADAAG -
Existing Condition: No WC seating space.	2004 ADAAG -
	2007 CBC -
	Other 1999 ADAAG-16.12.4

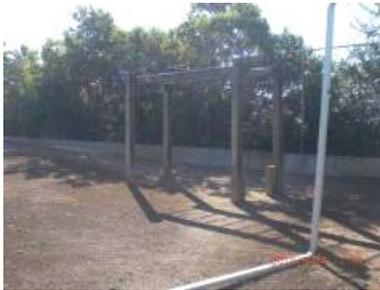
**Location:** Baseball Field/ Soccer Field  
**Photo #** 77

<b>Field Condition</b>	30.04 - Accessible Route - Facilities Connected - Accessible routes of travel do not connect all accessible buildings, facilities, elements and spaces on the same site with one another.  Existing Condition: No POT to monkey bar.	1991 ADAAG 4.1.2(2)(a)  2004 ADAAG 206.2.2;Advisory206.2.2  2007 CBC 1114B.1.2; 1127B.1  Other -
------------------------	--	--

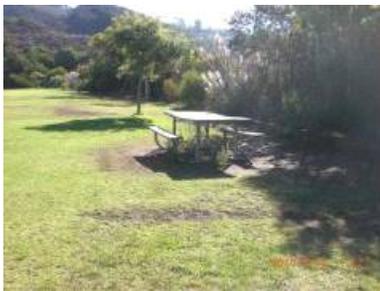
**Location:** Baseball Field/ Soccer Field  
**Photo #** 78

<b>Field Condition</b>	30.23 - Picnic Sites - Accessible Route - Accessible routes do not connect the picnic site to accessible building entrances, accessible site facilities and the accessible entrance to the site. (A picnic site exists wherever one or more picnic tables is located. In general, picnic areas must include accessible parking, restroom, picnic site and routes that connect each of the elements throughout the area.)  Existing Condition: No POT to picnic table.	1991 ADAAG 4.1.2(2)(a)  2004 ADAAG 206.2.2;Advisory206.2.2  2007 CBC 1127B.1; 1132B.2  Other 1999 ADAAG-16.1
------------------------	---	--

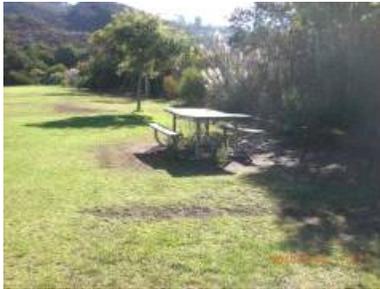
<b>Field Condition</b>	
30.34C - Picnic Table - Knee Space Depth - Picnic table does not provide at least 19" depth for accessible knee clearance.	<b>1991 ADAAG</b> 4.32.3
Existing Condition: 17" deep.	<b>2004 ADAAG</b> 305; 306
	<b>2007 CBC</b> 1122B.3
	<b>Other</b> 1999 ADAAG-16.5.4

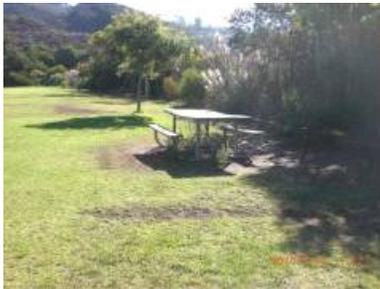
<b>Field Condition</b>	
30.29 - Picnic Site Surface - Picnic tables and benches are not on a firm and stable surface.	<b>1991 ADAAG</b> -
Existing Condition: Muddy surface around picnic table.	<b>2004 ADAAG</b> -
	<b>2007 CBC</b> -
	<b>Other</b> 1999 ADAAG-16.5.6

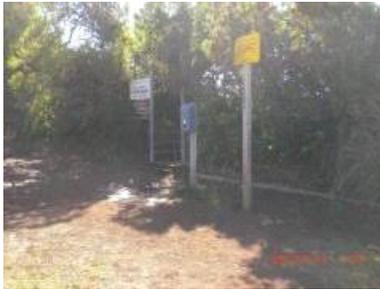
<b>Field Condition</b>	
30.04 - Accessible Route - Facilities Connected - Accessible routes of travel do not connect all accessible buildings, facilities, elements and spaces on the same site with one another.	<b>1991 ADAAG</b> 4.1.2(2)(a)
Existing Condition: No POT to dog waste bag dispenser.	<b>2004 ADAAG</b> 206.2.2; Advisory 206.2.2
	<b>2007 CBC</b> 1114B.1.2; 1127B.1
	<b>Other</b> -

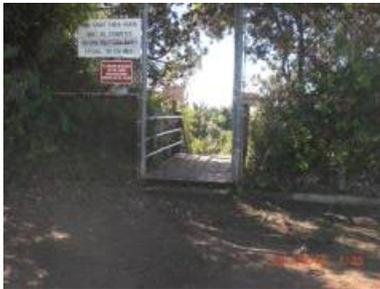
<b>Field Condition</b>	
08.09A - Handrail Extensions - Top Landing - At ends of handrails, less than 12" of handrail extends beyond the top nosing. (Top and bottom handrail extensions are important safety features for persons with balance problems and must extend in the direction of the stair run to permit the intended use.) (Per ADA/CBC Standards, in existing buildings and facilities, full extension of handrails at stairs shall not be required in alterations where such extensions would be hazardous or impossible due to plan configuration.)	<b>1991 ADAAG</b> 4.9.4(2)
Existing Condition: None provided.	<b>2004 ADAAG</b> 505.10; 505.10.2; Fig. 505.10.2
	<b>2007 CBC</b> 1133B.4.2.2
	<b>Other</b> -

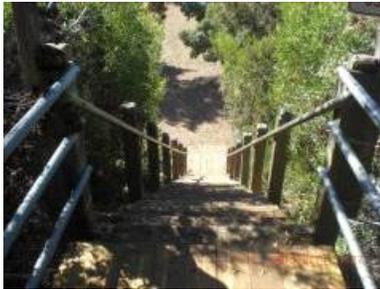
<b>Field Condition</b>	
08.05A - Exterior Stairs - Color Strip - Contrasting color strips have not been provided.	1991 ADAAG -
Existing Condition:	2004 ADAAG -
	2007 CBC 1133B.4.4
	Other -

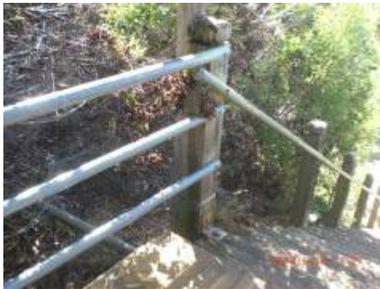
<b>Field Condition</b>	
08.09E - Handrails - Height above Stair Nosings - The tops of handrails are not between 34" and 38" above the stair nosings.	1991 ADAAG 4.9.4(5)
Existing Condition: 29" high.	2004 ADAAG 505.4; Advisory 505.4; Fig. 505.4
	2007 CBC 1133B.4.2.1
	Other -

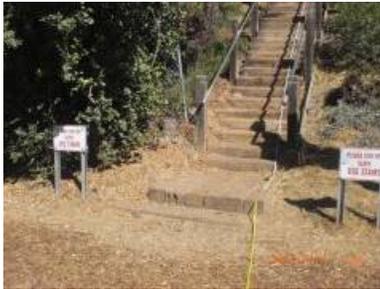
**Location:** Middle Stairs  
**Photo #** 87

Field Condition	
08.03A - Tread Depth - The treads are not uniform. OR The treads are less than 11" deep measured from riser to riser.	1991 ADAAG 4.9.2
Existing Condition: 11" to 14".	2004 ADAAG 504.2
	2007 CBC 1009.3; 1133B.4.5.3
	Other -

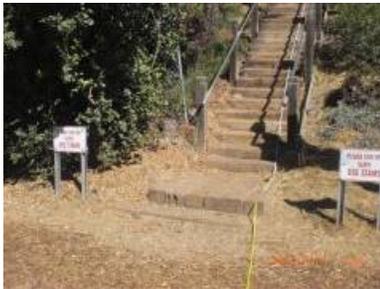
Field Condition	
08.02B - Riser Height - The risers are not uniform. OR The risers are not between 4" and 7" in height.	1991 ADAAG 4.9.2
Existing Condition: 6 1/2" to 7" high.	2004 ADAAG 504.2
	2007 CBC 1009.3; 1133B.4.5.3
	Other -

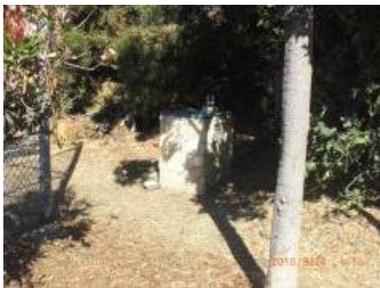
<b>Field Condition</b>	
05.03 - Accessible Route - The accessible drinking fountain is not located on an accessible route.	<b>1991 ADAAG</b> 4.1.3(10)(b)  <b>2004 ADAAG</b> 206.2.4  <b>2007 CBC</b> 1115B.4.6 item 1  <b>Other</b> -
Existing Condition: No POT to DF.

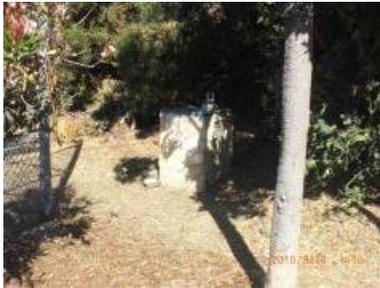
<b>Field Condition</b>	
05.01A - "Hi" Drinking Fountain Requirement - Where there is only one drinking fountain area on a floor (e.g., an area with a drinking fountain or separate drinking fountains), it is accessible to wheelchair users and not to persons who have difficulty bending or stooping (i.e., the required accessibility for persons who have difficulty bending or stooping on each floor has not been provided).	<b>1991 ADAAG</b> 4.1.3(10)(a); 4.15.1 <b>2004 ADAAG</b> 211.1; 211.2 <b>2007 CBC</b> 1115B.4.6 item 1 <b>Other</b> -
Existing Condition:

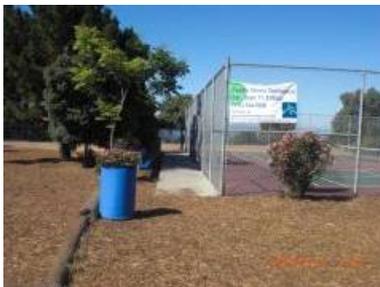
<b>Field Condition</b>	
30.04 - Accessible Route - Facilities Connected - Accessible routes of travel do not connect all accessible buildings, facilities, elements and spaces on the same site with one another.	<b>1991 ADAAG</b> 4.1.2(2)(a) <b>2004 ADAAG</b> 206.2.2; Advisory 206.2.2 <b>2007 CBC</b> 1114B.1.2; 1127B.1 <b>Other</b> -
Existing Condition: No POT connects to paddle tennis courts.

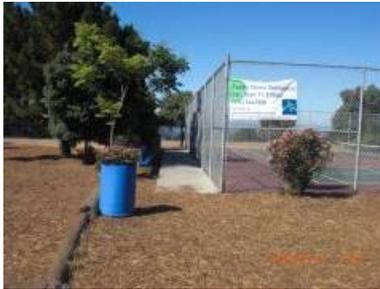
03B.13 - > 1/2" Changes in Level - Curb ramps, ramps, or elevators are not used for changes in level greater than 1/2 inch. (Lifts may only be used in certain limited situations.)

Existing Condition: 3/4" level change.

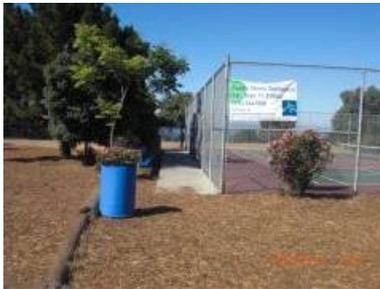
03B.09 - Cross Slope - Cross slope of the accessible route of travel exceeds 1:50.

Existing Condition: 2.3%.

006 - Concrete Walk - Remove non-compliant pavement and replace with new concrete (area as shown on the drawings). The walkway slope shall not exceed 5% along the POT and cross slope shall not exceed 2%.

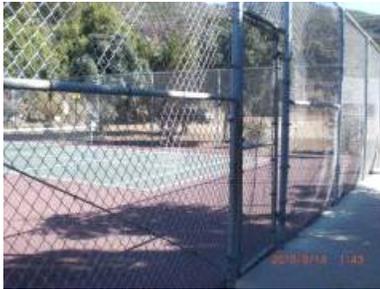
**Location:** Paddle Tennis Courts  
**Photo #** 97

<b>Field Condition</b>	10.08 - Kick Plate - Bottom 10" of door does not have a smooth, uninterrupted surface on the push side to allow the door to be opened by a wheelchair footrest without creating a trap or hazardous condition. (This requirement does not apply to automatic and sliding doors.)	<b>1991 ADAAG</b> -
Existing Condition:		<b>2004 ADAAG</b> 404.2.10
		<b>2007 CBC</b> 1133B.2.6
		<b>Other</b> -

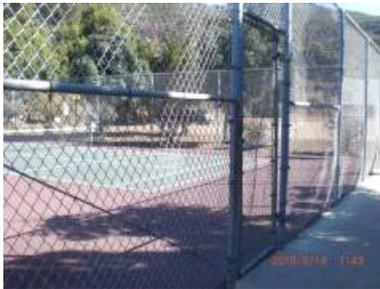
<b>Field Condition</b>	11.12 - Hardware Mounting Height - Mounting height of all operating hardware is not 30" min.. or 44" max., as measured to the highest operable part. (1994 ADA Standards permit a max.. height of 48"; CBC Standards permit a range of 30" min.. to 44" max..)	<b>1991 ADAAG</b> 4.13.9
Existing Condition: 48" high.		<b>2004 ADAAG</b> -
		<b>2007 CBC</b> 1133B.2.5.2
		<b>Other</b> -

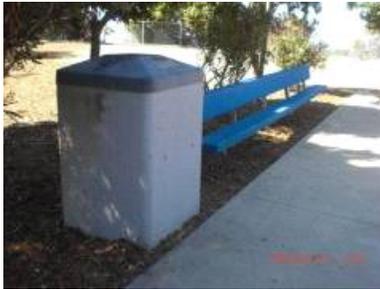
<b>Field Condition</b>	
30.15 - Fixed Bench - Ground/Floor Surface - The surface around the accessible bench is not firm or stable.	1991 ADAAG -
Existing Condition:	2004 ADAAG -
	2007 CBC -
	Other 1999 ADAAG-16.12.6

<b>Corrective Action</b>
006 - Concrete Walk - Remove non-compliant pavement and replace with new concrete (area as shown on the drawings). The walkway slope shall not exceed 5% along the POT and cross slope shall not exceed 2%.
Additional Comments: Provide concrete surface around bench.

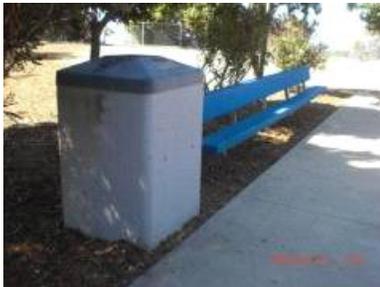
<b>Field Condition</b>	
30.16 - Fixed Bench / Wheelchair Seating Space - Shoulder Alignment - A clear space at least 30" x 48" in size has not been provided at one end of the fixed bench so that a wheelchair user may be seated shoulder-to-shoulder with an individual seated on the bench.	1991 ADAAG -
Existing Condition:	2004 ADAAG -
	2007 CBC -
	Other 1999 ADAAG-16.12.4

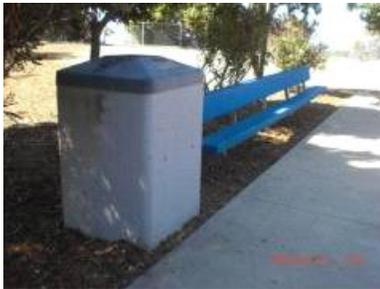
<b>Field Condition</b>	
30.22 - Fixed Bench Armrest - Less than 50% of the fixed benches required to be accessible have at least one armrest that can withstand 250 lbs. of force in any direction.	<b>1991 ADAAG</b> 4.26.3
Existing Condition:	<b>2004 ADAAG</b> 903.6
	<b>2007 CBC</b> 1115B.7.2
	<b>Other</b> 1999 ADAAG-16.12.2.2; 16.12.8

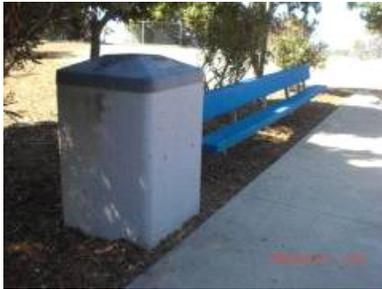
Field Condition	
30.21 - Fixed Bench Size - Accessible bench does not have seats that are 20" to 24" in depth and 42" min. in length. OR The back support does not extend from a point 2" maximum above the bench to 18" min. above the bench.	1991 ADAAG -
Existing Condition: 10" deep, back support extends 14 1/2" high and 5" from edge of seat.	2004 ADAAG 903.3
	903.4
	903.4
	2007 CBC -
	Other -

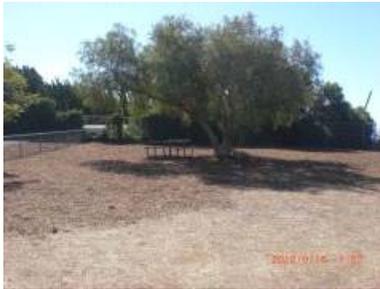
<b>Field Condition</b>	
30.23 - Picnic Sites - Accessible Route - Accessible routes do not connect the picnic site to accessible building entrances, accessible site facilities and the accessible entrance to the site. (A picnic site exists wherever one or more picnic tables is located. In general, picnic areas must include accessible parking, restroom, picnic site and routes that connect each of the elements throughout the area.)	<b>1991 ADAAG</b> 4.1.2(2)(a)  <b>2004 ADAAG</b> 206.2.2; Advisory 206.2.2  <b>2007 CBC</b> 1127B.1; 1132B.2  <b>Other</b> 1999 ADAAG-16.1
Existing Condition: No POT connects to picnic table.

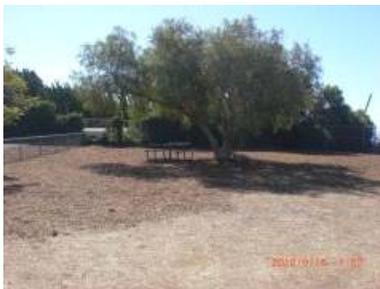
<b>Field Condition</b>	
30.29 - Picnic Site Surface - Picnic tables and benches are not on a firm and stable surface.	<b>1991 ADAAG</b> -  <b>2004 ADAAG</b> -  <b>2007 CBC</b> -  <b>Other</b> 1999 ADAAG-16.5.6
Existing Condition: Mulch around picnic area.

<b>Corrective Action</b>
006 - Concrete Walk - Remove non-compliant pavement and replace with new concrete (area as shown on the drawings). The walkway slope shall not exceed 5% along the POT and cross slope shall not exceed 2%.
Additional Comments: Provide concrete surface around picnic table.

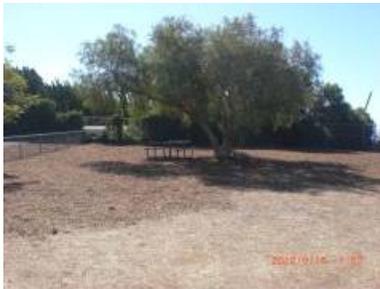
<b>Field Condition</b>	
30.25 - Number - Accessible Picnic Tables - Where fixed picnic tables are provided in a picnic area, the required number of fixed picnic tables is not provided. (1999 ADAAG: Where two or more fixed picnic tables are provided in a picnic area, at least 50%, but never less than two, shall comply with 16.5.4 through 16.5.6. In addition, at least 40%, but never less than two, of the accessible picnic tables shall be connected to an outdoor recreation access route complying with 16.3.)	<b>1991 ADAAG</b> -
Existing Condition: 2 picnic tables, 0 accessible.	<b>2004 ADAAG</b> -
	<b>2007 CBC</b> -
	<b>Other</b> 1999 ADAAG-16.5.1.2

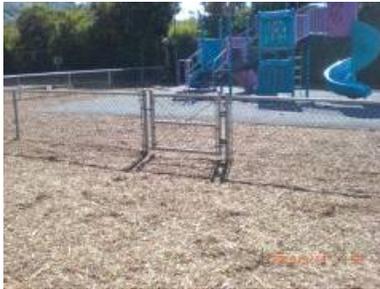
<b>Field Condition</b>	
10.08 - Kick Plate - Bottom 10" of door does not have a smooth, uninterrupted surface on the push side to allow the door to be opened by a wheelchair footrest without creating a trap or hazardous condition. (This requirement does not apply to automatic and sliding doors.)	<b>1991 ADAAG</b> -
Existing Condition:	<b>2004 ADAAG</b> 404.2.10
	<b>2007 CBC</b> 1133B.2.6
	<b>Other</b> -

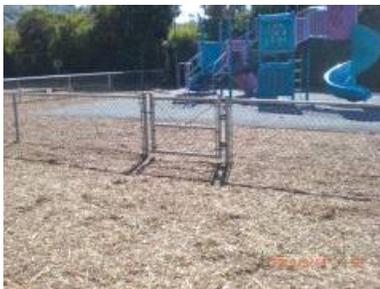
**Keynote 109**

<b>Field Condition</b>	
31.37A - Soft Contained Play Structures - 1 Entry Point Standard - Where three or fewer entry points are provided, there is not at least one entry point located on an accessible route.	<b>1991 ADAAG</b> -
Existing Condition:	<b>2004 ADAAG</b> 206.2.17.2
	<b>2007 CBC</b> -
	<b>Other</b> 2000 ADAAG-15.6.8.1

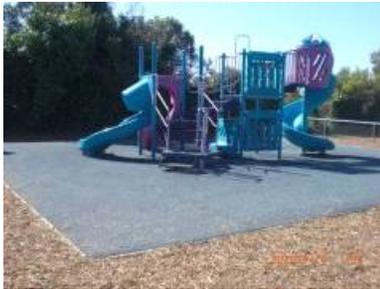
**Location:** Playground  
**Photo #** 110

<b>Field Condition</b>	
31.22A - Transfer Platforms - Transfer Space Size - Transfer space provided at the transfer platform is less than 30" x 48" min..	1991 ADAAG -
Existing Condition:	2004 ADAAG 1008.3.1.3
	2007 CBC -
	Other 2000 ADAAG-15.6.5.1.3

<b>Corrective Action</b>
516 - Replace Playground Equipment - Remove non-compliant playground equipment and replace with new accessible equipment.
Additional Comments:

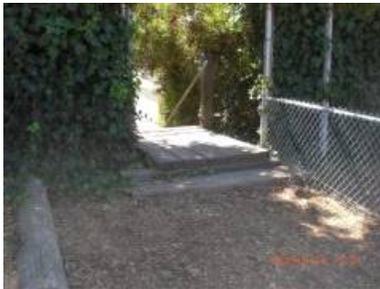
**Location:** Bottom Stairs  
**Photo #** 111

<b>Field Condition</b>	
08.09A - Handrail Extensions - Top Landing - At ends of handrails, less than 12" of handrail extends beyond the top nosing. (Top and bottom handrail extensions are important safety features for persons with balance problems and must extend in the direction of the stair run to permit the intended use.) (Per ADA/CBC Standards, in existing buildings and facilities, full extension of handrails at stairs shall not be required in alterations where such extensions would be hazardous or impossible due to plan configuration.)	1991 ADAAG 4.9.4(2)
Existing Condition: None provided.	2004 ADAAG 505.10; 505.10.2; Fig. 505.10.2
	2007 CBC 1133B.4.2.2
	Other -

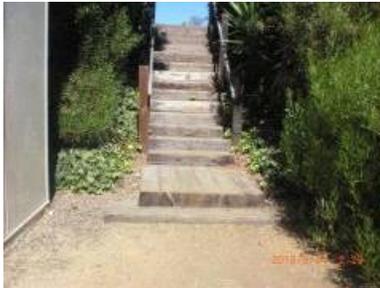
**Location:** Bottom Stairs      **Photo #** 112

<b>Field Condition</b>	
08.09B - Handrail Extensions - Bottom Landing - At ends of handrails, less than 12" plus the tread width extends beyond the bottom nosing. (Top and bottom handrail extensions are important safety features for persons with balance problems and must extend in the direction of the stair run to permit the intended use.) (Per ADA/CBC Standards, in existing buildings and facilities, full extension of handrails at stairs shall not be required in alterations where such extensions would be hazardous or impossible due to plan configuration.)	<b>1991 ADAAG</b> 4.9.4(2)  <b>2004 ADAAG</b> 505.10; 505.10.3; Fig. 505.10.3  <b>2007 CBC</b> 1133B.4.2.2  <b>Other</b> -
Existing Condition: None provided.

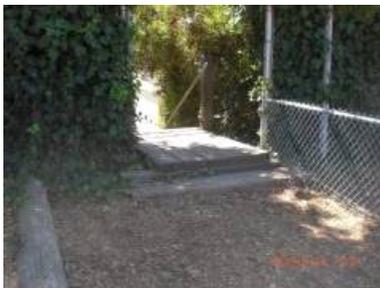
**Keynote 113**

<b>Field Condition</b>	
08.03D - Level Landing - Landing is not level (slope is greater than 2% in some or all directions).	<b>1991 ADAAG</b> -  <b>2004 ADAAG</b> -  <b>2007 CBC</b> 1009.5.1  <b>Other</b> -
Existing Condition: 3.3% RS, uneven landing.

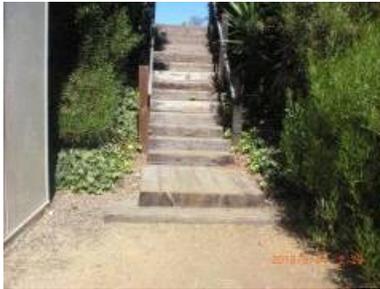
**Keynote 114**

<b>Field Condition</b>	
08.05A - Exterior Stairs - Color Strip - Contrasting color strips have not been provided.	1991 ADAAG -
Existing Condition: None provided.	2004 ADAAG -
	2007 CBC 1133B.4.4
	Other -
