*City of Rancho Palos Verdes*  
**Rancho Palos Verdes ADA Assessment**  
**Facility Report with Photos**

**Facility ID: # 08 - Ladera Linda Park & Community Center**

**Author: Vaish, B**

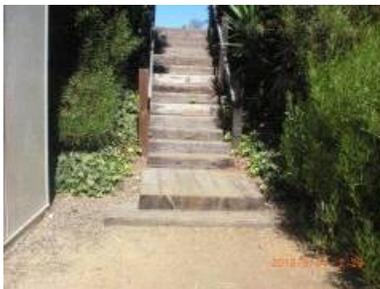
**Keynote 115**

<b>Field Condition</b>	
08.03C - Tread Slope - The treads have a slope steeper than 2%.	1991 ADAAG -
Existing Condition: Uneven tread slope.	2004 ADAAG 504.4 [Exception]
	2007 CBC 1009.5.1
	Other -

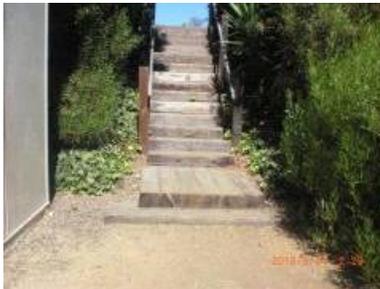
**Keynote 117**

Field Condition	
08.02B - Riser Height - The risers are not uniform. OR The risers are not between 4" and 7" in height.	1991 ADAAG 4.9.2
Existing Condition: 6 1/2" to 7".	2004 ADAAG 504.2
	2007 CBC 1009.3; 1133B.4.5.3
	Other -

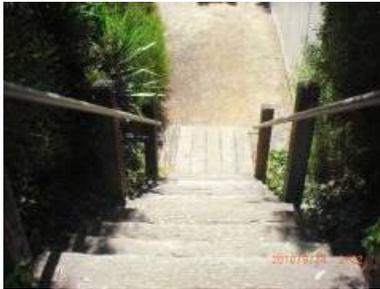
**Location:** Bottom Stairs  
**Photo #** 118

<b>Field Condition</b>	08.10A - Profile of Handrails - The diameter of the handrail is not between 1-1/4" and 1-1/2" in cross-sectional nominal dimension. OR The shape does not provide an equivalent gripping surface (equivalent gripping surfaces are 4" to 6-1/4" in perimeter, and 2-1/4" max. in any direction). (Note: Standard pipe sizes designated by the industry as 1-1/4" to 1-1/2" are acceptable).	<b>1991 ADAAG</b> 4.9.4; 4.26.2
	Existing Condition: 2".	<b>2004 ADAAG</b> 505.7.1; 505.7.2; Fig. 505.7.2
		<b>2007 CBC</b> 1133B.4.2.6
		<b>Other</b> -

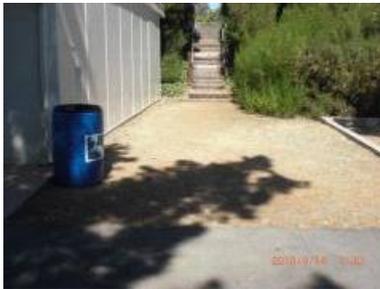
**Location:** Bottom Stairs  
**Photo #** 119

<b>Field Condition</b>	03B.01 - On-site Accessible Route of Travel - There is no accessible route within the property line of the site linking an accessible building entrance with site arrival points serving the following, if provided: public transportation stops, accessible parking, passenger loading zones, and public sidewalks.	<b>1991 ADAAG</b> 4.1.2(1)
	Existing Condition: No POT connects to stairs at top and bottom landings.	<b>2004 ADAAG</b> 202.2.1; Advisory 206.2.1
		<b>2007 CBC</b> 1114B.1.2; 1127B.1
		<b>Other</b> -

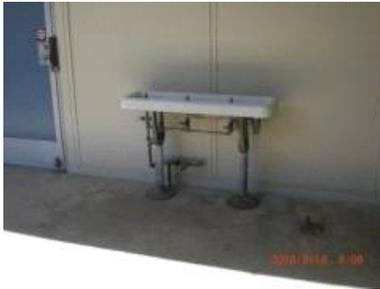
**Location:** School Grounds  
**Photo #** 120

<b>Field Condition</b>	05.13 - Operation - The controls are not compliant.(Accessible controls shall be operable with one hand, and without tight grasping, pinching, or twisting of the wrist, and the force to operate the controls shall be no greater than 5 lbs.)	<b>1991 ADAAG</b> 4.27.4
	Existing Condition: Knobs.	<b>2004 ADAAG</b> 602.3; 309.4
		<b>2007 CBC</b> 1115B.4.6 item 4
		<b>Other</b> -

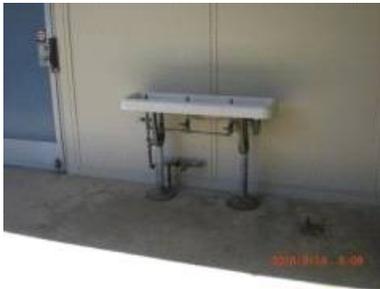
**Keynote 121**

<b>Field Condition</b>	05.01A - "HI" Drinking Fountain Requirement - Where there is only one drinking fountain area on a floor (e.g., an area with a drinking fountain or separate drinking fountains), it is accessible to wheelchair users and not to persons who have difficulty bending or stooping (i.e., the required accessibility for persons who have difficulty bending or stooping on each floor has not been provided).	<b>1991 ADAAG</b> 4.1.3(10)(a); 4.15.1
	Existing Condition: Missing bubblers.	<b>2004 ADAAG</b> 211.1; 211.2
		<b>2007 CBC</b> 1115B.4.6 item 1
		<b>Other</b> -

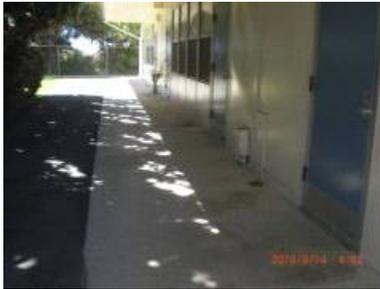
**Location:** School Grounds **Photo #** 122

03B.09 - Cross Slope - Cross slope of the accessible route of travel exceeds 1:50. **1991 ADAAG** 4.3.7

Existing Condition: 2.3% to 3.2% CS.

006 - Concrete Walk - Remove non-compliant pavement and replace with new concrete (area as shown on the drawings). The walkway slope shall not exceed 5% along the POT and cross slope shall not exceed 2%.

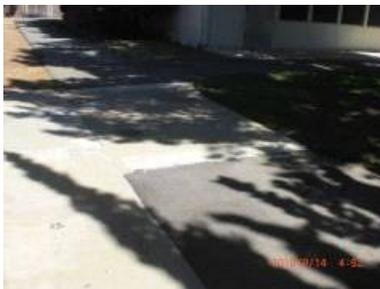
**Keynote 123**

03B.09 - Cross Slope - Cross slope of the accessible route of travel exceeds 1:50. **1991 ADAAG** 4.3.7

Existing Condition: 4.6%.

006 - Concrete Walk - Remove non-compliant pavement and replace with new concrete (area as shown on the drawings). The walkway slope shall not exceed 5% along the POT and cross slope shall not exceed 2%.

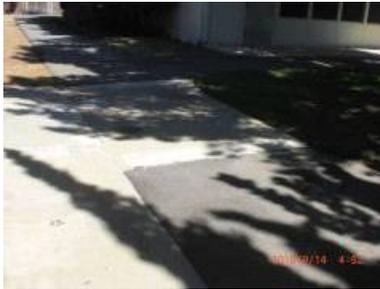
**Keynote 124**

<b>Field Condition</b>	
03B.13 - > 1/2" Changes in Level - Curb ramps, ramps, or elevators are not used for changes in level greater than 1/2 inch. (Lifts may only be used in certain limited situations.)	1991 ADAAG 4.5.2
Existing Condition: 1/2" level change.	2004 ADAAG 303.4
	2007 CBC 1124B.2
	Other -

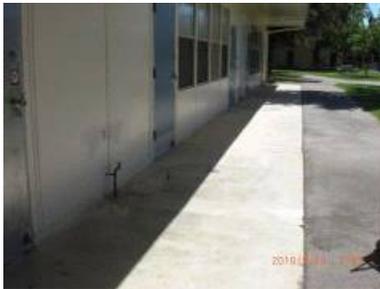
**Keynote 125**

<b>Field Condition</b>	
03B.09 - Cross Slope - Cross slope of the accessible route of travel exceeds 1:50.	1991 ADAAG 4.3.7
Existing Condition: 2.2% to 3.5% CS.	2004 ADAAG 403.3
	2007 CBC 1133B.7.1.3
	Other -

<b>Corrective Action</b>
006 - Concrete Walk - Remove non-compliant pavement and replace with new concrete (area as shown on the drawings). The walkway slope shall not exceed 5% along the POT and cross slope shall not exceed 2%.
Additional Comments:

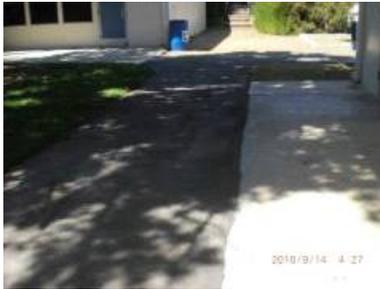
Location: School Grounds Photo # 126

<b>Field Condition</b>									
03B.09 - Cross Slope - Cross slope of the accessible route of travel exceeds 1:50. Existing Condition: 2.2%.

<b>Corrective Action</b>	
004A - Asphalt Paving - Remove non-compliant pavement and replace with new asphalt paving (area as shown on the drawings). The walkway slope shall not exceed 5% along the POT and cross slope shall not exceed 2%.	
Additional Comments:

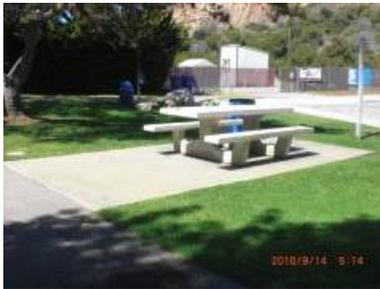
**Keynote 127**

<b>Field Condition</b>									
30.32 - 36" Aisle Width Standard - Around the picnic table, there is less than 36" clear space measured from the seat. Existing Condition: 20" to 27" aisle with around picnic table.

<b>Corrective Action</b>	
006 - Concrete Walk - Remove non-compliant pavement and replace with new concrete (area as shown on the drawings). The walkway slope shall not exceed 5% along the POT and cross slope shall not exceed 2%.	
Additional Comments: Provide compliant aisle width around picnic table, with compliant slopes.

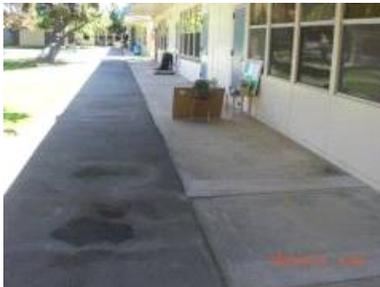
**Keynote 129**

<p><b>Field Condition</b></p> <p>03B.09 - Cross Slope - Cross slope of the accessible route of travel exceeds 1:50.</p> <p>Existing Condition: 2.3% to 4.0% CS.</p>

<p><b>Corrective Action</b></p> <p>006 - Concrete Walk - Remove non-compliant pavement and replace with new concrete (area as shown on the drawings). The walkway slope shall not exceed 5% along the POT and cross slope shall not exceed 2%.</p> <p>Additional Comments:</p>

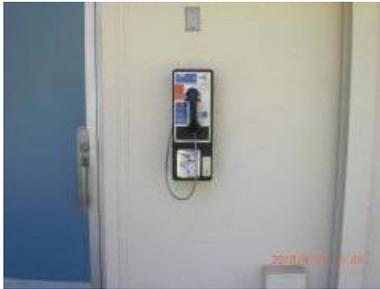
**Location:** School Grounds **Photo #** 130

<b>Field Condition</b>	
06.02B - ISA Sign - The wheelchair accessible telephone is not identified by the ISA.	<b>1991 ADAAG</b> 4.1.3(17)(b); 4.30.7(1)
Existing Condition:	<b>2004 ADAAG</b> 703.2.1; Fig. 703.2.1
	<b>2007 CBC</b> 1117B.5.8.1
	<b>Other</b> -

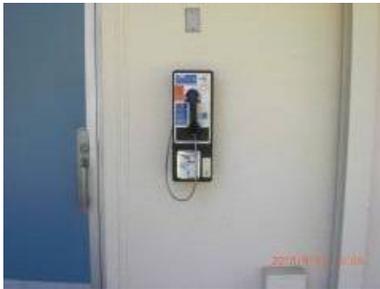
**Keynote 131**

<b>Field Condition</b>	
06.08 - Wall-Mounted Protruding Objects - Wall-mounted telephone(s) with leading edges between 27" and 80" from the floor projects more than 4" into the circulation path. (Wall mounted telephones or their enclosures with leading edges at or below 27" may project any amount as long as the required clear width of an accessible route is not reduced.)	<b>1991 ADAAG</b> 4.31.4; 4.4.1
Existing Condition:	<b>2004 ADAAG</b> 204; 307.2; Advisory 307.2; Fig. 307.2
	<b>2007 CBC</b> 1133B.8.6.1
	<b>Other</b> -

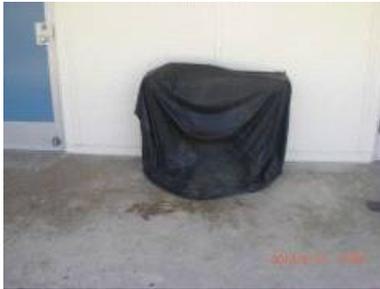
**Keynote 132**

<b>Field Condition</b>	
05.01A - "Hi" Drinking Fountain Requirement - Where there is only one drinking fountain area on a floor (e.g., an area with a drinking fountain or separate drinking fountains), it is accessible to wheelchair users and not to persons who have difficulty bending or stooping (i.e., the required accessibility for persons who have difficulty bending or stooping on each floor has not been provided).	<b>1991 ADAAG</b> 4.1.3(10)(a); 4.15.1 <b>2004 ADAAG</b> 211.1; 211.2 <b>2007 CBC</b> 1115B.4.6 item 1 <b>Other</b> -
Existing Condition: Non-functioning.

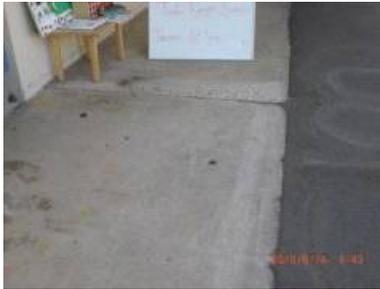
**Keynote 134**

<b>Field Condition</b>	
03B.12 - > 1/4" Changes in Level - Where walkway levels change abruptly, the vertical difference between them exceeds 1/4 inch. Or changes in level between 1/4 inch and 1/2 inch are beveled with a slope greater than 1:2.	1991 ADAAG 4.5.2
Existing Condition: 1/4" level change.	2004 ADAAG 303.2; 303.3
	2007 CBC 1124B.2
	Other -

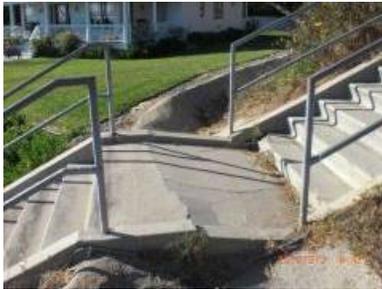
**Location:** Stairs  
**Photo #** 136

Field Condition	
08.03E - Drainage - Design of outside stairs and their approaches allows water to accumulate on walking surfaces.	1991 ADAAG 4.9.6
Existing Condition: Drain ditch runs along landings at 4 locations.	2004 ADAAG 504.7
	2007 CBC 1133B.4.5.1
	Other -

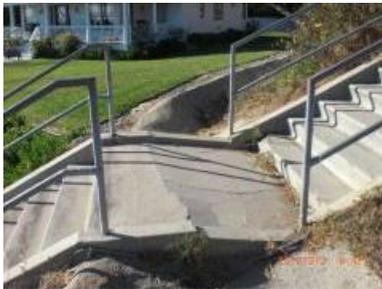
**Keynote 137**

Field Condition	
08.03D - Level Landing - Landing is not level (slope is greater than 2% in some or all directions).	1991 ADAAG -
Existing Condition: 2.7% to 12.9% RS at intermediate and bottom landings.	2004 ADAAG -
	2007 CBC 1009.5.1
	Other -

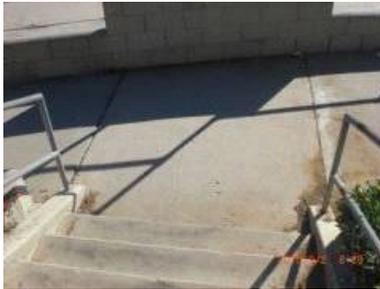
**Keynote 138**

08.09B - Handrail Extensions - Bottom Landing - At ends of handrails, less than 12" plus the tread width extends beyond the bottom nosing. (Top and bottom handrail extensions are important safety features for persons with balance problems and must extend in the direction of the stair run to permit the intended use.) (Per ADA/CBC Standards, in existing buildings and facilities, full extension of handrails at stairs shall not be required in alterations where such extensions would be hazardous or impossible due to plan configuration.)

Existing Condition: None provided.

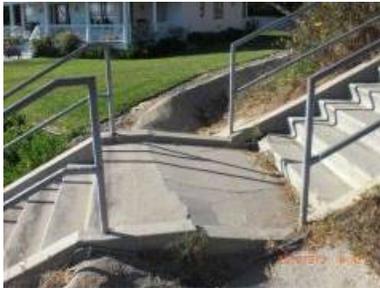
**Location:** Stairs  
**Photo #** 136

<b>Field Condition</b>	
08.07A - Continuous Handrails - Continuous handrails are not provided along both sides.	<b>1991 ADAAG</b> 4.9.4
Existing Condition:	<b>2004 ADAAG</b> 504.6; 505.2
	<b>2007 CBC</b> 1133B.4.1.1
	<b>Other</b> -

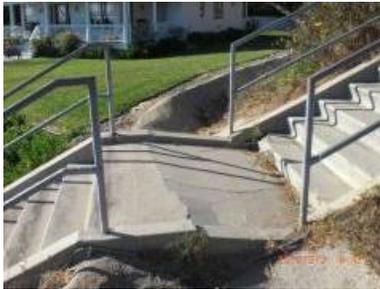
**Location:** Stairs  
**Photo #** 136

<b>Field Condition</b>	
08.15 - Landing Size - Landing depth in the direction of travel is not at least equal to the width of the stairway.	1991 ADAAG -
Existing Condition: Intermediate landings 66" wide x 58" deep.	2004 ADAAG -
	2007 CBC 1009.4
	Other -

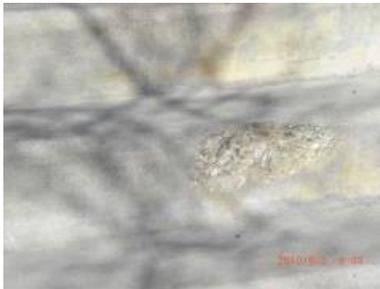
**Location:** Stairs  
**Photo #** 143

<b>Field Condition</b>	
08.18 - Other - Stairs - See Additional Comments	1991 ADAAG -
Existing Condition: Bad stair condition.	2004 ADAAG -
	2007 CBC -
	Other -

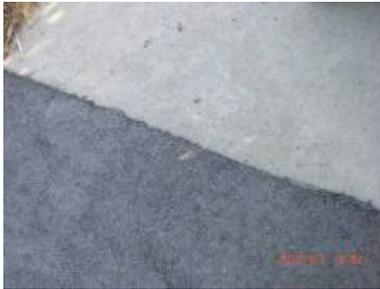
**Location:** Stairs  
**Photo #** 144

03B.13 - > 1/2" Changes in Level - Curb ramps, ramps, or elevators are not used for changes in level greater than 1/2 inch. (Lifts may only be used in certain limited situations.)

Existing Condition: 1" level change.

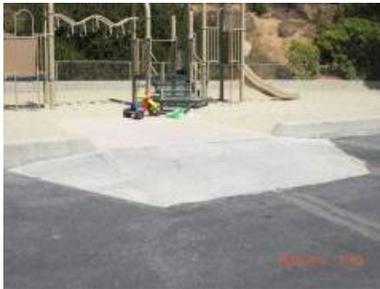
**Keynote 145**

31.14 - Play Area Ramp Standards - This portion of an accessible route with a slope greater than 5% (1:20) does not comply with the requirements for compliant ramps. (Ramps within play areas, ramps connecting ground level play components, and ramps connecting elevated play components shall comply with 1008.2.5 and 15.6.4.4.)

Existing Condition: 9.3%

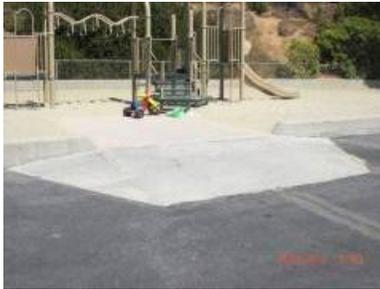
Location: Playground Photo # 145

<b>Field Condition</b>	
31.38 - Other - Play Areas - See Additional Comments	1991 ADAAG -
Existing Condition: Level change at transition from rubber surface to sand.	2004 ADAAG -
	2007 CBC -
	Other -

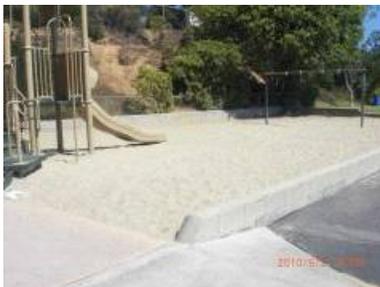
<b>Field Condition</b>	
31.34 - Play Areas - Ground Surfaces - Ground surfaces along accessible routes, clear floor or ground spaces, or turning spaces are not compliant.	1991 ADAAG -
Existing Condition: No rubber surface at swing.	2004 ADAAG 1008.2.6
	2007 CBC -
	Other 2000 ADAAG-15.6.7; PRC 5410-5411; H&SC 115725

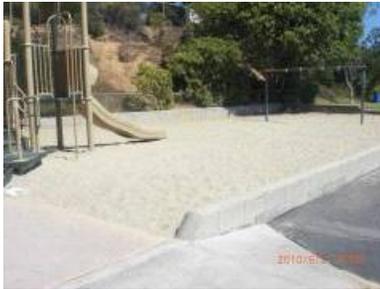
**Location:** Playground **Photo #** 147

<b>Field Condition</b>	31.10 - Accessible Routes - Location - Accessible routes required within the boundary of play area do not connect ground level play components and elevated components, including entry and exit points.	<b>1991 ADAAG</b> -
	Existing Condition: Playground entry point not connected to swings.	<b>2004 ADAAG</b> 1008.2
		<b>2007 CBC</b> -
		<b>Other</b> 2000 ADAAG-15.6.4.1

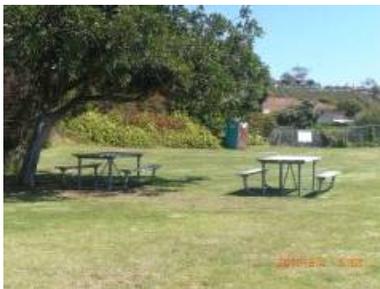
<b>Field Condition</b>	30.23 - Picnic Sites - Accessible Route - Accessible routes do not connect the picnic site to accessible building entrances, accessible site facilities and the accessible entrance to the site. (A picnic site exists wherever one or more picnic tables is located. In general, picnic areas must include accessible parking, restroom, picnic site and routes that connect each of the elements throughout the area.)	<b>1991 ADAAG</b> 4.1.2(2)(a)
	Existing Condition: No POT connects to picnic tables.	<b>2004 ADAAG</b> 206.2.2;Advisory206.2.2
		<b>2007 CBC</b> 1127B.1; 1132B.2
		<b>Other</b> 1999 ADAAG-16.1

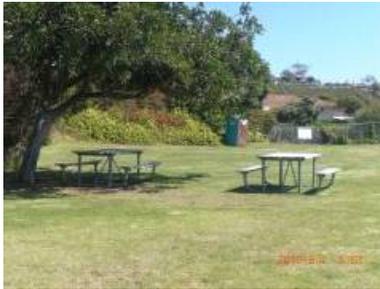
**Location:** Basketball Courts **Photo #** 149

<b>Field Condition</b>	<p>30.25 - Number - Accessible Picnic Tables - Where fixed picnic tables are provided in a picnic area, the required number of fixed picnic tables is not provided. (1999 ADAAG: Where two or more fixed picnic tables are provided in a picnic area, at least 50%, but never less than two, shall comply with 16.5.4 through 16.5.6. In addition, at least 40%, but never less than two, of the accessible picnic tables shall be connected to an outdoor recreation access route complying with 16.3.)</p> <p>Existing Condition:</p>	<p><b>1991 ADAAG</b> -</p> <p><b>2004 ADAAG</b> -</p> <p><b>2007 CBC</b> -</p> <p><b>Other</b> 1999 ADAAG-16.5.1.2</p>
------------------------	---	--

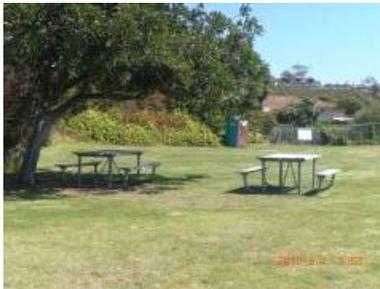
<b>Field Condition</b>	<p>30.29 - Picnic Site Surface - Picnic tables and benches are not on a firm and stable surface.</p> <p>Existing Condition:</p>	<p><b>1991 ADAAG</b> -</p> <p><b>2004 ADAAG</b> -</p> <p><b>2007 CBC</b> -</p> <p><b>Other</b> 1999 ADAAG-16.5.6</p>
------------------------	---	--

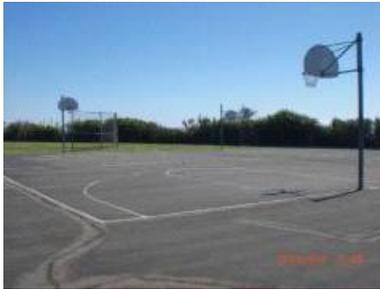
**Location:** Basketball Courts  
**Photo #** 152

<b>Field Condition</b>	
03B.09 - Cross Slope - Cross slope of the accessible route of travel exceeds 1:50. Existing Condition: 2.8% slope at basketball court.	<b>1991 ADAAG</b> 4.3.7  <b>2004 ADAAG</b> 403.3  <b>2007 CBC</b> 1133B.7.1.3  <b>Other</b> -

<b>Corrective Action</b>	
004A - Asphalt Paving - Remove non-compliant pavement and replace with new asphalt paving (area as shown on the drawings). The walkway slope shall not exceed 5% along the POT and cross slope shall not exceed 2%.	
Additional Comments:

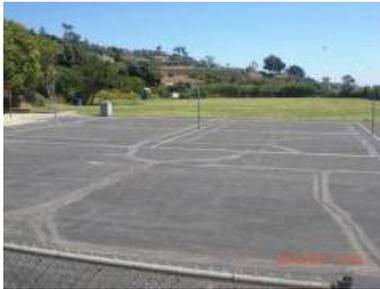
Location: Basketball Courts      Photo # 154

<b>Field Condition</b>									
03B.09 - Cross Slope - Cross slope of the accessible route of travel exceeds 1:50. Existing Condition: 2.7% to 3.4% CS at volleyball court

<b>Corrective Action</b>	
004A - Asphalt Paving - Remove non-compliant pavement and replace with new asphalt paving (area as shown on the drawings). The walkway slope shall not exceed 5% along the POT and cross slope shall not exceed 2%.  Additional Comments:

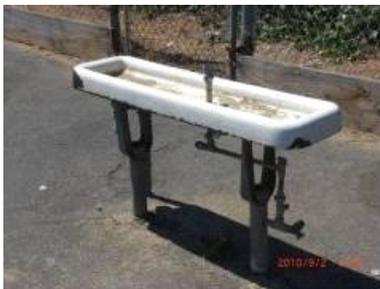
<b>Field Condition</b>									
05.01B - "Lo" Drinking Fountain Requirement - Where there is only one drinking fountain area on a floor (e.g., an area with a drinking fountain or separate drinking fountains), it is accessible to persons who have difficulty bending or stooping and not to wheelchair users (i.e., the required accessibility for wheelchair users on each floor has not been provided).  Existing Condition:

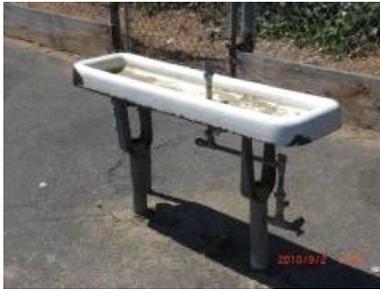
**Location:** Basketball Courts  
**Photo #** 155

<b>Field Condition</b>	05.01A - "Hi" Drinking Fountain Requirement - Where there is only one drinking fountain area on a floor (e.g., an area with a drinking fountain or separate drinking fountains), it is accessible to wheelchair users and not to persons who have difficulty bending or stooping (i.e., the required accessibility for persons who have difficulty bending or stooping on each floor has not been provided).	<b>1991 ADAAG</b>	4.1.3(10)(a); 4.15.1
		<b>2004 ADAAG</b>	211.1; 211.2
		<b>2007 CBC</b>	1115B.4.6 item 1
		<b>Other</b>	-
<b>Existing Condition:</b>

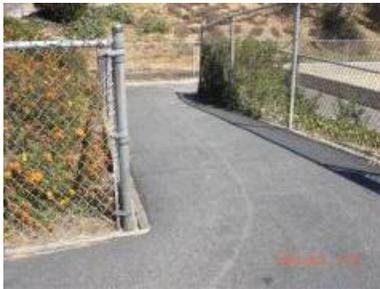
<b>Field Condition</b>	07.01A - Ramps - This portion of an accessible route with a slope greater than 5% does not comply with the requirements for compliant ramps.	<b>1991 ADAAG</b>	4.8.1
		<b>2004 ADAAG</b>	402.2; Advisory 402.2
		<b>2007 CBC</b>	1133B.5.1
		<b>Other</b>	-
<b>Existing Condition:</b>

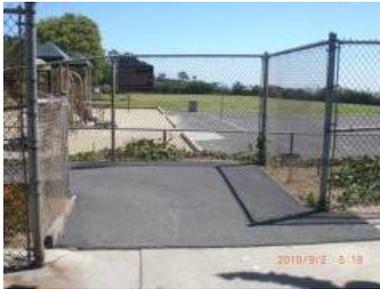
**Location:** Basketball Courts  
**Photo #** 158

<b>Field Condition</b>	
07.29 - Other - Ramps - See Additional Comments	1991 ADAAG -
Existing Condition: 3/4" level change at transition from concrete to asphalt.	2004 ADAAG -
	2007 CBC -
	Other -

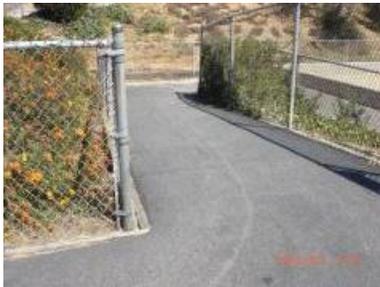
<b>Field Condition</b>	
07.02 - Running Slope - Slope of the ramp exceeds 8.33% (or the least possible compliant slope).	1991 ADAAG 4.8.2
Existing Condition: 12.4%.	2004 ADAAG 405.2; Advisory 405.2
	2007 CBC 1133B.5.3
	Other -

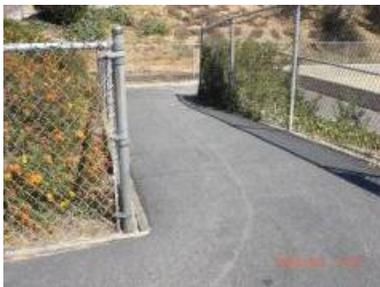
**Location:** Basketball Courts  
**Photo #** 157

<b>Field Condition</b>	
07.03 - Maximum Rise - The rise for any continuous run exceeds 30" high.	1991 ADAAG 4.8.2
Existing Condition: Greater than 30" with no intermediate landings.	2004 ADAAG 405.6
	2007 CBC 1133B.5.4.1
	Other -

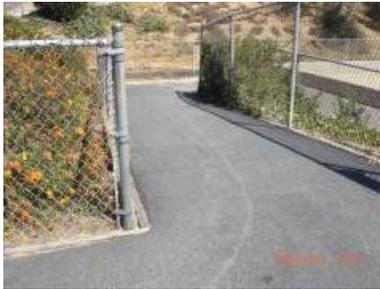
**Location:** Basketball Courts  
**Photo #** 157

<b>Field Condition</b>	
07.16 - Handrails - Slope of the ramp exceeds 5%, and handrails are not provided on each side. (Per CBC 1133B.5.5.1, at exterior door landings, handrails are not required on ramps less than 6" high or 72" long. Handrails are not required on curb ramps or adjacent to fixed seating in assembly areas.)	1991 ADAAG 4.8.5
Existing Condition: None provided.	2004 ADAAG 405.8; 505.2
	2007 CBC 1133B.5.5.1
	Other -

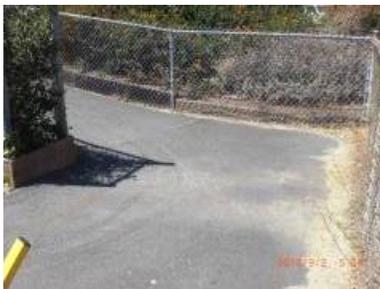
<b>Field Condition</b>	
03B.12 - > 1/4" Changes in Level - Where walkway levels change abruptly, the vertical difference between them exceeds 1/4 inch. Or changes in level between 1/4 inch and 1/2 inch are beveled with a slope greater than 1:2.	1991 ADAAG 4.5.2
Existing Condition: 1" crack.	2004 ADAAG 303.2; 303.3
	2007 CBC 1124B.2
	Other -

<b>Corrective Action</b>	
005B - Concrete Crack Repair - Clean-out existing concrete crack and inject with epoxy grout. Cracks over 1/4" in width will require a foam backer rod and sealant.	
Additional Comments:

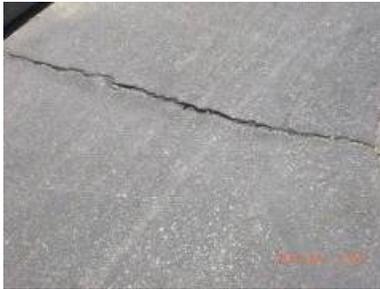
**Location:** Basketball Courts  
**Photo #** 164

<b>Field Condition</b>	
03B.12 - > 1/4" Changes in Level - Where walkway levels change abruptly, the vertical difference between them exceeds 1/4 inch. Or changes in level between 1/4 inch and 1/2 inch are beveled with a slope greater than 1:2.	1991 ADAAG 4.5.2
Existing Condition: 3/4" crack.	2004 ADAAG 303.2; 303.3
	2007 CBC 1124B.2
	Other -

<b>Corrective Action</b>	
005B - Concrete Crack Repair - Clean-out existing concrete crack and inject with epoxy grout. Cracks over 1/4" in width will require a foam backer rod and sealant.	
Additional Comments:

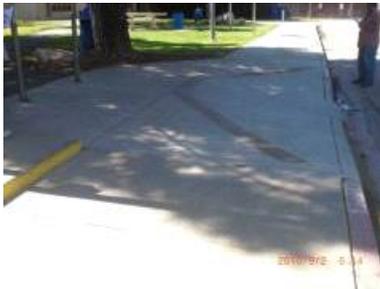
<b>Field Condition</b>	
04.01B - Curb Ramp Compliance - Where accessible route crosses a curb, a curb ramp has not been provided.	1991 ADAAG 4.7.1
Existing Condition:	2004 ADAAG 406.1
	2007 CBC 1127B.5 item 1
	Other 2005 PROWAG-R303

<b>Corrective Action</b>	
120D - Replace Curb Ramp - Remove existing curb ramp, provide new.	
Additional Comments:

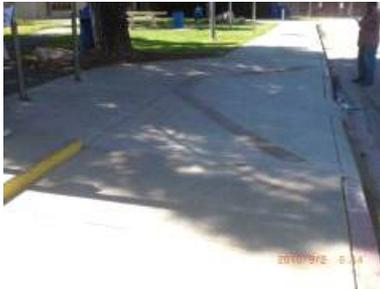
**Location:** School Grounds  
**Photo #** 165

Field Condition									
04.02 - Slope - Slope of the curb ramp exceeds 8.33% (or the least possible compliant slope).  Existing Condition: 14%.

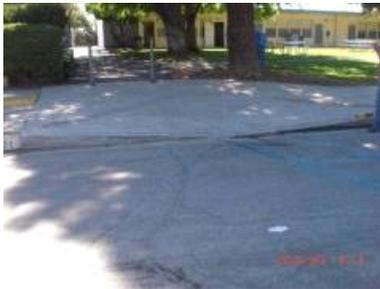
**Location:** School Grounds  
**Photo #** 167

Field Condition									
04.04 - Counter Slope - The running slopes of the road, gutter or accessible route adjoining the ramp exceed 5%.  Existing Condition: 9.1%.

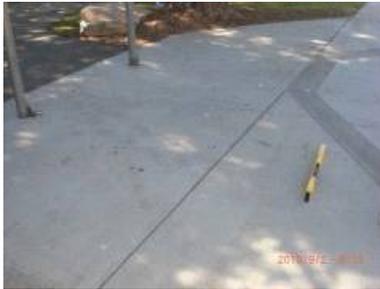
Location: School Grounds Photo # 170

<b>Field Condition</b>									
03B.09 - Cross Slope - Cross slope of the accessible route of travel exceeds 1:50. Existing Condition: 7.5% at curb ramp top landing.

<b>Corrective Action</b>
006 - Concrete Walk - Remove non-compliant pavement and replace with new concrete (area as shown on the drawings). The walkway slope shall not exceed 5% along the POT and cross slope shall not exceed 2%.  Additional Comments:

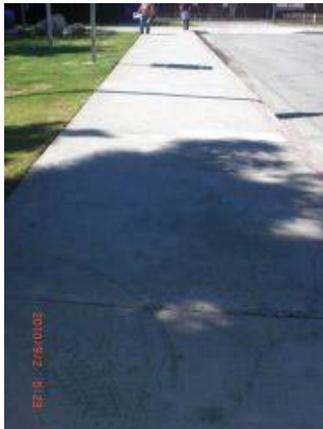
<b>Field Condition</b>									
03B.09 - Cross Slope - Cross slope of the accessible route of travel exceeds 1:50. Existing Condition: 2.4% to 6.6% CS.

<b>Corrective Action</b>
006 - Concrete Walk - Remove non-compliant pavement and replace with new concrete (area as shown on the drawings). The walkway slope shall not exceed 5% along the POT and cross slope shall not exceed 2%.  Additional Comments:

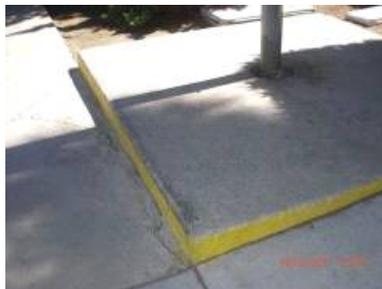
**Location:** School Grounds  
**Photo #** 173

Field Condition									
03B.22 - Other - On-Site Accessible Path of Travel - See Additional Comments Existing Condition: 4" level change to flag pole.

Corrective Action
006 - Concrete Walk - Remove non-compliant pavement and replace with new concrete (area as shown on the drawings). The walkway slope shall not exceed 5% along the POT and cross slope shall not exceed 2%.  Additional Comments: Provide compliant walk to flag pole.

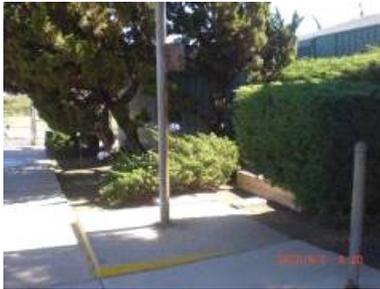
**Location:** School Grounds  
**Photo #** 174

<b>Field Condition</b>	
03B.22 - Other - On-Site Accessible Path of Travel - See Additional Comments	1991 ADAAG -
Existing Condition: 66" to rope.	2004 ADAAG -
	2007 CBC -
	Other -

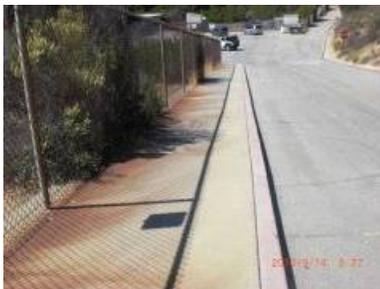
<b>Field Condition</b>	
03B.09 - Cross Slope - Cross slope of the accessible route of travel exceeds 1:50.	1991 ADAAG 4.3.7
Existing Condition: 2.5% to 6.3% CS.	2004 ADAAG 403.3
	2007 CBC 1133B.7.1.3
	Other -

<b>Corrective Action</b>	
006 - Concrete Walk - Remove non-compliant pavement and replace with new concrete (area as shown on the drawings). The walkway slope shall not exceed 5% along the POT and cross slope shall not exceed 2%.	
Additional Comments:

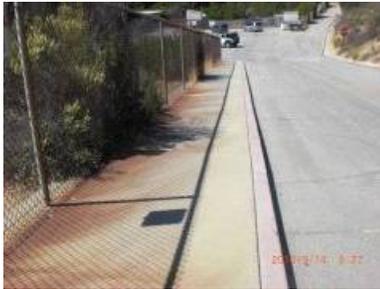
**Location:** Driveway  
**Photo #** 175

Field Condition									
03B.10 - Running Slope - Slope of the accessible route of travel exceeds 1:20.  Existing Condition: 6.6% to 12.1% RS.

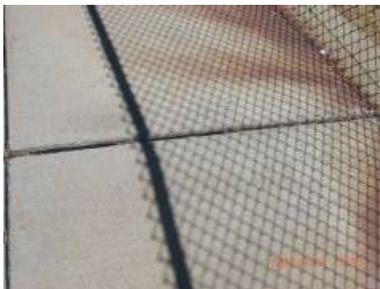
**Location:** Driveway  
**Photo #** 177

Field Condition									
03B.22 - Other - On-Site Accessible Path of Travel - See Additional Comments  Existing Condition: 1" gap.

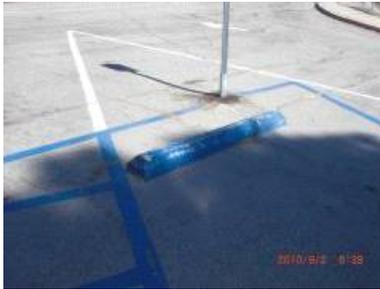
Location: Parking Lot Photo # 178

<b>Field Condition</b>	
01.23 - Other - Parking - See Additional Comments	1991 ADAAG -
Existing Condition: Tire stop adjacent to access aisle.	2004 ADAAG -
	2007 CBC -
	Other

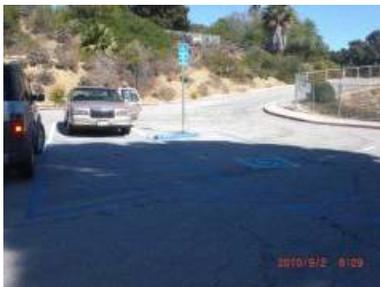
<b>Field Condition</b>	
01.10B - Van Access Aisle - Location - Where the parking space is designated as "van accessible," the adjacent access aisle is not located on the passenger side of the vehicle space.	1991 ADAAG 4.1.2(5)(b)
Existing Condition: Van access aisle not on passenger side.	2004 ADAAG -
	2007 CBC 1129B.3 item 2
	Other

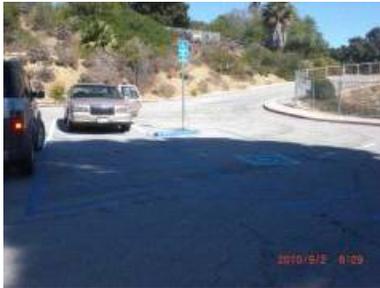
03B.21 - Hazardous Vehicular Areas - Detectable Warnings - Where a walk crosses or adjoins the vehicular way and the walking surface is not separated by curbs, railings, or other elements between the pedestrian areas and vehicular areas, the boundary between the areas is not defined by a continuous detectable warning at least 36" wide complying with CBC 1121B.3.1 item 8(a). (i.e., the warning surface shall contrast visually with adjoining surfaces, either light on dark or dark on light, and shall differ from adjoining walking surfaces in resiliency or sound on cane contact. Color: yellow conforming to Federal Color No. 33538, Table IV/ Standard No. 595B. Where the color value contrast between the yellow warning and the main walking surface is less than 70 percent, a 1" wide black strip shall separate the yellow warning from the main walking surface.)

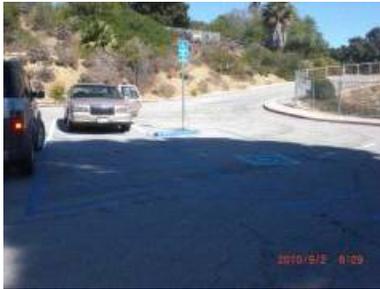
<b>Field Condition</b>	
01.19A - Lettering - The words "NO PARKING" is not provided in each access aisle, painted in white, 12" high letters.	1991 ADAAG -
Existing Condition:	2004 ADAAG -
	2007 CBC 1129B.3 items 1 & 2
	Other

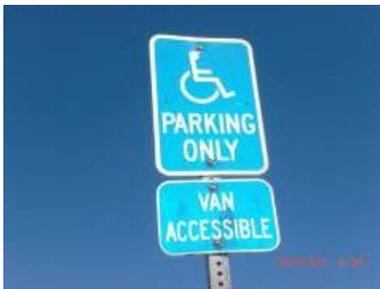
<b>Field Condition</b>	
01.15C - Minimum Fine Sign - Accessible parking space has no sign stating "Minimum Fine \$250" below the ISA.	1991 ADAAG -
Existing Condition:	2004 ADAAG -
	2007 CBC 1129B.4
	Other

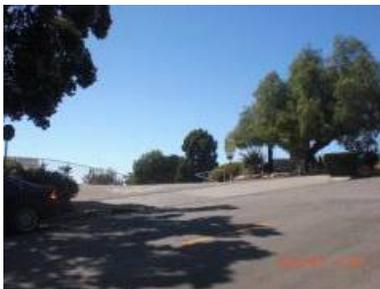
**Location:** Parking Lot  
**Photo #** 184

<b>Field Condition</b>	
01.19B - Tow-away Sign - A California tow-away sign is not posted in a conspicuous place at each entrance to off-street parking lot, or immediately adjacent to and visible from each accessible stall.	1991 ADAAG -
Existing Condition:	2004 ADAAG -
	2007 CBC 1129B.4
	Other

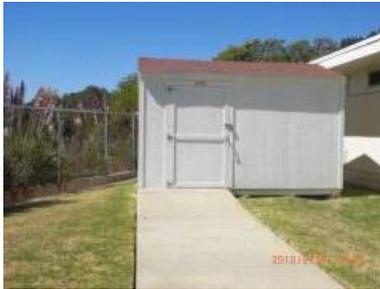
**Location:** Storage Room  
**Photo #** 185

Existing Condition: 10.3% RS at door landing.

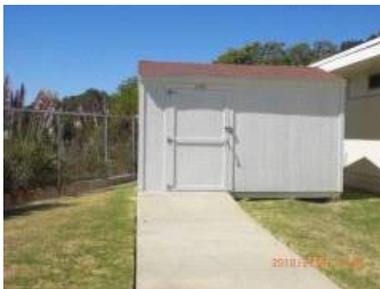
**Location:** Storage Room  
**Photo #** 185

Existing Condition: 51" to door hardware.

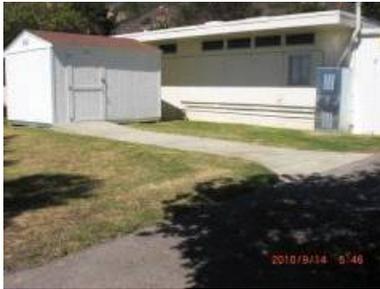
**Location:** Storage Room  
**Photo #** 187

<b>Field Condition</b>	
03B.10 - Running Slope - Slope of the accessible route of travel exceeds 1:20.  Existing Condition: 5.2%.	<b>1991 ADAAG</b> 4.3.7  <b>2004 ADAAG</b> 403.3  <b>2007 CBC</b> 1133B.7.3  <b>Other</b> -

<b>Corrective Action</b>
006 - Concrete Walk - Remove non-compliant pavement and replace with new concrete (area as shown on the drawings). The walkway slope shall not exceed 5% along the POT and cross slope shall not exceed 2%.  Additional Comments:

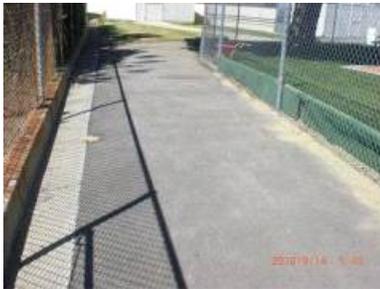
**Location:** School Grounds  
**Photo #** 188

<b>Field Condition</b>	
03B.09 - Cross Slope - Cross slope of the accessible route of travel exceeds 1:50.  Existing Condition: 3.25 to 5.2% RS.	<b>1991 ADAAG</b> 4.3.7  <b>2004 ADAAG</b> 403.3  <b>2007 CBC</b> 1133B.7.1.3  <b>Other</b> -

<b>Corrective Action</b>
004A - Asphalt Paving - Remove non-compliant pavement and replace with new asphalt paving (area as shown on the drawings). The walkway slope shall not exceed 5% along the POT and cross slope shall not exceed 2%.  Additional Comments:

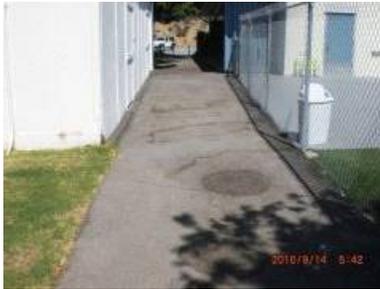
Location: School Grounds Photo # 189

<b>Field Condition</b>									
03B.09 - Cross Slope - Cross slope of the accessible route of travel exceeds 1:50. Existing Condition: 2.5%.

<b>Corrective Action</b>	
004A - Asphalt Paving - Remove non-compliant pavement and replace with new asphalt paving (area as shown on the drawings). The walkway slope shall not exceed 5% along the POT and cross slope shall not exceed 2%.	
Additional Comments:

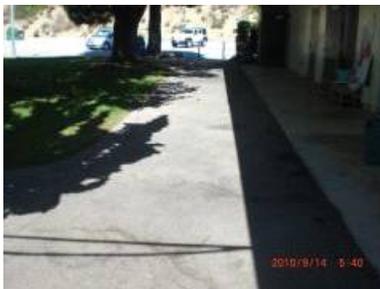
<b>Field Condition</b>									
03B.09 - Cross Slope - Cross slope of the accessible route of travel exceeds 1:50. Existing Condition: 2.2% to 2.3% CS.

<b>Corrective Action</b>	
004A - Asphalt Paving - Remove non-compliant pavement and replace with new asphalt paving (area as shown on the drawings). The walkway slope shall not exceed 5% along the POT and cross slope shall not exceed 2%.	
Additional Comments:

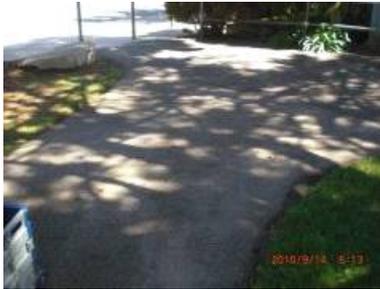
Location: School Grounds Photo #: 191

<b>Field Condition</b>									
03B.09 - Cross Slope - Cross slope of the accessible route of travel exceeds 1:50.  Existing Condition: 4.5%.

<b>Corrective Action</b>	
004A - Asphalt Paving - Remove non-compliant pavement and replace with new asphalt paving (area as shown on the drawings). The walkway slope shall not exceed 5% along the POT and cross slope shall not exceed 2%.	
Additional Comments:

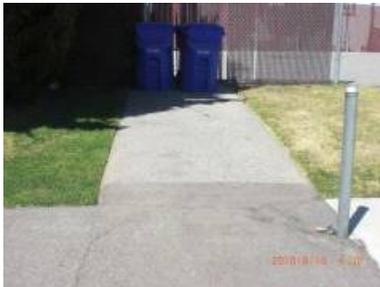
<b>Field Condition</b>									
03B.09 - Cross Slope - Cross slope of the accessible route of travel exceeds 1:50.  Existing Condition: 2.3% to 3.7% CS.

<b>Corrective Action</b>	
004A - Asphalt Paving - Remove non-compliant pavement and replace with new asphalt paving (area as shown on the drawings). The walkway slope shall not exceed 5% along the POT and cross slope shall not exceed 2%.	
Additional Comments:

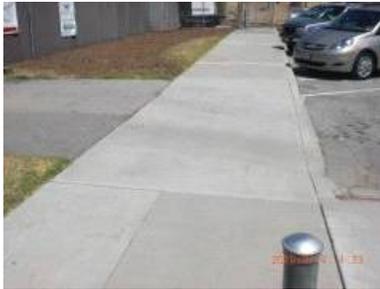
03B.21 - Hazardous Vehicular Areas - Detectable Warnings - Where a walk crosses or adjoins the vehicular way and the walking surface is not separated by curbs, railings, or other elements between the pedestrian areas and vehicular areas, the boundary between the areas is not defined by a continuous detectable warning at least 36" wide complying with CBC 1121B.3.1 item 8(a). (i.e., the warning surface shall contrast visually with adjoining surfaces, either light on dark or dark on light, and shall differ from adjoining walking surfaces in resiliency or sound on cane contact. Color: yellow conforming to Federal Color No. 33538, Table IV/ Standard No. 595B. Where the color value contrast between the yellow warning and the main walking surface is less than 70 percent, a 1" wide black strip shall separate the yellow warning from the main walking surface.)

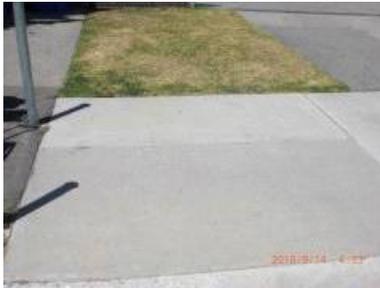
Location: School Grounds      Photo # 194

<b>Field Condition</b>									
03B.09 - Cross Slope - Cross slope of the accessible route of travel exceeds 1:50. Existing Condition: 3.0%.

<b>Corrective Action</b>
006 - Concrete Walk - Remove non-compliant pavement and replace with new concrete (area as shown on the drawings). The walkway slope shall not exceed 5% along the POT and cross slope shall not exceed 2%.
Additional Comments:

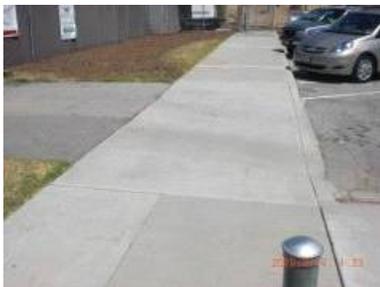
<b>Field Condition</b>									
03A.07B - Cross Slope - Driveway (PAR) - Cross slope of the pedestrian access route in a driveway exceeds 1:50. Existing Condition: 11.3%.

<b>Corrective Action</b>
006 - Concrete Walk - Remove non-compliant pavement and replace with new concrete (area as shown on the drawings). The walkway slope shall not exceed 5% along the POT and cross slope shall not exceed 2%.
Additional Comments:

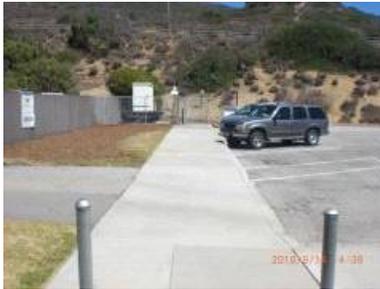
Location: School Grounds Photo #: 196

<b>Field Condition</b>									
03B.09 - Cross Slope - Cross slope of the accessible route of travel exceeds 1:50. Existing Condition: 2.5% to 3.7% CS.

<b>Corrective Action</b>	
006 - Concrete Walk - Remove non-compliant pavement and replace with new concrete (area as shown on the drawings). The walkway slope shall not exceed 5% along the POT and cross slope shall not exceed 2%. Additional Comments:

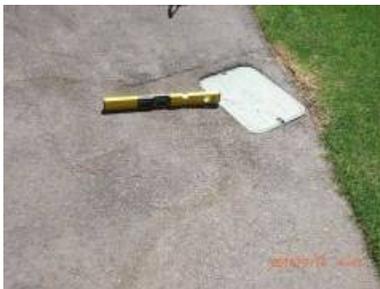
<b>Field Condition</b>									
03B.13 - > 1/2" Changes in Level - Curb ramps, ramps, or elevators are not used for changes in level greater than 1/2 inch. (Lifts may only be used in certain limited situations.) Existing Condition: 1/2" level change.

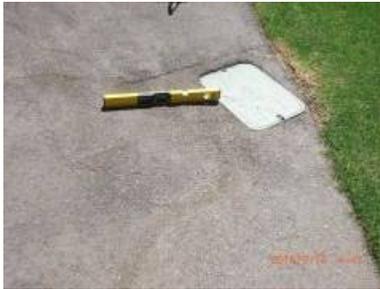
**Location:** School Grounds  
**Photo #** 197

<b>Field Condition</b>	
03B.09 - Cross Slope - Cross slope of the accessible route of travel exceeds 1:50. Existing Condition: 3.3% at irrigation valve.	<b>1991 ADAAG</b> 4.3.7  <b>2004 ADAAG</b> 403.3  <b>2007 CBC</b> 1133B.7.1.3  <b>Other</b> -

<b>Corrective Action</b>	
004A - Asphalt Paving - Remove non-compliant pavement and replace with new asphalt paving (area as shown on the drawings). The walkway slope shall not exceed 5% along the POT and cross slope shall not exceed 2%.  Additional Comments:

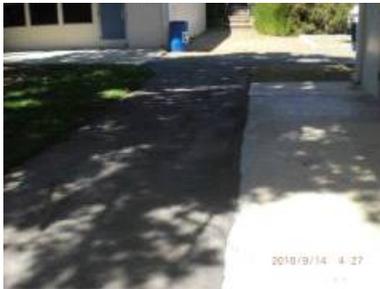
<b>Field Condition</b>	
03B.15 - Surface - Accessible route surfaces are not stable, firm and slip-resistant. Existing Condition: Uneven surface.	<b>1991 ADAAG</b> 4.5.1  <b>2004 ADAAG</b> 302.1; Advisory 302.1  <b>2007 CBC</b> 1124B.1  <b>Other</b> -

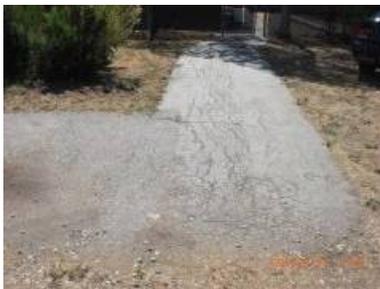
Field Condition									
03B.09 - Cross Slope - Cross slope of the accessible route of travel exceeds 1:50. Existing Condition: 2.6% to 7.3% CS.

Corrective Action	
004A - Asphalt Paving - Remove non-compliant pavement and replace with new asphalt paving (area as shown on the drawings). The walkway slope shall not exceed 5% along the POT and cross slope shall not exceed 2%.	
Additional Comments:

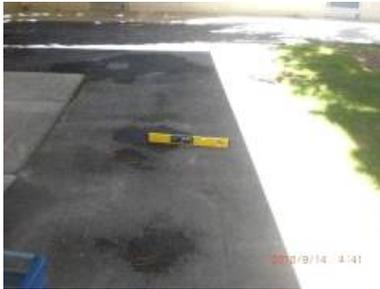
Location: School Grounds Photo # 202

<b>Field Condition</b>	
03B.15 - Surface - Accessible route surfaces are not stable, firm and slip-resistant.	1991 ADAAG 4.5.1
Existing Condition: Uneven surface, water accumulates.	2004 ADAAG 302.1; Advisory 302.1
	2007 CBC 1124B.1
	Other -

<b>Corrective Action</b>	
004A - Asphalt Paving - Remove non-compliant pavement and replace with new asphalt paving (area as shown on the drawings). The walkway slope shall not exceed 5% along the POT and cross slope shall not exceed 2%.	
Additional Comments:

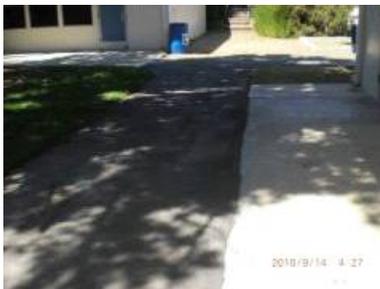
<b>Field Condition</b>	
03B.09 - Cross Slope - Cross slope of the accessible route of travel exceeds 1:50.	1991 ADAAG 4.3.7
Existing Condition: 3.5%.	2004 ADAAG 403.3
	2007 CBC 1133B.7.1.3
	Other -

<b>Corrective Action</b>	
004A - Asphalt Paving - Remove non-compliant pavement and replace with new asphalt paving (area as shown on the drawings). The walkway slope shall not exceed 5% along the POT and cross slope shall not exceed 2%.	
Additional Comments:

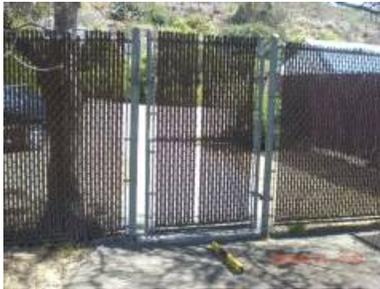
**Location:** School Grounds  
**Photo #** 204

<b>Field Condition</b>	
10.07A - Landing - Level and Clear - Floor is not level (slope is greater than 2% in some or all directions). OR Floor is not clear within the required maneuvering space.	<b>1991 ADAAG</b> 4.13.6; Fig. 25
Existing Condition: 3.5% RS at gate landing.	<b>2004 ADAAG</b> 305; 404.2.4.4
	<b>2007 CBC</b> 1133B.2.4
	<b>Other</b> -

<b>Corrective Action</b>
004A - Asphalt Paving - Remove non-compliant pavement and replace with new asphalt paving (area as shown on the drawings). The walkway slope shall not exceed 5% along the POT and cross slope shall not exceed 2%.
Additional Comments:

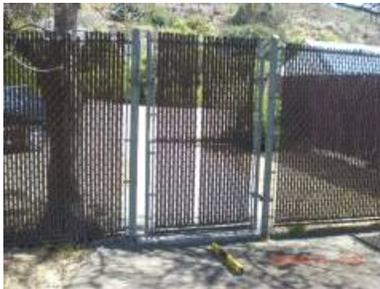
**Location:** School Grounds  
**Photo #** 204

<b>Field Condition</b>	
10.08 - Kick Plate - Bottom 10" of door does not have a smooth, uninterrupted surface on the push side to allow the door to be opened by a wheelchair footrest without creating a trap or hazardous condition. (This requirement does not apply to automatic and sliding doors.)	<b>1991 ADAAG</b> -
Existing Condition:	<b>2004 ADAAG</b> 404.2.10
	<b>2007 CBC</b> 1133B.2.6
	<b>Other</b> -

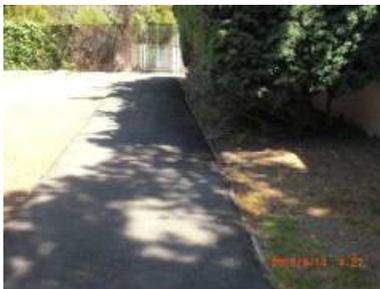
Field Condition									
03B.09 - Cross Slope - Cross slope of the accessible route of travel exceeds 1:50.

1991 ADAAG	4.3.7	2004 ADAAG	403.3	2007 CBC	1133B.7.1.3	Other	-
1991 ADAAG	4.3.7								
2004 ADAAG	403.3								
2007 CBC	1133B.7.1.3								
Other	-								
Existing Condition: 2.3%.

Corrective Action
004A - Asphalt Paving - Remove non-compliant pavement and replace with new asphalt paving (area as shown on the drawings). The walkway slope shall not exceed 5% along the POT and cross slope shall not exceed 2%.
Additional Comments:

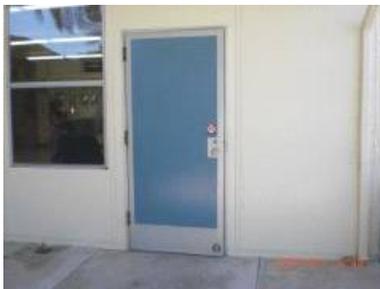
<b>Field Condition</b>	
10.11A - Door Operating Effort - The force required to operate door exceeds 5 lbs. (Fire doors may have up to 15 lbs to achieve positive latching).	1991 ADAAG 4.13.11
Existing Condition: 8 LBF.	2004 ADAAG 404.2.9
	2007 CBC 1133B.2.5
	Other -

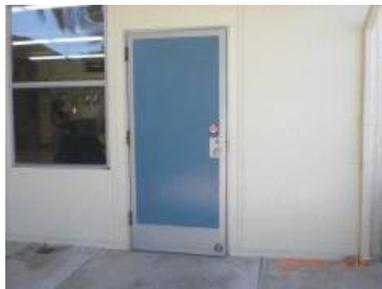
**Location:** Classroom G  
**Photo #** 211

<b>Field Condition</b>	
10.07A - Landing - Level and Clear - Floor is not level (slope is greater than 2% in some or all directions). OR Floor is not clear within the required maneuvering space.	<b>1991 ADAAG</b> 4.13.6; Fig. 25
Existing Condition: 4.7% RS at door landing.	<b>2004 ADAAG</b> 305; 404.2.4.4
	<b>2007 CBC</b> 1133B.2.4
	<b>Other</b> -

<b>Corrective Action</b>
008 - Concrete Landing - Remove non-compliant pavement and replace with new concrete. The landing slope shall not exceed 2% in any direction.
Additional Comments:

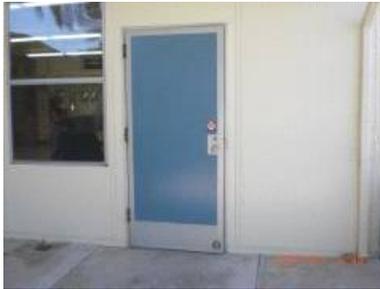
**Location:**  
Classroom G

<b>Field Condition</b>	
11.17A - Recommendation: Providing Room/Space ID Sign - A sign designating the permanent room or space has not been provided.	<b>1991 ADAAG</b> 4.1.2(7)
Existing Condition:	<b>2004 ADAAG</b> 216.2; 703.1; 703.2; 703.5
	<b>2007 CBC</b> 1117B.5.1 item 1
	<b>Other</b> -

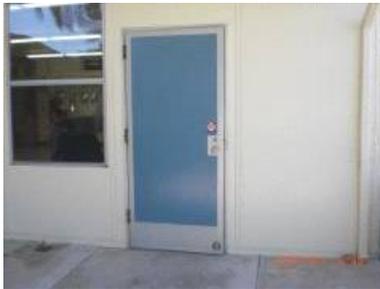
**Location:**  
Classroom G

<b>Field Condition</b>	
10.10 - Single-Action Hardware - Handles, locks, and latches or other operative devices are not operable with one hand and without tight grasping, pinching, or twisting of the wrist. (U-shaped handles, levers, and push/pull type mechanisms are acceptable designs.)	<b>1991 ADAAG</b> 4.13.9
Existing Condition: Knob.	<b>2004 ADAAG</b> 309.4; 404.2.7; Advisory 404.2.7
	<b>2007 CBC</b> 1133B.2.5.2
	<b>Other</b> -

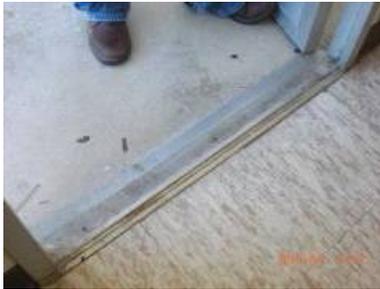
**Location:** Classroom G **Photo #** 216

<b>Field Condition</b>	
10.09B - Threshold - Height - The threshold at doorway exceeds 1/2" in height.	<b>1991 ADAAG</b> 4.13.8
Existing Condition: Compound threshold.	<b>2004 ADAAG</b> 303.3; Advisory 303.3; Fig. 303.3
	<b>2007 CBC</b> 1133B.2.4.1
	<b>Other</b> -

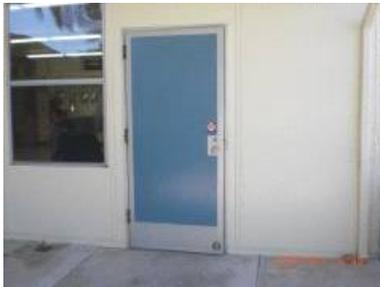
<b>Field Condition</b>	
14.31 - Head Room - Clear head room is at less than 80" within the pedestrian circulation area, including the accessible route of travel.	<b>1991 ADAAG</b> 4.4.2
Existing Condition: 79" to door frame and closer.	<b>2004 ADAAG</b> 307.2; Fig. 307.2
	<b>2007 CBC</b> 1133B.8.6.2
	<b>Other</b> -

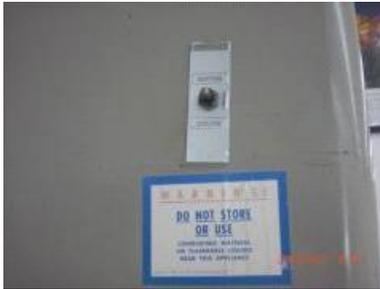
**Location:** Classroom G  
**Photo #** 218

Existing Condition: 65" to heating/cooling control.

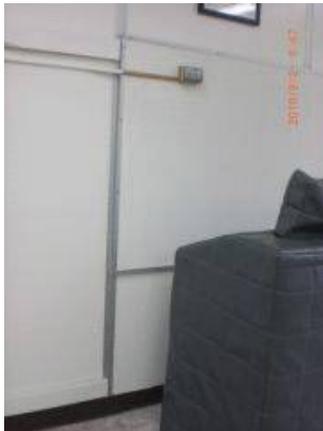
**Location:** Classroom G  
**Photo #** 219

Existing Condition: 67" to thermostat.

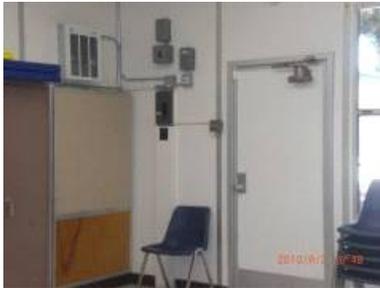
**Location:** Classroom G      **Photo #** 220

<b>Field Condition</b>	
14.32A - Reach Range - Controls - Controls, dispensers, and similar devices are not between 9" and 54" AFF when the clear floor space allows a parallel approach. OR They are not between 15" and 48" AFF when the clear floor space allows only a forward approach.	<b>1991 ADAAG</b> 4.1.3(13); 4.27.3; 4.2.5; 4.2.6 ; Fig. 5; Fig. 6 <b>2004 ADAAG</b> - <b>2007 CBC</b> 1117B.6(3); 1118.5; 1118.6; Fig. 11B-5C; Fig. 11B-5D <b>Other</b> -
Existing Condition: 60" to light switch.

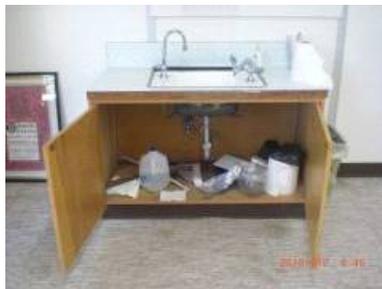
**Location:** Classroom G  
**Photo #** 223

<b>Field Condition</b>	
14.37 - Kitchen Sink - Sink does not provide accessible knee clearance (i.e. at least 27" high, 30" wide, and 19" deep).	<b>1991 ADAAG</b> 4.24.3 <b>2004 ADAAG</b> 305; 306; 606.2 <b>2007 CBC</b> 1115B.4.7(2); 1122B.4 <b>Other</b> -
Existing Condition: No knee space.

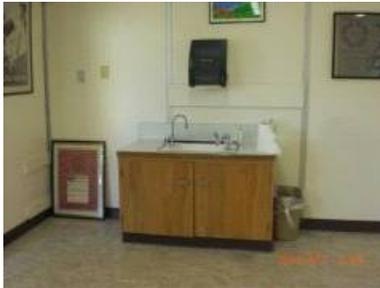
**Location:** Classroom G **Photo #** 224

<b>Field Condition</b>	16.84A - Paper Towel Dispenser - Operating Height - Mounting height of paper towel dispenser's highest operable part exceeds 40" AFF. (Where provided, ADA Standards require at least one paper towel dispenser to be accessible with the highest operable part placed within at least one of the reach ranges specified in 4.2.5 and 4.2.6; where provided, CBC Standards require at least one paper towel dispenser to be accessible with the highest operable part no higher than 40" AFF.)  Existing Condition: 53" high.	<b>1991 ADAAG</b> 4.22.7; 4.27.3; 4.2.5; 4.2.6  <b>2004 ADAAG</b> 308; 309  <b>2007 CBC</b> 1115B.8.3  <b>Other</b> -
------------------------	---	---

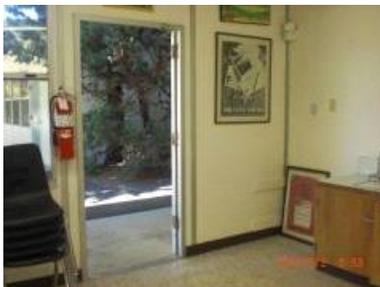
<b>Field Condition</b>	20.16B - Surface-Mounted Fire Extinguisher - Mounting Height - Where fire extinguishers are surface-mounted, mounting height of the extinguisher is not compliant. (Compliant surface-mounted extinguisher is 48" AFF maximum, as measured to the highest operable part, or in existing buildings, when the extinguisher is 54" AFF and parallel approach is provided)  Existing Condition: 58" high.	<b>1991 ADAAG</b> 4.27.3  <b>2004 ADAAG</b> 308.2.1; Fig. 308.2.1; 308.3.1; Fig. 308.3.1  <b>2007 CBC</b> 1118B.4(1); 1118B.5; 1118B.6  <b>Other</b> -
------------------------	---	--

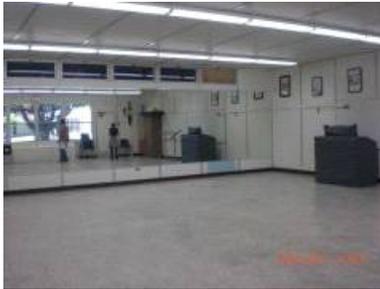
**Location:** Classroom G  
**Photo #** 226

<b>Field Condition</b>	20.04 - Common Use Areas - Visual Alarms - Visual alarms are not provided in common use area(s) of the building such as meeting and conference rooms, open office space, classrooms, cafeterias, filing and photocopy rooms, employee break rooms, dressing, examination, and treatment rooms, and similar spaces that are not used solely as employee work areas.	<b>1991 ADAAG</b> 4.28.1
Existing Condition:		<b>2004 ADAAG</b> 215.2; 702.1
		<b>2007 CBC</b> 907.9.1.1
		<b>Other</b> -

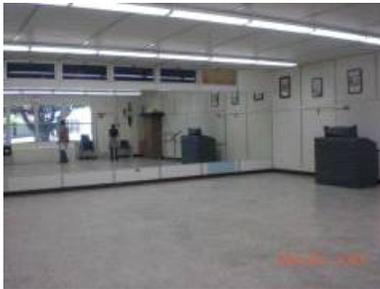
**Location:** Classroom G  
**Photo #** 226

<b>Field Condition</b>	14.34 - Electrical/Communications Receptacles - Mounting Height - Electrical/communications receptacle is not located between 15" min.. and 48" max.. AFF.	<b>1991 ADAAG</b> 4.1.3(13); 4.27.3; 4.2.5; 4.2.6 ; Fig. 5; Fig. 6
Existing Condition: 14" high receptacle.		<b>2004 ADAAG</b> 308.2.1; Fig. 308.2.1; 308.3.1; Fig. 308.3.1; 309.3
		<b>2007 CBC</b> 1117B.6(5.2)
		<b>Other</b> -

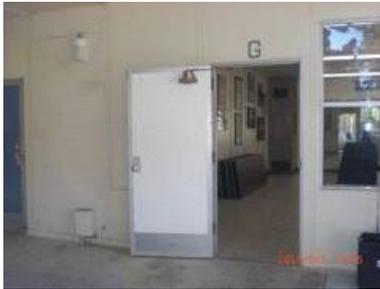
Field Condition	
10.02 - Entrance Sign - Accessible entrance is not identified by an ISA.	1991 ADAAG 28 CFR 35.163(b)1
Existing Condition:	2004 ADAAG 216.6
	2007 CBC 1117B.5.8.1.2
	Other -

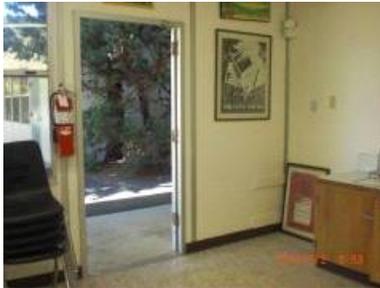
10.06A - Door Maneuvering Space - Door that is not automatic or power-assisted does not have compliant maneuvering space relative to the direction of approach as shown in CBC Fig. 11B-26. (Approach // Side // Width // Depth) (Front // Pull // D + 24" \* // 60") (Front // Push // D + 0" \*\* // 48") (Latch // Pull // D + 24" // 60") (Latch // Push // D + 24" // 44" \*\*\*) (Hinge // Pull // D + 36" // 60") (Hinge // Push // 54" \*\*\*\* // 44" \*\*\*\*\*) (\* D + 18" at interior doors.) (\*\* D + 12" if door has both a latch and a closer.) (\*\*\*) 48" if door has closer.) (\*\*\*\* Measured from latch toward hinge.) (\*\*\*\*\* 48" if door has both a latch and a closer.)

Existing Condition: 4" due to FE.

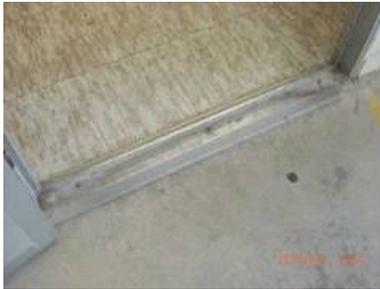
**Location:** Classroom G **Photo #** 230

<b>Field Condition</b>	
10.09B - Threshold - Height - The threshold at doorway exceeds 1/2" in height.	<b>1991 ADAAG</b> 4.13.8
Existing Condition: Compound threshold.	<b>2004 ADAAG</b> 303.3; Advisory 303.3; Fig. 303.3
	<b>2007 CBC</b> 1133B.2.4.1
	<b>Other</b> -

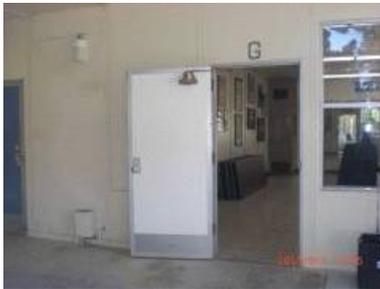
<b>Field Condition</b>	
10.10 - Single-Action Hardware - Handles, locks, and latches or other operative devices are not operable with one hand and without tight grasping, pinching, or twisting of the wrist. (U-shaped handles, levers, and push/pull type mechanisms are acceptable designs.)	<b>1991 ADAAG</b> 4.13.9
Existing Condition: Knob.	<b>2004 ADAAG</b> 309.4; 404.2.7; Advisory 404.2.7
	<b>2007 CBC</b> 1133B.2.5.2
	<b>Other</b> -

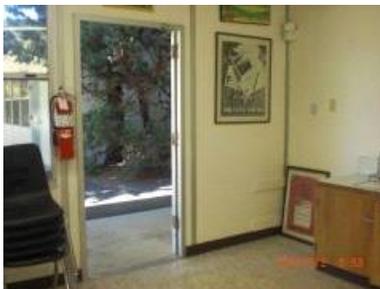
<b>Field Condition</b>	
10.13A - Required Exit Door Sign - At grade level exterior exit door, there is no tactile and CA Braille exit sign with the word "EXIT" mounted on the wall adjacent to the latch side of the door.	<b>1991 ADAAG</b> 4.1.3(16); 4.30.1
Existing Condition:	<b>2004 ADAAG</b> 216.4; 703.2; 703.3; 703.4
	<b>2007 CBC</b> 1011.3 item 1
	<b>Other</b> -

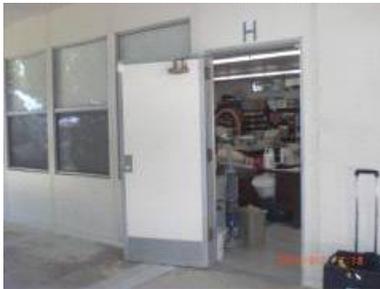
**Location:** Classroom H  
**Photo #** 237

<b>Field Condition</b>	
10.02 - Entrance Sign - Accessible entrance is not identified by an ISA.	1991 ADAAG 28 CFR 35.163(b)1
Existing Condition:	2004 ADAAG 216.6
	2007 CBC 1117B.5.8.1.2
	Other -
