*City of Rancho Palos Verdes*  
**Rancho Palos Verdes ADA Assessment**  
**Facility Report with Photos**

**Facility ID: # 08 - Ladera Linda Park & Community Center**

**Author: Vaish, B**

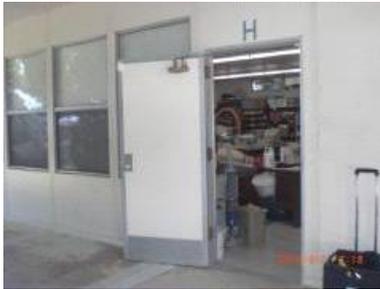
<b>Field Condition</b>	
10.10 - Single-Action Hardware - Handles, locks, and latches or other operative devices are not operable with one hand and without tight grasping, pinching, or twisting of the wrist. (U-shaped handles, levers, and push/pull type mechanisms are acceptable designs.)	<b>1991 ADAAG</b> 4.13.9
Existing Condition: Knob.	<b>2004 ADAAG</b> 309.4; 404.2.7; Advisory 404.2.7
	<b>2007 CBC</b> 1133B.2.5.2
	<b>Other</b> -

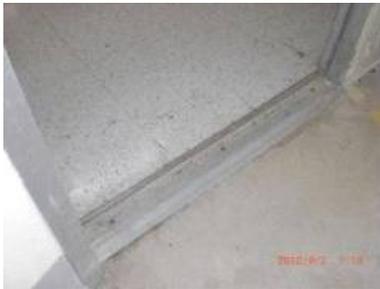
**Location:** Classroom H  
**Photo #** 241

Existing Condition: Compound threshold.

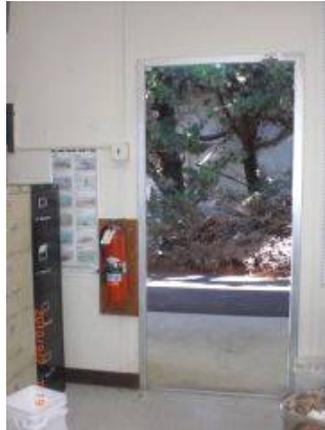
**Location:** Classroom H  
**Photo #** 242

Existing Condition: 4" due to FE.

388D - Relocate Fire Extinguisher - Relocate existing fire extinguisher. Repair and refinish.

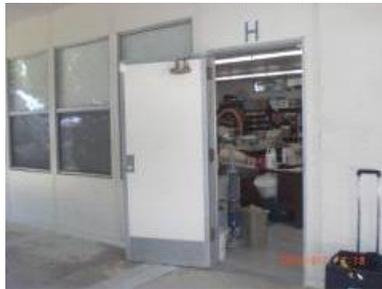
**Location:** Classroom H  
**Photo #** 237

Field Condition	
14.31 - Head Room - Clear head room is at less than 80" within the pedestrian circulation area, including the accessible route of travel.	1991 ADAAG 4.4.2
Existing Condition: 79" to door frame and closer.	2004 ADAAG 307.2; Fig. 307.2
	2007 CBC 1133B.8.6.2
	Other -

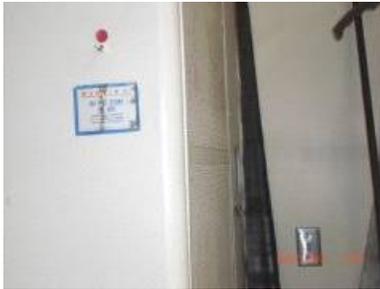
**Location:** Classroom H  
**Photo #** 247

<b>Field Condition</b>	
14.32A - Reach Range - Controls - Controls, dispensers, and similar devices are not between 9" and 54" AFF when the clear floor space allows a parallel approach. OR They are not between 15" and 48" AFF when the clear floor space allows only a forward approach.	<b>1991 ADAAG</b> 4.1.3(13); 4.27.3; 4.2.5; 4.2.6 ; Fig. 5; Fig. 6 <b>2004 ADAAG</b> - <b>2007 CBC</b> 1117B.6(3); 1118.5; 1118.6; Fig. 11B-5C; Fig. 11B-5D <b>Other</b> -
Existing Condition: 65" to heating/cooling control.

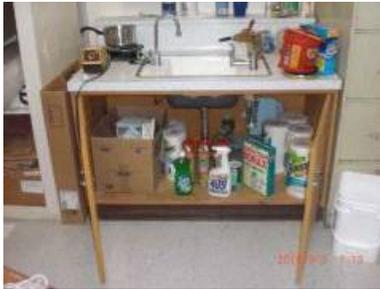
<b>Field Condition</b>	
14.37 - Kitchen Sink - Sink does not provide accessible knee clearance (i.e. at least 27" high, 30" wide, and 19" deep).	<b>1991 ADAAG</b> 4.24.3
Existing Condition: No knee space.	<b>2004 ADAAG</b> 305; 306; 606.2
	<b>2007 CBC</b> 1115B.4.7(2); 1122B.4
	<b>Other</b> -

<b>Corrective Action</b>
480A - New Counter Top and Sink - Remove existing cabinetry, and provide new counter at 34" above the finished floor. Remove and replace sink and faucet with new accessible sink and faucet. Provide accessible knee clearance (i.e. at least 27" high, 30" wide, and 19" deep) under the sink.
Additional Comments:

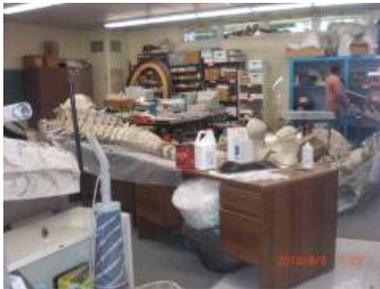
<b>Field Condition</b>	
20.04 - Common Use Areas - Visual Alarms - Visual alarms are not provided in common use area(s) of the building such as meeting and conference rooms, open office space, classrooms, cafeterias, filing and photocopy rooms, employee break rooms, dressing, examination, and treatment rooms, and similar spaces that are not used solely as employee work areas.	<b>1991 ADAAG</b> 4.28.1
Existing Condition:	<b>2004 ADAAG</b> 215.2; 702.1
	<b>2007 CBC</b> 907.9.1.1
	<b>Other</b> -

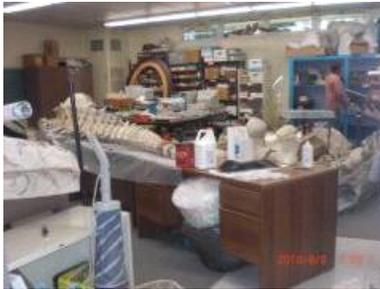
<b>Field Condition</b>	
14.21B - 36" Width Standard - The accessible route of travel is not at least 36" wide where the occupancy load is < 10. (For a depth of 24" max., clear opening width may be reduced to 32" min..) (Doorways are compliant when the door, open 90 degrees, affords a clear opening width of at least 32".)	<b>1991 ADAAG</b> 4.3.3; Fig. 7(a)(b)
Existing Condition: Furniture.	<b>2004 ADAAG</b> 403.5.1; Fig. 403.5.1
	<b>2007 CBC</b> 1133B.3.1
	<b>Other</b> -

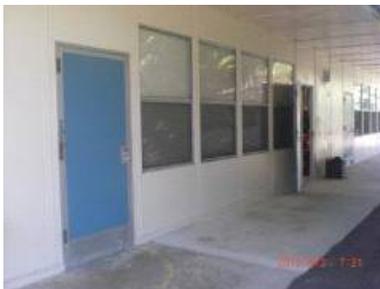
<b>Field Condition</b>	
10.10 - Single-Action Hardware - Handles, locks, and latches or other operative devices are not operable with one hand and without tight grasping, pinching, or twisting of the wrist. (U-shaped handles, levers, and push/pull type mechanisms are acceptable designs.)	<b>1991 ADAAG</b> 4.13.9
Existing Condition: Knob.	<b>2004 ADAAG</b> 309.4; 404.2.7; Advisory 404.2.7
	<b>2007 CBC</b> 1133B.2.5.2
	<b>Other</b> -

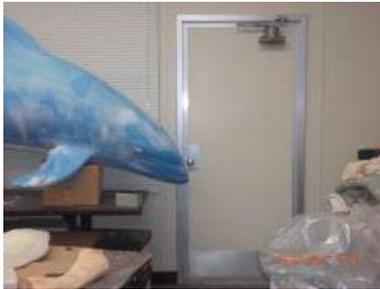
**Location:** Classroom H  
**Photo #** 253

<b>Field Condition</b>	
10.13A - Required Exit Door Sign - At grade level exterior exit door, there is no tactile and CA Braille exit sign with the word "EXIT" mounted on the wall adjacent to the latch side of the door.	<b>1991 ADAAG</b> 4.1.3(16); 4.30.1
Existing Condition:	<b>2004 ADAAG</b> 216.4; 703.2; 703.3; 703.4
	<b>2007 CBC</b> 1011.3 item 1
	<b>Other</b> -

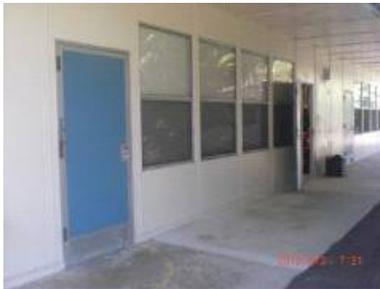
**Location:** Classroom H  
**Photo #** 252

<b>Field Condition</b>	
10.07A - Landing - Level and Clear - Floor is not level (slope is greater than 2% in some or all directions). OR Floor is not clear within the required maneuvering space.	<b>1991 ADAAG</b> 4.13.6; Fig. 25
Existing Condition: 3.3% RS at door landing.	<b>2004 ADAAG</b> 305; 404.2.4.4
	<b>2007 CBC</b> 1133B.2.4
	<b>Other</b> -

<b>Corrective Action</b>
006 - Concrete Walk - Remove non-compliant pavement and replace with new concrete (area as shown on the drawings). The walkway slope shall not exceed 5% along the POT and cross slope shall not exceed 2%.
Additional Comments:

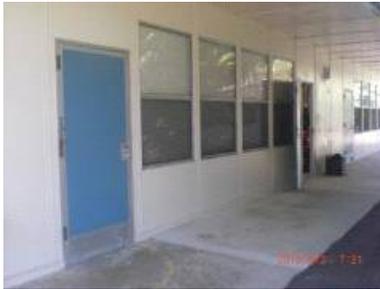
**Location:** Classroom H  
**Photo #** 252

Field Condition	
11.17A - Recommendation: Providing Room/Space ID Sign - A sign designating the permanent room or space has not been provided.	1991 ADAAG 4.1.2(7)
Existing Condition:	2004 ADAAG 216.2; 703.1; 703.2; 703.5
	2007 CBC 1117B.5.1 item 1
Other	-

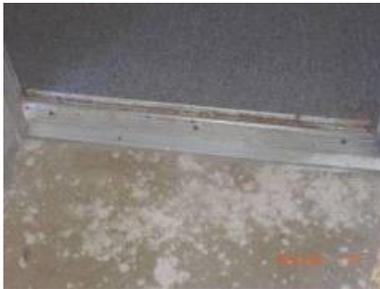
**Location:** Classroom H  
**Photo #** 256

Field Condition	
10.09B - Threshold - Height - The threshold at doorway exceeds 1/2" in height.	1991 ADAAG 4.13.8
Existing Condition: Compound threshold.	2004 ADAAG 303.3; Advisory 303.3; Fig. 303.3
	2007 CBC 1133B.2.4.1
Other	-

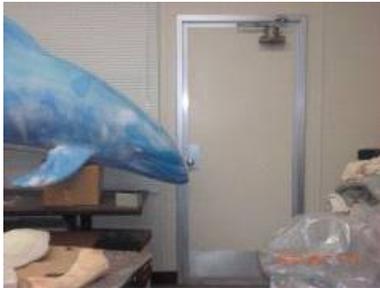
10.06A - Door Maneuvering Space - Door that is not automatic or power-assisted does not have compliant maneuvering space relative to the direction of approach as shown in CBC Fig. 11B-26. (Approach // Side // Width // Depth) (Front // Pull // D + 24" \* // 60") (Front // Push // D + 0" \*\* // 48") (Latch // Pull // D + 24" // 60") (Latch // Push // D + 24" // 44" \*\*\*) (Hinge // Pull // D + 36" // 60") (Hinge // Push // 54" \*\*\*\* // 44" \*\*\*\*\*) (\* D + 18" at interior doors.) (\*\* D + 12" if door has both a latch and a closer.) (\*\*\*) 48" if door has closer.) (\*\*\*\* Measured from latch toward hinge.) (\*\*\*\*\* 48" if door has both a latch and a closer.)

Existing Condition: 0" due to furniture.

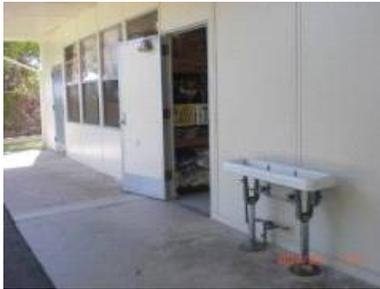
**Location:** Classroom  
**Photo #** 260

<b>Field Condition</b>	
10.02 - Entrance Sign - Accessible entrance is not identified by an ISA.	1991 ADAAG 28 CFR 35.163(b)1
Existing Condition:	2004 ADAAG 216.6
	2007 CBC 1117B.5.8.1.2
	Other -

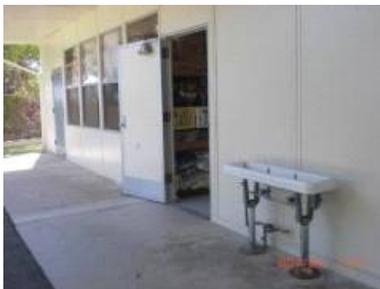
**Location:** Classroom  
**Photo #** 260

<b>Field Condition</b>	
10.10 - Single-Action Hardware - Handles, locks, and latches or other operative devices are not operable with one hand and without tight grasping, pinching, or twisting of the wrist. (U-shaped handles, levers, and push/pull type mechanisms are acceptable designs.)	1991 ADAAG 4.13.9
Existing Condition: Knob.	2004 ADAAG 309.4; 404.2.7; Advisory 404.2.7
	2007 CBC 1133B.2.5.2
	Other -

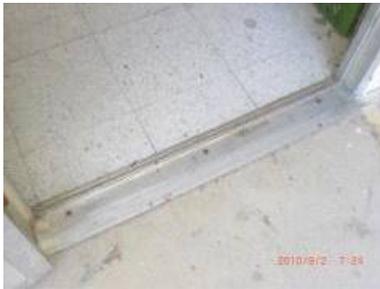
**Location:** Classroom  
**Photo #** 263

<b>Field Condition</b>	
10.09B - Threshold - Height - The threshold at doorway exceeds 1/2" in height.	<b>1991 ADAAG</b> 4.13.8
Existing Condition: Compound threshold.	<b>2004 ADAAG</b> 303.3; Advisory 303.3; Fig. 303.3
	<b>2007 CBC</b> 1133B.2.4.1
	<b>Other</b> -

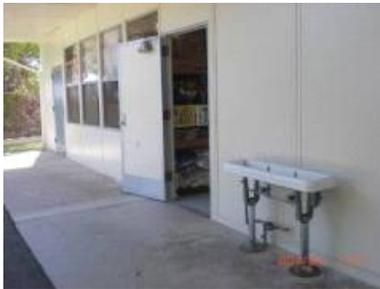
**Location:** Classroom  
**Photo #** 260

Field Condition	
10.07A - Landing - Level and Clear - Floor is not level (slope is greater than 2% in some or all directions). OR Floor is not clear within the required maneuvering space.	1991 ADAAG 4.13.6; Fig. 25
Existing Condition: 2.3% RS at door landing.	2004 ADAAG 305; 404.2.4.4
	2007 CBC 1133B.2.4
	Other -

Corrective Action
006 - Concrete Walk - Remove non-compliant pavement and replace with new concrete (area as shown on the drawings). The walkway slope shall not exceed 5% along the POT and cross slope shall not exceed 2%.
Additional Comments:

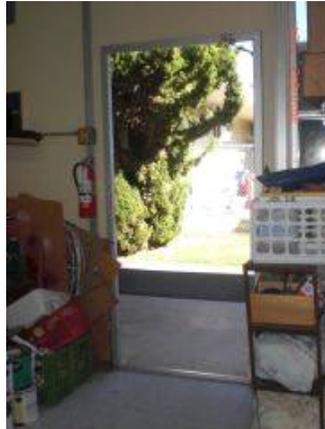
**Location:** Classroom      **Photo #** 264

Existing Condition: 60" to light switch.

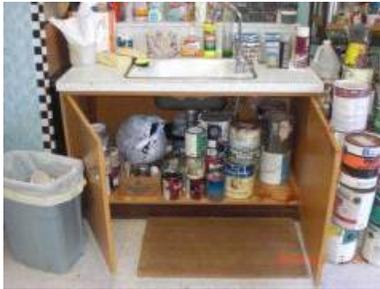
<b>Field Condition</b>	
14.37 - Kitchen Sink - Sink does not provide accessible knee clearance (i.e. at least 27" high, 30" wide, and 19" deep).	<b>1991 ADAAG</b> 4.24.3
Existing Condition: No knee space.	<b>2004 ADAAG</b> 305; 306; 606.2
	<b>2007 CBC</b> 1115B.4.7(2); 1122B.4
	<b>Other</b> -

<b>Corrective Action</b>
480A - New Counter Top and Sink - Remove existing cabinetry, and provide new counter at 34" above the finished floor. Remove and replace sink and faucet with new accessible sink and faucet. Provide accessible knee clearance (i.e. at least 27" high, 30" wide, and 19" deep) under the sink.
Additional Comments:

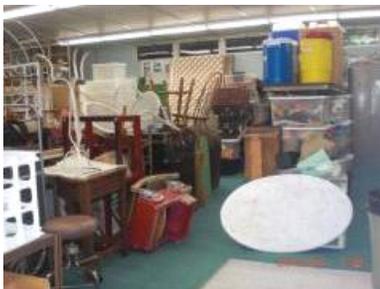
<b>Field Condition</b>	
14.21B - 36" Width Standard - The accessible route of travel is not at least 36" wide where the occupancy load is < 10. (For a depth of 24" max., clear opening width may be reduced to 32" min..) (Doorways are compliant when the door, open 90 degrees, affords a clear opening width of at least 32".)	<b>1991 ADAAG</b> 4.3.3; Fig. 7(a)(b)
Existing Condition: Furniture.	<b>2004 ADAAG</b> 403.5.1; Fig. 403.5.1
	<b>2007 CBC</b> 1133B.3.1
	<b>Other</b> -

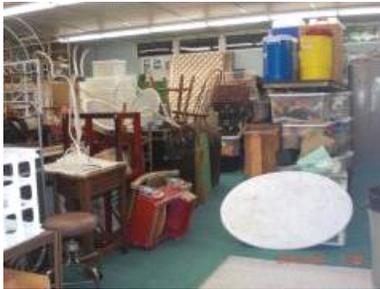
**Location:** Classroom  
**Photo #** 271

<b>Field Condition</b>	20.04 - Common Use Areas - Visual Alarms - Visual alarms are not provided in common use area(s) of the building such as meeting and conference rooms, open office space, classrooms, cafeterias, filing and photocopy rooms, employee break rooms, dressing, examination, and treatment rooms, and similar spaces that are not used solely as employee work areas.	<b>1991 ADAAG</b> 4.28.1
Existing Condition:		<b>2004 ADAAG</b> 215.2; 702.1
		<b>2007 CBC</b> 907.9.1.1
		<b>Other</b> -

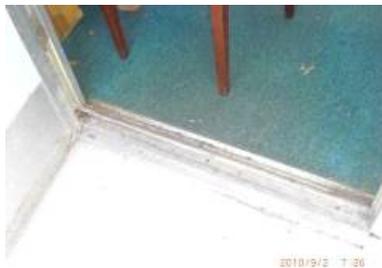
**Location:** Classroom **Photo #** 275

<b>Field Condition</b>	
10.09B - Threshold - Height - The threshold at doorway exceeds 1/2" in height.	<b>1991 ADAAG</b> 4.13.8 <b>2004 ADAAG</b> 303.3; Advisory 303.3; Fig. 303.3 <b>2007 CBC</b> 1133B.2.4.1 <b>Other</b> -
Existing Condition: Compound threshold.

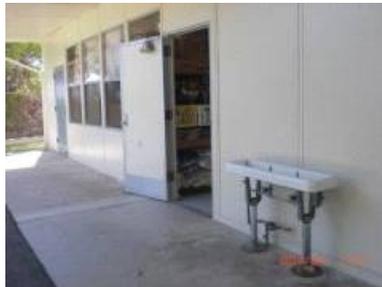
**Location:** Classroom **Photo #** 260

**Field Condition**

11.17A - Recommendation: Providing Room/Space ID Sign - A sign designating the permanent room or space has not been provided.

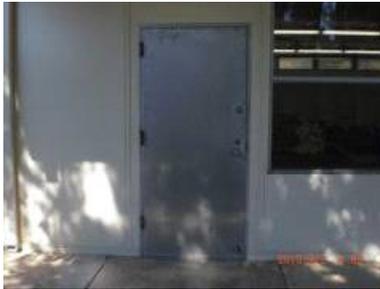
**Location:** Classroom K  
**Photo #** 280

Field Condition	
10.11A - Door Operating Effort - The force required to operate door exceeds 5 lbs. (Fire doors may have up to 15 lbs to achieve positive latching).	1991 ADAAG 4.13.11
Existing Condition: 10 LBF.	2004 ADAAG 404.2.9
	2007 CBC 1133B.2.5
	Other -

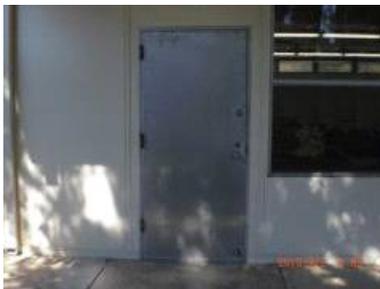
**Location:** Classroom K  
**Photo #** 280

Field Condition	
10.10 - Single-Action Hardware - Handles, locks, and latches or other operative devices are not operable with one hand and without tight grasping, pinching, or twisting of the wrist. (U-shaped handles, levers, and push/pull type mechanisms are acceptable designs.)	1991 ADAAG 4.13.9
Existing Condition: Knob.	2004 ADAAG 309.4; 404.2.7; Advisory 404.2.7
	2007 CBC 1133B.2.5.2
	Other -

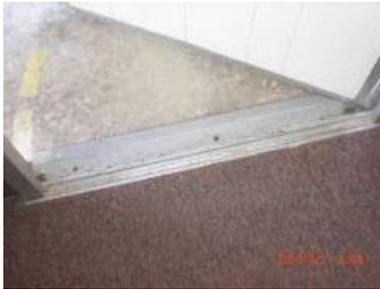
<b>Field Condition</b>	
10.09B - Threshold - Height - The threshold at doorway exceeds 1/2" in height.	<b>1991 ADAAG</b> 4.13.8
Existing Condition: Compound threshold.	<b>2004 ADAAG</b> 303.3; Advisory 303.3; Fig. 303.3
	<b>2007 CBC</b> 1133B.2.4.1
	<b>Other</b> -

<b>Classification</b>	
<b>DOJ Location Type:</b>	1
<b>Use:</b>	PV
<b>Severity:</b>	C
<b>Level of Difficulty</b>	Low to Moderate

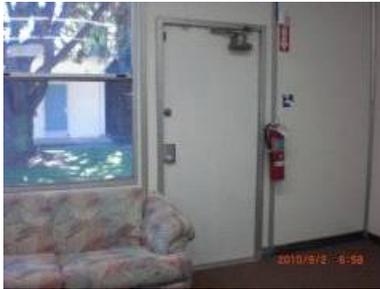
**Field Condition**

10.13A - Required Exit Door Sign - At grade level exterior exit door, there is no tactile and CA Braille exit sign with the word "EXIT" mounted on the wall adjacent to the latch side of the door.

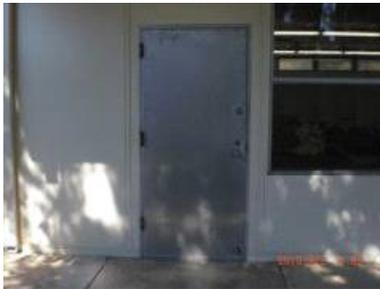
**Field Condition**

11.17A - Recommendation: Providing Room/Space ID Sign - A sign designating the permanent room or space has not been provided.

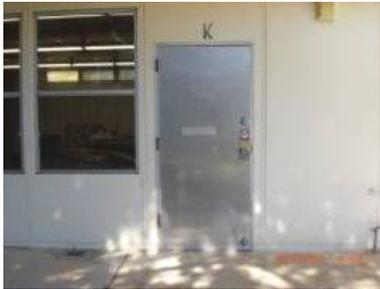
**Location:** Classroom K  
**Photo #** 288

<b>Field Condition</b>	
10.02 - Entrance Sign - Accessible entrance is not identified by an ISA.	1991 ADAAG 28 CFR 35.163(b)1
Existing Condition:	2004 ADAAG 216.6
	2007 CBC 1117B.5.8.1.2
	Other -

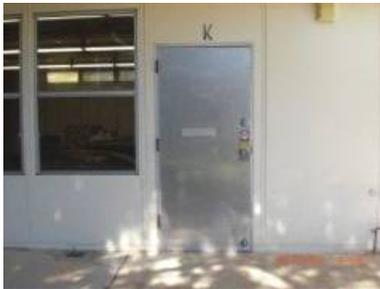
**Location:** Classroom K  
**Photo #** 288

<b>Field Condition</b>	
10.07A - Landing - Level and Clear - Floor is not level (slope is greater than 2% in some or all directions). OR Floor is not clear within the required maneuvering space.	1991 ADAAG 4.13.6; Fig. 25
Existing Condition: 3.1% RS at door landing.	2004 ADAAG 305; 404.2.4.4
	2007 CBC 1133B.2.4
	Other -

<b>Corrective Action</b>	
006 - Concrete Walk - Remove non-compliant pavement and replace with new concrete (area as shown on the drawings). The walkway slope shall not exceed 5% along the POT and cross slope shall not exceed 2%.	
Additional Comments:

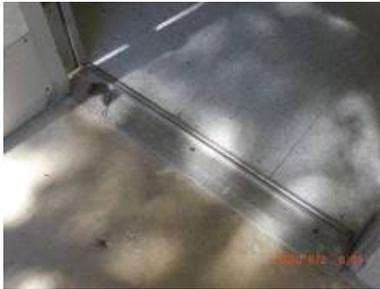
**Location:** Classroom K **Photo #** 290

<b>Field Condition</b>	
10.09B - Threshold - Height - The threshold at doorway exceeds 1/2" in height.	<b>1991 ADAAG</b> 4.13.8
Existing Condition: Compound threshold.	<b>2004 ADAAG</b> 303.3; Advisory 303.3; Fig. 303.3
	<b>2007 CBC</b> 1133B.2.4.1
	<b>Other</b> -

<b>Classification</b>	
<b>DOJ Location Type:</b>	1
<b>Use:</b>	PV
<b>Severity:</b>	C
<b>Level of Difficulty</b>	Low to Moderate

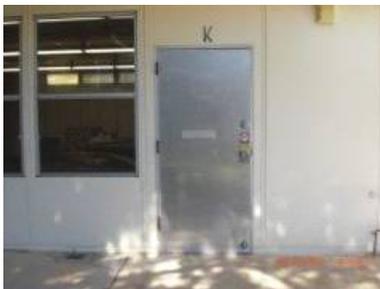
<b>Field Condition</b>	
10.10 - Single-Action Hardware - Handles, locks, and latches or other operative devices are not operable with one hand and without tight grasping, pinching, or twisting of the wrist. (U-shaped handles, levers, and push/pull type mechanisms are acceptable designs.)	<b>1991 ADAAG</b> 4.13.9
Existing Condition: Knob.	<b>2004 ADAAG</b> 309.4; 404.2.7; Advisory 404.2.7
	<b>2007 CBC</b> 1133B.2.5.2
	<b>Other</b> -

<b>Classification</b>	
<b>DOJ Location Type:</b>	1
<b>Use:</b>	PV
<b>Severity:</b>	C
<b>Level of Difficulty</b>	Low to Moderate

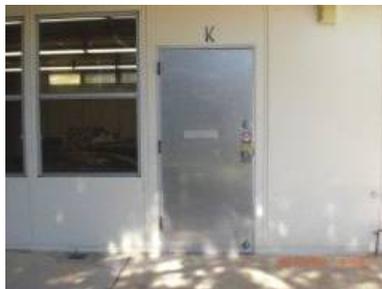
**Location:** Classroom K  
**Photo #** 288

Field Condition	
11.17B - Room/Space Identification Signs (Visual/Tactile Signs) - Sign designating the permanent room or space does not comply with ADAAG and CBC requirements for tactile signs.	1991 ADAAG 4.1.2(7); 4.30.1, 4, 5, 6
Existing Condition:	2004 ADAAG 216.2; 703.1; 703.2; 703.5
	2007 CBC 1117B.5.2, 3, 5, 6, 7
	Other -

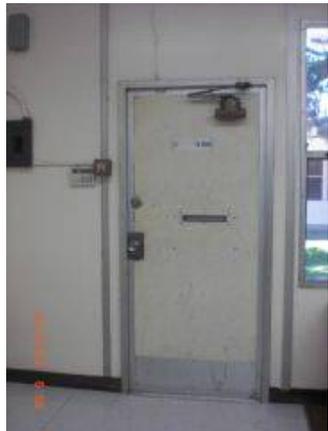
**Location:** Classroom K  
**Photo #** 292

**Field Condition**

Existing Condition: 53" to bolt.

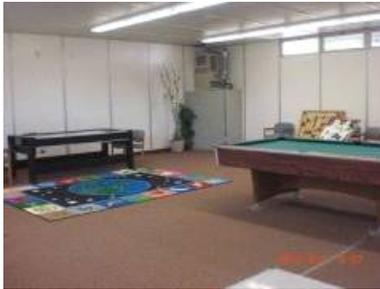
**Location:** Classroom K  
**Photo #** 298

<b>Field Condition</b>	20.04 - Common Use Areas - Visual Alarms - Visual alarms are not provided in common use area(s) of the building such as meeting and conference rooms, open office space, classrooms, cafeterias, filing and photocopy rooms, employee break rooms, dressing, examination, and treatment rooms, and similar spaces that are not used solely as employee work areas.	<b>1991 ADAAG</b> 4.28.1
Existing Condition:		<b>2004 ADAAG</b> 215.2; 702.1
		<b>2007 CBC</b> 907.9.1.1
		<b>Other</b> -

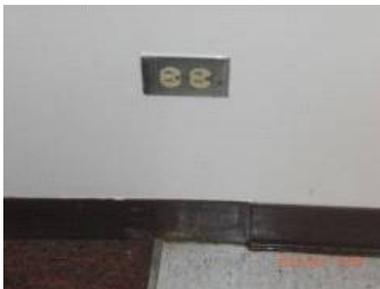
**Location:** Classroom K  
**Photo #** 299

<b>Field Condition</b>	14.34 - Electrical/Communications Receptacles - Mounting Height - Electrical/communications receptacle is not located between 15" min.. and 48" max.. AFF.	<b>1991 ADAAG</b> 4.1.3(13); 4.27.3; 4.2.5; 4.2.6 ; Fig. 5; Fig. 6
Existing Condition: 14" high receptacle.		<b>2004 ADAAG</b> 308.2.1; Fig. 308.2.1; 308.3.1; Fig. 308.3.1; 309.3
		<b>2007 CBC</b> 1117B.6(5.2)
		<b>Other</b> -

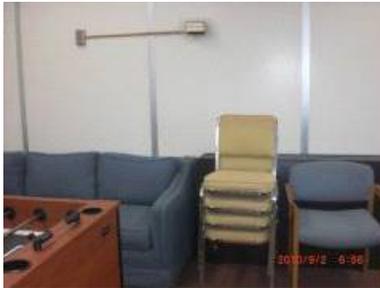
**Location:** Classroom K **Photo #** 300

14.32A - Reach Range - Controls - Controls, dispensers, and similar devices are not between 9" and 54" AFF when the clear floor space allows a parallel approach. OR They are not between 15" and 48" AFF when the clear floor space allows only a forward approach.

Existing Condition: 65" to thermostat.

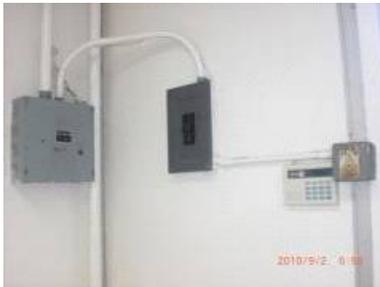
14.32A - Reach Range - Controls - Controls, dispensers, and similar devices are not between 9" and 54" AFF when the clear floor space allows a parallel approach. OR They are not between 15" and 48" AFF when the clear floor space allows only a forward approach.

Existing Condition: 60" to light switch.

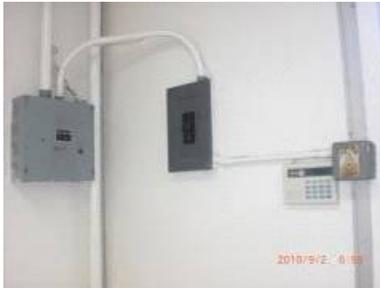
**Location:** Classroom K **Photo #** 301

<b>Field Condition</b>	
14.32A - Reach Range - Controls - Controls, dispensers, and similar devices are not between 9" and 54" AFF when the clear floor space allows a parallel approach. OR They are not between 15" and 48" AFF when the clear floor space allows only a forward approach.	<b>1991 ADAAG</b> 4.1.3(13); 4.27.3; 4.2.5; 4.2.6 ; Fig. 5; Fig. 6 <b>2004 ADAAG</b> - <b>2007 CBC</b> 1117B.6(3); 1118.5; 1118.6; Fig. 11B-5C; Fig. 11B-5D <b>Other</b> -
Existing Condition: 58" to alarm.

<b>Classification</b>	
<b>DOJ Location Type:</b>	2
<b>Use:</b>	PV
<b>Severity:</b>	C
<b>Level of Difficulty</b>	Low to Moderate

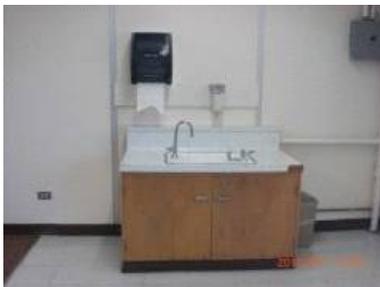
<b>Field Condition</b>	
16.84A - Paper Towel Dispenser - Operating Height - Mounting height of paper towel dispenser's highest operable part exceeds 40" AFF. (Where provided, ADA Standards require at least one paper towel dispenser to be accessible with the highest operable part placed within at least one of the reach ranges specified in 4.2.5 and 4.2.6; where provided, CBC Standards require at least one paper towel dispenser to be accessible with the highest operable part no higher than 40" AFF.)	<b>1991 ADAAG</b> 4.22.7; 4.27.3; 4.2.5; 4.2.6 <b>2004 ADAAG</b> 308; 309 <b>2007 CBC</b> 1115B.8.3 <b>Other</b> -
Existing Condition: 53" high.

<b>Classification</b>	
<b>DOJ Location Type:</b>	2
<b>Use:</b>	PV
<b>Severity:</b>	C
<b>Level of Difficulty</b>	Low to Moderate

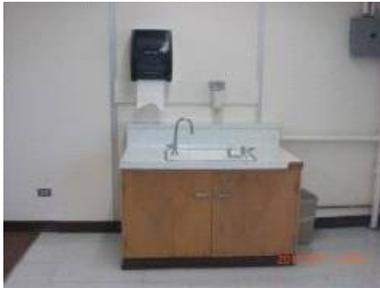
Location: Classroom K Photo # 303

<b>Field Condition</b>	
16.84C - Soap Dispenser - Operating Height - Mounting height of soap dispenser's highest operable part exceeds 40" AFF. (Where provided, ADA Standards require at least one soap dispenser to be accessible with the highest operable part placed within at least one of the reach ranges specified in 4.2.5 and 4.2.6; where provided, CBC Standards require at least one soap dispenser to be accessible with the highest operable part no higher than 40" AFF.)	1991 ADAAG 4.22.7; 4.27.3; 4.2.5; 4.2.6
Existing Condition: 41" high.	2004 ADAAG 308; 309
	2007 CBC 1115B.8.3
	Other -

<b>Classification</b>	
DOJ Location Type:	2
Use:	PV
Severity:	C
Level of Difficulty	Low to Moderate

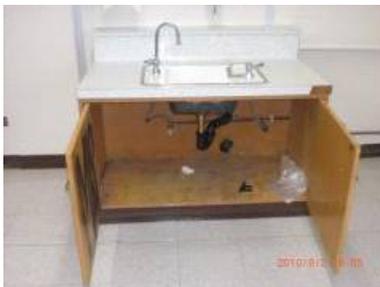
<b>Field Condition</b>	
14.37 - Kitchen Sink - Sink does not provide accessible knee clearance (i.e. at least 27" high, 30" wide, and 19" deep).	1991 ADAAG 4.24.3
Existing Condition: No knee space.	2004 ADAAG 305; 306; 606.2
	2007 CBC 1115B.4.7(2); 1122B.4
	Other -

<b>Classification</b>	
DOJ Location Type:	2
Use:	PV
Severity:	C
Level of Difficulty	Moderate to High

<b>Corrective Action</b>	
480A - New Counter Top and Sink - Remove existing cabinetry, and provide new counter at 34" above the finished floor. Remove and replace sink and faucet with new accessible sink and faucet. Provide accessible knee clearance (i.e. at least 27" high, 30" wide, and 19" deep) under the sink.	
Additional Comments:

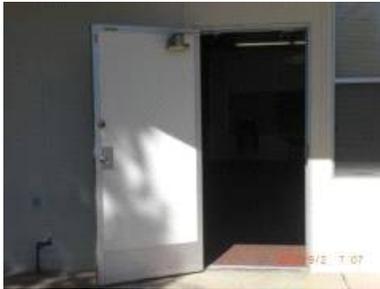
**Location:** Classroom J **Photo #** 306

10.07A - Landing - Level and Clear - Floor is not level (slope is greater than 2% in some or all directions). OR Floor is not clear within the required maneuvering space.

Existing Condition: 4.3% RS at door landing.

006 - Concrete Walk - Remove non-compliant pavement and replace with new concrete (area as shown on the drawings). The walkway slope shall not exceed 5% along the POT and cross slope shall not exceed 2%.

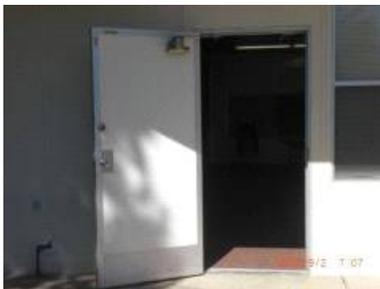
10.11A - Door Operating Effort - The force required to operate door exceeds 5 lbs. (Fire doors may have up to 15 lbs to achieve positive latching).

Existing Condition: 10 LBF.

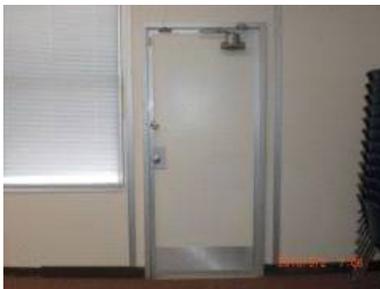
<b>Field Condition</b>	
10.13A - Required Exit Door Sign - At grade level exterior exit door, there is no tactile and CA Braille exit sign with the word "EXIT" mounted on the wall adjacent to the latch side of the door.	<b>1991 ADAAG</b> 4.1.3(16); 4.30.1
Existing Condition:	<b>2004 ADAAG</b> 216.4; 703.2; 703.3; 703.4
	<b>2007 CBC</b> 1011.3 item 1
	<b>Other</b> -

<b>Classification</b>	
<b>DOJ Location Type:</b>	4
<b>Use:</b>	PV
<b>Severity:</b>	C
<b>Level of Difficulty</b>	Low to Moderate

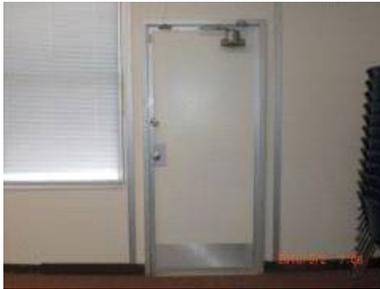
Location: Classroom J      Photo # 309

Field Condition									
11.12 - Hardware Mounting Height - Mounting height of all operating hardware is not 30" min.. or 44" max., as measured to the highest operable part. (1994 ADA Standards permit a max.. height of 48"; CBC Standards permit a range of 30" min.. to 44" max..)

1991 ADAAG	4.13.9	2004 ADAAG	-	2007 CBC	1133B.2.5.2	Other	-
1991 ADAAG	4.13.9								
2004 ADAAG	-								
2007 CBC	1133B.2.5.2								
Other	-								
Existing Condition: 53" to bolt.

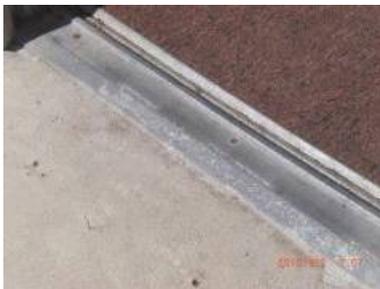
Field Condition									
10.09B - Threshold - Height - The threshold at doorway exceeds 1/2" in height.

1991 ADAAG	4.13.8	2004 ADAAG	303.3; Advisory 303.3; Fig. 303.3	2007 CBC	1133B.2.4.1	Other	-
1991 ADAAG	4.13.8								
2004 ADAAG	303.3; Advisory 303.3; Fig. 303.3								
2007 CBC	1133B.2.4.1								
Other	-								
Existing Condition: Compound threshold.

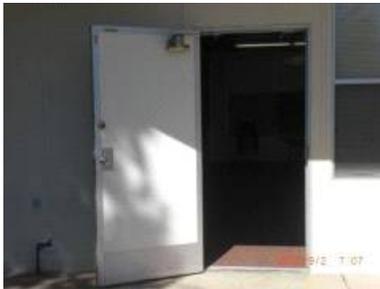
**Location:** Classroom J  
**Photo #** 306

Field Condition	
14.31 - Head Room - Clear head room is at less than 80" within the pedestrian circulation area, including the accessible route of travel.	1991 ADAAG 4.4.2
Existing Condition: 79" to door frame and closer.	2004 ADAAG 307.2; Fig. 307.2
	2007 CBC 1133B.8.6.2
Other	-

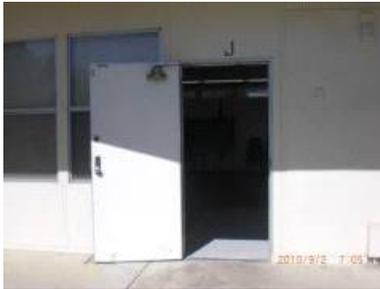
**Location:** Classroom J  
**Photo #** 314

<b>Field Condition</b>	10.02 - Entrance Sign - Accessible entrance is not identified by an ISA.	<b>1991 ADAAG</b>	28 CFR 35.163(b)1
Existing Condition:		<b>2004 ADAAG</b>	216.6
		<b>2007 CBC</b>	1117B.5.8.1.2
		<b>Other</b>	-

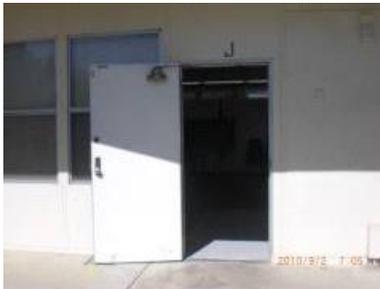
**Location:** Classroom J  
**Photo #** 314

<b>Field Condition</b>	10.11A - Door Operating Effort - The force required to operate door exceeds 5 lbs. (Fire doors may have up to 15 lbs to achieve positive latching).	<b>1991 ADAAG</b>	4.13.11
Existing Condition: 6 LBF.		<b>2004 ADAAG</b>	404.2.9
		<b>2007 CBC</b>	1133B.2.5
		<b>Other</b>	-

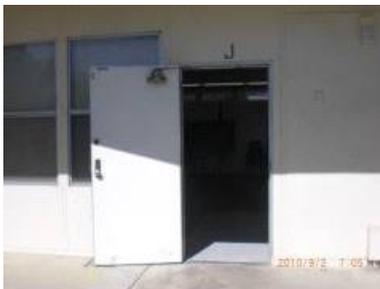
10.10 - Single-Action Hardware - Handles, locks, and latches or other operative devices are not operable with one hand and without tight grasping, pinching, or twisting of the wrist. (U-shaped handles, levers, and push/pull type mechanisms are acceptable designs.)

Existing Condition: Knob.

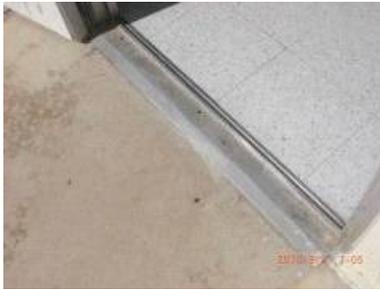
**Location:** Classroom J **Photo #** 318

<b>Field Condition</b>	
10.09B - Threshold - Height - The threshold at doorway exceeds 1/2" in height.	<b>1991 ADAAG</b> 4.13.8
Existing Condition: Compound threshold.	<b>2004 ADAAG</b> 303.3; Advisory 303.3; Fig. 303.3
	<b>2007 CBC</b> 1133B.2.4.1
	<b>Other</b> -

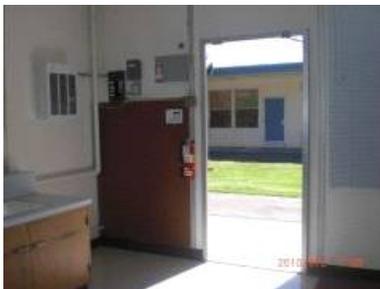
<b>Field Condition</b>	
10.13A - Required Exit Door Sign - At grade level exterior exit door, there is no tactile and CA Braille exit sign with the word "EXIT" mounted on the wall adjacent to the latch side of the door.	<b>1991 ADAAG</b> 4.1.3(16); 4.30.1
Existing Condition:	<b>2004 ADAAG</b> 216.4; 703.2; 703.3; 703.4
	<b>2007 CBC</b> 1011.3 item 1
	<b>Other</b> -

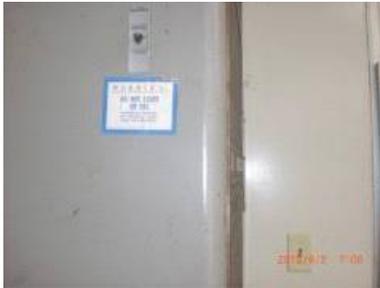
**Location:** Classroom J **Photo #** 324

<b>Field Condition</b>	
14.32A - Reach Range - Controls - Controls, dispensers, and similar devices are not between 9" and 54" AFF when the clear floor space allows a parallel approach. OR They are not between 15" and 48" AFF when the clear floor space allows only a forward approach.	<b>1991 ADAAG</b> 4.1.3(13); 4.27.3; 4.2.5; 4.2.6 ; Fig. 5; Fig. 6 <b>2004 ADAAG</b> - <b>2007 CBC</b> 1117B.6(3); 1118.5; 1118.6; Fig. 11B-5C; Fig. 11B-5D <b>Other</b> -
Existing Condition: 65" to heating/ cooling control.

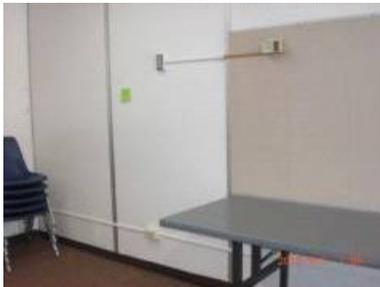
<b>Field Condition</b>	
14.32A - Reach Range - Controls - Controls, dispensers, and similar devices are not between 9" and 54" AFF when the clear floor space allows a parallel approach. OR They are not between 15" and 48" AFF when the clear floor space allows only a forward approach.	<b>1991 ADAAG</b> 4.1.3(13); 4.27.3; 4.2.5; 4.2.6 ; Fig. 5; Fig. 6 <b>2004 ADAAG</b> - <b>2007 CBC</b> 1117B.6(3); 1118.5; 1118.6; Fig. 11B-5C; Fig. 11B-5D <b>Other</b> -
Existing Condition: 69" to thermostat.

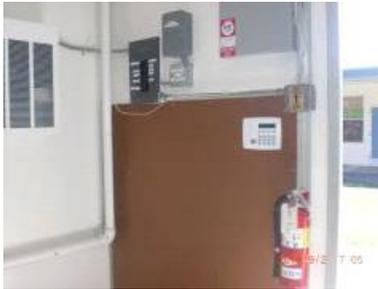
**Location:** Classroom J **Photo #** 326

<b>Field Condition</b>	
14.32A - Reach Range - Controls - Controls, dispensers, and similar devices are not between 9" and 54" AFF when the clear floor space allows a parallel approach. OR They are not between 15" and 48" AFF when the clear floor space allows only a forward approach.	<b>1991 ADAAG</b> 4.1.3(13); 4.27.3; 4.2.5; 4.2.6 ; Fig. 5; Fig. 6 <b>2004 ADAAG</b> - <b>2007 CBC</b> 1117B.6(3); 1118.5; 1118.6; Fig. 11B-5C; Fig. 11B-5D <b>Other</b> -
Existing Condition: 54 1/2" to alarm.

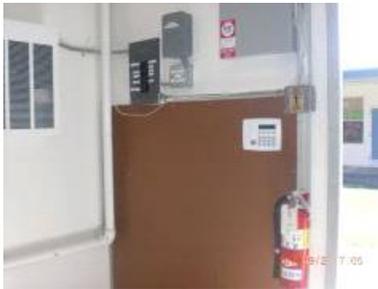
<b>Field Condition</b>	
14.32A - Reach Range - Controls - Controls, dispensers, and similar devices are not between 9" and 54" AFF when the clear floor space allows a parallel approach. OR They are not between 15" and 48" AFF when the clear floor space allows only a forward approach.	<b>1991 ADAAG</b> 4.1.3(13); 4.27.3; 4.2.5; 4.2.6 ; Fig. 5; Fig. 6 <b>2004 ADAAG</b> - <b>2007 CBC</b> 1117B.6(3); 1118.5; 1118.6; Fig. 11B-5C; Fig. 11B-5D <b>Other</b> -
Existing Condition: 60" to light switch.

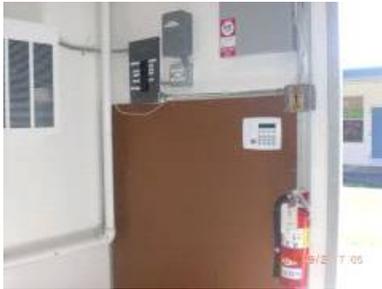
<b>Field Condition</b>	
14.32A - Reach Range - Controls - Controls, dispensers, and similar devices are not between 9" and 54" AFF when the clear floor space allows a parallel approach. OR They are not between 15" and 48" AFF when the clear floor space allows only a forward approach.	<b>1991 ADAAG</b> 4.1.3(13); 4.27.3; 4.2.5; 4.2.6 ; Fig. 5; Fig. 6
Existing Condition: 65" to gas switch.	<b>2004 ADAAG</b> -
	<b>2007 CBC</b> 1117B.6(3); 1118.5; 1118.6; Fig. 11B-5C; Fig. 11B-5D
	<b>Other</b> -

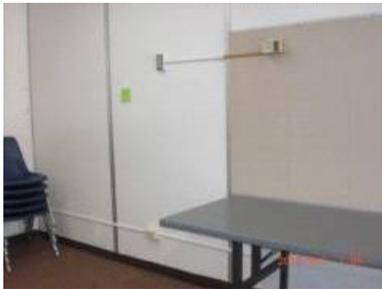
<b>Field Condition</b>	
14.34 - Electrical/Communications Receptacles - Mounting Height - Electrical/communications receptacle is not located between 15" min.. and 48" max.. AFF.	<b>1991 ADAAG</b> 4.1.3(13); 4.27.3; 4.2.5; 4.2.6 ; Fig. 5; Fig. 6
Existing Condition: 14" high receptacle.	<b>2004 ADAAG</b> 308.2.1; Fig. 308.2.1; 308.3.1; Fig. 308.3.1; 309.3
	<b>2007 CBC</b> 1117B.6(5.2)
	<b>Other</b> -

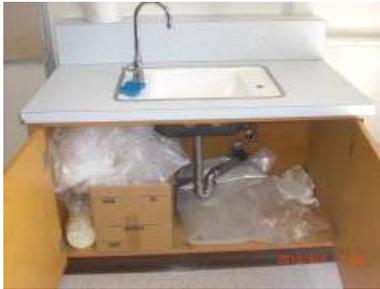
**Location:** Classroom J **Photo #** 330

<b>Field Condition</b>	
14.37 - Kitchen Sink - Sink does not provide accessible knee clearance (i.e. at least 27" high, 30" wide, and 19" deep).	<b>1991 ADAAG</b> 4.24.3
Existing Condition: No knee space.	<b>2004 ADAAG</b> 305; 306; 606.2
	<b>2007 CBC</b> 1115B.4.7(2); 1122B.4
	<b>Other</b> -

<b>Corrective Action</b>
480A - New Counter Top and Sink - Remove existing cabinetry, and provide new counter at 34" above the finished floor. Remove and replace sink and faucet with new accessible sink and faucet. Provide accessible knee clearance (i.e. at least 27" high, 30" wide, and 19" deep) under the sink.
Additional Comments:

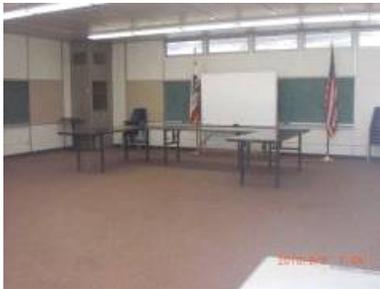
<b>Field Condition</b>	
20.04 - Common Use Areas - Visual Alarms - Visual alarms are not provided in common use area(s) of the building such as meeting and conference rooms, open office space, classrooms, cafeterias, filing and photocopy rooms, employee break rooms, dressing, examination, and treatment rooms, and similar spaces that are not used solely as employee work areas.	<b>1991 ADAAG</b> 4.28.1
Existing Condition:	<b>2004 ADAAG</b> 215.2; 702.1
	<b>2007 CBC</b> 907.9.1.1
	<b>Other</b> -

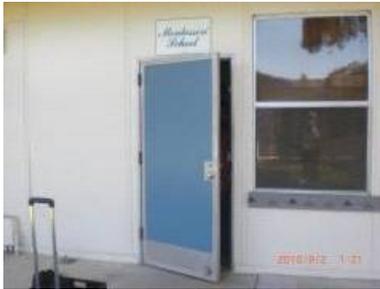
**Location:** Montessori Classroom  
**Photo #** 332

<b>Field Condition</b>	10.02 - Entrance Sign - Accessible entrance is not identified by an ISA.	<b>1991 ADAAG</b>	28 CFR 35.163(b)1
Existing Condition:		<b>2004 ADAAG</b>	216.6
		<b>2007 CBC</b>	1117B.5.8.1.2
		<b>Other</b>	-

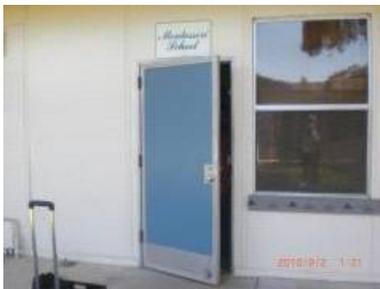
<b>Field Condition</b>	10.10 - Single-Action Hardware - Handles, locks, and latches or other operative devices are not operable with one hand and without tight grasping, pinching, or twisting of the wrist. (U-shaped handles, levers, and push/pull type mechanisms are acceptable designs.)	<b>1991 ADAAG</b>	4.13.9
Existing Condition: Knob.		<b>2004 ADAAG</b>	309.4; 404.2.7; Advisory 404.2.7
		<b>2007 CBC</b>	1133B.2.5.2
		<b>Other</b>	-

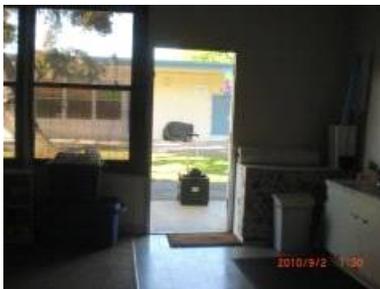
<b>Field Condition</b>	
10.13A - Required Exit Door Sign - At grade level exterior exit door, there is no tactile and CA Braille exit sign with the word "EXIT" mounted on the wall adjacent to the latch side of the door.	<b>1991 ADAAG</b> 4.1.3(16); 4.30.1
Existing Condition:	<b>2004 ADAAG</b> 216.4; 703.2; 703.3; 703.4
	<b>2007 CBC</b> 1011.3 item 1
	<b>Other</b> -

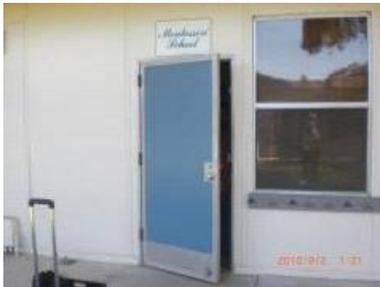
Field Condition	
11.17A - Recommendation: Providing Room/Space ID Sign - A sign designating the permanent room or space has not been provided.	1991 ADAAG 4.1.2(7)
Existing Condition:	2004 ADAAG 216.2; 703.1; 703.2; 703.5
	2007 CBC 1117B.5.1 item 1
	Other -

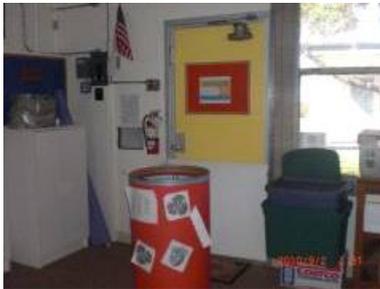
**Location:** Montessori Classroom  
**Photo #** 339

<b>Field Condition</b>	
10.12 - Other Door Requirements - Entrance door does not comply with all applicable ADAAG and CBC accessibility requirements.	1991 ADAAG 4.13
Existing Condition: Pinch type hardware for low door.	2004 ADAAG 404
	2007 CBC 1133B.1
	Other -

<b>Corrective Action</b>
067B - Lever Hardware - Replace door hardware with lever-type handset.
Additional Comments:

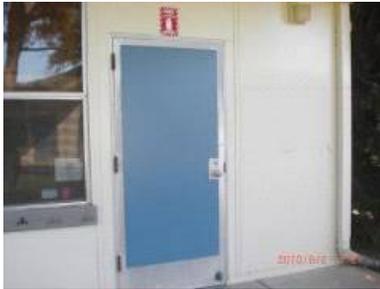
**Location:** Montessori Classroom **Photo #** 340

<b>Field Condition</b>									
10.10 - Single-Action Hardware - Handles, locks, and latches or other operative devices are not operable with one hand and without tight grasping, pinching, or twisting of the wrist. (U-shaped handles, levers, and push/pull type mechanisms are acceptable designs.)

<b>1991 ADAAG</b>	4.13.9	<b>2004 ADAAG</b>	309.4; 404.2.7; Advisory 404.2.7	<b>2007 CBC</b>	1133B.2.5.2	<b>Other</b>	-
<b>1991 ADAAG</b>	4.13.9								
<b>2004 ADAAG</b>	309.4; 404.2.7; Advisory 404.2.7								
<b>2007 CBC</b>	1133B.2.5.2								
<b>Other</b>	-								
Existing Condition: Knob.

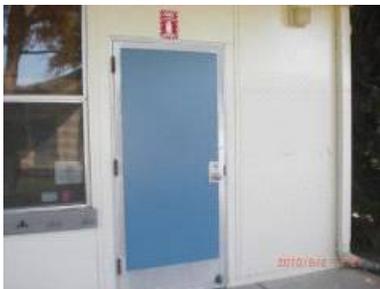
<b>Field Condition</b>									
10.09B - Threshold - Height - The threshold at doorway exceeds 1/2" in height.

<b>1991 ADAAG</b>	4.13.8	<b>2004 ADAAG</b>	303.3; Advisory 303.3; Fig. 303.3	<b>2007 CBC</b>	1133B.2.4.1	<b>Other</b>	-
<b>1991 ADAAG</b>	4.13.8								
<b>2004 ADAAG</b>	303.3; Advisory 303.3; Fig. 303.3								
<b>2007 CBC</b>	1133B.2.4.1								
<b>Other</b>	-								
Existing Condition: Compound threshold.

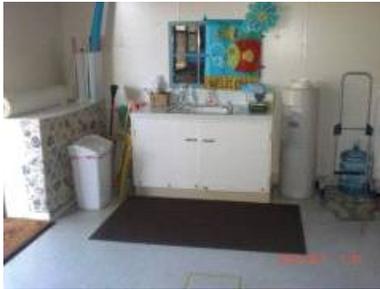
**Location:** Montessori Classroom  
**Photo #** 346

14.36B - Kitchen Counter/Sink Height - Where provided in public or common use areas, countertops and sinks are not mounted at 34" AFF. max..(Common use areas are those interior and exterior rooms, spaces, or elements that are made available for the use of a restricted group of people (for example, the occupants of an office building, or the guests of such occupants).

Existing Condition: 30 1/2" high, 24" maximum for kindergarten.

480A - New Counter Top and Sink - Remove existing cabinetry, and provide new counter at 34" above the finished floor. Remove and replace sink and faucet with new accessible sink and faucet. Provide accessible knee clearance (i.e. at least 27" high, 30" wide, and 19" deep) under the sink.

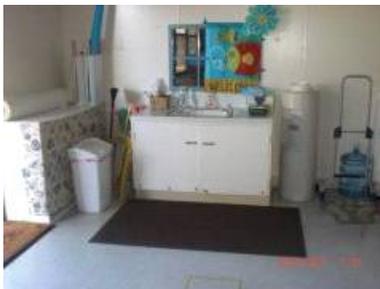
14.37 - Kitchen Sink - Sink does not provide accessible knee clearance (i.e. at least 27" high, 30" wide, and 19" deep).

Existing Condition: No knee space.

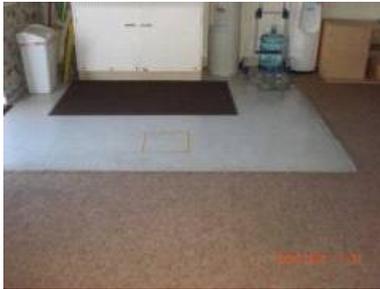
**Location:** Montessori Classroom  
**Photo #** 348

<b>Field Condition</b>									
14.23B - Floor Surface - Accessible route surfaces are not stable, firm and slip-resistant.  Existing Condition: Loose floor mats.

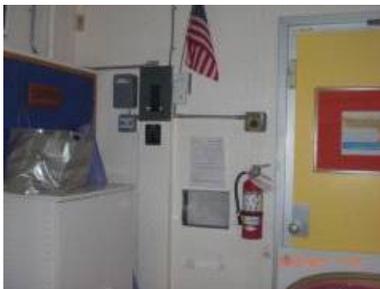
<b>Field Condition</b>									
14.32A - Reach Range - Controls - Controls, dispensers, and similar devices are not between 9" and 54" AFF when the clear floor space allows a parallel approach. OR They are not between 15" and 48" AFF when the clear floor space allows only a forward approach.  Existing Condition: 59" to light switch.

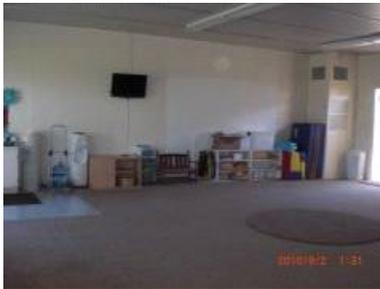
20.04 - Common Use Areas - Visual Alarms - Visual alarms are not provided in common use area(s) of the building such as meeting and conference rooms, open office space, classrooms, cafeterias, filing and photocopy rooms, employee break rooms, dressing, examination, and treatment rooms, and similar spaces that are not used solely as employee work areas.

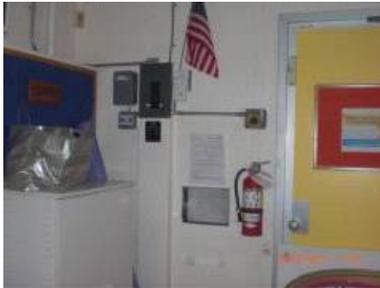
<b>Field Condition</b>	
14.32A - Reach Range - Controls - Controls, dispensers, and similar devices are not between 9" and 54" AFF when the clear floor space allows a parallel approach. OR They are not between 15" and 48" AFF when the clear floor space allows only a forward approach.	<b>1991 ADAAG</b> 4.1.3(13); 4.27.3; 4.2.5; 4.2.6 ; Fig. 5; Fig. 6 <b>2004 ADAAG</b> - <b>2007 CBC</b> 1117B.6(3); 1118.5; 1118.6; Fig. 11B-5C; Fig. 11B-5D <b>Other</b> -
Existing Condition: 59" to gas switch.

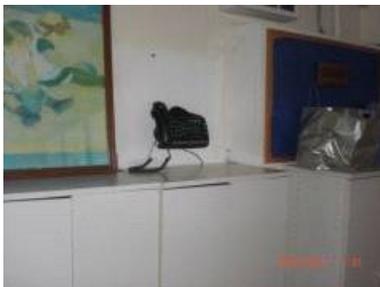
**Location:** Montessori Classroom  
**Photo #** 353

<b>Field Condition</b>	
14.32A - Reach Range - Controls - Controls, dispensers, and similar devices are not between 9" and 54" AFF when the clear floor space allows a parallel approach. OR They are not between 15" and 48" AFF when the clear floor space allows only a forward approach.	<b>1991 ADAAG</b> 4.1.3(13); 4.27.3; 4.2.5; 4.2.6 ; Fig. 5; Fig. 6 <b>2004 ADAAG</b> - <b>2007 CBC</b> 1117B.6(3); 1118.5; 1118.6; Fig. 11B-5C; Fig. 11B-5D <b>Other</b> -
Existing Condition: 55" to phone.

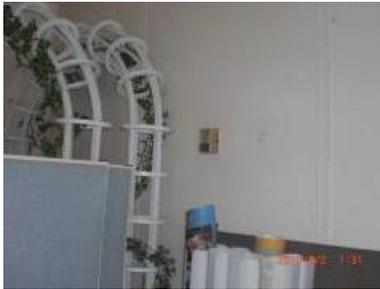
**Location:** Montessori Classroom **Photo #** 354

<b>Field Condition</b>	
14.32A - Reach Range - Controls - Controls, dispensers, and similar devices are not between 9" and 54" AFF when the clear floor space allows a parallel approach. OR They are not between 15" and 48" AFF when the clear floor space allows only a forward approach.	<b>1991 ADAAG</b> 4.1.3(13); 4.27.3; 4.2.5; 4.2.6 ; Fig. 5; Fig. 6 <b>2004 ADAAG</b> - <b>2007 CBC</b> 1117B.6(3); 1118.5; 1118.6; Fig. 11B-5C; Fig. 11B-5D <b>Other</b> -
Existing Condition: 66" to thermostat.

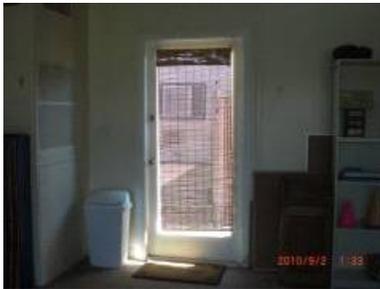
<b>Field Condition</b>	
10.09B - Threshold - Height - The threshold at doorway exceeds 1/2" in height.	<b>1991 ADAAG</b> 4.13.8 <b>2004 ADAAG</b> 303.3; Advisory 303.3; Fig. 303.3 <b>2007 CBC</b> 1133B.2.4.1 <b>Other</b> -
Existing Condition: 1 1/2" high.

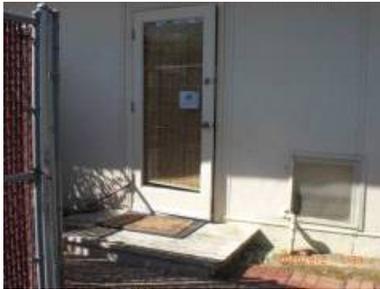
**Keynote 356**

Existing Condition: 7" step from door landing to patio.

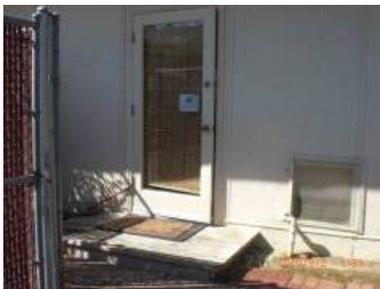
**Keynote 357**

Existing Condition: Knob.

067B - Lever Hardware - Replace door hardware with lever-type handset.

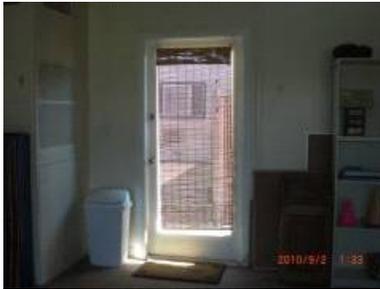
**Keynote 358**

10.13A - Required Exit Door Sign - At grade level exterior exit door, there is no tactile and CA Braille exit sign with the word "EXIT" mounted on the wall adjacent to the latch side of the door.

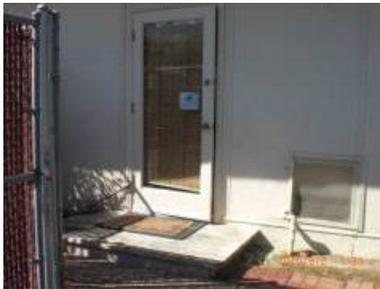
**Keynote 359**

11.12 - Hardware Mounting Height - Mounting height of all operating hardware is not 30" min.. or 44" max., as measured to the highest operable part. (1994 ADA Standards permit a max.. height of 48"; CBC Standards permit a range of 30" min.. to 44" max..)

Existing Condition: 53" to bolt.

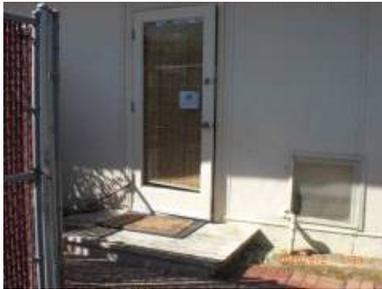
**Keynote 360**

<b>Field Condition</b>	
10.08 - Kick Plate - Bottom 10" of door does not have a smooth, uninterrupted surface on the push side to allow the door to be opened by a wheelchair footrest without creating a trap or hazardous condition. (This requirement does not apply to automatic and sliding doors.)	1991 ADAAG -
Existing Condition: 9 1/2".	2004 ADAAG 404.2.10
	2007 CBC 1133B.2.6
	Other -

<b>Classification</b>	
DOJ Location Type:	1
Use:	GS
Severity:	A
Level of Difficulty	Low to Moderate

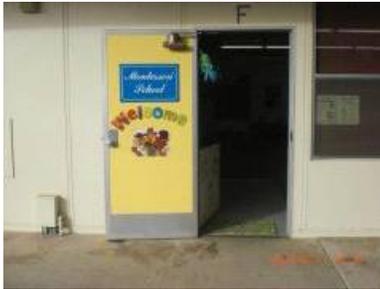
**Keynote 362**

<b>Field Condition</b>	10.02 - Entrance Sign - Accessible entrance is not identified by an ISA.	<b>1991 ADAAG</b>	28 CFR 35.163(b)1
Existing Condition:		<b>2004 ADAAG</b>	216.6
		<b>2007 CBC</b>	1117B.5.8.1.2
		<b>Other</b>	-

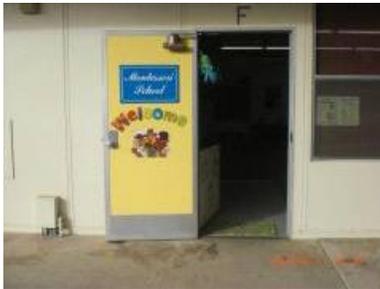
**Keynote 363**

<b>Field Condition</b>	10.10 - Single-Action Hardware - Handles, locks, and latches or other operative devices are not operable with one hand and without tight grasping, pinching, or twisting of the wrist. (U-shaped handles, levers, and push/pull type mechanisms are acceptable designs.)	<b>1991 ADAAG</b>	4.13.9
Existing Condition: Knob.		<b>2004 ADAAG</b>	309.4; 404.2.7; Advisory 404.2.7
		<b>2007 CBC</b>	1133B.2.5.2
		<b>Other</b>	-

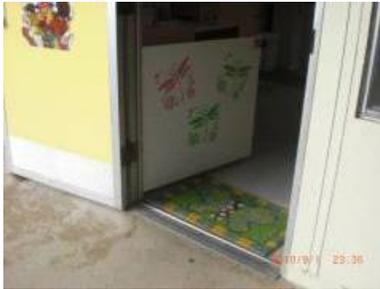
**Keynote 364**

<b>Field Condition</b>	
10.09B - Threshold - Height - The threshold at doorway exceeds 1/2" in height.	<b>1991 ADAAG</b> 4.13.8
Existing Condition: Compound threshold.	<b>2004 ADAAG</b> 303.3; Advisory 303.3; Fig. 303.3
	<b>2007 CBC</b> 1133B.2.4.1
	<b>Other</b> -

<b>Classification</b>	
<b>DOJ Location Type:</b>	1
<b>Use:</b>	GS
<b>Severity:</b>	C
<b>Level of Difficulty</b>	Low to Moderate

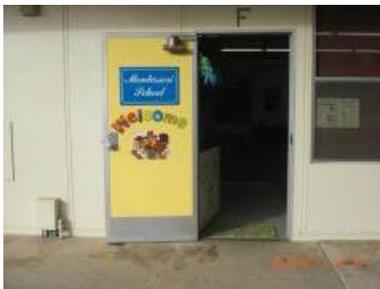
**Keynote 365**

<b>Field Condition</b>	
10.11A - Door Operating Effort - The force required to operate door exceeds 5 lbs. (Fire doors may have up to 15 lbs to achieve positive latching).	<b>1991 ADAAG</b> 4.13.11
Existing Condition: 7 LBF.	<b>2004 ADAAG</b> 404.2.9
	<b>2007 CBC</b> 1133B.2.5
	<b>Other</b> -

<b>Classification</b>	
<b>DOJ Location Type:</b>	1
<b>Use:</b>	GS
<b>Severity:</b>	B
<b>Level of Difficulty</b>	Low to Moderate

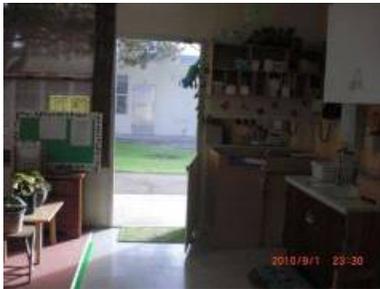
**Keynote 367**

<b>Field Condition</b>	
10.13A - Required Exit Door Sign - At grade level exterior exit door, there is no tactile and CA Braille exit sign with the word "EXIT" mounted on the wall adjacent to the latch side of the door.	1991 ADAAG 4.1.3(16); 4.30.1
Existing Condition:	2004 ADAAG 216.4; 703.2; 703.3; 703.4
	2007 CBC 1011.3 item 1
	Other -

<b>Classification</b>	
DOJ Location Type:	4
Use:	GS
Severity:	C
Level of Difficulty	Low to Moderate

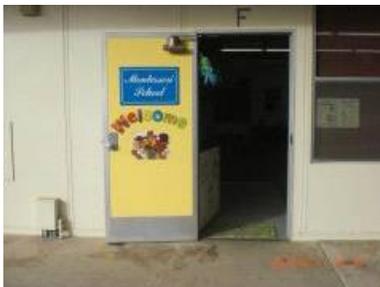
**Keynote 369**

<b>Field Condition</b>	
11.17B - Room/Space Identification Signs (Visual/Tactile Signs) - Sign designating the permanent room or space does not comply with ADAAG and CBC requirements for tactile signs.	<b>1991 ADAAG</b> 4.1.2(7); 4.30.1, 4, 5, 6
Existing Condition:	<b>2004 ADAAG</b> 216.2; 703.1; 703.2; 703.5
	<b>2007 CBC</b> 1117B.5.2, 3, 5, 6, 7
	<b>Other</b> -

<b>Classification</b>	
<b>DOJ Location Type:</b>	2
<b>Use:</b>	GS
<b>Severity:</b>	C
<b>Level of Difficulty</b>	Low to Moderate

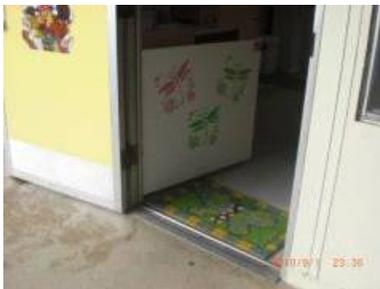
**Keynote 371**

Existing Condition: Pinch type hardware for low door.

067B - Lever Hardware - Replace door hardware with lever-type handset.

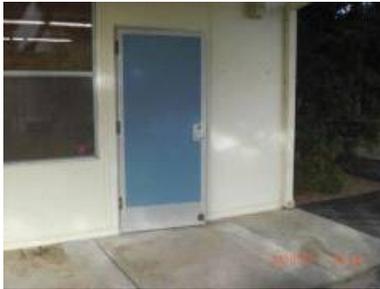
**Keynote 372**

<b>Field Condition</b>	
10.10 - Single-Action Hardware - Handles, locks, and latches or other operative devices are not operable with one hand and without tight grasping, pinching, or twisting of the wrist. (U-shaped handles, levers, and push/pull type mechanisms are acceptable designs.)	<b>1991 ADAAG</b> 4.13.9
Existing Condition: Knob.	<b>2004 ADAAG</b> 309.4; 404.2.7; Advisory 404.2.7
	<b>2007 CBC</b> 1133B.2.5.2
	<b>Other</b> -

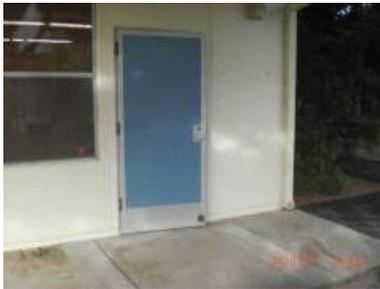
**Keynote 373**

<b>Field Condition</b>	
11.17A - Recommendation: Providing Room/Space ID Sign - A sign designating the permanent room or space has not been provided.	<b>1991 ADAAG</b> 4.1.2(7)
Existing Condition:	<b>2004 ADAAG</b> 216.2; 703.1; 703.2; 703.5
	<b>2007 CBC</b> 1117B.5.1 item 1
	<b>Other</b> -

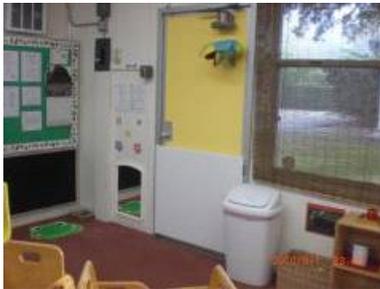
**Keynote 375**

<b>Field Condition</b>			
10.10 - Single-Action Hardware - Handles, locks, and latches or other operative devices are not operable with one hand and without tight grasping, pinching, or twisting of the wrist. (U-shaped handles, levers, and push/pull type mechanisms are acceptable designs.)	<b>1991 ADAAG</b>	4.13.9	
Existing Condition: Pinch type hardware for low door.	<b>2004 ADAAG</b>	309.4; 404.2.7; Advisory 404.2.7	
	<b>2007 CBC</b>	1133B.2.5.2	
	<b>Other</b>	-

<b>Classification</b>	
<b>DOJ Location Type:</b>	1
<b>Use:</b>	GS
<b>Severity:</b>	C
<b>Level of Difficulty</b>	Low to Moderate

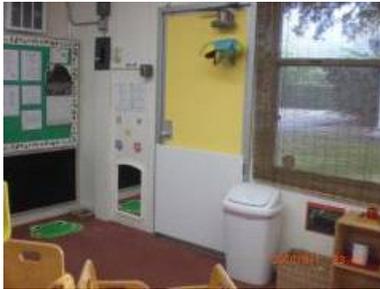
**Keynote 376**

<b>Field Condition</b>	
10.13A - Required Exit Door Sign - At grade level exterior exit door, there is no tactile and CA Braille exit sign with the word "EXIT" mounted on the wall adjacent to the latch side of the door.	<b>1991 ADAAG</b> 4.1.3(16); 4.30.1
Existing Condition:	<b>2004 ADAAG</b> 216.4; 703.2; 703.3; 703.4
	<b>2007 CBC</b> 1011.3 item 1
	<b>Other</b> -

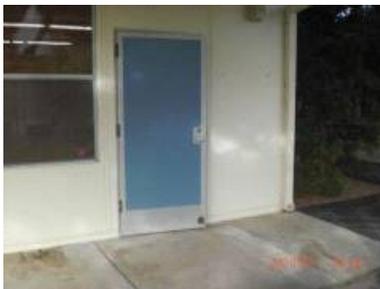
**Keynote 377**

<b>Field Condition</b>	
10.07A - Landing - Level and Clear - Floor is not level (slope is greater than 2% in some or all directions). OR Floor is not clear within the required maneuvering space.	<b>1991 ADAAG</b> 4.13.6; Fig. 25
Existing Condition: 3.3% RS at door landing.	<b>2004 ADAAG</b> 305; 404.2.4.4
	<b>2007 CBC</b> 1133B.2.4
	<b>Other</b> -

<b>Corrective Action</b>
006 - Concrete Walk - Remove non-compliant pavement and replace with new concrete (area as shown on the drawings). The walkway slope shall not exceed 5% along the POT and cross slope shall not exceed 2%.
Additional Comments:

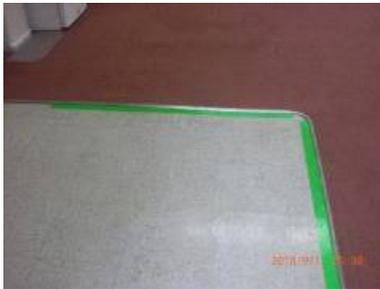
**Keynote 379**

Field Condition	
14.26 - Floor Material Changes - Where floor materials change, the vertical difference between them is not compliant. (Vertical difference shall be < 1/4". Changes in level between 1/4 inch and 1/2 inch shall be beveled with a slope no greater than 1:2.)	1991 ADAAG 4.1.3(5); 4.5.2
Existing Condition: 3/4" level change from tile to carpet.	2004 ADAAG 303.2; 303.3
	2007 CBC 1124B.1
	Other -

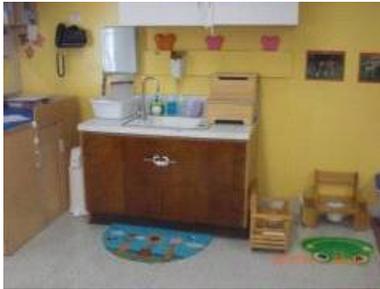
**Keynote 380**

14.36B - Kitchen Counter/Sink Height - Where provided in public or common use areas, countertops and sinks are not mounted at 34" AFF. max..(Common use areas are those interior and exterior rooms, spaces, or elements that are made available for the use of a restricted group of people (for example, the occupants of an office building, or the guests of such occupants).

Existing Condition: 30 1/2" high, 24" maximum for kindergarten.

480A - New Counter Top and Sink - Remove existing cabinetry, and provide new counter at 34" above the finished floor. Remove and replace sink and faucet with new accessible sink and faucet. Provide accessible knee clearance (i.e. at least 27" high, 30" wide, and 19" deep) under the sink.
