*City of Rancho Palos Verdes*  
**Rancho Palos Verdes ADA Assessment**  
**Facility Report with Photos**

**Facility ID: # 08 - Ladera Linda Park & Community Center**

**Author: Vaish, B**

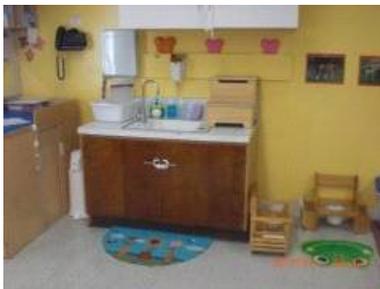
**Keynote 381**

14.37 - Kitchen Sink - Sink does not provide accessible knee clearance (i.e. at least 27" high, 30" wide, and 19" deep).

Existing Condition: No knee space.

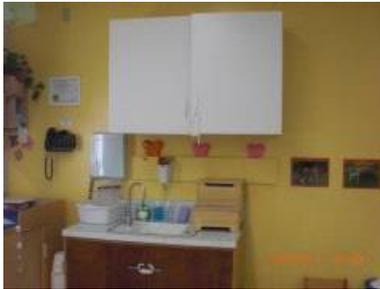
**Keynote 382**

<b>Field Condition</b>	
14.31 - Head Room - Clear head room is at less than 80" within the pedestrian circulation area, including the accessible route of travel.	1991 ADAAG 4.4.2
Existing Condition: 67" high cupboard, projects 16" from wall.	2004 ADAAG 307.2; Fig. 307.2
	2007 CBC 1133B.8.6.2
	Other -

<b>Classification</b>	
DOJ Location Type:	2
Use:	GS
Severity:	A
Level of Difficulty	Moderate

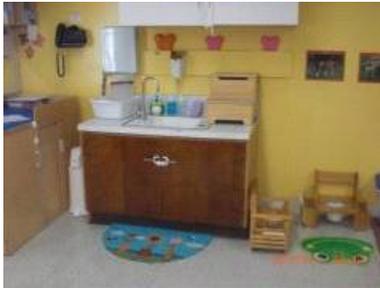
**Keynote 384**

<b>Field Condition</b>	
16.84C - Soap Dispenser - Operating Height - Mounting height of soap dispenser's highest operable part exceeds 40" AFF. (Where provided, ADA Standards require at least one soap dispenser to be accessible with the highest operable part placed within at least one of the reach ranges specified in 4.2.5 and 4.2.6; where provided, CBC Standards require at least one soap dispenser to be accessible with the highest operable part no higher than 40" AFF.)	<b>1991 ADAAG</b> 4.22.7; 4.27.3; 4.2.5; 4.2.6 <b>2004 ADAAG</b> 308; 309 <b>2007 CBC</b> 1115B.8.3 <b>Other</b> -
Existing Condition: 42" high.

<b>Classification</b>	
<b>DOJ Location Type:</b>	2
<b>Use:</b>	GS
<b>Severity:</b>	C
<b>Level of Difficulty</b>	Low to Moderate

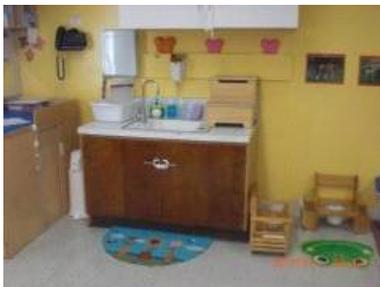
**Keynote 385**

<b>Field Condition</b>	
16.84A - Paper Towel Dispenser - Operating Height - Mounting height of paper towel dispenser's highest operable part exceeds 40" AFF. (Where provided, ADA Standards require at least one paper towel dispenser to be accessible with the highest operable part placed within at least one of the reach ranges specified in 4.2.5 and 4.2.6; where provided, CBC Standards require at least one paper towel dispenser to be accessible with the highest operable part no higher than 40" AFF.)	<b>1991 ADAAG</b> 4.22.7; 4.27.3; 4.2.5; 4.2.6 <b>2004 ADAAG</b> 308; 309 <b>2007 CBC</b> 1115B.8.3 <b>Other</b> -
Existing Condition: 42" high.

<b>Classification</b>	
<b>DOJ Location Type:</b>	2
<b>Use:</b>	GS
<b>Severity:</b>	C
<b>Level of Difficulty</b>	Low to Moderate

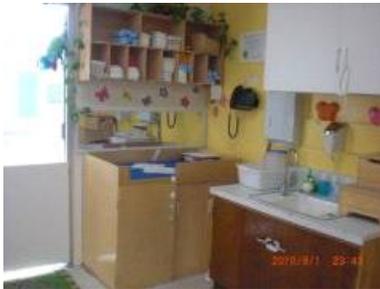
**Keynote 387**

<b>Field Condition</b>	
14.32A - Reach Range - Controls - Controls, dispensers, and similar devices are not between 9" and 54" AFF when the clear floor space allows a parallel approach. OR They are not between 15" and 48" AFF when the clear floor space allows only a forward approach.	<b>1991 ADAAG</b> 4.1.3(13); 4.27.3; 4.2.5; 4.2.6 ; Fig. 5; Fig. 6 <b>2004 ADAAG</b> - <b>2007 CBC</b> 1117B.6(3); 1118.5; 1118.6; Fig. 11B-5C; Fig. 11B-5D <b>Other</b> -
Existing Condition: 60" to diaper dispenser.

<b>Classification</b>	
<b>DOJ Location Type:</b>	2
<b>Use:</b>	GS
<b>Severity:</b>	C
<b>Level of Difficulty</b>	Moderate

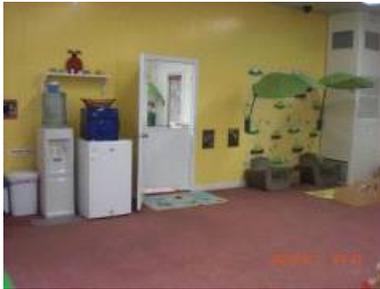
**Keynote 390**

<b>Field Condition</b>	
11.11 - Single-Action Hardware - Handles, locks, and latches or other operative devices are not operable with one hand and without tight grasping, pinching, or twisting of the wrist. (U-shaped handles, levers, and push/pull type mechanisms are acceptable designs.)	<b>1991 ADAAG</b> 4.13.9
Existing Condition: Knob and twist type lock.	<b>2004 ADAAG</b> 309.4; 404.2.7; Advisory 404.2.7
	<b>2007 CBC</b> 1133B.2.5.2
	<b>Other</b> -

<b>Classification</b>	
<b>DOJ Location Type:</b>	2
<b>Use:</b>	GS
<b>Severity:</b>	C
<b>Level of Difficulty</b>	Low to Moderate

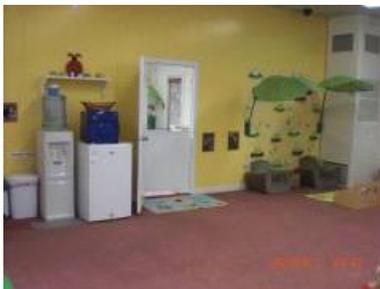
**Keynote 391**

<b>Field Condition</b>	
11.17A - Recommendation: Providing Room/Space ID Sign - A sign designating the permanent room or space has not been provided.	<b>1991 ADAAG</b> 4.1.2(7)
Existing Condition:	<b>2004 ADAAG</b> 216.2; 703.1; 703.2; 703.5
	<b>2007 CBC</b> 1117B.5.1 item 1
	<b>Other</b> -

<b>Classification</b>	
<b>DOJ Location Type:</b>	2
<b>Use:</b>	GS
<b>Severity:</b>	E
<b>Level of Difficulty</b>	Low to Moderate

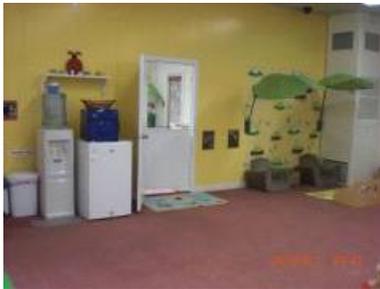
**Keynote 393**

Field Condition	
11.10B - Threshold - Height - The threshold at doorway exceeds 1/2" in height.	1991 ADAAG 4.13.8
Existing Condition: 1 1/2" high.	2004 ADAAG 303.3; Advisory 303.3; Fig. 303.3
	2007 CBC 1133B.2.4.1
	Other -

Classification	
DOJ Location Type:	2
Use:	GS
Severity:	C
Level of Difficulty	Low to Moderate

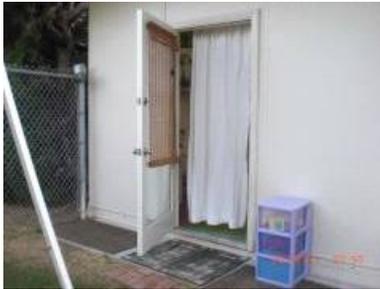
**Keynote 396**

<b>Field Condition</b>	
10.07A - Landing - Level and Clear - Floor is not level (slope is greater than 2% in some or all directions). OR Floor is not clear within the required maneuvering space.	<b>1991 ADAAG</b> 4.13.6; Fig. 25
Existing Condition: 2.3% RS at door landing.	<b>2004 ADAAG</b> 305; 404.2.4.4
	<b>2007 CBC</b> 1133B.2.4
	<b>Other</b> -

<b>Classification</b>	
<b>DOJ Location Type:</b>	1
<b>Use:</b>	GS
<b>Severity:</b>	C
<b>Level of Difficulty</b>	High

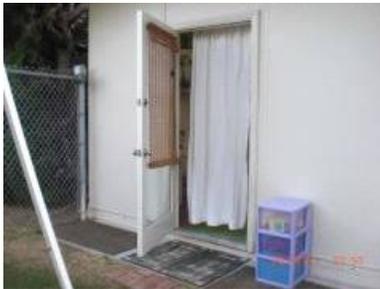
**Keynote 397**

<b>Field Condition</b>	
10.08 - Kick Plate - Bottom 10" of door does not have a smooth, uninterrupted surface on the push side to allow the door to be opened by a wheelchair footrest without creating a trap or hazardous condition. (This requirement does not apply to automatic and sliding doors.)	<b>1991 ADAAG</b> -
Existing Condition: 8" high.	<b>2004 ADAAG</b> 404.2.10
	<b>2007 CBC</b> 1133B.2.6
	<b>Other</b> -

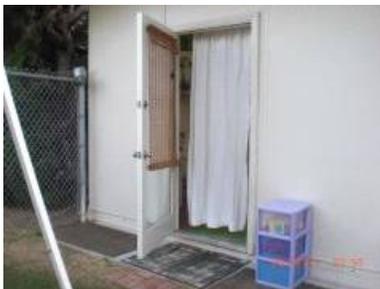
**Keynote 399**

<b>Field Condition</b>									
10.10 - Single-Action Hardware - Handles, locks, and latches or other operative devices are not operable with one hand and without tight grasping, pinching, or twisting of the wrist. (U-shaped handles, levers, and push/pull type mechanisms are acceptable designs.)  Existing Condition: Knob and twist type hardware.

<b>Corrective Action</b>
067B - Lever Hardware - Replace door hardware with lever-type handset.  Additional Comments:

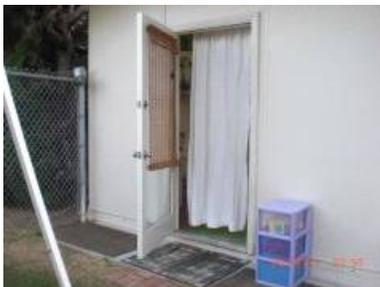
**Keynote 401**

Existing Condition: 5" level change from door threshold to patio.

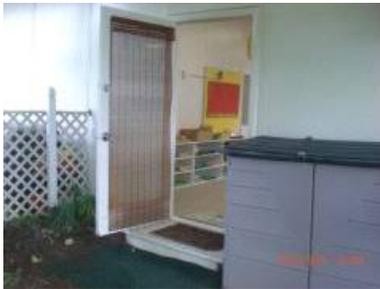
**Location:** Classroom E  
**Photo #** 403

Field Condition	
14.02 - Accessible Route - Accessible routes of travel do not connect the room or space to an accessible entrance within the building or facility.	1991 ADAAG 4.1.3(1); 4.3.2(3)
Existing Condition: 7" level change from door to patio.	2004 ADAAG 206.2.4; Advisory 206.2.4
	2007 CBC 1114B.1.2
	Other -

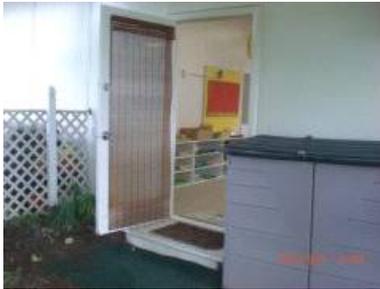
**Keynote 404**

<b>Field Condition</b>	
10.08 - Kick Plate - Bottom 10" of door does not have a smooth, uninterrupted surface on the push side to allow the door to be opened by a wheelchair footrest without creating a trap or hazardous condition. (This requirement does not apply to automatic and sliding doors.)	<b>1991 ADAAG</b> -
Existing Condition: 8" high.	<b>2004 ADAAG</b> 404.2.10
	<b>2007 CBC</b> 1133B.2.6
	<b>Other</b> -

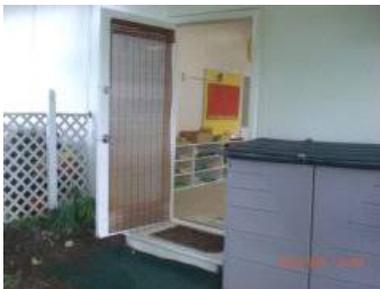
**Keynote 405**

<b>Field Condition</b>	
10.10 - Single-Action Hardware - Handles, locks, and latches or other operative devices are not operable with one hand and without tight grasping, pinching, or twisting of the wrist. (U-shaped handles, levers, and push/pull type mechanisms are acceptable designs.)	<b>1991 ADAAG</b> 4.13.9
Existing Condition: Knob and twist type hardware.	<b>2004 ADAAG</b> 309.4; 404.2.7; Advisory 404.2.7
	<b>2007 CBC</b> 1133B.2.5.2
	<b>Other</b> -

<b>Corrective Action</b>
067B - Lever Hardware - Replace door hardware with lever-type handset.
Additional Comments:

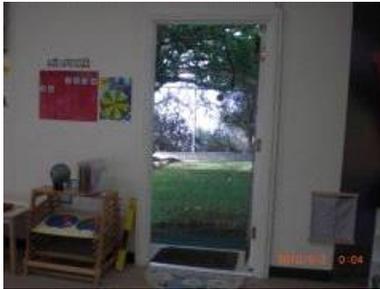
**Keynote 406**

<b>Field Condition</b>	
10.13A - Required Exit Door Sign - At grade level exterior exit door, there is no tactile and CA Braille exit sign with the word "EXIT" mounted on the wall adjacent to the latch side of the door.	<b>1991 ADAAG</b> 4.1.3(16); 4.30.1
Existing Condition:	<b>2004 ADAAG</b> 216.4; 703.2; 703.3; 703.4
	<b>2007 CBC</b> 1011.3 item 1
	<b>Other</b> -

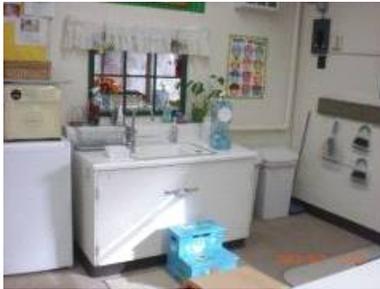
**Location:** Classroom E  
**Photo #** 410

Existing Condition: 30" high, 24" maximum for kindergarten.

480A - New Counter Top and Sink - Remove existing cabinetry, and provide new counter at 34" above the finished floor. Remove and replace sink and faucet with new accessible sink and faucet. Provide accessible knee clearance (i.e. at least 27" high, 30" wide, and 19" deep) under the sink.

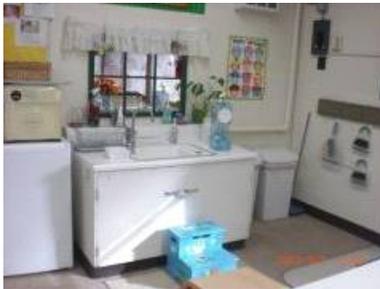
**Keynote 411**

Existing Condition: No knee space.

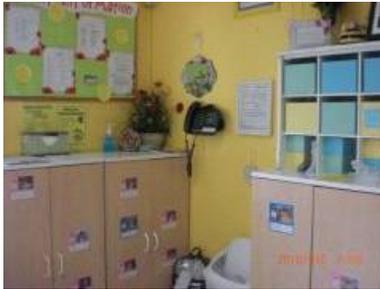
**Location:** Classroom E  
**Photo #** 412

<b>Field Condition</b>	
14.32A - Reach Range - Controls - Controls, dispensers, and similar devices are not between 9" and 54" AFF when the clear floor space allows a parallel approach. OR They are not between 15" and 48" AFF when the clear floor space allows only a forward approach.	<b>1991 ADAAG</b> 4.1.3(13); 4.27.3; 4.2.5; 4.2.6 ; Fig. 5; Fig. 6 <b>2004 ADAAG</b> - <b>2007 CBC</b> 1117B.6(3); 1118.5; 1118.6; Fig. 11B-5C; Fig. 11B-5D <b>Other</b> -
Existing Condition: 56" to phone.

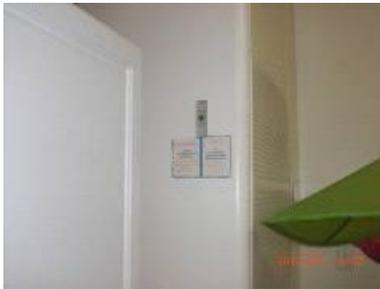
**Location:** Classroom E  
**Photo #** 413

<b>Field Condition</b>	
14.32A - Reach Range - Controls - Controls, dispensers, and similar devices are not between 9" and 54" AFF when the clear floor space allows a parallel approach. OR They are not between 15" and 48" AFF when the clear floor space allows only a forward approach.	<b>1991 ADAAG</b> 4.1.3(13); 4.27.3; 4.2.5; 4.2.6 ; Fig. 5; Fig. 6 <b>2004 ADAAG</b> - <b>2007 CBC</b> 1117B.6(3); 1118.5; 1118.6; Fig. 11B-5C; Fig. 11B-5D <b>Other</b> -
Existing Condition: 65 1/2" to heating/ cooling control.

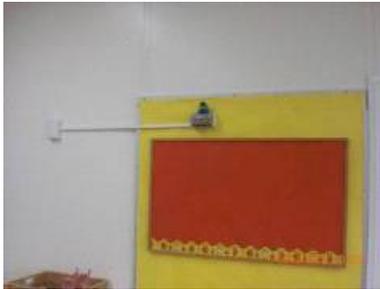
**Location:** Classroom E  
**Photo #** 414

<b>Field Condition</b>	
14.32A - Reach Range - Controls - Controls, dispensers, and similar devices are not between 9" and 54" AFF when the clear floor space allows a parallel approach. OR They are not between 15" and 48" AFF when the clear floor space allows only a forward approach.	<b>1991 ADAAG</b> 4.1.3(13); 4.27.3; 4.2.5; 4.2.6 ; Fig. 5; Fig. 6 <b>2004 ADAAG</b> - <b>2007 CBC</b> 1117B.6(3); 1118.5; 1118.6; Fig. 11B-5C; Fig. 11B-5D <b>Other</b> -
Existing Condition: 68" to thermostat.

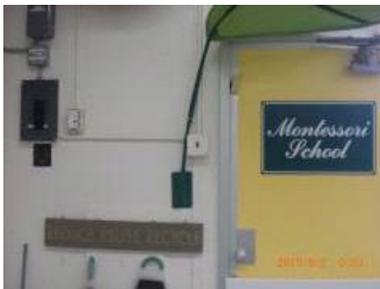
**Location:** Classroom E  
**Photo #** 415

<b>Field Condition</b>	
14.34 - Electrical/Communications Receptacles - Mounting Height - Electrical/communications receptacle is not located between 15" min.. and 48" max.. AFF.	<b>1991 ADAAG</b> 4.1.3(13); 4.27.3; 4.2.5; 4.2.6 ; Fig. 5; Fig. 6 <b>2004 ADAAG</b> 308.2.1; Fig. 308.2.1; 308.3.1; Fig. 308.3.1; 309.3 <b>2007 CBC</b> 1117B.6(5.2) <b>Other</b> -
Existing Condition: 60" to light switch.

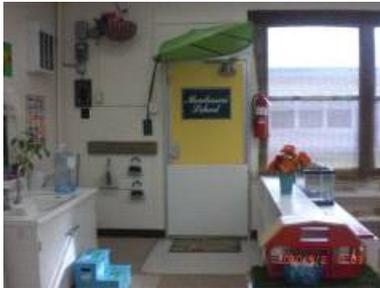
**Keynote 416**

<b>Field Condition</b>	
20.16B - Surface-Mounted Fire Extinguisher - Mounting Height - Where fire extinguishers are surface-mounted, mounting height of the extinguisher is not compliant. (Compliant surface-mounted extinguisher is 48" AFF maximum, as measured to the highest operable part, or in existing buildings, when the extinguisher is 54" AFF and parallel approach is provided)	<b>1991 ADAAG</b> 4.27.3
Existing Condition: 64" high.	<b>2004 ADAAG</b> 308.2.1; Fig. 308.2.1; 308.3.1; Fig. 308.3.1
	<b>2007 CBC</b> 1118B.4(1); 1118B.5; 1118B.6
	<b>Other</b> -

<b>Corrective Action</b>	
388D - Relocate Fire Extinguisher - Relocate existing fire extinguisher. Repair and refinish.	
Additional Comments:

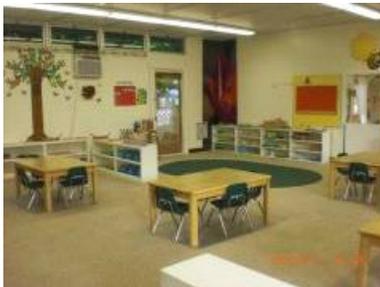
**Keynote 417**

<b>Field Condition</b>	
14.23B - Floor Surface - Accessible route surfaces are not stable, firm and slip-resistant.	<b>1991 ADAAG</b> 4.5.1
Existing Condition: Loose floor mats.	<b>2004 ADAAG</b> 302.1; Advisory 302.1
	<b>2007 CBC</b> 1124B.1
	<b>Other</b> -

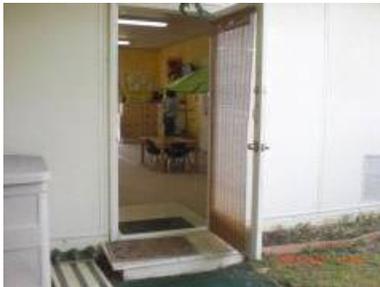
**Location:** Classroom E  
**Photo #** 419

Existing Condition: 7" level change from door to patio.

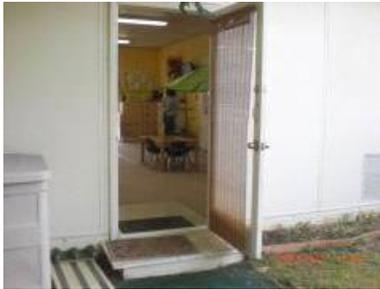
**Keynote 420**

<b>Field Condition</b>	
10.08 - Kick Plate - Bottom 10" of door does not have a smooth, uninterrupted surface on the push side to allow the door to be opened by a wheelchair footrest without creating a trap or hazardous condition. (This requirement does not apply to automatic and sliding doors.)	<b>1991 ADAAG</b> -
Existing Condition: 8" high.	<b>2004 ADAAG</b> 404.2.10
	<b>2007 CBC</b> 1133B.2.6
	<b>Other</b> -

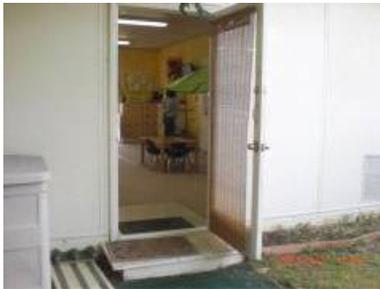
**Keynote 421**

<b>Field Condition</b>	
10.10 - Single-Action Hardware - Handles, locks, and latches or other operative devices are not operable with one hand and without tight grasping, pinching, or twisting of the wrist. (U-shaped handles, levers, and push/pull type mechanisms are acceptable designs.)	<b>1991 ADAAG</b> 4.13.9
Existing Condition: Knob and twist type hardware.	<b>2004 ADAAG</b> 309.4; 404.2.7; Advisory 404.2.7
	<b>2007 CBC</b> 1133B.2.5.2
	<b>Other</b> -

<b>Corrective Action</b>	
067B - Lever Hardware - Replace door hardware with lever-type handset.	
Additional Comments:

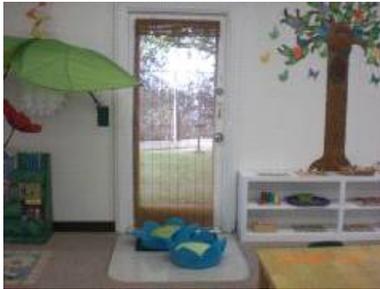
**Location:** Classroom E  
**Photo #** 422

<b>Field Condition</b>	
10.13A - Required Exit Door Sign - At grade level exterior exit door, there is no tactile and CA Braille exit sign with the word "EXIT" mounted on the wall adjacent to the latch side of the door.	1991 ADAAG 4.1.3(16); 4.30.1
Existing Condition:	2004 ADAAG 216.4; 703.2; 703.3; 703.4
	2007 CBC 1011.3 item 1
	Other -

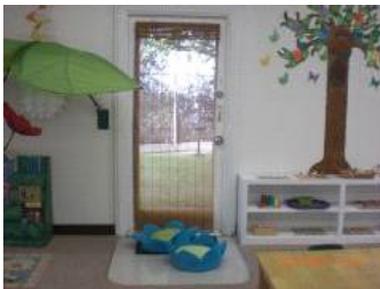
**Keynote 423**

<b>Field Condition</b>	
11.12 - Hardware Mounting Height - Mounting height of all operating hardware is not 30" min.. or 44" max., as measured to the highest operable part. (1994 ADA Standards permit a max.. height of 48"; CBC Standards permit a range of 30" min.. to 44" max..)	1991 ADAAG 4.13.9
Existing Condition: 52" to bolt.	2004 ADAAG -
	2007 CBC 1133B.2.5.2
	Other -

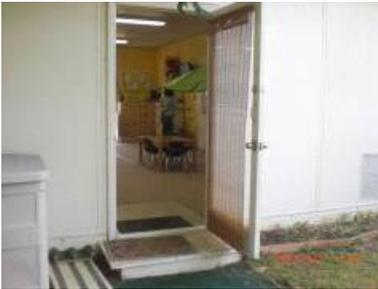
**Keynote 424**

Field Condition									
10.09B - Threshold - Height - The threshold at doorway exceeds 1/2" in height. Existing Condition: 1" threshold.

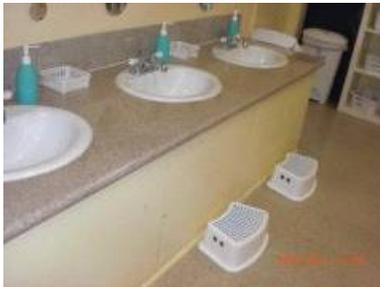
**Keynote 427**

<b>Field Condition</b>	16.71 - Lavatory - Rim Height - Height of lavatory rim or counter surface exceeds 34" AFF.	<b>1991 ADAAG</b>	4.19.2; Fig. 31
	Existing Condition: 25 1/2" high, 24" maximum allowed for kindergarten.	<b>2004 ADAAG</b>	606.3
		<b>2007 CBC</b>	1115B.4.3(2); Fig 11B-1D
		<b>Other</b>	-

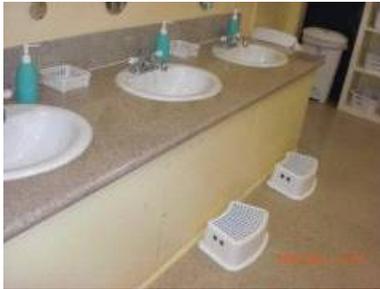
**Keynote 428**

<b>Field Condition</b>	
16.73 - Lavatory Knee Clearance - Lavatory does not provide accessible knee clearance (i.e. at least 27" clearance from the floor to the underside of the lavatory, extending 8" min.. measured from the front edge underneath the lavatory back towards the wall).	<b>1991 ADAAG</b> 4.19.2; Fig. 31
Existing Condition: No knee space.	<b>2004 ADAAG</b> 306.3; Fig. 306.3
	<b>2007 CBC</b> 1115B.4.3(2); Fig 11B-1D
	<b>Other</b> -

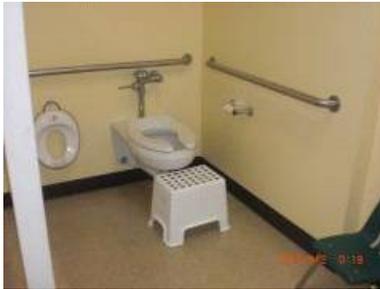
**Location:** Classroom E - Restrooms  
**Photo #** 430

<b>Field Condition</b>		
16.47A - WC Location from Sidewall - The centerline of the WC is not 18" absolute from a wall or partition.	1991 ADAAG	4.22.4
Existing Condition: 18 1/2" from sidewall, 12" allowed for kindergarten.	2004 ADAAG	-
	2007 CBC	1115B.4.1(1)
	Other	-

<b>Corrective Action</b>
319C - Water Closet - New Location - Replace existing water closet with compliant model in new location.
Additional Comments:

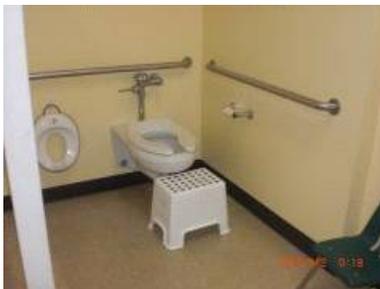
**Keynote 431**

<b>Field Condition</b>		
16.48 - WC Seat Height - The top of the WC seat is not between 17" and 19" AFF.	1991 ADAAG	4.16.3; Fig. 29(b)
Existing Condition:	2004 ADAAG	604.4
	2007 CBC	1115B.4.1(4); Fig. 11B-1A
	Other	-

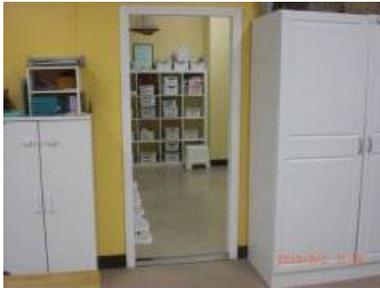
**Location:** Classroom E - Restrooms  
**Photo #** 436

<b>Field Condition</b>									
11.10B - Threshold - Height - The threshold at doorway exceeds 1/2" in height.  Existing Condition: 1 1/2" high.

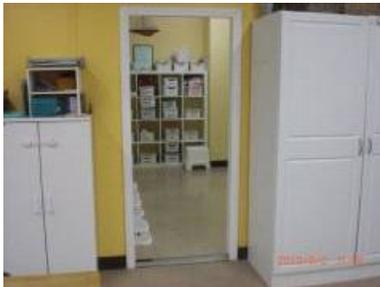
**Keynote 437**

<b>Field Condition</b>									
14.31 - Head Room - Clear head room is at less than 80" within the pedestrian circulation area, including the accessible route of travel.  Existing Condition: 71" to door frame.

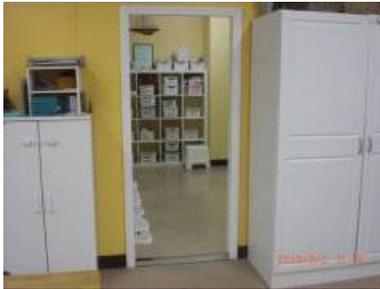
**Keynote 438**

16.13C - Unisex RR Geometric Symbol Signage - Circle/Triangle - Doorway leading to a unisex toilet room is not identified by a 12" circle, 1/4" with a 1/4" thick triangle superimposed and within the circle. OR Circle and triangle are provided, however they are accompanied by words in raised characters and Braille. (ADA and CBC Standards require a separate sign with raised characters and Braille mounted on the wall adjacent to the latch side of the door.)

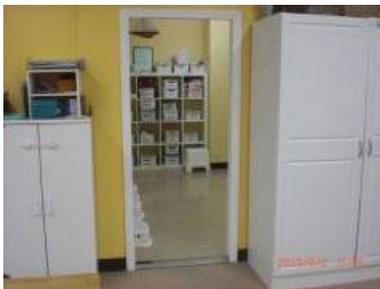
**Keynote 439**

20.02 - Toilet, Bathroom, or Shower Room - Visual Alarms - Visual alarms are not provided at public or common use toilet, bathroom, or shower room.

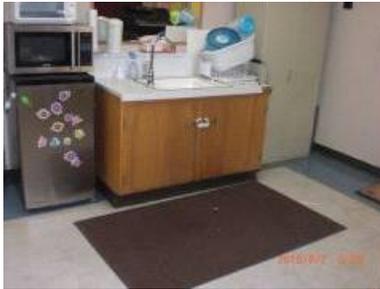
**Keynote 440**

<b>Field Condition</b>	
14.37 - Kitchen Sink - Sink does not provide accessible knee clearance (i.e. at least 27" high, 30" wide, and 19" deep).	<b>1991 ADAAG</b> 4.24.3
Existing Condition: No knee space.	<b>2004 ADAAG</b> 305; 306; 606.2
	<b>2007 CBC</b> 1115B.4.7(2); 1122B.4
	<b>Other</b> -

<b>Corrective Action</b>
480A - New Counter Top and Sink - Remove existing cabinetry, and provide new counter at 34" above the finished floor. Remove and replace sink and faucet with new accessible sink and faucet. Provide accessible knee clearance (i.e. at least 27" high, 30" wide, and 19" deep) under the sink.
Additional Comments:

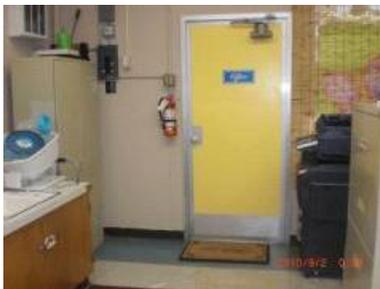
**Keynote 441**

<b>Field Condition</b>	
14.32A - Reach Range - Controls - Controls, dispensers, and similar devices are not between 9" and 54" AFF when the clear floor space allows a parallel approach. OR They are not between 15" and 48" AFF when the clear floor space allows only a forward approach.	<b>1991 ADAAG</b> 4.1.3(13); 4.27.3; 4.2.5; 4.2.6 ; Fig. 5; Fig. 6
Existing Condition: 60" to light switch.	<b>2004 ADAAG</b> -
	<b>2007 CBC</b> 1117B.6(3); 1118.5; 1118.6; Fig. 11B-5C; Fig. 11B-5D
	<b>Other</b> -

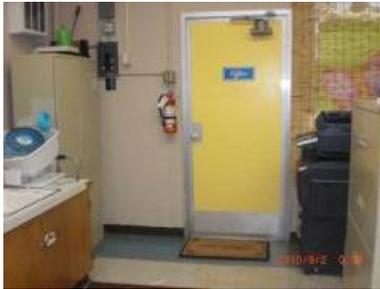
**Keynote 442**

20.16B - Surface-Mounted Fire Extinguisher - Mounting Height - Where fire extinguishers are surface-mounted, mounting height of the extinguisher is not compliant. (Compliant surface-mounted extinguisher is 48" AFF maximum, as measured to the highest operable part, or in existing buildings, when the extinguisher is 54" AFF and parallel approach is provided)

Existing Condition: 54" high.

388D - Relocate Fire Extinguisher - Relocate existing fire extinguisher. Repair and refinish.

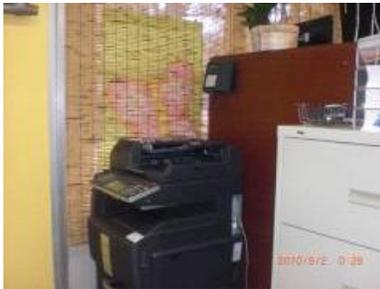
**Keynote 443**

14.32A - Reach Range - Controls - Controls, dispensers, and similar devices are not between 9" and 54" AFF when the clear floor space allows a parallel approach. OR They are not between 15" and 48" AFF when the clear floor space allows only a forward approach.

Existing Condition: Card swipe at 64" high over obstruction.

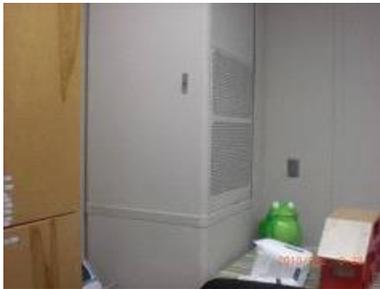
**Keynote 445**

<b>Field Condition</b>									
14.32A - Reach Range - Controls - Controls, dispensers, and similar devices are not between 9" and 54" AFF when the clear floor space allows a parallel approach. OR They are not between 15" and 48" AFF when the clear floor space allows only a forward approach.  Existing Condition: 65" to heating/cooling control.

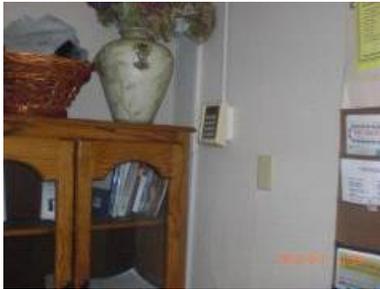
**Keynote 446**

<b>Field Condition</b>	
14.32A - Reach Range - Controls - Controls, dispensers, and similar devices are not between 9" and 54" AFF when the clear floor space allows a parallel approach. OR They are not between 15" and 48" AFF when the clear floor space allows only a forward approach.	<b>1991 ADAAG</b> 4.1.3(13); 4.27.3; 4.2.5; 4.2.6 ; Fig. 5; Fig. 6 <b>2004 ADAAG</b> - <b>2007 CBC</b> 1117B.6(3); 1118.5; 1118.6; Fig. 11B-5C; Fig. 11B-5D <b>Other</b> -
Existing Condition: 62" to alarm.

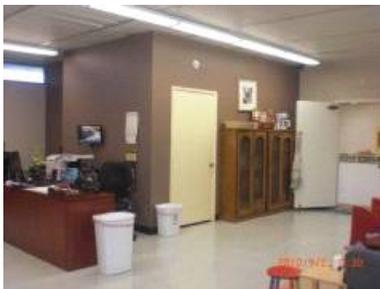
**Keynote 447**

<b>Field Condition</b>	
20.04 - Common Use Areas - Visual Alarms - Visual alarms are not provided in common use area(s) of the building such as meeting and conference rooms, open office space, classrooms, cafeterias, filing and photocopy rooms, employee break rooms, dressing, examination, and treatment rooms, and similar spaces that are not used solely as employee work areas.	<b>1991 ADAAG</b> 4.28.1 <b>2004 ADAAG</b> 215.2; 702.1 <b>2007 CBC</b> 907.9.1.1 <b>Other</b> -
Existing Condition:

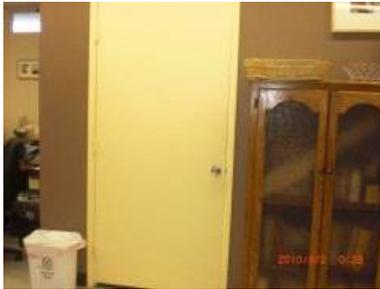
**Keynote 448**

<b>Field Condition</b>	
16.10 - Single-Action Hardware - Handles, locks, and latches or other operative devices are not operable with one hand. OR They are not operable without tight grasping, pinching, or twisting of the wrist. (U-shaped handles, levers, and push/pull type mechanisms are acceptable designs.)	1991 ADAAG 4.13.9
Existing Condition: Knob.	2004 ADAAG 309.4; 404.2.7; Advisory 404.2.7
	2007 CBC 1133B.2.5.2
	Other -

<b>Corrective Action</b>
067B - Lever Hardware - Replace door hardware with lever-type handset.
Additional Comments:

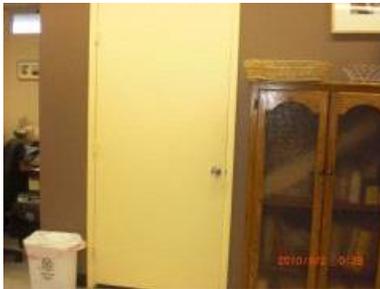
**Keynote 449**

<b>Field Condition</b>	
16.13C - Unisex RR Geometric Symbol Signage - Circle/Triangle - Doorway leading to a unisex toilet room is not identified by a 12" circle, 1/4" with a 1/4" thick triangle superimposed and within the circle. OR Circle and triangle are provided, however they are accompanied by words in raised characters and Braille. (ADA and CBC Standards require a separate sign with raised characters and Braille mounted on the wall adjacent to the latch side of the door.)	1991 ADAAG -
Existing Condition:	2004 ADAAG -
	2007 CBC 1115B.6
	Other -

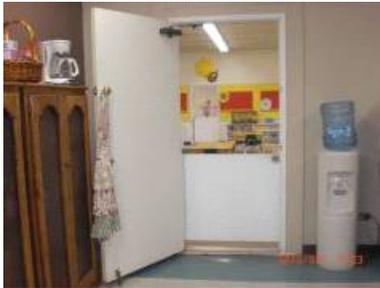
**Keynote 451**

<b>Field Condition</b>									
11.10B - Threshold - Height - The threshold at doorway exceeds 1/2" in height.  Existing Condition: 1 3/4" high.

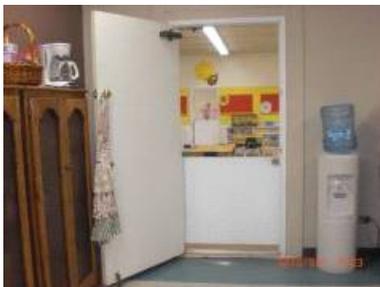
**Keynote 452**

<b>Field Condition</b>									
11.11 - Single-Action Hardware - Handles, locks, and latches or other operative devices are not operable with one hand and without tight grasping, pinching, or twisting of the wrist. (U-shaped handles, levers, and push/pull type mechanisms are acceptable designs.)  Existing Condition: Knob.

<b>Corrective Action</b>	
067B - Lever Hardware - Replace door hardware with lever-type handset.	
Additional Comments:

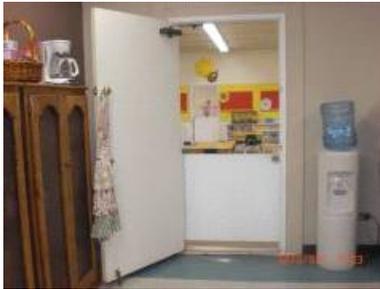
**Keynote 455**

<b>Field Condition</b>	
11.12 - Hardware Mounting Height - Mounting height of all operating hardware is not 30" min.. or 44" max., as measured to the highest operable part. (1994 ADA Standards permit a max.. height of 48"; CBC Standards permit a range of 30" min.. to 44" max..)	1991 ADAAG 4.13.9
Existing Condition: Pinch type hardware for low door.	2004 ADAAG -
	2007 CBC 1133B.2.5.2
	Other -

<b>Corrective Action</b>	
067B - Lever Hardware - Replace door hardware with lever-type handset.	
Additional Comments:

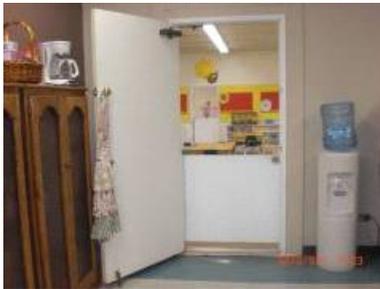
**Keynote 456**

<b>Field Condition</b>	
11.15A - Kick Plate - Bottom 10" of door does not have a smooth, uninterrupted surface on the push side to allow the door to be opened by a wheelchair footrest without creating a trap or hazardous condition. (This requirement does not apply to automatic and sliding doors.)	1991 ADAAG -
Existing Condition: Door stop.	2004 ADAAG 404.2.10
	2007 CBC 1133B.2.6
	Other -

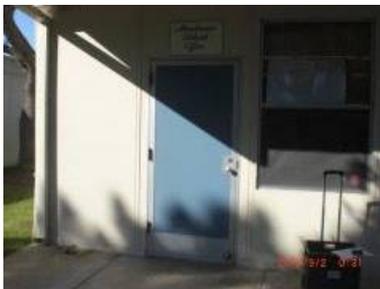
**Keynote 458**

<b>Field Condition</b>	
10.02 - Entrance Sign - Accessible entrance is not identified by an ISA.	1991 ADAAG 28 CFR 35.163(b)1
Existing Condition:	2004 ADAAG 216.6
	2007 CBC 1117B.5.8.1.2
	Other -

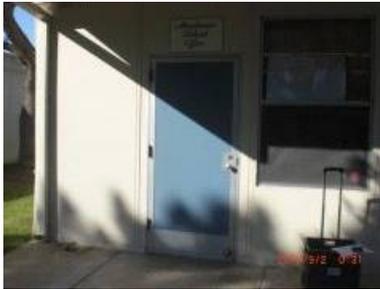
**Keynote 459**

<b>Field Condition</b>	
10.10 - Single-Action Hardware - Handles, locks, and latches or other operative devices are not operable with one hand and without tight grasping, pinching, or twisting of the wrist. (U-shaped handles, levers, and push/pull type mechanisms are acceptable designs.)	<b>1991 ADAAG</b> 4.13.9
Existing Condition: Knob.	<b>2004 ADAAG</b> 309.4; 404.2.7; Advisory 404.2.7
	<b>2007 CBC</b> 1133B.2.5.2
	<b>Other</b> -

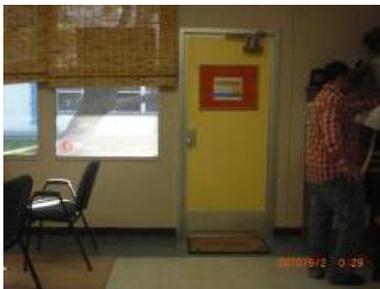
**Keynote 460**

<b>Field Condition</b>	
10.13A - Required Exit Door Sign - At grade level exterior exit door, there is no tactile and CA Braille exit sign with the word "EXIT" mounted on the wall adjacent to the latch side of the door.	<b>1991 ADAAG</b> 4.1.3(16); 4.30.1
Existing Condition:	<b>2004 ADAAG</b> 216.4; 703.2; 703.3; 703.4
	<b>2007 CBC</b> 1011.3 item 1
	<b>Other</b> -

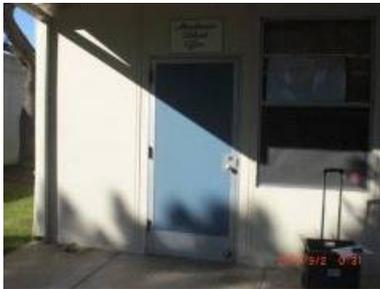
**Keynote 462**

Field Condition	
10.07A - Landing - Level and Clear - Floor is not level (slope is greater than 2% in some or all directions). OR Floor is not clear within the required maneuvering space.	1991 ADAAG 4.13.6; Fig. 25
Existing Condition: 4.9% slope at door landing.	2004 ADAAG 305; 404.2.4.4
	2007 CBC 1133B.2.4
	Other -

Corrective Action
006 - Concrete Walk - Remove non-compliant pavement and replace with new concrete (area as shown on the drawings). The walkway slope shall not exceed 5% along the POT and cross slope shall not exceed 2%.
Additional Comments:

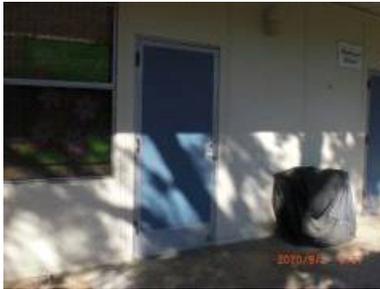
**Keynote 467**

<b>Field Condition</b>	
10.10 - Single-Action Hardware - Handles, locks, and latches or other operative devices are not operable with one hand and without tight grasping, pinching, or twisting of the wrist. (U-shaped handles, levers, and push/pull type mechanisms are acceptable designs.)	<b>1991 ADAAG</b> 4.13.9
Existing Condition: Knob.	<b>2004 ADAAG</b> 309.4; 404.2.7; Advisory 404.2.7
	<b>2007 CBC</b> 1133B.2.5.2
	<b>Other</b> -

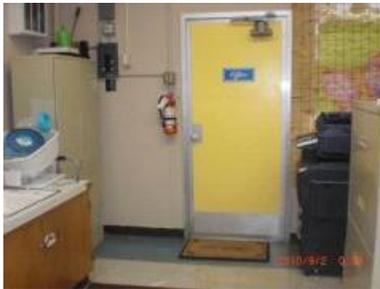
**Keynote 468**

<b>Field Condition</b>	
10.13A - Required Exit Door Sign - At grade level exterior exit door, there is no tactile and CA Braille exit sign with the word "EXIT" mounted on the wall adjacent to the latch side of the door.	<b>1991 ADAAG</b> 4.1.3(16); 4.30.1
Existing Condition:	<b>2004 ADAAG</b> 216.4; 703.2; 703.3; 703.4
	<b>2007 CBC</b> 1011.3 item 1
	<b>Other</b> -

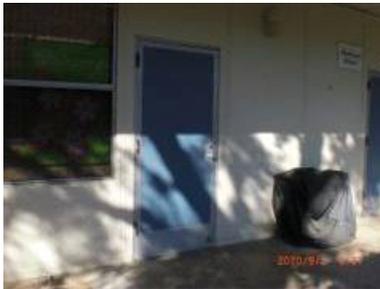
**Keynote 470**

Field Condition	
10.07A - Landing - Level and Clear - Floor is not level (slope is greater than 2% in some or all directions). OR Floor is not clear within the required maneuvering space.	1991 ADAAG 4.13.6; Fig. 25
Existing Condition: 2.6% slope at door landing.	2004 ADAAG 305; 404.2.4.4
	2007 CBC 1133B.2.4
	Other -

Corrective Action
006 - Concrete Walk - Remove non-compliant pavement and replace with new concrete (area as shown on the drawings). The walkway slope shall not exceed 5% along the POT and cross slope shall not exceed 2%.
Additional Comments:

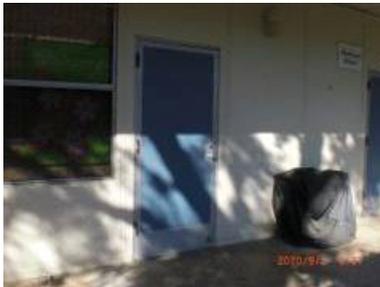
**Keynote 472**

Field Condition	
11.17A - Recommendation: Providing Room/Space ID Sign - A sign designating the permanent room or space has not been provided.	1991 ADAAG 4.1.2(7)
Existing Condition:	2004 ADAAG 216.2; 703.1; 703.2; 703.5
	2007 CBC 1117B.5.1 item 1
	Other -

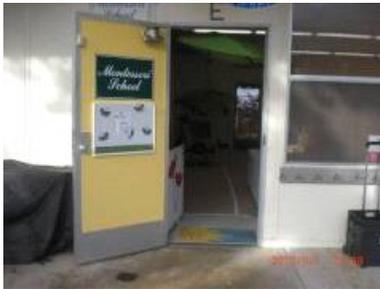
**Keynote 474**

<b>Field Condition</b>	
10.01 - Entrances Serving Site Arrival Points - There is not at least one accessible building entrance connected by an on-site accessible route to each type of site arrival points (i.e., public transportation stops, accessible parking, passenger loading zones, and public streets or sidewalks).	<b>1991 ADAAG</b> 4.14.1; 4.3; 4.3.2(1)
Existing Condition:	<b>2004 ADAAG</b> 206.4; 206.5.1
	<b>2007 CBC</b> 1114B.1.2
	<b>Other</b> -

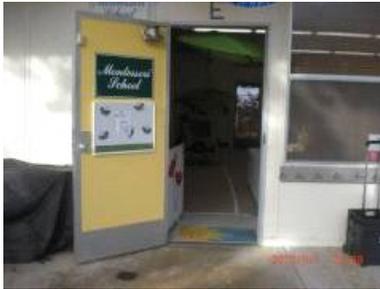
**Keynote 475**

<b>Field Condition</b>	
10.10 - Single-Action Hardware - Handles, locks, and latches or other operative devices are not operable with one hand and without tight grasping, pinching, or twisting of the wrist. (U-shaped handles, levers, and push/pull type mechanisms are acceptable designs.)	<b>1991 ADAAG</b> 4.13.9
Existing Condition: Knob.	<b>2004 ADAAG</b> 309.4; 404.2.7; Advisory 404.2.7
	<b>2007 CBC</b> 1133B.2.5.2
	<b>Other</b> -

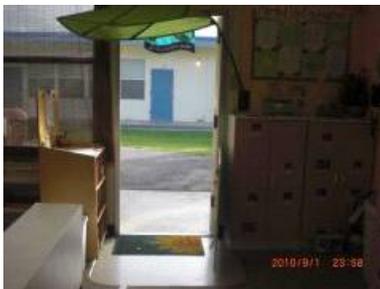
**Keynote 476**

<b>Field Condition</b>	
10.13A - Required Exit Door Sign - At grade level exterior exit door, there is no tactile and CA Braille exit sign with the word "EXIT" mounted on the wall adjacent to the latch side of the door.	<b>1991 ADAAG</b> 4.1.3(16); 4.30.1
Existing Condition:	<b>2004 ADAAG</b> 216.4; 703.2; 703.3; 703.4
	<b>2007 CBC</b> 1011.3 item 1
	<b>Other</b> -

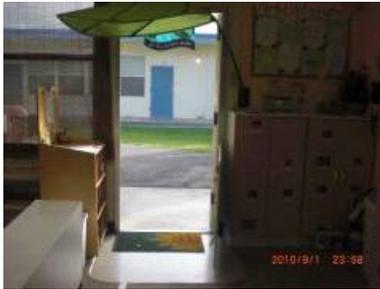
**Keynote 478**

10.06A - Door Maneuvering Space - Door that is not automatic or power-assisted does not have compliant maneuvering space relative to the direction of approach as shown in CBC Fig. 11B-26. (Approach // Side // Width // Depth) (Front // Pull // D + 24" \* // 60") (Front // Push // D + 0" \*\* // 48") (Latch // Pull // D + 24" // 60") (Latch // Push // D + 24" // 44" \*\*\*) (Hinge // Pull // D + 36" // 60") (Hinge // Push // 54" \*\*\*\* // 44" \*\*\*\*\*) (\* D + 18" at interior doors.) (\*\* D + 12" if door has both a latch and a closer.) (\*\*\*) 48" if door has closer.) (\*\*\*\* Measured from latch toward hinge.) (\*\*\*\*\* 48" if door has both a latch and a closer.)

Existing Condition: 3" strike clearance due to furniture.

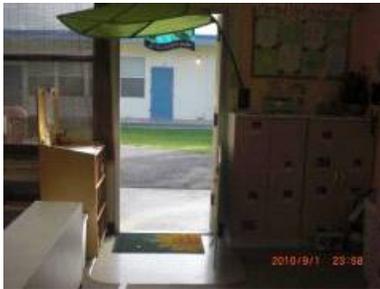
**Location:** Classroom E  
**Photo #** 476

<b>Field Condition</b>	
14.26 - Floor Material Changes - Where floor materials change, the vertical difference between them is not compliant. (Vertical difference shall be < 1/4". Changes in level between 1/4 inch and 1/2 inch shall be beveled with a slope no greater than 1:2.)	<b>1991 ADAAG</b> 4.1.3(5); 4.5.2
Existing Condition: 5/8" level change from tile to carpet.	<b>2004 ADAAG</b> 303.2; 303.3
	<b>2007 CBC</b> 1124B.1
	<b>Other</b> -

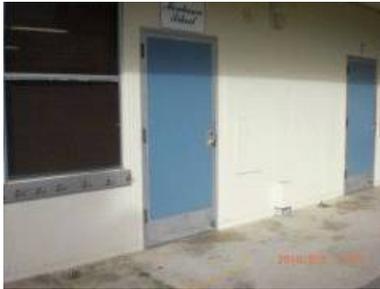
**Location:** Classroom E  
**Photo #** 485

<b>Field Condition</b>	
10.10 - Single-Action Hardware - Handles, locks, and latches or other operative devices are not operable with one hand and without tight grasping, pinching, or twisting of the wrist. (U-shaped handles, levers, and push/pull type mechanisms are acceptable designs.)	<b>1991 ADAAG</b> 4.13.9
Existing Condition: Knob.	<b>2004 ADAAG</b> 309.4; 404.2.7; Advisory 404.2.7
	<b>2007 CBC</b> 1133B.2.5.2
	<b>Other</b> -

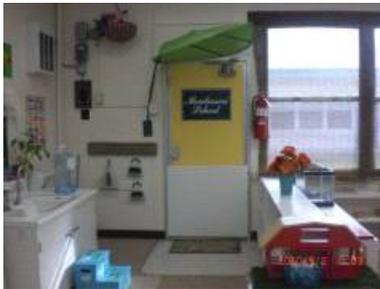
**Location:** Classroom E  
**Photo #** 416

<b>Field Condition</b>	
10.13A - Required Exit Door Sign - At grade level exterior exit door, there is no tactile and CA Braille exit sign with the word "EXIT" mounted on the wall adjacent to the latch side of the door.	<b>1991 ADAAG</b> 4.1.3(16); 4.30.1
Existing Condition:	<b>2004 ADAAG</b> 216.4; 703.2; 703.3; 703.4
	<b>2007 CBC</b> 1011.3 item 1
	<b>Other</b> -

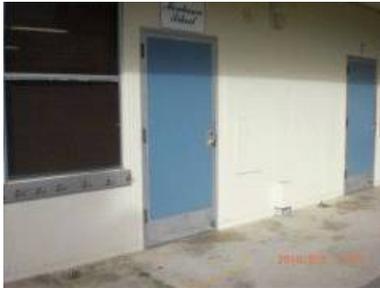
**Location:** Classroom E  
**Photo #** 485

<b>Field Condition</b>	
10.09A - > 1/4" Changes in Level - Threshold - Where threshold is 1/4" min.. to 1/2" max.. in height, change in level is not beveled at 1:2 or less.	<b>1991 ADAAG</b> 4.13.8
Existing Condition: Compound threshold.	<b>2004 ADAAG</b> 303.3; Advisory 303.3; Fig. 303.3
	<b>2007 CBC</b> 1133B.2.4.1
	<b>Other</b> -

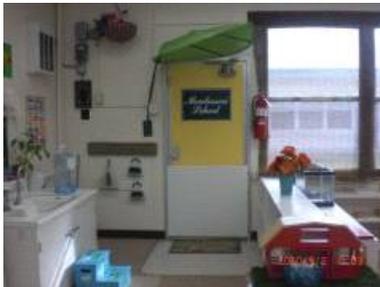
**Location:** Classroom E  
**Photo #** 416

<b>Field Condition</b>	
10.12 - Other Door Requirements - Entrance door does not comply with all applicable ADAAG and CBC accessibility requirements.	<b>1991 ADAAG</b> 4.13
Existing Condition: Non-compliant hardware for low door.	<b>2004 ADAAG</b> 404
	<b>2007 CBC</b> 1133B.1
	<b>Other</b> -

<b>Corrective Action</b>
067B - Lever Hardware - Replace door hardware with lever-type handset.
Additional Comments:

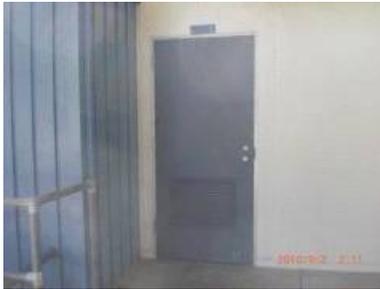
**Location:** Men's Restroom **Photo #** 493

<b>Field Condition</b>	
16.11A - Door Operating Effort - The force required to operate door exceeds 5 lbs. (Fire doors may have up to 15 lbs to achieve positive latching).	<b>1991 ADAAG</b> 4.13.11
Existing Condition: 10 LBF., (fire rated door).	<b>2004 ADAAG</b> 404.2.9
	<b>2007 CBC</b> 1133B.2.5
	<b>Other</b> -

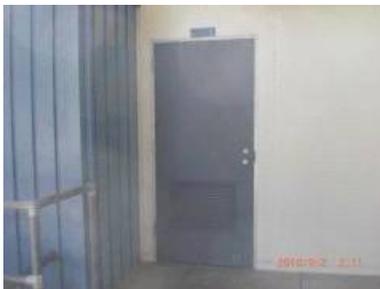
<b>Field Condition</b>	
16.10 - Single-Action Hardware - Handles, locks, and latches or other operative devices are not operable with one hand. OR They are not operable without tight grasping, pinching, or twisting of the wrist. (U-shaped handles, levers, and push/pull type mechanisms are acceptable designs.)	<b>1991 ADAAG</b> 4.13.9
Existing Condition: Knob.	<b>2004 ADAAG</b> 309.4; 404.2.7; Advisory 404.2.7
	<b>2007 CBC</b> 1133B.2.5.2
	<b>Other</b> -

<b>Corrective Action</b>	
067B - Lever Hardware - Replace door hardware with lever-type handset.	
Additional Comments:

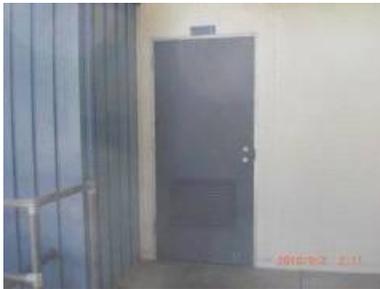
<b>Field Condition</b>	
16.19B - Mounting Height (Visual/Tactile Signs) - Sign is not mounted at 60" o.c. AFF to the centerline of the sign. (If the sign contains pictorial symbols (pictograms) or other non-tactile information, mounting height is measured to the centerline of the tactile characters / Braille portion of the sign.)	1991 ADAAG 4.30.6
Existing Condition: 83" high.	2004 ADAAG 703.4.1
	2007 CBC 1117B.5.7
	Other -

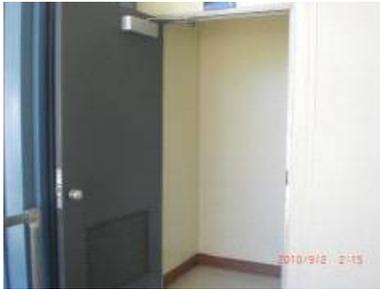
16.09A - Door Maneuvering Space - Door that is not automatic or power-assisted does not have compliant maneuvering space relative to the direction of approach as shown in CBC Fig. 11B-26. (Approach // Side // Width // Depth) (Front // Pull // D + 24" \* // 60") (Front // Push // D + 0" \*\* // 48") (Latch // Pull // D + 24" // 60") (Latch // Push // D + 24" // 44" \*\*\* ) (Hinge // Pull // D + 36" // 60") (Hinge // Push // 54" \*\*\*\* // 44" \*\*\*\*\*) (\* D + 18" at interior doors.) (\*\* D + 12" if door has both a latch and a closer.) (\*\*\*) 48" if door has closer.) (\*\*\*\* Measured from latch toward hinge.) (\*\*\*\*\* 48" if door has both a latch and a closer.)

Existing Condition: 38" deep door landing on push side.

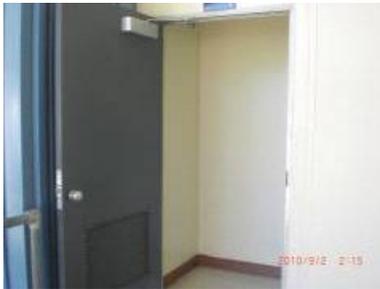
<b>Field Condition</b>	
14.22 - U-Turn - Where the accessible route of travel makes a U-turn around an obstacle which is less than 48" wide, the pathway width does not increase to at least 42" on the approaches or 48" in the turn.	<b>1991 ADAAG</b> 4.3.3; Fig. 7(b)
Existing Condition: 38" on approach, 37" at turn.	<b>2004 ADAAG</b> 403.5.2; Fig. 403.5.2
	<b>2007 CBC</b> Fig 11B-5E
	<b>Other</b> -

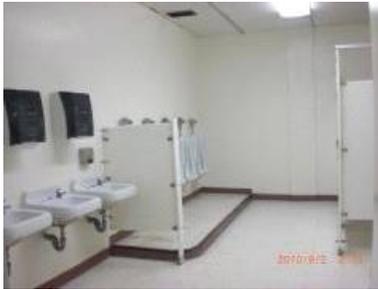
**Location:** Men's Restroom  
**Photo #** 503

<b>Field Condition</b>	
20.02 - Toilet, Bathroom, or Shower Room - Visual Alarms - Visual alarms are not provided at public or common use toilet, bathroom, or shower room.	<b>1991 ADAAG</b> 4.28.1
Existing Condition:	<b>2004 ADAAG</b> 215.1; Advisory 215.1; 702.1
	<b>2007 CBC</b> 907.9.1.1
	<b>Other</b> -

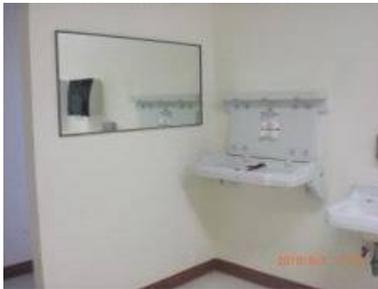
**Location:** Men's Restroom  
**Photo #** 504

<b>Field Condition</b>	
16.82B - Mirror Height - Max. 35" AFF Standard - Mirror not above accessible lavatory or countertop is mounted so the bottom edge of the reflective surface is not 35" max.. AFF. (Effective August 1, 2009, where mirrors are provided at locations other than lavatories or countertops, amended CBC Standards require at least one to be accessible.)	<b>1991 ADAAG</b> -
Existing Condition:	<b>2004 ADAAG</b> 213.3.5; 606.3; Advisory 603.3
	<b>2007 CBC</b> 1115B.8.1
	<b>Other</b> -

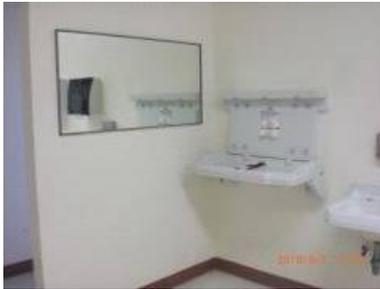
Location: Men's Restroom Photo # 504

<b>Field Condition</b>	
16.84F - Diaper Changing Table - Operating Height - Mounting height of diaper changing table's highest operable part exceeds 40" AFF. (Where provided, at least one shall be accessible.)	1991 ADAAG 4.27.3
Existing Condition: 56" high.	2004 ADAAG 308; 309
	2007 CBC -
	Other -

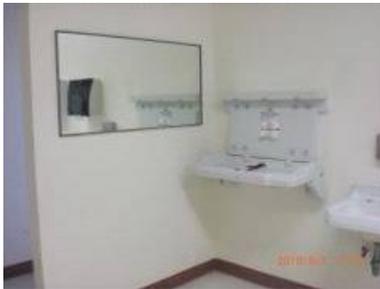
Location: Men's Restroom Photo # 504

<b>Field Condition</b>	
16.84G - Diaper Changing Table - Table Surface Height - Height of diaper changing table surface is not between 28" to 34" AFF. (Where provided, at least one shall be accessible.)	1991 ADAAG 4.1.3(18), 4.32.4
Existing Condition: 38" high.	2004 ADAAG 308; 309
	2007 CBC 1122B.1, 1122B.4
	Other -

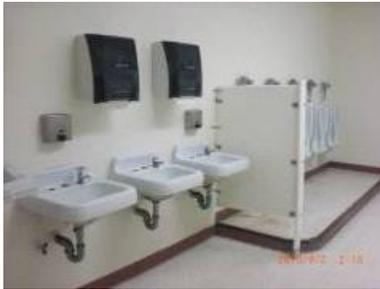
**Location:** Men's Restroom **Photo #** 507

<b>Field Condition</b>	16.84A - Paper Towel Dispenser - Operating Height - Mounting height of paper towel dispenser's highest operable part exceeds 40" AFF. (Where provided, ADA Standards require at least one paper towel dispenser to be accessible with the highest operable part placed within at least one of the reach ranges specified in 4.2.5 and 4.2.6; where provided, CBC Standards require at least one paper towel dispenser to be accessible with the highest operable part no higher than 40" AFF.)	<b>1991 ADAAG</b> 4.22.7; 4.27.3; 4.2.5; 4.2.6
	Existing Condition: 54" high.	<b>2004 ADAAG</b> 308; 309
		<b>2007 CBC</b> 1115B.8.3
		<b>Other</b> -

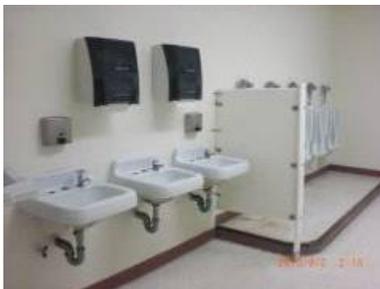
<b>Field Condition</b>	16.84C - Soap Dispenser - Operating Height - Mounting height of soap dispenser's highest operable part exceeds 40" AFF. (Where provided, ADA Standards require at least one soap dispenser to be accessible with the highest operable part placed within at least one of the reach ranges specified in 4.2.5 and 4.2.6; where provided, CBC Standards require at least one soap dispenser to be accessible with the highest operable part no higher than 40" AFF.)	<b>1991 ADAAG</b> 4.22.7; 4.27.3; 4.2.5; 4.2.6
	Existing Condition: 41" high.	<b>2004 ADAAG</b> 308; 309
		<b>2007 CBC</b> 1115B.8.3
		<b>Other</b> -

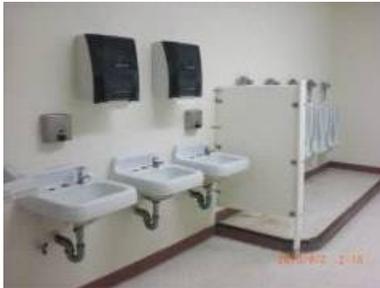
**Location:** Men's Restroom      **Photo #** 507

<b>Field Condition</b>	
16.72 - Lavatory Apron Clearance - Lavatory does not provide accessible apron clearance (i.e. at least 29" clearance from the floor to the bottom of the apron).  Existing Condition: 27 3/4" high.	<b>1991 ADAAG</b> 4.19.2; Fig. 31  <b>2004 ADAAG</b> 606.3  <b>2007 CBC</b> 1115B.4.3(2); Fig 11B-1D  <b>Other</b> -

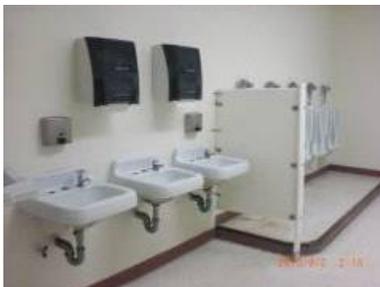
<b>Field Condition</b>	
16.73 - Lavatory Knee Clearance - Lavatory does not provide accessible knee clearance (i.e. at least 27" clearance from the floor to the underside of the lavatory, extending 8" min.. measured from the front edge underneath the lavatory back towards the wall).  Existing Condition: 25" high.	<b>1991 ADAAG</b> 4.19.2; Fig. 31  <b>2004 ADAAG</b> 306.3; Fig. 306.3  <b>2007 CBC</b> 1115B.4.3(2); Fig 11B-1D  <b>Other</b> -

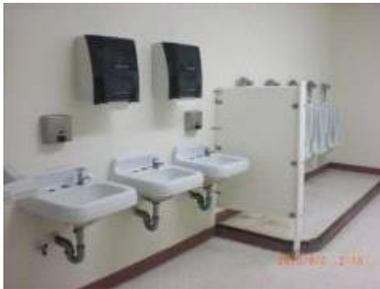
**Location:** Men's Restroom  
**Photo #** 507

Field Condition	
16.79 - Smooth Surfaces at Lavatory - The area below the lavatory is not free of sharp or abrasive surfaces.	1991 ADAAG 4.19.4
Existing Condition:	2004 ADAAG 606.5
	2007 CBC 1115B.4.3(4)
	Other -

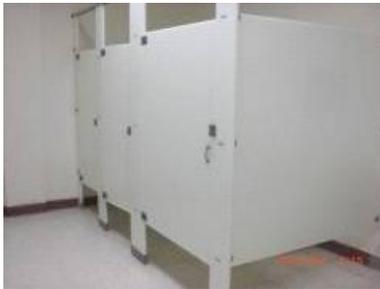
**Location:** Men's Restroom  
**Photo #** 514

<b>Field Condition</b>									
16.62A_04AG - Semi-Ambulant Stall - A semi-ambulant stall is not provided, in addition to the 60" wide standard stall, where 6 or more toilet stalls are provided, or where a combination of 6 or more urinals and water closets are provided.

1991 ADAAG	4.22.4	2004 ADAAG	213.3.1; Advisory 213.3.1; 604.8.2; Fig. 604.8.2	2007 CBC	1115B.3.1(5)	Other	-
1991 ADAAG	4.22.4								
2004 ADAAG	213.3.1; Advisory 213.3.1; 604.8.2; Fig. 604.8.2								
2007 CBC	1115B.3.1(5)								
Other	-								
Existing Condition: 5 urinals and 3 stalls, 0 semi-ambulant stalls.

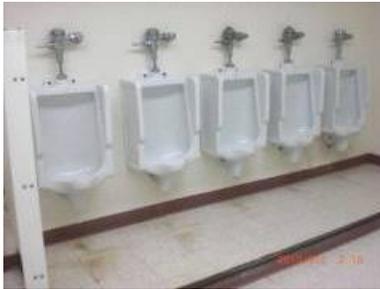
Location: Men's Restroom Photo # 515

<b>Field Condition</b>	
16.64A - Urinals - An accessible urinal has not been provided where urinals are provided. (If urinals are provided, ADA Standards require at least one accessible urinal.)	1991 ADAAG 4.22.5
Existing Condition:	2004 ADAAG 213.3.3; 605.1; Advisory 605.1
	2007 CBC 1115B.4.2
	Other -

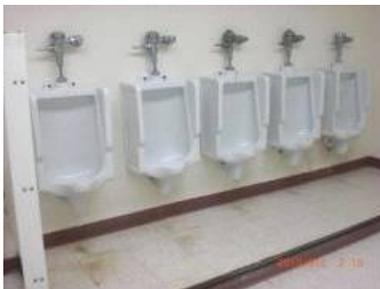
Location: Men's Restroom Photo # 515

<b>Field Condition</b>	
16.88 - Other - Toilet Facilities - See Additional Comments	1991 ADAAG -
Existing Condition: 4" step to urinals.	2004 ADAAG -
	2007 CBC -
	Other -

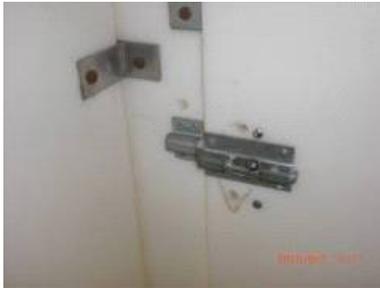
**Location:** Men's Restroom **Photo #** 517

<b>Field Condition</b>	
16.32A - U-Pulls at Stall Door - The stall door does not have U-pulls on both sides.	<b>1991 ADAAG</b> 4.13.9; 4.17.5
Existing Condition:	<b>2004 ADAAG</b> 309.4; 404.27; 604.8.1.2
	<b>2007 CBC</b> 1115B.3.1(4.4)
	<b>Other</b> -

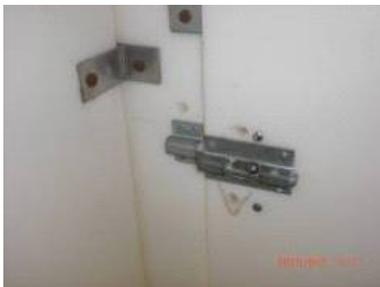
<b>Field Condition</b>	
16.32B - Single-Action Stall Door Hardware - The stall door's locking mechanism is not operable with one hand. OR It is not operable without tight grasping, pinching, or twisting of the wrist.	<b>1991 ADAAG</b> 4.13.9; 4.17.5
Existing Condition:	<b>2004 ADAAG</b> 309.4; 404.2.7; Advisory 404.2.7
	<b>2007 CBC</b> 1117B.6(4)
	<b>Other</b> -

<b>Corrective Action</b>	
316C - Single-Action Stall Door Hardware - Replace existing stall door locking mechanism with new single-action door hardware.	
Additional Comments:

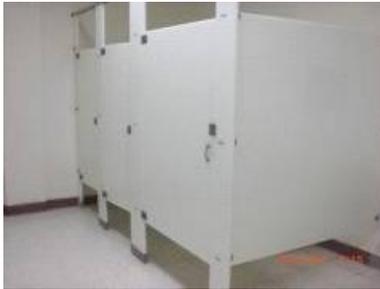
**Location:** Men's Restroom **Photo #** 514

16.34 - Strike Side Clearance at Stall Door - Where the stall door opens out at the end of an aisle, there is less than 18" of maneuvering space at the latch side of the stall door.

Existing Condition: 3" strike clearance.

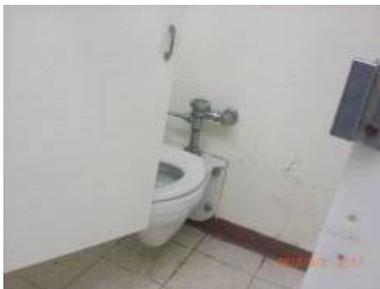
16.36A - Stall Width - The stall is less than 60" wide.

Existing Condition: 44" wide.

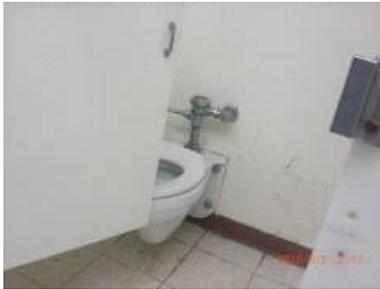
16.39B - Maneuvering Space - In-Swinging End-Opening Door - Where the stall has an in-swinging end-opening stall door, the clear space in front of the WC is less than 60" wide by 60" deep.

Existing Condition: 44" x 30".

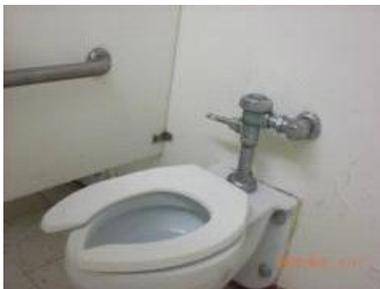
**Keynote 522**

16.47A - WC Location from Sidewall - The centerline of the WC is not 18" absolute from a wall or partition.

Existing Condition: 15".

319C - Water Closet - New Location - Replace existing water closet with compliant model in new location.

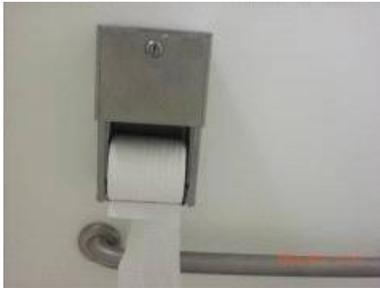
**Keynote 523**

16.50\_07CBC - TP Dispenser - Location - Location of the toilet paper dispenser is not compliant. (Effective January 1, 2008, CBC Standards require toilet tissue dispensers located on the wall within 12" of the front edge of the toilet seat, mounted below the grab bar, centered at a min. height of 19" AFF, and 36" maximum to the dispenser's far edge from the rear wall; there is no requirement to retroactively alter existing toilet paper dispensers when installed in compliance with CBC Standards in effect at the time of original construction.)

Existing Condition: 4" from WC and 33" from finish floor.

325B - Replace Toilet Paper Dispenser - Remove existing toilet paper dispenser and provide a new dispenser 19" above finish floor and 12" from toilet face. The dispenser is recessed or projects no more than 3" from the wall. Patch and repair wall substrate and finishes, to match adjacent undist

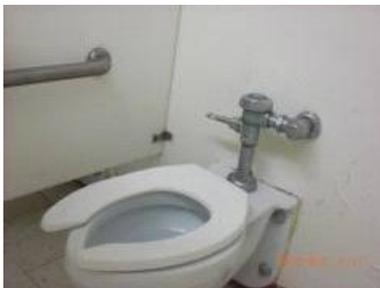
**Keynote 524**

16.54B - Side Grab Bar Length - Side grab bar is less than 42" long. (ADA Standards require the side grab bar for WC's not located in stalls to be 42" long min...; ADA Standards require the side grab bar for WC's located in stalls to be 40" to 42" long min...; CBC Standards require the side grab bar to be 42" long min..)

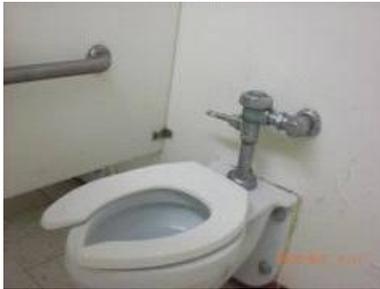
**Keynote 525**

<b>Field Condition</b>	
16.54A - Grab Bar - Grab bar is not provided.	<b>1991 ADAAG</b> 4.17.6; Figs. 29 & 30
Existing Condition: None provided.	<b>2004 ADAAG</b> 604.5; Advisory 604.5; 609.4
	<b>2007 CBC</b> 1115B.4.1(3.1) & (3.2); Fig. 11B-1A
	<b>Other</b> -

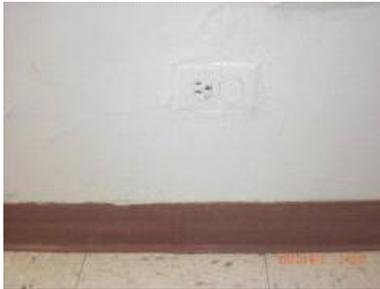
**Keynote 527**

Field Condition									
14.34 - Electrical/Communications Receptacles - Mounting Height - Electrical/communications receptacle is not located between 15" min.. and 48" max.. AFF.  Existing Condition: 12" to outlet.

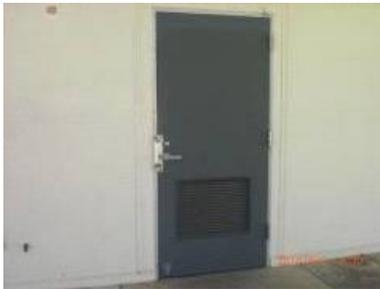
**Keynote 528**

Field Condition									
11.17A - Recommendation: Providing Room/Space ID Sign - A sign designating the permanent room or space has not been provided.  Existing Condition:
