*City of Rancho Palos Verdes*  
**Rancho Palos Verdes ADA Assessment**  
**Facility Report with Photos**

**Facility ID: # 08 - Ladera Linda Park & Community Center**

**Author: Vaish, B**

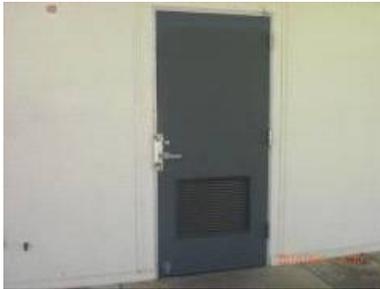
**Keynote 529**

Field Condition	
10.09A - > 1/4" Changes in Level - Threshold - Where threshold is 1/4" min.. to 1/2" max.. in height, change in level is not beveled at 1:2 or less.	1991 ADAAG 4.13.8
Existing Condition: Compound threshold.	2004 ADAAG 303.3; Advisory 303.3; Fig. 303.3
	2007 CBC 1133B.2.4.1
	Other -

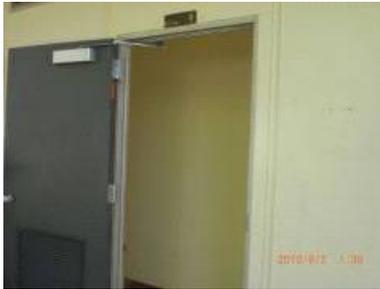
**Keynote 530**

16.09A - Door Maneuvering Space - Door that is not automatic or power-assisted does not have compliant maneuvering space relative to the direction of approach as shown in CBC Fig. 11B-26. (Approach // Side // Width // Depth) (Front // Pull // D + 24" \* // 60") (Front // Push // D + 0" \*\* // 48") (Latch // Pull // D + 24" // 60") (Latch // Push // D + 24" // 44" \*\*\*) (Hinge // Pull // D + 36" // 60") (Hinge // Push // 54" \*\*\*\* // 44" \*\*\*\*\*) (\* D + 18" at interior doors.) (\*\* D + 12" if door has both a latch and a closer.) (\*\*\*) 48" if door has closer.) (\*\*\*\* Measured from latch toward hinge.) (\*\*\*\*\* 48" if door has both a latch and a closer.)

Existing Condition: 2" on push side, 37" deep landing on push side.

053 - Reverse Door Swing - Remove existing door and frame and replace with new frame. Reinstall existing door (reverse door swing). Provide new accessible door hardware.

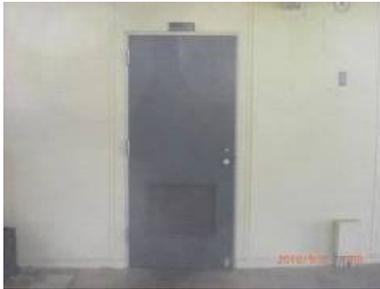
**Keynote 531**

<b>Field Condition</b>									
16.10 - Single-Action Hardware - Handles, locks, and latches or other operative devices are not operable with one hand. OR They are not operable without tight grasping, pinching, or twisting of the wrist. (U-shaped handles, levers, and push/pull type mechanisms are acceptable designs.)

<b>1991 ADAAG</b>	4.13.9	<b>2004 ADAAG</b>	309.4; 404.2.7; Advisory 404.2.7	<b>2007 CBC</b>	1133B.2.5.2	<b>Other</b>	-
<b>1991 ADAAG</b>	4.13.9								
<b>2004 ADAAG</b>	309.4; 404.2.7; Advisory 404.2.7								
<b>2007 CBC</b>	1133B.2.5.2								
<b>Other</b>	-								
Existing Condition: Knob.

<b>Corrective Action</b>
067B - Lever Hardware - Replace door hardware with lever-type handset.
Additional Comments:

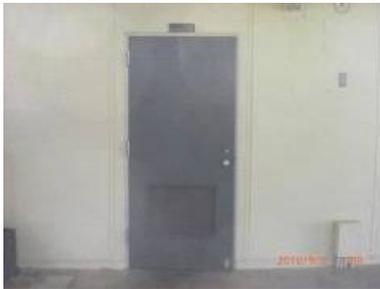
**Keynote 532**

<b>Field Condition</b>									
16.11A - Door Operating Effort - The force required to operate door exceeds 5 lbs. (Fire doors may have up to 15 lbs to achieve positive latching).

<b>1991 ADAAG</b>	4.13.11	<b>2004 ADAAG</b>	404.2.9	<b>2007 CBC</b>	1133B.2.5	<b>Other</b>	-
<b>1991 ADAAG</b>	4.13.11								
<b>2004 ADAAG</b>	404.2.9								
<b>2007 CBC</b>	1133B.2.5								
<b>Other</b>	-								
Existing Condition: 11 LBF., (fire rated door).

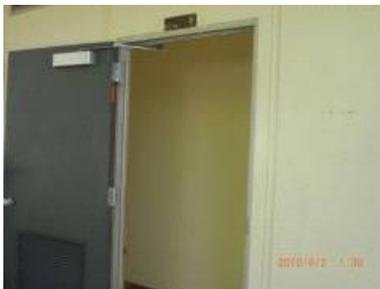
**Keynote 538**

<b>Field Condition</b>	
14.22 - U-Turn - Where the accessible route of travel makes a U-turn around an obstacle which is less than 48" wide, the pathway width does not increase to at least 42" on the approaches or 48" in the turn.	1991 ADAAG 4.3.3; Fig. 7(b)
Existing Condition: 36" at turn, 39 1/2" at approach.	2004 ADAAG 403.5.2; Fig. 403.5.2
	2007 CBC Fig 11B-5E
	Other -

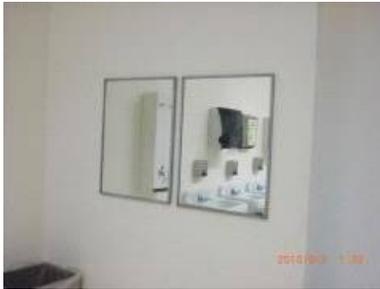
**Keynote 539**

16.82B - Mirror Height - Max. 35" AFF Standard - Mirror not above accessible lavatory or countertop is mounted so the bottom edge of the reflective surface is not 35" max.. AFF. (Effective August 1, 2009, where mirrors are provided at locations other than lavatories or countertops, amended CBC Standards require at least one to be accessible.)

Existing Condition: 41 3/4" high.

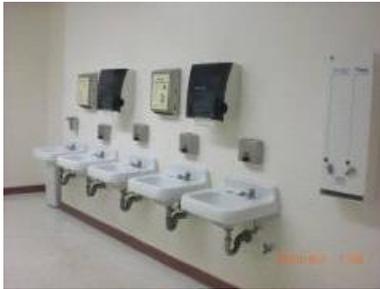
**Keynote 540**

Field Condition	
16.84D - Sanitary Napkin/Feminine Hygiene Dispenser - Operating Height - Mounting height of sanitary napkin/feminine hygiene dispenser's highest operable part exceeds 40" AFF. (Where provided, ADA Standards require at least one sanitary napkin/feminine hygiene dispenser to be accessible with the highest operable part placed within at least one of the reach ranges specified in 4.2.5 and 4.2.6; where provided, CBC Standards require at least one sanitary napkin/feminine hygiene dispenser to be accessible with the highest operable part no higher than 40" AFF.)	<b>1991 ADAAG</b> 4.22.7; 4.27.3; 4.2.5; 4.2.6 <b>2004 ADAAG</b> 308; 309 <b>2007 CBC</b> 1115B.8.3 <b>Other</b> -
Existing Condition: 44" high.

Corrective Action	
292 - Relocate Sanitary Napkin/ Feminine Hygiene Dispenser - Women's Restroom - Relocate existing sanitary napkin/feminine hygiene dispenser so height of operating handles is no higher than 40" above finish floor. Patch and repair wall substrate and finishes, to match adjacent undisturbed surfaces.	
Additional Comments:

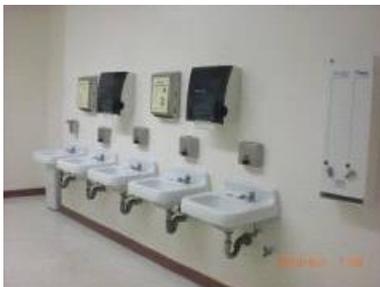
**Keynote 542**

<b>Field Condition</b>	16.84C - Soap Dispenser - Operating Height - Mounting height of soap dispenser's highest operable part exceeds 40" AFF. (Where provided, ADA Standards require at least one soap dispenser to be accessible with the highest operable part placed within at least one of the reach ranges specified in 4.2.5 and 4.2.6; where provided, CBC Standards require at least one soap dispenser to be accessible with the highest operable part no higher than 40" AFF.)	<b>1991 ADAAG</b> 4.22.7; 4.27.3; 4.2.5; 4.2.6
	Existing Condition: 41" high.	<b>2004 ADAAG</b> 308; 309
		<b>2007 CBC</b> 1115B.8.3
		<b>Other</b> -

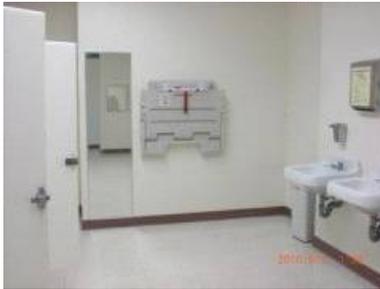
**Keynote 543**

16.84G - Diaper Changing Table - Table Surface Height - Height of diaper changing table surface is not between 28" to 34" AFF. (Where provided, at least one shall be accessible.)

Existing Condition: 39 1/2" high.

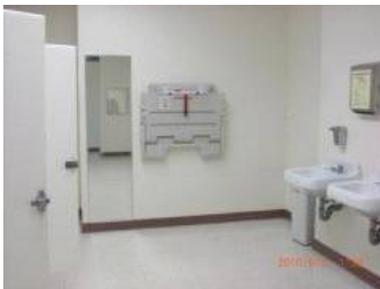
**Keynote 544**

16.84F - Diaper Changing Table - Operating Height - Mounting height of diaper changing table's highest operable part exceeds 40" AFF. (Where provided, at least one shall be accessible.)

Existing Condition: 56" to liners.

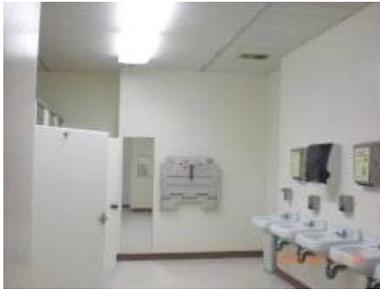
**Keynote 545**

<b>Field Condition</b>	
20.02 - Toilet, Bathroom, or Shower Room - Visual Alarms - Visual alarms are not provided at public or common use toilet, bathroom, or shower room.	<b>1991 ADAAG</b> 4.28.1
Existing Condition:	<b>2004 ADAAG</b> 215.1; Advisory 215.1; 702.1
	<b>2007 CBC</b> 907.9.1.1
	<b>Other</b> -

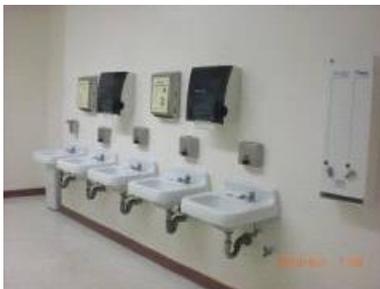
**Keynote 546**

<b>Field Condition</b>	
16.72 - Lavatory Apron Clearance - Lavatory does not provide accessible apron clearance (i.e. at least 29" clearance from the floor to the bottom of the apron).	<b>1991 ADAAG</b> 4.19.2; Fig. 31
Existing Condition: 28 3/8" high.	<b>2004 ADAAG</b> 606.3
	<b>2007 CBC</b> 1115B.4.3(2); Fig 11B-1D
	<b>Other</b> -

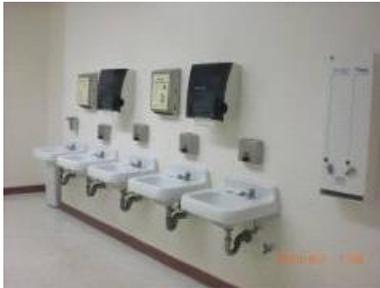
**Keynote 549**

<b>Field Condition</b>	
16.79 - Smooth Surfaces at Lavatory - The area below the lavatory is not free of sharp or abrasive surfaces.	1991 ADAAG 4.19.4
Existing Condition:	2004 ADAAG 606.5
	2007 CBC 1115B.4.3(4)
	Other -

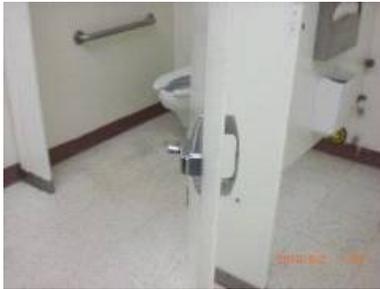
**Keynote 551**

<b>Field Condition</b>	16.32A - U-Pulls at Stall Door - The stall door does not have U-pulls on both sides.	<b>1991 ADAAG</b>	4.13.9; 4.17.5
Existing Condition:		<b>2004 ADAAG</b>	309.4; 404.27; 604.8.1.2
		<b>2007 CBC</b>	1115B.3.1(4.4)
		<b>Other</b>	-

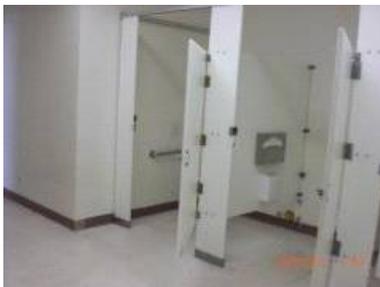
**Keynote 552**

<b>Field Condition</b>	16.33 - Self-Closing Stall Door - The stall door is not self-closing.	<b>1991 ADAAG</b>	4.13.10
Existing Condition:		<b>2004 ADAAG</b>	604.8.1.2
		<b>2007 CBC</b>	1115B.3.1(4.4)
		<b>Other</b>	-

<b>Corrective Action</b>	316D - Self-Closing Stall Door - Replace existing stall door spring hinges or closer with new self-closing hardware.
Additional Comments:

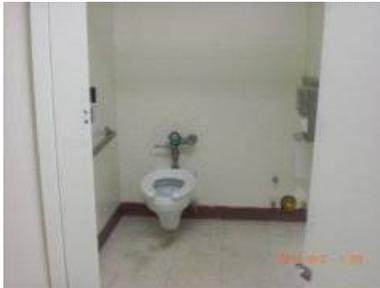
**Keynote 557**

16.50\_07CBC - TP Dispenser - Location - Location of the toilet paper dispenser is not compliant. (Effective January 1, 2008, CBC Standards require toilet tissue dispensers located on the wall within 12" of the front edge of the toilet seat, mounted below the grab bar, centered at a min. height of 19" AFF, and 36" maximum to the dispenser's far edge from the rear wall; there is no requirement to retroactively alter existing toilet paper dispensers when installed in compliance with CBC Standards in effect at the time of original construction.)

Existing Condition: 5" from WC and 36" high.

325B - Replace Toilet Paper Dispenser - Remove existing toilet paper dispenser and provide a new dispenser 19" above finish floor and 12" from toilet face. The dispenser is recessed or projects no more than 3" from the wall. Patch and repair wall substrate and finishes, to match adjacent undist

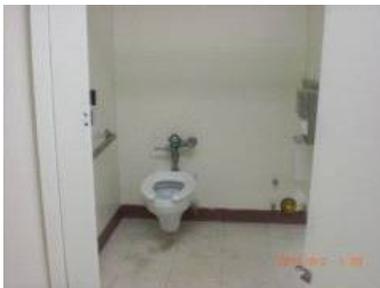
**Keynote 558**

16.54B - Side Grab Bar Length - Side grab bar is less than 42" long. (ADA Standards require the side grab bar for WC's not located in stalls to be 42" long min...; ADA Standards require the side grab bar for WC's located in stalls to be 40" to 42" long min...; CBC Standards require the side grab bar to be 42" long min..)

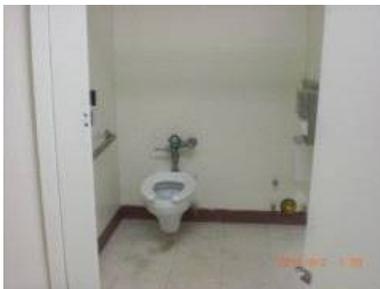
**Keynote 560**

16.55A - Side Grab Bar Height - Side grab bar is not centered at 33" AFF. (ADA Standards require side grab bars to be centered from 33" to 36" AFF; CBC Standards require side grab bars to be centered at 33" AFF.)

Existing Condition: 27" high.

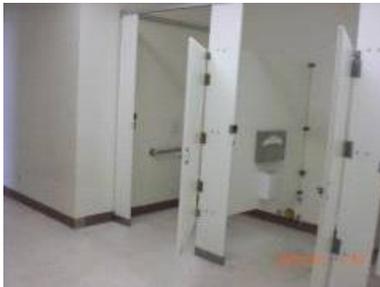
**Keynote 562**

16.83 - Coat Hook - Height - Where a coat hook is provided In an accessible stall, height of coat hook exceeds 48" AFF.

Existing Condition: 64" high.

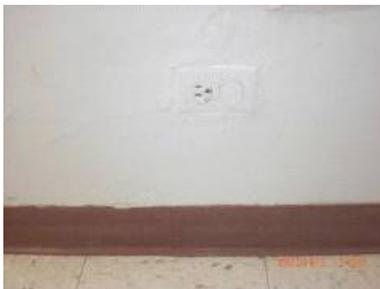
**Keynote 564**

14.34 - Electrical/Communications Receptacles - Mounting Height - Electrical/communications receptacle is not located between 15" min.. and 48" max.. AFF.

Existing Condition: 12" outlet.

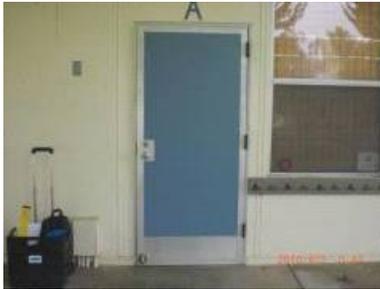
**Keynote 565**

<b>Field Condition</b>	
10.02 - Entrance Sign - Accessible entrance is not identified by an ISA.	1991 ADAAG 28 CFR 35.163(b)1
Existing Condition:	2004 ADAAG 216.6
	2007 CBC 1117B.5.8.1.2
	Other -

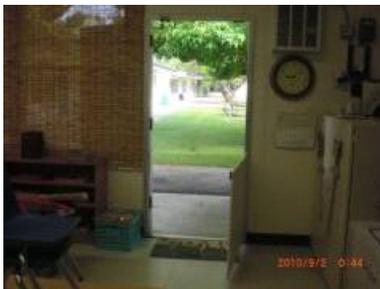
**Keynote 566**

<b>Field Condition</b>	
10.13A - Required Exit Door Sign - At grade level exterior exit door, there is no tactile and CA Braille exit sign with the word "EXIT" mounted on the wall adjacent to the latch side of the door.	1991 ADAAG 4.1.3(16); 4.30.1
Existing Condition:	2004 ADAAG 216.4; 703.2; 703.3; 703.4
	2007 CBC 1011.3 item 1
	Other -

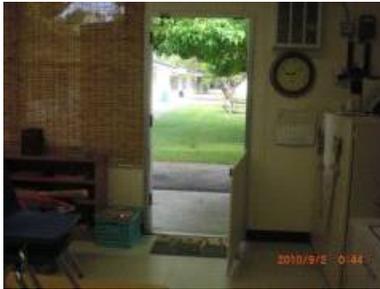
**Keynote 568**

10.06A - Door Maneuvering Space - Door that is not automatic or power-assisted does not have compliant maneuvering space relative to the direction of approach as shown in CBC Fig. 11B-26. (Approach // Side // Width // Depth) (Front // Pull // D + 24" \* // 60") (Front // Push // D + 0" \*\* // 48") (Latch // Pull // D + 24" // 60") (Latch // Push // D + 24" // 44" \*\*\*) (Hinge // Pull // D + 36" // 60") (Hinge // Push // 54" \*\*\*\* // 44" \*\*\*\*\*) (\* D + 18" at interior doors.) (\*\* D + 12" if door has both a latch and a closer.) (\*\*\*) 48" if door has closer.) (\*\*\*\* Measured from latch toward hinge.) (\*\*\*\*\* 48" if door has both a latch and a closer.)

Existing Condition: Low door encroaches door maneuvering space.

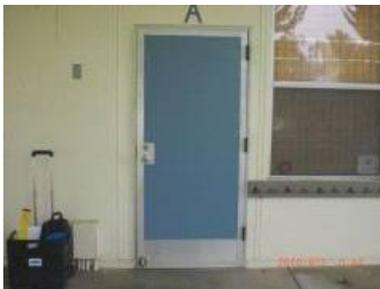
**Keynote 570**

10.09A - > 1/4" Changes in Level - Threshold - Where threshold is 1/4" min.. to 1/2" max.. in height, change in level is not beveled at 1:2 or less.

Existing Condition: Compound threshold.

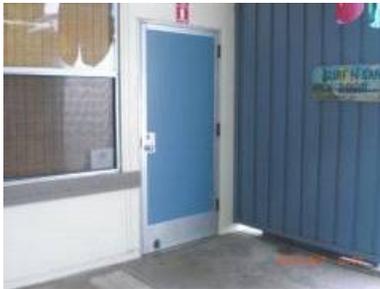
**Keynote 576**

Existing Condition: Knob.

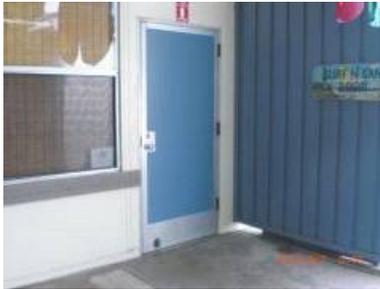
**Location:** Classroom A  
**Photo #** 576

**Field Condition**

Existing Condition: 2.4% slope at door landing.

006 - Concrete Walk - Remove non-compliant pavement and replace with new concrete (area as shown on the drawings). The walkway slope shall not exceed 5% along the POT and cross slope shall not exceed 2%.

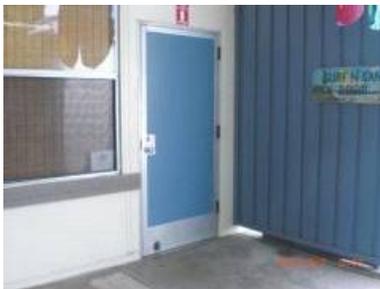
**Location:** Classroom A  
**Photo #** 576

<b>Field Condition</b>	
10.11A - Door Operating Effort - The force required to operate door exceeds 5 lbs. (Fire doors may have up to 15 lbs to achieve positive latching).	1991 ADAAG 4.13.11
Existing Condition: 8 LBF.	2004 ADAAG 404.2.9
	2007 CBC 1133B.2.5
	Other -

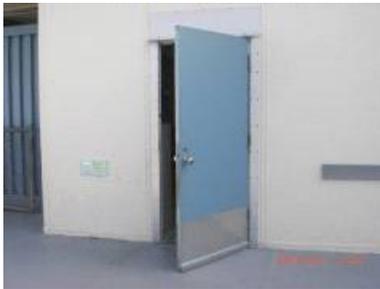
**Location:** Classroom A  
**Photo #** 582

<b>Field Condition</b>	
10.10 - Single-Action Hardware - Handles, locks, and latches or other operative devices are not operable with one hand and without tight grasping, pinching, or twisting of the wrist. (U-shaped handles, levers, and push/pull type mechanisms are acceptable designs.)	<b>1991 ADAAG</b> 4.13.9
Existing Condition: Knob.	<b>2004 ADAAG</b> 309.4; 404.2.7; Advisory 404.2.7
	<b>2007 CBC</b> 1133B.2.5.2
	<b>Other</b> -

<b>Corrective Action</b>
067B - Lever Hardware - Replace door hardware with lever-type handset.
Additional Comments:

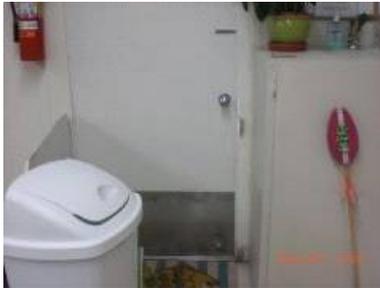
**Location:** Classroom A  
**Photo #** 583

<b>Field Condition</b>	
10.08 - Kick Plate - Bottom 10" of door does not have a smooth, uninterrupted surface on the push side to allow the door to be opened by a wheelchair footrest without creating a trap or hazardous condition. (This requirement does not apply to automatic and sliding doors.)	<b>1991 ADAAG</b> -
Existing Condition: Door stop.	<b>2004 ADAAG</b> 404.2.10
	<b>2007 CBC</b> 1133B.2.6
	<b>Other</b> -

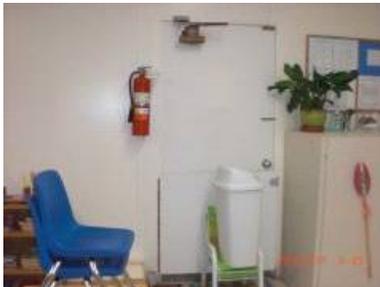
**Location:** Classroom A  
**Photo #** 584

<b>Field Condition</b>	
10.13A - Required Exit Door Sign - At grade level exterior exit door, there is no tactile and CA Braille exit sign with the word "EXIT" mounted on the wall adjacent to the latch side of the door.	<b>1991 ADAAG</b> 4.1.3(16); 4.30.1
Existing Condition:	<b>2004 ADAAG</b> 216.4; 703.2; 703.3; 703.4
	<b>2007 CBC</b> 1011.3 item 1
	<b>Other</b> -

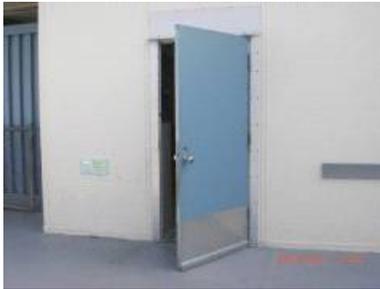
**Location:**  
Classroom A

Field Condition	
11.17A - Recommendation: Providing Room/Space ID Sign - A sign designating the permanent room or space has not been provided.	1991 ADAAG 4.1.2(7)
Existing Condition:	2004 ADAAG 216.2; 703.1; 703.2; 703.5
	2007 CBC 1117B.5.1 item 1
	Other -

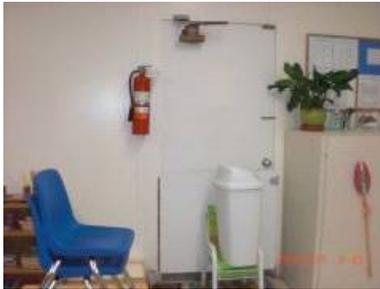
10.06A - Door Maneuvering Space - Door that is not automatic or power-assisted does not have compliant maneuvering space relative to the direction of approach as shown in CBC Fig. 11B-26. (Approach // Side // Width // Depth) (Front // Pull // D + 24" \* // 60") (Front // Push // D + 0" \*\* // 48") (Latch // Pull // D + 24" // 60") (Latch // Push // D + 24" // 44" \*\*\*) (Hinge // Pull // D + 36" // 60") (Hinge // Push // 54" \*\*\*\* // 44" \*\*\*\*\*) (\* D + 18" at interior doors.) (\*\* D + 12" if door has both a latch and a closer.) (\*\*\*) 48" if door has closer.) (\*\*\*\* Measured from latch toward hinge.) (\*\*\*\*\* 48" if door has both a latch and a closer.)

Existing Condition: 3 1/2" strike clearance to cabinet.

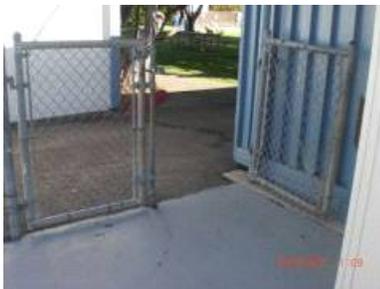
<b>Field Condition</b>									
10.02 - Entrance Sign - Accessible entrance is not identified by an ISA.  Existing Condition:

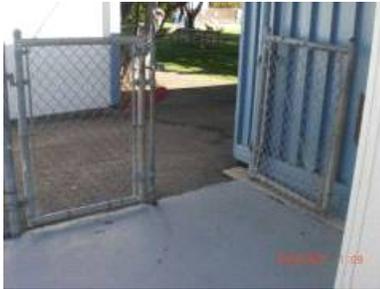
<b>Field Condition</b>	
10.07A - Landing - Level and Clear - Floor is not level (slope is greater than 2% in some or all directions). OR Floor is not clear within the required maneuvering space.	<b>1991 ADAAG</b> 4.13.6; Fig. 25
Existing Condition: 2.2% to 2.9% slope at gate landing.	<b>2004 ADAAG</b> 305; 404.2.4.4
	<b>2007 CBC</b> 1133B.2.4
	<b>Other</b> -

<b>Corrective Action</b>	
006 - Concrete Walk - Remove non-compliant pavement and replace with new concrete (area as shown on the drawings). The walkway slope shall not exceed 5% along the POT and cross slope shall not exceed 2%.	
Additional Comments:

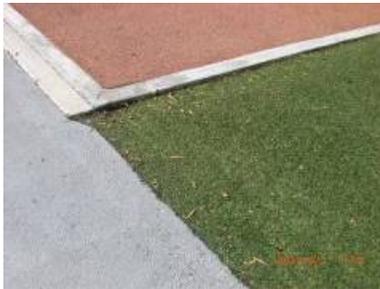
**Location:** Playground  
**Photo #** 592

<b>Field Condition</b>	31.38 - Other - Play Areas - See Additional Comments	<b>1991 ADAAG</b>	-
	Existing Condition: Transition from grass to playground and asphalt is greater than 1/2".	<b>2004 ADAAG</b>	-
		<b>2007 CBC</b>	-
		<b>Other</b>	-

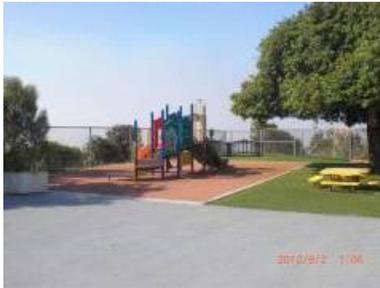
**Location:** Playground  
**Photo #** 593

<b>Field Condition</b>	
31.38 - Other - Play Areas - See Additional Comments	1991 ADAAG -
Existing Condition: No WC accessible picnic table.	2004 ADAAG -
	2007 CBC -
	Other -

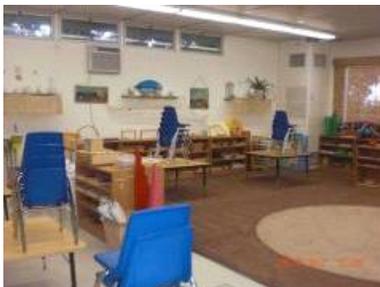
**Location:** Classroom A  
**Photo #** 594

<b>Field Condition</b>	
20.04 - Common Use Areas - Visual Alarms - Visual alarms are not provided in common use area(s) of the building such as meeting and conference rooms, open office space, classrooms, cafeterias, filing and photocopy rooms, employee break rooms, dressing, examination, and treatment rooms, and similar spaces that are not used solely as employee work areas.	1991 ADAAG 4.28.1
Existing Condition:	2004 ADAAG 215.2; 702.1
	2007 CBC 907.9.1.1
	Other -

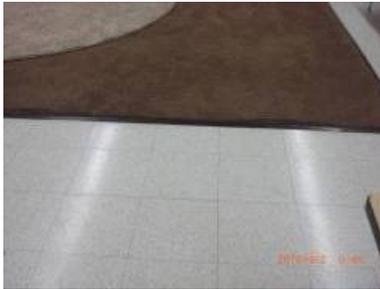
**Location:** Classroom A  
**Photo #** 595

<b>Field Condition</b>	
14.23B - Floor Surface - Accessible route surfaces are not stable, firm and slip-resistant.	1991 ADAAG 4.5.1
Existing Condition: Loose floor mats.	2004 ADAAG 302.1; Advisory 302.1
	2007 CBC 1124B.1
	Other -

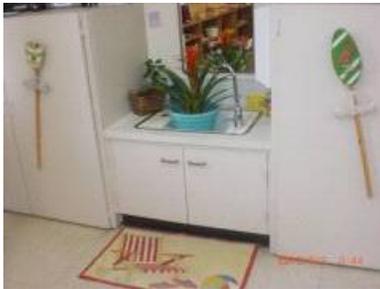
<b>Field Condition</b>	
16.88 - Other - Toilet Facilities - See Additional Comments	1991 ADAAG -
Existing Condition: 24 3/8" high to sink, 24" maximum allowed for kindergarten.	2004 ADAAG -
	2007 CBC -
	Other -

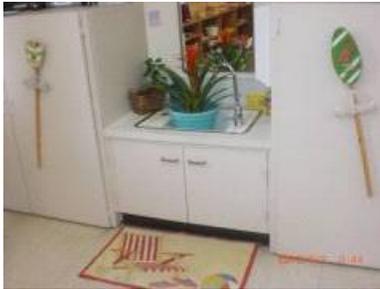
16.82A - Mirror Height - Max. 40" AFF Standard - Mirror above accessible lavatory or countertop is mounted so the bottom edge of the reflective surface is not 40" max.. AFF. (ADA Standards require at least one mirror to be accessible; CBC Standards prior to August 1, 2009 required all mirrors to be accessible. Effective August 1, 2009, amended CBC Standards require all mirrors above accessible lavatories or countertops to be accessible.)

Existing Condition: 32 3/8" high mirror, 32" maximum allowed for kindergarten.

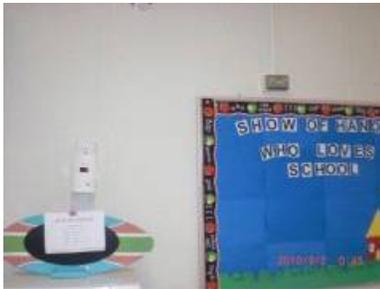
14.32A - Reach Range - Controls - Controls, dispensers, and similar devices are not between 9" and 54" AFF when the clear floor space allows a parallel approach. OR They are not between 15" and 48" AFF when the clear floor space allows only a forward approach.

Existing Condition: 76" high thermostat.

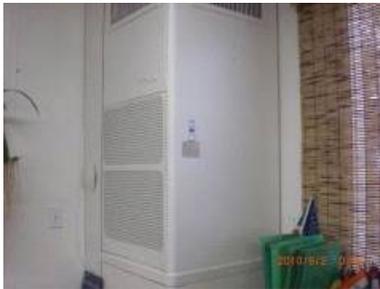
14.32A - Reach Range - Controls - Controls, dispensers, and similar devices are not between 9" and 54" AFF when the clear floor space allows a parallel approach. OR They are not between 15" and 48" AFF when the clear floor space allows only a forward approach.

Existing Condition: 65" to heating/ cooling control.

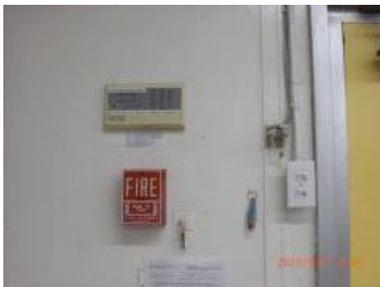
<b>Field Condition</b>	14.32A - Reach Range - Controls - Controls, dispensers, and similar devices are not between 9" and 54" AFF when the clear floor space allows a parallel approach. OR They are not between 15" and 48" AFF when the clear floor space allows only a forward approach.	<b>1991 ADAAG</b> 4.1.3(13); 4.27.3; 4.2.5; 4.2.6 ; Fig. 5; Fig. 6
	Existing Condition: 62" light switch.	<b>2004 ADAAG</b> -
		<b>2007 CBC</b> 1117B.6(3); 1118.5; 1118.6; Fig. 11B-5C; Fig. 11B-5D
		<b>Other</b> -

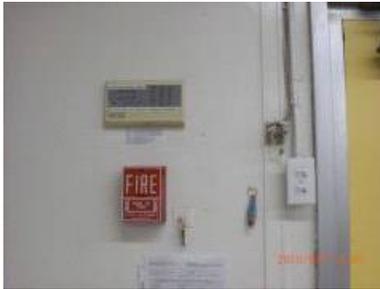
<b>Field Condition</b>	
20.15 - Alarm Initiating Devices - Operation - Operating hardware of the pull station is not accessible (i.e.: it requires tight grasping, pinching, or twisting of the wrist, or requires a force exceeding 5 lbs.)	1991 ADAAG 4.27.4
Existing Condition:	2004 ADAAG 309.4
	2007 CBC 907.3.2, 1117B.6(4)
	Other -

<b>Corrective Action</b>
374 - Replace and Relocate Fire Alarm Pull Station - Replace existing fire alarm pull station with compliant model in new location.
Additional Comments:

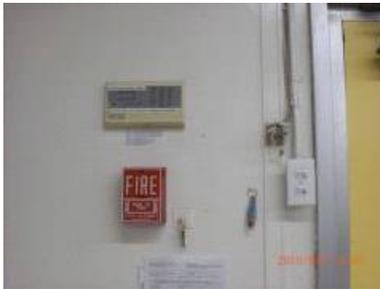
<b>Field Condition</b>	
20.14 - Alarm Initiating Devices - Mounting Height - Height of manual alarm pull station is not compliant. (Compliant devices are mounted 42" min. to 48" maximum, as measured to highest point of the activating handle or lever, or in existing buildings, the initiating device is 54" AFF and parallel approach is provided.)	1991 ADAAG 4.27.3
Existing Condition: 59" high.	2004 ADAAG 308.2.1; Fig. 308.2.1; 308.3.1; Fig. 308.3.1
	2007 CBC 907.3.2
	Other -

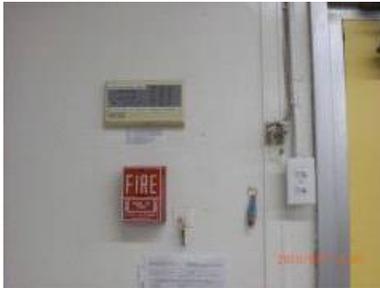
<b>Field Condition</b>	
14.32A - Reach Range - Controls - Controls, dispensers, and similar devices are not between 9" and 54" AFF when the clear floor space allows a parallel approach. OR They are not between 15" and 48" AFF when the clear floor space allows only a forward approach.	<b>1991 ADAAG</b> 4.1.3(13); 4.27.3; 4.2.5; 4.2.6 ; Fig. 5; Fig. 6 <b>2004 ADAAG</b> - <b>2007 CBC</b> 1117B.6(3); 1118.5; 1118.6; Fig. 11B-5C; Fig. 11B-5D <b>Other</b> -
Existing Condition: 70" to alarm panel.

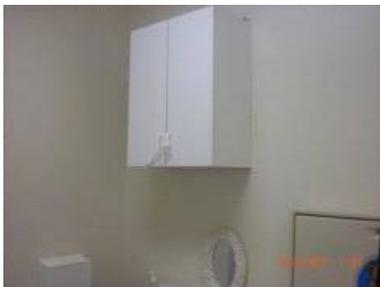
<b>Field Condition</b>	
14.32A - Reach Range - Controls - Controls, dispensers, and similar devices are not between 9" and 54" AFF when the clear floor space allows a parallel approach. OR They are not between 15" and 48" AFF when the clear floor space allows only a forward approach.	<b>1991 ADAAG</b> 4.1.3(13); 4.27.3; 4.2.5; 4.2.6 ; Fig. 5; Fig. 6 <b>2004 ADAAG</b> - <b>2007 CBC</b> 1117B.6(3); 1118.5; 1118.6; Fig. 11B-5C; Fig. 11B-5D <b>Other</b> -
Existing Condition: Wall cabinet not within reach range.

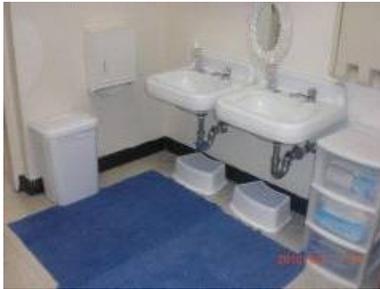
**Location:** Classroom A - Restroom  
**Photo #** 607

<b>Field Condition</b>	
16.88 - Other - Toilet Facilities - See Additional Comments	1991 ADAAG -
Existing Condition: Lavatory 26 1/2" high, 24" maximum allowed for kindergarten.	2004 ADAAG -
	2007 CBC -
	Other -

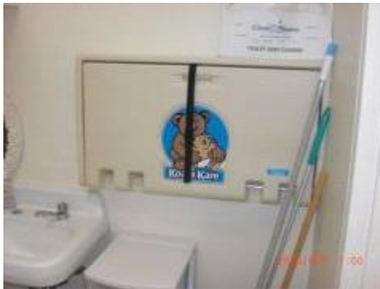
**Location:** Classroom A - Restroom  
**Photo #** 608

<b>Field Condition</b>	
16.84G - Diaper Changing Table - Table Surface Height - Height of diaper changing table surface is not between 28" to 34" AFF. (Where provided, at least one shall be accessible.)	1991 ADAAG 4.1.3(18), 4.32.4
Existing Condition: 36" high.	2004 ADAAG 308; 309
	2007 CBC 1122B.1, 1122B.4
	Other -

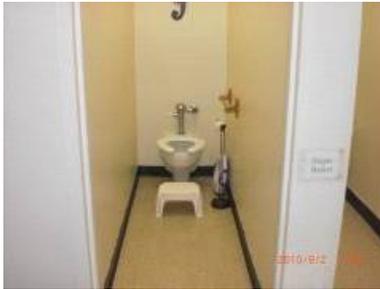
<b>Field Condition</b>	16.01 - Toilet Rooms - Toilet room does not comply with all applicable ADAAG and CBC accessibility requirements.	<b>1991 ADAAG</b>	4.1.2(6); 4.1.3(11); 4.22.1
	Existing Condition: No accessible restroom.	<b>2004 ADAAG</b>	213.2; Advisory 213.2
		<b>2007 CBC</b>	1115B.1
		<b>Other</b>	-

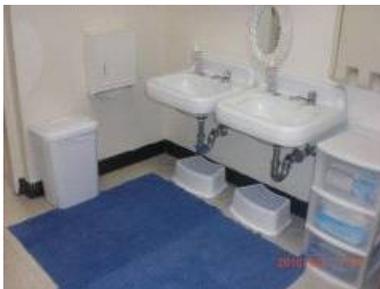
<b>Field Condition</b>	14.23B - Floor Surface - Accessible route surfaces are not stable, firm and slip-resistant.	<b>1991 ADAAG</b>	4.5.1
	Existing Condition: Loose floor mat.	<b>2004 ADAAG</b>	302.1; Advisory 302.1
		<b>2007 CBC</b>	1124B.1
		<b>Other</b>	-

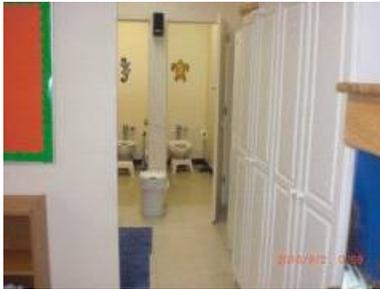
16.13C - Unisex RR Geometric Symbol Signage - Circle/Triangle - Doorway leading to a unisex toilet room is not identified by a 12" circle, 1/4" with a 1/4" thick triangle superimposed and within the circle. OR Circle and triangle are provided, however they are accompanied by words in raised characters and Braille. (ADA and CBC Standards require a separate sign with raised characters and Braille mounted on the wall adjacent to the latch side of the door.)

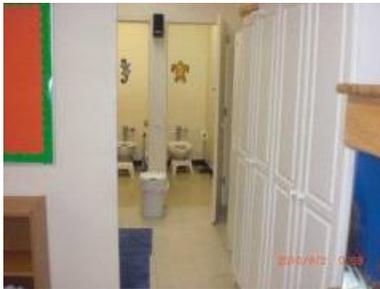
20.02 - Toilet, Bathroom, or Shower Room - Visual Alarms - Visual alarms are not provided at public or common use toilet, bathroom, or shower room.

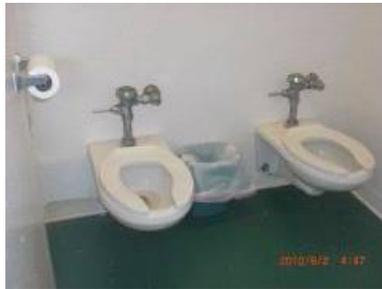
**Location:** Children's Restroom      **Photo #** 614

Field Condition	
16.01 - Toilet Rooms - Toilet room does not comply with all applicable ADAAG and CBC accessibility requirements.	1991 ADAAG 4.1.2(6); 4.1.3(11); 4.22.1
Existing Condition:	2004 ADAAG 213.2; Advisory 213.2
	2007 CBC 1115B.1
	Other -

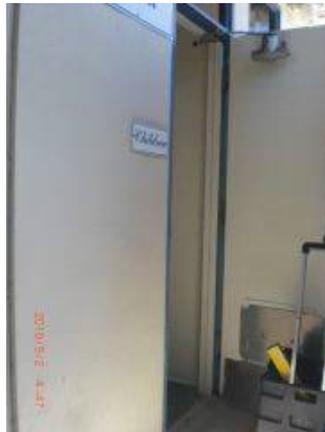
**Location:** Children's Restroom  
**Photo #** 615

Existing Condition: 34" deep door landing on pull side.

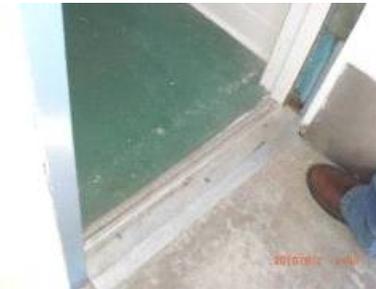
**Location:** Children's Restroom      **Photo #** 618

<b>Field Condition</b>	
16.12 - Other Door Requirements - Door does not comply with all applicable ADAAG and CBC accessibility requirements.	<b>1991 ADAAG</b> 4.13  <b>2004 ADAAG</b> 404.1; Advisory 404.1  <b>2007 CBC</b> 1133B.2  <b>Other</b> -
Existing Condition: Compound threshold.

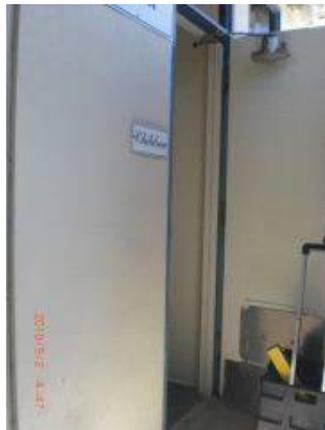
**Location:** Children's Restroom  
**Photo #** 615

<b>Field Condition</b>	
16.12 - Other Door Requirements - Door does not comply with all applicable ADAAG and CBC accessibility requirements.	<b>1991 ADAAG</b> 4.13
Existing Condition: 2.3% RS at door landing.	<b>2004 ADAAG</b> 404.1; Advisory 404.1
	<b>2007 CBC</b> 1133B.2
	<b>Other</b> -

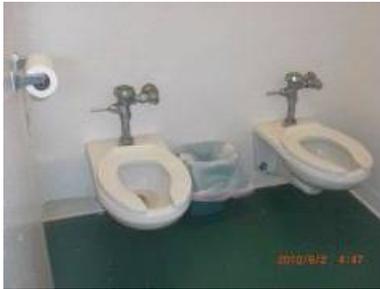
<b>Field Condition</b>	
16.50_07CBC - TP Dispenser - Location - Location of the toilet paper dispenser is not compliant. (Effective January 1, 2008, CBC Standards require toilet tissue dispensers located on the wall within 12" of the front edge of the toilet seat, mounted below the grab bar, centered at a min. height of 19" AFF, and 36" maximum to the dispenser's far edge from the rear wall; there is no requirement to retroactively alter existing toilet paper dispensers when installed in compliance with CBC Standards in effect at the time of original construction.)	<b>1991 ADAAG</b> 4.16.6; Fig. 29(b)  <b>2004 ADAAG</b> 604.7; Advisory 604.7; Fig. 604.7  <b>2007 CBC</b> 1115B.8.4; Fig. 11B-1A  <b>Other</b> -
Existing Condition: 38" high.

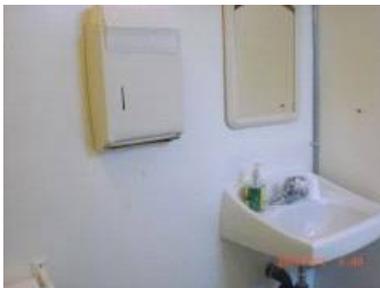
<b>Field Condition</b>	
16.88 - Other - Toilet Facilities - See Additional Comments	<b>1991 ADAAG</b> -  <b>2004 ADAAG</b> -  <b>2007 CBC</b> -  <b>Other</b> -
Existing Condition: 45" high PTD, 44" maximum allowed for kindergarten.

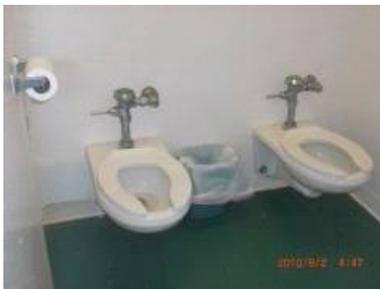
<b>Field Condition</b>	
16.88 - Other - Toilet Facilities - See Additional Comments	1991 ADAAG -
Existing Condition: 15 1/2" to WC, 12" allowed for kindergarten.	2004 ADAAG -
	2007 CBC -
	Other -

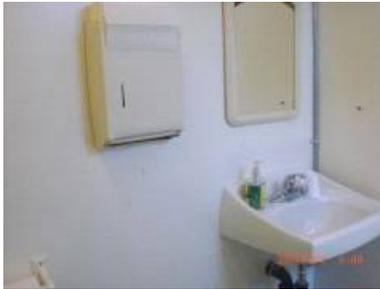
**Location:** Children's Restroom  
**Photo #** 626

Existing Condition: 46" high mirror, 32" maximum allowed for kindergarten.

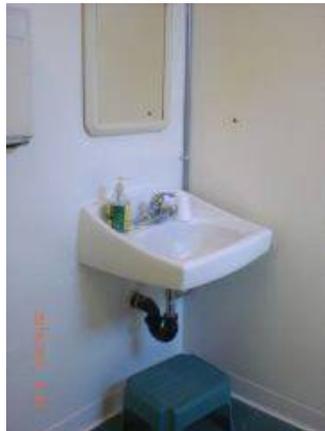
**Location:** Children's Restroom  
**Photo #** 630

Existing Condition: Lavatory height 31 1/2", 24" maximum allowed for kindergarten.

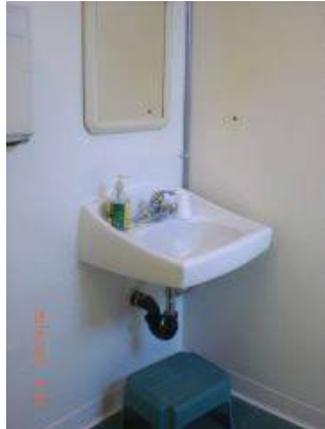
**Location:** Children's Restroom  
**Photo #** 630

Field Condition	
16.78 - Pipe Insulation at Lavatory - Drainpipes and hot water pipes are not insulated to protect against contact.	1991 ADAAG 4.19.4
Existing Condition:	2004 ADAAG 606.5
	2007 CBC 1115B.4.3(4)
	Other -

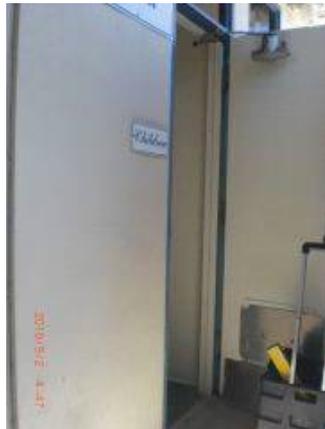
**Location:** Children's Restroom  
**Photo #** 615

Field Condition	
14.31 - Head Room - Clear head room is at less than 80" within the pedestrian circulation area, including the accessible route of travel.	1991 ADAAG 4.4.2
Existing Condition: 74" to closer.	2004 ADAAG 307.2; Fig. 307.2
	2007 CBC 1133B.8.6.2
	Other -

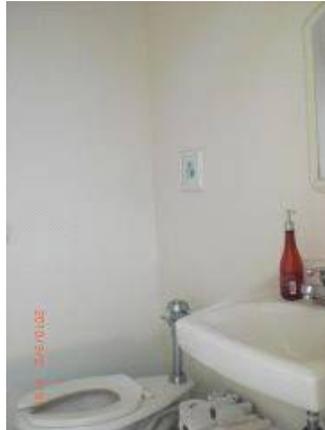
**Location:** Faculty Restroom  
**Photo #** 633

Field Condition	
16.01 - Toilet Rooms - Toilet room does not comply with all applicable ADAAG and CBC accessibility requirements.	1991 ADAAG 4.1.2(6); 4.1.3(11); 4.22.1
Existing Condition:	2004 ADAAG 213.2; Advisory 213.2
	2007 CBC 1115B.1
	Other -

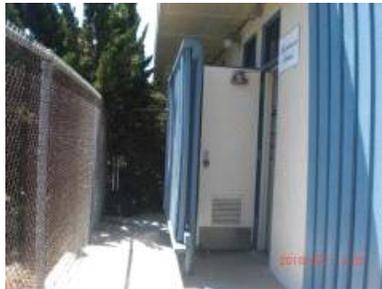
**Location:** Faculty Restroom  
**Photo #** 634

Field Condition	
16.07 - Clear Door Opening - When the door is open 90 degrees, clear opening width is less than 32" measured between the face of the door and the doorstop on the latch side.	1991 ADAAG 4.13.5
Existing Condition: 23" wide.	2004 ADAAG 404.2.3
	2007 CBC 1133B.1.1.1.1; 1133B.2.2
	Other -

Corrective Action
056 - Widen Door Opening - Remove existing door and replace with new door and door frame. Cut existing wall to widen door opening. Provide new accessible door hardware.
Additional Comments:

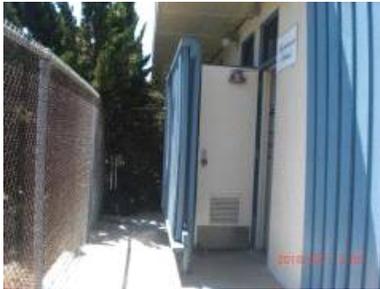
16.09A - Door Maneuvering Space - Door that is not automatic or power-assisted does not have compliant maneuvering space relative to the direction of approach as shown in CBC Fig. 11B-26. (Approach // Side // Width // Depth) (Front // Pull // D + 24" \* // 60") (Front // Push // D + 0" \*\* // 48") (Latch // Pull // D + 24" // 60") (Latch // Push // D + 24" // 44" \*\*\*) (Hinge // Pull // D + 36" // 60") (Hinge // Push // 54" \*\*\*\* // 44" \*\*\*\*\*) (\* D + 18" at interior doors.) (\*\* D + 12" if door has both a latch and a closer.) (\*\*\*) 48" if door has closer.) (\*\*\*\* Measured from latch toward hinge.) (\*\*\*\*\* 48" if door has both a latch and a closer.)

Existing Condition: 35" deep door landing on pull side.

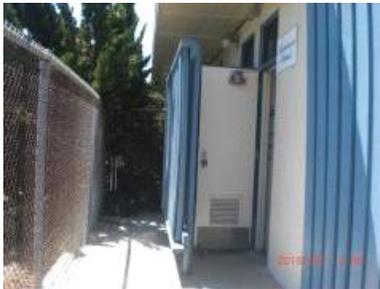
**Location:** Faculty Restroom  
**Photo #** 634

<b>Field Condition</b>	
16.12 - Other Door Requirements - Door does not comply with all applicable ADAAG and CBC accessibility requirements.	1991 ADAAG 4.13
Existing Condition: 6.2% RS at door landing.	2004 ADAAG 404.1; Advisory 404.1
	2007 CBC 1133B.2
	Other -

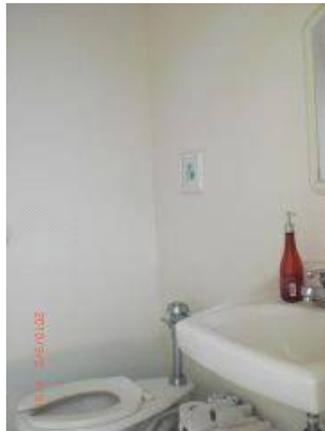
**Location:** Faculty Restroom **Photo #** 633

<b>Field Condition</b>	
16.47A - WC Location from Sidewall - The centerline of the WC is not 18" absolute from a wall or partition.	<b>1991 ADAAG</b> 4.22.4
Existing Condition: 13 1/2".	<b>2004 ADAAG</b> -
	<b>2007 CBC</b> 1115B.4.1(1)
	<b>Other</b> -

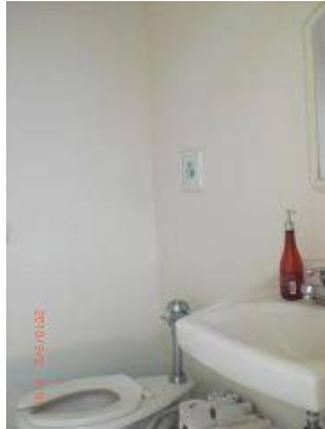
**Location:** Faculty Restroom  
**Photo #** 633

<b>Field Condition</b>	
16.48 - WC Seat Height - The top of the WC seat is not between 17" and 19" AFF. Existing Condition: 15 1/2" high.	<b>1991 ADAAG</b> 4.16.3; Fig. 29(b)  <b>2004 ADAAG</b> 604.4  <b>2007 CBC</b> 1115B.4.1(4); Fig. 11B-1A  <b>Other</b> -

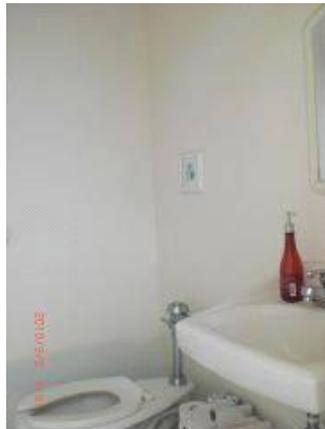
**Location:** Faculty Restroom  
**Photo #** 633

<b>Field Condition</b>	
16.49B - WC Flush Controls - Location - Flush controls are not located on the wide side of the WC where the clear floor space is provided. Existing Condition:	<b>1991 ADAAG</b> 4.16.5  <b>2004 ADAAG</b> 604.6; Advisory 604.6  <b>2007 CBC</b> 1115B.4.1(5); Fig. 11B-1A  <b>Other</b> -

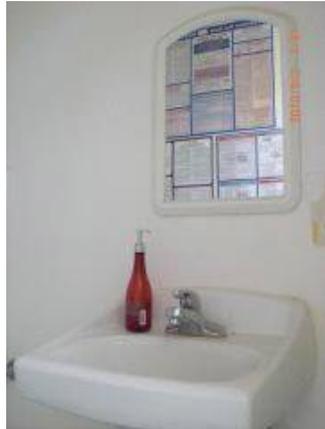
**Location:** Faculty Restroom **Photo #** 646

Field Condition	
16.82A - Mirror Height - Max. 40" AFF Standard - Mirror above accessible lavatory or countertop is mounted so the bottom edge of the reflective surface is not 40" max.. AFF. (ADA Standards require at least one mirror to be accessible; CBC Standards prior to August 1, 2009 required all mirrors to be accessible. Effective August 1, 2009, amended CBC Standards require all mirrors above accessible lavatories or countertops to be accessible.)	<b>1991 ADAAG</b> 4.19.6; Fig. 31 <b>2004 ADAAG</b> 213.3.5; 603.3; Advisory 603.3 <b>2007 CBC</b> 1115B.8.1 <b>Other</b> -
Existing Condition: 45".

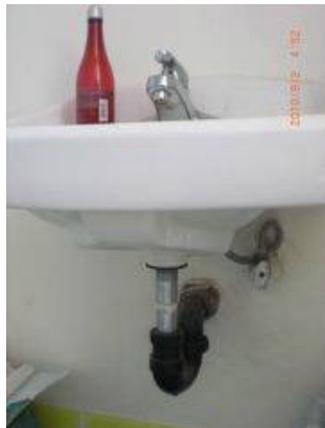
**Location:** Faculty Restroom **Photo #** 647

Field Condition	
16.72 - Lavatory Apron Clearance - Lavatory does not provide accessible apron clearance (i.e. at least 29" clearance from the floor to the bottom of the apron).	<b>1991 ADAAG</b> 4.19.2; Fig. 31 <b>2004 ADAAG</b> 606.3 <b>2007 CBC</b> 1115B.4.3(2); Fig 11B-1D <b>Other</b> -
Existing Condition: 27 1/2".

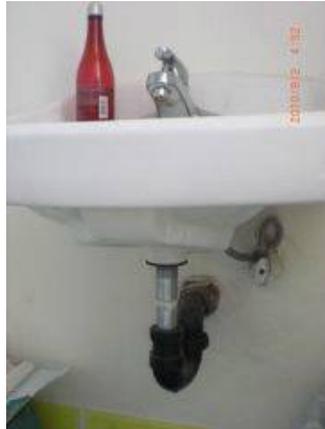
**Location:** Faculty Restroom **Photo #** 647

Field Condition	
16.73 - Lavatory Knee Clearance - Lavatory does not provide accessible knee clearance (i.e. at least 27" clearance from the floor to the underside of the lavatory, extending 8" min.. measured from the front edge underneath the lavatory back towards the wall).	1991 ADAAG 4.19.2; Fig. 31
Existing Condition: 26".	2004 ADAAG 306.3; Fig. 306.3
	2007 CBC 1115B.4.3(2); Fig 11B-1D
	Other -

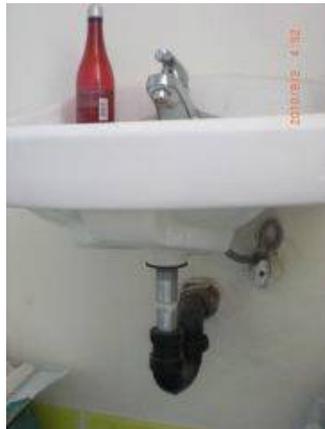
**Location:** Faculty Restroom **Photo #** 647

Field Condition	
16.78 - Pipe Insulation at Lavatory - Drainpipes and hot water pipes are not insulated to protect against contact.	1991 ADAAG 4.19.4
Existing Condition:	2004 ADAAG 606.5
	2007 CBC 1115B.4.3(4)
	Other -

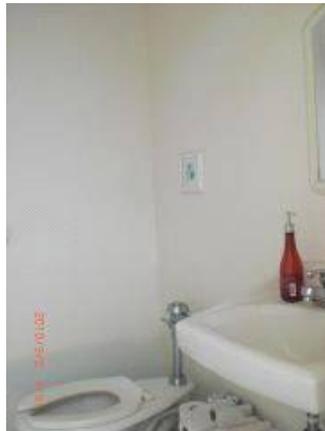
**Location:** Faculty Restroom  
**Photo #** 633

<b>Field Condition</b>	
20.02 - Toilet, Bathroom, or Shower Room - Visual Alarms - Visual alarms are not provided at public or common use toilet, bathroom, or shower room.	<b>1991 ADAAG</b> 4.28.1
Existing Condition:	<b>2004 ADAAG</b> 215.1; Advisory 215.1; 702.1
	<b>2007 CBC</b> 907.9.1.1
	<b>Other</b> -

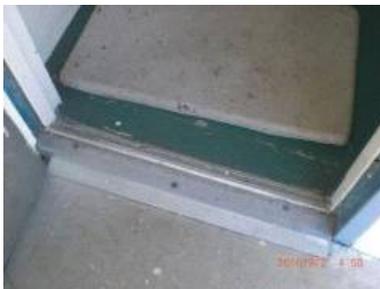
**Location:** Faculty Restroom  
**Photo #** 651

<b>Field Condition</b>	
16.12 - Other Door Requirements - Door does not comply with all applicable ADAAG and CBC accessibility requirements.	<b>1991 ADAAG</b> 4.13
Existing Condition: Compound threshold.	<b>2004 ADAAG</b> 404.1; Advisory 404.1
	<b>2007 CBC</b> 1133B.2
	<b>Other</b> -

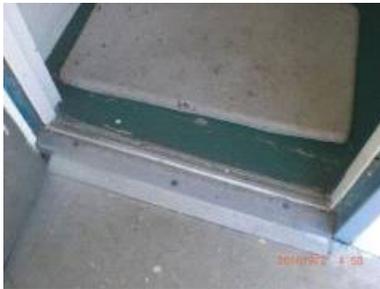
**Location:** Faculty Restroom  
**Photo #** 651

<b>Field Condition</b>	
16.88 - Other - Toilet Facilities - See Additional Comments	1991 ADAAG -
Existing Condition: Loose floor mat.	2004 ADAAG -
	2007 CBC -
	Other -

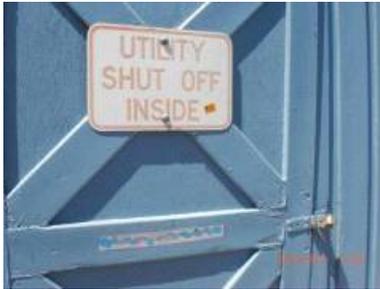
10.10 - Single-Action Hardware - Handles, locks, and latches or other operative devices are not operable with one hand and without tight grasping, pinching, or twisting of the wrist. (U-shaped handles, levers, and push/pull type mechanisms are acceptable designs.)

Existing Condition: Non-compliant hardware.

067B - Lever Hardware - Replace door hardware with lever-type handset.

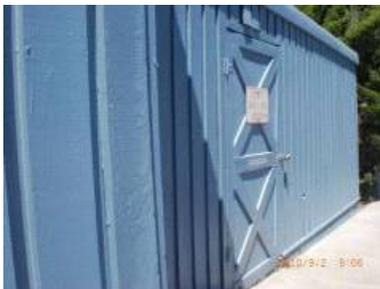
11.17A - Recommendation: Providing Room/Space ID Sign - A sign designating the permanent room or space has not been provided.

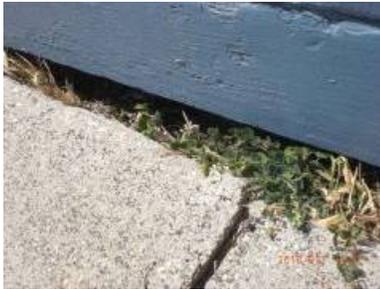
Field Condition	
10.16 - Other - Building Entrances and Exits - See Additional Comments	1991 ADAAG -
Existing Condition: Concrete to grass transition.	2004 ADAAG -
	2007 CBC -
	Other -

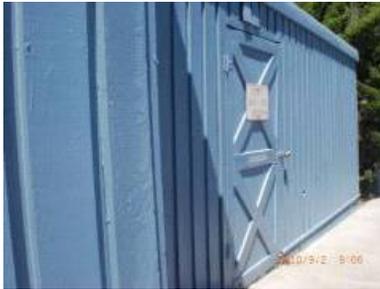
10.06A - Door Maneuvering Space - Door that is not automatic or power-assisted does not have compliant maneuvering space relative to the direction of approach as shown in CBC Fig. 11B-26. (Approach // Side // Width // Depth) (Front // Pull // D + 24" \* // 60") (Front // Push // D + 0" \*\* // 48") (Latch // Pull // D + 24" // 60") (Latch // Push // D + 24" // 44" \*\*\*) (Hinge // Pull // D + 36" // 60") (Hinge // Push // 54" \*\*\*\* // 44" \*\*\*\*\*) (\* D + 18" at interior doors.) (\*\* D + 12" if door has both a latch and a closer.) (\*\*\*) 48" if door has closer.) (\*\*\*\* Measured from latch toward hinge.) (\*\*\*\*\* 48" if door has both a latch and a closer.)

Existing Condition: 6.7% CS at door landing.

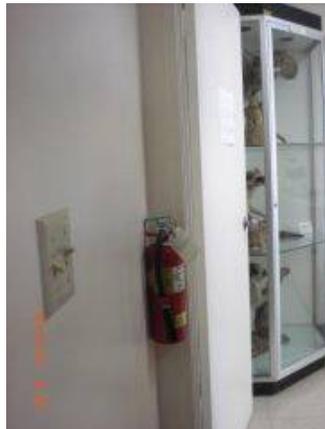
**Location:** Discovery room  
**Photo #** 659

Existing Condition: Knob and twist type lock.

067B - Lever Hardware - Replace door hardware with lever-type handset.

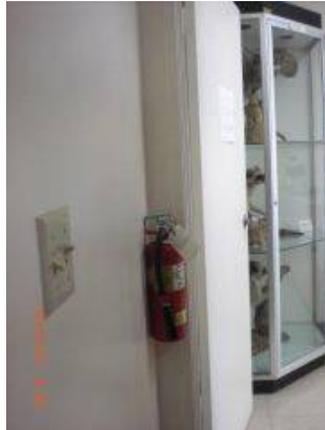
**Location:** Discovery room  
**Photo #** 659

Field Condition	
11.17A - Recommendation: Providing Room/Space ID Sign - A sign designating the permanent room or space has not been provided.	1991 ADAAG 4.1.2(7)
Existing Condition:	2004 ADAAG 216.2; 703.1; 703.2; 703.5
	2007 CBC 1117B.5.1 item 1
	Other -

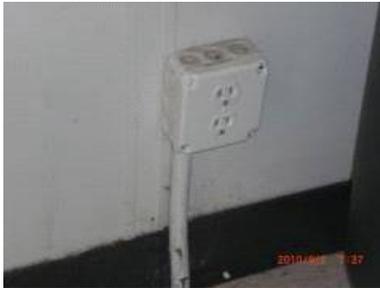
<b>Field Condition</b>	
14.32A - Reach Range - Controls - Controls, dispensers, and similar devices are not between 9" and 54" AFF when the clear floor space allows a parallel approach. OR They are not between 15" and 48" AFF when the clear floor space allows only a forward approach.	<b>1991 ADAAG</b> 4.1.3(13); 4.27.3; 4.2.5; 4.2.6 ; Fig. 5; Fig. 6 <b>2004 ADAAG</b> - <b>2007 CBC</b> 1117B.6(3); 1118.5; 1118.6; Fig. 11B-5C; Fig. 11B-5D <b>Other</b> -
Existing Condition: 14" high receptacle.

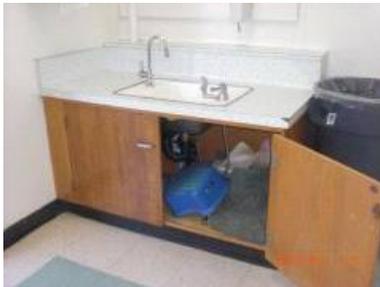
<b>Field Condition</b>	
14.37 - Kitchen Sink - Sink does not provide accessible knee clearance (i.e. at least 27" high, 30" wide, and 19" deep).	<b>1991 ADAAG</b> 4.24.3 <b>2004 ADAAG</b> 305; 306; 606.2 <b>2007 CBC</b> 1115B.4.7(2); 1122B.4 <b>Other</b> -
Existing Condition: No knee space.

<b>Corrective Action</b>
480A - New Counter Top and Sink - Remove existing cabinetry, and provide new counter at 34" above the finished floor. Remove and replace sink and faucet with new accessible sink and faucet. Provide accessible knee clearance (i.e. at least 27" high, 30" wide, and 19" deep) under the sink.
Additional Comments:

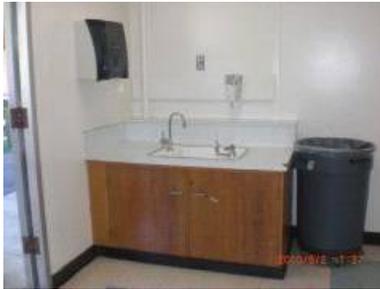
**Location:** Multi-purpose Room  
**Photo #** 664

<b>Field Condition</b>	16.84A - Paper Towel Dispenser - Operating Height - Mounting height of paper towel dispenser's highest operable part exceeds 40" AFF. (Where provided, ADA Standards require at least one paper towel dispenser to be accessible with the highest operable part placed within at least one of the reach ranges specified in 4.2.5 and 4.2.6; where provided, CBC Standards require at least one paper towel dispenser to be accessible with the highest operable part no higher than 40" AFF.)	<b>1991 ADAAG</b> 4.22.7; 4.27.3; 4.2.5; 4.2.6
	Existing Condition: 51" high.	<b>2004 ADAAG</b> 308; 309
		<b>2007 CBC</b> 1115B.8.3
		<b>Other</b> -

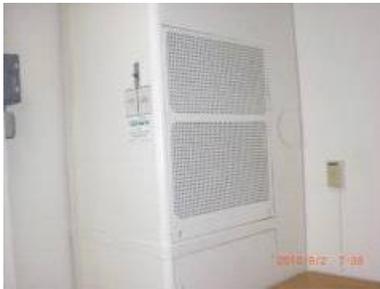
**Keynote 665**

<b>Field Condition</b>	14.32A - Reach Range - Controls - Controls, dispensers, and similar devices are not between 9" and 54" AFF when the clear floor space allows a parallel approach. OR They are not between 15" and 48" AFF when the clear floor space allows only a forward approach.	<b>1991 ADAAG</b> 4.1.3(13); 4.27.3; 4.2.5; 4.2.6 ; Fig. 5; Fig. 6
	Existing Condition: 65" to heating/ cooling controls.	<b>2004 ADAAG</b> -
		<b>2007 CBC</b> 1117B.6(3); 1118.5; 1118.6; Fig. 11B-5C; Fig. 11B-5D
		<b>Other</b> -

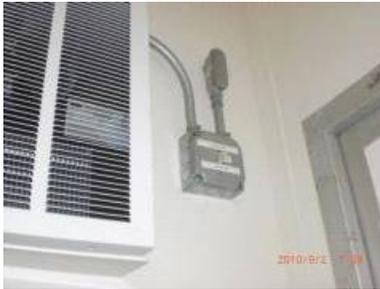
**Location:** Multi-purpose Room **Photo #** 666

14.32A - Reach Range - Controls - Controls, dispensers, and similar devices are not between 9" and 54" AFF when the clear floor space allows a parallel approach. OR They are not between 15" and 48" AFF when the clear floor space allows only a forward approach.

Existing Condition: 79" to electrical switch.

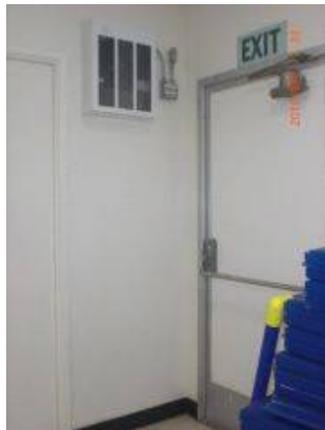
**Keynote 667**

14.30A - Wall-Mounted Protruding Objects - Wall-mounted object(s) with leading edges between 27 and 80" from the floor project more than 4" into the pathway. (Wall mounted objects with leading edges at or below 27" may project any amount as long as the required clear width of an accessible route is not reduced.)

Existing Condition: 5" protrusion at 71" high.

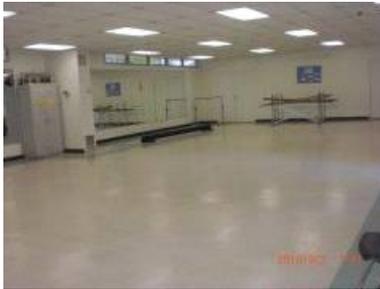
**Location:** Multi-purpose Room  
**Photo #** 668

<b>Field Condition</b>	
20.04 - Common Use Areas - Visual Alarms - Visual alarms are not provided in common use area(s) of the building such as meeting and conference rooms, open office space, classrooms, cafeterias, filing and photocopy rooms, employee break rooms, dressing, examination, and treatment rooms, and similar spaces that are not used solely as employee work areas.	<b>1991 ADAAG</b> 4.28.1
Existing Condition:	<b>2004 ADAAG</b> 215.2; 702.1
	<b>2007 CBC</b> 907.9.1.1
	<b>Other</b> -

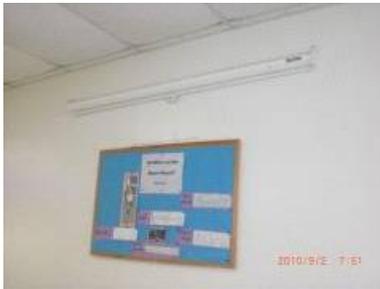
**Keynote 669**

<b>Field Condition</b>	
14.32A - Reach Range - Controls - Controls, dispensers, and similar devices are not between 9" and 54" AFF when the clear floor space allows a parallel approach. OR They are not between 15" and 48" AFF when the clear floor space allows only a forward approach.	<b>1991 ADAAG</b> 4.1.3(13); 4.27.3; 4.2.5; 4.2.6 ; Fig. 5; Fig. 6
Existing Condition: 88" to pull screen.	<b>2004 ADAAG</b> -
	<b>2007 CBC</b> 1117B.6(3); 1118.5; 1118.6; Fig. 11B-5C; Fig. 11B-5D
	<b>Other</b> -

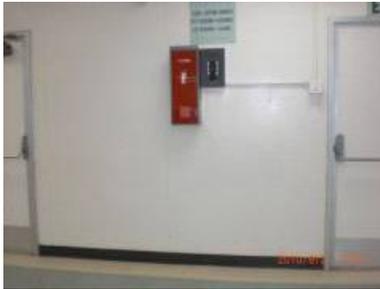
Location: Multi-purpose Room Photo # 670

Field Condition	
20.16A - Fire Extinguisher Cabinet Hardware - Mounting Height - Where fire extinguishers are provided in cabinets, mounting height of the cabinet opening hardware is not compliant. (Compliant opening hardware is mounted 48" AFF maximum, or in existing buildings, the opening hardware is 54" AFF and parallel approach is provided.)	1991 ADAAG 4.27.3
Existing Condition: 68" high.	2004 ADAAG 308.2.1; Fig. 308.2.1; 308.3.1; Fig. 308.3.1
	2007 CBC 1118B.4(1); 1118B.5; 1118B.6
	Other -

Corrective Action
388C - Replace and Relocate Fire Extinguisher Cabinet - Replace existing fire extinguisher cabinet with compliant model in new location.
Additional Comments:

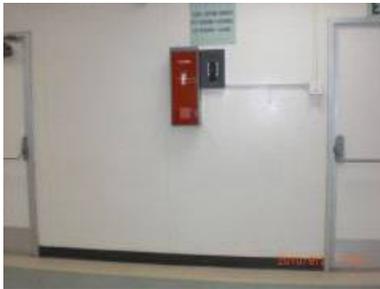
**Keynote 671**

Field Condition	
14.30A - Wall-Mounted Protruding Objects - Wall-mounted object(s) with leading edges between 27 and 80" from the floor project more than 4" into the pathway. (Wall mounted objects with leading edges at or below 27" may project any amount as long as the required clear width of an accessible route is not reduced.)	1991 ADAAG 4.4.1
Existing Condition: FE protrudes 6" at 48" high.	2004 ADAAG 307.2; Fig. 307.2
	2007 CBC 1133B.8.6.1
	Other -

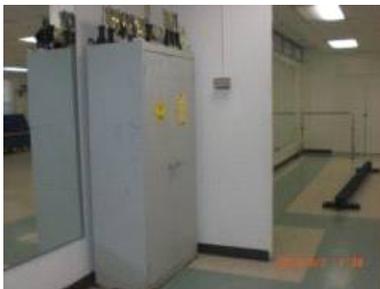
**Keynote 673**

<b>Field Condition</b>	
14.32A - Reach Range - Controls - Controls, dispensers, and similar devices are not between 9" and 54" AFF when the clear floor space allows a parallel approach. OR They are not between 15" and 48" AFF when the clear floor space allows only a forward approach.	<b>1991 ADAAG</b> 4.1.3(13); 4.27.3; 4.2.5; 4.2.6 ; Fig. 5; Fig. 6 <b>2004 ADAAG</b> - <b>2007 CBC</b> 1117B.6(3); 1118.5; 1118.6; Fig. 11B-5C; Fig. 11B-5D <b>Other</b> -
Existing Condition: 63" to thermostat.

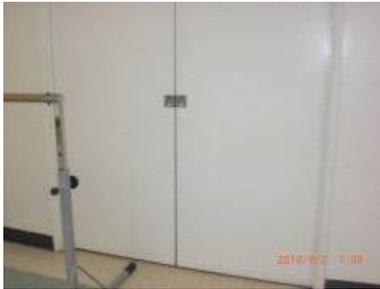
Location: Multi-purpose Room Photo # 674

Field Condition	
11.13A - Door Operating Effort - The force required to operate door exceeds 5 lbs. (Fire doors may have up to 15 lbs to achieve positive latching).	1991 ADAAG 4.13.11
Existing Condition: 6 LBF. operating force for closet sliding doors.	2004 ADAAG 404.2.9
	2007 CBC 1133B.2.5
	Other -

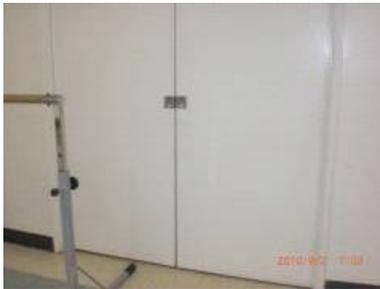
**Keynote 675**

Field Condition	
11.11 - Single-Action Hardware - Handles, locks, and latches or other operative devices are not operable with one hand and without tight grasping, pinching, or twisting of the wrist. (U-shaped handles, levers, and push/pull type mechanisms are acceptable designs.)	1991 ADAAG 4.13.9
Existing Condition: Non-compliant hardware.	2004 ADAAG 309.4; 404.2.7; Advisory 404.2.7
	2007 CBC 1133B.2.5.2
	Other -

Corrective Action
067B - Lever Hardware - Replace door hardware with lever-type handset.
Additional Comments:
