*City of Rancho Palos Verdes*  
**Rancho Palos Verdes ADA Assessment**  
**Facility Report with Photos**

**Facility ID: # 08 - Ladera Linda Park & Community Center**

**Author: Vaish, B**

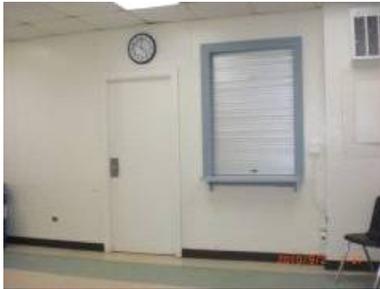
**Location:** Multi-purpose Room  
**Photo #** 676

14.28 - Fixed/Built-in Seating, Tables or Counters - At fixed or built-in seating, tables, or counters in public or common employee areas, less than 5% of the provided seating spaces are wheelchair accessible and have a 30" by 48" clear space which overlaps an accessible route of travel. (Wheelchair accessible seating spaces are between 28" - 34" high and with knee space measuring at least 27" high, 30" wide, and 19" deep.) (These elements include study carrels and student laboratory stations.)

Existing Condition: 36" high.

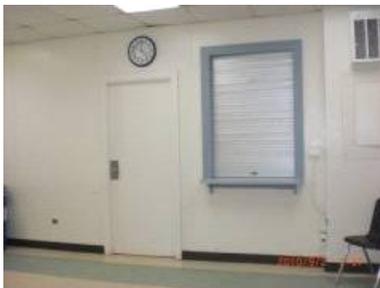
**Keynote 677**

14.29C - Counter - Knee Space Depth - Where seating for persons in wheelchairs is provided at table or counter, knee space is less than 19" deep.

Existing Condition: 7 1/2".

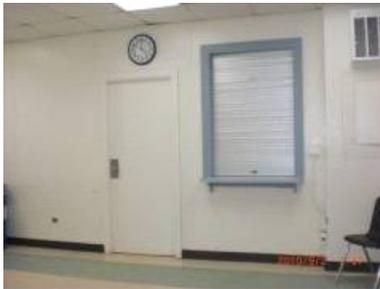
**Keynote 679**

<b>Field Condition</b>	
11.17A - Recommendation: Providing Room/Space ID Sign - A sign designating the permanent room or space has not been provided.	<b>1991 ADAAG</b> 4.1.2(7)
Existing Condition:	<b>2004 ADAAG</b> 216.2; 703.1; 703.2; 703.5
	<b>2007 CBC</b> 1117B.5.1 item 1
	<b>Other</b> -

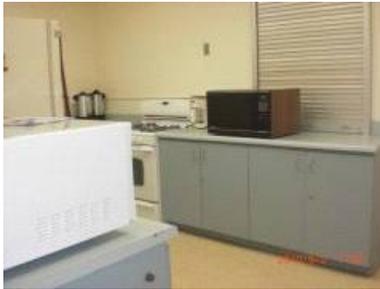
**Keynote 680**

11.06A - Door Maneuvering Space - Door that is not automatic or power-assisted does not have compliant maneuvering space relative to the direction of approach as shown in CBC Fig. 11B-26. (Approach // Side // Width // Depth) (Front // Pull // D + 24" \* // 60") (Front // Push // D + 0" \*\* // 48") (Latch // Pull // D + 24" // 60") (Latch // Push // D + 24" // 44" \*\*\*) (Hinge // Pull // D + 36" // 60") (Hinge // Push // 54" \*\*\*\* // 44" \*\*\*\*\*) (\* D + 18" at interior doors.) (\*\* D + 12" if door has both a latch and a closer.) (\*\*\*) 48" if door has closer.) (\*\*\*\* Measured from latch toward hinge.) (\*\*\*\*\* 48" if door has both a latch and a closer.)

Existing Condition: 2" on pull side due to cabinet.

053 - Reverse Door Swing - Remove existing door and frame and replace with new frame. Reinstall existing door (reverse door swing). Provide new accessible door hardware.

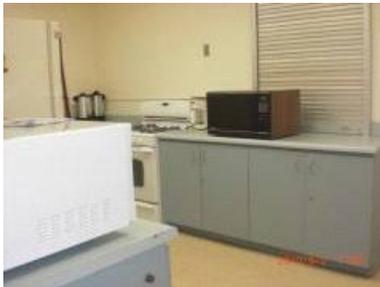
**Keynote 682**

<b>Field Condition</b>	
14.36A - Counter Height - Where provided in public or common use areas, countertops are not between 28" - 34" high. (Common use areas are those interior and exterior rooms, spaces, or elements that are made available for the use of a restricted group of people (for example, the occupants of an office building, or the guests of such occupants).	1991 ADAAG 4.32.4
Existing Condition: 36" high.	2004 ADAAG 902.3
	2007 CBC 1122B.4
	Other -

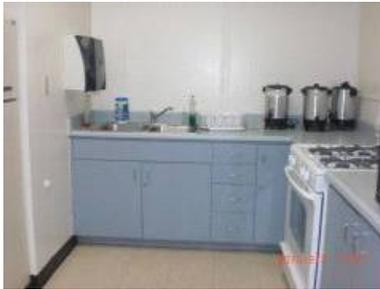
**Location:** Kitchen **Photo #** 683

<b>Field Condition</b>	
14.36B - Kitchen Counter/Sink Height - Where provided in public or common use areas, countertops and sinks are not mounted at 34" AFF. max..(Common use areas are those interior and exterior rooms, spaces, or elements that are made available for the use of a restricted group of people (for example, the occupants of an office building, or the guests of such occupants).	<b>1991 ADAAG</b> 4.24.2  <b>2004 ADAAG</b> 212.3; 606.3  <b>2007 CBC</b> 1115B.4.7(2); 1122B.4  <b>Other</b> -
Existing Condition: 36" high.

<b>Corrective Action</b>	
480A - New Counter Top and Sink - Remove existing cabinetry, and provide new counter at 34" above the finished floor. Remove and replace sink and faucet with new accessible sink and faucet. Provide accessible knee clearance (i.e. at least 27" high, 30" wide, and 19" deep) under the sink.	
Additional Comments:

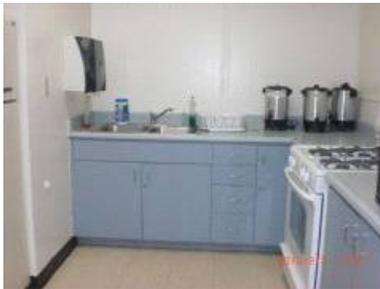
**Keynote 684**

<b>Field Condition</b>	
14.37 - Kitchen Sink - Sink does not provide accessible knee clearance (i.e. at least 27" high, 30" wide, and 19" deep).	<b>1991 ADAAG</b> 4.24.3  <b>2004 ADAAG</b> 305; 306; 606.2  <b>2007 CBC</b> 1115B.4.7(2); 1122B.4  <b>Other</b> -
Existing Condition:

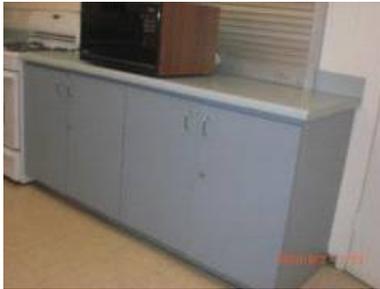
**Keynote 687**

<b>Field Condition</b>	
14.50 - Other - Rooms and Spaces - See Additional Comments	1991 ADAAG -
Existing Condition: Roll-up gate over counter at 37" high, 19 LBF Operating force.	2004 ADAAG -
	2007 CBC -
	Other -

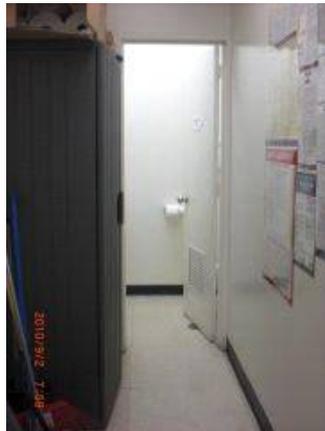
**Location:** Hallway  
**Photo #** 688

<b>Field Condition</b>	
12A.02B - 36" Width Standard - The accessible route of travel is not at least 36" wide where the occupancy load is < 10. (For a depth of 24" max., clear opening width may be reduced to 32" min..) (Doorways are compliant when the door, open 90 degrees, affords a clear opening width of at least 32".)	<b>1991 ADAAG</b> 4.3.3
Existing Condition: 29" to furniture.	<b>2004 ADAAG</b> 403.5.1
	<b>2007 CBC</b> 1133B.3.1
	<b>Other</b> -

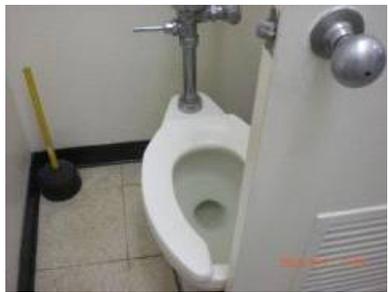
**Location:** Staff Restroom  
**Photo #** 690

<b>Field Condition</b>	
16.01 - Toilet Rooms - Toilet room does not comply with all applicable ADAAG and CBC accessibility requirements.	<b>1991 ADAAG</b> 4.1.2(6); 4.1.3(11); 4.22.1
Existing Condition:	<b>2004 ADAAG</b> 213.2; Advisory 213.2
	<b>2007 CBC</b> 1115B.1
	<b>Other</b> -

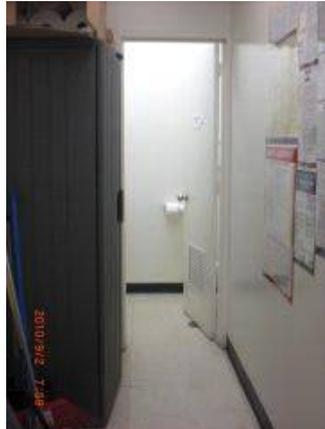
**Location:** Staff Restroom **Photo #** 688

<b>Field Condition</b>	
16.07 - Clear Door Opening - When the door is open 90 degrees, clear opening width is less than 32" measured between the face of the door and the doorstop on the latch side.	<b>1991 ADAAG</b> 4.13.5
Existing Condition: 24" wide.	<b>2004 ADAAG</b> 404.2.3
	<b>2007 CBC</b> 1133B.1.1.1.1; 1133B.2.2
	<b>Other</b> -

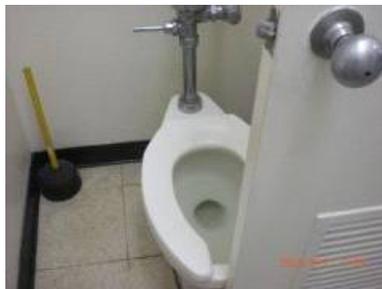
**Location:** Staff Restroom **Photo #** 690

<b>Field Condition</b>	
16.08A - Door Swing - The door swing intrudes into the clear floor space of one or more fixtures.	<b>1991 ADAAG</b> 4.22.2
Existing Condition:	<b>2004 ADAAG</b> 603.2.3; Advisory 603.2.3
	<b>2007 CBC</b> 1115B.3.1 item 2; 1115B.3.2 item 2; 1115B.5
	<b>Other</b> -

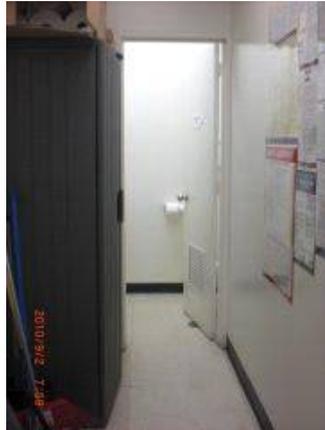
**Keynote 693**

16.09A - Door Maneuvering Space - Door that is not automatic or power-assisted does not have compliant maneuvering space relative to the direction of approach as shown in CBC Fig. 11B-26. (Approach // Side // Width // Depth) (Front // Pull // D + 24" \* // 60") (Front // Push // D + 0" \*\* // 48") (Latch // Pull // D + 24" // 60") (Latch // Push // D + 24" // 44" \*\*\*) (Hinge // Pull // D + 36" // 60") (Hinge // Push // 54" \*\*\*\* // 44" \*\*\*\*\*) (\* D + 18" at interior doors.) (\*\* D + 12" if door has both a latch and a closer.) (\*\*\*) 48" if door has closer.) (\*\*\*\* Measured from latch toward hinge.) (\*\*\*\*\* 48" if door has both a latch and a closer.)

Existing Condition: 47" deep landing on pull side, 6" strike side.

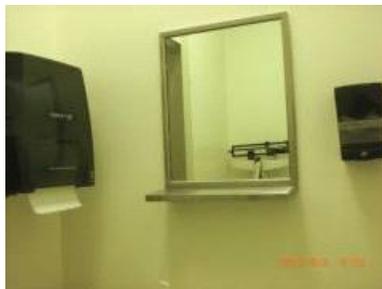
**Location:** Staff Restroom **Photo #** 697

<b>Field Condition</b>	
16.84A - Paper Towel Dispenser - Operating Height - Mounting height of paper towel dispenser's highest operable part exceeds 40" AFF. (Where provided, ADA Standards require at least one paper towel dispenser to be accessible with the highest operable part placed within at least one of the reach ranges specified in 4.2.5 and 4.2.6; where provided, CBC Standards require at least one paper towel dispenser to be accessible with the highest operable part no higher than 40" AFF.)	1991 ADAAG 4.22.7; 4.27.3; 4.2.5; 4.2.6
Existing Condition: 51" high.	2004 ADAAG 308; 309
	2007 CBC 1115B.8.3
	Other -

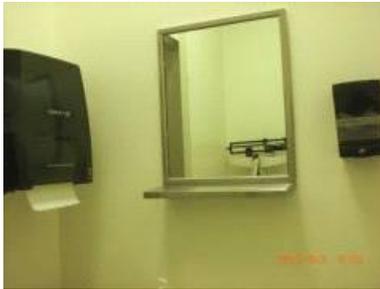
**Location:** Staff Restroom **Photo #** 697

<b>Field Condition</b>	
16.84C - Soap Dispenser - Operating Height - Mounting height of soap dispenser's highest operable part exceeds 40" AFF. (Where provided, ADA Standards require at least one soap dispenser to be accessible with the highest operable part placed within at least one of the reach ranges specified in 4.2.5 and 4.2.6; where provided, CBC Standards require at least one soap dispenser to be accessible with the highest operable part no higher than 40" AFF.)	<b>1991 ADAAG</b> 4.22.7; 4.27.3; 4.2.5; 4.2.6 <b>2004 ADAAG</b> 308; 309 <b>2007 CBC</b> 1115B.8.3 <b>Other</b> -
Existing Condition: 52" high.

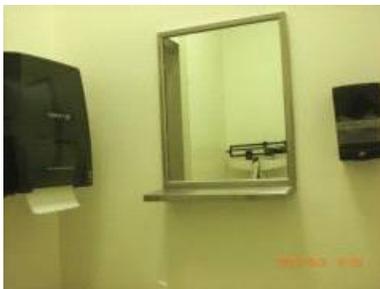
<b>Field Condition</b>	
16.82A - Mirror Height - Max. 40" AFF Standard - Mirror above accessible lavatory or countertop is mounted so the bottom edge of the reflective surface is not 40" max.. AFF. (ADA Standards require at least one mirror to be accessible; CBC Standards prior to August 1, 2009 required all mirrors to be accessible. Effective August 1, 2009, amended CBC Standards require all mirrors above accessible lavatories or countertops to be accessible.)	<b>1991 ADAAG</b> 4.19.6; Fig. 31 <b>2004 ADAAG</b> 213.3.5; 603.3; Advisory 603.3 <b>2007 CBC</b> 1115B.8.1 <b>Other</b> -
Existing Condition: 49 1/2" high.

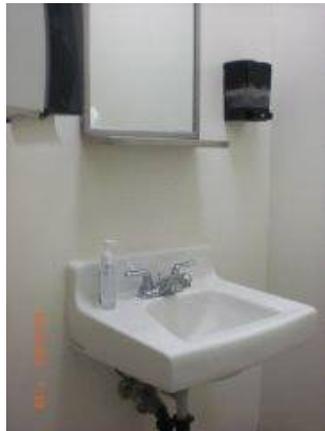
**Location:** Staff Restroom **Photo #** 700

Field Condition	
16.72 - Lavatory Apron Clearance - Lavatory does not provide accessible apron clearance (i.e. at least 29" clearance from the floor to the bottom of the apron).	1991 ADAAG 4.19.2; Fig. 31
Existing Condition: 28".	2004 ADAAG 606.3
	2007 CBC 1115B.4.3(2); Fig 11B-1D
	Other -

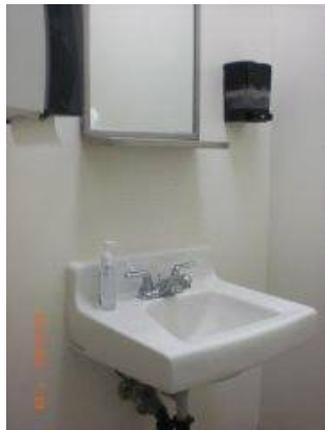
**Location:** Staff Restroom **Photo #** 700

Field Condition	
16.73 - Lavatory Knee Clearance - Lavatory does not provide accessible knee clearance (i.e. at least 27" clearance from the floor to the underside of the lavatory, extending 8" min.. measured from the front edge underneath the lavatory back towards the wall).	1991 ADAAG 4.19.2; Fig. 31
Existing Condition: 25".	2004 ADAAG 306.3; Fig. 306.3
	2007 CBC 1115B.4.3(2); Fig 11B-1D
	Other -

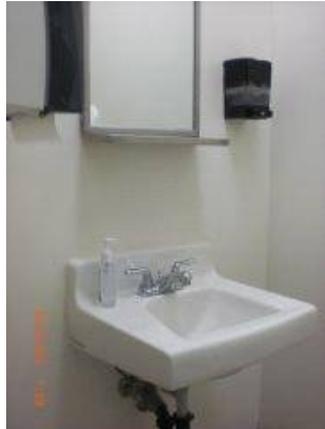
**Location:** Staff Restroom      **Photo #** 700

Field Condition	
16.78 - Pipe Insulation at Lavatory - Drainpipes and hot water pipes are not insulated to protect against contact.	1991 ADAAG 4.19.4
Existing Condition:	2004 ADAAG 606.5
	2007 CBC 1115B.4.3(4)
	Other -

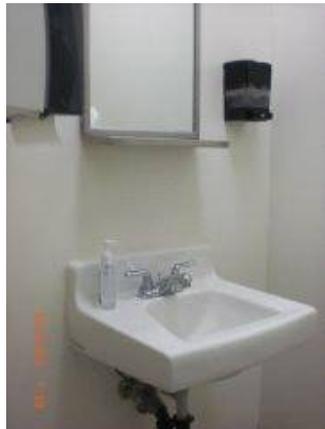
**Location:** Staff Restroom      **Photo #** 700

Field Condition	
16.79 - Smooth Surfaces at Lavatory - The area below the lavatory is not free of sharp or abrasive surfaces.	1991 ADAAG 4.19.4
Existing Condition:	2004 ADAAG 606.5
	2007 CBC 1115B.4.3(4)
	Other -

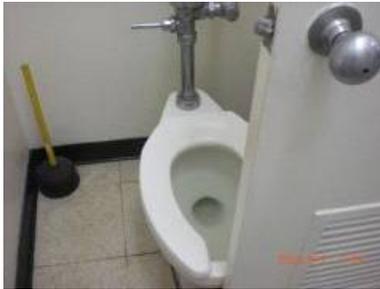
Location: Staff Restroom Photo # 690

<b>Field Condition</b>	
16.47A - WC Location from Sidewall - The centerline of the WC is not 18" absolute from a wall or partition.	1991 ADAAG 4.22.4
Existing Condition: 26".	2004 ADAAG -
	2007 CBC 1115B.4.1(1)
	Other -

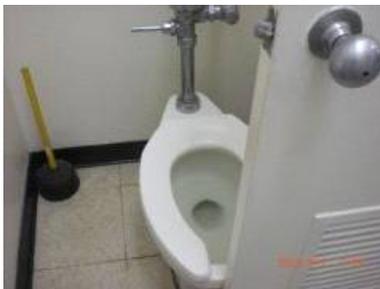
Location: Staff Restroom Photo # 690

<b>Field Condition</b>	
16.48 - WC Seat Height - The top of the WC seat is not between 17" and 19" AFF.	1991 ADAAG 4.16.3; Fig. 29(b)
Existing Condition: 15 1/2" high.	2004 ADAAG 604.4
	2007 CBC 1115B.4.1(4); Fig. 11B-1A
	Other -

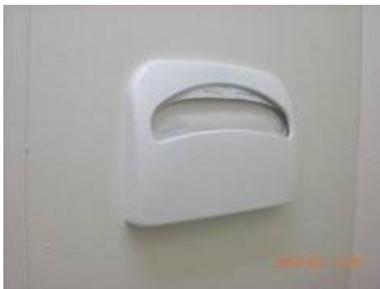
16.53 - SC Dispenser Height - Mounting height of seat cover dispenser's highest operable part exceeds 40" AFF.

Existing Condition: 55".

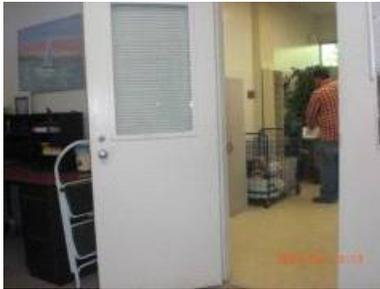
**Location:** Office **Photo #** 710

<b>Field Condition</b>	
11.11 - Single-Action Hardware - Handles, locks, and latches or other operative devices are not operable with one hand and without tight grasping, pinching, or twisting of the wrist. (U-shaped handles, levers, and push/pull type mechanisms are acceptable designs.)	<b>1991 ADAAG</b> 4.13.9
Existing Condition: Knob.	<b>2004 ADAAG</b> 309.4; 404.2.7; Advisory 404.2.7
	<b>2007 CBC</b> 1133B.2.5.2
	<b>Other</b> -

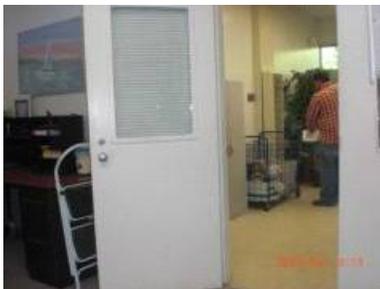
<b>Field Condition</b>	
11.17A - Recommendation: Providing Room/Space ID Sign - A sign designating the permanent room or space has not been provided.	<b>1991 ADAAG</b> 4.1.2(7)
Existing Condition:	<b>2004 ADAAG</b> 216.2; 703.1; 703.2; 703.5
	<b>2007 CBC</b> 1117B.5.1 item 1
	<b>Other</b> -

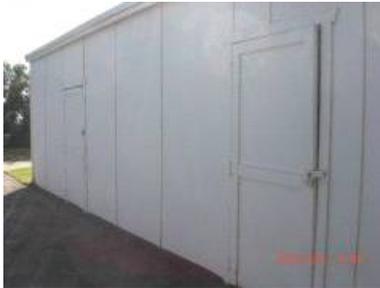
**Location:** Storage  
**Photo #** 716

<b>Field Condition</b>	<p>10.10 - Single-Action Hardware - Handles, locks, and latches or other operative devices are not operable with one hand and without tight grasping, pinching, or twisting of the wrist. (U-shaped handles, levers, and push/pull type mechanisms are acceptable designs.)</p> <p>Existing Condition: Hardware not compliant.</p>	<p><b>1991 ADAAG</b> 4.13.9</p> <p><b>2004 ADAAG</b> 309.4; 404.2.7; Advisory 404.2.7</p> <p><b>2007 CBC</b> 1133B.2.5.2</p> <p><b>Other</b> -</p>
------------------------	--	--

<b>Corrective Action</b>	<p>067B - Lever Hardware - Replace door hardware with lever-type handset.</p> <p>Additional Comments:</p>
--------------------------	---

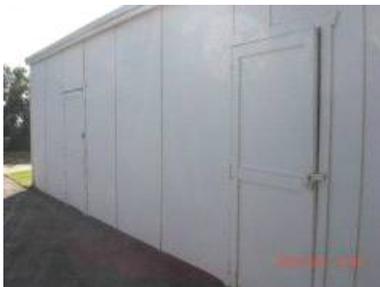
**Location:** Storage  
**Photo #** 716

<b>Field Condition</b>	<p>11.17A - Recommendation: Providing Room/Space ID Sign - A sign designating the permanent room or space has not been provided.</p> <p>Existing Condition:</p>	<p><b>1991 ADAAG</b> 4.1.2(7)</p> <p><b>2004 ADAAG</b> 216.2; 703.1; 703.2; 703.5</p> <p><b>2007 CBC</b> 1117B.5.1 item 1</p> <p><b>Other</b> -</p>
------------------------	---	---

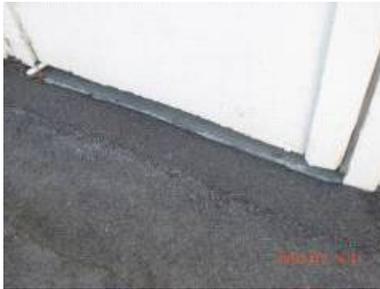
Field Condition	
10.09A - > 1/4" Changes in Level - Threshold - Where threshold is 1/4" min.. to 1/2" max.. in height, change in level is not beveled at 1:2 or less.	1991 ADAAG 4.13.8
Existing Condition: Not leveled.	2004 ADAAG 303.3; Advisory 303.3; Fig. 303.3
	2007 CBC 1133B.2.4.1
	Other -

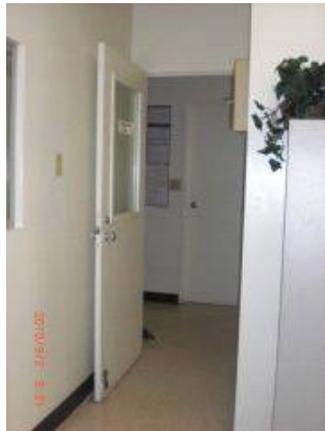
**Location:** Office      **Photo #** 719

Field Condition									
11.11 - Single-Action Hardware - Handles, locks, and latches or other operative devices are not operable with one hand and without tight grasping, pinching, or twisting of the wrist. (U-shaped handles, levers, and push/pull type mechanisms are acceptable designs.)

<b>1991 ADAAG</b>	4.13.9	<b>2004 ADAAG</b>	309.4; 404.2.7; Advisory 404.2.7	<b>2007 CBC</b>	1133B.2.5.2	<b>Other</b>	-
<b>1991 ADAAG</b>	4.13.9								
<b>2004 ADAAG</b>	309.4; 404.2.7; Advisory 404.2.7								
<b>2007 CBC</b>	1133B.2.5.2								
<b>Other</b>	-								
Existing Condition: Knob.

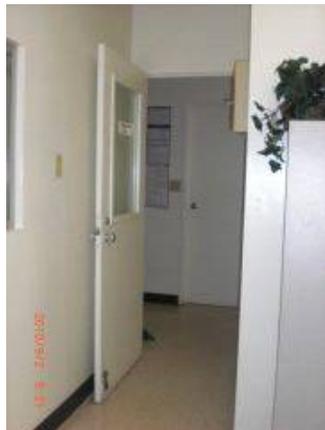
**Location:** Office      **Photo #** 719

Field Condition									
11.05A - Clear Opening - Single-Leaf Door - When the door is open 90 degrees, clear opening width is not at least 32" measured between the face of the door and the doorstop on the latch side.

<b>1991 ADAAG</b>	4.13.5	<b>2004 ADAAG</b>	404.2.3	<b>2007 CBC</b>	1133B.1.1.1.1; 1133B.2.2	<b>Other</b>	-
<b>1991 ADAAG</b>	4.13.5								
<b>2004 ADAAG</b>	404.2.3								
<b>2007 CBC</b>	1133B.1.1.1.1; 1133B.2.2								
<b>Other</b>	-								
Existing Condition: 30" wide.

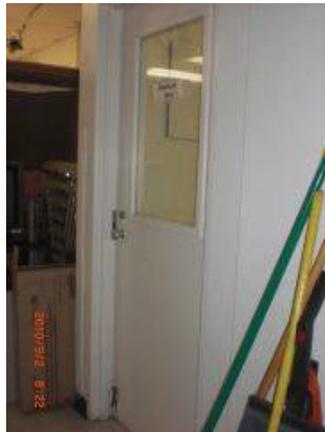
**Location:** Office **Photo #** 722

<b>Field Condition</b>	
11.17A - Recommendation: Providing Room/Space ID Sign - A sign designating the permanent room or space has not been provided.	<b>1991 ADAAG</b> 4.1.2(7)
Existing Condition:	<b>2004 ADAAG</b> 216.2; 703.1; 703.2; 703.5
	<b>2007 CBC</b> 1117B.5.1 item 1
	<b>Other</b> -

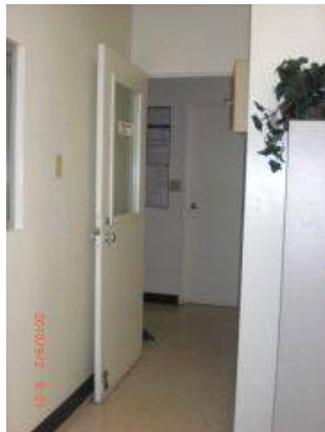
**Location:** Office **Photo #** 719

<b>Field Condition</b>	
11.15A - Kick Plate - Bottom 10" of door does not have a smooth, uninterrupted surface on the push side to allow the door to be opened by a wheelchair footrest without creating a trap or hazardous condition. (This requirement does not apply to automatic and sliding doors.)	<b>1991 ADAAG</b> -
Existing Condition: Door stop.	<b>2004 ADAAG</b> 404.2.10
	<b>2007 CBC</b> 1133B.2.6
	<b>Other</b> -

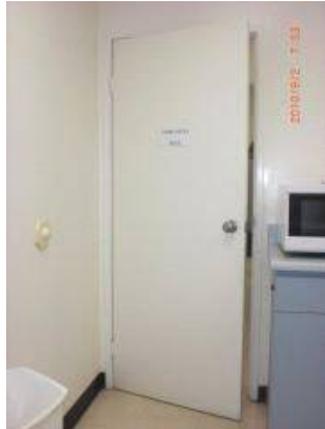
**Location:** Hallway **Photo #** 724

Existing Condition: 30" wide.

056 - Widen Door Opening - Remove existing door and replace with new door and door frame. Cut existing wall to widen door opening. Provide new accessible door hardware.

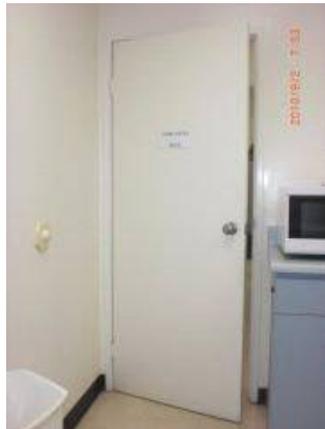
**Location:** Hallway **Photo #** 724

Existing Condition: Knob.

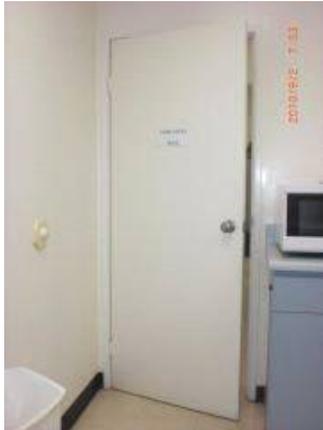
**Location:** Hallway  
**Photo #** 724

Field Condition	
11.06A - Door Maneuvering Space - Door that is not automatic or power-assisted does not have compliant maneuvering space relative to the direction of approach as shown in CBC Fig. 11B-26. (Approach // Side // Width // Depth) (Front // Pull // D + 24" * // 60") (Front // Push // D + 0" ** // 48") (Latch // Pull // D + 24" // 60") (Latch // Push // D + 24" // 44" ***) (Hinge // Pull // D + 36" // 60") (Hinge // Push // 54" **** // 44" *****) (* D + 18" at interior doors.) (** D + 12" if door has both a latch and a closer.) (***) 48" if door has closer.) (**** Measured from latch toward hinge.) (***** 48" if door has both a latch and a closer.)	<b>1991 ADAAG</b> 4.13.6; Fig. 25  <b>2004 ADAAG</b> 404.2.4.1; Tab. 404.2.4.1; Fig. 404.2.4.1  <b>2007 CBC</b> 1133B.2.4.2 Fig. 11B-26  <b>Other</b> -
Existing Condition: No strike side clearance due to cabinet.

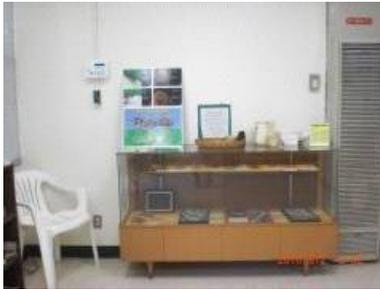
**Location:** Discovery Room **Photo #** 728

<b>Field Condition</b>	
14.32A - Reach Range - Controls - Controls, dispensers, and similar devices are not between 9" and 54" AFF when the clear floor space allows a parallel approach. OR They are not between 15" and 48" AFF when the clear floor space allows only a forward approach.	<b>1991 ADAAG</b> 4.1.3(13); 4.27.3; 4.2.5; 4.2.6 ; Fig. 5; Fig. 6 <b>2004 ADAAG</b> - <b>2007 CBC</b> 1117B.6(3); 1118.5; 1118.6; Fig. 11B-5C; Fig. 11B-5D <b>Other</b> -
Existing Condition: 60" alarm.

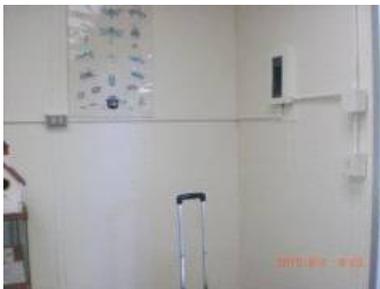
<b>Field Condition</b>	
14.34 - Electrical/Communications Receptacles - Mounting Height - Electrical/communications receptacle is not located between 15" min.. and 48" max.. AFF.	<b>1991 ADAAG</b> 4.1.3(13); 4.27.3; 4.2.5; 4.2.6 ; Fig. 5; Fig. 6 <b>2004 ADAAG</b> 308.2.1; Fig. 308.2.1; 308.3.1; Fig. 308.3.1; 309.3 <b>2007 CBC</b> 1117B.6(5.2) <b>Other</b> -
Existing Condition: 57" high receptacle.

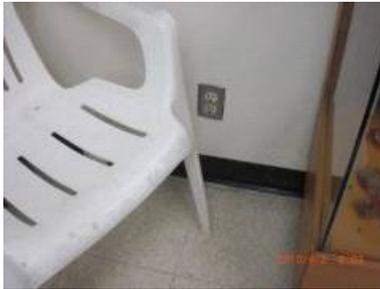
14.34 - Electrical/Communications Receptacles - Mounting Height - Electrical/communications receptacle is not located between 15" min.. and 48" max.. AFF.  
 Existing Condition: 13" high receptacle.

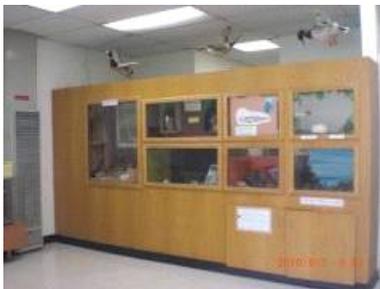
20.04 - Common Use Areas - Visual Alarms - Visual alarms are not provided in common use area(s) of the building such as meeting and conference rooms, open office space, classrooms, cafeterias, filing and photocopy rooms, employee break rooms, dressing, examination, and treatment rooms, and similar spaces that are not used solely as employee work areas.  
 Existing Condition:

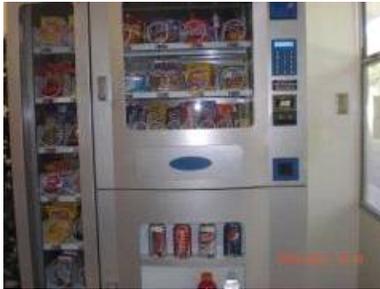
**Location:** Office **Photo #** 732

<b>Field Condition</b>	
14.32A - Reach Range - Controls - Controls, dispensers, and similar devices are not between 9" and 54" AFF when the clear floor space allows a parallel approach. OR They are not between 15" and 48" AFF when the clear floor space allows only a forward approach.	<b>1991 ADAAG</b> 4.1.3(13); 4.27.3; 4.2.5; 4.2.6 ; Fig. 5; Fig. 6 <b>2004 ADAAG</b> - <b>2007 CBC</b> 1117B.6(3); 1118.5; 1118.6; Fig. 11B-5C; Fig. 11B-5D <b>Other</b> -
Existing Condition: 67" vending machine.

<b>Corrective Action</b>
890 - Miscellaneous - See Additional Comments
Additional Comments: Replace vending machine.

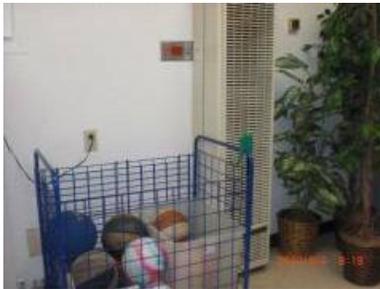
<b>Field Condition</b>	
14.32A - Reach Range - Controls - Controls, dispensers, and similar devices are not between 9" and 54" AFF when the clear floor space allows a parallel approach. OR They are not between 15" and 48" AFF when the clear floor space allows only a forward approach.	<b>1991 ADAAG</b> 4.1.3(13); 4.27.3; 4.2.5; 4.2.6 ; Fig. 5; Fig. 6 <b>2004 ADAAG</b> - <b>2007 CBC</b> 1117B.6(3); 1118.5; 1118.6; Fig. 11B-5C; Fig. 11B-5D <b>Other</b> -
Existing Condition: Fire alarm switch at 53" high.

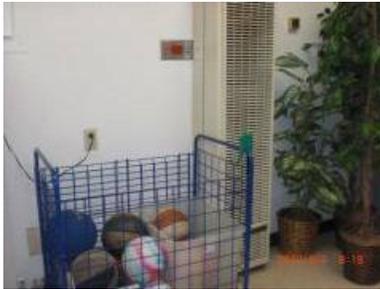
Location: Office Photo # 733

<b>Field Condition</b>									
14.35 - Controls - Operation - The controls are not accessible. (Accessible controls shall be operable with one hand, and without tight grasping, pinching, or twisting of the wrist, and the force to operate the controls shall be no greater than 5 lbs.)

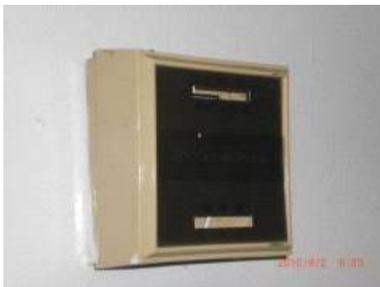
<b>Field Condition</b>									
14.32A - Reach Range - Controls - Controls, dispensers, and similar devices are not between 9" and 54" AFF when the clear floor space allows a parallel approach. OR They are not between 15" and 48" AFF when the clear floor space allows only a forward approach.

1991 ADAAG	4.1.3(13); 4.27.3; 4.2.5; 4.2.6 ; Fig. 5; Fig. 6	2004 ADAAG	-	2007 CBC	1117B.6(3); 1118.5; 1118.6; Fig. 11B-5C; Fig. 11B-5D	Other	-
1991 ADAAG	4.1.3(13); 4.27.3; 4.2.5; 4.2.6 ; Fig. 5; Fig. 6								
2004 ADAAG	-								
2007 CBC	1117B.6(3); 1118.5; 1118.6; Fig. 11B-5C; Fig. 11B-5D								
Other	-								
Existing Condition: 64" thermostat.

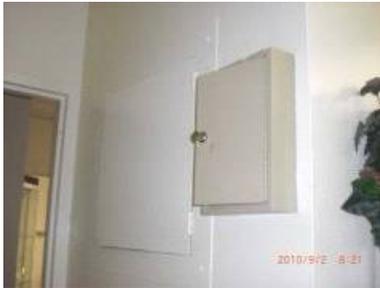
**Keynote 736**

<b>Field Condition</b>	
14.32A - Reach Range - Controls - Controls, dispensers, and similar devices are not between 9" and 54" AFF when the clear floor space allows a parallel approach. OR They are not between 15" and 48" AFF when the clear floor space allows only a forward approach.	<b>1991 ADAAG</b> 4.1.3(13); 4.27.3; 4.2.5; 4.2.6 ; Fig. 5; Fig. 6 <b>2004 ADAAG</b> - <b>2007 CBC</b> 1117B.6(3); 1118.5; 1118.6; Fig. 11B-5C; Fig. 11B-5D <b>Other</b> -
Existing Condition: 66" key box.

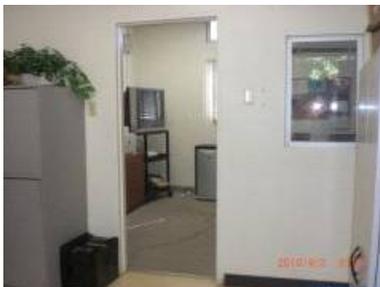
**Keynote 737**

<b>Field Condition</b>	
14.32A - Reach Range - Controls - Controls, dispensers, and similar devices are not between 9" and 54" AFF when the clear floor space allows a parallel approach. OR They are not between 15" and 48" AFF when the clear floor space allows only a forward approach.	<b>1991 ADAAG</b> 4.1.3(13); 4.27.3; 4.2.5; 4.2.6 ; Fig. 5; Fig. 6 <b>2004 ADAAG</b> - <b>2007 CBC</b> 1117B.6(3); 1118.5; 1118.6; Fig. 11B-5C; Fig. 11B-5D <b>Other</b> -
Existing Condition: 55" light switch.

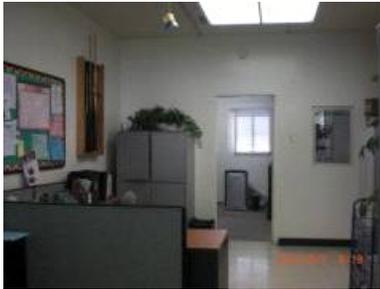
**Keynote 738**

<b>Field Condition</b>	
20.04 - Common Use Areas - Visual Alarms - Visual alarms are not provided in common use area(s) of the building such as meeting and conference rooms, open office space, classrooms, cafeterias, filing and photocopy rooms, employee break rooms, dressing, examination, and treatment rooms, and similar spaces that are not used solely as employee work areas.	<b>1991 ADAAG</b> 4.28.1 <b>2004 ADAAG</b> 215.2; 702.1 <b>2007 CBC</b> 907.9.1.1 <b>Other</b> -
Existing Condition:

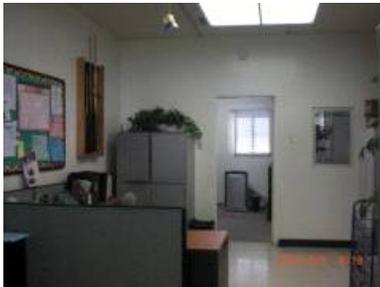
**Keynote 739**

<b>Field Condition</b>	
14.28 - Fixed/Built-in Seating, Tables or Counters - At fixed or built-in seating, tables, or counters in public or common employee areas, less than 5% of the provided seating spaces are wheelchair accessible and have a 30" by 48" clear space which overlaps an accessible route of travel. (Wheelchair accessible seating spaces are between 28" - 34" high and with knee space measuring at least 27" high, 30" wide, and 19" deep.) (These elements include study carrels and student laboratory stations.)	<b>1991 ADAAG</b> 4.1.3(18); 4.32.1; 4.32.4 <b>2004 ADAAG</b> 226.1; Advisory 226.1; 305; 306; 902.2 <b>2007 CBC</b> 1122B.1 <b>Other</b> -
Existing Condition: Desk not accessible to public.

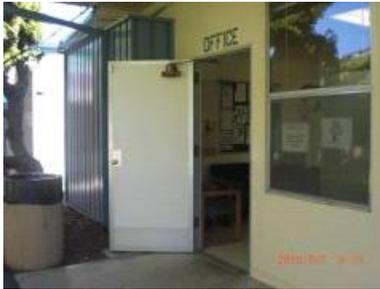
**Keynote 740**

<b>Field Condition</b>	10.02 - Entrance Sign - Accessible entrance is not identified by an ISA.	<b>1991 ADAAG</b>	28 CFR 35.163(b)1
Existing Condition:		<b>2004 ADAAG</b>	216.6
		<b>2007 CBC</b>	1117B.5.8.1.2
		<b>Other</b>	-

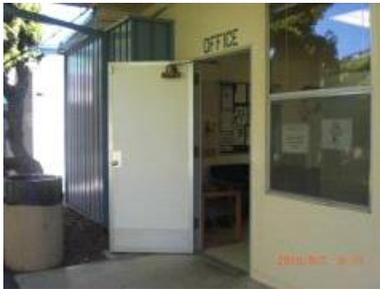
**Keynote 741**

<b>Field Condition</b>	11.17B - Room/Space Identification Signs (Visual/Tactile Signs) - Sign designating the permanent room or space does not comply with ADAAG and CBC requirements for tactile signs.	<b>1991 ADAAG</b>	4.1.2(7); 4.30.1, 4, 5, 6
Existing Condition:		<b>2004 ADAAG</b>	216.2; 703.1; 703.2; 703.5
		<b>2007 CBC</b>	1117B.5.2, 3, 5, 6, 7
		<b>Other</b>	-

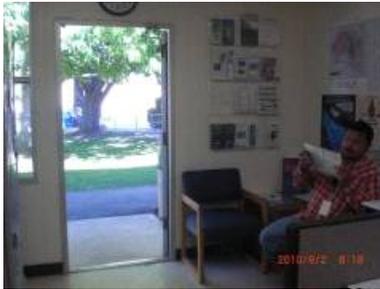
**Keynote 744**

10.13A - Required Exit Door Sign - At grade level exterior exit door, there is no tactile and CA Braille exit sign with the word "EXIT" mounted on the wall adjacent to the latch side of the door.

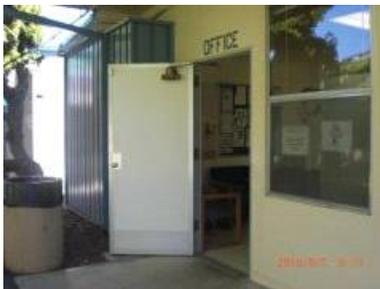
**Keynote 745**

10.07A - Landing - Level and Clear - Floor is not level (slope is greater than 2% in some or all directions). OR Floor is not clear within the required maneuvering space.

Existing Condition: 3.4% slope at door landing.

006 - Concrete Walk - Remove non-compliant pavement and replace with new concrete (area as shown on the drawings). The walkway slope shall not exceed 5% along the POT and cross slope shall not exceed 2%.

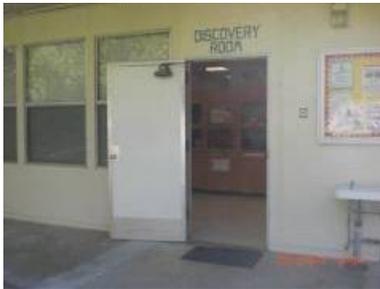
**Keynote 749**

Field Condition	
10.02 - Entrance Sign - Accessible entrance is not identified by an ISA.	1991 ADAAG 28 CFR 35.163(b)1
Existing Condition:	2004 ADAAG 216.6
	2007 CBC 1117B.5.8.1.2
	Other -

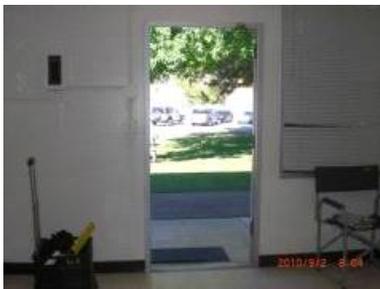
**Keynote 753**

<b>Field Condition</b>	
10.13A - Required Exit Door Sign - At grade level exterior exit door, there is no tactile and CA Braille exit sign with the word "EXIT" mounted on the wall adjacent to the latch side of the door.	<b>1991 ADAAG</b> 4.1.3(16); 4.30.1
Existing Condition:	<b>2004 ADAAG</b> 216.4; 703.2; 703.3; 703.4
	<b>2007 CBC</b> 1011.3 item 1
	<b>Other</b> -

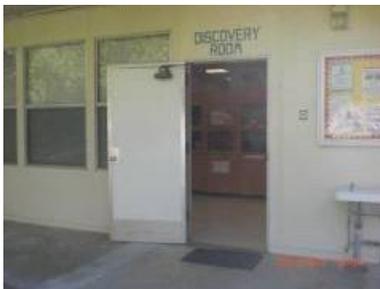
**Keynote 755**

Field Condition	
10.09B - Threshold - Height - The threshold at doorway exceeds 1/2" in height.	<b>1991 ADAAG</b> 4.13.8  <b>2004 ADAAG</b> 303.3; Advisory 303.3; Fig. 303.3  <b>2007 CBC</b> 1133B.2.4.1  <b>Other</b> -
Existing Condition:

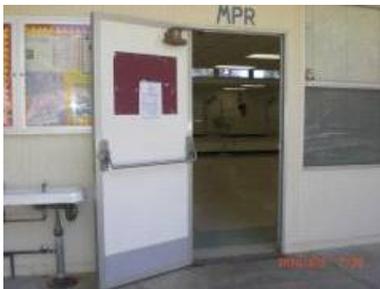
**Keynote 759**

<b>Field Condition</b>	
10.02 - Entrance Sign - Accessible entrance is not identified by an ISA.	<b>1991 ADAAG</b> 28 CFR 35.163(b)1
Existing Condition:	<b>2004 ADAAG</b> 216.6
	<b>2007 CBC</b> 1117B.5.8.1.2
	<b>Other</b> -

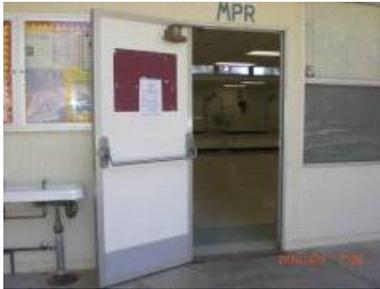
**Keynote 760**

<b>Field Condition</b>	
10.10 - Single-Action Hardware - Handles, locks, and latches or other operative devices are not operable with one hand and without tight grasping, pinching, or twisting of the wrist. (U-shaped handles, levers, and push/pull type mechanisms are acceptable designs.)	<b>1991 ADAAG</b> 4.13.9
Existing Condition: Thumb latch.	<b>2004 ADAAG</b> 309.4; 404.2.7; Advisory 404.2.7
	<b>2007 CBC</b> 1133B.2.5.2
	<b>Other</b> -

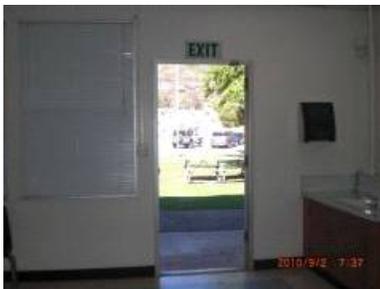
**Keynote 761**

<b>Field Condition</b>	
10.13A - Required Exit Door Sign - At grade level exterior exit door, there is no tactile and CA Braille exit sign with the word "EXIT" mounted on the wall adjacent to the latch side of the door.	<b>1991 ADAAG</b> 4.1.3(16); 4.30.1
Existing Condition:	<b>2004 ADAAG</b> 216.4; 703.2; 703.3; 703.4
	<b>2007 CBC</b> 1011.3 item 1
	<b>Other</b> -

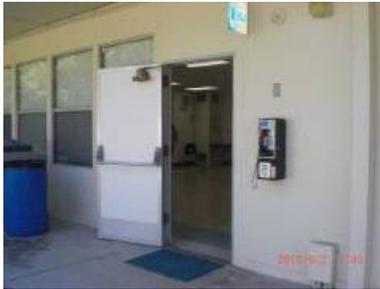
**Keynote 768**

<b>Field Condition</b>	
11.07D - Floor Mat - Attachment to Floor - Floor mat used on a ground or floor surface is not securely attached.	<b>1991 ADAAG</b> 4.5.3
Existing Condition: Loose floor mat.	<b>2004 ADAAG</b> 303.2; Advisory 302.2
	<b>2007 CBC</b> 1124B.3
	<b>Other</b> -

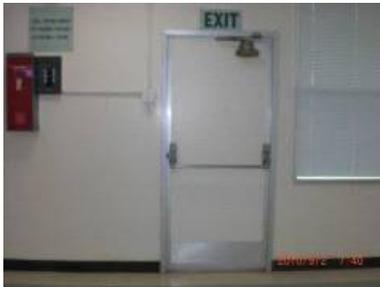
**Keynote 769**

<b>Field Condition</b>	
10.13A - Required Exit Door Sign - At grade level exterior exit door, there is no tactile and CA Braille exit sign with the word "EXIT" mounted on the wall adjacent to the latch side of the door.	<b>1991 ADAAG</b> 4.1.3(16); 4.30.1
Existing Condition:	<b>2004 ADAAG</b> 216.4; 703.2; 703.3; 703.4
	<b>2007 CBC</b> 1011.3 item 1
	<b>Other</b> -

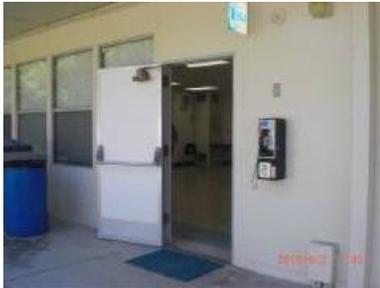
**Keynote 770**

Field Condition	
10.10 - Single-Action Hardware - Handles, locks, and latches or other operative devices are not operable with one hand and without tight grasping, pinching, or twisting of the wrist. (U-shaped handles, levers, and push/pull type mechanisms are acceptable designs.)	<b>1991 ADAAG</b> 4.13.9 <b>2004 ADAAG</b> 309.4; 404.2.7; Advisory 404.2.7 <b>2007 CBC</b> 1133B.2.5.2 <b>Other</b> -
Existing Condition: Thumb latch.

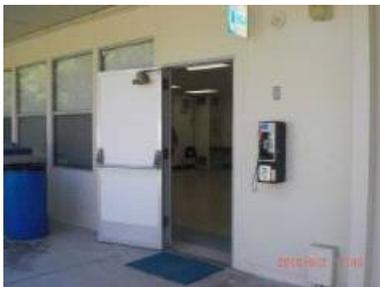
**Keynote 771**

Field Condition	
11.17A - Recommendation: Providing Room/Space ID Sign - A sign designating the permanent room or space has not been provided.	<b>1991 ADAAG</b> 4.1.2(7) <b>2004 ADAAG</b> 216.2; 703.1; 703.2; 703.5 <b>2007 CBC</b> 1117B.5.1 item 1 <b>Other</b> -
Existing Condition:

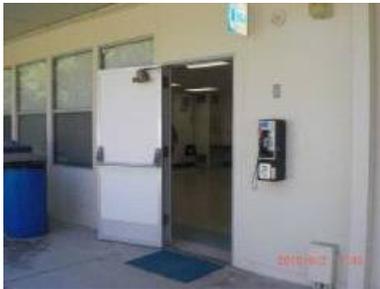
**Keynote 773**

<b>Field Condition</b>	
10.11A - Door Operating Effort - The force required to operate door exceeds 5 lbs. (Fire doors may have up to 15 lbs to achieve positive latching).	<b>1991 ADAAG</b> 4.13.11
Existing Condition: 12 LBF.	<b>2004 ADAAG</b> 404.2.9
	<b>2007 CBC</b> 1133B.2.5
	<b>Other</b> -

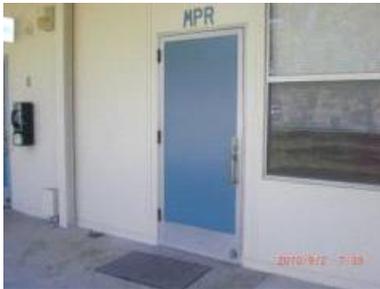
**Keynote 777**

<b>Field Condition</b>	
10.10 - Single-Action Hardware - Handles, locks, and latches or other operative devices are not operable with one hand and without tight grasping, pinching, or twisting of the wrist. (U-shaped handles, levers, and push/pull type mechanisms are acceptable designs.)	<b>1991 ADAAG</b> 4.13.9
Existing Condition: Thumb latch.	<b>2004 ADAAG</b> 309.4; 404.2.7; Advisory 404.2.7
	<b>2007 CBC</b> 1133B.2.5.2
	<b>Other</b> -

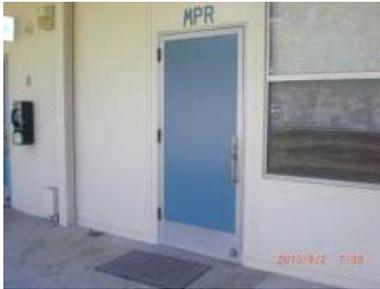
**Keynote 778**

<b>Field Condition</b>	
10.11A - Door Operating Effort - The force required to operate door exceeds 5 lbs. (Fire doors may have up to 15 lbs to achieve positive latching).	1991 ADAAG 4.13.11
Existing Condition: 10 LBF.	2004 ADAAG 404.2.9
	2007 CBC 1133B.2.5
	Other -

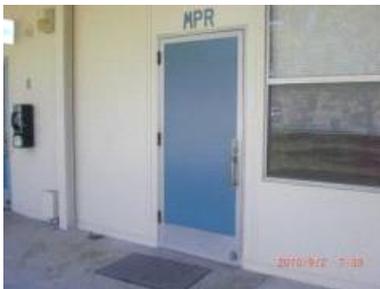
**Keynote 779**

<b>Field Condition</b>	
10.11B - Hardware Operating Effort - The force required to activate handles, pulls, latches, locks, and other operable parts of door exceeds 5 lbs.	1991 ADAAG 4.27.4
Existing Condition: 10 LBF.	2004 ADAAG 309.4
	2007 CBC 1117B.6 item 4
	Other -

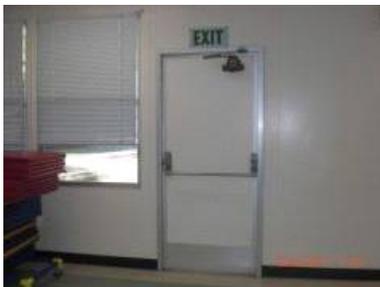
**Keynote 781**

<b>Field Condition</b>	
10.13A - Required Exit Door Sign - At grade level exterior exit door, there is no tactile and CA Braille exit sign with the word "EXIT" mounted on the wall adjacent to the latch side of the door.	<b>1991 ADAAG</b> 4.1.3(16); 4.30.1
Existing Condition:	<b>2004 ADAAG</b> 216.4; 703.2; 703.3; 703.4
	<b>2007 CBC</b> 1011.3 item 1
	<b>Other</b> -

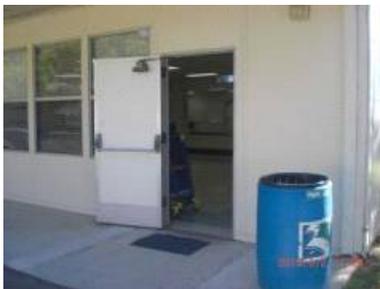
**Keynote 787**

<b>Field Condition</b>	
10.07A - Landing - Level and Clear - Floor is not level (slope is greater than 2% in some or all directions). OR Floor is not clear within the required maneuvering space.	<b>1991 ADAAG</b> 4.13.6; Fig. 25 <b>2004 ADAAG</b> 305; 404.2.4.4 <b>2007 CBC</b> 1133B.2.4 <b>Other</b> -
Existing Condition: 3.5% slope at door landing.

<b>Corrective Action</b>	
008 - Concrete Landing - Remove non-compliant pavement and replace with new concrete. The landing slope shall not exceed 2% in any direction.	
Additional Comments:

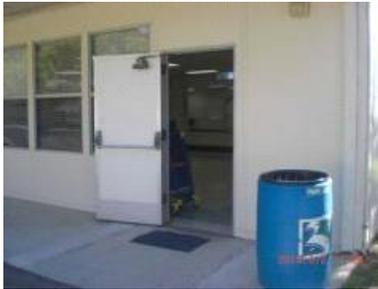
**Keynote 788**

Field Condition	
10.11A - Door Operating Effort - The force required to operate door exceeds 5 lbs. (Fire doors may have up to 15 lbs to achieve positive latching).	1991 ADAAG 4.13.11
Existing Condition: 10 LBF.	2004 ADAAG 404.2.9
	2007 CBC 1133B.2.5
	Other -

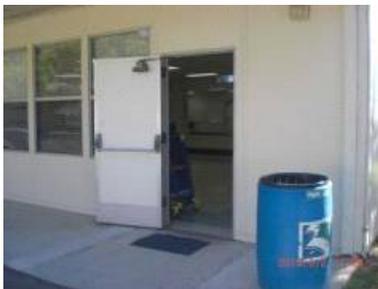
**Keynote 789**

Field Condition	
10.11B - Hardware Operating Effort - The force required to activate handles, pulls, latches, locks, and other operable parts of door exceeds 5 lbs.	1991 ADAAG 4.27.4
Existing Condition: 10 LBF.	2004 ADAAG 309.4
	2007 CBC 1117B.6 item 4
	Other -

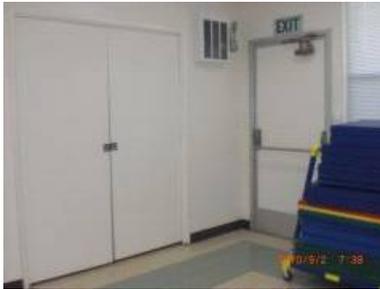
**Keynote 790**

10.06A - Door Maneuvering Space - Door that is not automatic or power-assisted does not have compliant maneuvering space relative to the direction of approach as shown in CBC Fig. 11B-26. (Approach // Side // Width // Depth) (Front // Pull // D + 24" \* // 60") (Front // Push // D + 0" \*\* // 48") (Latch // Pull // D + 24" // 60") (Latch // Push // D + 24" // 44" \*\*\*\*) (Hinge // Pull // D + 36" // 60") (Hinge // Push // 54" \*\*\*\* // 44" \*\*\*\*\*) (\* D + 18" at interior doors.) (\*\* D + 12" if door has both a latch and a closer.) (\*\*\* 48" if door has closer.) (\*\*\*\* Measured from latch toward hinge.) (\*\*\*\*\* 48" if door has both a latch and a closer.)

Existing Condition: 7" on push side.

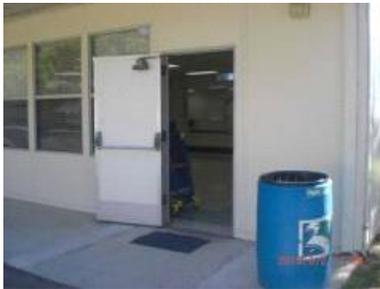
**Keynote 794**

<b>Field Condition</b>	
11.07D - Floor Mat - Attachment to Floor - Floor mat used on a ground or floor surface is not securely attached.	<b>1991 ADAAG</b> 4.5.3
Existing Condition: Loose floor mat.	<b>2004 ADAAG</b> 303.2; Advisory 302.2
	<b>2007 CBC</b> 1124B.3
	<b>Other</b> -

<b>Classification</b>	
<b>DOJ Location Type:</b>	1
<b>Use:</b>	PV
<b>Severity:</b>	A
<b>Level of Difficulty</b>	Low

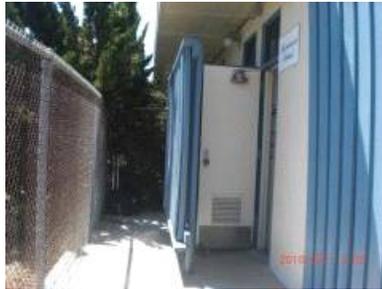
**Keynote 797**

Field Condition	
03B.11 - Ramps - This portion of an accessible route with a slope greater than 5% does not comply with the requirements for compliant ramps.	1991 ADAAG 4.8.1
Existing Condition: 5.7% slope.	2004 ADAAG 405
	2007 CBC 1133B.5
	Other -

Classification	
DOJ Location Type:	1
Use:	PV
Severity:	C
Level of Difficulty	Moderate to High

Corrective Action
004A - Asphalt Paving - Remove non-compliant pavement and replace with new asphalt paving (area as shown on the drawings). The walkway slope shall not exceed 5% along the POT and cross slope shall not exceed 2%.
Additional Comments:
