City of Rancho Palos Verdes
Rancho Palos Verdes ADA Assessment
Facility Report with Photos

Reporting: 380 of 4367 Rcd Facility ID: # 09 - Lower Point Vicente Park & Point Vicente Interpretive Center (PVIC)

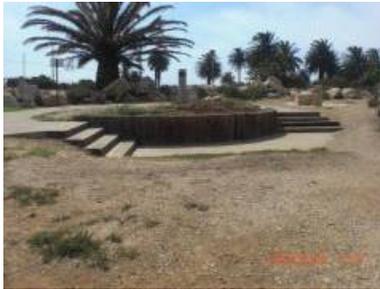
Keystone 3

Field Condition	
08.07A - Continuous Handrails - Continuous handrails are not provided along both sides.	1991 ADAAG 4.9.4
Existing Condition: None provided.	2004 ADAAG 504.6; 505.2
	2007 CBC 1133B.4.1.1
	Other -

Corrective Action
244 - Freestanding Steel Stair Handrails - Provide new freestanding handrails. Handrails shall be of galvanized steel tubing 1 1/2" outside diameter, mounted 36" above nosing of the stair treads, and shall extend a minimum of 12" beyond the top nosing and shall extend a minimum of tread width (1' m
Additional Comments: Remove one stair and replace w/ new ramp per keynote 2.

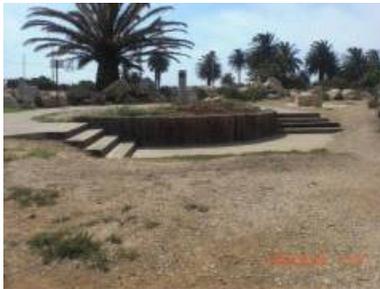
Keystone 4

Field Condition	
08.05A - Exterior Stairs - Color Strip - Contrasting color strips have not been provided.	1991 ADAAG -
Existing Condition: None provided.	2004 ADAAG -
	2007 CBC 1133B.4.4
	Other -

Corrective Action
255D - Paint-Applied Warning Striping - All Treads and Top Landing - Paint 2" wide stripes a maximum of 1" from the tread nosing on all treads and top landing. Stripes shall extend the full width of stair. Apply epoxy paint of clearly contrasting color (70% minimum contrast) with band grit to achieve compliant slip resista
Additional Comments: Remove one stair and replace w/ new ramp per keynote 2.

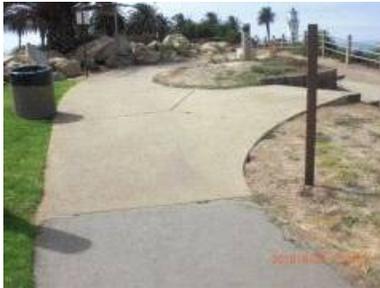
Keynote 5

Field Condition									
03B.09 - Cross Slope - Cross slope of the accessible route of travel exceeds 1:50. Existing Condition: 2.1% to 2.7% CS.

Corrective Action	
006 - Concrete Walk - Remove non-compliant pavement and replace with new concrete (area as shown on the drawings). The walkway slope shall not exceed 5% along the POT and cross slope shall not exceed 2%.	
Additional Comments:

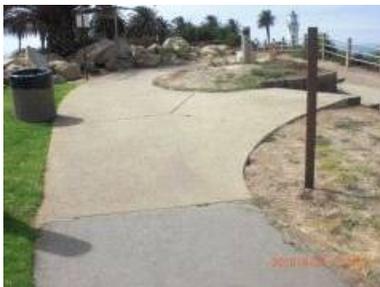
Keynote 6

Field Condition									
03B.10 - Running Slope - Slope of the accessible route of travel exceeds 1:20. Existing Condition: 5.55 to 6.8% RS.

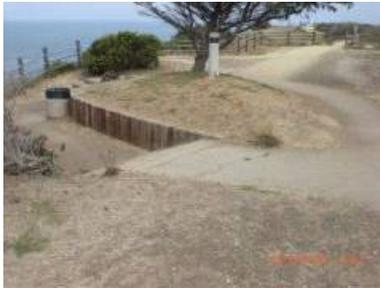
Keynote 29

Field Condition									
03B.09 - Cross Slope - Cross slope of the accessible route of travel exceeds 1:50. Existing Condition: 6.4% CS.

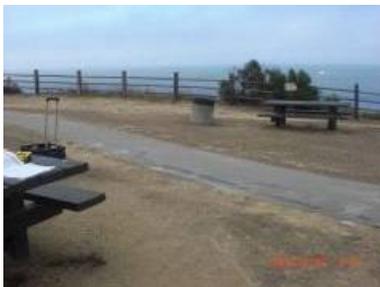
Keynote 30

Field Condition									
30.25 - Number - Accessible Picnic Tables - Where fixed picnic tables are provided in a picnic area, the required number of fixed picnic tables is not provided. (1999 ADAAG: Where two or more fixed picnic tables are provided in a picnic area, at least 50%, but never less than two, shall comply with 16.5.4 through 16.5.6. In addition, at least 40%, but never less than two, of the accessible picnic tables shall be connected to an outdoor recreation access route complying with 16.3.) Existing Condition: 6 picnic tables, 1 with ISA Sign w/ water pond at asphalt.

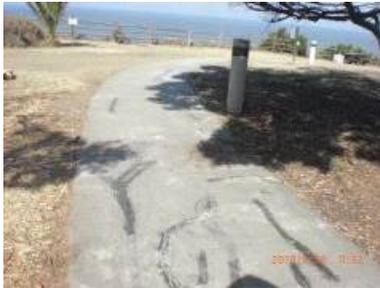
Keynote 35

Field Condition	
30.68 - Other - Parks - See Additional Comments	1991 ADAAG -
Existing Condition: Loose surface at dog waste bag area.	2004 ADAAG -
	2007 CBC -
	Other -

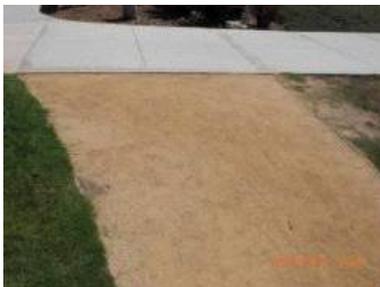
Keynote 36

Field Condition	
03B.13 - > 1/2" Changes in Level - Curb ramps, ramps, or elevators are not used for changes in level greater than 1/2 inch. (Lifts may only be used in certain limited situations.)	1991 ADAAG 4.5.2
Existing Condition:	2004 ADAAG 303.4
	2007 CBC 1124B.2
	Other -

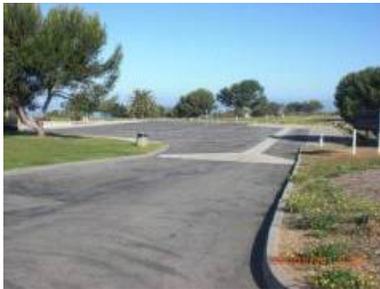
Keynote 40

01.19B - Tow-away Sign - A California tow-away sign is not posted in a conspicuous place at each entrance to off-street parking lot, or immediately adjacent to and visible from each accessible stall.

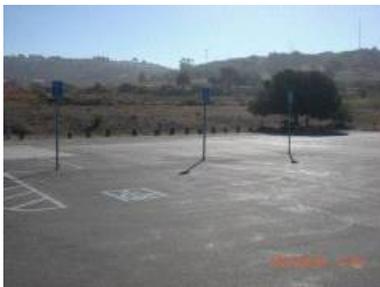
Keynote 42

Field Condition	01.06 - Lot Layout - Parking stalls are so arranged that persons with disabilities are compelled to wheel or walk behind parked cars other than their own.	1991 ADAAG -
Existing Condition:		2004 ADAAG Advisory 502.3
		2007 CBC 1129B.3 item 3
		Other

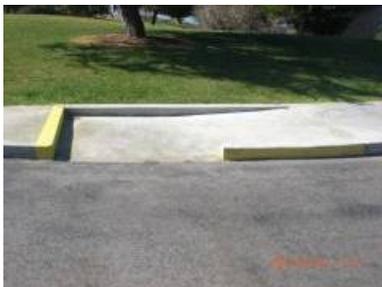
Keynote 50

Field Condition									
04.10 - Detectable Warning Requirement - Regardless of slope, the curb ramp does not have a detectable warning. Existing Condition:

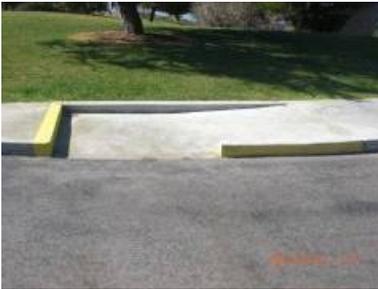
Keynote 51

04.09A - Grooved Border Requirement - Curb ramp does not have a 12" wide grooved border around upper edges of curb ramp and flares to indicate transition from sidewalk to curb ramp.

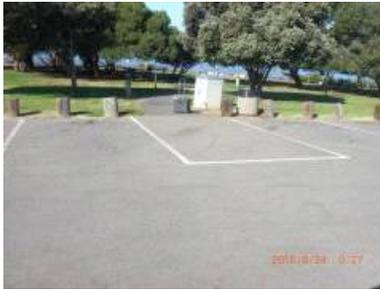
Keynote 52

01.02 - Number - Accessible Parking Spaces - Where parking spaces are provided for self-parking by employees or visitors or both, the required number of accessible parking spaces is not provided. (Note: All or some of the accessible parking spaces may be in a different location if equivalent or greater accessibility is ensured.) (Spaces required: (1 to 25 // 1) (26 to 50 // 2) (51 to 75 // 3) (76 to 100 // 4) (101 to 150 // 5) (151 to 200 // 6) (201 to 300 // 7) (301 to 400 // 8) (401 to 500 // 9) (501 to 1,000 // *) (1,000 and over // **) (*Two percent of total.) (**Twenty plus one for each 100, or fraction over 1,001.)

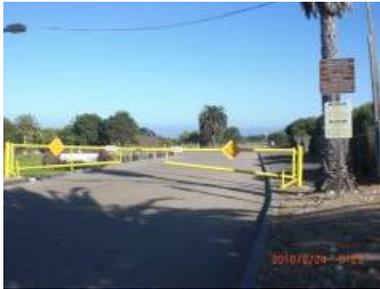
Keynote 53

01.19B - Tow-away Sign - A California tow-away sign is not posted in a conspicuous place at each entrance to off-street parking lot, or immediately adjacent to and visible from each accessible stall.

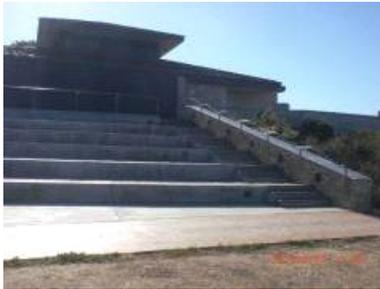
Keynote 54

15A.33 - Accessible Assembly Seating - In assembly areas with fixed seating, the required number of accessible seating is not provided. (Seating Capacity // W // C // S // A // ALS Receiver) (4 to 26 // 1 // 1 // 2 // 1 // 2) (27 to 50 // 2 // 2 // 2 // 1 // 2) (51 to 100 // 4 // 4 // 2 // 1 // 4%) (101 to 200 // 4 // 4 // 2 // 1 // 4%) (201 to 300 // 4 // 4 // 1 // 1 // 4%) (301 to 500 // 6 // 6 // 1 // 1 // 4%) (501 + // 6 + 1 per add. 100 seats over 500 // 6 + 1 per add. 100 seats over 500 // 1 // 1 // 4%)) W= Wheelchair spaces, A= Aisle (transfer) seats, C= Companion seats, S= Semi-ambulant seats

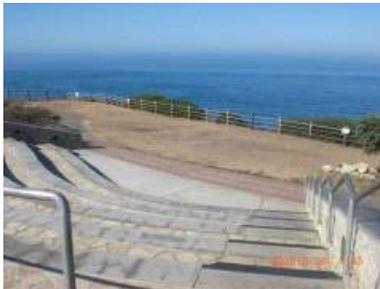
Keynote 56

Field Condition	
15A.45 - Accessible Route - Performing Areas - Accessible routes of travel do not connect wheelchair seating locations and performance areas including stages, arena floors, dressing rooms, locker rooms, and other spaces used by performers.	1991 ADAAG 4.33.5
Existing Condition:	2004 ADAAG 206.2.4; 206.2.6
	2007 CBC 1104B.3.10
	Other -

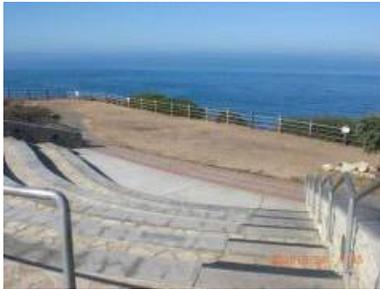
Keynote 57

15A.30 - Portable ALS - For assembly areas without fixed seats (e.g., conference or meeting rooms), a permanently installed assistive listening system or a portable assistive listening system, including an adequate number of electrical outlets or other supplementary wiring necessary to support a portable ALS, has not been provided. (A permanently installed ALS is required where (1) the assembly area accommodates 50 or more persons or has an audio-amplification system and (2) it has fixed seats.) (If portable assistive-listening systems are used for conference or meeting rooms, the system may serve more than one room.)

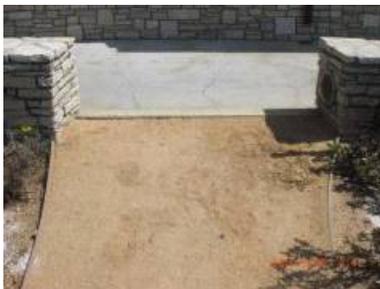
Keynote 59

Field Condition	
30.68 - Other - Parks - See Additional Comments	1991 ADAAG -
Existing Condition: 3/4" level change.	2004 ADAAG -
	2007 CBC -
	Other -

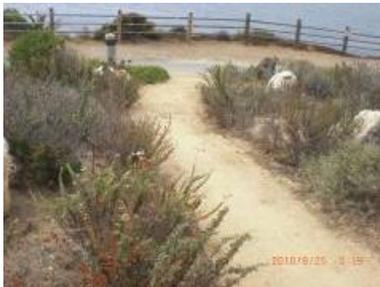
Keynote 67

Field Condition	
30.06A - Outdoor Recreation Access Route (ORAR) Segment - Running Slope - Running slope of access route segment in the direction of travel does not comply with the following: a. 5% or less for any distance. b. From 5.1% to 8.33% for 50' maximum. c. From 8.34% to 10% for 30' maximum.	1991 ADAAG -
Existing Condition: 7.1% to 12.2% RS.	2004 ADAAG -
	2007 CBC -
	Other 1999 ADAAG-16.3.7.2.1; 16.3.7.2.2; 16.3.7.2.3

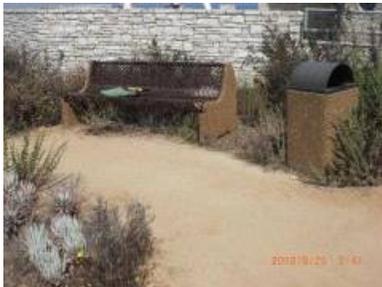
Keynote 71

Field Condition	
30.15 - Fixed Bench - Ground/Floor Surface - The surface around the accessible bench is not firm or stable.	1991 ADAAG -
Existing Condition:	2004 ADAAG -
	2007 CBC -
	Other 1999 ADAAG-16.12.6

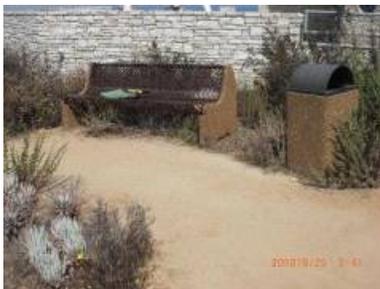
Keynote 73

Field Condition	30.17 - Fixed Bench - Surface Slope - Clear space has a slope greater than 2% in some or all directions.(1999 ADAAG: 3% slope is allowed when necessary for drainage).	1991 ADAAG 4.3.7
	Existing Condition:	2004 ADAAG 403.3
		2007 CBC -
		Other 1999 ADAAG-16.12.7

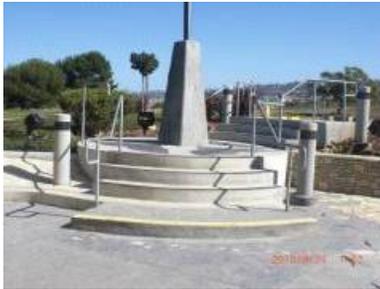
Keynote 76

08.09B - Handrail Extensions - Bottom Landing - At ends of handrails, less than 12" plus the tread width extends beyond the bottom nosing. (Top and bottom handrail extensions are important safety features for persons with balance problems and must extend in the direction of the stair run to permit the intended use.) (Per ADA/CBC Standards, in existing buildings and facilities, full extension of handrails at stairs shall not be required in alterations where such extensions would be hazardous or impossible due to plan configuration.)

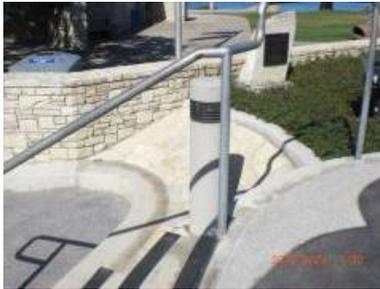
Keynote 77

Field Condition	
08.09A - Handrail Extensions - Top Landing - At ends of handrails, less than 12" of handrail extends beyond the top nosing. (Top and bottom handrail extensions are important safety features for persons with balance problems and must extend in the direction of the stair run to permit the intended use.) (Per ADA/CBC Standards, in existing buildings and facilities, full extension of handrails at stairs shall not be required in alterations where such extensions would be hazardous or impossible due to plan configuration.)	1991 ADAAG 4.9.4(2) 2004 ADAAG 505.10; 505.10.2; Fig. 505.10.2 2007 CBC 1133B.4.2.2 Other -
Existing Condition: 6" top extensions.

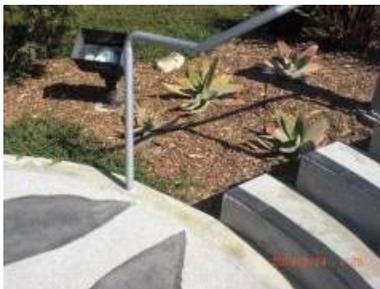
Keynote 78

Field Condition	
08.09D - Handrail Extension - Sloping versus Bottom Landing - At the bottom, the handrail extension does not continue to slope for a distance of the width of one tread from the bottom riser. OR The remainder of the extension is not horizontal.	1991 ADAAG 4.9.4(2) 2004 ADAAG 505.10.3 2007 CBC 1133B.4.2.2 Other -
Existing Condition:

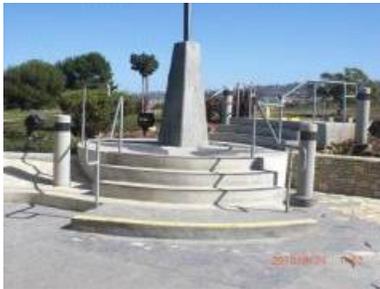
Keynote 80

Field Condition	
08.02B - Riser Height - The risers are not uniform. OR The risers are not between 4" and 7" in height.	1991 ADAAG 4.9.2
Existing Condition: Risers not uniform, 6" to 7 3/8".	2004 ADAAG 504.2
	2007 CBC 1009.3; 1133B.4.5.3
	Other -

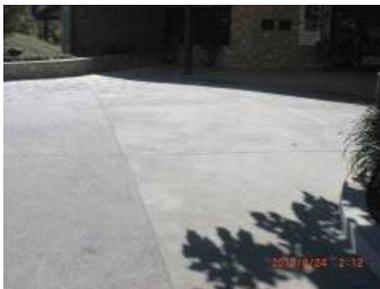
Keynote 82

Field Condition	
03B.09 - Cross Slope - Cross slope of the accessible route of travel exceeds 1:50.	1991 ADAAG 4.3.7
Existing Condition: 2.1% to 6.7% CS.	2004 ADAAG 403.3
	2007 CBC 1133B.7.1.3
	Other -

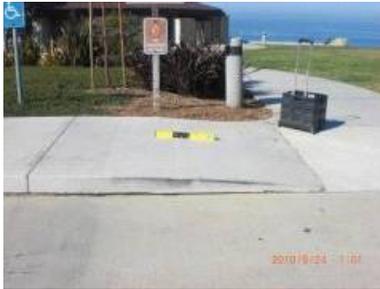
Keynote 83

Field Condition									
03B.09 - Cross Slope - Cross slope of the accessible route of travel exceeds 1:50. Existing Condition: 3.9%.

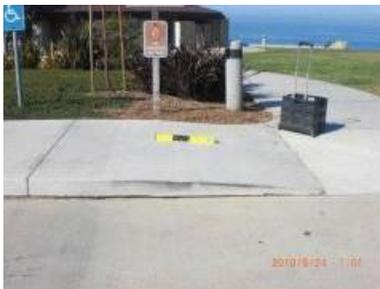
Keynote 84

Field Condition									
03B.10 - Running Slope - Slope of the accessible route of travel exceeds 1:20. Existing Condition: 9.2%.

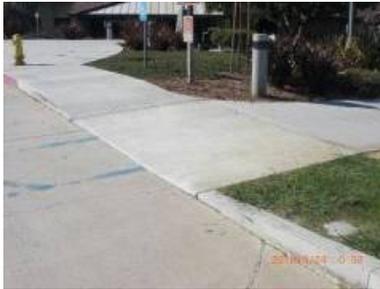
Keynote 85

Field Condition	
03B.19B - Directional Signs - Directional signs, utilizing the ISA and visible to persons along approaching circulation paths, are not provided at junctions where the accessible route of travel diverges from the regular circulation path.	1991 ADAAG 4.1.2(7)
Existing Condition: ISA sign has no arrow to direct people to accessible POT.	2004 ADAAG 216.3; Advisory 216.3; 703.5
	2007 CBC 1127B.3
	Other -

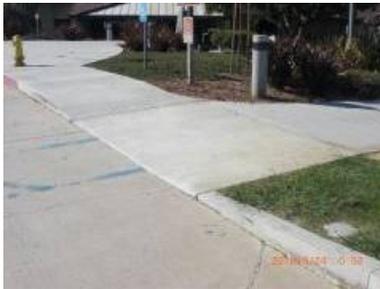
Keynote 86

Field Condition	
04.09A - Grooved Border Requirement - Curb ramp does not have a 12" wide grooved border around upper edges of curb ramp and flares to indicate transition from sidewalk to curb ramp.	1991 ADAAG -
Existing Condition:	2004 ADAAG -
	2007 CBC 1127B.5 item 6
	Other -

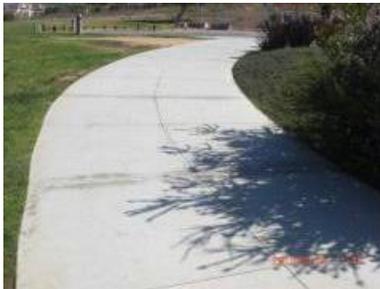
Keynote 88

Field Condition	
07.08 - Top Landing - Size - Top landing is less than 60" x 60".	1991 ADAAG 4.8.4(1)
Existing Condition: No top landing.	2004 ADAAG 405.7.4
	2007 CBC 1133B.5.4.2
	Other -

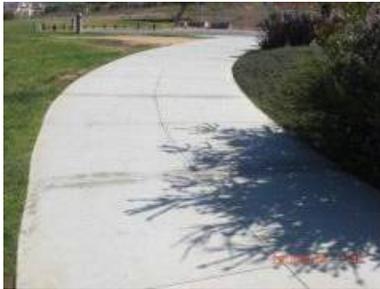
Keynote 89

Field Condition	
07.07A - Level Landings - Landings at the top or bottom of each ramp or each ramp run is not level (slope is greater than 2% in some or all directions).	1991 ADAAG 4.8.4
Existing Condition: 5.7% RS at bottom landing.	2004 ADAAG 405.7; 405.7.1
	2007 CBC 1133B.5.4.1
	Other -

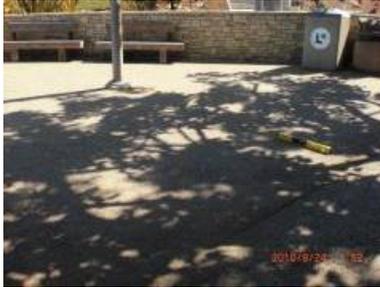
Keynote 91

Field Condition	
03B.09 - Cross Slope - Cross slope of the accessible route of travel exceeds 1:50. Existing Condition: 2.3% to 4.5% CS.	1991 ADAAG 4.3.7 2004 ADAAG 403.3 2007 CBC 1133B.7.1.3 Other -

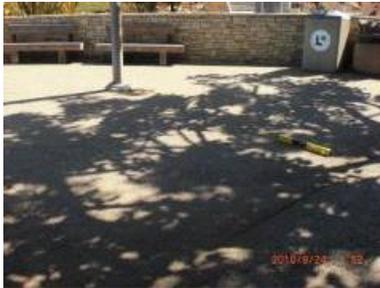
Keynote 93

Field Condition	
03B.22 - Other - On-Site Accessible Path of Travel - See Additional Comments	1991 ADAAG -
Existing Condition: 1" gap.	2004 ADAAG -
	2007 CBC -
	Other -

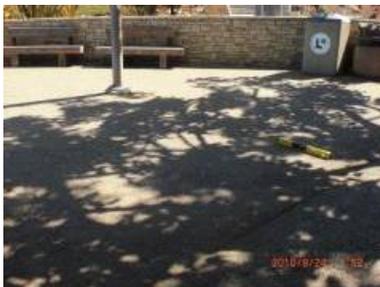
Keynote 94

Field Condition	
03B.22 - Other - On-Site Accessible Path of Travel - See Additional Comments	1991 ADAAG -
Existing Condition: 1" gap at two locations.	2004 ADAAG -
	2007 CBC -
	Other -

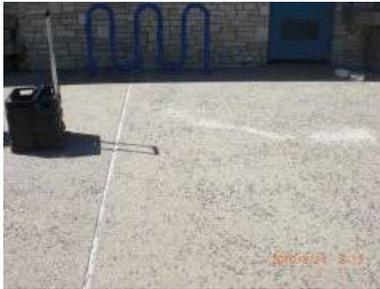
Keynote 95

Field Condition	
03B.12 - > 1/4" Changes in Level - Where walkway levels change abruptly, the vertical difference between them exceeds 1/4 inch. Or changes in level between 1/4 inch and 1/2 inch are beveled with a slope greater than 1:2.	1991 ADAAG 4.5.2
Existing Condition:	2004 ADAAG 303.2; 303.3
	2007 CBC 1124B.2
	Other -

Classification	
DOJ Location Type:	1
Use:	PV
Severity:	C
Level of Difficulty	Moderate

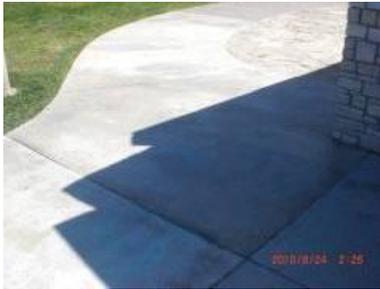
Keynote 97

Field Condition	
03B.09 - Cross Slope - Cross slope of the accessible route of travel exceeds 1:50. Existing Condition: 2.3% to 3.7% CS.	1991 ADAAG 4.3.7 2004 ADAAG 403.3 2007 CBC 1133B.7.1.3 Other -

Classification	
DOJ Location Type:	1
Use:	PV
Severity:	C
Level of Difficulty	High

Corrective Action	
006 - Concrete Walk - Remove non-compliant pavement and replace with new concrete (area as shown on the drawings). The walkway slope shall not exceed 5% along the POT and cross slope shall not exceed 2%.	
Additional Comments:

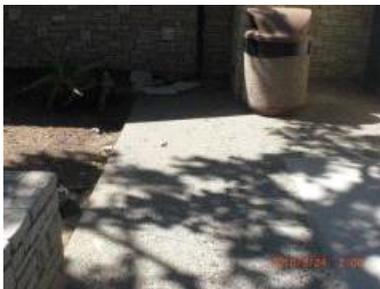
Keynote 98

Field Condition	
03B.09 - Cross Slope - Cross slope of the accessible route of travel exceeds 1:50. Existing Condition: 2.5%.	1991 ADAAG 4.3.7 2004 ADAAG 403.3 2007 CBC 1133B.7.1.3 Other -

Classification	
DOJ Location Type:	1
Use:	PV
Severity:	C
Level of Difficulty	High

Corrective Action	
006 - Concrete Walk - Remove non-compliant pavement and replace with new concrete (area as shown on the drawings). The walkway slope shall not exceed 5% along the POT and cross slope shall not exceed 2%.	
Additional Comments:

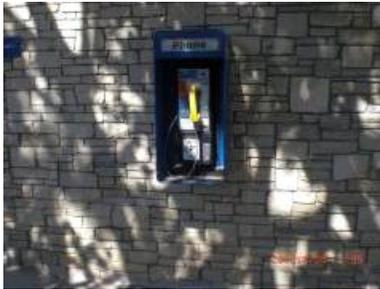
Location: Entry Plaza
Photo # 99

Field Condition	
06.02B - ISA Sign - The wheelchair accessible telephone is not identified by the ISA.	1991 ADAAG 4.1.3(17)(b); 4.30.7(1)
Existing Condition:	2004 ADAAG 703.2.1; Fig. 703.2.1
	2007 CBC 1117B.5.8.1
	Other -

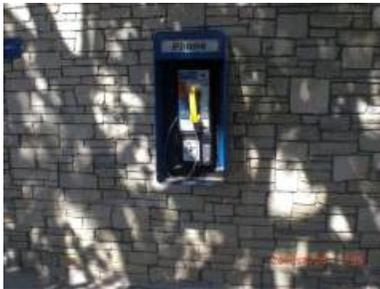
Keynote 100

Field Condition	
06.08 - Wall-Mounted Protruding Objects - Wall-mounted telephone(s) with leading edges between 27" and 80" from the floor projects more than 4" into the circulation path. (Wall mounted telephones or their enclosures with leading edges at or below 27" may project any amount as long as the required clear width of an accessible route is not reduced.)	1991 ADAAG 4.31.4; 4.4.1
Existing Condition: Telephone protrudes 12 1/2" at 30" high.	2004 ADAAG 204; 307.2; Advisory 307.2; Fig. 307.2
	2007 CBC 1133B.8.6.1
	Other -

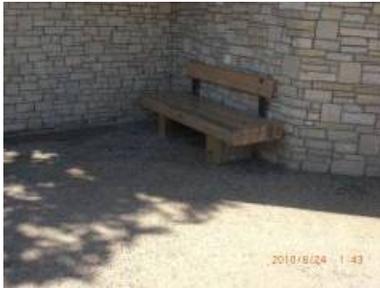
Keynote 101

Field Condition	
30.21 - Fixed Bench Size - Accessible bench does not have seats that are 20" to 24" in depth and 42" min. in length. OR The back support does not extend from a point 2" maximum above the bench to 18" min. above the bench.	1991 ADAAG -
Existing Condition: Back support extends 14" from seat, 7 1/2" above bench.	2004 ADAAG 903.3 903.4 903.4 Fig.
	2007 CBC -
	Other -

Classification	
DOJ Location Type:	1
Use:	PV
Severity:	C
Level of Difficulty	Low to Moderate

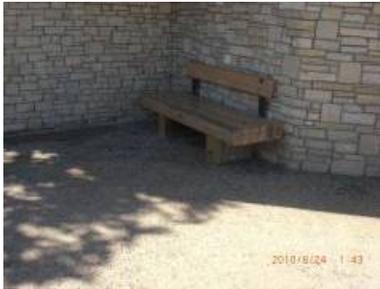
Keynote 102

Field Condition	
30.22 - Fixed Bench Armrest - Less than 50% of the fixed benches required to be accessible have at least one armrest that can withstand 250 lbs. of force in any direction.	1991 ADAAG 4.26.3
Existing Condition:	2004 ADAAG 903.6
	2007 CBC 1115B.7.2
	Other 1999 ADAAG-16.12.2.2; 16.12.8

Classification	
DOJ Location Type:	1
Use:	PV
Severity:	C
Level of Difficulty	Moderate

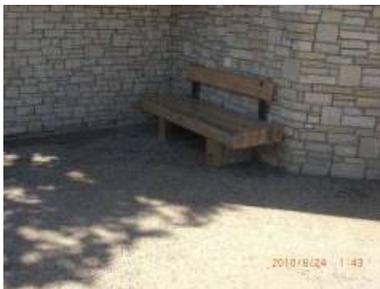
Keynote 103

Field Condition	
30.20 - Fixed Bench - Back Support - Back support is not provided along the full length of the accessible bench.	1991 ADAAG -
Existing Condition: Back support does not run the full length of the bench.	2004 ADAAG 903.4
	2007 CBC -
	Other 1999 ADAAG-16.12.5

Classification	
DOJ Location Type:	1
Use:	PV
Severity:	C
Level of Difficulty	Moderate

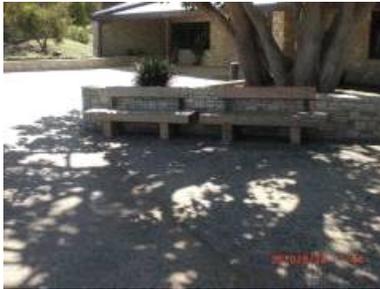
Location: Entry Plaza Photo # 106

Field Condition	
30.16 - Fixed Bench / Wheelchair Seating Space - Shoulder Alignment - A clear space at least 30" x 48" in size has not been provided at one end of the fixed bench so that a wheelchair user may be seated shoulder-to-shoulder with an individual seated on the bench.	1991 ADAAG -
Existing Condition:	2004 ADAAG -
	2007 CBC -
	Other 1999 ADAAG-16.12.4

Classification	
DOJ Location Type:	1
Use:	PV
Severity:	C
Level of Difficulty	Moderate

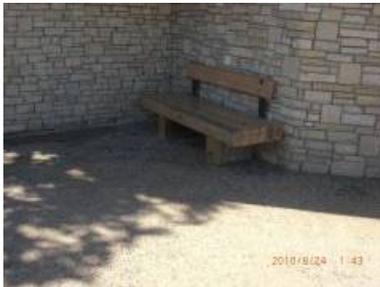
Keynote 107

Field Condition	
30.17 - Fixed Bench - Surface Slope - Clear space has a slope greater than 2% in some or all directions.(1999 ADAAG: 3% slope is allowed when necessary for drainage).	1991 ADAAG 4.3.7
Existing Condition: 2.4%.	2004 ADAAG 403.3
	2007 CBC -
	Other 1999 ADAAG-16.12.7

Classification	
DOJ Location Type:	1
Use:	PV
Severity:	C
Level of Difficulty	High

Corrective Action
006 - Concrete Walk - Remove non-compliant pavement and replace with new concrete (area as shown on the drawings). The walkway slope shall not exceed 5% along the POT and cross slope shall not exceed 2%.
Additional Comments:

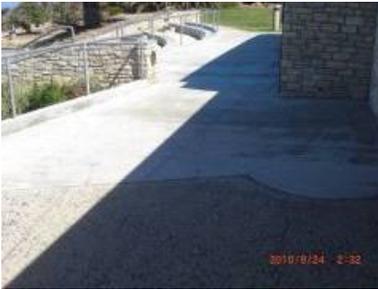
Keynote 108

Field Condition	
03B.09 - Cross Slope - Cross slope of the accessible route of travel exceeds 1:50.	1991 ADAAG 4.3.7
Existing Condition: 3.9% to 6.9% CS.	2004 ADAAG 403.3
	2007 CBC 1133B.7.1.3
	Other -

Classification	
DOJ Location Type:	1
Use:	PV
Severity:	C
Level of Difficulty	High

Corrective Action	
006 - Concrete Walk - Remove non-compliant pavement and replace with new concrete (area as shown on the drawings). The walkway slope shall not exceed 5% along the POT and cross slope shall not exceed 2%.	
Additional Comments:

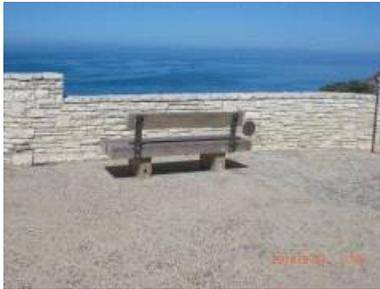
Keynote 109

30.21 - Fixed Bench Size - Accessible bench does not have seats that are 20" to 24" in depth and 42" min. in length. OR The back support does not extend from a point 2" maximum above the bench to 18" min. above the bench.

Existing Condition: Back support extends 14" from seat, 7 1/2" above bench.

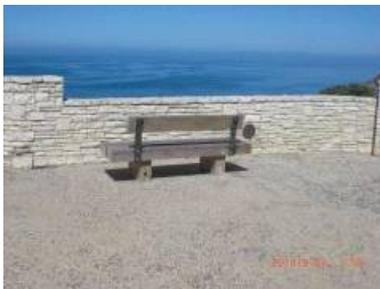
Keynote 111

Field Condition	
30.20 - Fixed Bench - Back Support - Back support is not provided along the full length of the accessible bench.	1991 ADAAG -
Existing Condition: Back support does not extend the full length of the bench.	2004 ADAAG 903.4
	2007 CBC -
	Other 1999 ADAAG-16.12.5

Classification	
DOJ Location Type:	1
Use:	PV
Severity:	C
Level of Difficulty	Moderate

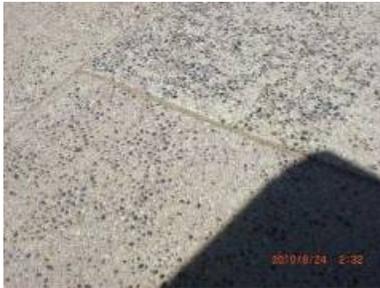
Location: Terrace Photo # 114

Field Condition	
03B.12 -> 1/4" Changes in Level - Where walkway levels change abruptly, the vertical difference between them exceeds 1/4 inch. Or changes in level between 1/4 inch and 1/2 inch are beveled with a slope greater than 1:2.	1991 ADAAG 4.5.2
Existing Condition: 1/2" level change	2004 ADAAG 303.2; 303.3
	2007 CBC 1124B.2
	Other -

Classification	
DOJ Location Type:	1
Use:	PV
Severity:	C
Level of Difficulty	Moderate

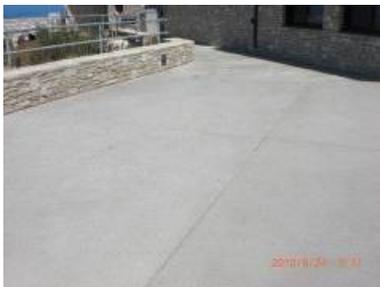
Keynote 115

Field Condition	
03B.09 - Cross Slope - Cross slope of the accessible route of travel exceeds 1:50.	1991 ADAAG 4.3.7
Existing Condition: 2.4% to 6.1% CS at seven locations.	2004 ADAAG 403.3
	2007 CBC 1133B.7.1.3
	Other -

Classification	
DOJ Location Type:	1
Use:	PV
Severity:	C
Level of Difficulty	High

Corrective Action
006 - Concrete Walk - Remove non-compliant pavement and replace with new concrete (area as shown on the drawings). The walkway slope shall not exceed 5% along the POT and cross slope shall not exceed 2%.
Additional Comments:

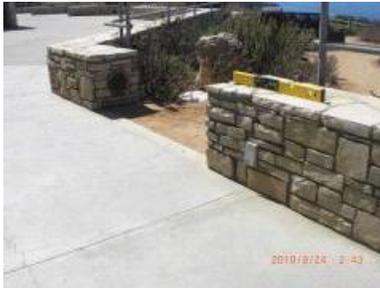
Location: Terrace **Photo #** 116

Field Condition	
14.34 - Electrical/Communications Receptacles - Mounting Height - Electrical/communications receptacle is not located between 15" min.. and 48" max.. AFF. Existing Condition: 8" high receptacle.	1991 ADAAG 4.1.3(13); 4.27.3; 4.2.5; 4.2.6 ; Fig. 5; Fig. 6 2004 ADAAG 308.2.1; Fig. 308.2.1; 308.3.1; Fig. 308.3.1; 309.3 2007 CBC 1117B.6(5.2) Other -

Classification	
DOJ Location Type:	1
Use:	PV
Severity:	C
Level of Difficulty	Low to Moderate

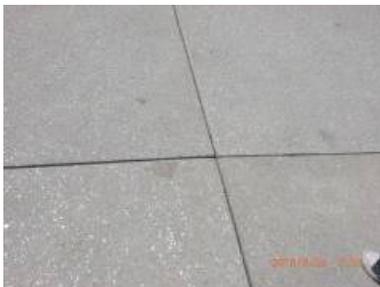
Keynote 117

Field Condition	
03B.22 - Other - On-Site Accessible Path of Travel - See Additional Comments Existing Condition: 1/2" to 3/4" gap between concrete slabs.	1991 ADAAG - 2004 ADAAG - 2007 CBC - Other -

Classification	
DOJ Location Type:	1
Use:	PV
Severity:	C
Level of Difficulty	Moderate

Corrective Action	
005B - Concrete Crack Repair - Clean-out existing concrete crack and inject with epoxy grout. Cracks over 1/4" in width will require a foam backer rod and sealant. Additional Comments:

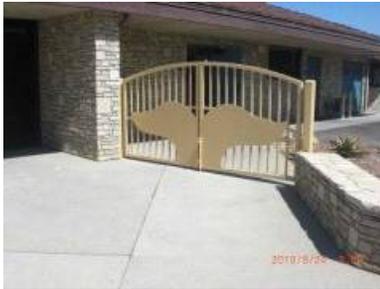
Location: Terrace
Photo # 118

Field Condition	
10.08 - Kick Plate - Bottom 10" of door does not have a smooth, uninterrupted surface on the push side to allow the door to be opened by a wheelchair footrest without creating a trap or hazardous condition. (This requirement does not apply to automatic and sliding doors.)	1991 ADAAG -
Existing Condition: None provided.	2004 ADAAG 404.2.10
	2007 CBC 1133B.2.6
	Other -

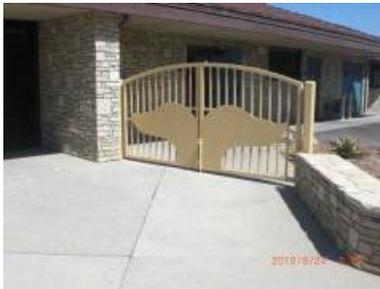
Keynote 119

Field Condition	
11.12 - Hardware Mounting Height - Mounting height of all operating hardware is not 30" min.. or 44" max., as measured to the highest operable part. (1994 ADA Standards permit a max.. height of 48"; CBC Standards permit a range of 30" min.. to 44" max..)	1991 ADAAG 4.13.9
Existing Condition: 61" to gate hardware.	2004 ADAAG -
	2007 CBC 1133B.2.5.2
	Other -

Corrective Action
067B - Lever Hardware - Replace door hardware with lever-type handset.
Additional Comments: Replace hardware & mount at 44" max.

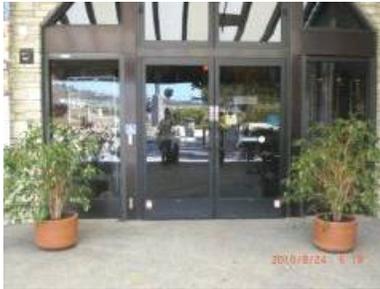
Location: Lobby **Photo #** 120

Field Condition									
10.09B - Threshold - Height - The threshold at doorway exceeds 1/2" in height. Existing Condition: Compound threshold.

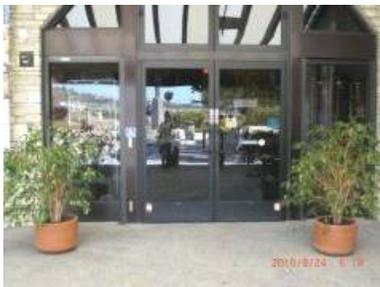
Keynote 121

Field Condition									
10.11A - Door Operating Effort - The force required to operate door exceeds 5 lbs. (Fire doors may have up to 15 lbs to achieve positive latching). Existing Condition: 8 LBF. at non-motorized door.

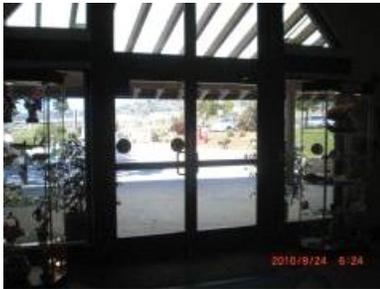
Location: Lobby Photo # 122

Field Condition	
10.13A - Required Exit Door Sign - At grade level exterior exit door, there is no tactile and CA Braille exit sign with the word "EXIT" mounted on the wall adjacent to the latch side of the door.	1991 ADAAG 4.1.3(16); 4.30.1
Existing Condition:	2004 ADAAG 216.4; 703.2; 703.3; 703.4
	2007 CBC 1011.3 item 1
	Other -

Classification	
DOJ Location Type:	4
Use:	PV
Severity:	C
Level of Difficulty	Low to Moderate

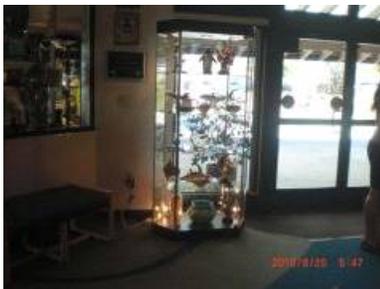
Keynote 123

Field Condition	
14.35 - Controls - Operation - The controls are not accessible. (Accessible controls shall be operable with one hand, and without tight grasping, pinching, or twisting of the wrist, and the force to operate the controls shall be no greater than 5 lbs.)	1991 ADAAG 4.27.4
Existing Condition: No single action hardware at display cabinets.	2004 ADAAG 309.4
	2007 CBC 1117B.6(4)
	Other -

Classification	
DOJ Location Type:	2
Use:	PV
Severity:	C
Level of Difficulty	Low to Moderate

Corrective Action	
031A - Modify Control - Modify control. Repair/refinish as required.	
Additional Comments:

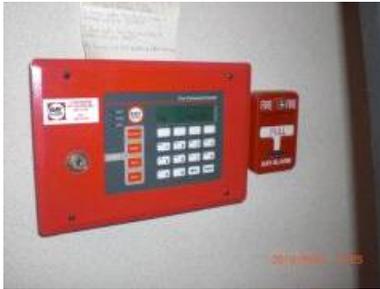
Location: Lobby **Photo #** 124

Field Condition	20.15 - Alarm Initiating Devices - Operation - Operating hardware of the pull station is not accessible (i.e.: it requires tight grasping, pinching, or twisting of the wrist, or requires a force exceeding 5 lbs.)	1991 ADAAG	4.27.4
	Existing Condition:	2004 ADAAG	309.4
		2007 CBC	907.3.2, 1117B.6(4)
		Other	-

Classification	
DOJ Location Type:	4
Use:	PV
Severity:	C
Level of Difficulty	Moderate

Corrective Action	373 - Replace Fire Alarm Pull Station - Replace existing fire alarm pull station with compliant model in existing location.
Additional Comments:

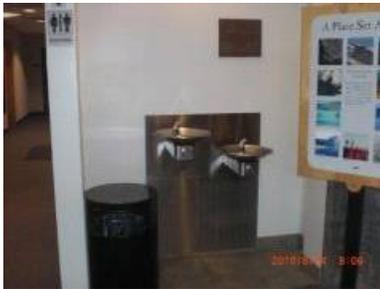
Keynote 125

Field Condition	05.05A - Knee Space Height - Drinking fountain provides less than 27" high accessible knee clearance between the bottom of the apron and the floor.	1991 ADAAG	4.15.5(1); Figs. 27(a) and (b)
	Existing Condition: 26 3/4" high.	2004 ADAAG	306.3; Fig. 306.3
		2007 CBC	1115B.4.6 item 2
		Other	-

Classification	
DOJ Location Type:	4
Use:	PV
Severity:	C
Level of Difficulty	High

Corrective Action	277B - Replace Drinking Fountain - Replace existing drinking fountain with high-low fixture.
Additional Comments:

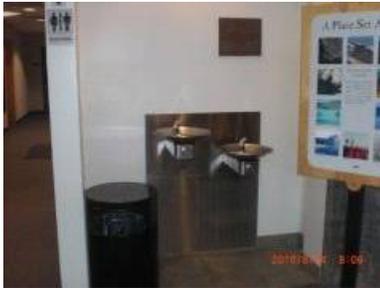
Location: Lobby
Photo # 125

Field Condition	
05.11 - Water Flow - Round or Oval Bowl - For a fountain with a round or oval bowl, the water flow is not within 3" of the fountain's front edge.	1991 ADAAG 4.15.3
Existing Condition: 4" from front edge.	2004 ADAAG -
	2007 CBC 1115B.4.6 item 5
	Other -

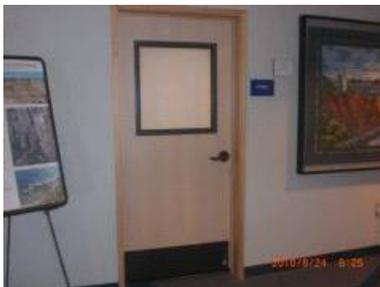
Location: Studio
Photo # 127

Field Condition	
11.15A - Kick Plate - Bottom 10" of door does not have a smooth, uninterrupted surface on the push side to allow the door to be opened by a wheelchair footrest without creating a trap or hazardous condition. (This requirement does not apply to automatic and sliding doors.)	1991 ADAAG -
Existing Condition: Door stop.	2004 ADAAG 404.2.10
	2007 CBC 1133B.2.6
	Other -

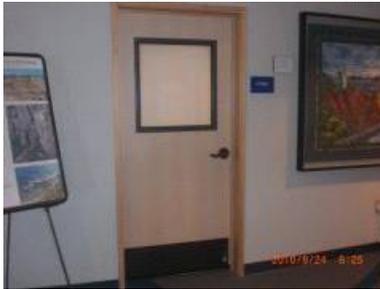
Location: Studio **Photo #** 127

11.15B_04AG - Vision Lights - Door, gate, or adjacent sidelight, containing one or more vision lights, does not include at least one vision light mounted with the bottom edge of the glazed panel at 43" max.. AFF. (Exception: Vision lights with the lowest part more than 66" AFF.)

Existing Condition: 47 1/2" high.

054A - Replace Door - Remove existing door and replace with new door and door frame. Provide new accessible door hardware.

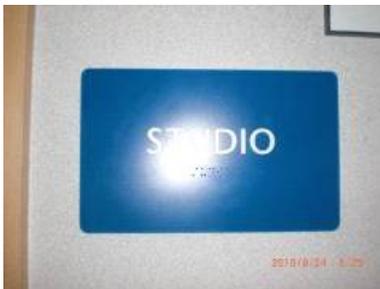
Keynote 129

11.25A - Raised Characters and Braille (Visual/Tactile Signs) - The raised characters on this sign are not accompanied by California Grade 2 Braille (California Grade 2 Braille requires the dots within each cell to be domed and spaced 1/10" o.c.)

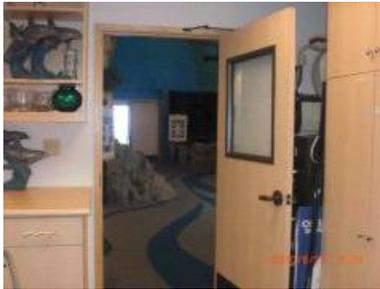
Keynote 130

11.06A - Door Maneuvering Space - Door that is not automatic or power-assisted does not have compliant maneuvering space relative to the direction of approach as shown in CBC Fig. 11B-26. (Approach // Side // Width // Depth) (Front // Pull // D + 24" * // 60") (Front // Push // D + 0" ** // 48") (Latch // Pull // D + 24" // 60") (Latch // Push // D + 24" // 44" ****) (Hinge // Pull // D + 36" // 60") (Hinge // Push // 54" **** // 44" *****) (* D + 18" at interior doors.) (** D + 12" if door has both a latch and a closer.) (*** 48" if door has closer.) (**** Measured from latch toward hinge.) (***** 48" if door has both a latch and a closer.)

Existing Condition: 2" strike clearance due to fixed counter.

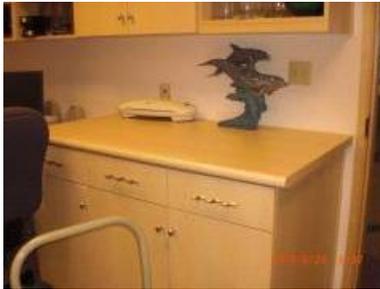
Keynote 131

Field Condition	
14.35 - Controls - Operation - The controls are not accessible. (Accessible controls shall be operable with one hand, and without tight grasping, pinching, or twisting of the wrist, and the force to operate the controls shall be no greater than 5 lbs.)	1991 ADAAG 4.27.4
Existing Condition: Non-single action cabinet hardware.	2004 ADAAG 309.4
	2007 CBC 1117B.6(4)
	Other -

Classification	
DOJ Location Type:	2
Use:	EW
Severity:	C
Level of Difficulty	Moderate

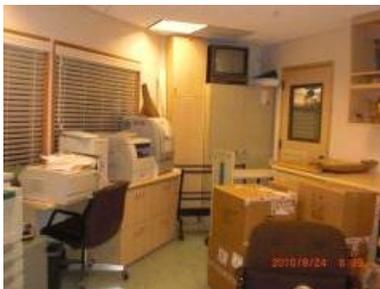
Keynote 132

Field Condition	
20.04 - Common Use Areas - Visual Alarms - Visual alarms are not provided in common use area(s) of the building such as meeting and conference rooms, open office space, classrooms, cafeterias, filing and photocopy rooms, employee break rooms, dressing, examination, and treatment rooms, and similar spaces that are not used solely as employee work areas.	1991 ADAAG 4.28.1
Existing Condition:	2004 ADAAG 215.2; 702.1
	2007 CBC 907.9.1.1
	Other -

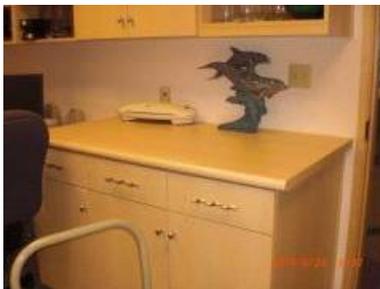
Keynote 134

Field Condition									
14.32B - Forward Reach Range over Obstruction - Controls - Controls, dispensers, and similar devices over an obstruction are mounted higher than 44" AFF when the clear floor space allows only a forward approach and the horizontal reach limit is between 20" to 25". (Mounting height of 48" max.. AFF is permitted when the horizontal reach is less than 20".) Existing Condition: 46 3/4" high light switch over 31" deep counter.

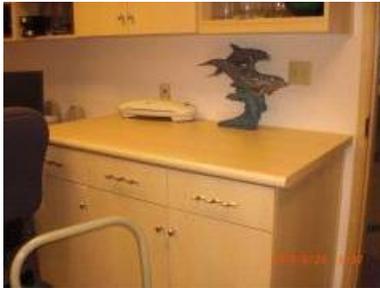
Keynote 135

14.32B - Forward Reach Range over Obstruction - Controls - Controls, dispensers, and similar devices over an obstruction are mounted higher than 44" AFF when the clear floor space allows only a forward approach and the horizontal reach limit is between 20" to 25". (Mounting height of 48" max.. AFF is permitted when the horizontal reach is less than 20".)

Existing Condition: Data outlet 42 3/4" high over 31" deep counter.

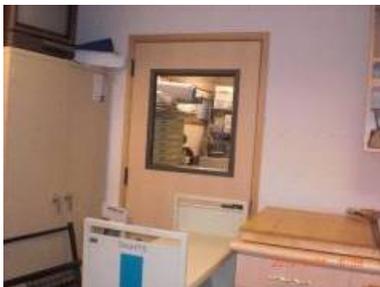
Keynote 136

11.17A - Recommendation: Providing Room/Space ID Sign - A sign designating the permanent room or space has not been provided.

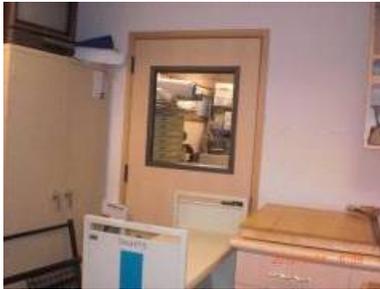
Keynote 137

Existing Condition: 47 1/2" high.

054A - Replace Door - Remove existing door and replace with new door and door frame. Provide new accessible door hardware.

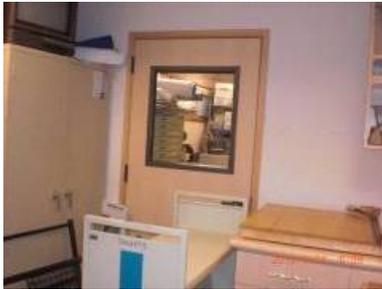
Keynote 138

11.06A - Door Maneuvering Space - Door that is not automatic or power-assisted does not have compliant maneuvering space relative to the direction of approach as shown in CBC Fig. 11B-26. (Approach // Side // Width // Depth) (Front // Pull // D + 24" * // 60") (Front // Push // D + 0" ** // 48") (Latch // Pull // D + 24" // 60") (Latch // Push // D + 24" // 44" ***) (Hinge // Pull // D + 36" // 60") (Hinge // Push // 54" **** // 44" *****) (* D + 18" at interior doors.) (** D + 12" if door has both a latch and a closer.) (***) 48" if door has closer.) (**** Measured from latch toward hinge.) (***** 48" if door has both a latch and a closer.)

Existing Condition: No strike side clearance due to counter.

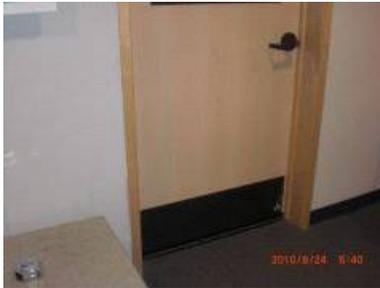
Keynote 139

Field Condition	
11.15A - Kick Plate - Bottom 10" of door does not have a smooth, uninterrupted surface on the push side to allow the door to be opened by a wheelchair footrest without creating a trap or hazardous condition. (This requirement does not apply to automatic and sliding doors.)	1991 ADAAG -
Existing Condition: Door stop.	2004 ADAAG 404.2.10
	2007 CBC 1133B.2.6
	Other -

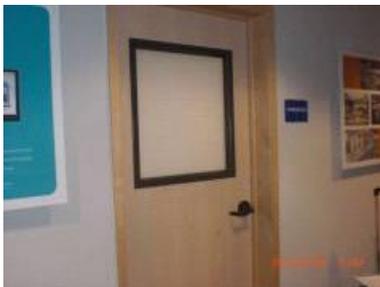
Keynote 140

Field Condition	
11.15B_04AG - Vision Lights - Door, gate, or adjacent sidelight, containing one or more vision lights, does not include at least one vision light mounted with the bottom edge of the glazed panel at 43" max.. AFF. (Exception: Vision lights with the lowest part more than 66" AFF.)	1991 ADAAG -
Existing Condition: 47 1/2" high.	2004 ADAAG 404.2.11
	2007 CBC -
	Other -

Corrective Action
054A - Replace Door - Remove existing door and replace with new door and door frame. Provide new accessible door hardware.
Additional Comments:

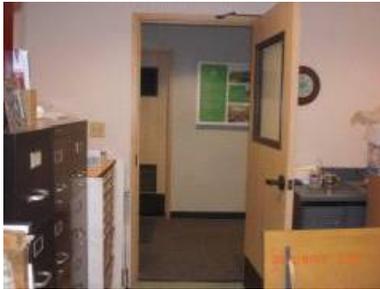
Keynote 142

11.06A - Door Maneuvering Space - Door that is not automatic or power-assisted does not have compliant maneuvering space relative to the direction of approach as shown in CBC Fig. 11B-26. (Approach // Side // Width // Depth) (Front // Pull // D + 24" * // 60") (Front // Push // D + 0" ** // 48") (Latch // Pull // D + 24" // 60") (Latch // Push // D + 24" // 44" ***) (Hinge // Pull // D + 36" // 60") (Hinge // Push // 54" **** // 44" *****) (* D + 18" at interior doors.) (** D + 12" if door has both a latch and a closer.) (***) 48" if door has closer.) (**** Measured from latch toward hinge.) (***** 48" if door has both a latch and a closer.)

Existing Condition: Non-fixed furniture obstructs door strike clearance.

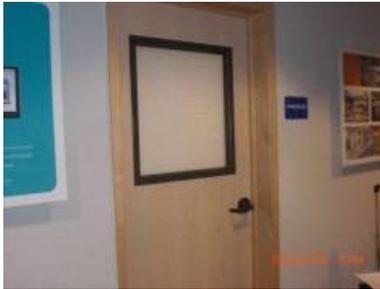
Keynote 143

Field Condition	
11.13A - Door Operating Effort - The force required to operate door exceeds 5 lbs. (Fire doors may have up to 15 lbs to achieve positive latching).	1991 ADAAG 4.13.11
Existing Condition: 9 LBF.	2004 ADAAG 404.2.9
	2007 CBC 1133B.2.5
	Other -

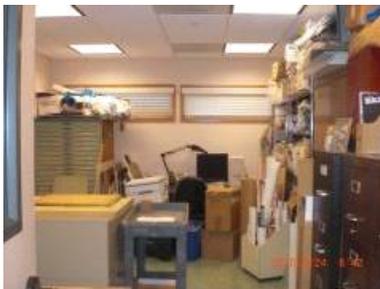
Keynote 144

Field Condition	
20.04 - Common Use Areas - Visual Alarms - Visual alarms are not provided in common use area(s) of the building such as meeting and conference rooms, open office space, classrooms, cafeterias, filing and photocopy rooms, employee break rooms, dressing, examination, and treatment rooms, and similar spaces that are not used solely as employee work areas.	1991 ADAAG 4.28.1
Existing Condition:	2004 ADAAG 215.2; 702.1
	2007 CBC 907.9.1.1
	Other -

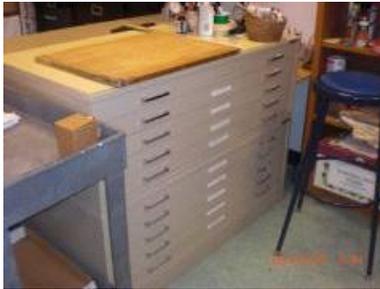
Keynote 145

Field Condition									
14.36A - Counter Height - Where provided in public or common use areas, countertops are not between 28" - 34" high. (Common use areas are those interior and exterior rooms, spaces, or elements that are made available for the use of a restricted group of people (for example, the occupants of an office building, or the guests of such occupants).

1991 ADAAG	4.32.4	2004 ADAAG	902.3	2007 CBC	1122B.4	Other	-
1991 ADAAG	4.32.4								
2004 ADAAG	902.3								
2007 CBC	1122B.4								
Other	-								
Existing Condition: 35" high counter.

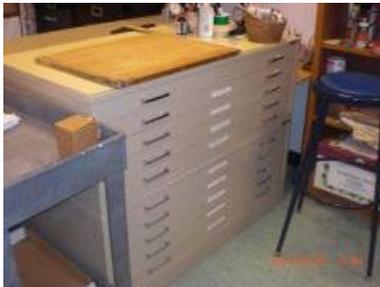
Keynote 146

Field Condition									
14.28 - Fixed/Built-in Seating, Tables or Counters - At fixed or built-in seating, tables, or counters in public or common employee areas, less than 5% of the provided seating spaces are wheelchair accessible and have a 30" by 48" clear space which overlaps an accessible route of travel. (Wheelchair accessible seating spaces are between 28" - 34" high and with knee space measuring at least 27" high, 30" wide, and 19" deep.) (These elements include study carrels and student laboratory stations.)

1991 ADAAG	4.1.3(18); 4.32.1; 4.32.4	2004 ADAAG	226.1; Advisory 226.1; 305; 306; 902.2	2007 CBC	1122B.1	Other	-
1991 ADAAG	4.1.3(18); 4.32.1; 4.32.4								
2004 ADAAG	226.1; Advisory 226.1; 305; 306; 902.2								
2007 CBC	1122B.1								
Other	-								
Existing Condition: No knee space.

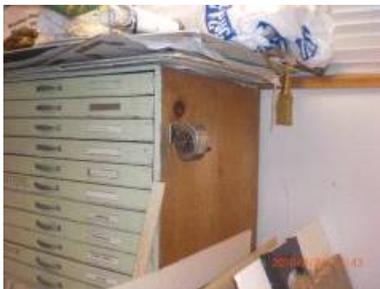
Keynote 148

14.35 - Controls - Operation - The controls are not accessible. (Accessible controls shall be operable with one hand, and without tight grasping, pinching, or twisting of the wrist, and the force to operate the controls shall be no greater than 5 lbs.)

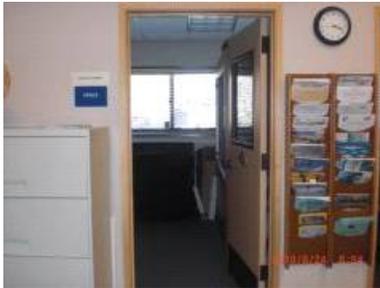
Keynote 149

Field Condition	
11.25A - Raised Characters and Braille (Visual/Tactile Signs) - The raised characters on this sign are not accompanied by California Grade 2 Braille (California Grade 2 Braille requires the dots within each cell to be domed and spaced 1/10" o.c.)	1991 ADAAG 4.30.4
Existing Condition:	2004 ADAAG 703.2; 703.3
	2007 CBC 1117B.5.5 item 1, 1117B.5.6
	Other -

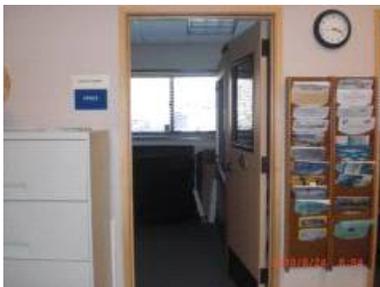
Keynote 150

Field Condition	
11.15B_04AG - Vision Lights - Door, gate, or adjacent sidelight, containing one or more vision lights, does not include at least one vision light mounted with the bottom edge of the glazed panel at 43" max.. AFF. (Exception: Vision lights with the lowest part more than 66" AFF.)	1991 ADAAG -
Existing Condition: 47 1/2" high.	2004 ADAAG 404.2.11
	2007 CBC -
	Other -

Corrective Action	
054A - Replace Door - Remove existing door and replace with new door and door frame. Provide new accessible door hardware.	
Additional Comments:

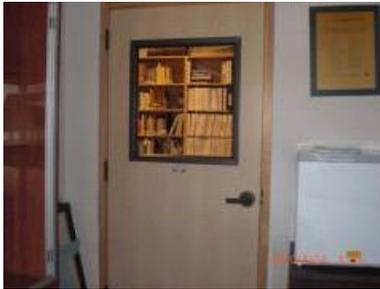
Keynote 151

11.06A - Door Maneuvering Space - Door that is not automatic or power-assisted does not have compliant maneuvering space relative to the direction of approach as shown in CBC Fig. 11B-26. (Approach // Side // Width // Depth) (Front // Pull // D + 24" * // 60") (Front // Push // D + 0" ** // 48") (Latch // Pull // D + 24" // 60") (Latch // Push // D + 24" // 44" ***) (Hinge // Pull // D + 36" // 60") (Hinge // Push // 54" **** // 44" *****) (* D + 18" at interior doors.) (** D + 12" if door has both a latch and a closer.) (***) 48" if door has closer.) (**** Measured from latch toward hinge.) (***** 48" if door has both a latch and a closer.)

Existing Condition: Non-fixed cabinets obstructs door strike clearance.

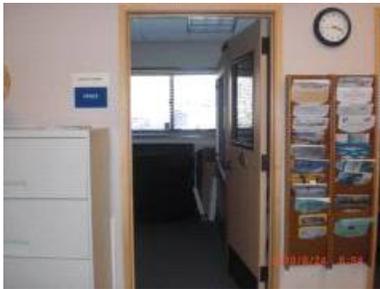
Keynote 153

Field Condition									
20.04 - Common Use Areas - Visual Alarms - Visual alarms are not provided in common use area(s) of the building such as meeting and conference rooms, open office space, classrooms, cafeterias, filing and photocopy rooms, employee break rooms, dressing, examination, and treatment rooms, and similar spaces that are not used solely as employee work areas.

1991 ADAAG	4.28.1	2004 ADAAG	215.2; 702.1	2007 CBC	907.9.1.1	Other	-
1991 ADAAG	4.28.1								
2004 ADAAG	215.2; 702.1								
2007 CBC	907.9.1.1								
Other	-								
Existing Condition:

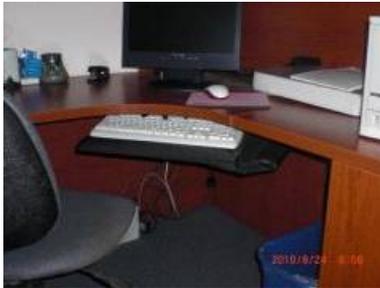
Keynote 154

Field Condition	
14.29A - Counter - Knee Space Height - Where seating for persons in wheelchairs is provided at table or counter, knee space is less than 27" high.	1991 ADAAG 4.32.3
Existing Condition: 23" to keyboard.	2004 ADAAG 306.3.1; Fig. 306.3
	2007 CBC 1122B.3; Fig. 11B-13
	Other -

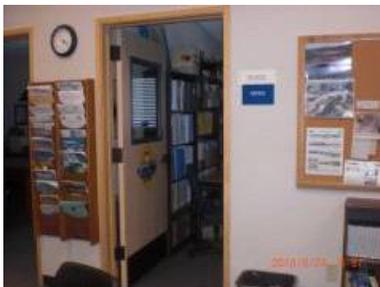
Keynote 155

Field Condition	
11.25A - Raised Characters and Braille (Visual/Tactile Signs) - The raised characters on this sign are not accompanied by California Grade 2 Braille (California Grade 2 Braille requires the dots within each cell to be domed and spaced 1/10" o.c.)	1991 ADAAG 4.30.4
Existing Condition:	2004 ADAAG 703.2; 703.3
	2007 CBC 1117B.5.5 item 1, 1117B.5.6
	Other -

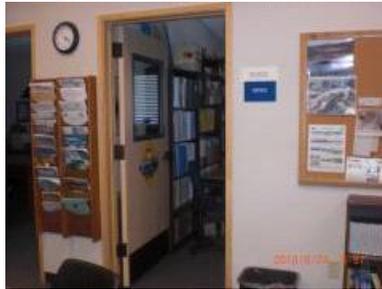
Keynote 156

11.15B_04AG - Vision Lights - Door, gate, or adjacent sidelight, containing one or more vision lights, does not include at least one vision light mounted with the bottom edge of the glazed panel at 43" max.. AFF. (Exception: Vision lights with the lowest part more than 66" AFF.)

Existing Condition: 47 1/2" high.

054A - Replace Door - Remove existing door and replace with new door and door frame. Provide new accessible door hardware.

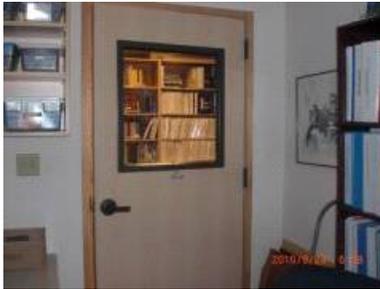
Keynote 157

11.06A - Door Maneuvering Space - Door that is not automatic or power-assisted does not have compliant maneuvering space relative to the direction of approach as shown in CBC Fig. 11B-26. (Approach // Side // Width // Depth) (Front // Pull // D + 24" * // 60") (Front // Push // D + 0" ** // 48") (Latch // Pull // D + 24" // 60") (Latch // Push // D + 24" // 44" ***) (Hinge // Pull // D + 36" // 60") (Hinge // Push // 54" **** // 44" *****) (* D + 18" at interior doors.) (** D + 12" if door has both a latch and a closer.) (***) 48" if door has closer.) (**** Measured from latch toward hinge.) (***** 48" if door has both a latch and a closer.)

Existing Condition: Non-fixed cabinet obstruct door strike clearance.

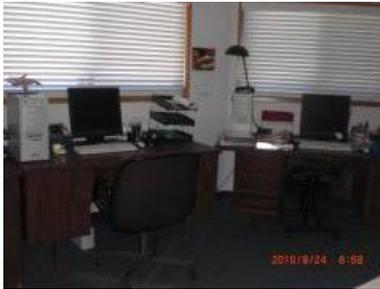
Keynote 158

Field Condition	
20.04 - Common Use Areas - Visual Alarms - Visual alarms are not provided in common use area(s) of the building such as meeting and conference rooms, open office space, classrooms, cafeterias, filing and photocopy rooms, employee break rooms, dressing, examination, and treatment rooms, and similar spaces that are not used solely as employee work areas.	1991 ADAAG 4.28.1 2004 ADAAG 215.2; 702.1 2007 CBC 907.9.1.1 Other -
Existing Condition:

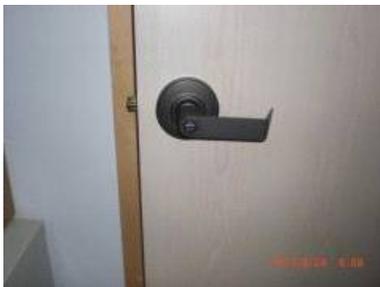
Keynote 159

Field Condition	
11.11 - Single-Action Hardware - Handles, locks, and latches or other operative devices are not operable with one hand and without tight grasping, pinching, or twisting of the wrist. (U-shaped handles, levers, and push/pull type mechanisms are acceptable designs.)	1991 ADAAG 4.13.9 2004 ADAAG 309.4; 404.2.7; Advisory 404.2.7 2007 CBC 1133B.2.5.2 Other -
Existing Condition: Twist type lock.

Corrective Action	
067B - Lever Hardware - Replace door hardware with lever-type handset.	
Additional Comments:

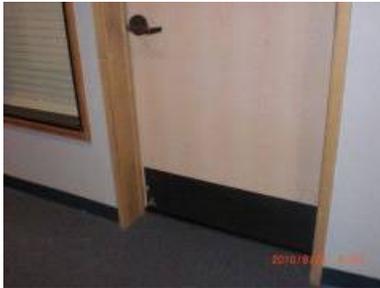
Keynote 160

Field Condition	
11.15A - Kick Plate - Bottom 10" of door does not have a smooth, uninterrupted surface on the push side to allow the door to be opened by a wheelchair footrest without creating a trap or hazardous condition. (This requirement does not apply to automatic and sliding doors.)	1991 ADAAG -
Existing Condition: Door stop.	2004 ADAAG 404.2.10
	2007 CBC 1133B.2.6
	Other -

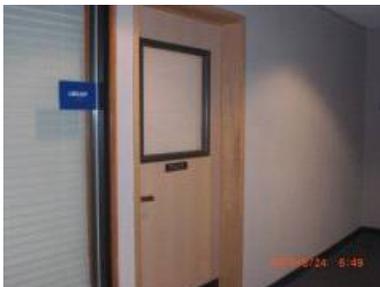
Keynote 161

Field Condition	
11.15B_04AG - Vision Lights - Door, gate, or adjacent sidelight, containing one or more vision lights, does not include at least one vision light mounted with the bottom edge of the glazed panel at 43" max.. AFF. (Exception: Vision lights with the lowest part more than 66" AFF.)	1991 ADAAG -
Existing Condition: 47 1/2" high.	2004 ADAAG 404.2.11
	2007 CBC -
	Other -

Corrective Action
054A - Replace Door - Remove existing door and replace with new door and door frame. Provide new accessible door hardware.
Additional Comments:

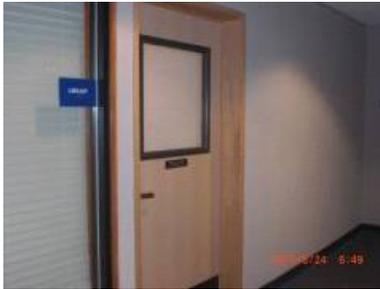
Keynote 162

Field Condition	
11.25A - Raised Characters and Braille (Visual/Tactile Signs) - The raised characters on this sign are not accompanied by California Grade 2 Braille (California Grade 2 Braille requires the dots within each cell to be domed and spaced 1/10" o.c.)	1991 ADAAG 4.30.4
Existing Condition:	2004 ADAAG 703.2; 703.3
	2007 CBC 1117B.5.5 item 1, 1117B.5.6
	Other -

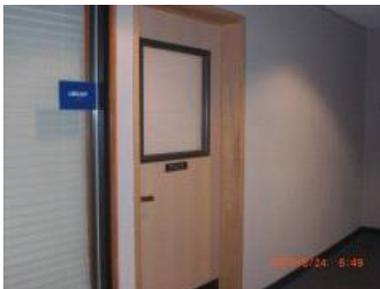
Keynote 163

Field Condition	
11.13A - Door Operating Effort - The force required to operate door exceeds 5 lbs. (Fire doors may have up to 15 lbs to achieve positive latching).	1991 ADAAG 4.13.11
Existing Condition: 9 LBF.	2004 ADAAG 404.2.9
	2007 CBC 1133B.2.5
	Other -

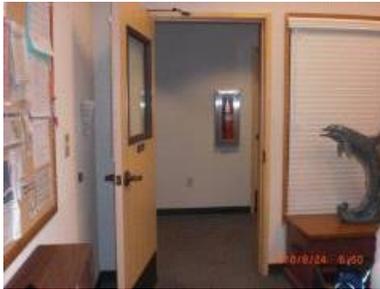
Keynote 164

11.06A - Door Maneuvering Space - Door that is not automatic or power-assisted does not have compliant maneuvering space relative to the direction of approach as shown in CBC Fig. 11B-26. (Approach // Side // Width // Depth) (Front // Pull // D + 24" * // 60") (Front // Push // D + 0" ** // 48") (Latch // Pull // D + 24" // 60") (Latch // Push // D + 24" // 44" ***) (Hinge // Pull // D + 36" // 60") (Hinge // Push // 54" **** // 44" *****) (* D + 18" at interior doors.) (** D + 12" if door has both a latch and a closer.) (***) 48" if door has closer.) (**** Measured from latch toward hinge.) (***** 48" if door has both a latch and a closer.)

Existing Condition: Non-fixed furniture obstructs door strike clearance.

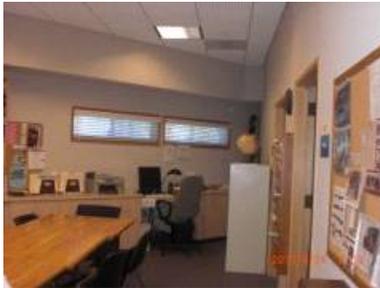
Location: Library
Photo # 166

Field Condition
 14.32A - Reach Range - Controls - Controls, dispensers, and similar devices are not between 9" and 54" AFF when the clear floor space allows a parallel approach. OR They are not between 15" and 48" AFF when the clear floor space allows only a forward approach.
 Existing Condition: Coat hook at 60 1/2" high.

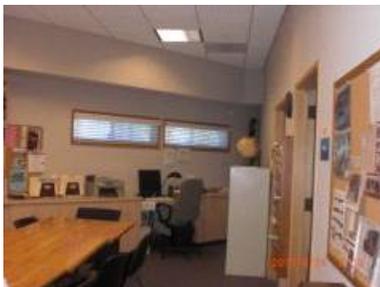
Location: Library
Photo # 166

Field Condition
 20.04 - Common Use Areas - Visual Alarms - Visual alarms are not provided in common use area(s) of the building such as meeting and conference rooms, open office space, classrooms, cafeterias, filing and photocopy rooms, employee break rooms, dressing, examination, and treatment rooms, and similar spaces that are not used solely as employee work areas.
 Existing Condition:
