City of Rancho Palos Verdes
Rancho Palos Verdes ADA Assessment
Facility Report with Photos

Reporting: 380 of 4367 Rcd Facility ID: # 09 - Lower Point Vicente Park & Point Vicente Interpretive Center (PVIC)

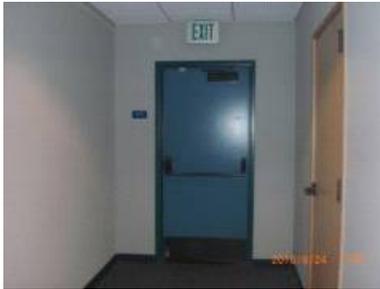
Location: Hallway
Photo # 167

Field Condition	
10.08 - Kick Plate - Bottom 10" of door does not have a smooth, uninterrupted surface on the push side to allow the door to be opened by a wheelchair footrest without creating a trap or hazardous condition. (This requirement does not apply to automatic and sliding doors.)	1991 ADAAG -
Existing Condition: Door stop.	2004 ADAAG 404.2.10
	2007 CBC 1133B.2.6
	Other -

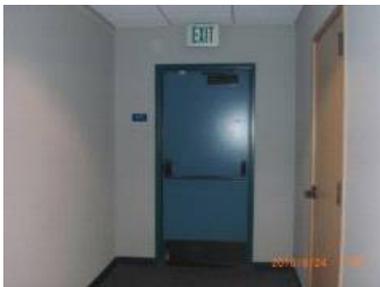
Location: Hallway
Photo # 167

Field Condition	
10.11B - Hardware Operating Effort - The force required to activate handles, pulls, latches, locks, and other operable parts of door exceeds 5 lbs.	1991 ADAAG 4.27.4
Existing Condition: 6 LBF.	2004 ADAAG 309.4
	2007 CBC 1117B.6 item 4
	Other -

Corrective Action
072D - Replace Hardware with Panic Device - Replace door hardware with panic device.
Additional Comments:

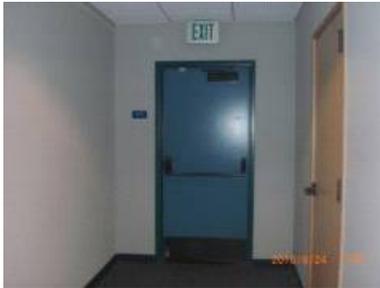
Location: Hallway
Photo # 167

Field Condition	
10.11A - Door Operating Effort - The force required to operate door exceeds 5 lbs. (Fire doors may have up to 15 lbs to achieve positive latching).	1991 ADAAG 4.13.11
Existing Condition: 14 LBF., (fire rated door).	2004 ADAAG 404.2.9
	2007 CBC 1133B.2.5
	Other -

Corrective Action
072B - Replace Closer - Replace door closer.
Additional Comments:

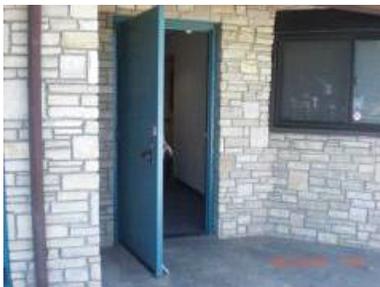
Location: Hallway
Photo # 170

Field Condition	
11.17A - Recommendation: Providing Room/Space ID Sign - A sign designating the permanent room or space has not been provided.	1991 ADAAG 4.1.2(7)
Existing Condition:	2004 ADAAG 216.2; 703.1; 703.2; 703.5
	2007 CBC 1117B.5.1 item 1
	Other -

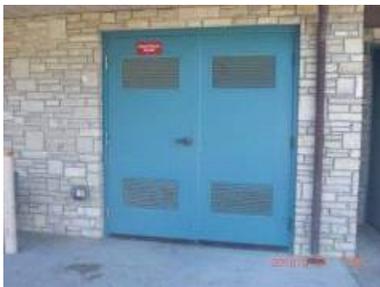
Location: Electrical Room
Photo # 172

Field Condition	
11.23A - Mounting Location (Visual/Tactile Signs) - Sign is not mounted on the wall adjacent to the latch side of the door. OR At double leaf doors, the sign is not placed on the nearest adjacent wall.	1991 ADAAG 4.30.6
Existing Condition: Sign on door.	2004 ADAAG 703.4.2
	2007 CBC 1117B.5.7
	Other -

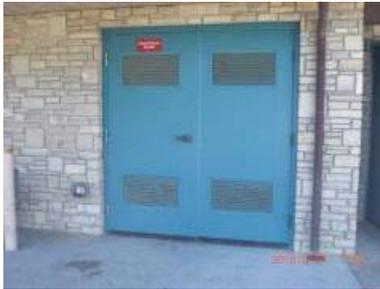
Location: Electrical Room
Photo # 172

Field Condition	
11.23B - Mounting Height (Visual/Tactile Signs) - Sign is not mounted at 60" o.c. AFF to the centerline of the sign. (If the sign contains pictorial symbols (pictograms) or other non-tactile information, mounting height is measured to the centerline of the tactile characters / Braille portion of the sign.)	1991 ADAAG 4.30.6 2004 ADAAG 703.4.1 2007 CBC 1117B.5.7 Other -
Existing Condition: 75" high.

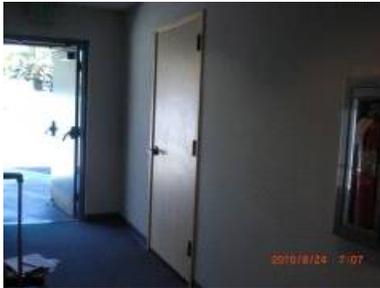
Location: Kitchen
Photo # 175

Field Condition	
11.17A - Recommendation: Providing Room/Space ID Sign - A sign designating the permanent room or space has not been provided.	1991 ADAAG 4.1.2(7)
Existing Condition:	2004 ADAAG 216.2; 703.1; 703.2; 703.5
	2007 CBC 1117B.5.1 item 1
	Other -

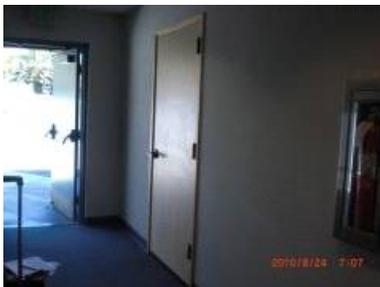
Location: Kitchen
Photo # 175

Field Condition	
11.15A - Kick Plate - Bottom 10" of door does not have a smooth, uninterrupted surface on the push side to allow the door to be opened by a wheelchair footrest without creating a trap or hazardous condition. (This requirement does not apply to automatic and sliding doors.)	1991 ADAAG -
Existing Condition: Door stop.	2004 ADAAG 404.2.10
	2007 CBC 1133B.2.6
	Other -

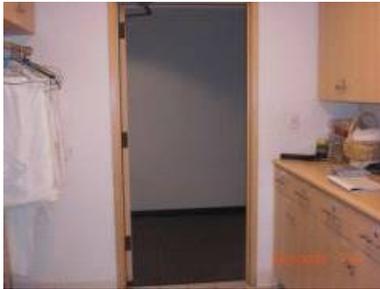
Location: Kitchen **Photo #** 177

Field Condition	
11.13A - Door Operating Effort - The force required to operate door exceeds 5 lbs. (Fire doors may have up to 15 lbs to achieve positive latching).	1991 ADAAG 4.13.11
Existing Condition: 8 LBF.	2004 ADAAG 404.2.9
	2007 CBC 1133B.2.5
	Other -

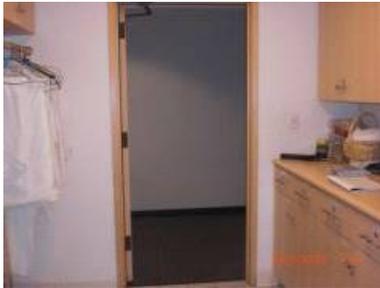
Keynote 178

11.06A - Door Maneuvering Space - Door that is not automatic or power-assisted does not have compliant maneuvering space relative to the direction of approach as shown in CBC Fig. 11B-26. (Approach // Side // Width // Depth) (Front // Pull // D + 24" * // 60") (Front // Push // D + 0" ** // 48") (Latch // Pull // D + 24" // 60") (Latch // Push // D + 24" // 44" ***) (Hinge // Pull // D + 36" // 60") (Hinge // Push // 54" **** // 44" *****) (* D + 18" at interior doors.) (** D + 12" if door has both a latch and a closer.) (***) 48" if door has closer.) (**** Measured from latch toward hinge.) (***** 48" if door has both a latch and a closer.)

Existing Condition: Counter obstructs door strike clearance.

053 - Reverse Door Swing - Remove existing door and frame and replace with new frame. Reinstall existing door (reverse door swing). Provide new accessible door hardware.

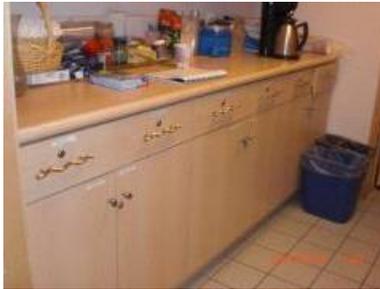
Keynote 179

Field Condition									
14.35 - Controls - Operation - The controls are not accessible. (Accessible controls shall be operable with one hand, and without tight grasping, pinching, or twisting of the wrist, and the force to operate the controls shall be no greater than 5 lbs.)

1991 ADAAG	4.27.4	2004 ADAAG	309.4	2007 CBC	1117B.6(4)	Other	-
1991 ADAAG	4.27.4								
2004 ADAAG	309.4								
2007 CBC	1117B.6(4)								
Other	-								
Existing Condition: Knob type hardware for cabinet.

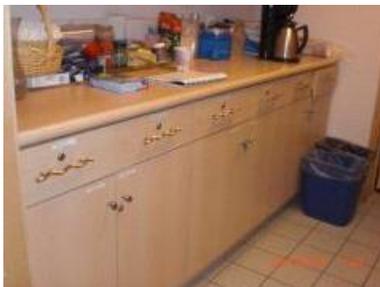
Keynote 180

Field Condition									
14.36A - Counter Height - Where provided in public or common use areas, countertops are not between 28" - 34" high. (Common use areas are those interior and exterior rooms, spaces, or elements that are made available for the use of a restricted group of people (for example, the occupants of an office building, or the guests of such occupants).)

1991 ADAAG	4.32.4	2004 ADAAG	902.3	2007 CBC	1122B.4	Other	-
1991 ADAAG	4.32.4								
2004 ADAAG	902.3								
2007 CBC	1122B.4								
Other	-								
Existing Condition: 37" high.

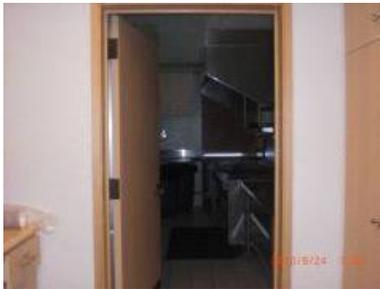
Keynote 182

Field Condition	
11.17A - Recommendation: Providing Room/Space ID Sign - A sign designating the permanent room or space has not been provided.	1991 ADAAG 4.1.2(7)
Existing Condition:	2004 ADAAG 216.2; 703.1; 703.2; 703.5
	2007 CBC 1117B.5.1 item 1
	Other -

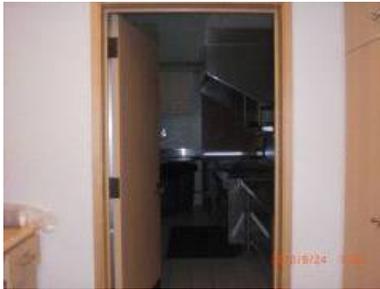
Keynote 183

11.06A - Door Maneuvering Space - Door that is not automatic or power-assisted does not have compliant maneuvering space relative to the direction of approach as shown in CBC Fig. 11B-26. (Approach // Side // Width // Depth) (Front // Pull // D + 24" * // 60") (Front // Push // D + 0" ** // 48") (Latch // Pull // D + 24" // 60") (Latch // Push // D + 24" // 44" ***) (Hinge // Pull // D + 36" // 60") (Hinge // Push // 54" **** // 44" *****) (* D + 18" at interior doors.) (** D + 12" if door has both a latch and a closer.) (***) 48" if door has closer.) (**** Measured from latch toward hinge.) (***** 48" if door has both a latch and a closer.)

Existing Condition: Kitchen counter obstructs door strike clearance.

053 - Reverse Door Swing - Remove existing door and frame and replace with new frame. Reinstall existing door (reverse door swing). Provide new accessible door hardware.

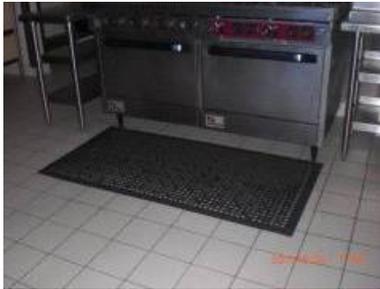
Keynote 184

Field Condition	
11.07D - Floor Mat - Attachment to Floor - Floor mat used on a ground or floor surface is not securely attached.	1991 ADAAG 4.5.3
Existing Condition: Loose floor mat.	2004 ADAAG 303.2; Advisory 302.2
	2007 CBC 1124B.3
	Other -

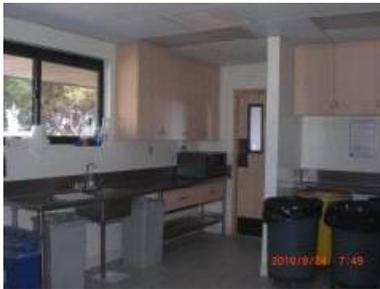
Keynote 185

Field Condition	
20.04 - Common Use Areas - Visual Alarms - Visual alarms are not provided in common use area(s) of the building such as meeting and conference rooms, open office space, classrooms, cafeterias, filing and photocopy rooms, employee break rooms, dressing, examination, and treatment rooms, and similar spaces that are not used solely as employee work areas.	1991 ADAAG 4.28.1
Existing Condition:	2004 ADAAG 215.2; 702.1
	2007 CBC 907.9.1.1
	Other -

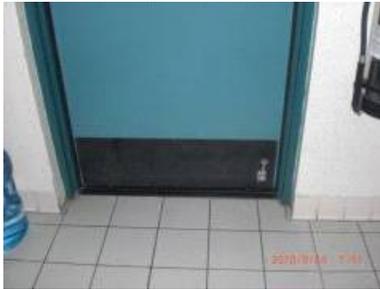
Keynote 186

Field Condition	
10.08 - Kick Plate - Bottom 10" of door does not have a smooth, uninterrupted surface on the push side to allow the door to be opened by a wheelchair footrest without creating a trap or hazardous condition. (This requirement does not apply to automatic and sliding doors.)	1991 ADAAG -
Existing Condition: Door stop.	2004 ADAAG 404.2.10
	2007 CBC 1133B.2.6
	Other -

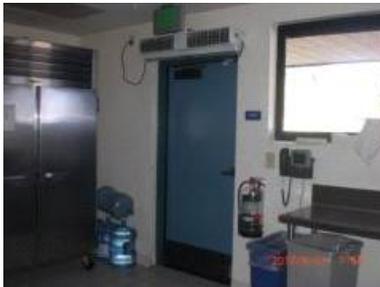
Keynote 187

Field Condition	
10.13B - Exit Door Signs - At grade level exterior exit door, a non-compliant exit sign with the word "EXIT" in raised characters and Braille is mounted on the wall adjacent to the latch side of the door (e.g.. Braille symbols are not California Grade 2 Braille).	1991 ADAAG 4.1.3(16); 4.30.1
Existing Condition: Non-compliant Braille.	2004 ADAAG 216.4; 703.2; 703.3; 703.4
	2007 CBC 1117B.5.1 item 1
	Other -

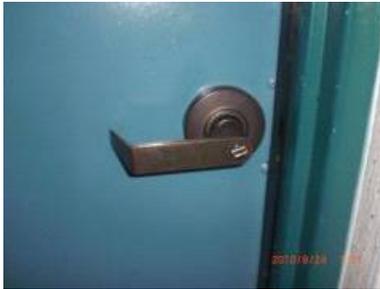
Keynote 188

10.10 - Single-Action Hardware - Handles, locks, and latches or other operative devices are not operable with one hand and without tight grasping, pinching, or twisting of the wrist. (U-shaped handles, levers, and push/pull type mechanisms are acceptable designs.)

Existing Condition: Twist type lock.

067B - Lever Hardware - Replace door hardware with lever-type handset.

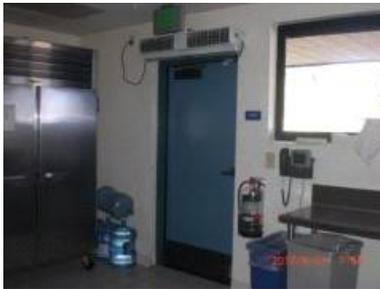
Keynote 189

10.11A - Door Operating Effort - The force required to operate door exceeds 5 lbs. (Fire doors may have up to 15 lbs to achieve positive latching).

Existing Condition: 7 LBF., (fire rated door).

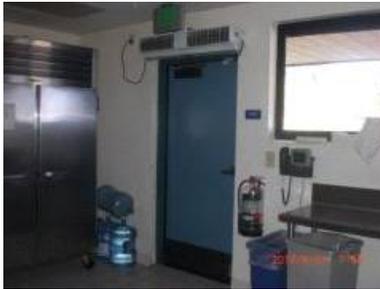
Location: Kitchen
Photo # 187

Field Condition	
11.14 - Closers - Door closer is not adjusted so that from an open position of 70 degrees, the door will take at least 3 seconds to move to a point 3" from the latch (measured to the leading edge of the door).	1991 ADAAG 4.13.10
Existing Condition: 2.3 seconds.	2004 ADAAG 404.2.8.1
	2007 CBC 1133B.2.5.1
	Other -

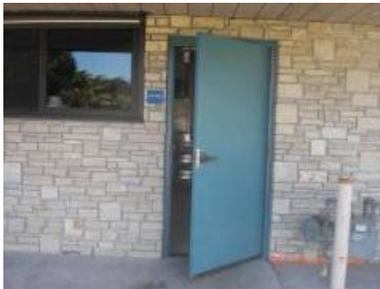
Location: Kitchen
Photo # 191

Field Condition	
11.25A - Raised Characters and Braille (Visual/Tactile Signs) - The raised characters on this sign are not accompanied by California Grade 2 Braille (California Grade 2 Braille requires the dots within each cell to be domed and spaced 1/10" o.c.)	1991 ADAAG 4.30.4
Existing Condition:	2004 ADAAG 703.2; 703.3
	2007 CBC 1117B.5.5 item 1, 1117B.5.6
	Other -

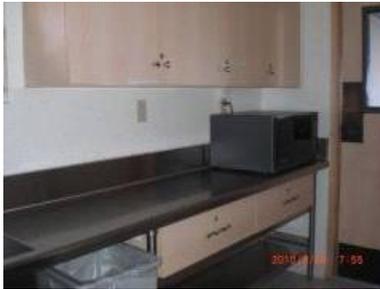
Location: Kitchen
Photo # 192

Field Condition									
14.35 - Controls - Operation - The controls are not accessible. (Accessible controls shall be operable with one hand, and without tight grasping, pinching, or twisting of the wrist, and the force to operate the controls shall be no greater than 5 lbs.)

1991 ADAAG	4.27.4	2004 ADAAG	309.4	2007 CBC	1117B.6(4)	Other	-
1991 ADAAG	4.27.4								
2004 ADAAG	309.4								
2007 CBC	1117B.6(4)								
Other	-								
Existing Condition: Knob type hardware for kitchen cabinets.

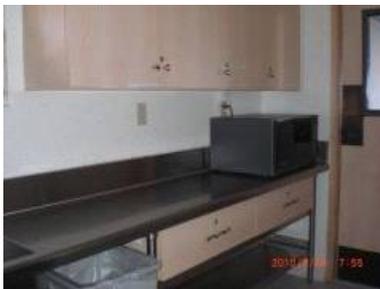
Location: Kitchen
Photo # 192

Field Condition									
14.32B - Forward Reach Range over Obstruction - Controls - Controls, dispensers, and similar devices over an obstruction are mounted higher than 44" AFF when the clear floor space allows only a forward approach and the horizontal reach limit is between 20" to 25". (Mounting height of 48" max.. AFF is permitted when the horizontal reach is less than 20".)

1991 ADAAG	4.2.5; Fig. 5(b)	2004 ADAAG	308.2.2; Fig. 308.2.2	2007 CBC	1117B.6(3); 1118.5; Fig. 11B-5C	Other	-
1991 ADAAG	4.2.5; Fig. 5(b)								
2004 ADAAG	308.2.2; Fig. 308.2.2								
2007 CBC	1117B.6(3); 1118.5; Fig. 11B-5C								
Other	-								
Existing Condition: 49" high receptacle over 21" deep counter.

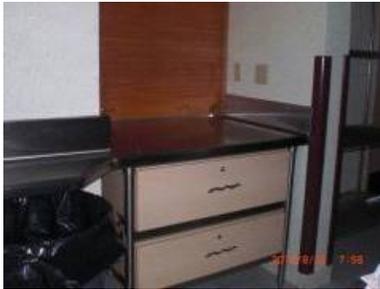
Keynote 194

Field Condition									
14.36A - Counter Height - Where provided in public or common use areas, countertops are not between 28" - 34" high. (Common use areas are those interior and exterior rooms, spaces, or elements that are made available for the use of a restricted group of people (for example, the occupants of an office building, or the guests of such occupants). Existing Condition: 35 3/4" high.

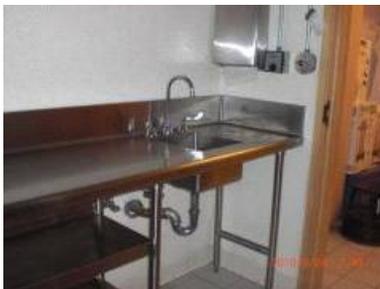
Keynote 199

Field Condition									
16.78 - Pipe Insulation at Lavatory - Drainpipes and hot water pipes are not insulated to protect against contact.

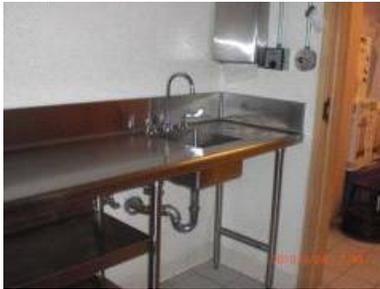
Keynote 200

Field Condition	
16.84A - Paper Towel Dispenser - Operating Height - Mounting height of paper towel dispenser's highest operable part exceeds 40" AFF. (Where provided, ADA Standards require at least one paper towel dispenser to be accessible with the highest operable part placed within at least one of the reach ranges specified in 4.2.5 and 4.2.6; where provided, CBC Standards require at least one paper towel dispenser to be accessible with the highest operable part no higher than 40" AFF.)	1991 ADAAG 4.22.7; 4.27.3; 4.2.5; 4.2.6
Existing Condition:	2004 ADAAG 308; 309
	2007 CBC 1115B.8.3
	Other -

Classification	
DOJ Location Type:	2
Use:	EW
Severity:	C
Level of Difficulty	Low to Moderate

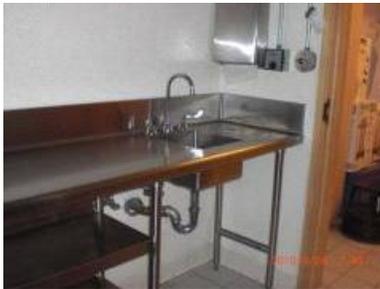
Keynote 201

Field Condition	
14.35 - Controls - Operation - The controls are not accessible. (Accessible controls shall be operable with one hand, and without tight grasping, pinching, or twisting of the wrist, and the force to operate the controls shall be no greater than 5 lbs.)	1991 ADAAG 4.27.4
Existing Condition: Twist type controls.	2004 ADAAG 309.4
	2007 CBC 1117B.6(4)
	Other -

Classification	
DOJ Location Type:	2
Use:	EW
Severity:	C
Level of Difficulty	Low to Moderate

Corrective Action	
031A - Modify Control - Modify control. Repair/refinish as required.	
Additional Comments:

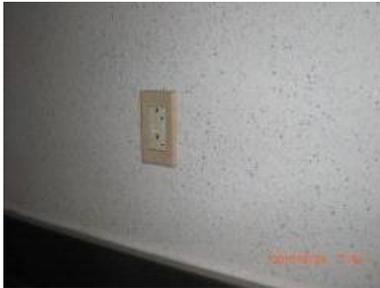
Keynote 202

Field Condition	
14.32B - Forward Reach Range over Obstruction - Controls - Controls, dispensers, and similar devices over an obstruction are mounted higher than 44" AFF when the clear floor space allows only a forward approach and the horizontal reach limit is between 20" to 25". (Mounting height of 48" max.. AFF is permitted when the horizontal reach is less than 20".) Existing Condition: 48" high receptacle over 21" deep counter.	1991 ADAAG 4.2.5; Fig. 5(b) 2004 ADAAG 308.2.2; Fig. 308.2.2 2007 CBC 1117B.6(3); 1118.5; Fig. 11B-5C Other -

Classification	
DOJ Location Type:	2
Use:	EW
Severity:	C
Level of Difficulty	Moderate

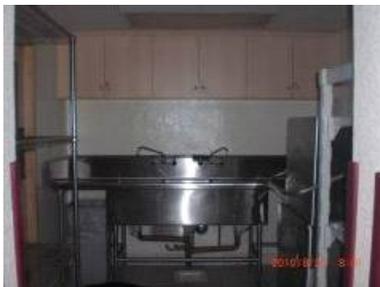
Keynote 203

Field Condition	
20.04 - Common Use Areas - Visual Alarms - Visual alarms are not provided in common use area(s) of the building such as meeting and conference rooms, open office space, classrooms, cafeterias, filing and photocopy rooms, employee break rooms, dressing, examination, and treatment rooms, and similar spaces that are not used solely as employee work areas. Existing Condition:	1991 ADAAG 4.28.1 2004 ADAAG 215.2; 702.1 2007 CBC 907.9.1.1 Other -

Classification	
DOJ Location Type:	2
Use:	EW
Severity:	B
Level of Difficulty	Moderate to High

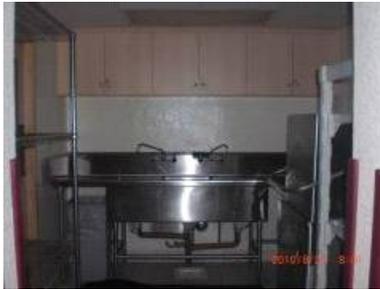
Keynote 204

Field Condition	
14.35 - Controls - Operation - The controls are not accessible. (Accessible controls shall be operable with one hand, and without tight grasping, pinching, or twisting of the wrist, and the force to operate the controls shall be no greater than 5 lbs.)	1991 ADAAG 4.27.4
Existing Condition: Knob type hardware for cabinets.	2004 ADAAG 309.4
	2007 CBC 1117B.6(4)
	Other -

Classification	
DOJ Location Type:	2
Use:	EW
Severity:	C
Level of Difficulty	Moderate

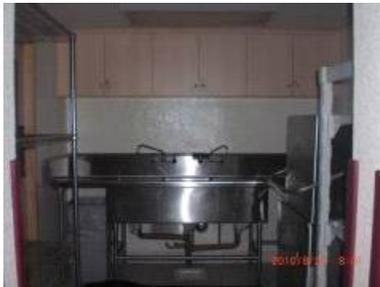
Keynote 205

Field Condition	
14.36B - Kitchen Counter/Sink Height - Where provided in public or common use areas, countertops and sinks are not mounted at 34" AFF. max..(Common use areas are those interior and exterior rooms, spaces, or elements that are made available for the use of a restricted group of people (for example, the occupants of an office building, or the guests of such occupants).	1991 ADAAG 4.24.2
Existing Condition: 37" high.	2004 ADAAG 212.3; 606.3
	2007 CBC 1115B.4.7(2); 1122B.4
	Other -

Classification	
DOJ Location Type:	2
Use:	EW
Severity:	C
Level of Difficulty	High

Corrective Action
480B - New Lower Cabinet with Counter Top and Kitchen Sink - Remove portion of existing cabinetry, and provide new counter at 34" above the finished floor. Remove and replace sink and faucet with new accessible sink and faucet. Provide accessible knee clearance (i.e. at least 27" high, 30" wide, and 19" deep) under
Additional Comments:

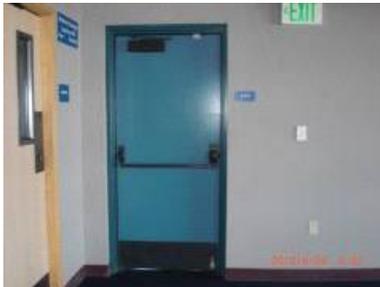
Keynote 207

Field Condition	
10.13B - Exit Door Signs - At grade level exterior exit door, a non-compliant exit sign with the word "EXIT" in raised characters and Braille is mounted on the wall adjacent to the latch side of the door (e.g.. Braille symbols are not California Grade 2 Braille).	1991 ADAAG 4.1.3(16); 4.30.1
Existing Condition:	2004 ADAAG 216.4; 703.2; 703.3; 703.4
	2007 CBC 1117B.5.1 item 1
	Other -

Classification	
DOJ Location Type:	4
Use:	PV
Severity:	D
Level of Difficulty	Low to Moderate

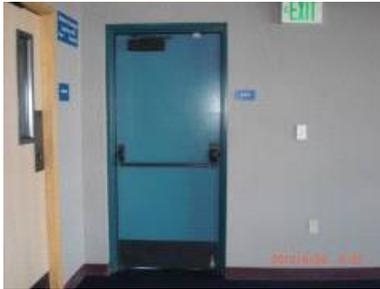
Keynote 208

Field Condition	
11.23B - Mounting Height (Visual/Tactile Signs) - Sign is not mounted at 60" o.c. AFF to the centerline of the sign. (If the sign contains pictorial symbols (pictograms) or other non-tactile information, mounting height is measured to the centerline of the tactile characters / Braille portion of the sign.)	1991 ADAAG 4.30.6 2004 ADAAG 703.4.1 2007 CBC 1117B.5.7 Other -
Existing Condition: 59" high.

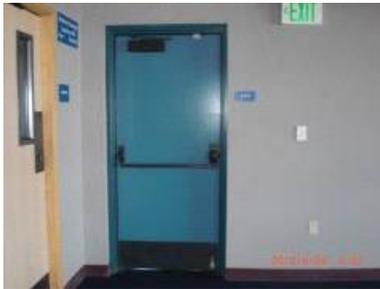
Keynote 209

Field Condition	
10.11A - Door Operating Effort - The force required to operate door exceeds 5 lbs. (Fire doors may have up to 15 lbs to achieve positive latching).	1991 ADAAG 4.13.11 2004 ADAAG 404.2.9 2007 CBC 1133B.2.5 Other -
Existing Condition: 10 LBF., (fire rated door).

Corrective Action
072B - Replace Closer - Replace door closer.
Additional Comments:

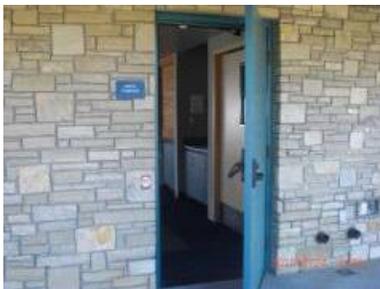
Keynote 211

Field Condition	
11.25A - Raised Characters and Braille (Visual/Tactile Signs) - The raised characters on this sign are not accompanied by California Grade 2 Braille (California Grade 2 Braille requires the dots within each cell to be domed and spaced 1/10" o.c.)	1991 ADAAG 4.30.4
Existing Condition:	2004 ADAAG 703.2; 703.3
	2007 CBC 1117B.5.5 item 1, 1117B.5.6
	Other -

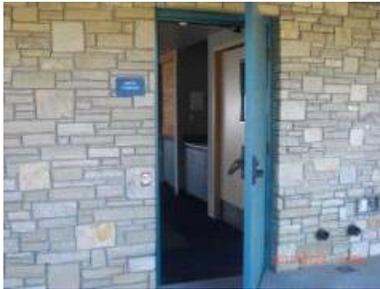
Keynote 212

Field Condition	
11.14 - Closers - Door closer is not adjusted so that from an open position of 70 degrees, the door will take at least 3 seconds to move to a point 3" from the latch (measured to the leading edge of the door).	1991 ADAAG 4.13.10
Existing Condition: 2.6 seconds.	2004 ADAAG 404.2.8.1
	2007 CBC 1133B.2.5.1
	Other -

Classification	
DOJ Location Type:	1
Use:	PV
Severity:	A
Level of Difficulty	Low to Moderate

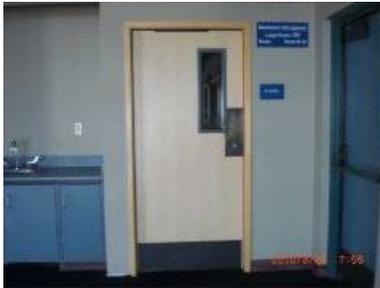
Keynote 214

Existing Condition: 48 1/2" high.

054A - Replace Door - Remove existing door and replace with new door and door frame. Provide new accessible door hardware.

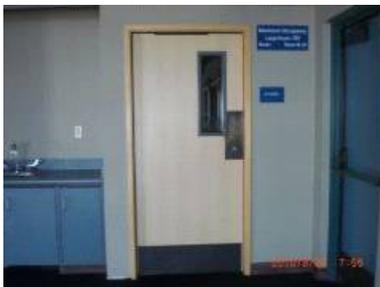
Keynote 215

Existing Condition: 7 LBF.

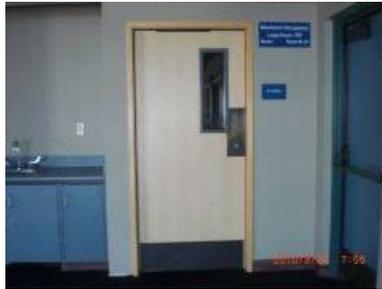
Keynote 216

Field Condition	
11.25A - Raised Characters and Braille (Visual/Tactile Signs) - The raised characters on this sign are not accompanied by California Grade 2 Braille (California Grade 2 Braille requires the dots within each cell to be domed and spaced 1/10" o.c.)	1991 ADAAG 4.30.4
Existing Condition:	2004 ADAAG 703.2; 703.3
	2007 CBC 1117B.5.5 item 1, 1117B.5.6
	Other -

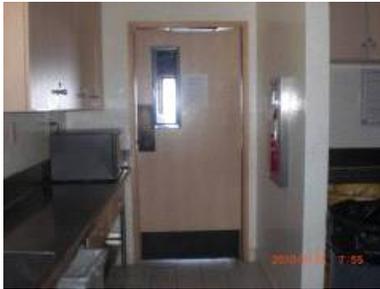
Keynote 217

11.06A - Door Maneuvering Space - Door that is not automatic or power-assisted does not have compliant maneuvering space relative to the direction of approach as shown in CBC Fig. 11B-26. (Approach // Side // Width // Depth) (Front // Pull // D + 24" * // 60") (Front // Push // D + 0" ** // 48") (Latch // Pull // D + 24" // 60") (Latch // Push // D + 24" // 44" ****) (Hinge // Pull // D + 36" // 60") (Hinge // Push // 54" **** // 44" *****) (* D + 18" at interior doors.) (** D + 12" if door has both a latch and a closer.) (***) 48" if door has closer.) (**** Measured from latch toward hinge.) (***** 48" if door has both a latch and a closer.)

Existing Condition: Kitchen counter obstructs door strike clearance.

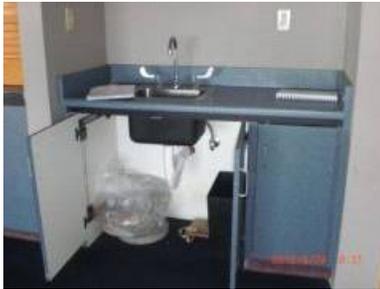
Keynote 218

Field Condition	
14.37 - Kitchen Sink - Sink does not provide accessible knee clearance (i.e. at least 27" high, 30" wide, and 19" deep).	1991 ADAAG 4.24.3
Existing Condition: 14 1/2" knee height, 3" knee depth.	2004 ADAAG 305; 306; 606.2
	2007 CBC 1115B.4.7(2); 1122B.4
	Other -

Classification	
DOJ Location Type:	2
Use:	PV
Severity:	C
Level of Difficulty	High

Corrective Action	
480B - New Lower Cabinet with Counter Top and Kitchen Sink - Remove portion of existing cabinetry, and provide new counter at 34" above the finished floor. Remove and replace sink and faucet with new accessible sink and faucet. Provide accessible knee clearance (i.e. at least 27" high, 30" wide, and 19" deep) under	
Additional Comments:

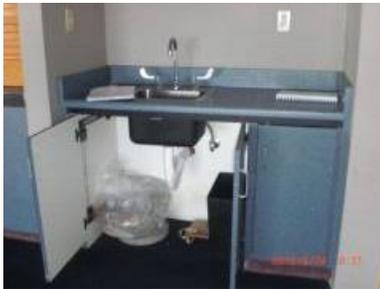
Keynote 219

Field Condition	
14.32B - Forward Reach Range over Obstruction - Controls - Controls, dispensers, and similar devices over an obstruction are mounted higher than 44" AFF when the clear floor space allows only a forward approach and the horizontal reach limit is between 20" to 25". (Mounting height of 48" max.. AFF is permitted when the horizontal reach is less than 20".)	1991 ADAAG 4.2.5; Fig. 5(b)
Existing Condition: 48" high receptacle over 23" deep counter.	2004 ADAAG 308.2.2; Fig. 308.2.2
	2007 CBC 1117B.6(3); 1118.5; Fig. 11B-5C
	Other -

Classification	
DOJ Location Type:	2
Use:	PV
Severity:	C
Level of Difficulty	Moderate

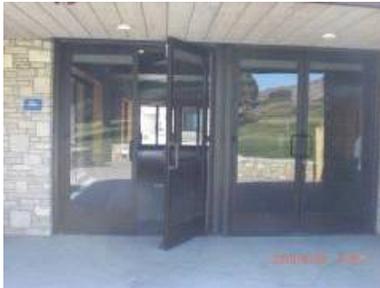
Keynote 220

Field Condition	
11.25A - Raised Characters and Braille (Visual/Tactile Signs) - The raised characters on this sign are not accompanied by California Grade 2 Braille (California Grade 2 Braille requires the dots within each cell to be domed and spaced 1/10" o.c.)	1991 ADAAG 4.30.4
Existing Condition:	2004 ADAAG 703.2; 703.3
	2007 CBC 1117B.5.5 item 1, 1117B.5.6
	Other -

Classification	
DOJ Location Type:	2
Use:	PV
Severity:	D
Level of Difficulty	Low to Moderate

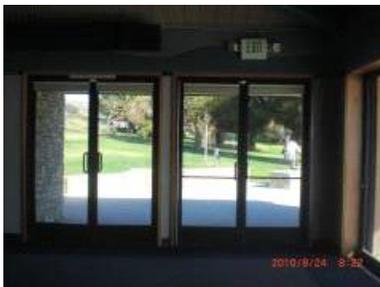
Keynote 221

Field Condition	
10.13A - Required Exit Door Sign - At grade level exterior exit door, there is no tactile and CA Braille exit sign with the word "EXIT" mounted on the wall adjacent to the latch side of the door.	1991 ADAAG 4.1.3(16); 4.30.1
Existing Condition:	2004 ADAAG 216.4; 703.2; 703.3; 703.4
	2007 CBC 1011.3 item 1
	Other -

Classification	
DOJ Location Type:	4
Use:	PV
Severity:	C
Level of Difficulty	Low to Moderate

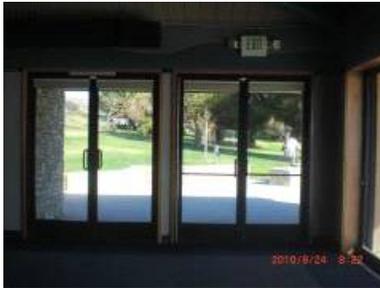
Keynote 222

Field Condition	
10.08 - Kick Plate - Bottom 10" of door does not have a smooth, uninterrupted surface on the push side to allow the door to be opened by a wheelchair footrest without creating a trap or hazardous condition. (This requirement does not apply to automatic and sliding doors.)	1991 ADAAG -
Existing Condition: Door stops.	2004 ADAAG 404.2.10
	2007 CBC 1133B.2.6
	Other -

Classification	
DOJ Location Type:	1
Use:	PV
Severity:	A
Level of Difficulty	Low to Moderate

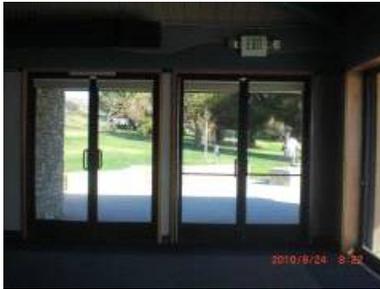
Keynote 224

Field Condition	
10.11A - Door Operating Effort - The force required to operate door exceeds 5 lbs. (Fire doors may have up to 15 lbs to achieve positive latching).	1991 ADAAG 4.13.11
Existing Condition: 17 and 20 LBF.	2004 ADAAG 404.2.9
	2007 CBC 1133B.2.5
	Other -

Classification	
DOJ Location Type:	1
Use:	PV
Severity:	B
Level of Difficulty	Moderate

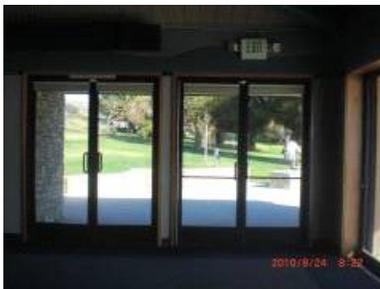
Keynote 225

Field Condition	
10.05 - Clear Door Opening - When the door is open 90 degrees, clear opening width is not at least 32" measured between the face of the door and the doorstop on the latch side.	1991 ADAAG 4.13.5
Existing Condition: 31" wide.	2004 ADAAG 404.2.3; Fig. 404.2.3
	2007 CBC 1133B.1.1.1.1; 1133B.2.2
	Other -

Classification	
DOJ Location Type:	1
Use:	PV
Severity:	C
Level of Difficulty	High

Corrective Action
056 - Widen Door Opening - Remove existing door and replace with new door and door frame. Cut existing wall to widen door opening. Provide new accessible door hardware.
Additional Comments:

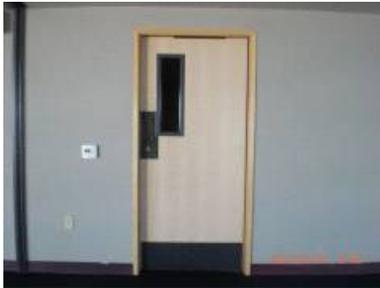
Keynote 226

Field Condition	
11.13A - Door Operating Effort - The force required to operate door exceeds 5 lbs. (Fire doors may have up to 15 lbs to achieve positive latching).	1991 ADAAG 4.13.11
Existing Condition: 9 LBF.	2004 ADAAG 404.2.9
	2007 CBC 1133B.2.5
	Other -

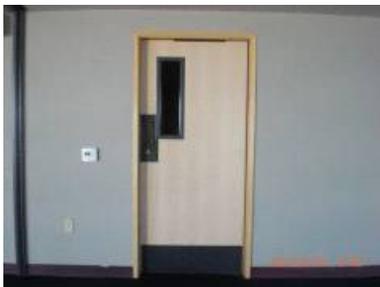
Keynote 227

Field Condition	
11.15B_04AG - Vision Lights - Door, gate, or adjacent sidelight, containing one or more vision lights, does not include at least one vision light mounted with the bottom edge of the glazed panel at 43" max.. AFF. (Exception: Vision lights with the lowest part more than 66" AFF.)	1991 ADAAG -
Existing Condition: 48 1/2" high.	2004 ADAAG 404.2.11
	2007 CBC -
	Other -

Corrective Action
054A - Replace Door - Remove existing door and replace with new door and door frame. Provide new accessible door hardware.
Additional Comments:

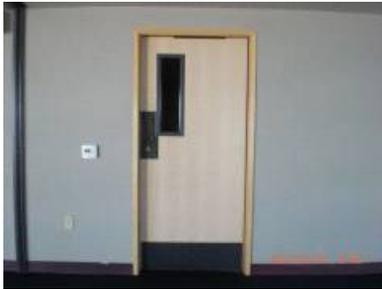
Keynote 228

11.06A - Door Maneuvering Space - Door that is not automatic or power-assisted does not have compliant maneuvering space relative to the direction of approach as shown in CBC Fig. 11B-26. (Approach // Side // Width // Depth) (Front // Pull // D + 24" * // 60") (Front // Push // D + 0" ** // 48") (Latch // Pull // D + 24" // 60") (Latch // Push // D + 24" // 44" ***) (Hinge // Pull // D + 36" // 60") (Hinge // Push // 54" **** // 44" *****) (* D + 18" at interior doors.) (** D + 12" if door has both a latch and a closer.) (***) 48" if door has closer.) (**** Measured from latch toward hinge.) (***** 48" if door has both a latch and a closer.)

Existing Condition: Kitchen counter obstructs door strike clearance.

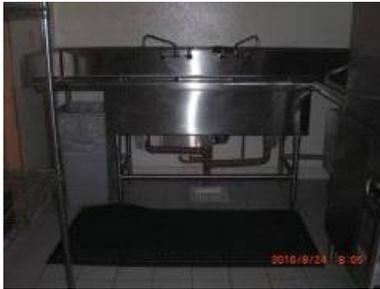
Keynote 229

Field Condition	
11.07D - Floor Mat - Attachment to Floor - Floor mat used on a ground or floor surface is not securely attached.	1991 ADAAG 4.5.3
Existing Condition: Loose floor mat.	2004 ADAAG 303.2; Advisory 302.2
	2007 CBC 1124B.3
	Other -

Classification	
DOJ Location Type:	2
Use:	EW
Severity:	A
Level of Difficulty	Low

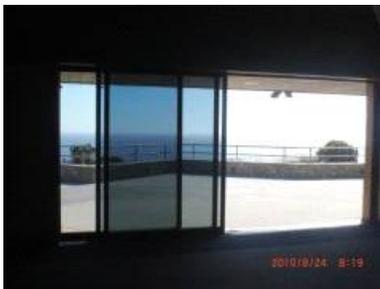
Keynote 230

Field Condition	
10.09B - Threshold - Height - The threshold at doorway exceeds 1/2" in height.	1991 ADAAG 4.13.8
Existing Condition: 1/2" high at two locations.	2004 ADAAG 303.3; Advisory 303.3; Fig. 303.3
	2007 CBC 1133B.2.4.1
	Other -

Classification	
DOJ Location Type:	1
Use:	PV
Severity:	C
Level of Difficulty	Low to Moderate

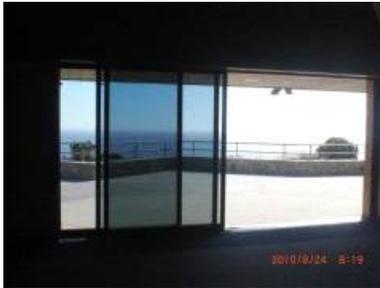
Keynote 231

Field Condition	
10.10 - Single-Action Hardware - Handles, locks, and latches or other operative devices are not operable with one hand and without tight grasping, pinching, or twisting of the wrist. (U-shaped handles, levers, and push/pull type mechanisms are acceptable designs.)	1991 ADAAG 4.13.9 2004 ADAAG 309.4; 404.2.7; Advisory 404.2.7 2007 CBC 1133B.2.5.2 Other -
Existing Condition: None provided.

Corrective Action
067B - Lever Hardware - Replace door hardware with lever-type handset.
Additional Comments:

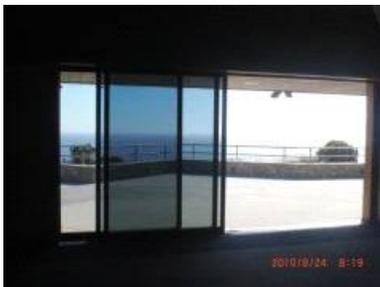
Keynote 232

Field Condition	
10.11A - Door Operating Effort - The force required to operate door exceeds 5 lbs. (Fire doors may have up to 15 lbs to achieve positive latching).	1991 ADAAG 4.13.11 2004 ADAAG 404.2.9 2007 CBC 1133B.2.5 Other -
Existing Condition: Greater than 5 LBF.

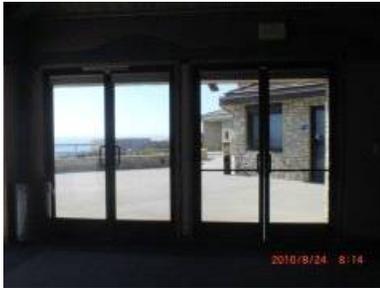
Keynote 233

Field Condition	
10.08 - Kick Plate - Bottom 10" of door does not have a smooth, uninterrupted surface on the push side to allow the door to be opened by a wheelchair footrest without creating a trap or hazardous condition. (This requirement does not apply to automatic and sliding doors.)	1991 ADAAG -
Existing Condition: Door stop.	2004 ADAAG 404.2.10
	2007 CBC 1133B.2.6
	Other -

Classification	
DOJ Location Type:	1
Use:	PV
Severity:	A
Level of Difficulty	Low to Moderate

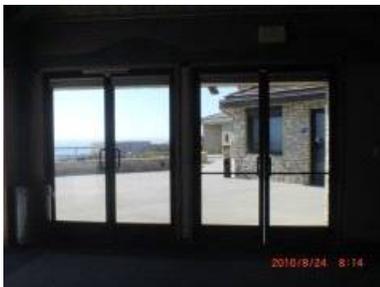
Keynote 234

Field Condition	
10.13A - Required Exit Door Sign - At grade level exterior exit door, there is no tactile and CA Braille exit sign with the word "EXIT" mounted on the wall adjacent to the latch side of the door.	1991 ADAAG 4.1.3(16); 4.30.1
Existing Condition:	2004 ADAAG 216.4; 703.2; 703.3; 703.4
	2007 CBC 1011.3 item 1
	Other -

Classification	
DOJ Location Type:	4
Use:	PV
Severity:	C
Level of Difficulty	Low to Moderate

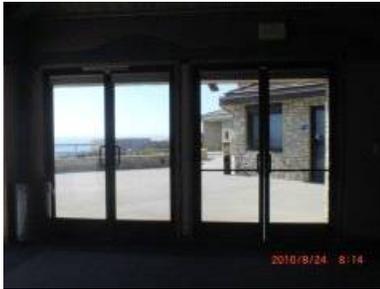
Keynote 235

Field Condition	
10.11B - Hardware Operating Effort - The force required to activate handles, pulls, latches, locks, and other operable parts of door exceeds 5 lbs.	1991 ADAAG 4.27.4
Existing Condition: 9 LBF.	2004 ADAAG 309.4
	2007 CBC 1117B.6 item 4
	Other -

Classification	
DOJ Location Type:	1
Use:	PV
Severity:	B
Level of Difficulty	Low to Moderate

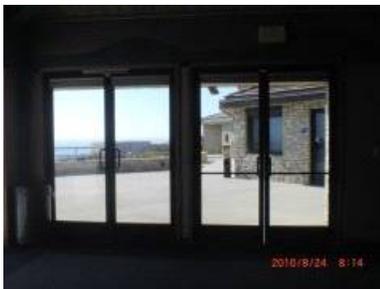
Keynote 236

Field Condition	
10.11A - Door Operating Effort - The force required to operate door exceeds 5 lbs. (Fire doors may have up to 15 lbs to achieve positive latching).	1991 ADAAG 4.13.11
Existing Condition: 10 and 12 LBF.	2004 ADAAG 404.2.9
	2007 CBC 1133B.2.5
	Other -

Classification	
DOJ Location Type:	1
Use:	PV
Severity:	B
Level of Difficulty	Low to Moderate

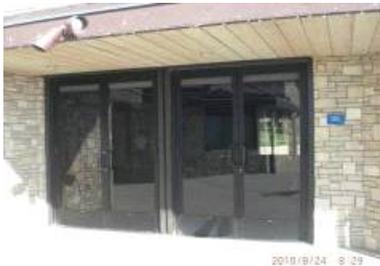
Keynote 238

Field Condition	
10.05 - Clear Door Opening - When the door is open 90 degrees, clear opening width is not at least 32" measured between the face of the door and the doorstop on the latch side.	1991 ADAAG 4.13.5
Existing Condition: 31" wide.	2004 ADAAG 404.2.3; Fig. 404.2.3
	2007 CBC 1133B.1.1.1.1; 1133B.2.2
	Other -

Classification	
DOJ Location Type:	1
Use:	PV
Severity:	C
Level of Difficulty	High

Corrective Action
056 - Widen Door Opening - Remove existing door and replace with new door and door frame. Cut existing wall to widen door opening. Provide new accessible door hardware.
Additional Comments:

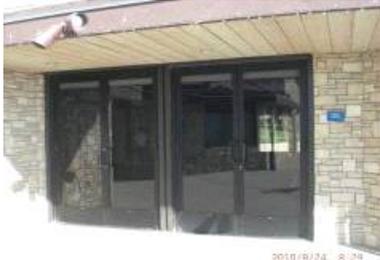
Keynote 239

Field Condition	
11.25A - Raised Characters and Braille (Visual/Tactile Signs) - The raised characters on this sign are not accompanied by California Grade 2 Braille (California Grade 2 Braille requires the dots within each cell to be domed and spaced 1/10" o.c.)	1991 ADAAG 4.30.4
Existing Condition:	2004 ADAAG 703.2; 703.3
	2007 CBC 1117B.5.5 item 1, 1117B.5.6
	Other -

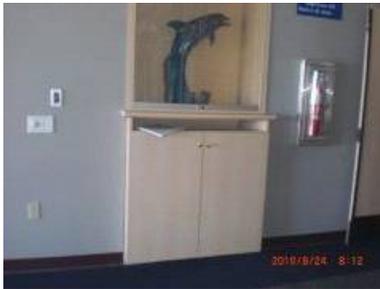
Keynote 240

Field Condition	
14.35 - Controls - Operation - The controls are not accessible. (Accessible controls shall be operable with one hand, and without tight grasping, pinching, or twisting of the wrist, and the force to operate the controls shall be no greater than 5 lbs.)	1991 ADAAG 4.27.4
Existing Condition: Knob hardware for cabinet.	2004 ADAAG 309.4
	2007 CBC 1117B.6(4)
	Other -

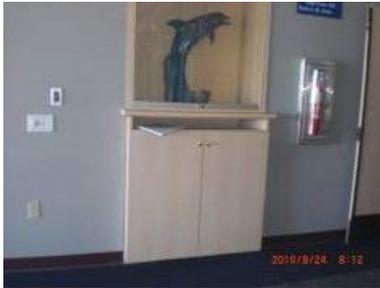
Keynote 241

Field Condition									
14.35 - Controls - Operation - The controls are not accessible. (Accessible controls shall be operable with one hand, and without tight grasping, pinching, or twisting of the wrist, and the force to operate the controls shall be no greater than 5 lbs.)

1991 ADAAG	4.27.4	2004 ADAAG	309.4	2007 CBC	1117B.6(4)	Other	-
1991 ADAAG	4.27.4								
2004 ADAAG	309.4								
2007 CBC	1117B.6(4)								
Other	-								
Existing Condition: No hardware for display cabinet.

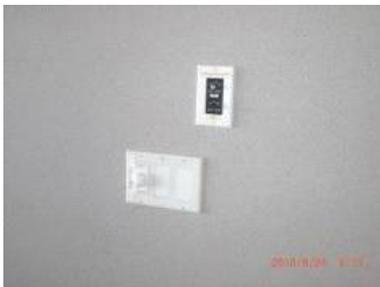
Keynote 242

Field Condition									
14.35 - Controls - Operation - The controls are not accessible. (Accessible controls shall be operable with one hand, and without tight grasping, pinching, or twisting of the wrist, and the force to operate the controls shall be no greater than 5 lbs.)

1991 ADAAG	4.27.4	2004 ADAAG	309.4	2007 CBC	1117B.6(4)	Other	-
1991 ADAAG	4.27.4								
2004 ADAAG	309.4								
2007 CBC	1117B.6(4)								
Other	-								
Existing Condition:

Corrective Action
031A - Modify Control - Modify control. Repair/refinish as required.
Additional Comments:

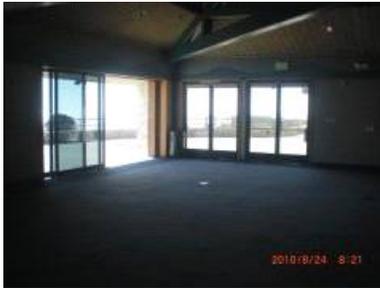
Keynote 243

Field Condition	20.04 - Common Use Areas - Visual Alarms - Visual alarms are not provided in common use area(s) of the building such as meeting and conference rooms, open office space, classrooms, cafeterias, filing and photocopy rooms, employee break rooms, dressing, examination, and treatment rooms, and similar spaces that are not used solely as employee work areas.	1991 ADAAG 4.28.1
		2004 ADAAG 215.2; 702.1
		2007 CBC 907.9.1.1
		Other -
Existing Condition:

Classification	
DOJ Location Type:	2
Use:	PV
Severity:	B
Level of Difficulty	Moderate to High

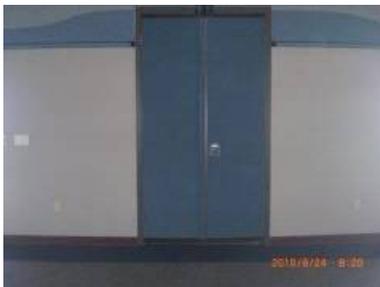
Keynote 244

Field Condition	11.11 - Single-Action Hardware - Handles, locks, and latches or other operative devices are not operable with one hand and without tight grasping, pinching, or twisting of the wrist. (U-shaped handles, levers, and push/pull type mechanisms are acceptable designs.)	1991 ADAAG 4.13.9
		2004 ADAAG 309.4; 404.2.7; Advisory 404.2.7
		2007 CBC 1133B.2.5.2
		Other -
Existing Condition:

Classification	
DOJ Location Type:	2
Use:	PV
Severity:	C
Level of Difficulty	Low to Moderate

Corrective Action
067B - Lever Hardware - Replace door hardware with lever-type handset.
Additional Comments:

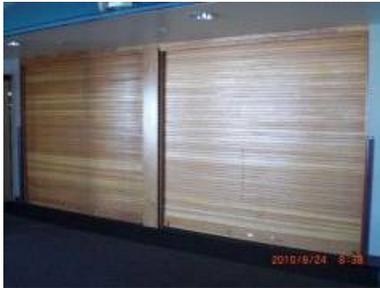
Keynote 245

Field Condition	
11.13A - Door Operating Effort - The force required to operate door exceeds 5 lbs. (Fire doors may have up to 15 lbs to achieve positive latching).	1991 ADAAG 4.13.11
Existing Condition: 30 LBF.	2004 ADAAG 404.2.9
	2007 CBC 1133B.2.5
	Other -

Classification	
DOJ Location Type:	2
Use:	PV
Severity:	B
Level of Difficulty	Low to Moderate

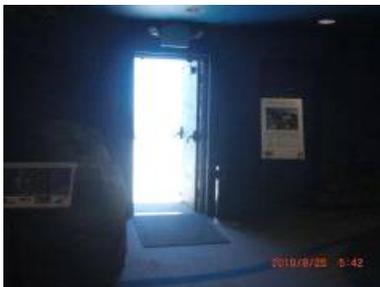
Keynote 246

Field Condition	
11.07D - Floor Mat - Attachment to Floor - Floor mat used on a ground or floor surface is not securely attached.	1991 ADAAG 4.5.3
Existing Condition: Loose floor mat.	2004 ADAAG 303.2; Advisory 302.2
	2007 CBC 1124B.3
	Other -

Classification	
DOJ Location Type:	1
Use:	PV
Severity:	A
Level of Difficulty	Low

Corrective Action
075B - Surface-Mounted Walk-Off Mat - Remove existing walk-off mat and replace with new surface-mounted walk-off mat. Permanently attach mat to floor. Edges of mat shall be beveled with a slope no greater than 1:2 or shall not exceed 1/4" in height.
Additional Comments:

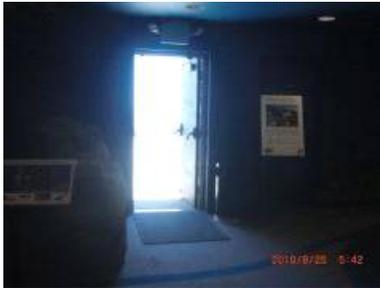
Keynote 247

Field Condition	
10.13A - Required Exit Door Sign - At grade level exterior exit door, there is no tactile and CA Braille exit sign with the word "EXIT" mounted on the wall adjacent to the latch side of the door.	1991 ADAAG 4.1.3(16); 4.30.1
Existing Condition:	2004 ADAAG 216.4; 703.2; 703.3; 703.4
	2007 CBC 1011.3 item 1
	Other -

Classification	
DOJ Location Type:	4
Use:	PV
Severity:	C
Level of Difficulty	Low to Moderate

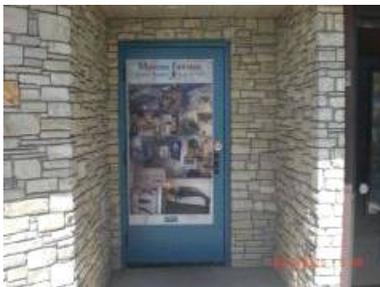
Keynote 248

Field Condition	
11.17B - Room/Space Identification Signs (Visual/Tactile Signs) - Sign designating the permanent room or space does not comply with ADAAG and CBC requirements for tactile signs.	1991 ADAAG 4.1.2(7); 4.30.1, 4, 5, 6
Existing Condition:	2004 ADAAG 216.2; 703.1; 703.2; 703.5
	2007 CBC 1117B.5.2, 3, 5, 6, 7
	Other -

Classification	
DOJ Location Type:	2
Use:	PV
Severity:	C
Level of Difficulty	Low to Moderate

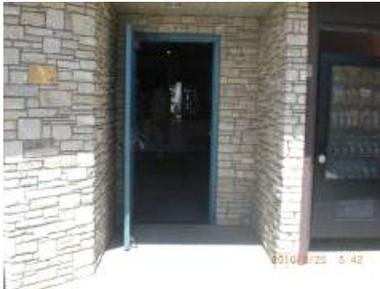
Keynote 250

10.06A - Door Maneuvering Space - Door that is not automatic or power-assisted does not have compliant maneuvering space relative to the direction of approach as shown in CBC Fig. 11B-26. (Approach // Side // Width // Depth) (Front // Pull // D + 24" * // 60") (Front // Push // D + 0" ** // 48") (Latch // Pull // D + 24" // 60") (Latch // Push // D + 24" // 44" ***) (Hinge // Pull // D + 36" // 60") (Hinge // Push // 54" **** // 44" *****) (* D + 18" at interior doors.) (** D + 12" if door has both a latch and a closer.) (***) 48" if door has closer.) (**** Measured from latch toward hinge.) (***** 48" if door has both a latch and a closer.)

Existing Condition: 18" strike clearance on pull side in lieu of 24".

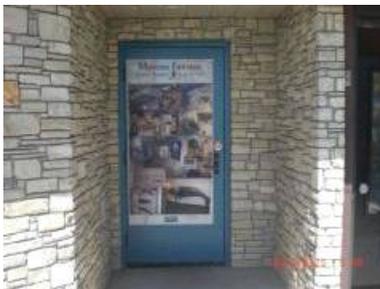
Keynote 252

Field Condition	
11.23A - Mounting Location (Visual/Tactile Signs) - Sign is not mounted on the wall adjacent to the latch side of the door. OR At double leaf doors, the sign is not placed on the nearest adjacent wall.	1991 ADAAG 4.30.6
Existing Condition: Sing on door.	2004 ADAAG 703.4.2
	2007 CBC 1117B.5.7
	Other -

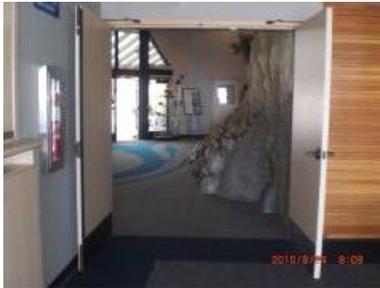
Keynote 253

Field Condition	
11.17A - Recommendation: Providing Room/Space ID Sign - A sign designating the permanent room or space has not been provided.	1991 ADAAG 4.1.2(7)
Existing Condition:	2004 ADAAG 216.2; 703.1; 703.2; 703.5
	2007 CBC 1117B.5.1 item 1
	Other -

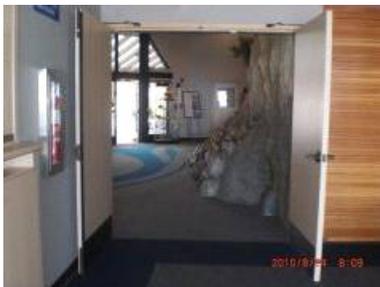
Keynote 254

Field Condition	
11.13A - Door Operating Effort - The force required to operate door exceeds 5 lbs. (Fire doors may have up to 15 lbs to achieve positive latching).	1991 ADAAG 4.13.11
Existing Condition: 10 LBF.	2004 ADAAG 404.2.9
	2007 CBC 1133B.2.5
	Other -

Corrective Action	
072B - Replace Closer - Replace door closer.	
Additional Comments:

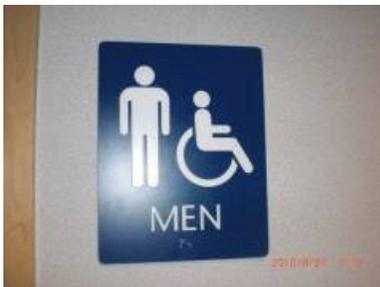
Keynote 256

Field Condition	
16.21A - Raised Characters and Braille (Visual/Tactile Signs) - The raised characters on this sign are not accompanied by California Grade 2 Braille (i.e., the dots within each cell are domed and spaced 1/10" o.c.)	1991 ADAAG 4.30.4
Existing Condition: Bad Braille.	2004 ADAAG 703.2; 703.3
	2007 CBC 1117B.5.5 item 1, 1117B.5.6
	Other -

Classification	
DOJ Location Type:	4
Use:	PV
Severity:	D
Level of Difficulty	Low to Moderate

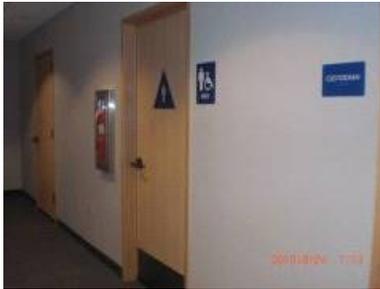
Keynote 257

Field Condition	
16.11A - Door Operating Effort - The force required to operate door exceeds 5 lbs. (Fire doors may have up to 15 lbs to achieve positive latching).	1991 ADAAG 4.13.11
Existing Condition: 10 LBF.	2004 ADAAG 404.2.9
	2007 CBC 1133B.2.5
	Other -

Classification	
DOJ Location Type:	3
Use:	PV
Severity:	B
Level of Difficulty	Moderate

Corrective Action
072B - Replace Closer - Replace door closer.
Additional Comments:

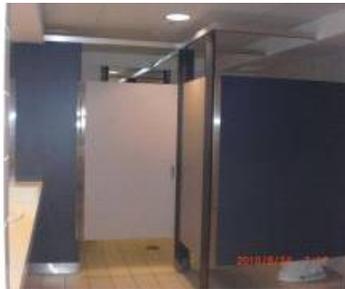
Keynote 258

Field Condition	
20.02 - Toilet, Bathroom, or Shower Room - Visual Alarms - Visual alarms are not provided at public or common use toilet, bathroom, or shower room.	1991 ADAAG 4.28.1
Existing Condition:	2004 ADAAG 215.1; Advisory 215.1; 702.1
	2007 CBC 907.9.1.1
	Other -

Classification	
DOJ Location Type:	2
Use:	PV
Severity:	B
Level of Difficulty	High

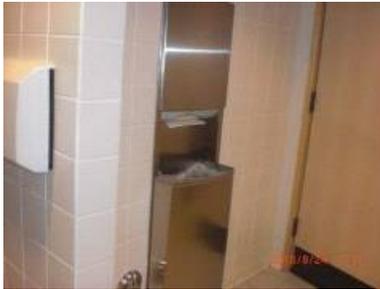
Keynote 259

Field Condition	
16.08A - Door Swing - The door swing intrudes into the clear floor space of one or more fixtures.	1991 ADAAG 4.22.2
Existing Condition: Door swings into PTD clear floor space.	2004 ADAAG 603.2.3; Advisory 603.2.3
	2007 CBC 1115B.3.1 item 2; 1115B.3.2 item 2; 1115B.5
	Other -

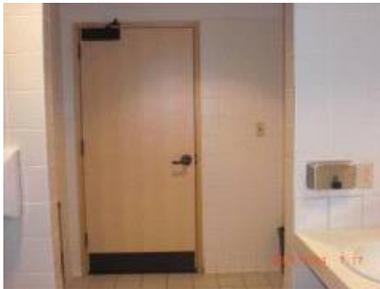
Keynote 260

Field Condition	
16.27B - Unobstructed Access to Accessible Stalls - Clear, unobstructed access at least 44" wide is not provided to accessible water closet compartment(s).	1991 ADAAG 4.17.3; Fig 30(a)
Existing Condition: 42" wide.	2004 ADAAG 604.8.1.2; Fig. 604.8.1.2
	2007 CBC 1115B.3.1(4.5)
	Other -

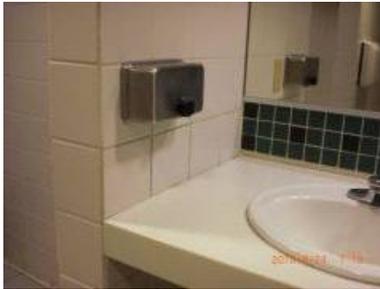
Keynote 261

Field Condition	
16.84C - Soap Dispenser - Operating Height - Mounting height of soap dispenser's highest operable part exceeds 40" AFF. (Where provided, ADA Standards require at least one soap dispenser to be accessible with the highest operable part placed within at least one of the reach ranges specified in 4.2.5 and 4.2.6; where provided, CBC Standards require at least one soap dispenser to be accessible with the highest operable part no higher than 40" AFF.)	1991 ADAAG 4.22.7; 4.27.3; 4.2.5; 4.2.6 2004 ADAAG 308; 309 2007 CBC 1115B.8.3 Other -
Existing Condition: 41 1/2" high.

Classification	
DOJ Location Type:	3
Use:	PV
Severity:	C
Level of Difficulty	Low to Moderate

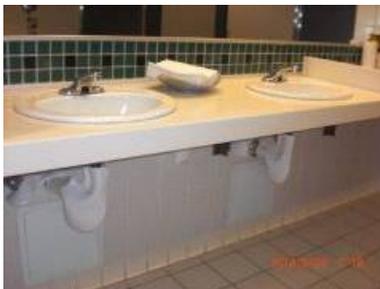
Keynote 262

Field Condition	
16.82A - Mirror Height - Max. 40" AFF Standard - Mirror above accessible lavatory or countertop is mounted so the bottom edge of the reflective surface is not 40" max.. AFF. (ADA Standards require at least one mirror to be accessible; CBC Standards prior to August 1, 2009 required all mirrors to be accessible. Effective August 1, 2009, amended CBC Standards require all mirrors above accessible lavatories or countertops to be accessible.)	1991 ADAAG 4.19.6; Fig. 31 2004 ADAAG 213.3.5; 603.3; Advisory 603.3 2007 CBC 1115B.8.1 Other -
Existing Condition: 40 1/2" high.

Classification	
DOJ Location Type:	3
Use:	PV
Severity:	C
Level of Difficulty	Low to Moderate

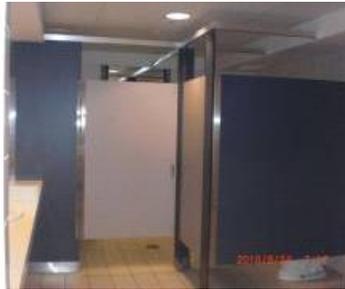
Keynote 263

Field Condition
 16.34 - Strike Side Clearance at Stall Door - Where the stall door opens out at the end of an aisle, there is less than 18" of maneuvering space at the latch side of the stall door.
 Existing Condition: 1/2" strike clearance on pull side.

1991 ADAAG 4.17.5; 4.13.6; Fig. 25
2004 ADAAG 404.2.4.1; Tab.404.2.4.1; Fig.404.2.4.1
2007 CBC 1133B.2.4.3; Figs. 11B-26B
Other -

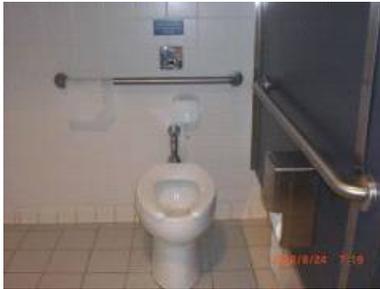
Keynote 265

Existing Condition: TPD 14" from water closet.

325B - Replace Toilet Paper Dispenser - Remove existing toilet paper dispenser and provide a new dispenser 19" above finish floor and 12" from toilet face. The dispenser is recessed or projects no more than 3" from the wall. Patch and repair wall substrate and finishes, to match adjacent undist

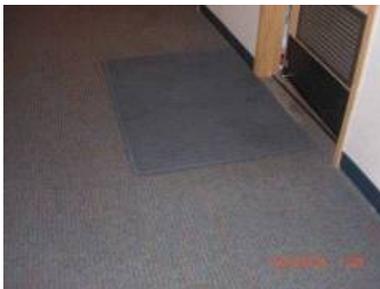
Keynote 266

Existing Condition: Loose floor mat.

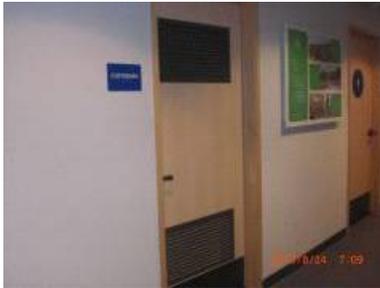
Keynote 267

Field Condition	
11.23B - Mounting Height (Visual/Tactile Signs) - Sign is not mounted at 60" o.c. AFF to the centerline of the sign. (If the sign contains pictorial symbols (pictograms) or other non-tactile information, mounting height is measured to the centerline of the tactile characters / Braille portion of the sign.)	1991 ADAAG 4.30.6
Existing Condition: 59" high.	2004 ADAAG 703.4.1
	2007 CBC 1117B.5.7
	Other -

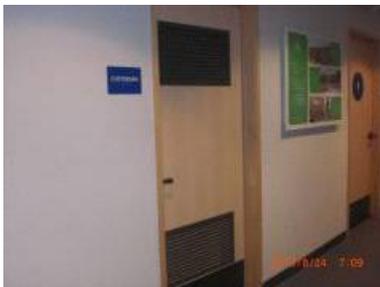
Keynote 268

Field Condition	
11.25A - Raised Characters and Braille (Visual/Tactile Signs) - The raised characters on this sign are not accompanied by California Grade 2 Braille (California Grade 2 Braille requires the dots within each cell to be domed and spaced 1/10" o.c.)	1991 ADAAG 4.30.4
Existing Condition: Bad Braille.	2004 ADAAG 703.2; 703.3
	2007 CBC 1117B.5.5 item 1, 1117B.5.6
	Other -

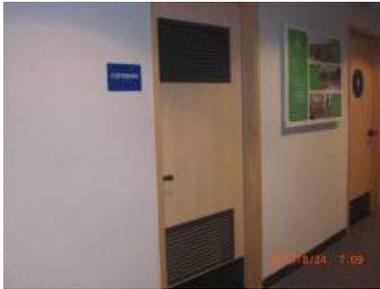
Keynote 269

Field Condition	
11.15A - Kick Plate - Bottom 10" of door does not have a smooth, uninterrupted surface on the push side to allow the door to be opened by a wheelchair footrest without creating a trap or hazardous condition. (This requirement does not apply to automatic and sliding doors.)	1991 ADAAG -
Existing Condition: Door stop.	2004 ADAAG 404.2.10
	2007 CBC 1133B.2.6
	Other -

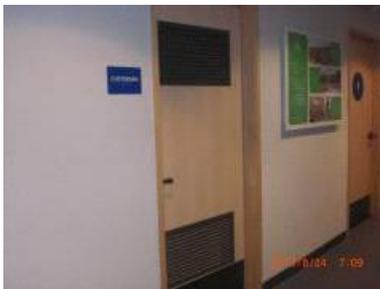
Keynote 270

Field Condition	
11.13A - Door Operating Effort - The force required to operate door exceeds 5 lbs. (Fire doors may have up to 15 lbs to achieve positive latching).	1991 ADAAG 4.13.11
Existing Condition: 10 LBF.	2004 ADAAG 404.2.9
	2007 CBC 1133B.2.5
	Other -

Corrective Action
072B - Replace Closer - Replace door closer.
Additional Comments:

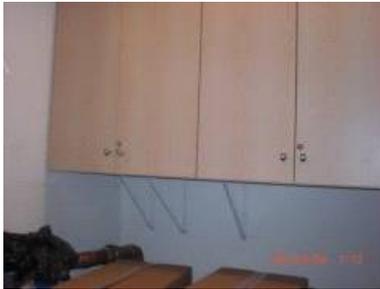
Keynote 271

Field Condition	
14.35 - Controls - Operation - The controls are not accessible. (Accessible controls shall be operable with one hand, and without tight grasping, pinching, or twisting of the wrist, and the force to operate the controls shall be no greater than 5 lbs.)	1991 ADAAG 4.27.4
Existing Condition: Non-compliant cabinet hardware.	2004 ADAAG 309.4
	2007 CBC 1117B.6(4)
	Other -

Classification	
DOJ Location Type:	2
Use:	MS
Severity:	C
Level of Difficulty	Moderate

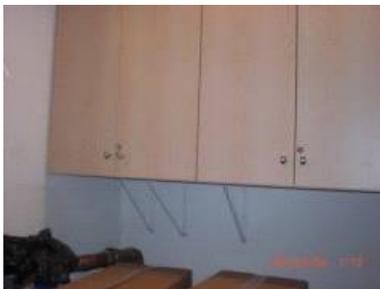
Keynote 272

Field Condition	
14.31 - Head Room - Clear head room is at less than 80" within the pedestrian circulation area, including the accessible route of travel.	1991 ADAAG 4.4.2
Existing Condition: 16" protruding shelf at 59" high.	2004 ADAAG 307.2; Fig. 307.2
	2007 CBC 1133B.8.6.2
	Other -

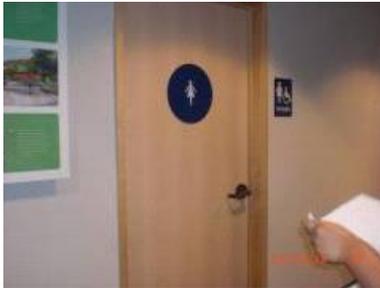
Keynote 273

Field Condition	
16.21A - Raised Characters and Braille (Visual/Tactile Signs) - The raised characters on this sign are not accompanied by California Grade 2 Braille (i.e., the dots within each cell are domed and spaced 1/10" o.c.)	1991 ADAAG 4.30.4
Existing Condition: Bad Braille.	2004 ADAAG 703.2; 703.3
	2007 CBC 1117B.5.5 item 1, 1117B.5.6
	Other -

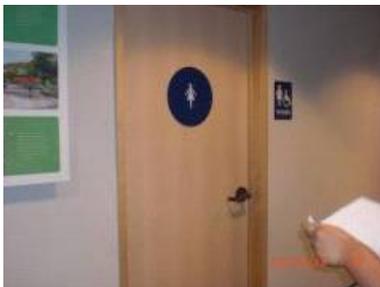
Keynote 274

Field Condition	
16.11A - Door Operating Effort - The force required to operate door exceeds 5 lbs. (Fire doors may have up to 15 lbs to achieve positive latching).	1991 ADAAG 4.13.11
Existing Condition: 7 LBF.	2004 ADAAG 404.2.9
	2007 CBC 1133B.2.5
	Other -

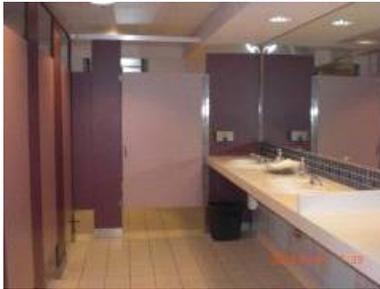
Keynote 275

Field Condition	20.02 - Toilet, Bathroom, or Shower Room - Visual Alarms - Visual alarms are not provided at public or common use toilet, bathroom, or shower room.	1991 ADAAG	4.28.1
Existing Condition:		2004 ADAAG	215.1; Advisory 215.1; 702.1
		2007 CBC	907.9.1.1
		Other	-
