City of Rancho Palos Verdes
Rancho Palos Verdes ADA Assessment
Facility Report with Photos

Reporting: 380 of 4367 Rcd Facility ID: # 09 - Lower Point Vicente Park & Point Vicente Interpretive Center (PVIC)

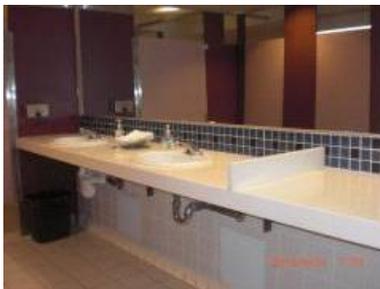
Keynote 276

Field Condition	16.84C - Soap Dispenser - Operating Height - Mounting height of soap dispenser's highest operable part exceeds 40" AFF. (Where provided, ADA Standards require at least one soap dispenser to be accessible with the highest operable part placed within at least one of the reach ranges specified in 4.2.5 and 4.2.6; where provided, CBC Standards require at least one soap dispenser to be accessible with the highest operable part no higher than 40" AFF.)	1991 ADAAG	4.22.7; 4.27.3; 4.2.5; 4.2.6
Existing Condition: 41" high.		2004 ADAAG	308; 309
		2007 CBC	1115B.8.3
		Other	-

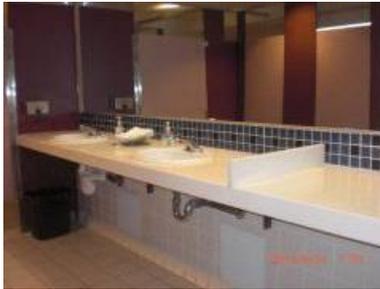
Keynote 277

Field Condition	
16.82A - Mirror Height - Max. 40" AFF Standard - Mirror above accessible lavatory or countertop is mounted so the bottom edge of the reflective surface is not 40" max.. AFF. (ADA Standards require at least one mirror to be accessible; CBC Standards prior to August 1, 2009 required all mirrors to be accessible. Effective August 1, 2009, amended CBC Standards require all mirrors above accessible lavatories or countertops to be accessible.)	1991 ADAAG 4.19.6; Fig. 31 2004 ADAAG 213.3.5; 603.3; Advisory 603.3 2007 CBC 1115B.8.1 Other -
Existing Condition: 41" high.

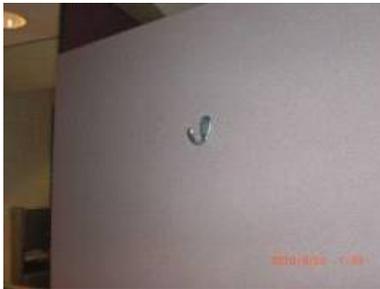
Keynote 278

Field Condition	
16.83 - Coat Hook - Height - Where a coat hook is provided In an accessible stall, height of coat hook exceeds 48" AFF.	1991 ADAAG 4.2.5 2004 ADAAG 213.3.7; 308; 603.4 2007 CBC 1117B.8 Other -
Existing Condition: 61" high.

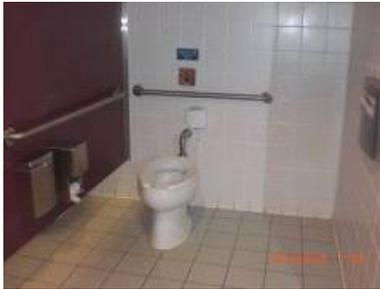
Keynote 279

Field Condition	
16.47A - WC Location from Sidewall - The centerline of the WC is not 18" absolute from a wall or partition.	1991 ADAAG 4.22.4
Existing Condition: 18 1/4" from side wall.	2004 ADAAG -
	2007 CBC 1115B.4.1(1)
	Other -

Corrective Action
319C - Water Closet - New Location - Replace existing water closet with compliant model in new location.
Additional Comments:

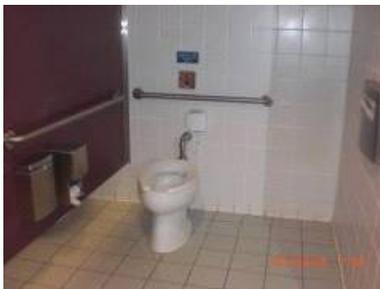
Keynote 280

Field Condition	
16.50 - TP Dispenser - Location - Pre-2007 CBC Facility - Location of the toilet paper dispenser does not comply with the Standard in effect at the time of construction. (The 2001 CBC required toilet tissue dispensers located on the wall within 12" of the front edge of the toilet seat, measured to the centerline of the dispenser; mounted below the grab bar; and centered at a min. height of 19" AFF.)	1991 ADAAG 4.16.6; Fig. 29(b)
Existing Condition: PTD 14" from water closet.	2004 ADAAG 604.7; Advisory 604.7; Fig. 604.7
	2007 CBC -
	Other -

Corrective Action
325B - Replace Toilet Paper Dispenser - Remove existing toilet paper dispenser and provide a new dispenser 19" above finish floor and 12" from toilet face. The dispenser is recessed or projects no more than 3" from the wall. Patch and repair wall substrate and finishes, to match adjacent undist
Additional Comments:

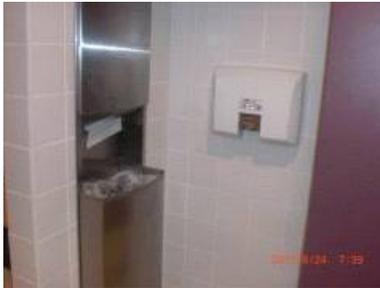
Keynote 281

Field Condition	
16.85A - Clear Floor Space at Dispensers - There is no clear floor space at least 30" x 48" in front of the dispenser to allow either a forward or a parallel approach to the dispenser. (Where provided, at least one dispenser of each type shall be accessible.)	1991 ADAAG 4.27.2; 4.2.4
Existing Condition: 28" wide clear floor space at hand dryer.	2004 ADAAG 305.3
	2007 CBC 1117B.6(2); 1118B.4
	Other -

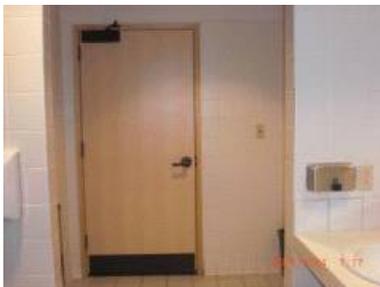
Keynote 282

Field Condition	
16.27B - Unobstructed Access to Accessible Stalls - Clear, unobstructed access at least 44" wide is not provided to accessible water closet compartment(s).	1991 ADAAG 4.17.3; Fig 30(a)
Existing Condition: 42 1/2" wide.	2004 ADAAG 604.8.1.2; Fig. 604.8.1.2
	2007 CBC 1115B.3.1(4.5)
	Other -

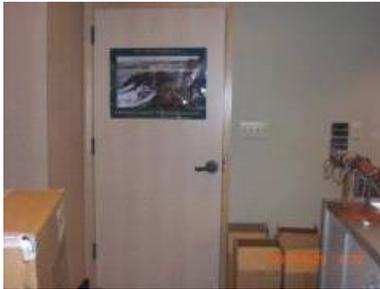
Keynote 285

Field Condition	
16.83 - Coat Hook - Height - Where a coat hook is provided In an accessible stall, height of coat hook exceeds 48" AFF.	1991 ADAAG 4.2.5
Existing Condition: 69" high.	2004 ADAAG 213.3.7; 308; 603.4
	2007 CBC 1117B.8
	Other -

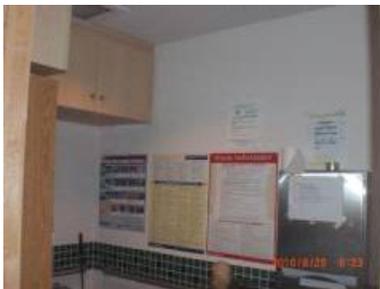
Keynote 286

Field Condition	
16.88 - Other - Toilet Facilities - See Additional Comments	1991 ADAAG -
Existing Condition: Headroom clearance 74" to upper cabinets.	2004 ADAAG -
	2007 CBC -
	Other -

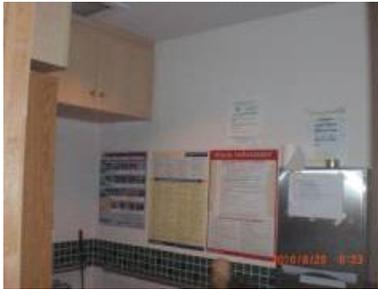
Keynote 287

Field Condition	
14.35 - Controls - Operation - The controls are not accessible. (Accessible controls shall be operable with one hand, and without tight grasping, pinching, or twisting of the wrist, and the force to operate the controls shall be no greater than 5 lbs.)	1991 ADAAG 4.27.4
Existing Condition: Non-compliant cabinet hardware.	2004 ADAAG 309.4
	2007 CBC 1117B.6(4)
	Other -

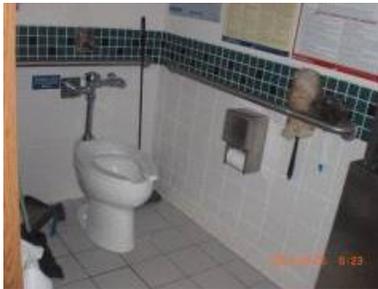
Keynote 288

Field Condition	
16.47A - WC Location from Sidewall - The centerline of the WC is not 18" absolute from a wall or partition.	1991 ADAAG 4.22.4
Existing Condition: 20" from side wall.	2004 ADAAG -
	2007 CBC 1115B.4.1(1)
	Other -

Corrective Action
319C - Water Closet - New Location - Replace existing water closet with compliant model in new location.
Additional Comments:

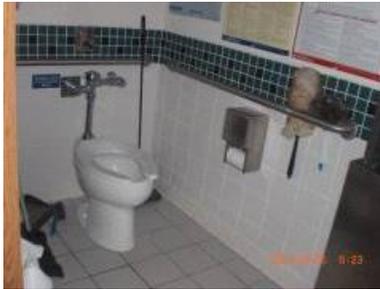
Keynote 289

Existing Condition: Clear floor space at SCD obstructed by non-fixed furniture.

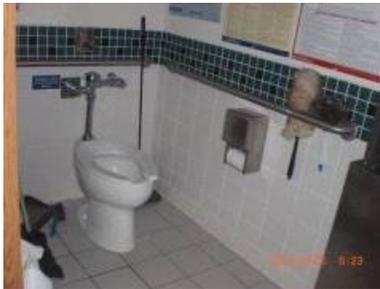
Keynote 290

Existing Condition: 33 1/2" high.

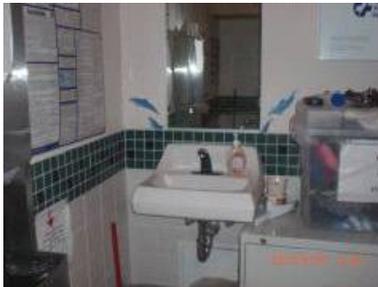
Keynote 292

Field Condition	16.82A - Mirror Height - Max. 40" AFF Standard - Mirror above accessible lavatory or countertop is mounted so the bottom edge of the reflective surface is not 40" max.. AFF. (ADA Standards require at least one mirror to be accessible; CBC Standards prior to August 1, 2009 required all mirrors to be accessible. Effective August 1, 2009, amended CBC Standards require all mirrors above accessible lavatories or countertops to be accessible.)	1991 ADAAG	4.19.6; Fig. 31
Existing Condition: 40 1/2" high.		2004 ADAAG	213.3.5; 603.3; Advisory 603.3
		2007 CBC	1115B.8.1
		Other	-

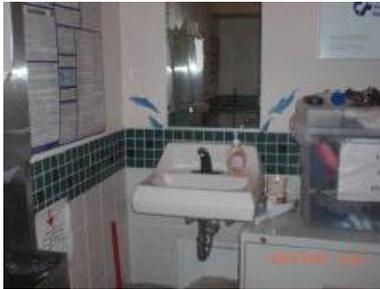
Keynote 295

Existing Condition: No clear floor space at First Aid Kit.

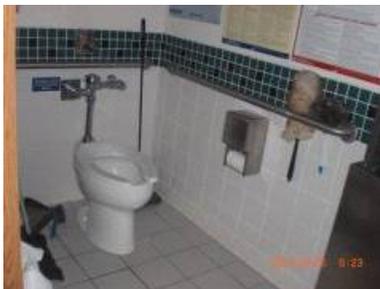
Keynote 296

Existing Condition: 33 1/2" high.

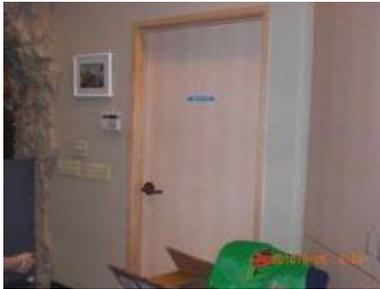
Keynote 297

Field Condition	
11.13A - Door Operating Effort - The force required to operate door exceeds 5 lbs. (Fire doors may have up to 15 lbs to achieve positive latching).	1991 ADAAG 4.13.11
Existing Condition: 10 LBF.	2004 ADAAG 404.2.9
	2007 CBC 1133B.2.5
	Other -

Corrective Action
072B - Replace Closer - Replace door closer.
Additional Comments:

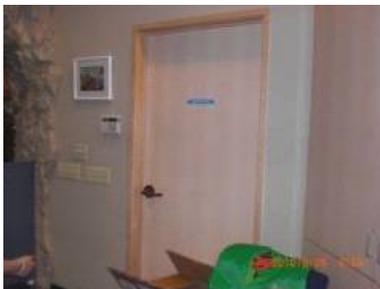
Keynote 298

Field Condition	
11.17A - Recommendation: Providing Room/Space ID Sign - A sign designating the permanent room or space has not been provided.	1991 ADAAG 4.1.2(7)
Existing Condition:	2004 ADAAG 216.2; 703.1; 703.2; 703.5
	2007 CBC 1117B.5.1 item 1
	Other -

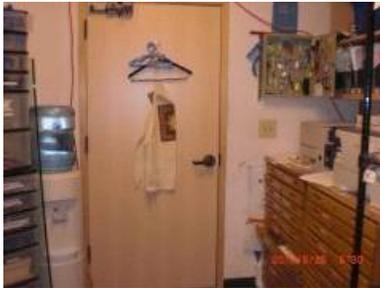
Keynote 299

Existing Condition: Key box at 70" high.

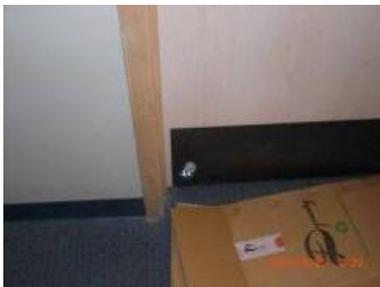
Keynote 300

11.15A - Kick Plate - Bottom 10" of door does not have a smooth, uninterrupted surface on the push side to allow the door to be opened by a wheelchair footrest without creating a trap or hazardous condition. (This requirement does not apply to automatic and sliding doors.)

Existing Condition: Door stop.

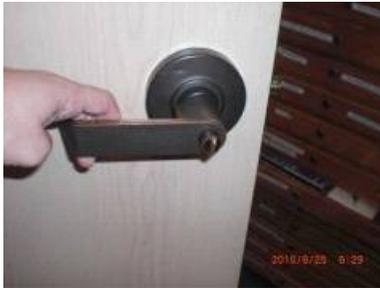
Keynote 301

Field Condition	
11.11 - Single-Action Hardware - Handles, locks, and latches or other operative devices are not operable with one hand and without tight grasping, pinching, or twisting of the wrist. (U-shaped handles, levers, and push/pull type mechanisms are acceptable designs.)	1991 ADAAG 4.13.9
Existing Condition: Twist type lock.	2004 ADAAG 309.4; 404.2.7; Advisory 404.2.7
	2007 CBC 1133B.2.5.2
	Other -

Corrective Action	
067B - Lever Hardware - Replace door hardware with lever-type handset.	
Additional Comments:

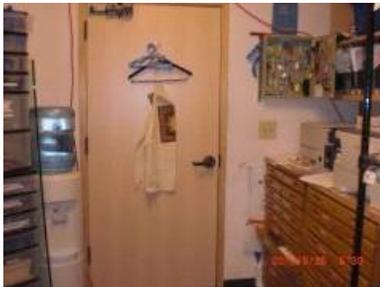
Keynote 302

Field Condition	
14.32A - Reach Range - Controls - Controls, dispensers, and similar devices are not between 9" and 54" AFF when the clear floor space allows a parallel approach. OR They are not between 15" and 48" AFF when the clear floor space allows only a forward approach.	1991 ADAAG 4.1.3(13); 4.27.3; 4.2.5; 4.2.6 ; Fig. 5; Fig. 6
Existing Condition: coat hook at 70" high.	2004 ADAAG -
	2007 CBC 1117B.6(3); 1118.5; 1118.6; Fig. 11B-5C; Fig. 11B-5D
	Other -

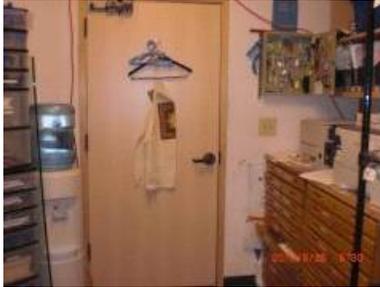
Keynote 303

11.06A - Door Maneuvering Space - Door that is not automatic or power-assisted does not have compliant maneuvering space relative to the direction of approach as shown in CBC Fig. 11B-26. (Approach // Side // Width // Depth) (Front // Pull // D + 24" * // 60") (Front // Push // D + 0" ** // 48") (Latch // Pull // D + 24" // 60") (Latch // Push // D + 24" // 44" ***) (Hinge // Pull // D + 36" // 60") (Hinge // Push // 54" **** // 44" *****) (* D + 18" at interior doors.) (** D + 12" if door has both a latch and a closer.) (***) 48" if door has closer.) (**** Measured from latch toward hinge.) (***** 48" if door has both a latch and a closer.)

Existing Condition: 13" strike clearance on pull side.

053 - Reverse Door Swing - Remove existing door and frame and replace with new frame. Reinstall existing door (reverse door swing). Provide new accessible door hardware.

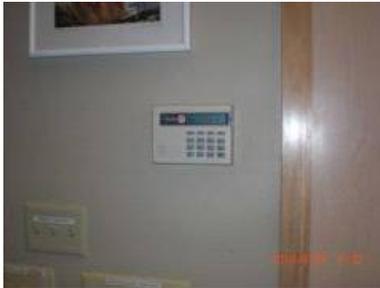
Keynote 304

Field Condition	
14.32A - Reach Range - Controls - Controls, dispensers, and similar devices are not between 9" and 54" AFF when the clear floor space allows a parallel approach. OR They are not between 15" and 48" AFF when the clear floor space allows only a forward approach.	1991 ADAAG 4.1.3(13); 4.27.3; 4.2.5; 4.2.6 ; Fig. 5; Fig. 6 2004 ADAAG - 2007 CBC 1117B.6(3); 1118.5; 1118.6; Fig. 11B-5C; Fig. 11B-5D Other -
Existing Condition: Key pad at 56 1/2" high.

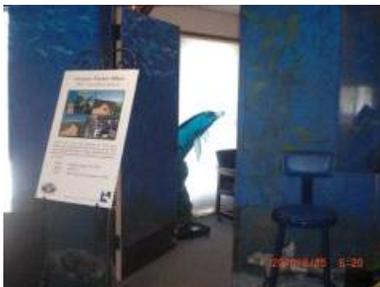
Keynote 305

Field Condition	
11.17A - Recommendation: Providing Room/Space ID Sign - A sign designating the permanent room or space has not been provided.	1991 ADAAG 4.1.2(7) 2004 ADAAG 216.2; 703.1; 703.2; 703.5 2007 CBC 1117B.5.1 item 1 Other -
Existing Condition:

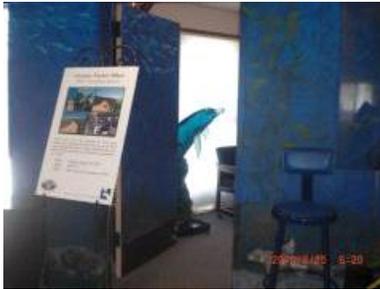
Keynote 306

Field Condition	
11.15A - Kick Plate - Bottom 10" of door does not have a smooth, uninterrupted surface on the push side to allow the door to be opened by a wheelchair footrest without creating a trap or hazardous condition. (This requirement does not apply to automatic and sliding doors.)	1991 ADAAG -
Existing Condition: Door stop.	2004 ADAAG 404.2.10
	2007 CBC 1133B.2.6
	Other -

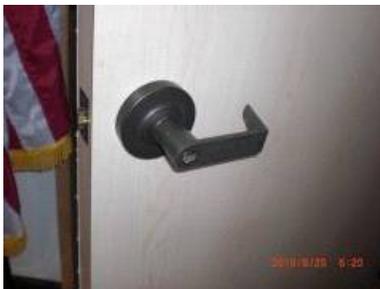
Keynote 307

Field Condition	
11.11 - Single-Action Hardware - Handles, locks, and latches or other operative devices are not operable with one hand and without tight grasping, pinching, or twisting of the wrist. (U-shaped handles, levers, and push/pull type mechanisms are acceptable designs.)	1991 ADAAG 4.13.9
Existing Condition: Twist type lock.	2004 ADAAG 309.4; 404.2.7; Advisory 404.2.7
	2007 CBC 1133B.2.5.2
	Other -

Corrective Action
067B - Lever Hardware - Replace door hardware with lever-type handset.
Additional Comments:

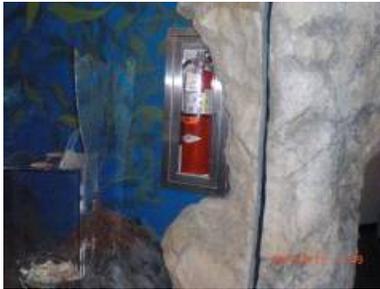
Keynote 308

Field Condition	
20.18 - Other - Alarms - See Additional Comments	1991 ADAAG -
Existing Condition: Approach to FE obstructed by wall.	2004 ADAAG -
	2007 CBC -
	Other -

Corrective Action	
388A - Relocate Fire Extinguisher Cabinet - Relocate existing fire extinguisher cabinet. Repair and refinish.	
Additional Comments:

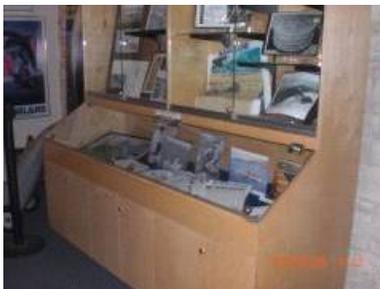
Keynote 309

Field Condition	
14.35 - Controls - Operation - The controls are not accessible. (Accessible controls shall be operable with one hand, and without tight grasping, pinching, or twisting of the wrist, and the force to operate the controls shall be no greater than 5 lbs.)	1991 ADAAG 4.27.4
Existing Condition: Knob type controls for display cabinets.	2004 ADAAG 309.4
	2007 CBC 1117B.6(4)
	Other -

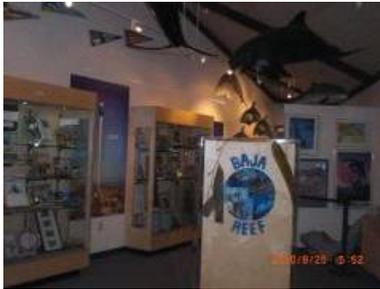
Location: Exhibit Room
Photo # 310

Field Condition	20.04 - Common Use Areas - Visual Alarms - Visual alarms are not provided in common use area(s) of the building such as meeting and conference rooms, open office space, classrooms, cafeterias, filing and photocopy rooms, employee break rooms, dressing, examination, and treatment rooms, and similar spaces that are not used solely as employee work areas.	1991 ADAAG 4.28.1
Existing Condition:		2004 ADAAG 215.2; 702.1
		2007 CBC 907.9.1.1
		Other -

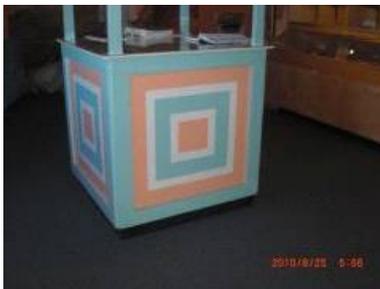
Location: Exhibit Room
Photo # 311

Field Condition	14.36A - Counter Height - Where provided in public or common use areas, countertops are not between 28" - 34" high. (Common use areas are those interior and exterior rooms, spaces, or elements that are made available for the use of a restricted group of people (for example, the occupants of an office building, or the guests of such occupants).	1991 ADAAG 4.32.4
Existing Condition: 40 1/4" high.		2004 ADAAG 902.3
		2007 CBC 1122B.4
		Other -

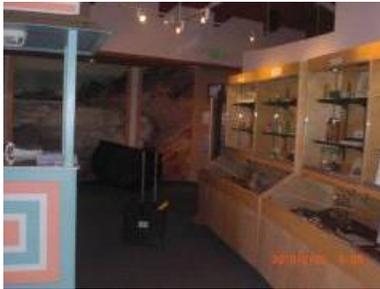
Location: Exhibit Room
Photo # 312

Field Condition	
20.04 - Common Use Areas - Visual Alarms - Visual alarms are not provided in common use area(s) of the building such as meeting and conference rooms, open office space, classrooms, cafeterias, filing and photocopy rooms, employee break rooms, dressing, examination, and treatment rooms, and similar spaces that are not used solely as employee work areas.	1991 ADAAG 4.28.1 2004 ADAAG 215.2; 702.1 2007 CBC 907.9.1.1 Other -
Existing Condition:

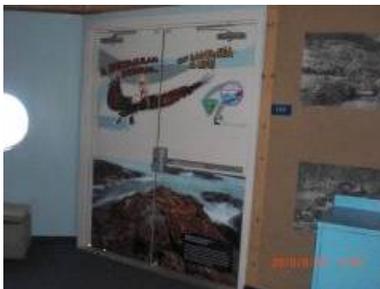
Location: Exhibit Room
Photo # 313

Field Condition	
10.08 - Kick Plate - Bottom 10" of door does not have a smooth, uninterrupted surface on the push side to allow the door to be opened by a wheelchair footrest without creating a trap or hazardous condition. (This requirement does not apply to automatic and sliding doors.)	1991 ADAAG - 2004 ADAAG 404.2.10 2007 CBC 1133B.2.6 Other -
Existing Condition: Door stop.

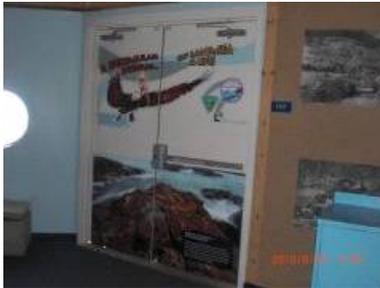
Keynote 314

Field Condition									
11.23B - Mounting Height (Visual/Tactile Signs) - Sign is not mounted at 60" o.c. AFF to the centerline of the sign. (If the sign contains pictorial symbols (pictograms) or other non-tactile information, mounting height is measured to the centerline of the tactile characters / Braille portion of the sign.)

1991 ADAAG	4.30.6	2004 ADAAG	703.4.1	2007 CBC	1117B.5.7	Other	-
1991 ADAAG	4.30.6								
2004 ADAAG	703.4.1								
2007 CBC	1117B.5.7								
Other	-								
Existing Condition: 58" high.

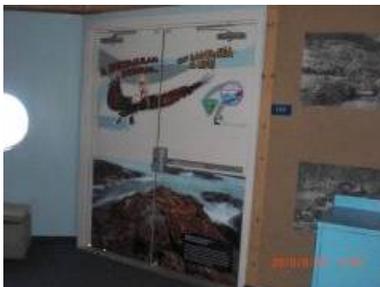
Keynote 315

Field Condition									
11.25A - Raised Characters and Braille (Visual/Tactile Signs) - The raised characters on this sign are not accompanied by California Grade 2 Braille (California Grade 2 Braille requires the dots within each cell to be domed and spaced 1/10" o.c.)

1991 ADAAG	4.30.4	2004 ADAAG	703.2; 703.3	2007 CBC	1117B.5.5 item 1, 1117B.5.6	Other	-
1991 ADAAG	4.30.4								
2004 ADAAG	703.2; 703.3								
2007 CBC	1117B.5.5 item 1, 1117B.5.6								
Other	-								
Existing Condition: Bad Braille.

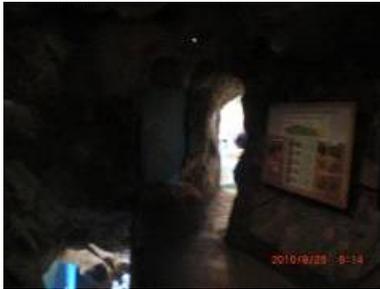
Location: Exhibit Room
Photo # 316

Field Condition	20.04 - Common Use Areas - Visual Alarms - Visual alarms are not provided in common use area(s) of the building such as meeting and conference rooms, open office space, classrooms, cafeterias, filing and photocopy rooms, employee break rooms, dressing, examination, and treatment rooms, and similar spaces that are not used solely as employee work areas.	1991 ADAAG 4.28.1
Existing Condition:		2004 ADAAG 215.2; 702.1
		2007 CBC 907.9.1.1
		Other -

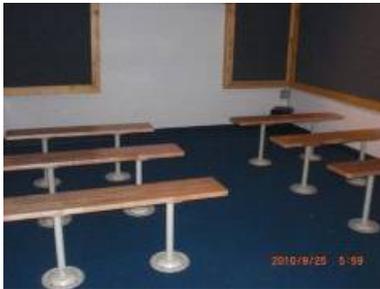
Location: Exhibit Room
Photo # 317

Field Condition	14.50 - Other - Rooms and Spaces - See Additional Comments	1991 ADAAG -
Existing Condition:		2004 ADAAG -
		2007 CBC -
		Other -

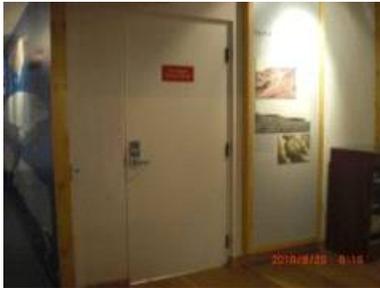
Location: Fire Alarm Room
Photo # 318

Field Condition									
11.25A - Raised Characters and Braille (Visual/Tactile Signs) - The raised characters on this sign are not accompanied by California Grade 2 Braille (California Grade 2 Braille requires the dots within each cell to be domed and spaced 1/10" o.c.)

1991 ADAAG	4.30.4	2004 ADAAG	703.2; 703.3	2007 CBC	1117B.5.5 item 1, 1117B.5.6	Other	-
1991 ADAAG	4.30.4								
2004 ADAAG	703.2; 703.3								
2007 CBC	1117B.5.5 item 1, 1117B.5.6								
Other	-								
Existing Condition:

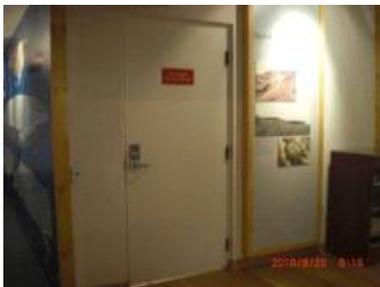
Keynote 319

Field Condition									
11.23A - Mounting Location (Visual/Tactile Signs) - Sign is not mounted on the wall adjacent to the latch side of the door. OR At double leaf doors, the sign is not placed on the nearest adjacent wall.

1991 ADAAG	4.30.6	2004 ADAAG	703.4.2	2007 CBC	1117B.5.7	Other	-
1991 ADAAG	4.30.6								
2004 ADAAG	703.4.2								
2007 CBC	1117B.5.7								
Other	-								
Existing Condition: On door.

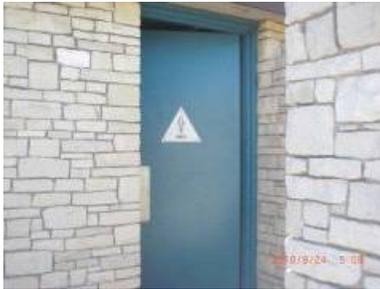
Keynote 322

Field Condition	
16.11A - Door Operating Effort - The force required to operate door exceeds 5 lbs. (Fire doors may have up to 15 lbs to achieve positive latching).	1991 ADAAG 4.13.11
Existing Condition: 10 LBF.	2004 ADAAG 404.2.9
	2007 CBC 1133B.2.5
	Other -

Corrective Action
072B - Replace Closer - Replace door closer.
Additional Comments:

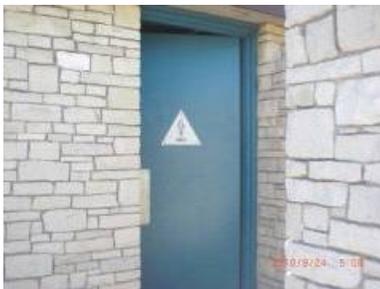
Keynote 323

Field Condition	
16.15A - Providing Room/Space ID Sign - A sign designating the permanent room or space has not been provided.	1991 ADAAG 4.30.1
Existing Condition:	2004 ADAAG 216.2; 703.1; 703.2; 703.5
	2007 CBC 1117B.5.1(1)
	Other -

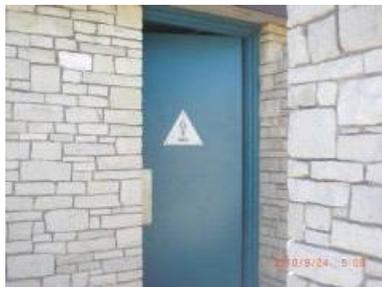
Keynote 325

Field Condition	
16.14A - Mounting Height - Geometric Symbol Signage - The geometric symbol is not centered on the door leaf. OR The symbol is not mounted at a height of 60" AFF.	1991 ADAAG -
Existing Condition: 59" high.	2004 ADAAG -
	2007 CBC 1115B.6
	Other -

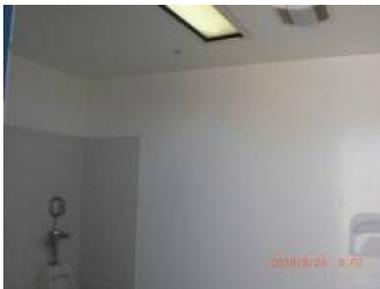
Keynote 327

Field Condition	
20.02 - Toilet, Bathroom, or Shower Room - Visual Alarms - Visual alarms are not provided at public or common use toilet, bathroom, or shower room.	1991 ADAAG 4.28.1
Existing Condition:	2004 ADAAG 215.1; Advisory 215.1; 702.1
	2007 CBC 907.9.1.1
	Other -

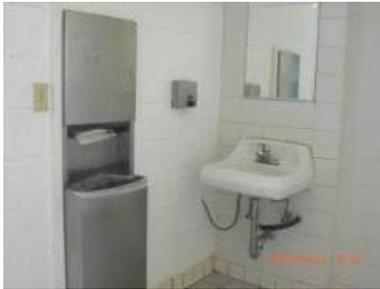
Location: Men's Restroom
Photo # 328

Field Condition	16.84A - Paper Towel Dispenser - Operating Height - Mounting height of paper towel dispenser's highest operable part exceeds 40" AFF. (Where provided, ADA Standards require at least one paper towel dispenser to be accessible with the highest operable part placed within at least one of the reach ranges specified in 4.2.5 and 4.2.6; where provided, CBC Standards require at least one paper towel dispenser to be accessible with the highest operable part no higher than 40" AFF.)	1991 ADAAG 4.22.7; 4.27.3; 4.2.5; 4.2.6
	Existing Condition: 42 1/2" high.	2004 ADAAG 308; 309
		2007 CBC 1115B.8.3
		Other -

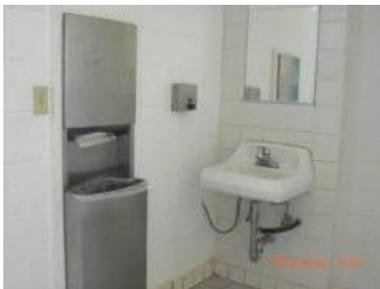
Keynote 329

Field Condition	16.84C - Soap Dispenser - Operating Height - Mounting height of soap dispenser's highest operable part exceeds 40" AFF. (Where provided, ADA Standards require at least one soap dispenser to be accessible with the highest operable part placed within at least one of the reach ranges specified in 4.2.5 and 4.2.6; where provided, CBC Standards require at least one soap dispenser to be accessible with the highest operable part no higher than 40" AFF.)	1991 ADAAG 4.22.7; 4.27.3; 4.2.5; 4.2.6
	Existing Condition: 46" high.	2004 ADAAG 308; 309
		2007 CBC 1115B.8.3
		Other -

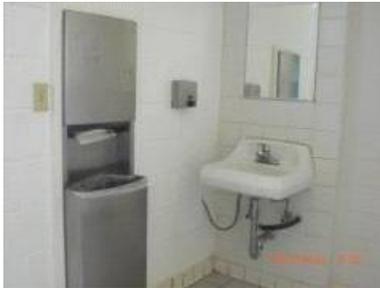
Keynote 330

16.82A - Mirror Height - Max. 40" AFF Standard - Mirror above accessible lavatory or countertop is mounted so the bottom edge of the reflective surface is not 40" max.. AFF. (ADA Standards require at least one mirror to be accessible; CBC Standards prior to August 1, 2009 required all mirrors to be accessible. Effective August 1, 2009, amended CBC Standards require all mirrors above accessible lavatories or countertops to be accessible.)

Existing Condition: 48 3/4" high.

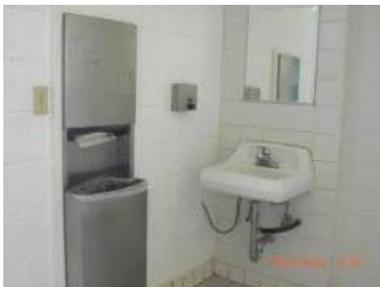
Keynote 331

16.76 - Lavatory - Clearance near Sidewall - The centerline of the lavatory is not 18" min.. from the nearest sidewall or partition.

Existing Condition: 16 1/2" from side wall.

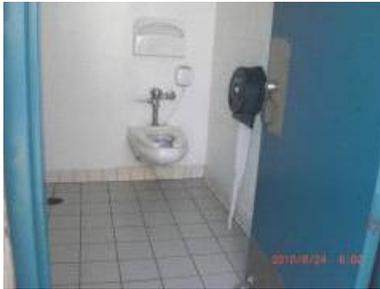
Keynote 334

16.50 - TP Dispenser - Location - Pre-2007 CBC Facility - Location of the toilet paper dispenser does not comply with the Standard in effect at the time of construction. (The 2001 CBC required toilet tissue dispensers located on the wall within 12" of the front edge of the toilet seat, measured to the centerline of the dispenser; mounted below the grab bar; and centered at a min. height of 19" AFF.)

Existing Condition: 18" from water closet.

325B - Replace Toilet Paper Dispenser - Remove existing toilet paper dispenser and provide a new dispenser 19" above finish floor and 12" from toilet face. The dispenser is recessed or projects no more than 3" from the wall. Patch and repair wall substrate and finishes, to match adjacent undist

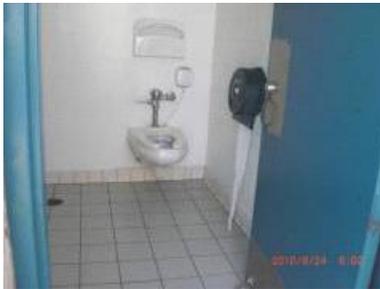
Keynote 335

14.30A - Wall-Mounted Protruding Objects - Wall-mounted object(s) with leading edges between 27 and 80" from the floor project more than 4" into the pathway. (Wall mounted objects with leading edges at or below 27" may project any amount as long as the required clear width of an accessible route is not reduced.)

Existing Condition: TPD protrudes 5 1/2" from wall at 29" high.

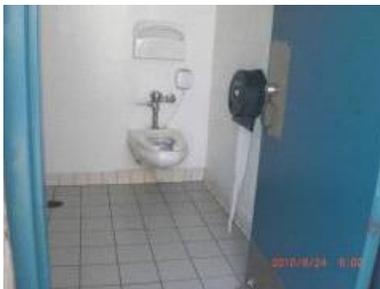
Keynote 337

Field Condition	
16.85A - Clear Floor Space at Dispensers - There is no clear floor space at least 30" x 48" in front of the dispenser to allow either a forward or a parallel approach to the dispenser. (Where provided, at least one dispenser of each type shall be accessible.)	1991 ADAAG 4.27.2; 4.2.4
Existing Condition: SCD above water closet.	2004 ADAAG 305.3
	2007 CBC 1117B.6(2); 1118B.4
	Other -

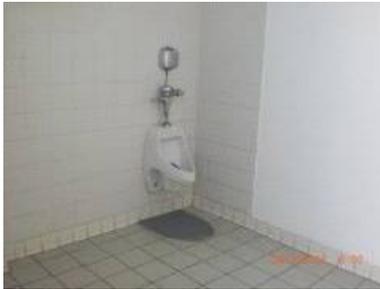
Keynote 340

Field Condition	
16.65B - Wall-Hung Urinal - Rim Height - Height of wall-hung urinal's rim exceeds 17" AFF. Existing Condition: 17 1/2" high.	1991 ADAAG 4.18.2 2004 ADAAG 605.2; Fig. 605.2(a) 2007 CBC 1115B.4.2(1) Other -

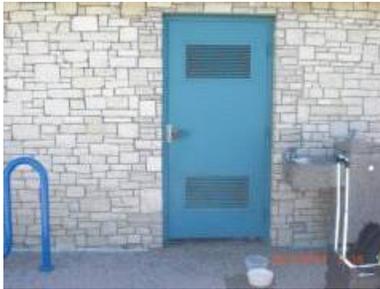
Keynote 342

Field Condition	
11.17A - Recommendation: Providing Room/Space ID Sign - A sign designating the permanent room or space has not been provided.	1991 ADAAG 4.1.2(7)
Existing Condition:	2004 ADAAG 216.2; 703.1; 703.2; 703.5
	2007 CBC 1117B.5.1 item 1
	Other -

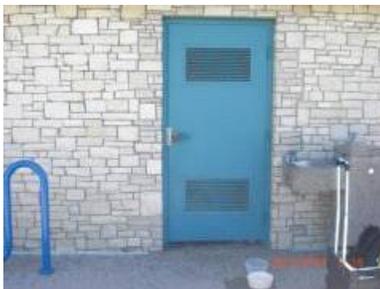
Field Condition	
10.09B - Threshold - Height - The threshold at doorway exceeds 1/2" in height.	1991 ADAAG 4.13.8
Existing Condition: 2 1/2" high.	2004 ADAAG 303.3; Advisory 303.3; Fig. 303.3
	2007 CBC 1133B.2.4.1
	Other -

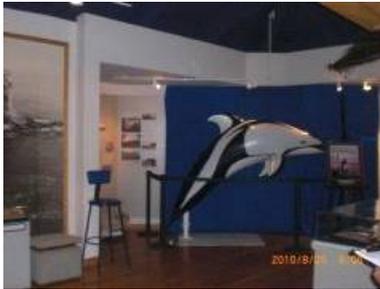
Location: Exhibit Room
Photo # 344

Field Condition	20.04 - Common Use Areas - Visual Alarms - Visual alarms are not provided in common use area(s) of the building such as meeting and conference rooms, open office space, classrooms, cafeterias, filing and photocopy rooms, employee break rooms, dressing, examination, and treatment rooms, and similar spaces that are not used solely as employee work areas.	1991 ADAAG 4.28.1
Existing Condition:		2004 ADAAG 215.2; 702.1
		2007 CBC 907.9.1.1
		Other -

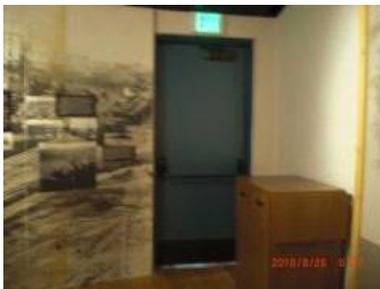
Location: Exhibit Room
Photo # 345

Field Condition	10.13A - Required Exit Door Sign - At grade level exterior exit door, there is no tactile and CA Braille exit sign with the word "EXIT" mounted on the wall adjacent to the latch side of the door.	1991 ADAAG 4.1.3(16); 4.30.1
Existing Condition:		2004 ADAAG 216.4; 703.2; 703.3; 703.4
		2007 CBC 1011.3 item 1
		Other -

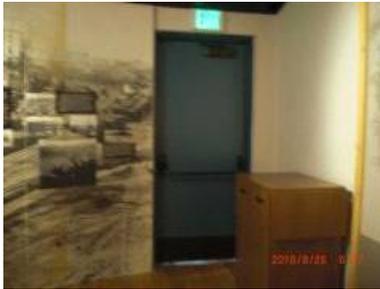
Keynote 346

10.06A - Door Maneuvering Space - Door that is not automatic or power-assisted does not have compliant maneuvering space relative to the direction of approach as shown in CBC Fig. 11B-26. (Approach // Side // Width // Depth) (Front // Pull // D + 24" * // 60") (Front // Push // D + 0" ** // 48") (Latch // Pull // D + 24" // 60") (Latch // Push // D + 24" // 44" ***) (Hinge // Pull // D + 36" // 60") (Hinge // Push // 54" **** // 44" *****) (* D + 18" at interior doors.) (** D + 12" if door has both a latch and a closer.) (***) 48" if door has closer.) (**** Measured from latch toward hinge.) (***** 48" if door has both a latch and a closer.)

Existing Condition: No strike side clearance due to exhibit wall.

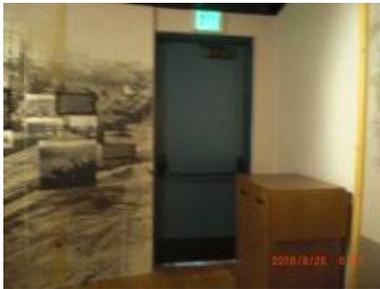
Keynote 348

Field Condition	
10.11A - Door Operating Effort - The force required to operate door exceeds 5 lbs. (Fire doors may have up to 15 lbs to achieve positive latching).	1991 ADAAG 4.13.11
Existing Condition: 14 LBF.	2004 ADAAG 404.2.9
	2007 CBC 1133B.2.5
	Other -

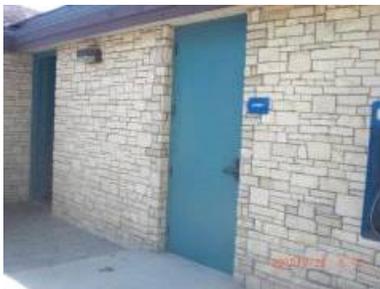
Location: Exhibit Room
Photo # 350

Field Condition	
10.07A - Landing - Level and Clear - Floor is not level (slope is greater than 2% in some or all directions). OR Floor is not clear within the required maneuvering space.	1991 ADAAG 4.13.6; Fig. 25
Existing Condition: 8.7% CS & 9.2% RS.	2004 ADAAG 305; 404.2.4.4
	2007 CBC 1133B.2.4
	Other -

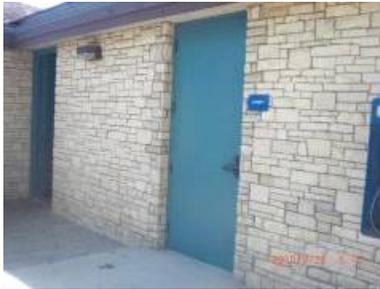
Keynote 351

Field Condition	
11.23B - Mounting Height (Visual/Tactile Signs) - Sign is not mounted at 60" o.c. AFF to the centerline of the sign. (If the sign contains pictorial symbols (pictograms) or other non-tactile information, mounting height is measured to the centerline of the tactile characters / Braille portion of the sign.)	1991 ADAAG 4.30.6
Existing Condition: 59" high.	2004 ADAAG 703.4.1
	2007 CBC 1117B.5.7
	Other -

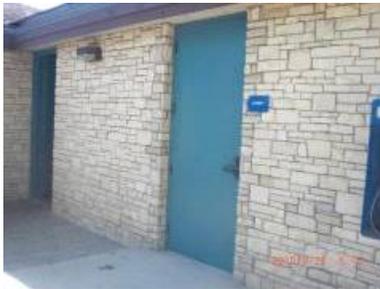
Keynote 352

Field Condition	
11.25A - Raised Characters and Braille (Visual/Tactile Signs) - The raised characters on this sign are not accompanied by California Grade 2 Braille (California Grade 2 Braille requires the dots within each cell to be domed and spaced 1/10" o.c.)	1991 ADAAG 4.30.4
Existing Condition: Bad Braille.	2004 ADAAG 703.2; 703.3
	2007 CBC 1117B.5.5 item 1, 1117B.5.6
	Other -

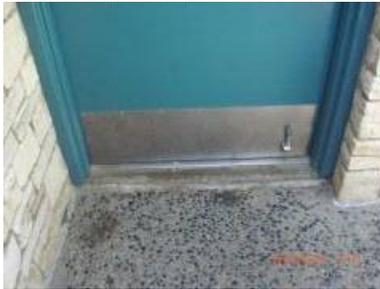
Keynote 353

Field Condition	
16.88 - Other - Toilet Facilities - See Additional Comments	1991 ADAAG -
Existing Condition: Door stop.	2004 ADAAG -
	2007 CBC -
	Other -

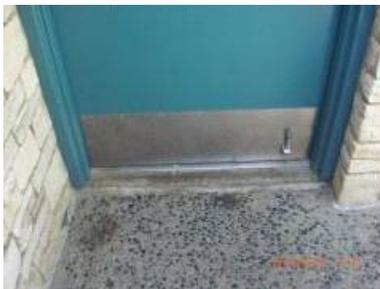
Keynote 354

Field Condition	
16.88 - Other - Toilet Facilities - See Additional Comments	1991 ADAAG -
Existing Condition: 3/4" threshold.	2004 ADAAG -
	2007 CBC -
	Other -

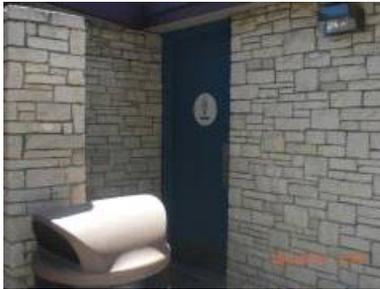
Keynote 355

Field Condition	
16.15A - Providing Room/Space ID Sign - A sign designating the permanent room or space has not been provided.	1991 ADAAG 4.30.1
Existing Condition:	2004 ADAAG 216.2; 703.1; 703.2; 703.5
	2007 CBC 1117B.5.1(1)
	Other -

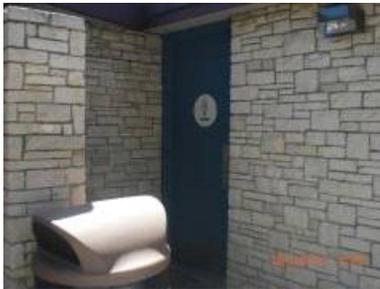
Keynote 356

Field Condition	
16.18A - ISA - Accessible toilet room is not identified by an ISA.	1991 ADAAG 4.1.3(16)(b)
Existing Condition:	2004 ADAAG 216.8
	2007 CBC 1117B.5.1(3)
	Other -

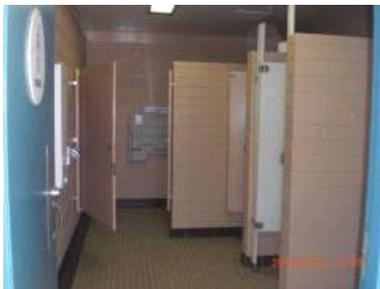
Keynote 358

Field Condition	
20.02 - Toilet, Bathroom, or Shower Room - Visual Alarms - Visual alarms are not provided at public or common use toilet, bathroom, or shower room.	1991 ADAAG 4.28.1
Existing Condition:	2004 ADAAG 215.1; Advisory 215.1; 702.1
	2007 CBC 907.9.1.1
	Other -

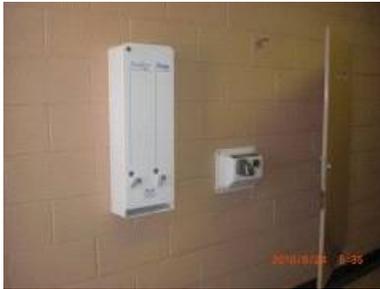
Keynote 359

Field Condition	
14.30A - Wall-Mounted Protruding Objects - Wall-mounted object(s) with leading edges between 27 and 80" from the floor project more than 4" into the pathway. (Wall mounted objects with leading edges at or below 27" may project any amount as long as the required clear width of an accessible route is not reduced.)	1991 ADAAG 4.4.1
Existing Condition: FND protrudes 5 1/2" at 35" high.	2004 ADAAG 307.2; Fig. 307.2
	2007 CBC 1133B.8.6.1
	Other -

Corrective Action
292 - Relocate Sanitary Napkin/ Feminine Hygiene Dispenser - Women's Restroom - Relocate existing sanitary napkin/feminine hygiene dispenser so height of operating handles is no higher than 40" above finish floor. Patch and repair wall substrate and finishes, to match adjacent undisturbed surfaces.
Additional Comments:

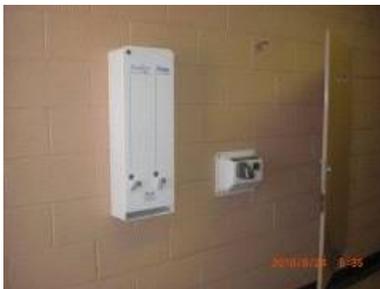
Keynote 360

Field Condition	
14.30A - Wall-Mounted Protruding Objects - Wall-mounted object(s) with leading edges between 27 and 80" from the floor project more than 4" into the pathway. (Wall mounted objects with leading edges at or below 27" may project any amount as long as the required clear width of an accessible route is not reduced.)	1991 ADAAG 4.4.1
Existing Condition: Hand dryer protrudes 7 1/2" at 39" high.	2004 ADAAG 307.2; Fig. 307.2
	2007 CBC 1133B.8.6.1
	Other -

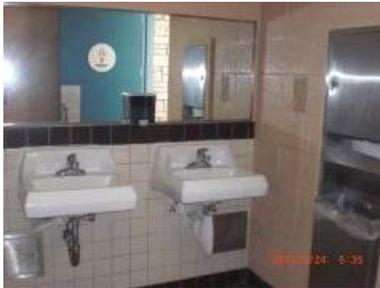
Keynote 361

Field Condition	16.84C - Soap Dispenser - Operating Height - Mounting height of soap dispenser's highest operable part exceeds 40" AFF. (Where provided, ADA Standards require at least one soap dispenser to be accessible with the highest operable part placed within at least one of the reach ranges specified in 4.2.5 and 4.2.6; where provided, CBC Standards require at least one soap dispenser to be accessible with the highest operable part no higher than 40" AFF.)	1991 ADAAG 4.22.7; 4.27.3; 4.2.5; 4.2.6
	Existing Condition: 43" high.	2004 ADAAG 308; 309
		2007 CBC 1115B.8.3
		Other -

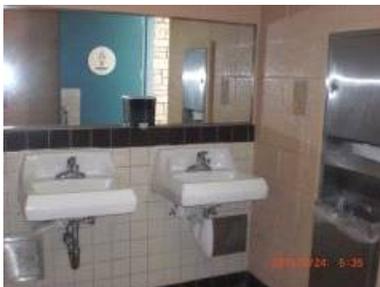
Keynote 362

Field Condition	16.82A - Mirror Height - Max. 40" AFF Standard - Mirror above accessible lavatory or countertop is mounted so the bottom edge of the reflective surface is not 40" max.. AFF. (ADA Standards require at least one mirror to be accessible; CBC Standards prior to August 1, 2009 required all mirrors to be accessible. Effective August 1, 2009, amended CBC Standards require all mirrors above accessible lavatories or countertops to be accessible.)	1991 ADAAG 4.19.6; Fig. 31
	Existing Condition: 43 3/4" high.	2004 ADAAG 213.3.5; 603.3; Advisory 603.3
		2007 CBC 1115B.8.1
		Other -

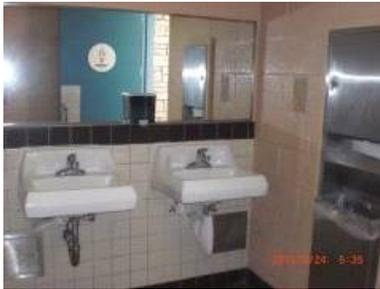
Keynote 363

Field Condition	
16.76 - Lavatory - Clearance near Sidewall - The centerline of the lavatory is not 18" min.. from the nearest sidewall or partition.	1991 ADAAG -
Existing Condition: 17 1/8" from side wall.	2004 ADAAG -
	2007 CBC 1115B.4.3(2); Fig 11B-1D
	Other -

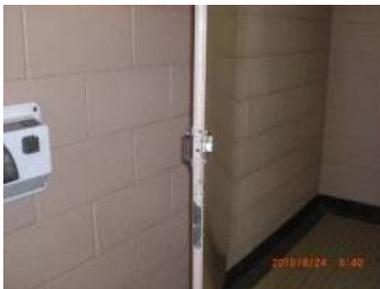
Keynote 364

Field Condition	
16.32A - U-Pulls at Stall Door - The stall door does not have U-pulls on both sides.	1991 ADAAG 4.13.9; 4.17.5
Existing Condition: U-pulls not on both sides.	2004 ADAAG 309.4; 404.27; 604.8.1.2
	2007 CBC 1115B.3.1(4.4)
	Other -

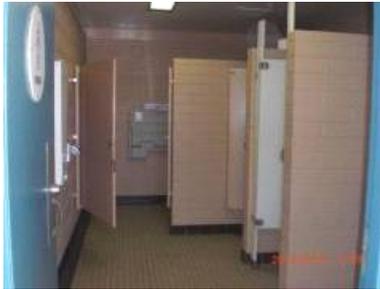
Keynote 365

Field Condition	
16.33 - Self-Closing Stall Door - The stall door is not self-closing.	1991 ADAAG 4.13.10
Existing Condition:	2004 ADAAG 604.8.1.2
	2007 CBC 1115B.3.1(4.4)
	Other -

Corrective Action	
316D - Self-Closing Stall Door - Replace existing stall door spring hinges or closer with new self-closing hardware.	
Additional Comments:

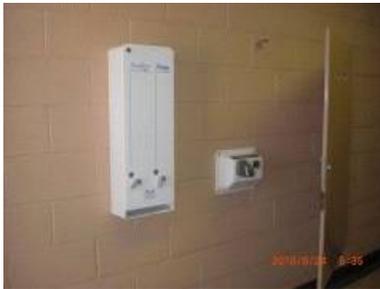
Keynote 366

Field Condition	
16.83 - Coat Hook - Height - Where a coat hook is provided In an accessible stall, height of coat hook exceeds 48" AFF.	1991 ADAAG 4.2.5
Existing Condition: 60 1/2" high.	2004 ADAAG 213.3.7; 308; 603.4
	2007 CBC 1117B.8
	Other -

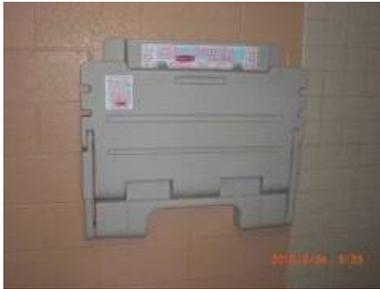
Keynote 367

Field Condition	
16.84F - Diaper Changing Table - Operating Height - Mounting height of diaper changing table's highest operable part exceeds 40" AFF. (Where provided, at least one shall be accessible.)	1991 ADAAG 4.27.3
Existing Condition: 52" high.	2004 ADAAG 308; 309
	2007 CBC -
	Other -

Corrective Action
337 - Toilet and Bathing Rooms - Miscellaneous - See Additional Comments
Additional Comments: Replace diaper changing table.

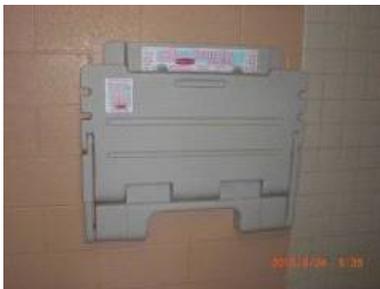
Keynote 368

Field Condition	
16.84G - Diaper Changing Table - Table Surface Height - Height of diaper changing table surface is not between 28" to 34" AFF. (Where provided, at least one shall be accessible.)	1991 ADAAG 4.1.3(18), 4.32.4
Existing Condition: 35 1/2" high.	2004 ADAAG 308; 309
	2007 CBC 1122B.1, 1122B.4
	Other -

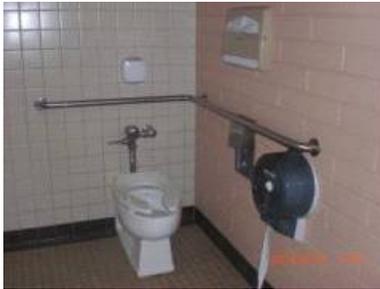
Keynote 369

Field Condition
 16.36A - Stall Width - The stall is less than 60" wide.
 Existing Condition: 57" wide.

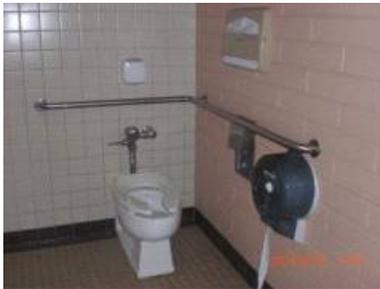
Keynote 370

Field Condition
 16.53 - SC Dispenser Height - Mounting height of seat cover dispenser's highest operable part exceeds 40" AFF.
 Existing Condition: 52" high.

Corrective Action
 324 - Replace Seat Cover Dispenser - Remove existing toilet seat cover dispenser and replace with new dispenser.
 Additional Comments: Lower and relocate.

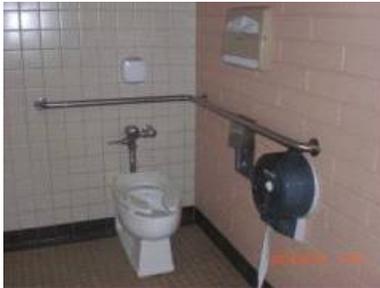
Keynote 371

16.50 - TP Dispenser - Location - Pre-2007 CBC Facility - Location of the toilet paper dispenser does not comply with the Standard in effect at the time of construction. (The 2001 CBC required toilet tissue dispensers located on the wall within 12" of the front edge of the toilet seat, measured to the centerline of the dispenser; mounted below the grab bar; and centered at a min. height of 19" AFF.)

Existing Condition: TPD 24" from WC, and 12" above floor.

325B - Replace Toilet Paper Dispenser - Remove existing toilet paper dispenser and provide a new dispenser 19" above finish floor and 12" from toilet face. The dispenser is recessed or projects no more than 3" from the wall. Patch and repair wall substrate and finishes, to match adjacent undist

Additional Comments: Replace and relocate.

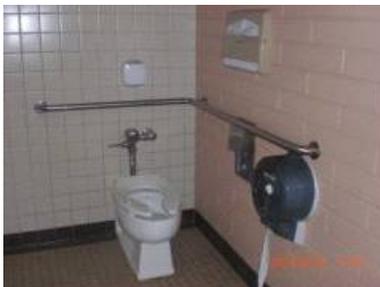
Keynote 372

16.56 - Grab Bar Wall Clearance - The space between the grab bar and the wall is not 1-1/2" absolute.

Existing Condition: 1 3/4".

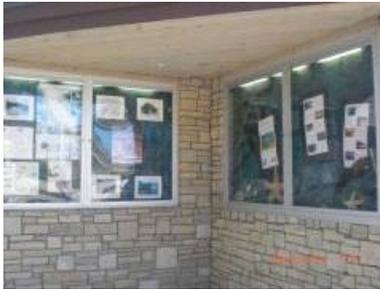
Keynote 379

Field Condition									
14.35 - Controls - Operation - The controls are not accessible. (Accessible controls shall be operable with one hand, and without tight grasping, pinching, or twisting of the wrist, and the force to operate the controls shall be no greater than 5 lbs.)

1991 ADAAG	4.27.4	2004 ADAAG	309.4	2007 CBC	1117B.6(4)	Other	-
1991 ADAAG	4.27.4								
2004 ADAAG	309.4								
2007 CBC	1117B.6(4)								
Other	-								
Existing Condition: Not single action at display.

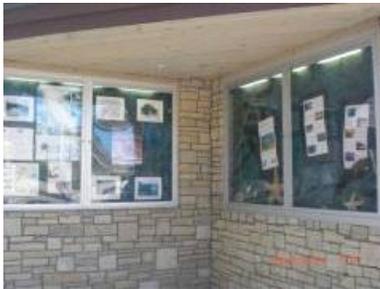
Keynote 380

Field Condition									
14.32A - Reach Range - Controls - Controls, dispensers, and similar devices are not between 9" and 54" AFF when the clear floor space allows a parallel approach. OR They are not between 15" and 48" AFF when the clear floor space allows only a forward approach.

1991 ADAAG	4.1.3(13); 4.27.3; 4.2.5; 4.2.6 ; Fig. 5; Fig. 6	2004 ADAAG	-	2007 CBC	1117B.6(3); 1118.5; 1118.6; Fig. 11B-5C; Fig. 11B-5D	Other	-
1991 ADAAG	4.1.3(13); 4.27.3; 4.2.5; 4.2.6 ; Fig. 5; Fig. 6								
2004 ADAAG	-								
2007 CBC	1117B.6(3); 1118.5; 1118.6; Fig. 11B-5C; Fig. 11B-5D								
Other	-								
Existing Condition: 65" to hardware.
