City of Rancho Palos Verdes
Rancho Palos Verdes ADA Assessment
Facility Report with Photos

Reporting: 325 of 4367 Rcds

Facility ID: # 12 - Robert E. Ryan Park

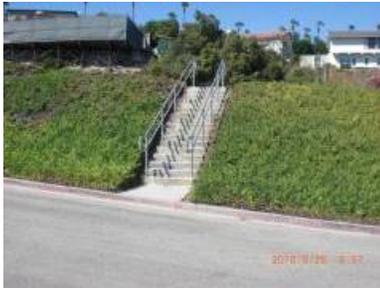
Keynote 3

Field Condition	
08.05A - Exterior Stairs - Color Strip - Contrasting color strips have not been provided.	1991 ADAAG -
Existing Condition: No stripes.	2004 ADAAG -
	2007 CBC 1133B.4.4
	Other -

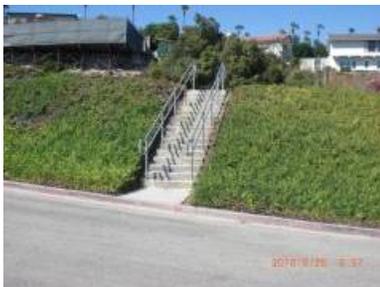
Keynote 4

Field Condition	
08.10A - Profile of Handrails - The diameter of the handrail is not between 1-1/4" and 1-1/2" in cross-sectional nominal dimension. OR The shape does not provide an equivalent gripping surface (equivalent gripping surfaces are 4" to 6-1/4" in perimeter, and 2-1/4" max. in any direction). (Note: Standard pipe sizes designated by the industry as 1-1/4" to 1-1/2" are acceptable).	1991 ADAAG 4.9.4; 4.26.2
Existing Condition: 2" profile.	2004 ADAAG 505.7.1; 505.7.2; Fig. 505.7.2
	2007 CBC 1133B.4.2.6
	Other -

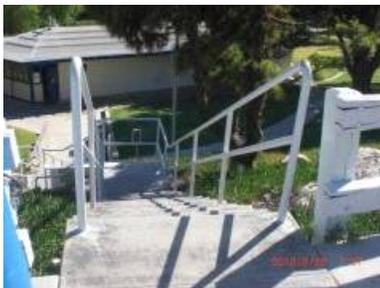
Keynote 7

Existing Condition: 1.4% CS & 4.7% RS at top landing.

008 - Concrete Landing - Remove non-compliant pavement and replace with new concrete. The landing slope shall not exceed 2% in any direction.
Additional Comments:

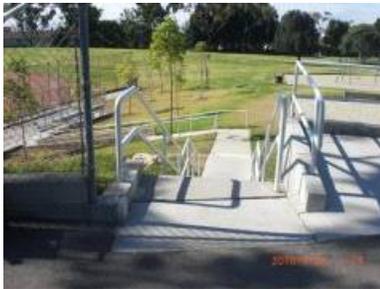
Keynote 62

Field Condition	
03B.13 - > 1/2" Changes in Level - Curb ramps, ramps, or elevators are not used for changes in level greater than 1/2 inch. (Lifts may only be used in certain limited situations.)	1991 ADAAG 4.5.2
Existing Condition: 1" level change.	2004 ADAAG 303.4
	2007 CBC 1124B.2
	Other -

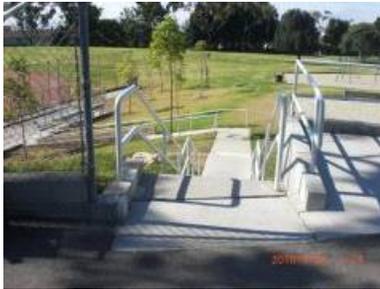
Keynote 65

Field Condition	
08.09A - Handrail Extensions - Top Landing - At ends of handrails, less than 12" of handrail extends beyond the top nosing. (Top and bottom handrail extensions are important safety features for persons with balance problems and must extend in the direction of the stair run to permit the intended use.) (Per ADA/CBC Standards, in existing buildings and facilities, full extension of handrails at stairs shall not be required in alterations where such extensions would be hazardous or impossible due to plan configuration.)	1991 ADAAG 4.9.4(2) 2004 ADAAG 505.10; 505.10.2; Fig. 505.10.2 2007 CBC 1133B.4.2.2 Other -
Existing Condition: Top handrail extensions at 10".

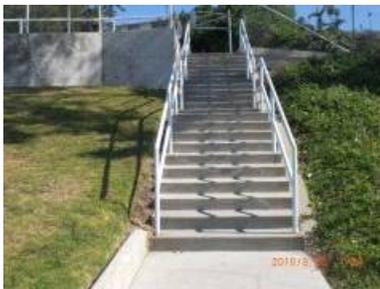
Keynote 66

Field Condition	
08.10A - Profile of Handrails - The diameter of the handrail is not between 1-1/4" and 1-1/2" in cross-sectional nominal dimension. OR The shape does not provide an equivalent gripping surface (equivalent gripping surfaces are 4" to 6-1/4" in perimeter, and 2-1/4" max. in any direction). (Note: Standard pipe sizes designated by the industry as 1-1/4" to 1-1/2" are acceptable).	1991 ADAAG 4.9.4; 4.26.2 2004 ADAAG 505.7.1; 505.7.2; Fig. 505.7.2 2007 CBC 1133B.4.2.6 Other -
Existing Condition: 2" profile.

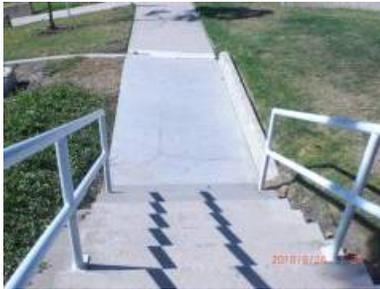
Keynote 69

Field Condition	
08.03D - Level Landing - Landing is not level (slope is greater than 2% in some or all directions).	1991 ADAAG -
Existing Condition: 6.5% RS at bottom landing.	2004 ADAAG -
	2007 CBC 1009.5.1
	Other -

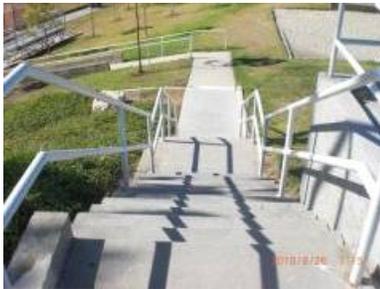
Keynote 70

Field Condition	
08.07A - Continuous Handrails - Continuous handrails are not provided along both sides.	1991 ADAAG 4.9.4
Existing Condition: Non continuous at intermediate landing.	2004 ADAAG 504.6; 505.2
	2007 CBC 1133B.4.1.1
	Other -

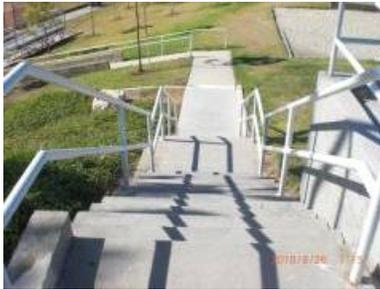
Keynote 71

Field Condition	
08.09E - Handrails - Height above Stair Nosings - The tops of handrails are not between 34" and 38" above the stair nosings.	1991 ADAAG 4.9.4(5)
Existing Condition: Handrails at 31" H.	2004 ADAAG 505.4; Advisory 505.4; Fig. 505.4
	2007 CBC 1133B.4.2.1
	Other -

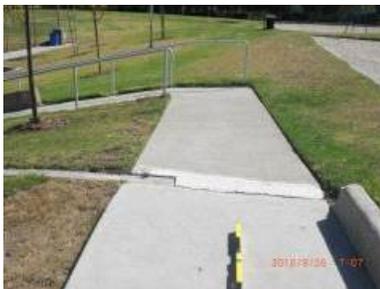
Keynote 72

Field Condition	
03B.09 - Cross Slope - Cross slope of the accessible route of travel exceeds 1:50.	1991 ADAAG 4.3.7
Existing Condition: 3.5% to 11.2% CS.	2004 ADAAG 403.3
	2007 CBC 1133B.7.1.3
	Other -

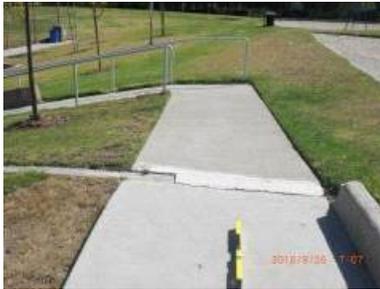
Keynote 73

Field Condition									
03B.10 - Running Slope - Slope of the accessible route of travel exceeds 1:20. Existing Condition: 7.3% and 10.8% RS.

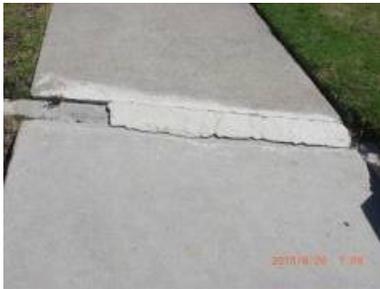
Keynote 74

Field Condition									
03B.13 - > 1/2" Changes in Level - Curb ramps, ramps, or elevators are not used for changes in level greater than 1/2 inch. (Lifts may only be used in certain limited situations.) Existing Condition: 1/2" level change.

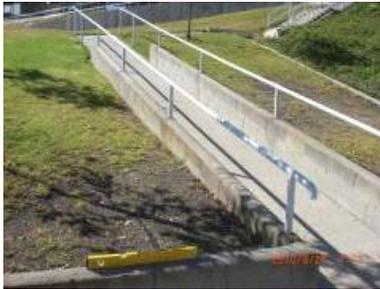
Keynote 75

Field Condition	
30.03 - Route for General Public - Accessible route of travel, to the maximum extent feasible, does not coincide with the route for the general public. (Elements such as ramps, elevators, or other circulation devices, shall be placed to minimize the distance which wheelchair users and other persons who cannot negotiate steps may have to travel compared to the general public.)	1991 ADAAG 4.3.2(1)
Existing Condition: No accessible P.O.T. from lower area (Baseball Field) to accessible parking lot.	2004 ADAAG 206.3;Advisory206.3
	2007 CBC 1114B.1.2
	Other -

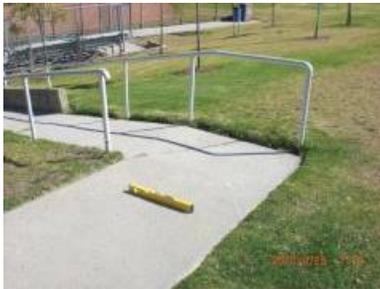
Keynote 76

Field Condition	
07.08 - Top Landing - Size - Top landing is less than 60" x 60".	1991 ADAAG 4.8.4(1)
Existing Condition: No top landing.	2004 ADAAG 405.7.4
	2007 CBC 1133B.5.4.2
	Other -

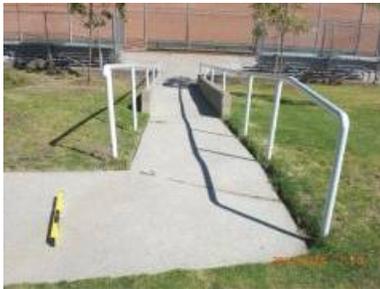
Keynote 78

Field Condition	
07.23 - Profile of Handrails - The diameter of the handrail is not between 1-1/4" and 1-1/2" in cross-sectional nominal dimension. OR The shape does not provide an equivalent gripping surface (i.e. 4" to 6-1/4" perimeter, and 2-1/4" max. in any direction). (Note: Standard pipe sizes designated by the industry as 1-1/4" to 1-1/2" are acceptable).	1991 ADAAG 4.8.5; 4.26.2; Fig. 39
Existing Condition: 2" profile.	2004 ADAAG 505.7.1; 505.7.2; Fig. 505.7.2
	2007 CBC 1133B.5.5.1
	Other -

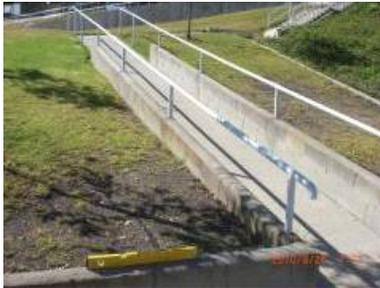
Keynote 79

Field Condition	
07.21A - Extensions - Required Length - At ends of handrails, less than 12" of handrail extends beyond the top and bottom of the ramp segment. (Top and bottom handrail extensions are important safety features for persons with mobility impairments and must extend in the direction of the ramp run to permit the intended use.) (Per CBC 1133B.5.5.1.1, in existing buildings or facilities, where the extension of the handrail in the direction of the ramp run would create a hazard, the extension on the handrail may be turned 90 degrees to the run of the ramp.)	1991 ADAAG 4.8.5 (2) 2004 ADAAG 505.10; 505.10.1; Fig. 505.10.1 2007 CBC 1133B.5.5.1; 1133B.5.5.1.1 Other -
Existing Condition: No top and bottom extensions.

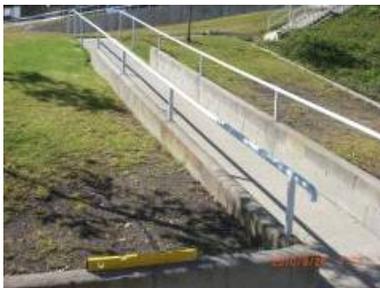
Keynote 80

Field Condition	
07.02 - Running Slope - Slope of the ramp exceeds 8.33% (or the least possible compliant slope).	1991 ADAAG 4.8.2 2004 ADAAG 405.2; Advisory 405.2 2007 CBC 1133B.5.3 Other -
Existing Condition: 24.4% and 25% RS.

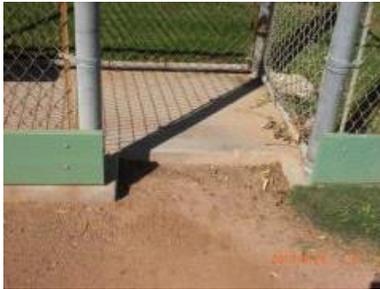
Keynote 83

Field Condition	
03B.13 - > 1/2" Changes in Level - Curb ramps, ramps, or elevators are not used for changes in level greater than 1/2 inch. (Lifts may only be used in certain limited situations.)	1991 ADAAG 4.5.2
Existing Condition: 5" step.	2004 ADAAG 303.4
	2007 CBC 1124B.2
	Other -

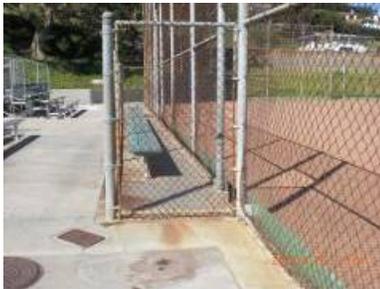
Keynote 84

Field Condition	
30.14 - Fixed Benches on Accessible Route - Less than 40% of the fixed benches required to be accessible are along an accessible route of travel.	1991 ADAAG -
Existing Condition:	2004 ADAAG -
	2007 CBC -
	Other 1999 ADAAG-16.12.2.2

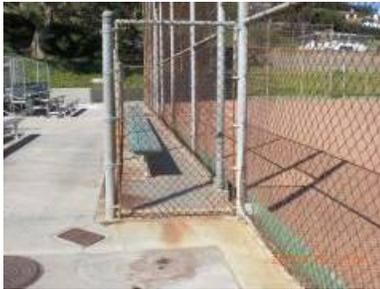
Keynote 85

Field Condition	
30.12 - Fixed Bench - Fixed bench is not accessible for users with various types of disabilities.	1991 ADAAG -
Existing Condition:	2004 ADAAG 903.1
	2007 CBC -
	Other 1999 ADAAG-16.12.2.1

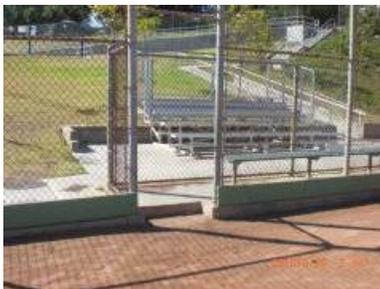
Keynote 86

Field Condition	
30.16 - Fixed Bench / Wheelchair Seating Space - Shoulder Alignment - A clear space at least 30" x 48" in size has not been provided at one end of the fixed bench so that a wheelchair user may be seated shoulder-to-shoulder with an individual seated on the bench.	1991 ADAAG -
Existing Condition:	2004 ADAAG -
	2007 CBC -
	Other 1999 ADAAG-16.12.4

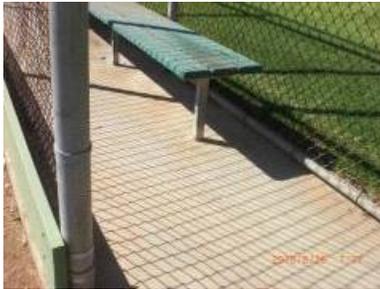
Keynote 87

Field Condition	
30.19 - Fixed Bench Height - The height of the front edge of the seating surface is not between 17" and 19" above the adjacent grade or floor space.	1991 ADAAG -
Existing Condition: Bench at 16 3/4" high.	2004 ADAAG 903.5
	2007 CBC -
	Other 1999 ADAAG-16.12.3

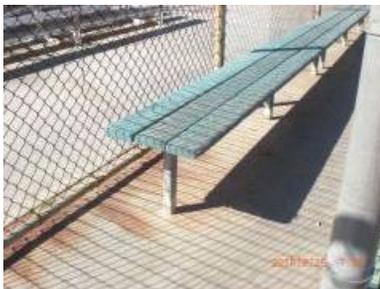
Keynote 88

Field Condition	
30.20 - Fixed Bench - Back Support - Back support is not provided along the full length of the accessible bench.	1991 ADAAG -
Existing Condition:	2004 ADAAG 903.4
	2007 CBC -
	Other 1999 ADAAG-16.12.5

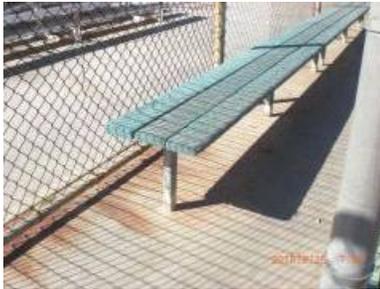
Keynote 89

Field Condition	
30.21 - Fixed Bench Size - Accessible bench does not have seats that are 20" to 24" in depth and 42" min. in length. OR The back support does not extend from a point 2" maximum above the bench to 18" min. above the bench.	1991 ADAAG -
Existing Condition: Bench at 17" deep.	2004 ADAAG 903.3
	903.4 Fig.
	903.4
	2007 CBC -
	Other -

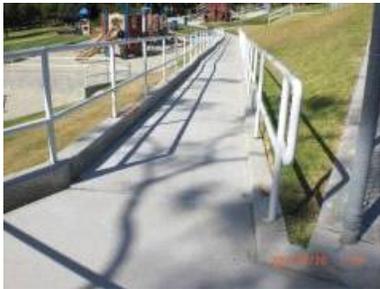
Keynote 91

Field Condition									
07.04 - Cross Slope - Cross slope of the ramp surface exceeds 2%. Existing Condition: 4.2% CS.

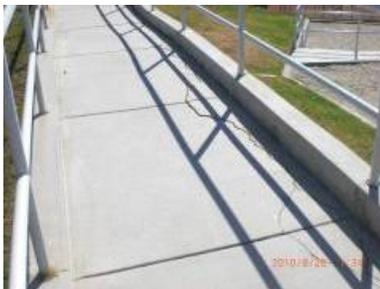
Keynote 93

Field Condition	
07.29 - Other - Ramps - See Additional Comments	1991 ADAAG -
Existing Condition: Level change. Cracked surface.	2004 ADAAG -
	2007 CBC -
	Other -

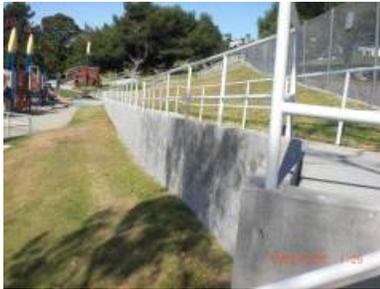
Keynote 94

Field Condition	
07.14B - Guards - Where drop exceeds 30", a min.. 42" high guard has not been provided as a vertical barrier along the open edges of ramp or landing to prevent persons from falling off the open edge.	1991 ADAAG 4.8.7
Existing Condition: 48" drop. Guardrail at 35 1/2" H.	2004 ADAAG 405.9; 405.9.2
	2007 CBC 1013; 1133B.5.7
	Other -

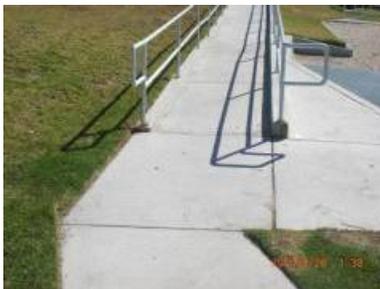
Keynote 95

Field Condition	
07.07A - Level Landings - Landings at the top or bottom of each ramp or each ramp run is not level (slope is greater than 2% in some or all directions).	1991 ADAAG 4.8.4
Existing Condition: 2.1% and 2.6% CS at bottom landing.	2004 ADAAG 405.7; 405.7.1
	2007 CBC 1133B.5.4.1
	Other -

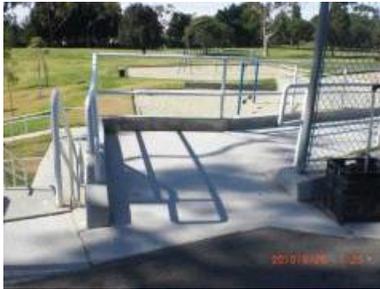
Keynote 96

Field Condition	
07.08 - Top Landing - Size - Top landing is less than 60" x 60".	1991 ADAAG 4.8.4(1)
Existing Condition:	2004 ADAAG 405.7.4
	2007 CBC 1133B.5.4.2
	Other -

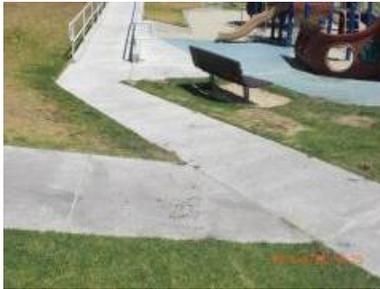
Keynote 100

Field Condition									
03B.09 - Cross Slope - Cross slope of the accessible route of travel exceeds 1:50. Existing Condition: 2.5% CS.

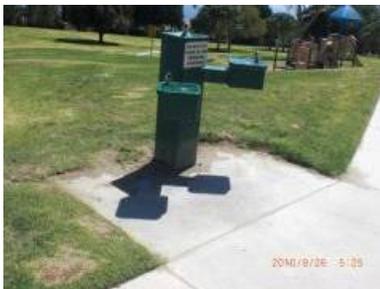
Keynote 101

Field Condition									
05.04 - Depth - Drinking fountain is not 18" min.. to 19" max.. in depth. Existing Condition: Drinking fountain at 17" deep.

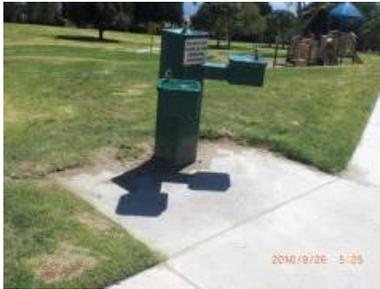
Keynote 102

Field Condition	
05.05A - Knee Space Height - Drinking fountain provides less than 27" high accessible knee clearance between the bottom of the apron and the floor.	1991 ADAAG 4.15.5(1); Figs. 27(a) and (b)
Existing Condition: Knee at 26 3/4" H.	2004 ADAAG 306.3; Fig. 306.3
	2007 CBC 1115B.4.6 item 2
	Other -

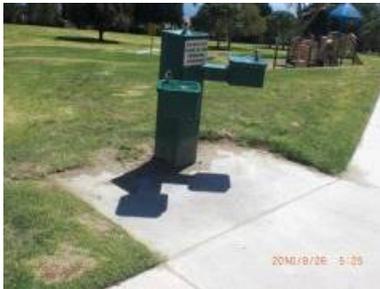
Location: Path
Photo # 101

Field Condition	
05.07 - Clear Floor Space - Drinking fountain does not have a 30" x 48" clear floor space that adjoins or overlaps an accessible route of travel and that allows a forward approach by wheelchair users. (A side approach is not acceptable.)	1991 ADAAG 4.15.5(1); Figs. 27(c) and (d)
Existing Condition:	2004 ADAAG 305.1
	2007 CBC 1115B.4.6 item 2
	Other -

Corrective Action
006 - Concrete Walk - Remove non-compliant pavement and replace with new concrete (area as shown on the drawings). The walkway slope shall not exceed 5% along the POT and cross slope shall not exceed 2%.
Additional Comments: Provide concrete walk at drinking fountain to provide required clear floor space.

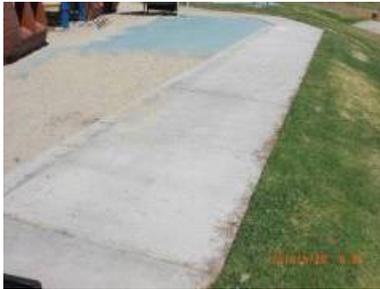
Field Condition									
03B.09 - Cross Slope - Cross slope of the accessible route of travel exceeds 1:50. Existing Condition: 2.8% to 4.2% CS.

Corrective Action	
006 - Concrete Walk - Remove non-compliant pavement and replace with new concrete (area as shown on the drawings). The walkway slope shall not exceed 5% along the POT and cross slope shall not exceed 2%.	
Additional Comments:

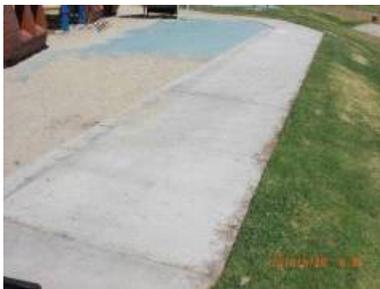
Field Condition									
03B.13 - > 1/2" Changes in Level - Curb ramps, ramps, or elevators are not used for changes in level greater than 1/2 inch. (Lifts may only be used in certain limited situations.) Existing Condition: 1/2" level change. 10 LF.

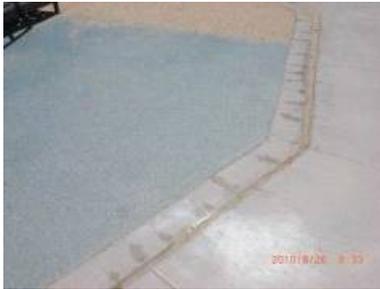
Field Condition	
03B.22 - Other - On-Site Accessible Path of Travel - See Additional Comments	1991 ADAAG -
Existing Condition: 3/4" gap. 50 LF.	2004 ADAAG -
	2007 CBC -
	Other -

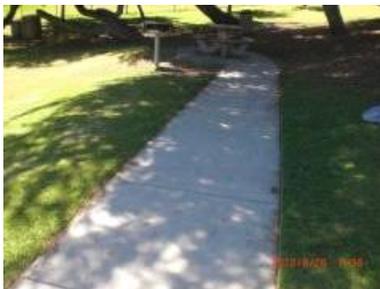
Field Condition	
03B.09 - Cross Slope - Cross slope of the accessible route of travel exceeds 1:50.	1991 ADAAG 4.3.7
Existing Condition: 4.2% to 6.0% CS.	2004 ADAAG 403.3
	2007 CBC 1133B.7.1.3
	Other -

Corrective Action	
006 - Concrete Walk - Remove non-compliant pavement and replace with new concrete (area as shown on the drawings). The walkway slope shall not exceed 5% along the POT and cross slope shall not exceed 2%.	
Additional Comments:

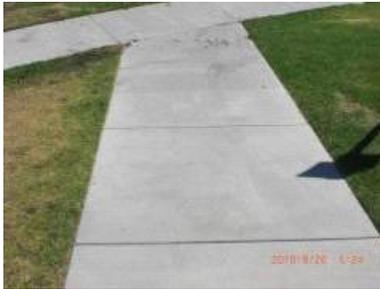
03B.09 - Cross Slope - Cross slope of the accessible route of travel exceeds 1:50. **1991 ADAAG** 4.3.7

Existing Condition: 2.8% to 7.9% CS.

006 - Concrete Walk - Remove non-compliant pavement and replace with new concrete (area as shown on the drawings). The walkway slope shall not exceed 5% along the POT and cross slope shall not exceed 2%.

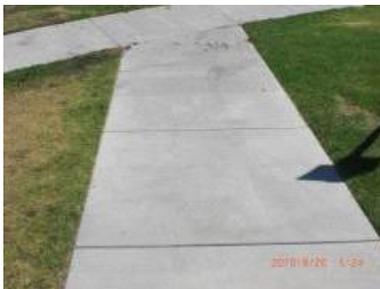
03B.10 - Running Slope - Slope of the accessible route of travel exceeds 1:20. **1991 ADAAG** 4.3.7

Existing Condition: 11.7% and 12.4% RS.

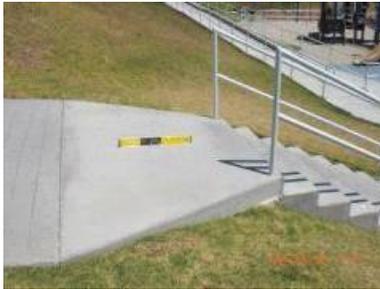
Field Condition	
08.03D - Level Landing - Landing is not level (slope is greater than 2% in some or all directions).	1991 ADAAG -
Existing Condition: 10.1% CS & 1.2% RS at top landing.	2004 ADAAG -
	2007 CBC 1009.5.1
	Other -

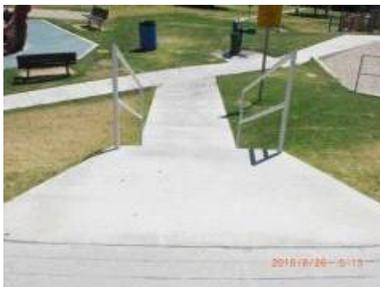
Field Condition	
08.09A - Handrail Extensions - Top Landing - At ends of handrails, less than 12" of handrail extends beyond the top nosing. (Top and bottom handrail extensions are important safety features for persons with balance problems and must extend in the direction of the stair run to permit the intended use.) (Per ADA/CBC Standards, in existing buildings and facilities, full extension of handrails at stairs shall not be required in alterations where such extensions would be hazardous or impossible due to plan configuration.)	1991 ADAAG 4.9.4(2)
Existing Condition: No extensions.	2004 ADAAG 505.10; 505.10.2; Fig. 505.10.2
	2007 CBC 1133B.4.2.2
	Other -

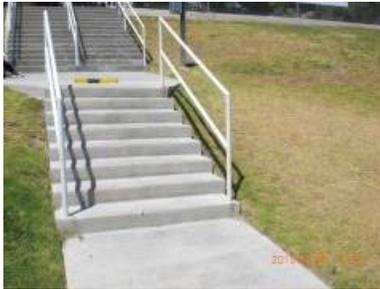
Location: Stairway
Photo # 112

Field Condition	08.09B - Handrail Extensions - Bottom Landing - At ends of handrails, less than 12" plus the tread width extends beyond the bottom nosing. (Top and bottom handrail extensions are important safety features for persons with balance problems and must extend in the direction of the stair run to permit the intended use.) (Per ADA/CBC Standards, in existing buildings and facilities, full extension of handrails at stairs shall not be required in alterations where such extensions would be hazardous or impossible due to plan configuration.)	1991 ADAAG 4.9.4(2)
	Existing Condition:	2004 ADAAG 505.10; 505.10.3; Fig. 505.10.3
		2007 CBC 1133B.4.2.2
		Other -

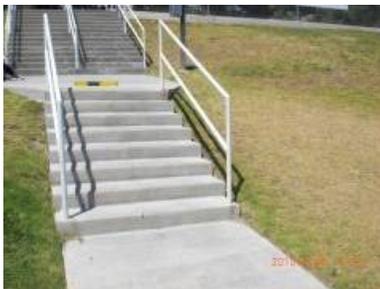
Location: Stairway
Photo # 112

Field Condition	08.05A - Exterior Stairs - Color Strip - Contrasting color strips have not been provided.	1991 ADAAG -
	Existing Condition: No stripes.	2004 ADAAG -
		2007 CBC 1133B.4.4
		Other -

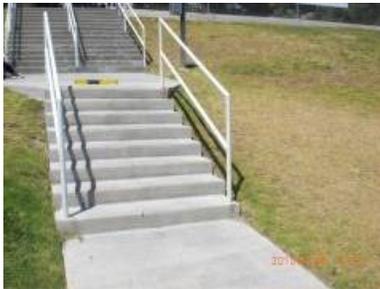
Location: Stairway
Photo # 112

Field Condition	
08.03D - Level Landing - Landing is not level (slope is greater than 2% in some or all directions).	1991 ADAAG -
Existing Condition: 9.4% RS at bottom landing.	2004 ADAAG -
	2007 CBC 1009.5.1
	Other -

Corrective Action
008 - Concrete Landing - Remove non-compliant pavement and replace with new concrete. The landing slope shall not exceed 2% in any direction.
Additional Comments:

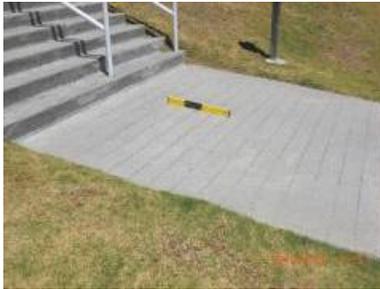
Field Condition	
08.03D - Level Landing - Landing is not level (slope is greater than 2% in some or all directions).	1991 ADAAG -
Existing Condition: 12.2% RS at bottom landing.	2004 ADAAG -
	2007 CBC 1009.5.1
	Other -

Corrective Action
008 - Concrete Landing - Remove non-compliant pavement and replace with new concrete. The landing slope shall not exceed 2% in any direction.
Additional Comments:

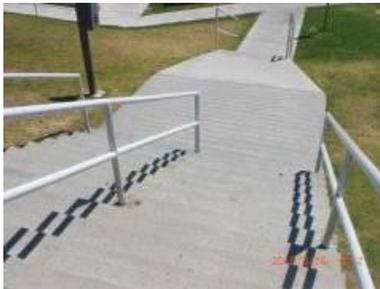
Field Condition	
08.09E - Handrails - Height above Stair Nosings - The tops of handrails are not between 34" and 38" above the stair nosings.	1991 ADAAG 4.9.4(5)
Existing Condition: Handrails at 31" H.	2004 ADAAG 505.4; Advisory 505.4; Fig. 505.4
	2007 CBC 1133B.4.2.1
	Other -

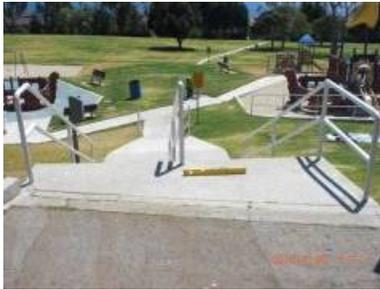
Location: Stairway
Photo # 118

Field Condition	
08.03D - Level Landing - Landing is not level (slope is greater than 2% in some or all directions).	1991 ADAAG -
Existing Condition: 0.71% CS & 7.0% RS at top landing.	2004 ADAAG -
	2007 CBC 1009.5.1
	Other -

Corrective Action
008 - Concrete Landing - Remove non-compliant pavement and replace with new concrete. The landing slope shall not exceed 2% in any direction.
Additional Comments:

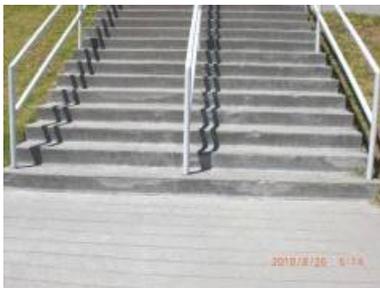
08.05A - Exterior Stairs - Color Strip - Contrasting color strips have not been provided.
Existing Condition: No stripes.

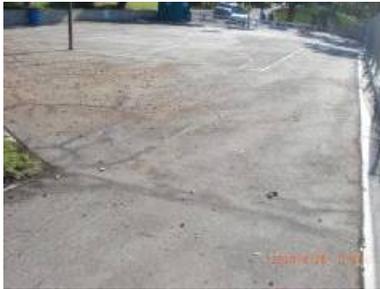
Field Condition	
03B.09 - Cross Slope - Cross slope of the accessible route of travel exceeds 1:50. Existing Condition: 4.4% to 6.2% CS.	1991 ADAAG 4.3.7 2004 ADAAG 403.3 2007 CBC 1133B.7.1.3 Other -

Corrective Action	
004A - Asphalt Paving - Remove non-compliant pavement and replace with new asphalt paving (area as shown on the drawings). The walkway slope shall not exceed 5% along the POT and cross slope shall not exceed 2%.	
Additional Comments:

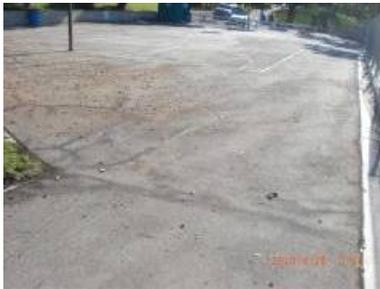
Field Condition	
03B.10 - Running Slope - Slope of the accessible route of travel exceeds 1:20. Existing Condition: 4.6% to 11.8% CS.	1991 ADAAG 4.3.7 2004 ADAAG 403.3 2007 CBC 1133B.7.3 Other -

Corrective Action	
004A - Asphalt Paving - Remove non-compliant pavement and replace with new asphalt paving (area as shown on the drawings). The walkway slope shall not exceed 5% along the POT and cross slope shall not exceed 2%.	
Additional Comments:

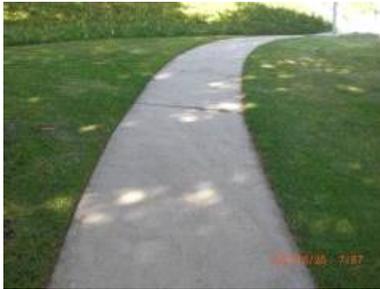
Field Condition									
03B.09 - Cross Slope - Cross slope of the accessible route of travel exceeds 1:50. Existing Condition: 6.1% to 10.5% CS.

Corrective Action	
006 - Concrete Walk - Remove non-compliant pavement and replace with new concrete (area as shown on the drawings). The walkway slope shall not exceed 5% along the POT and cross slope shall not exceed 2%. Additional Comments:

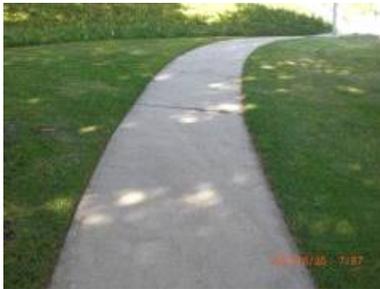
Field Condition									
03B.10 - Running Slope - Slope of the accessible route of travel exceeds 1:20. Existing Condition: 8.5% and 12.1% RS.

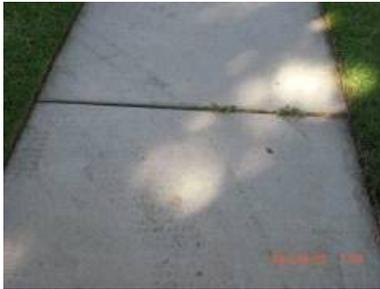
03B.12 - > 1/4" Changes in Level - Where walkway levels change abruptly, the vertical difference between them exceeds 1/4 inch. Or changes in level between 1/4 inch and 1/2 inch are beveled with a slope greater than 1:2.

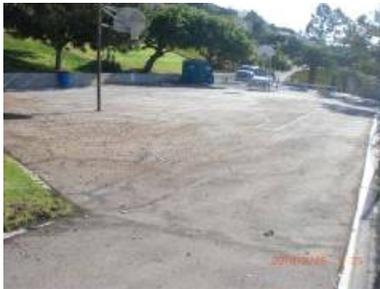
03B.09 - Cross Slope - Cross slope of the accessible route of travel exceeds 1:50.

Existing Condition: 2.4% to 5.3% CS.

004A - Asphalt Paving - Remove non-compliant pavement and replace with new asphalt paving (area as shown on the drawings). The walkway slope shall not exceed 5% along the POT and cross slope shall not exceed 2%.

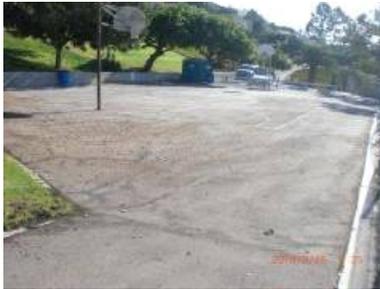
Field Condition									
03B.09 - Cross Slope - Cross slope of the accessible route of travel exceeds 1:50. Existing Condition: 2.1% to 4.0% CS.

Corrective Action	
004A - Asphalt Paving - Remove non-compliant pavement and replace with new asphalt paving (area as shown on the drawings). The walkway slope shall not exceed 5% along the POT and cross slope shall not exceed 2%.	
Additional Comments:

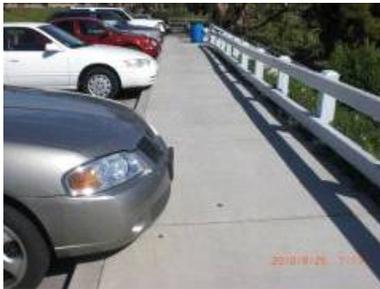
Field Condition									
03B.22 - Other - On-Site Accessible Path of Travel - See Additional Comments Existing Condition:

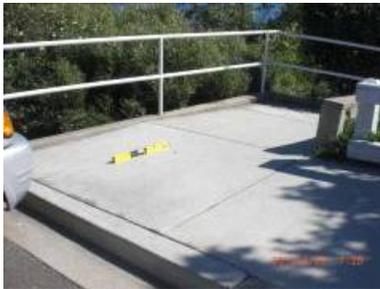
Location: Ramp
Photo # 132

Existing Condition: Top landing slope at 10.5%.

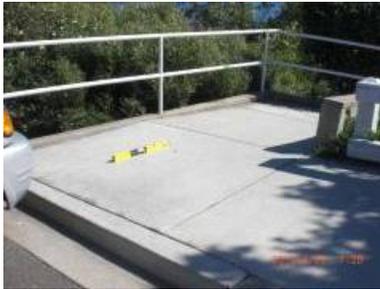
Location: Ramp
Photo # 132

Existing Condition: Greater than 30" drop. Railing at 38" H.

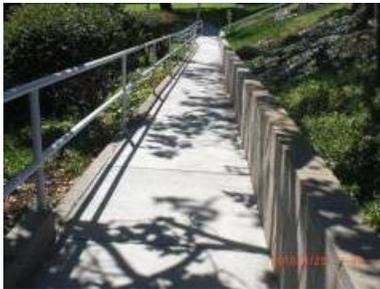
Location: Ramp
Photo # 134

Existing Condition: No intermediate landings.

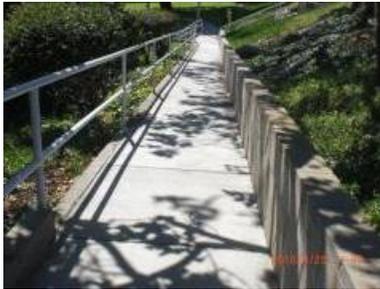
Field Condition	
07.02 - Running Slope - Slope of the ramp exceeds 8.33% (or the least possible compliant slope).	1991 ADAAG 4.8.2
Existing Condition: 9.2% and 13.2% RS.	2004 ADAAG 405.2; Advisory 405.2
	2007 CBC 1133B.5.3
	Other -

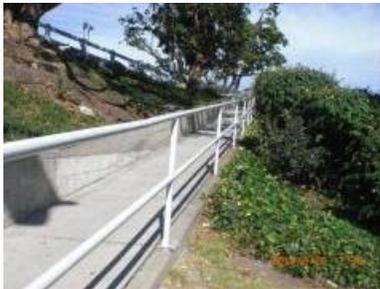
Field Condition	
07.03 - Maximum Rise - The rise for any continuous run exceeds 30" high.	1991 ADAAG 4.8.2
Existing Condition:	2004 ADAAG 405.6
	2007 CBC 1133B.5.4.1
	Other -

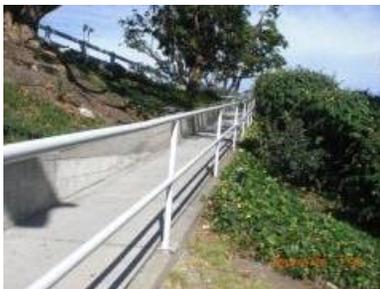
Field Condition	
07.16 - Handrails - Slope of the ramp exceeds 5%, and handrails are not provided on each side. (Per CBC 1133B.5.5.1, at exterior door landings, handrails are not required on ramps less than 6" high or 72" long. Handrails are not required on curb ramps or adjacent to fixed seating in assembly areas.)	1991 ADAAG 4.8.5
Existing Condition:	2004 ADAAG 405.8; 505.2
	2007 CBC 1133B.5.5.1
	Other -

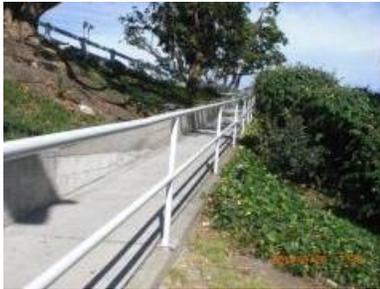
Location: Ramp
Photo # 136

Field Condition	07.23 - Profile of Handrails - The diameter of the handrail is not between 1-1/4" and 1-1/2" in cross-sectional nominal dimension. OR The shape does not provide an equivalent gripping surface (i.e. 4" to 6-1/4" perimeter, and 2-1/4" max. in any direction). (Note: Standard pipe sizes designated by the industry as 1-1/4" to 1-1/2" are acceptable). Existing Condition: 2" profile.	1991 ADAAG 4.8.5; 4.26.2; Fig. 39
		2004 ADAAG 505.7.1; 505.7.2; Fig. 505.7.2
		2007 CBC 1133B.5.5.1
		Other -

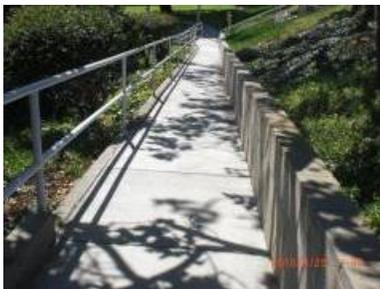
Location: Ramp
Photo # 134

Field Condition	07.21A - Extensions - Required Length - At ends of handrails, less than 12" of handrail extends beyond the top and bottom of the ramp segment. (Top and bottom handrail extensions are important safety features for persons with mobility impairments and must extend in the direction of the ramp run to permit the intended use.) (Per CBC 1133B.5.5.1.1, in existing buildings or facilities, where the extension of the handrail in the direction of the ramp run would create a hazard, the extension on the handrail may be turned 90 degrees to the run of the ramp.) Existing Condition: No bottom extensions.	1991 ADAAG 4.8.5 (2)
		2004 ADAAG 505.10; 505.10.1; Fig. 505.10.1
		2007 CBC 1133B.5.5.1; 1133B.5.5.1.1
		Other -

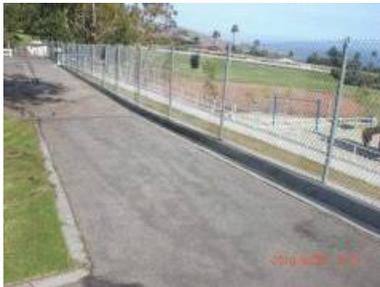
Field Condition	
03B.09 - Cross Slope - Cross slope of the accessible route of travel exceeds 1:50.	1991 ADAAG 4.3.7
Existing Condition: 5.2% to 15.2% CS.	2004 ADAAG 403.3
	2007 CBC 1133B.7.1.3
	Other -

Corrective Action
004A - Asphalt Paving - Remove non-compliant pavement and replace with new asphalt paving (area as shown on the drawings). The walkway slope shall not exceed 5% along the POT and cross slope shall not exceed 2%.
Additional Comments:

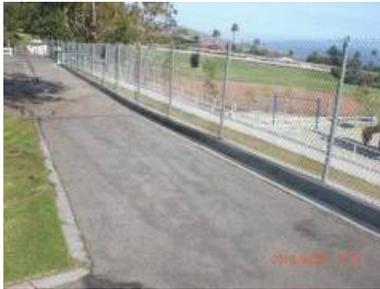
Location: Path
Photo # 142

Field Condition									
03B.10 - Running Slope - Slope of the accessible route of travel exceeds 1:20. Existing Condition: 13.4% and 16.7% RS.

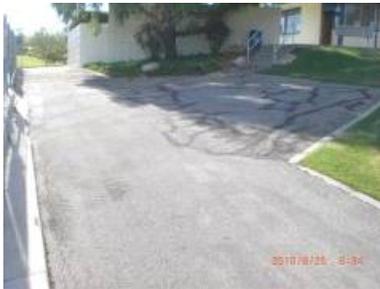
Location: Path
Photo # 144

Field Condition									
03B.09 - Cross Slope - Cross slope of the accessible route of travel exceeds 1:50. Existing Condition: 2.3% to 15.6% CS.

Corrective Action
004A - Asphalt Paving - Remove non-compliant pavement and replace with new asphalt paving (area as shown on the drawings). The walkway slope shall not exceed 5% along the POT and cross slope shall not exceed 2%. Additional Comments:

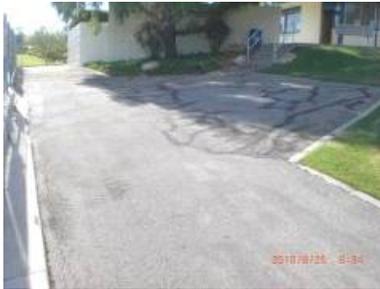
Field Condition									
03B.10 - Running Slope - Slope of the accessible route of travel exceeds 1:20. Existing Condition: 7.2% and 8.6% RS.

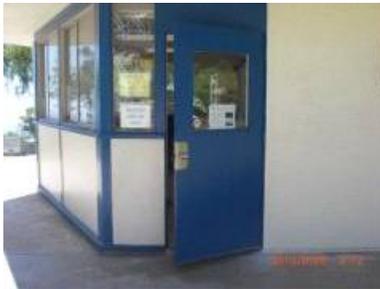
Field Condition									
11.17A - Recommendation: Providing Room/Space ID Sign - A sign designating the permanent room or space has not been provided. Existing Condition:

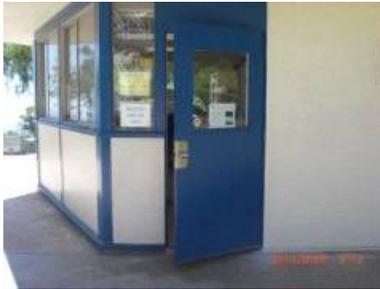
Field Condition									
10.10 - Single-Action Hardware - Handles, locks, and latches or other operative devices are not operable with one hand and without tight grasping, pinching, or twisting of the wrist. (U-shaped handles, levers, and push/pull type mechanisms are acceptable designs.)

Corrective Action	
067A - Replace Knob(s) with Lever Hardware - Remove knobs and existing latch and lock set. Provide new levers with new latch and lock sets.	
Additional Comments:

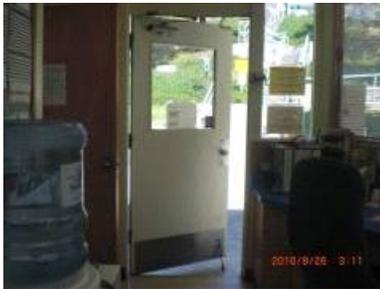
Field Condition									
10.08 - Kick Plate - Bottom 10" of door does not have a smooth, uninterrupted surface on the push side to allow the door to be opened by a wheelchair footrest without creating a trap or hazardous condition. (This requirement does not apply to automatic and sliding doors.)

1991 ADAAG	-	2004 ADAAG	404.2.10	2007 CBC	1133B.2.6	Other	-
1991 ADAAG	-								
2004 ADAAG	404.2.10								
2007 CBC	1133B.2.6								
Other	-								
Existing Condition: Door stop.

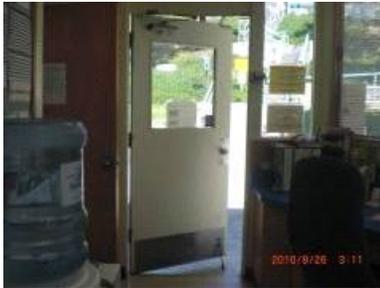
Location: Office
Photo # 148

Field Condition	
10.11A - Door Operating Effort - The force required to operate door exceeds 5 lbs. (Fire doors may have up to 15 lbs to achieve positive latching).	1991 ADAAG 4.13.11
Existing Condition: 10 LBF Operating effort	2004 ADAAG 404.2.9
	2007 CBC 1133B.2.5
	Other -

Corrective Action
072B - Replace Closer - Replace door closer.
Additional Comments:

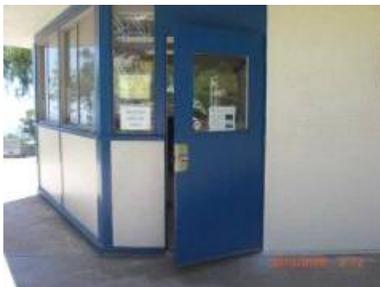
Location: Office
Photo # 146

Field Condition	
10.09B - Threshold - Height - The threshold at doorway exceeds 1/2" in height.	1991 ADAAG 4.13.8
Existing Condition: 2 1/2" high Threshold.	2004 ADAAG 303.3; Advisory 303.3; Fig. 303.3
	2007 CBC 1133B.2.4.1
	Other -

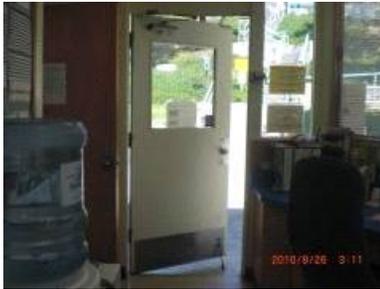
Field Condition	
11.14 - Closers - Door closer is not adjusted so that from an open position of 70 degrees, the door will take at least 3 seconds to move to a point 3" from the latch (measured to the leading edge of the door).	1991 ADAAG 4.13.10
Existing Condition: 1.97 seconds closer delay.	2004 ADAAG 404.2.8.1
	2007 CBC 1133B.2.5.1
	Other -

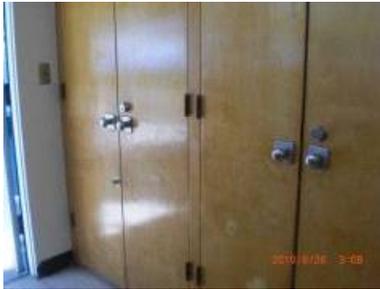
Field Condition									
11.11 - Single-Action Hardware - Handles, locks, and latches or other operative devices are not operable with one hand and without tight grasping, pinching, or twisting of the wrist. (U-shaped handles, levers, and push/pull type mechanisms are acceptable designs.)

1991 ADAAG	4.13.9	2004 ADAAG	309.4; 404.2.7; Advisory 404.2.7	2007 CBC	1133B.2.5.2	Other	-
1991 ADAAG	4.13.9								
2004 ADAAG	309.4; 404.2.7; Advisory 404.2.7								
2007 CBC	1133B.2.5.2								
Other	-								
Existing Condition: Door knobs at closet doors.

Corrective Action
067A - Replace Knob(s) with Lever Hardware - Remove knobs and existing latch and lock set. Provide new levers with new latch and lock sets.
Additional Comments:

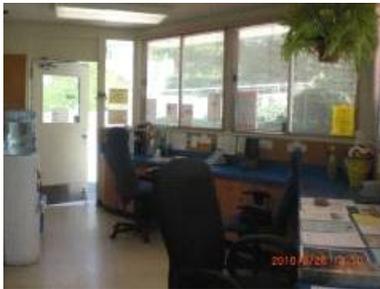
Field Condition									
20.04 - Common Use Areas - Visual Alarms - Visual alarms are not provided in common use area(s) of the building such as meeting and conference rooms, open office space, classrooms, cafeterias, filing and photocopy rooms, employee break rooms, dressing, examination, and treatment rooms, and similar spaces that are not used solely as employee work areas.

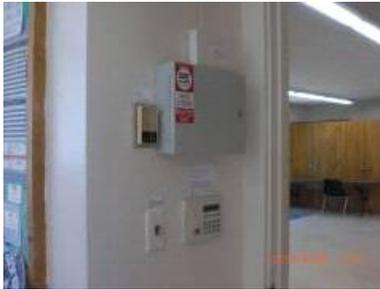
Field Condition	
14.32A - Reach Range - Controls - Controls, dispensers, and similar devices are not between 9" and 54" AFF when the clear floor space allows a parallel approach. OR They are not between 15" and 48" AFF when the clear floor space allows only a forward approach.	1991 ADAAG 4.1.3(13); 4.27.3; 4.2.5; 4.2.6 ; Fig. 5; Fig. 6 2004 ADAAG - 2007 CBC 1117B.6(3); 1118.5; 1118.6; Fig. 11B-5C; Fig. 11B-5D Other -
Existing Condition: 57" high thermostat.

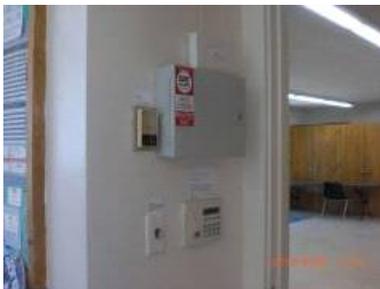
Field Condition	
14.32A - Reach Range - Controls - Controls, dispensers, and similar devices are not between 9" and 54" AFF when the clear floor space allows a parallel approach. OR They are not between 15" and 48" AFF when the clear floor space allows only a forward approach.	1991 ADAAG 4.1.3(13); 4.27.3; 4.2.5; 4.2.6 ; Fig. 5; Fig. 6 2004 ADAAG - 2007 CBC 1117B.6(3); 1118.5; 1118.6; Fig. 11B-5C; Fig. 11B-5D Other -
Existing Condition: 61" high Alarm.

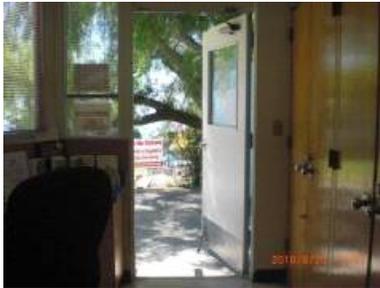
11.14 - Closers - Door closer is not adjusted so that from an open position of 70 degrees, the door will take at least 3 seconds to move to a point 3" from the latch (measured to the leading edge of the door).

Existing Condition: 2.84 second closer delay

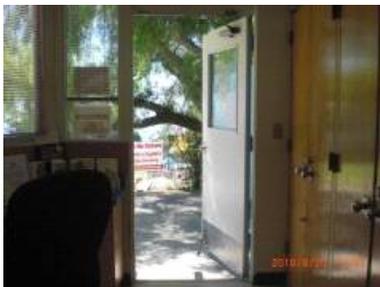
10.11A - Door Operating Effort - The force required to operate door exceeds 5 lbs. (Fire doors may have up to 15 lbs to achieve positive latching).

Existing Condition: 9 LBF Operating effort

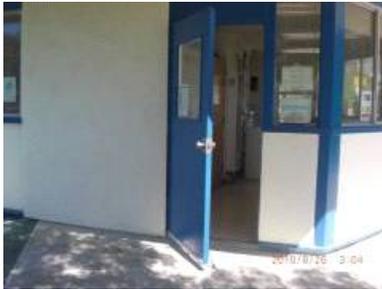
Location: Office
Photo # 164

Field Condition	
11.17A - Recommendation: Providing Room/Space ID Sign - A sign designating the permanent room or space has not been provided.	1991 ADAAG 4.1.2(7)
Existing Condition:	2004 ADAAG 216.2; 703.1; 703.2; 703.5
	2007 CBC 1117B.5.1 item 1
	Other -

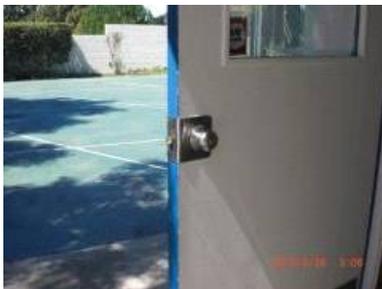
Location: Office
Photo # 165

Field Condition	
10.10 - Single-Action Hardware - Handles, locks, and latches or other operative devices are not operable with one hand and without tight grasping, pinching, or twisting of the wrist. (U-shaped handles, levers, and push/pull type mechanisms are acceptable designs.)	1991 ADAAG 4.13.9
Existing Condition: Door knob. Twist type lock on door knob.	2004 ADAAG 309.4; 404.2.7; Advisory 404.2.7
	2007 CBC 1133B.2.5.2
	Other -

Corrective Action
067A - Replace Knob(s) with Lever Hardware - Remove knobs and existing latch and lock set. Provide new levers with new latch and lock sets.
Additional Comments:

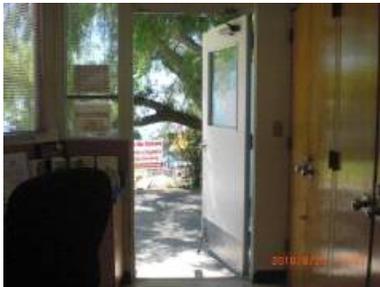
Field Condition	
10.09B - Threshold - Height - The threshold at doorway exceeds 1/2" in height.	1991 ADAAG 4.13.8
Existing Condition: 2 1/2" high Threshold.	2004 ADAAG 303.3; Advisory 303.3; Fig. 303.3
	2007 CBC 1133B.2.4.1
	Other -

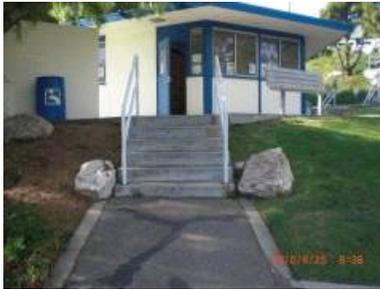
Location: Path
Photo # 170

Existing Condition: 4" - 9" drop.

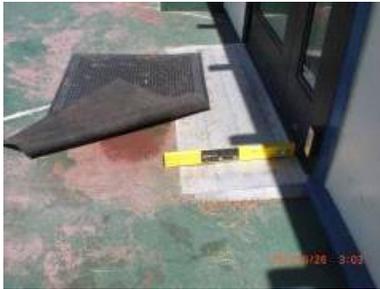
Location: Multi-Purpose Room
Photo # 172

Field Condition	
10.07A - Landing - Level and Clear - Floor is not level (slope is greater than 2% in some or all directions). OR Floor is not clear within the required maneuvering space.	1991 ADAAG 4.13.6; Fig. 25
Existing Condition: Landing slope at 9.4%.	2004 ADAAG 305; 404.2.4.4
	2007 CBC 1133B.2.4
	Other -

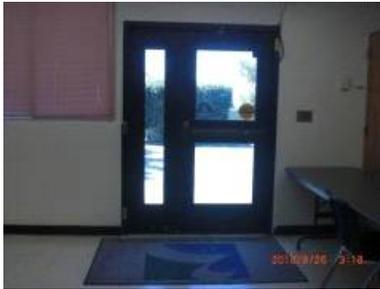
Field Condition	
10.11B - Hardware Operating Effort - The force required to activate handles, pulls, latches, locks, and other operable parts of door exceeds 5 lbs.	1991 ADAAG 4.27.4
Existing Condition: 10 LBF Panic.	2004 ADAAG 309.4
	2007 CBC 1117B.6 item 4
	Other -

Corrective Action	
079 - Doors - Miscellaneous - See Additional Comments	
Additional Comments: Replace panic hardware.

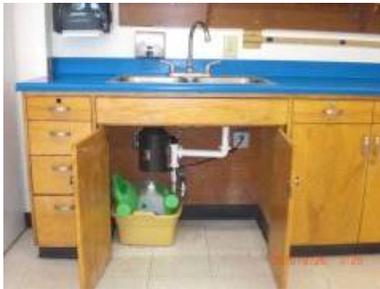
Field Condition	
14.36B - Kitchen Counter/Sink Height - Where provided in public or common use areas, countertops and sinks are not mounted at 34" AFF. max..(Common use areas are those interior and exterior rooms, spaces, or elements that are made available for the use of a restricted group of people (for example, the occupants of an office building, or the guests of such occupants).	1991 ADAAG 4.24.2
Existing Condition: 36 1/2" high Counter/sink.	2004 ADAAG 212.3; 606.3
	2007 CBC 1115B.4.7(2); 1122B.4
	Other -

Corrective Action	
480A - New Counter Top and Sink - Remove existing cabinetry, and provide new counter at 34" above the finished floor. Remove and replace sink and faucet with new accessible sink and faucet. Provide accessible knee clearance (i.e. at least 27" high, 30" wide, and 19" deep) under the sink.	
Additional Comments:

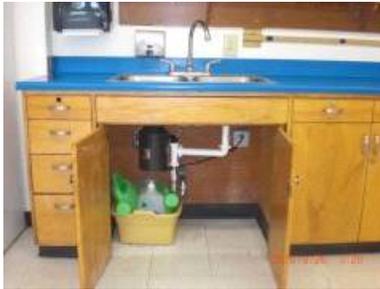
Field Condition	
14.37 - Kitchen Sink - Sink does not provide accessible knee clearance (i.e. at least 27" high, 30" wide, and 19" deep).	1991 ADAAG 4.24.3
Existing Condition: Knee clearance at 7" deep.	2004 ADAAG 305; 306; 606.2
	2007 CBC 1115B.4.7(2); 1122B.4
	Other -

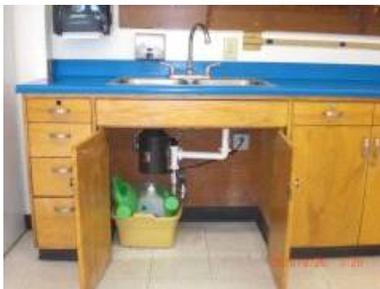
Field Condition	
16.78 - Pipe Insulation at Lavatory - Drainpipes and hot water pipes are not insulated to protect against contact.	1991 ADAAG 4.19.4
Existing Condition: No insulation.	2004 ADAAG 606.5
	2007 CBC 1115B.4.3(4)
	Other -

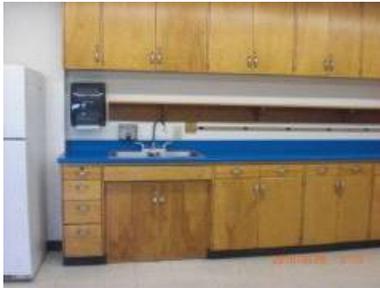
Location: Multi-Purpose Room
Photo # 178

Field Condition									
14.35 - Controls - Operation - The controls are not accessible. (Accessible controls shall be operable with one hand, and without tight grasping, pinching, or twisting of the wrist, and the force to operate the controls shall be no greater than 5 lbs.)

Corrective Action
039 - Operable Parts - Miscellaneous - See Additional Comments
Additional Comments: Replace knobs with pull hardware.

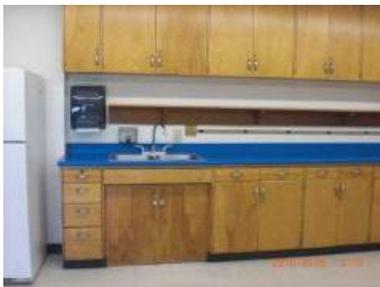
Location: Multi-Purpose Room
Photo # 178

Field Condition									
16.84C - Soap Dispenser - Operating Height - Mounting height of soap dispenser's highest operable part exceeds 40" AFF. (Where provided, ADA Standards require at least one soap dispenser to be accessible with the highest operable part placed within at least one of the reach ranges specified in 4.2.5 and 4.2.6; where provided, CBC Standards require at least one soap dispenser to be accessible with the highest operable part no higher than 40" AFF.)

1991 ADAAG	4.22.7; 4.27.3; 4.2.5; 4.2.6	2004 ADAAG	308; 309	2007 CBC	1115B.8.3	Other	-
1991 ADAAG	4.22.7; 4.27.3; 4.2.5; 4.2.6								
2004 ADAAG	308; 309								
2007 CBC	1115B.8.3								
Other	-								
Existing Condition: 40 1/2" high SD.

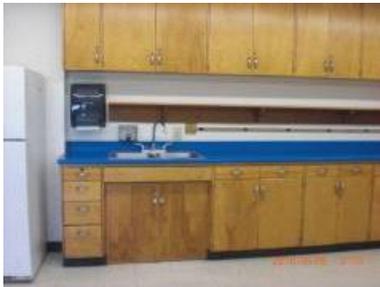
Location:
Multi-Purpose Room

Field Condition	
16.86A - Dispenser or Control - Single-Action Operation - The dispenser or control cannot be operated with one hand or without tight grasping, pinching, or twisting of the wrist. (Where provided, at least one dispenser or control of each type shall be accessible.)	1991 ADAAG 4.27.4 2004 ADAAG 309.4 2007 CBC 1117B.6 item 4 Other -
Existing Condition: Twist type operation.

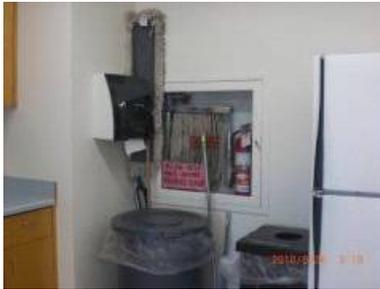
20.16A - Fire Extinguisher Cabinet Hardware - Mounting Height - Where fire extinguishers are provided in cabinets, mounting height of the cabinet opening hardware is not compliant. (Compliant opening hardware is mounted 48" AFF maximum, or in existing buildings, the opening hardware is 54" AFF and parallel approach is provided.)

Existing Condition: F.E. at 49 1/2" H.

388A - Relocate Fire Extinguisher Cabinet - Relocate existing fire extinguisher cabinet. Repair and refinish.

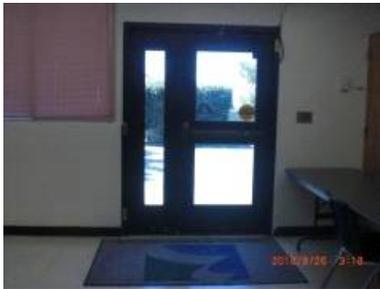
14.32A - Reach Range - Controls - Controls, dispensers, and similar devices are not between 9" and 54" AFF when the clear floor space allows a parallel approach. OR They are not between 15" and 48" AFF when the clear floor space allows only a forward approach.

Existing Condition: 63" high thermostat.

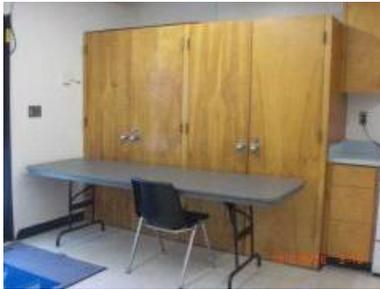
Location: Multi-Purpose Room
Photo # 184

Field Condition	<p>11.11 - Single-Action Hardware - Handles, locks, and latches or other operative devices are not operable with one hand and without tight grasping, pinching, or twisting of the wrist. (U-shaped handles, levers, and push/pull type mechanisms are acceptable designs.)</p> <p>Existing Condition: Door knobs.</p>	<p>1991 ADAAG 4.13.9</p> <p>2004 ADAAG 309.4; 404.2.7; Advisory 404.2.7</p> <p>2007 CBC 1133B.2.5.2</p> <p>Other -</p>
------------------------	--	--

Corrective Action	<p>067A - Replace Knob(s) with Lever Hardware - Remove knobs and existing latch and lock set. Provide new levers with new latch and lock sets.</p> <p>Additional Comments:</p>
--------------------------	--

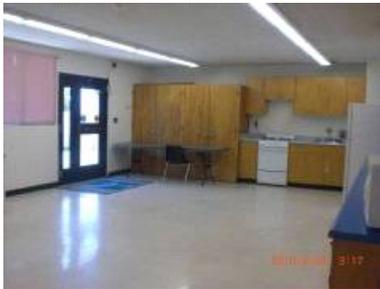
Location: Multi-Purpose Room
Photo # 185

Field Condition	<p>20.04 - Common Use Areas - Visual Alarms - Visual alarms are not provided in common use area(s) of the building such as meeting and conference rooms, open office space, classrooms, cafeterias, filing and photocopy rooms, employee break rooms, dressing, examination, and treatment rooms, and similar spaces that are not used solely as employee work areas.</p> <p>Existing Condition: No fire strobe.</p>	<p>1991 ADAAG 4.28.1</p> <p>2004 ADAAG 215.2; 702.1</p> <p>2007 CBC 907.9.1.1</p> <p>Other -</p>
------------------------	--	--

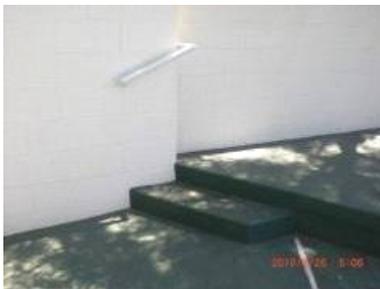
Location: Stage
Photo # 187

Existing Condition: No stripes.

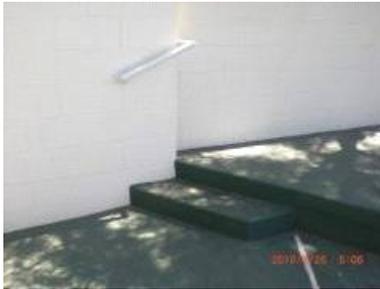
Field Condition	
08.07A - Continuous Handrails - Continuous handrails are not provided along both sides.	1991 ADAAG 4.9.4
Existing Condition: Handrails not on both sides.	2004 ADAAG 504.6; 505.2
	2007 CBC 1133B.4.1.1
	Other -

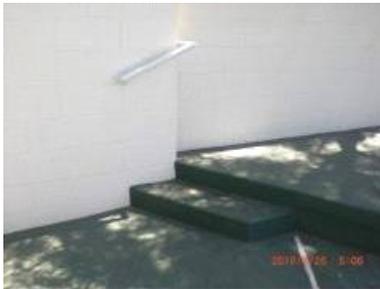
Field Condition	
08.09A - Handrail Extensions - Top Landing - At ends of handrails, less than 12" of handrail extends beyond the top nosing. (Top and bottom handrail extensions are important safety features for persons with balance problems and must extend in the direction of the stair run to permit the intended use.) (Per ADA/CBC Standards, in existing buildings and facilities, full extension of handrails at stairs shall not be required in alterations where such extensions would be hazardous or impossible due to plan configuration.)	1991 ADAAG 4.9.4(2)
Existing Condition:	2004 ADAAG 505.10; 505.10.2; Fig. 505.10.2
	2007 CBC 1133B.4.2.2
	Other -

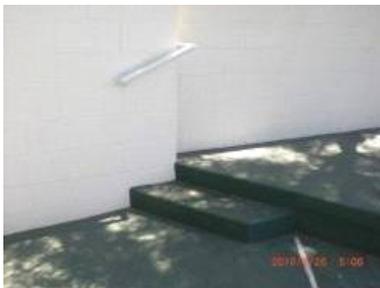
08.10B - Clearance - The clear space between handrails and walls is not 1-1/2" absolute. (ADA/CBC Standards apply an absolute dimension of 1-1/2", which provides knuckle clearance while generally disallowing entrapment of the forearm or elbow.)

Existing Condition: 2" clear.

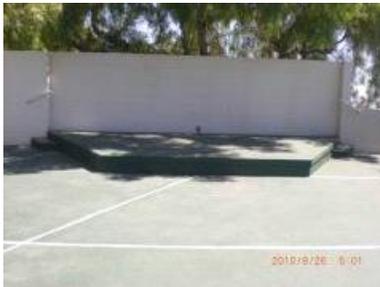
Field Condition	
14.34 - Electrical/Communications Receptacles - Mounting Height - Electrical/communications receptacle is not located between 15" min.. and 48" max.. AFF.	1991 ADAAG 4.1.3(13); 4.27.3; 4.2.5; 4.2.6 ; Fig. 5; Fig. 6
Existing Condition: 5" high receptacle.	2004 ADAAG 308.2.1; Fig. 308.2.1; 308.3.1; Fig. 308.3.1; 309.3
	2007 CBC 1117B.6(5.2)
	Other -

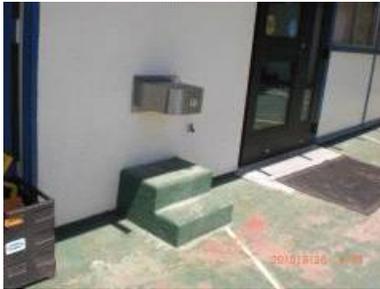
Location: Photo #
 Stage 194

Existing Condition: Steps obstruct clear floor space.

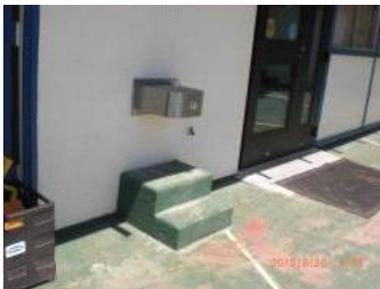
Location: Photo #
 Stage 194

Existing Condition: 13" deep DF.

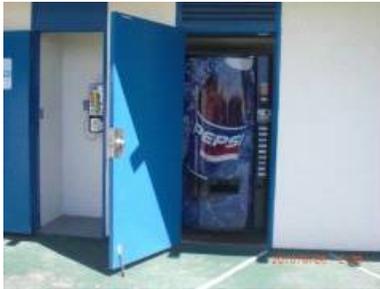
Keynote 196

Field Condition	
10.10 - Single-Action Hardware - Handles, locks, and latches or other operative devices are not operable with one hand and without tight grasping, pinching, or twisting of the wrist. (U-shaped handles, levers, and push/pull type mechanisms are acceptable designs.)	1991 ADAAG 4.13.9 2004 ADAAG 309.4; 404.2.7; Advisory 404.2.7 2007 CBC 1133B.2.5.2 Other -
Existing Condition: Door knob.

Corrective Action
067A - Replace Knob(s) with Lever Hardware - Remove knobs and existing latch and lock set. Provide new levers with new latch and lock sets.
Additional Comments:

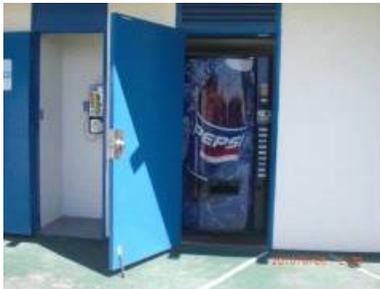
Keynote 197

Field Condition	
10.08 - Kick Plate - Bottom 10" of door does not have a smooth, uninterrupted surface on the push side to allow the door to be opened by a wheelchair footrest without creating a trap or hazardous condition. (This requirement does not apply to automatic and sliding doors.)	1991 ADAAG - 2004 ADAAG 404.2.10 2007 CBC 1133B.2.6 Other -
Existing Condition: Door stop.

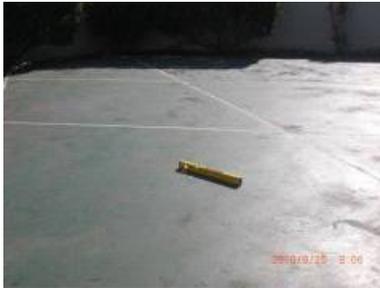
Keynote 198

Field Condition									
03B.09 - Cross Slope - Cross slope of the accessible route of travel exceeds 1:50. Existing Condition: 4.1% CS.

Corrective Action
006 - Concrete Walk - Remove non-compliant pavement and replace with new concrete (area as shown on the drawings). The walkway slope shall not exceed 5% along the POT and cross slope shall not exceed 2%. Additional Comments:

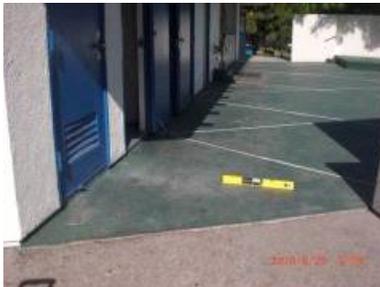
Keynote 199

Field Condition									
03B.22 - Other - On-Site Accessible Path of Travel - See Additional Comments Existing Condition:

Corrective Action
005B - Concrete Crack Repair - Clean-out existing concrete crack and inject with epoxy grout. Cracks over 1/4" in width will require a foam backer rod and sealant. Additional Comments:
