City of Rancho Palos Verdes
Rancho Palos Verdes ADA Assessment
Facility Report with Photos

Reporting: 325 of 4367 Rcds

Facility ID: # 12 - Robert E. Ryan Park

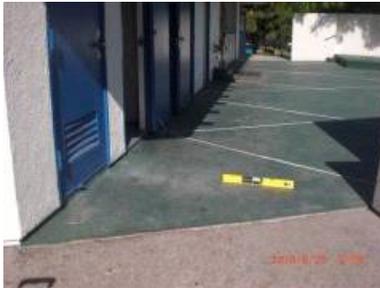
Keynote 200

03B.13 - > 1/2" Changes in Level - Curb ramps, ramps, or elevators are not used for changes in level greater than 1/2 inch. (Lifts may only be used in certain limited situations.)

Existing Condition: 1/2" level change.

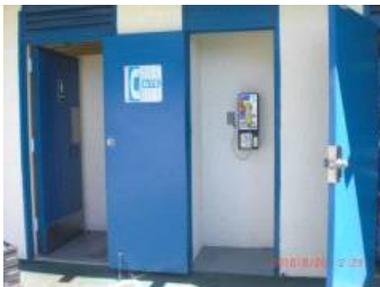
Keynote 201

10.10 - Single-Action Hardware - Handles, locks, and latches or other operative devices are not operable with one hand and without tight grasping, pinching, or twisting of the wrist. (U-shaped handles, levers, and push/pull type mechanisms are acceptable designs.)

Existing Condition: No door hardware.

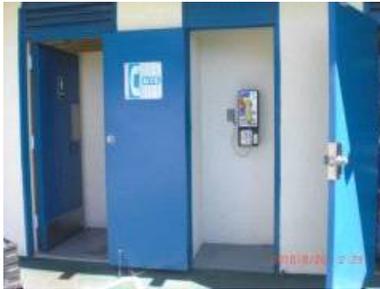
Keynote 202

Field Condition	
10.08 - Kick Plate - Bottom 10" of door does not have a smooth, uninterrupted surface on the push side to allow the door to be opened by a wheelchair footrest without creating a trap or hazardous condition. (This requirement does not apply to automatic and sliding doors.)	1991 ADAAG -
Existing Condition: Door stop.	2004 ADAAG 404.2.10
	2007 CBC 1133B.2.6
	Other -

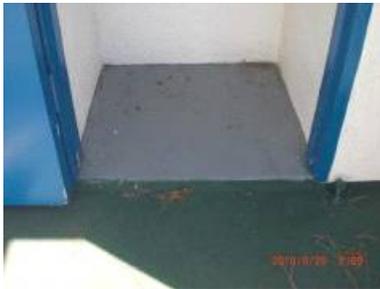
Keynote 203

Field Condition	
10.09B - Threshold - Height - The threshold at doorway exceeds 1/2" in height.	1991 ADAAG 4.13.8
Existing Condition: 1 1/2" high Threshold.	2004 ADAAG 303.3; Advisory 303.3; Fig. 303.3
	2007 CBC 1133B.2.4.1
	Other -

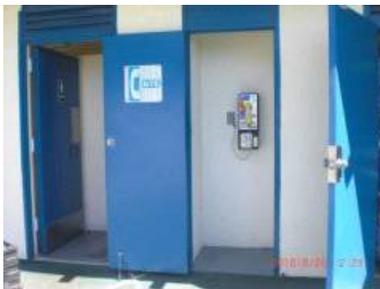
Keynote 205

Field Condition	
06.01A - One Telephone per Floor - Where there is only one public telephone per floor, that telephone is not wheelchair accessible. (This requirement applies to public pay telephones, public closed-circuit telephones, and other public telephones.)	1991 ADAAG 4.1.3(17)(a)
Existing Condition:	2004 ADAAG 217.2; Tab. 217.2; 704.2
	2007 CBC 1117B.2.1
	Other -

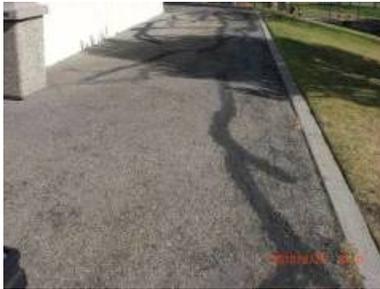
Keynote 208

Field Condition	
03B.09 - Cross Slope - Cross slope of the accessible route of travel exceeds 1:50. Existing Condition: 2.3% to 10.7% CS.	1991 ADAAG 4.3.7 2004 ADAAG 403.3 2007 CBC 1133B.7.1.3 Other -

Corrective Action	
004A - Asphalt Paving - Remove non-compliant pavement and replace with new asphalt paving (area as shown on the drawings). The walkway slope shall not exceed 5% along the POT and cross slope shall not exceed 2%. Additional Comments:

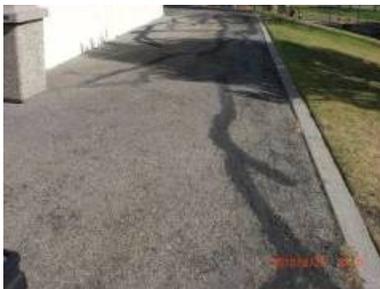
Keynote 209

Field Condition	
03B.10 - Running Slope - Slope of the accessible route of travel exceeds 1:20. Existing Condition: 6.1% and 9.8% RS.	1991 ADAAG 4.3.7 2004 ADAAG 403.3 2007 CBC 1133B.7.3 Other -

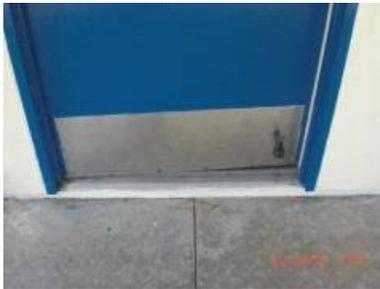
Keynote 211

16.88 - Other - Toilet Facilities - See Additional Comments

Existing Condition: Door stop.

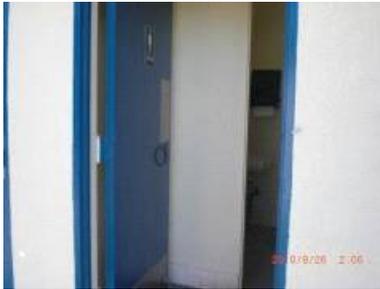
Keynote 213

16.09A - Door Maneuvering Space - Door that is not automatic or power-assisted does not have compliant maneuvering space relative to the direction of approach as shown in CBC Fig. 11B-26. (Approach // Side // Width // Depth) (Front // Pull // D + 24" * // 60") (Front // Push // D + 0" ** // 48") (Latch // Pull // D + 24" // 60") (Latch // Push // D + 24" // 44" ***) (Hinge // Pull // D + 36" // 60") (Hinge // Push // 54" **** // 44" *****) (* D + 18" at interior doors.) (** D + 12" if door has both a latch and a closer.) (***) 48" if door has closer.) (**** Measured from latch toward hinge.) (***** 48" if door has both a latch and a closer.)

Existing Condition: Door maneuvering space at 41".

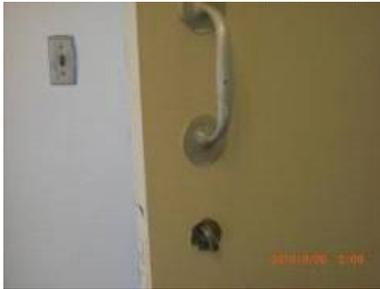
Keynote 214

Field Condition	
16.10 - Single-Action Hardware - Handles, locks, and latches or other operative devices are not operable with one hand. OR They are not operable without tight grasping, pinching, or twisting of the wrist. (U-shaped handles, levers, and push/pull type mechanisms are acceptable designs.)	1991 ADAAG 4.13.9 2004 ADAAG 309.4; 404.2.7; Advisory 404.2.7 2007 CBC 1133B.2.5.2 Other -
Existing Condition: Twist type lock.

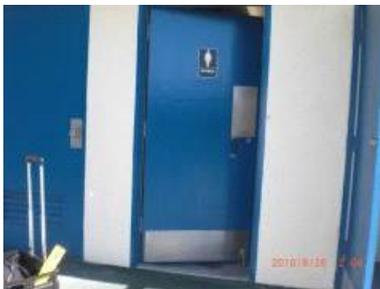
Keynote 215

Field Condition	
16.11A - Door Operating Effort - The force required to operate door exceeds 5 lbs. (Fire doors may have up to 15 lbs to achieve positive latching).	1991 ADAAG 4.13.11 2004 ADAAG 404.2.9 2007 CBC 1133B.2.5 Other -
Existing Condition: 11 LBF Operating effort

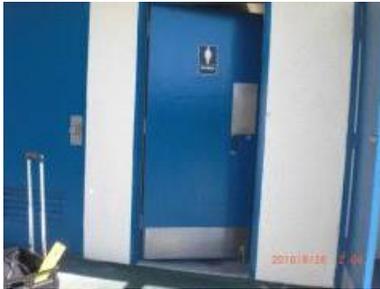
Keynote 216

Existing Condition: 2.9 second closer delay

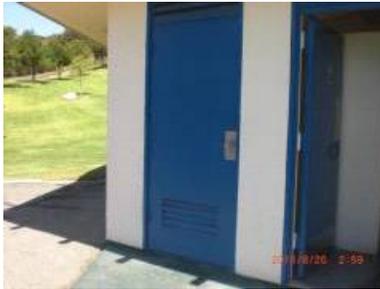
Keynote 222

Field Condition	
10.10 - Single-Action Hardware - Handles, locks, and latches or other operative devices are not operable with one hand and without tight grasping, pinching, or twisting of the wrist. (U-shaped handles, levers, and push/pull type mechanisms are acceptable designs.)	1991 ADAAG 4.13.9
Existing Condition: Door knob.	2004 ADAAG 309.4; 404.2.7; Advisory 404.2.7
	2007 CBC 1133B.2.5.2
	Other -

Corrective Action
067A - Replace Knob(s) with Lever Hardware - Remove knobs and existing latch and lock set. Provide new levers with new latch and lock sets.
Additional Comments:

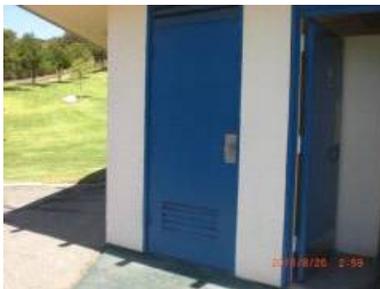
Keynote 223

Field Condition	
11.17A - Recommendation: Providing Room/Space ID Sign - A sign designating the permanent room or space has not been provided.	1991 ADAAG 4.1.2(7)
Existing Condition:	2004 ADAAG 216.2; 703.1; 703.2; 703.5
	2007 CBC 1117B.5.1 item 1
	Other -

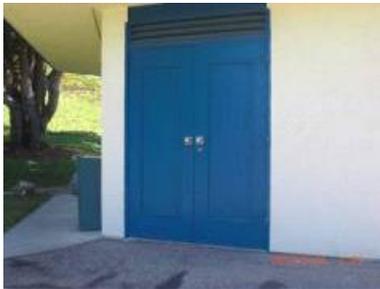
Keynote 225

Field Condition									
10.10 - Single-Action Hardware - Handles, locks, and latches or other operative devices are not operable with one hand and without tight grasping, pinching, or twisting of the wrist. (U-shaped handles, levers, and push/pull type mechanisms are acceptable designs.) Existing Condition: Door knobs.

Corrective Action
067A - Replace Knob(s) with Lever Hardware - Remove knobs and existing latch and lock set. Provide new levers with new latch and lock sets. Additional Comments:

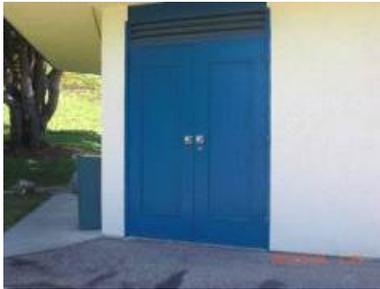
Keynote 226

Field Condition	
11.17A - Recommendation: Providing Room/Space ID Sign - A sign designating the permanent room or space has not been provided.	1991 ADAAG 4.1.2(7)
Existing Condition:	2004 ADAAG 216.2; 703.1; 703.2; 703.5
	2007 CBC 1117B.5.1 item 1
	Other -

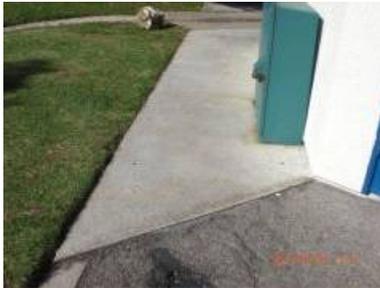
Keynote 228

03B.12 - > 1/4" Changes in Level - Where walkway levels change abruptly, the vertical difference between them exceeds 1/4 inch. Or changes in level between 1/4 inch and 1/2 inch are beveled with a slope greater than 1:2.

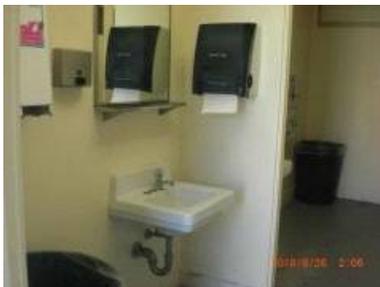
Keynote 229

16.82A - Mirror Height - Max. 40" AFF Standard - Mirror above accessible lavatory or countertop is mounted so the bottom edge of the reflective surface is not 40" max.. AFF. (ADA Standards require at least one mirror to be accessible; CBC Standards prior to August 1, 2009 required all mirrors to be accessible. Effective August 1, 2009, amended CBC Standards require all mirrors above accessible lavatories or countertops to be accessible.)

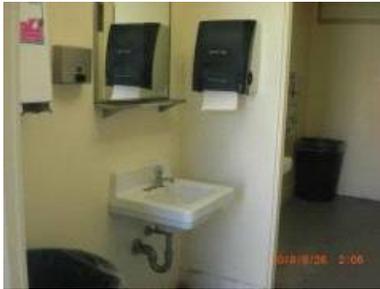
Keynote 230

Field Condition	
16.84A - Paper Towel Dispenser - Operating Height - Mounting height of paper towel dispenser's highest operable part exceeds 40" AFF. (Where provided, ADA Standards require at least one paper towel dispenser to be accessible with the highest operable part placed within at least one of the reach ranges specified in 4.2.5 and 4.2.6; where provided, CBC Standards require at least one paper towel dispenser to be accessible with the highest operable part no higher than 40" AFF.)	1991 ADAAG 4.22.7; 4.27.3; 4.2.5; 4.2.6 2004 ADAAG 308; 309 2007 CBC 1115B.8.3 Other -
Existing Condition: 52" high PTD

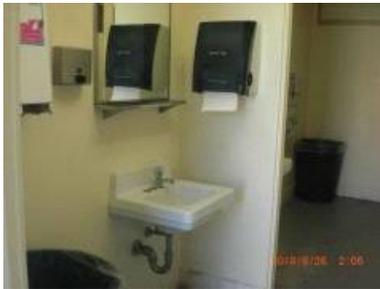
Keynote 231

Field Condition	
16.88 - Other - Toilet Facilities - See Additional Comments	1991 ADAAG - 2004 ADAAG - 2007 CBC - Other -
Existing Condition: PTD requires twist type operation.

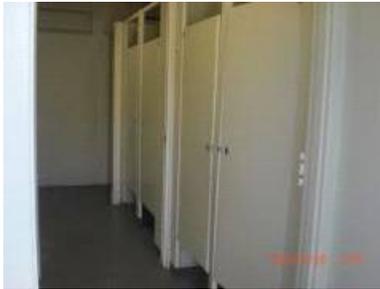
Keynote 232

Field Condition	
20.02 - Toilet, Bathroom, or Shower Room - Visual Alarms - Visual alarms are not provided at public or common use toilet, bathroom, or shower room.	1991 ADAAG 4.28.1
Existing Condition: No fire strobe.	2004 ADAAG 215.1; Advisory 215.1; 702.1
	2007 CBC 907.9.1.1
	Other -

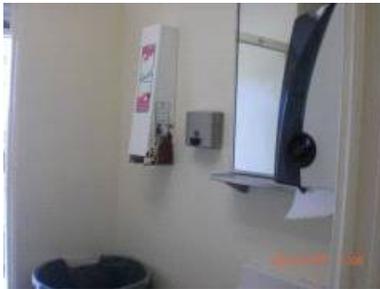
Keynote 233

Field Condition	
16.84C - Soap Dispenser - Operating Height - Mounting height of soap dispenser's highest operable part exceeds 40" AFF. (Where provided, ADA Standards require at least one soap dispenser to be accessible with the highest operable part placed within at least one of the reach ranges specified in 4.2.5 and 4.2.6; where provided, CBC Standards require at least one soap dispenser to be accessible with the highest operable part no higher than 40" AFF.)	1991 ADAAG 4.22.7; 4.27.3; 4.2.5; 4.2.6
Existing Condition: 53" and 45" high SD.	2004 ADAAG 308; 309
	2007 CBC 1115B.8.3
	Other -

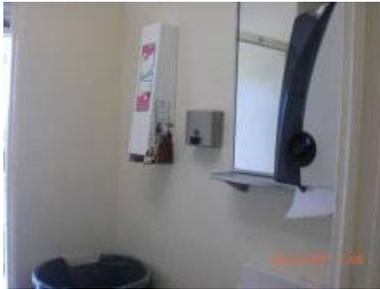
Keynote 234

Field Condition	
16.84D - Sanitary Napkin/Feminine Hygiene Dispenser - Operating Height - Mounting height of sanitary napkin/femin.ine hygiene dispenser's highest operable part exceeds 40" AFF. (Where provided, ADA Standards require at least one sanitary napkin/femin.ine hygiene dispenser to be accessible with the highest operable part placed within at least one of the reach ranges specified in 4.2.5 and 4.2.6; where provided, CBC Standards require at least one sanitary napkin/femin.ine hygiene dispenser to be accessible with the highest operable part no higher than 40" AFF.)	1991 ADAAG 4.22.7; 4.27.3; 4.2.5; 4.2.6 2004 ADAAG 308; 309 2007 CBC 1115B.8.3 Other -
Existing Condition: SND at 55" H.

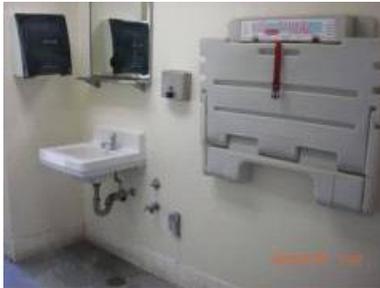
Keynote 235

Field Condition	
16.84F - Diaper Changing Table - Operating Height - Mounting height of diaper changing table's highest operable part exceeds 40" AFF. (Where provided, at least one shall be accessible.)	1991 ADAAG 4.27.3
Existing Condition: 57" to highest operable part.	2004 ADAAG 308; 309
	2007 CBC -
	Other -

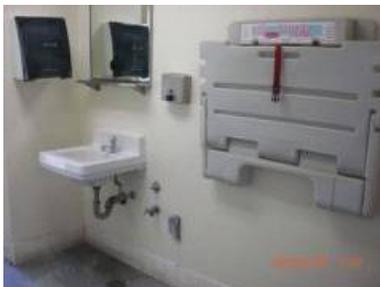
Keynote 236

Field Condition	
16.84G - Diaper Changing Table - Table Surface Height - Height of diaper changing table surface is not between 28" to 34" AFF. (Where provided, at least one shall be accessible.)	1991 ADAAG 4.1.3(18), 4.32.4
Existing Condition: Changing station table at 40" H.	2004 ADAAG 308; 309
	2007 CBC 1122B.1, 1122B.4
	Other -

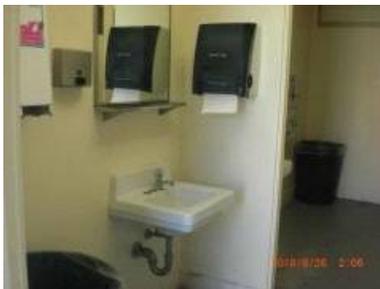
Keynote 240

Field Condition	
16.72 - Lavatory Apron Clearance - Lavatory does not provide accessible apron clearance (i.e. at least 29" clearance from the floor to the bottom of the apron).	1991 ADAAG 4.19.2; Fig. 31
Existing Condition: 28 1/2" high apron.	2004 ADAAG 606.3
	2007 CBC 1115B.4.3(2); Fig 11B-1D
	Other -

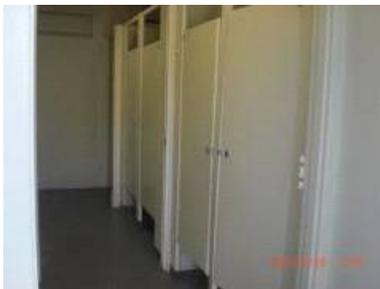
Keynote 244

Field Condition	16.27A - 60" Wide Circle or T-Shaped Maneuvering Space - The toilet room does not include an unobstructed turning space (a 60" diameter, 27" high circle or T-shaped space). (Note: The clear floor space of fixtures and controls, the accessible path of travel, and the turning space may overlap.)	1991 ADAAG	4.22.3; Fig 3
Existing Condition: None provided.		2004 ADAAG	304.3.2; Fig.304.3.2; 603.2.1
		2007 CBC	1115B.3.1(1); 1115B.3.2(1)
		Other	-

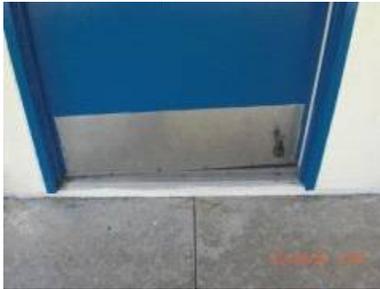
Keynote 245

Field Condition	
16.88 - Other - Toilet Facilities - See Additional Comments	1991 ADAAG -
Existing Condition: Door stop.	2004 ADAAG -
	2007 CBC -
	Other -

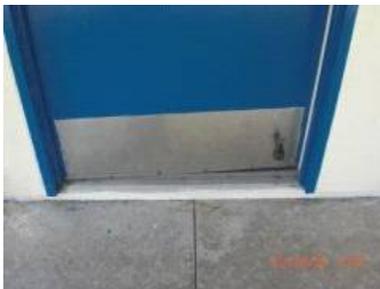
Keynote 246

Field Condition	
16.88 - Other - Toilet Facilities - See Additional Comments	1991 ADAAG -
Existing Condition: 2" high Threshold.	2004 ADAAG -
	2007 CBC -
	Other -

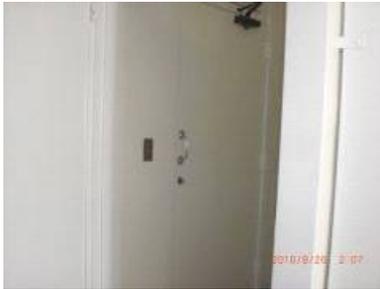
Keynote 247

16.09A - Door Maneuvering Space - Door that is not automatic or power-assisted does not have compliant maneuvering space relative to the direction of approach as shown in CBC Fig. 11B-26. (Approach // Side // Width // Depth) (Front // Pull // D + 24" * // 60") (Front // Push // D + 0" ** // 48") (Latch // Pull // D + 24" // 60") (Latch // Push // D + 24" // 44" ***) (Hinge // Pull // D + 36" // 60") (Hinge // Push // 54" **** // 44" *****) (* D + 18" at interior doors.) (** D + 12" if door has both a latch and a closer.) (***) 48" if door has closer.) (**** Measured from latch toward hinge.) (***** 48" if door has both a latch and a closer.)

Existing Condition: Door maneuvering space at 31 1/2".

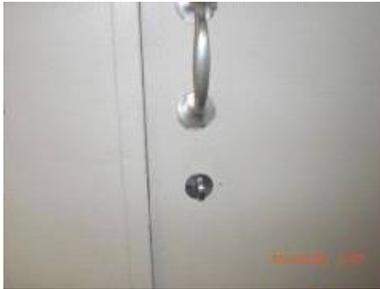
Keynote 248

Field Condition	
16.10 - Single-Action Hardware - Handles, locks, and latches or other operative devices are not operable with one hand. OR They are not operable without tight grasping, pinching, or twisting of the wrist. (U-shaped handles, levers, and push/pull type mechanisms are acceptable designs.)	1991 ADAAG 4.13.9 2004 ADAAG 309.4; 404.2.7; Advisory 404.2.7 2007 CBC 1133B.2.5.2 Other -
Existing Condition: Twist type lock.

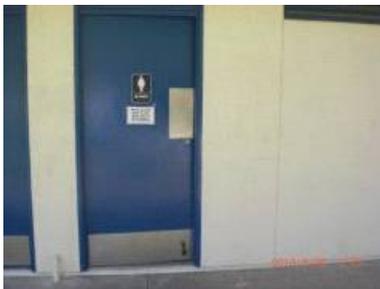
Keynote 249

Field Condition	
16.11A - Door Operating Effort - The force required to operate door exceeds 5 lbs. (Fire doors may have up to 15 lbs to achieve positive latching).	1991 ADAAG 4.13.11 2004 ADAAG 404.2.9 2007 CBC 1133B.2.5 Other -
Existing Condition: 15 LBF Operating effort

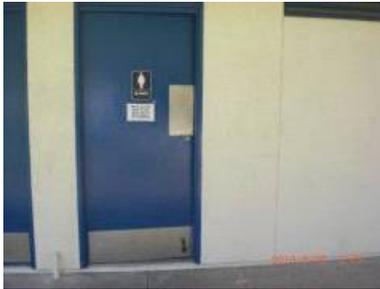
Keynote 250

16.13B - Women's RR Geometric Symbol Signage - Circle - Doorway leading to a women's toilet room is not identified by a circle, 1/4" thick and 12" in diameter. OR Circle is provided, however it is accompanied by words in raised characters and Braille. (ADA and CBC Standards require a separate sign with raised characters and Braille mounted on the wall adjacent to the latch side of the door.)

Existing Condition: None provided.

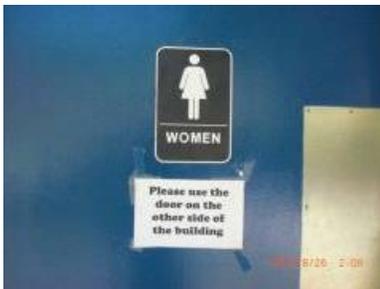
Keynote 251

16.19A - Mounting Location (Visual/Tactile Signs) - Sign is not mounted on the wall adjacent to the latch side of the door. OR At double leaf doors, the sign is not placed on the nearest adjacent wall.

Existing Condition: Wall sign located on door.

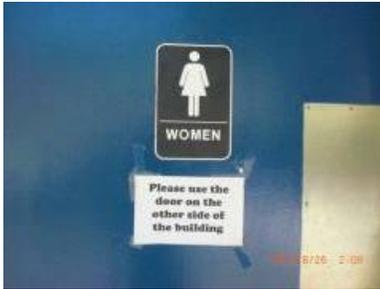
Keynote 254

Field Condition	16.21A - Raised Characters and Braille (Visual/Tactile Signs) - The raised characters on this sign are not accompanied by California Grade 2 Braille (i.e., the dots within each cell are domed and spaced 1/10" o.c.)	1991 ADAAG 4.30.4
	Existing Condition: Braille spacing too narrow.	2004 ADAAG 703.2; 703.3
		2007 CBC 1117B.5.5 item 1, 1117B.5.6
		Other -

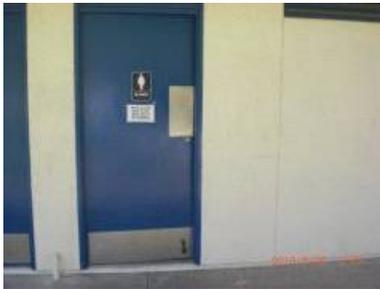
Keynote 255

Field Condition	10.03 - Directional Sign - When an entrance is not accessible, there are no directional signs indicating the location of the nearest accessible entrance.	1991 ADAAG 4.1.2(7); 4.30.1
	Existing Condition:	2004 ADAAG 216.6; Advisory 216.6
		2007 CBC 1117B.5.8.1.2
		Other -

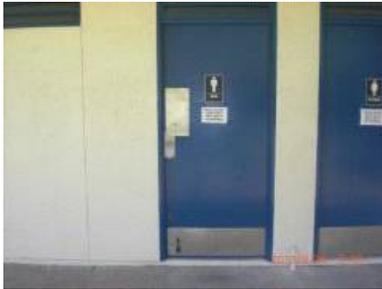
Keynote 256

Existing Condition: Door stop.

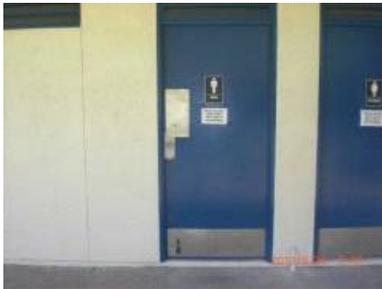
Keynote 257

Existing Condition: 2" high Threshold.

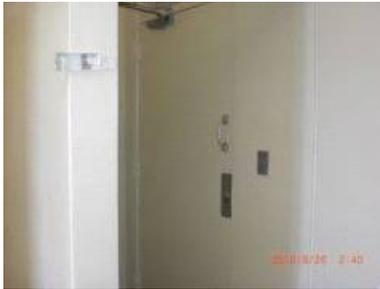
Keynote 258

16.09A - Door Maneuvering Space - Door that is not automatic or power-assisted does not have compliant maneuvering space relative to the direction of approach as shown in CBC Fig. 11B-26. (Approach // Side // Width // Depth) (Front // Pull // D + 24" * // 60") (Front // Push // D + 0" ** // 48") (Latch // Pull // D + 24" // 60") (Latch // Push // D + 24" // 44" ***) (Hinge // Pull // D + 36" // 60") (Hinge // Push // 54" **** // 44" *****) (* D + 18" at interior doors.) (** D + 12" if door has both a latch and a closer.) (***) 48" if door has closer.) (**** Measured from latch toward hinge.) (***** 48" if door has both a latch and a closer.)

Existing Condition: Door maneuvering space at 37".

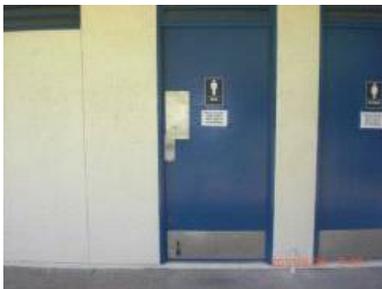
Keynote 260

Field Condition	
16.13A - Men's RR Geometric Symbol Signage - Triangle - Doorway leading to a men's toilet room is not identified by an equilateral triangle 1/4" thick with edges 12" long. OR Equilateral triangle is provided, however it is accompanied by words in raised characters and Braille. (ADA and CBC Standards require a separate sign with raised characters and Braille mounted on the wall adjacent to the latch side of the door.)	1991 ADAAG -
Existing Condition: None provided.	2004 ADAAG -
	2007 CBC 1115B.6
	Other -

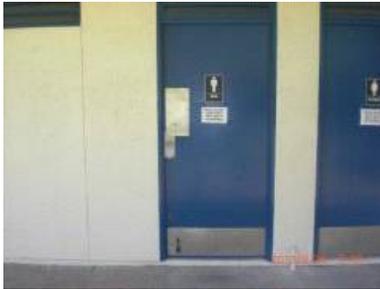
Keynote 261

Existing Condition: Wall sign on door.

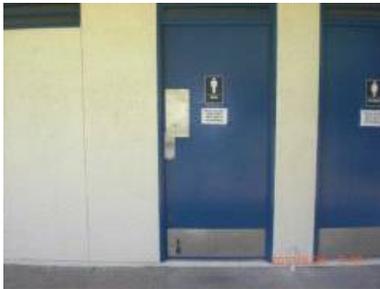
Keynote 262

Existing Condition: 65" high Sign.

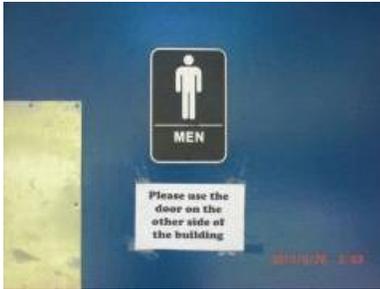
Keynote 263

Field Condition									
16.20 - Approach (Visual/Tactile Signs) - A person cannot approach to within 3" of sign without encountering protruding objects or standing within the swing of the door. Existing Condition: Braille on door.

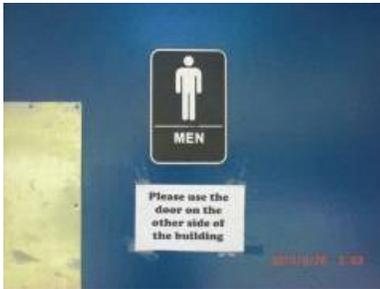
Keynote 264

Field Condition									
16.21A - Raised Characters and Braille (Visual/Tactile Signs) - The raised characters on this sign are not accompanied by California Grade 2 Braille (i.e., the dots within each cell are domed and spaced 1/10" o.c.) Existing Condition: Braille spacing too narrow.

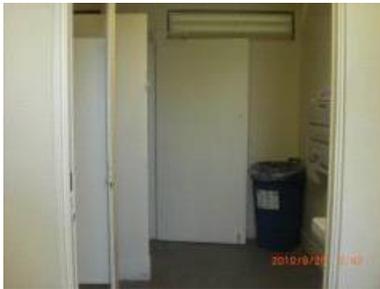
Keynote 266

Field Condition	16.88 - Other - Toilet Facilities - See Additional Comments	1991 ADAAG -
Existing Condition:	Door stop.	2004 ADAAG -
		2007 CBC -
		Other -

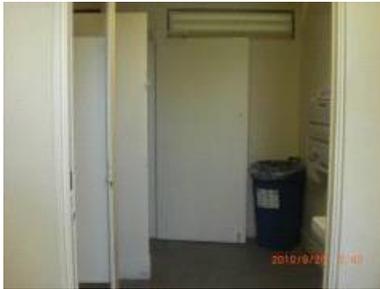
Keynote 267

Field Condition	
16.11A - Door Operating Effort - The force required to operate door exceeds 5 lbs. (Fire doors may have up to 15 lbs to achieve positive latching).	1991 ADAAG 4.13.11
Existing Condition: 10 LBF Operating effort	2004 ADAAG 404.2.9
	2007 CBC 1133B.2.5
	Other -

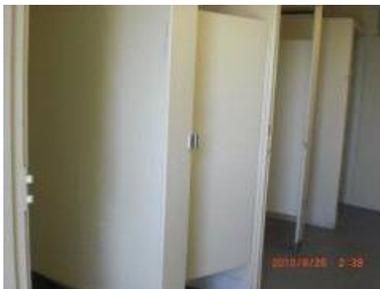
Keynote 268

Field Condition	
16.01 - Toilet Rooms - Toilet room does not comply with all applicable ADAAG and CBC accessibility requirements.	1991 ADAAG 4.1.2(6); 4.1.3(11); 4.22.1
Existing Condition: No accessible stall provided.	2004 ADAAG 213.2; Advisory 213.2
	2007 CBC 1115B.1
	Other -

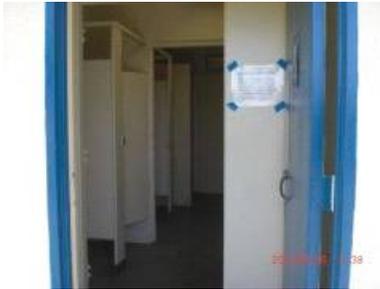
Keynote 269

Field Condition	
16.27A - 60" Wide Circle or T-Shaped Maneuvering Space - The toilet room does not include an unobstructed turning space (a 60" diameter, 27" high circle or T-shaped space). (Note: The clear floor space of fixtures and controls, the accessible path of travel, and the turning space may overlap.)	1991 ADAAG 4.22.3; Fig 3
Existing Condition: None provided.	2004 ADAAG 304.3.2; Fig.304.3.2; 603.2.1
	2007 CBC 1115B.3.1(1); 1115B.3.2(1)
	Other -

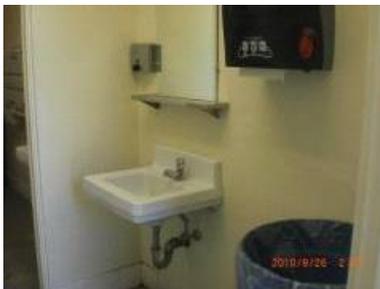
Keynote 270

Field Condition	
16.82A - Mirror Height - Max. 40" AFF Standard - Mirror above accessible lavatory or countertop is mounted so the bottom edge of the reflective surface is not 40" max.. AFF. (ADA Standards require at least one mirror to be accessible; CBC Standards prior to August 1, 2009 required all mirrors to be accessible. Effective August 1, 2009, amended CBC Standards require all mirrors above accessible lavatories or countertops to be accessible.)	1991 ADAAG 4.19.6; Fig. 31
Existing Condition: 46 1/2" high mirror.	2004 ADAAG 213.3.5; 603.3; Advisory 603.3
	2007 CBC 1115B.8.1
	Other -

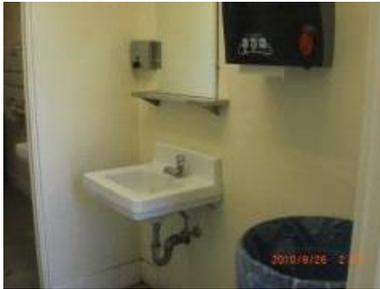
Keynote 271

Field Condition	16.84A - Paper Towel Dispenser - Operating Height - Mounting height of paper towel dispenser's highest operable part exceeds 40" AFF. (Where provided, ADA Standards require at least one paper towel dispenser to be accessible with the highest operable part placed within at least one of the reach ranges specified in 4.2.5 and 4.2.6; where provided, CBC Standards require at least one paper towel dispenser to be accessible with the highest operable part no higher than 40" AFF.)	1991 ADAAG 4.22.7; 4.27.3; 4.2.5; 4.2.6
	Existing Condition: 51" & 52" high PTD	2004 ADAAG 308; 309
		2007 CBC 1115B.8.3
		Other -

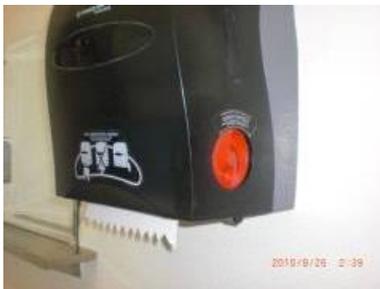
Keynote 272

Field Condition	16.86A - Dispenser or Control - Single-Action Operation - The dispenser or control cannot be operated with one hand or without tight grasping, pinching, or twisting of the wrist. (Where provided, at least one dispenser or control of each type shall be accessible.)	1991 ADAAG 4.27.4
	Existing Condition: PTD requires twist type operation.	2004 ADAAG 309.4
		2007 CBC 1117B.6 item 4
		Other -

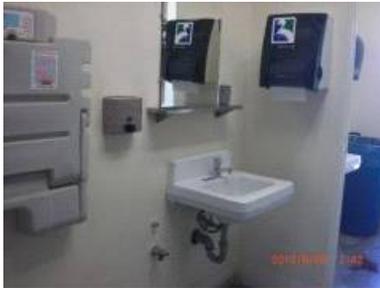
Keynote 273

Existing Condition: 42 1/2" and 51" high SD.

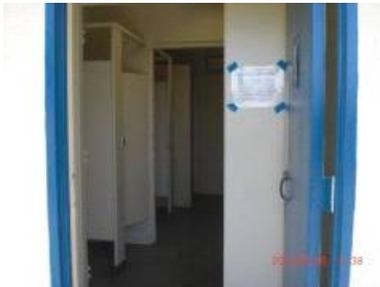
Keynote 274

Existing Condition: No fire strobe.

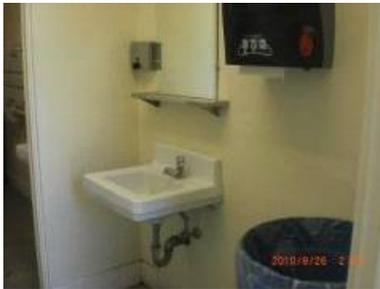
Keynote 276

Field Condition	
16.78 - Pipe Insulation at Lavatory - Drainpipes and hot water pipes are not insulated to protect against contact.	1991 ADAAG 4.19.4
Existing Condition: None provided.	2004 ADAAG 606.5
	2007 CBC 1115B.4.3(4)
	Other -

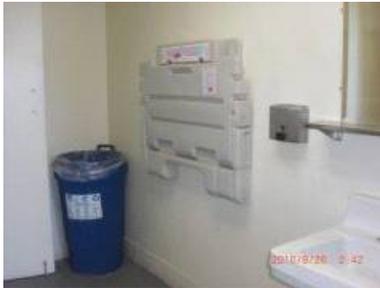
Keynote 279

Existing Condition: 57" to the highest operable part.

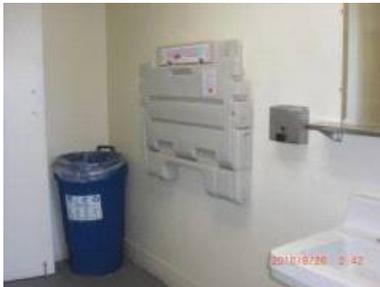
Keynote 280

Existing Condition: Table at 40" H.

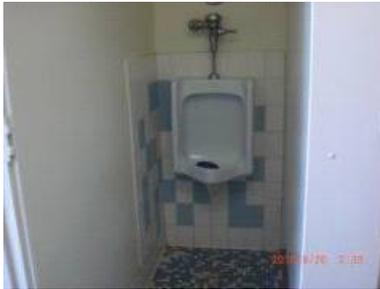
Keynote 281

Field Condition	
16.65A - Wall-Hung Urinal - Rim Projection from Wall - The wall-hung urinal's elongated rim does not project 14" min.. to 17" max.. from the wall.	1991 ADAAG 4.18.2
Existing Condition: 12" projection.	2004 ADAAG 605.2; Fig. 605.2(a)
	2007 CBC 1115B.4.2(1)
	Other -

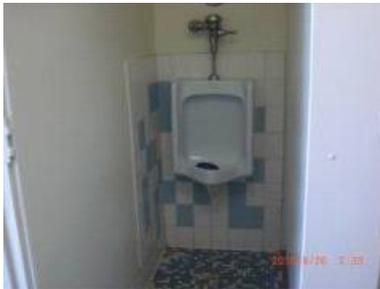
Keynote 282

Field Condition	
16.65B - Wall-Hung Urinal - Rim Height - Height of wall-hung urinal's rim exceeds 17" AFF.	1991 ADAAG 4.18.2
Existing Condition: 25" high rim.	2004 ADAAG 605.2; Fig. 605.2(a)
	2007 CBC 1115B.4.2(1)
	Other -

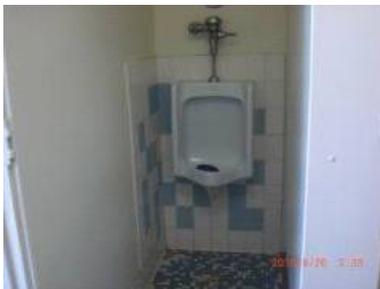
Keynote 284

Field Condition									
16.66 - Clear Floor Space at Urinal - There is no clear floor space at least 30" x 48" to allow a forward approach to the urinal. Existing Condition: 29 1/2" wide clear floor space at urinal.

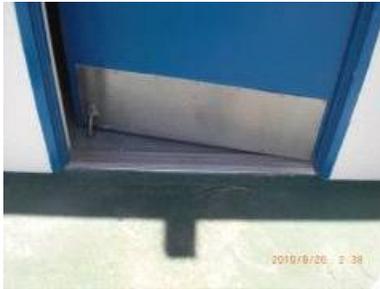
Keynote 285

Existing Condition: Door stop.

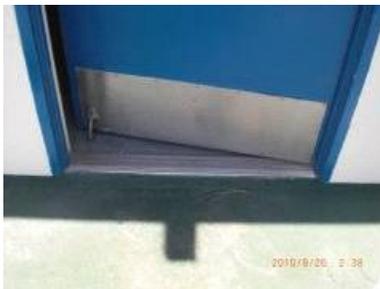
Keynote 286

Existing Condition: 1 1/2" high Threshold.

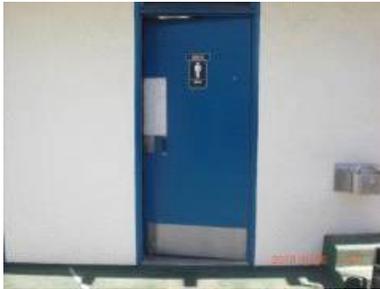
Keynote 288

Existing Condition: None provided.

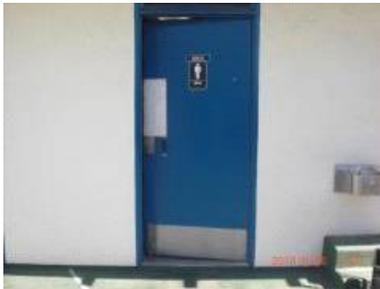
Keynote 289

Existing Condition: 9 LBF Operating effort

072B - Replace Closer - Replace door closer.

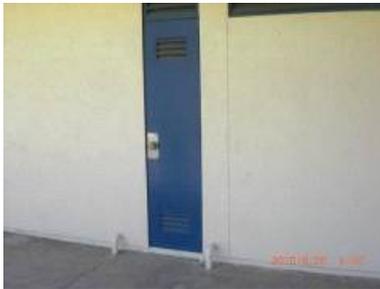
Keynote 295

Field Condition	
10.10 - Single-Action Hardware - Handles, locks, and latches or other operative devices are not operable with one hand and without tight grasping, pinching, or twisting of the wrist. (U-shaped handles, levers, and push/pull type mechanisms are acceptable designs.)	1991 ADAAG 4.13.9
Existing Condition: Door knob.	2004 ADAAG 309.4; 404.2.7; Advisory 404.2.7
	2007 CBC 1133B.2.5.2
	Other -

Corrective Action
067A - Replace Knob(s) with Lever Hardware - Remove knobs and existing latch and lock set. Provide new levers with new latch and lock sets.
Additional Comments:

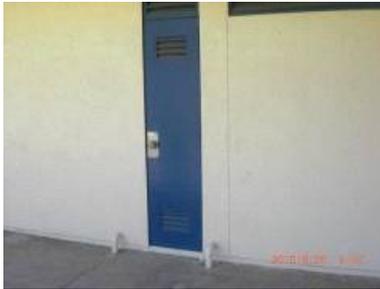
Keynote 296

Field Condition									
10.09B - Threshold - Height - The threshold at doorway exceeds 1/2" in height. Existing Condition: 2" high Threshold.

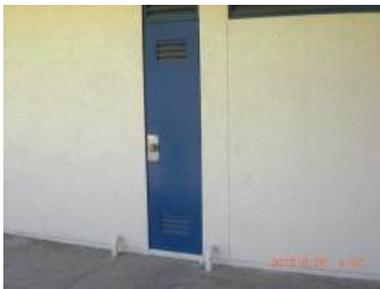
Keynote 297

Field Condition									
10.08 - Kick Plate - Bottom 10" of door does not have a smooth, uninterrupted surface on the push side to allow the door to be opened by a wheelchair footrest without creating a trap or hazardous condition. (This requirement does not apply to automatic and sliding doors.) Existing Condition: 7" high at Kick plate vent.

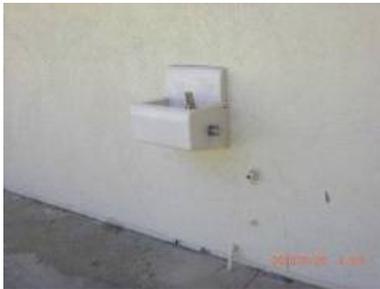
Location: Drinking Fountain
Photo # 299

Field Condition	
05.01A - "Hi" Drinking Fountain Requirement - Where there is only one drinking fountain area on a floor (e.g., an area with a drinking fountain or separate drinking fountains), it is accessible to wheelchair users and not to persons who have difficulty bending or stooping (i.e., the required accessibility for persons who have difficulty bending or stooping on each floor has not been provided).	1991 ADAAG 4.1.3(10)(a); 4.15.1
Existing Condition:	2004 ADAAG 211.1; 211.2
	2007 CBC 1115B.4.6 item 1
	Other -

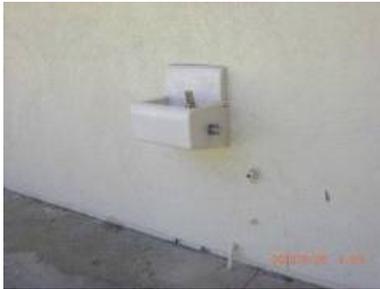
Field Condition	
05.08A - Wall-Mounted Protruding Objects - Wall mounted drinking fountain with leading edges between 27" and 80" from the floor projects more than 4" into the circulation path.	1991 ADAAG 4.4.1
Existing Condition: Drinking fountain protrudes 13" at 29" H.	2004 ADAAG 204; 307.2; Advisory 307.2; Fig.
	2007 CBC 1133B.8.6.1
	Other -

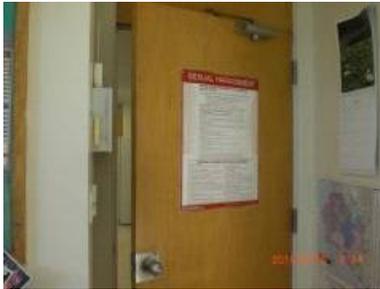
Location: Office **Photo #** 302

Field Condition									
11.11 - Single-Action Hardware - Handles, locks, and latches or other operative devices are not operable with one hand and without tight grasping, pinching, or twisting of the wrist. (U-shaped handles, levers, and push/pull type mechanisms are acceptable designs.)

1991 ADAAG	4.13.9	2004 ADAAG	309.4; 404.2.7; Advisory 404.2.7	2007 CBC	1133B.2.5.2	Other	-
1991 ADAAG	4.13.9								
2004 ADAAG	309.4; 404.2.7; Advisory 404.2.7								
2007 CBC	1133B.2.5.2								
Other	-								
Existing Condition: Door knob. Twist type lock.

Corrective Action	
067A - Replace Knob(s) with Lever Hardware - Remove knobs and existing latch and lock set. Provide new levers with new latch and lock sets.	
Additional Comments:

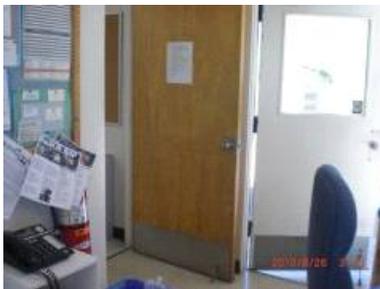
Field Condition									
11.15A - Kick Plate - Bottom 10" of door does not have a smooth, uninterrupted surface on the push side to allow the door to be opened by a wheelchair footrest without creating a trap or hazardous condition. (This requirement does not apply to automatic and sliding doors.)

1991 ADAAG	-	2004 ADAAG	404.2.10	2007 CBC	1133B.2.6	Other	-
1991 ADAAG	-								
2004 ADAAG	404.2.10								
2007 CBC	1133B.2.6								
Other	-								
Existing Condition: Door stop.

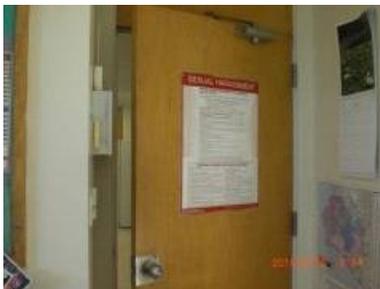
Location: Office Photo # 302

Field Condition	
11.14 - Closers - Door closer is not adjusted so that from an open position of 70 degrees, the door will take at least 3 seconds to move to a point 3" from the latch (measured to the leading edge of the door).	1991 ADAAG 4.13.10
Existing Condition: 2.3 second closer delay	2004 ADAAG 404.2.8.1
	2007 CBC 1133B.2.5.1
	Other -

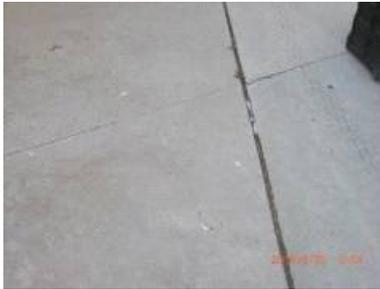
Location: Path Photo # 307

Field Condition									
03B.12 - > 1/4" Changes in Level - Where walkway levels change abruptly, the vertical difference between them exceeds 1/4 inch. Or changes in level between 1/4 inch and 1/2 inch are beveled with a slope greater than 1:2.

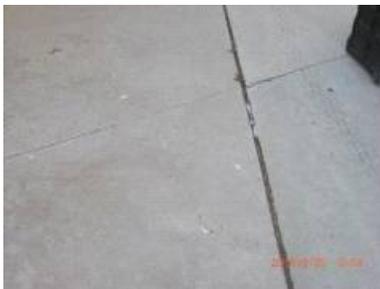
Location: Path Photo # 307

Field Condition									
03B.22 - Other - On-Site Accessible Path of Travel - See Additional Comments

1991 ADAAG	-	2004 ADAAG	-	2007 CBC	-	Other	-
1991 ADAAG	-								
2004 ADAAG	-								
2007 CBC	-								
Other	-								
Existing Condition: 3/4" gap.

Corrective Action	
005B - Concrete Crack Repair - Clean-out existing concrete crack and inject with epoxy grout. Cracks over 1/4" in width will require a foam backer rod and sealant.	
Additional Comments:

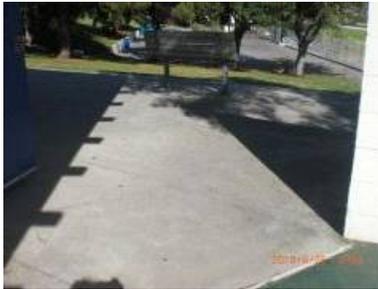
Location: Path Photo # 309

Field Condition									
03B.09 - Cross Slope - Cross slope of the accessible route of travel exceeds 1:50. Existing Condition: 2.4% to 4.4% CS.

Corrective Action
006 - Concrete Walk - Remove non-compliant pavement and replace with new concrete (area as shown on the drawings). The walkway slope shall not exceed 5% along the POT and cross slope shall not exceed 2%. Additional Comments:

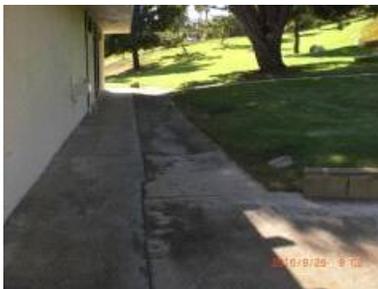
Field Condition									
03B.13 - > 1/2" Changes in Level - Curb ramps, ramps, or elevators are not used for changes in level greater than 1/2 inch. (Lifts may only be used in certain limited situations.) Existing Condition:

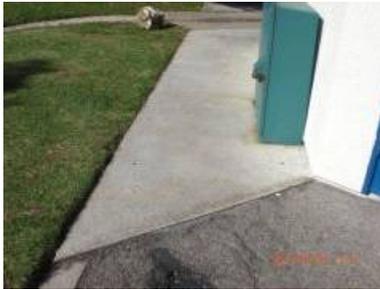
Location: Path **Photo #** 311

Field Condition	
03B.09 - Cross Slope - Cross slope of the accessible route of travel exceeds 1:50. Existing Condition: 2.7% CS.	1991 ADAAG 4.3.7 2004 ADAAG 403.3 2007 CBC 1133B.7.1.3 Other -

Corrective Action
006 - Concrete Walk - Remove non-compliant pavement and replace with new concrete (area as shown on the drawings). The walkway slope shall not exceed 5% along the POT and cross slope shall not exceed 2%. Additional Comments:

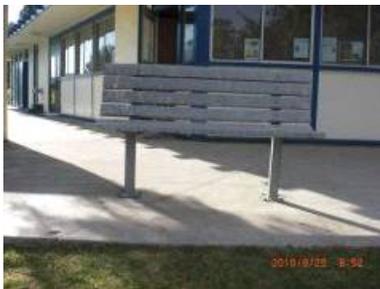
Field Condition	
30.13 - Number and Dispersal - Accessible Fixed Benches - Less than 50% of the fixed benches being provided in an area are accessible. OR They are not dispersed among the types provided. Existing Condition:	1991 ADAAG - 2004 ADAAG - 2007 CBC - Other 1999 ADAAG-16.12.2.2; 16.12.2

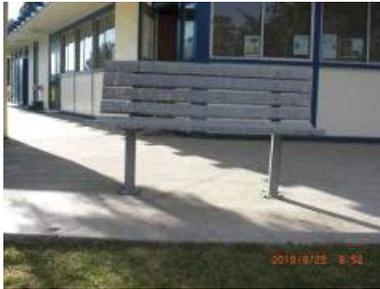
Location: Path
Photo # 312

Field Condition	
30.17 - Fixed Bench - Surface Slope - Clear space has a slope greater than 2% in some or all directions.(1999 ADAAG: 3% slope is allowed when necessary for drainage).	1991 ADAAG 4.3.7
Existing Condition: 2.4% and 2.8% slope.	2004 ADAAG 403.3
	2007 CBC -
	Other 1999 ADAAG-16.12.7

Corrective Action	
006 - Concrete Walk - Remove non-compliant pavement and replace with new concrete (area as shown on the drawings). The walkway slope shall not exceed 5% along the POT and cross slope shall not exceed 2%.	
Additional Comments:

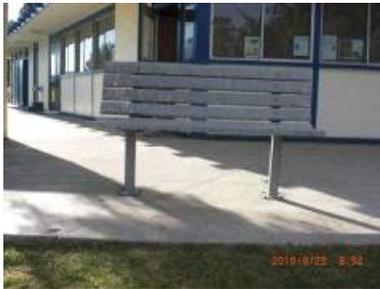
Location: Path
Photo # 312

Field Condition	
30.19 - Fixed Bench Height - The height of the front edge of the seating surface is not between 17" and 19" above the adjacent grade or floor space.	1991 ADAAG -
Existing Condition: Bench height at 20 1/4" high	2004 ADAAG 903.5
	2007 CBC -
	Other 1999 ADAAG-16.12.3

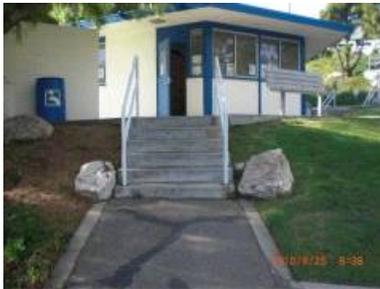
Location: Stairway Photo # 317

Field Condition	
08.03D - Level Landing - Landing is not level (slope is greater than 2% in some or all directions).	1991 ADAAG -
Existing Condition: 3.7% CS & 14.7% RS, uneven landing.	2004 ADAAG -
	2007 CBC 1009.5.1
	Other -

Corrective Action
008 - Concrete Landing - Remove non-compliant pavement and replace with new concrete. The landing slope shall not exceed 2% in any direction.
Additional Comments:

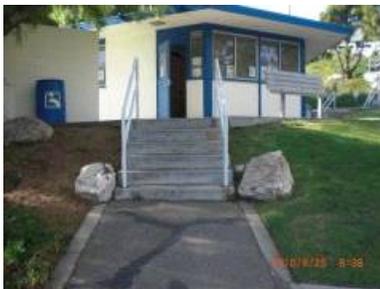
Location: Stairway
Photo # 317

Field Condition									
08.03E - Drainage - Design of outside stairs and their approaches allows water to accumulate on walking surfaces. Existing Condition: Water accumulates on stairs.

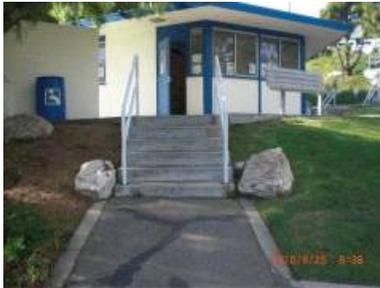
Location: Stairway
Photo # 317

08.09A - Handrail Extensions - Top Landing - At ends of handrails, less than 12" of handrail extends beyond the top nosing. (Top and bottom handrail extensions are important safety features for persons with balance problems and must extend in the direction of the stair run to permit the intended use.) (Per ADA/CBC Standards, in existing buildings and facilities, full extension of handrails at stairs shall not be required in alterations where such extensions would be hazardous or impossible due to plan configuration.)

Existing Condition: No top extension.

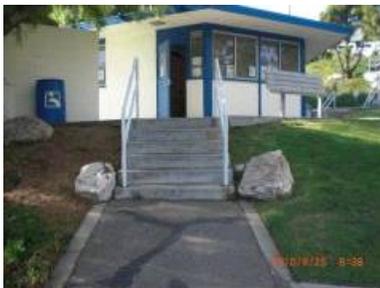
Location: Stairway
Photo # 317

Existing Condition: 2" profile.
