City of Rancho Palos Verdes
**Rancho Palos Verdes ADA Assessment
 Facility Report with Photos**

Facility ID: # 01 - Abalone Cove Shoreline Park

Author: Vaish, B

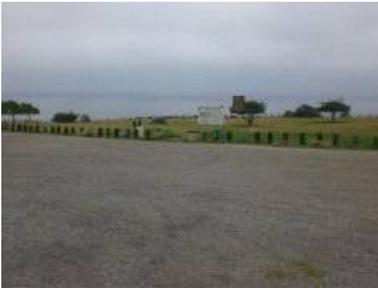
Location: Photo #
Parking Lot 1

Field Condition	
01.04 - Van Accessible Spaces - Lot does not provides the required number of designated "van accessible" parking spaces (one in every eight accessible parking spaces; one in every six per 2004 ADAAG).	1991 ADAAG 4.1.2(5)(b); 4.6.4 2004 ADAAG 208.2.4 2007 CBC 1129B.3 item 2, 1129B.4 Other
Existing Condition:

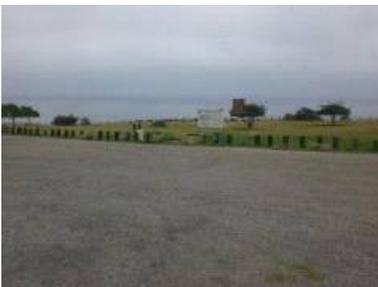
Location: Photo #
Parking Lot 1

Field Condition	
01.09 - Stall Dimensions - Accessible parking spaces, including van spaces, are not at least 9' wide and 18' long with a demarcated access aisle. (Two spaces may share a common aisle; parking space width is measured from the center line of the stripe on one side to the center line of the stripe on the other.)	1991 ADAAG 4.6.3 2004 ADAAG 502.2 2007 CBC 1129B.3 items 1 & 2 Other
Existing Condition: Not demarcated, none provided.

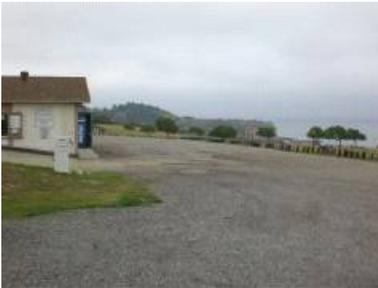
Location: Photo #
Facility to park routes 12

Field Condition	
30.04 - Accessible Route - Facilities Connected - Accessible routes of travel do not connect all accessible buildings, facilities, elements and spaces on the same site with one another.	1991 ADAAG 4.1.2(2)(a)
Existing Condition: No P.O.T. from restrooms to accessible parking & to route entrances..	2004 ADAAG 206.2.2; Advisory 206.2.2
	2007 CBC 1114B.1.2; 1127B.1
	Other -

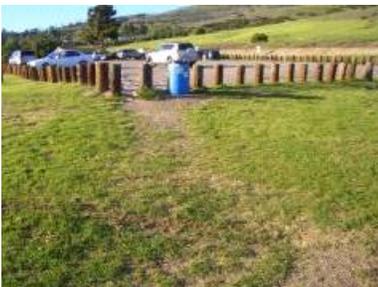
Location: Photo #
East Route entrance 13

Field Condition	
30.05 - Accessible Route - Width - Accessible route of travel is less than 48" wide (note: 48" wide requirement does not apply to doorways or gates).	1991 ADAAG 4.3.3
Existing Condition: 26 1/2" clear between posts.	2004 ADAAG 403.5.1
	2007 CBC 1133B.7.1
	Other -

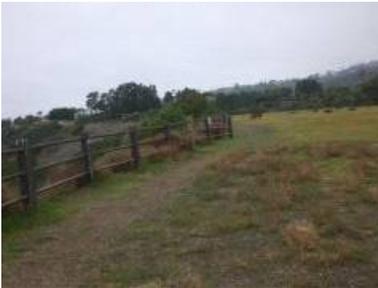
Location: Perimeter Route Photo # 16

Field Condition	
30.06B - Outdoor Recreation Access Route (ORAR) Resting Space - Resting space does not comply with 1999 ADAAG Section 16.3.8 (Resting intervals shall be 60" min. in length, shall have a width at least as wide as the access route and have a slope of 3.33% or less in any direction. The installation of resting spaces is required as follows: Percent slope, maximum length, Rest interval: 0% to 5.0%, No restriction, No restriction; 5.1% to 8.33%, 50', Every 50'; 8.34% to 10%, 30', Every 30'.)	1991 ADAAG - 2004 ADAAG - 2007 CBC - Other 1999 ADAAG-16.3.8
Existing Condition: Grass on P.O.T.

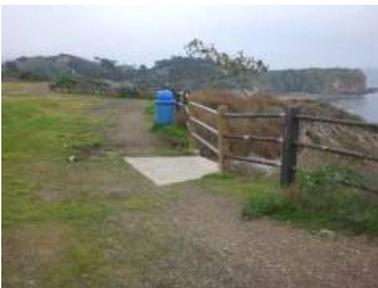
Location: Perimeter Route Photo # 17

Field Condition	
30.06C - Outdoor Recreation Access Route (ORAR) Surface - The surface of the access route is not firm or stable.	1991 ADAAG - 2004 ADAAG - 2007 CBC - Other 1999 ADAAG-16.3.1
Existing Condition: Loose dirt, erosion, and grass on trail.

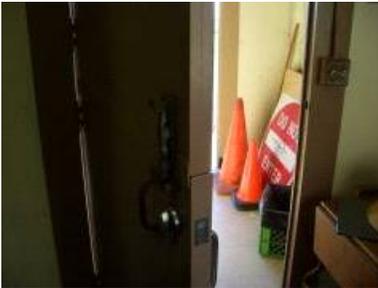
Location: Concession - Office
 Photo # 32

Field Condition	
11.11 - Single-Action Hardware - Handles, locks, and latches or other operative devices are not operable with one hand and without tight grasping, pinching, or twisting of the wrist. (U-shaped handles, levers, and push/pull type mechanisms are acceptable designs.)	1991 ADAAG 4.13.9
Existing Condition: Deadbolt & sliding latch.	2004 ADAAG 309.4; 404.2.7; Advisory 404.2.7
	2007 CBC 1133B.2.5.2
	Other -

Classification	
DOJ Location Type:	6
Use:	EW
Severity:	C
Level of Difficulty	Low to Moderate

Corrective Action	
067B - Lever Hardware - Replace door hardware with lever-type handset.	
Additional Comments: Provide compliant latch.

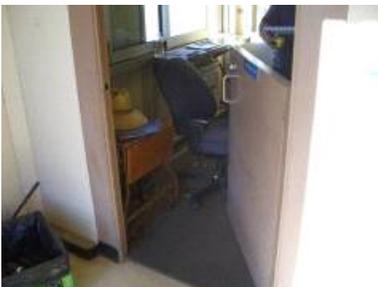
Field Condition	
11.17B - Room/Space Identification Signs (Visual/Tactile Signs) - Sign designating the permanent room or space does not comply with ADAAG and CBC requirements for tactile signs.	1991 ADAAG 4.1.2(7); 4.30.1, 4, 5, 6
Existing Condition:	2004 ADAAG 216.2; 703.1; 703.2; 703.5
	2007 CBC 1117B.5.2, 3, 5, 6, 7
	Other -

Classification	
DOJ Location Type:	6
Use:	EW
Severity:	D
Level of Difficulty	Low to Moderate

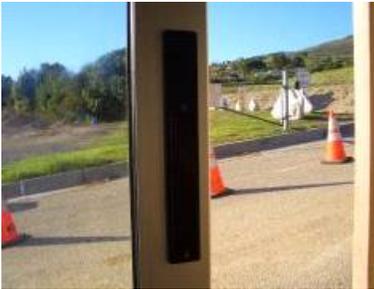
Location: Photo #
 Concession - Office 37

Field Condition	
14.35 - Controls - Operation - The controls are not accessible. (Accessible controls shall be operable with one hand, and without tight grasping, pinching, or twisting of the wrist, and the force to operate the controls shall be no greater than 5 lbs.)	1991 ADAAG 4.27.4
Existing Condition:	2004 ADAAG 309.4
	2007 CBC 1117B.6(4)
	Other -

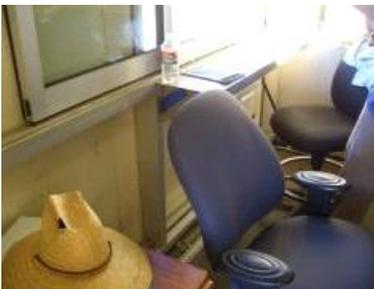
Location: Photo #
 Concession - Office 39

Field Condition	
14.28 - Fixed/Built-in Seating, Tables or Counters - At fixed or built-in seating, tables, or counters in public or common employee areas, less than 5% of the provided seating spaces are wheelchair accessible and have a 30" by 48" clear space which overlaps an accessible route of travel. (Wheelchair accessible seating spaces are between 28" - 34" high and with knee space measuring at least 27" high, 30" wide, and 19" deep.) (These elements include study carrels and student laboratory stations.)	1991 ADAAG 4.1.3(18); 4.32.1; 4.32.4
Existing Condition: 35 3/4" high.	2004 ADAAG 226.1; Advisory 226.1; 305; 306; 902.2
	2007 CBC 1122B.1
	Other -

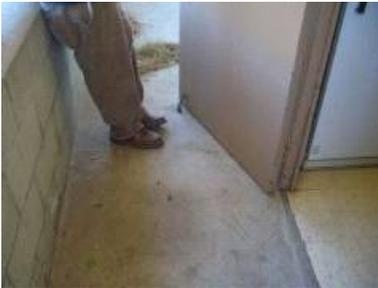
Location: Storage Photo # 47

Field Condition	
10.08 - Kick Plate - Bottom 10" of door does not have a smooth, uninterrupted surface on the push side to allow the door to be opened by a wheelchair footrest without creating a trap or hazardous condition. (This requirement does not apply to automatic and sliding doors.)	1991 ADAAG -
Existing Condition: Door stop.	2004 ADAAG 404.2.10
	2007 CBC 1133B.2.6
	Other -

Classification	
DOJ Location Type:	1
Use:	EC
Severity:	C
Level of Difficulty	Low to Moderate

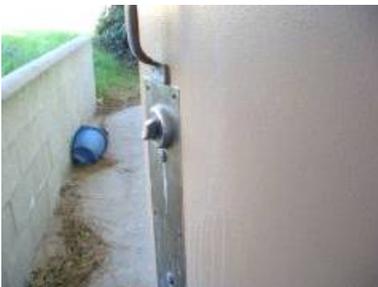
Location: Storage Photo # 49

Field Condition	
10.10 - Single-Action Hardware - Handles, locks, and latches or other operative devices are not operable with one hand and without tight grasping, pinching, or twisting of the wrist. (U-shaped handles, levers, and push/pull type mechanisms are acceptable designs.)	1991 ADAAG 4.13.9
Existing Condition:	2004 ADAAG 309.4; 404.2.7; Advisory 404.2.7
	2007 CBC 1133B.2.5.2
	Other -

Classification	
DOJ Location Type:	1
Use:	EC
Severity:	C
Level of Difficulty	Low to Moderate

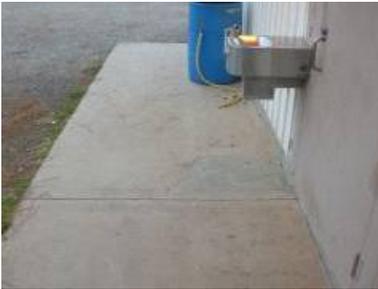
Location: N. Path leading to storage Rm.
 Photo # 52

Field Condition	
03B.04 - Width - Accessible route of travel is less than 48" wide (note: 48" wide requirement does not apply to doorways or gates).	1991 ADAAG 4.3.3
Existing Condition: 40" wide walkway.	2004 ADAAG 403.5.1
	2007 CBC 1133B.7.1
	Other -

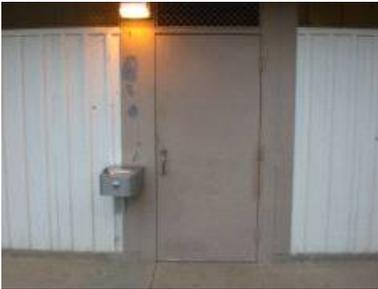
Location: Concession Bldg. Photo # 53

10.06A - Door Maneuvering Space - Door that is not automatic or power-assisted does not have compliant maneuvering space relative to the direction of approach as shown in CBC Fig. 11B-26. (Approach // Side // Width // Depth) (Front // Pull // D + 24" * // 60") (Front // Push // D + 0" ** // 48") (Latch // Pull // D + 24" // 60") (Latch // Push // D + 24" // 44" ***) (Hinge // Pull // D + 36" // 60") (Hinge // Push // 54" **** // 44" *****) (* D + 18" at interior doors.) (** D + 12" if door has both a latch and a closer.) (***) 48" if door has closer.) (**** Measured from latch toward hinge.) (***** 48" if door has both a latch and a closer.)

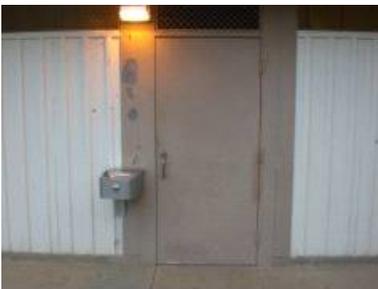
Location: Concession Bldg. Photo # 53

Field Condition	
05.05C - Knee Space Depth - Drinking fountain provides less than 8" deep accessible knee clearance between the bottom of the apron and the floor, the depth measured from the front edge of the drinking fountain back towards the wall or post.	1991 ADAAG 4.15.5(1); Figs. 27(a) and (b)
Existing Condition: 4"	2004 ADAAG 306.3; Figs. 306.3
	2007 CBC 1115B.4.6 item 2
	Other -

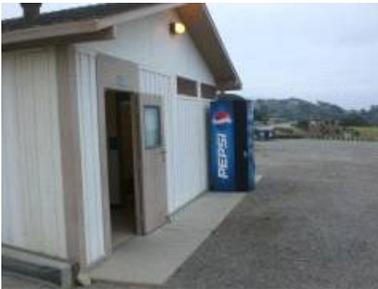
Location: Near Concession Bldg. Photo # 59

Field Condition	
03B.22 - Other - On-Site Accessible Path of Travel - See Additional Comments	1991 ADAAG -
Existing Condition: Vending machine on P.O.T.	2004 ADAAG -
	2007 CBC -
	Other -

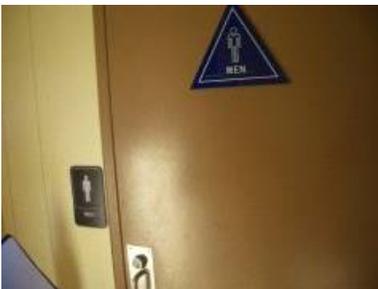
Location: Men's Restroom. Photo # 61

Field Condition	
16.14A - Mounting Height - Geometric Symbol Signage - The geometric symbol is not centered on the door leaf. OR The symbol is not mounted at a height of 60" AFF.	1991 ADAAG -
Existing Condition: 65" high.	2004 ADAAG -
	2007 CBC 1115B.6
	Other -

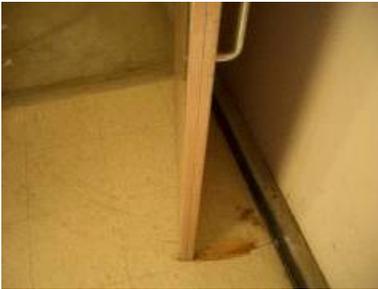
Location: Men's Restroom. Photo # 64

Field Condition	
16.11A - Door Operating Effort - The force required to operate door exceeds 5 lbs. (Fire doors may have up to 15 lbs to achieve positive latching).	1991 ADAAG 4.13.11
Existing Condition: 14 LBF. door rubs on floor.	2004 ADAAG 404.2.9
	2007 CBC 1133B.2.5
	Other -

Classification	
DOJ Location Type:	1
Use:	PV
Severity:	B
Level of Difficulty	Moderate

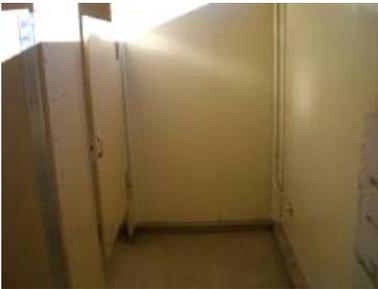
Field Condition	
16.39A - Maneuvering Space in Front of WC - End-Opening Door - Where the stall has an end-opening stall door, the clear space in front of the WC is less than 60" wide by 48" deep.	1991 ADAAG 4.17.3; Fig. 30(b)
Existing Condition: 47" clear.	2004 ADAAG 404.2.4.1; Table 404.2.4.1; Fig. 404.2.4.1
	2007 CBC 1115B.4.1(2); Fig. 11B-1A
	Other -

Classification	
DOJ Location Type:	3
Use:	PV
Severity:	C
Level of Difficulty	Moderate to High

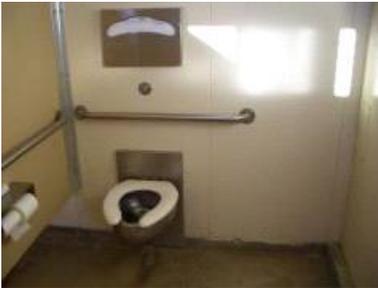
Location: Photo #
 Men's Restroom. 66

Field Condition	
16.49B - WC Flush Controls - Location - Flush controls are not located on the wide side of the WC where the clear floor space is provided.	1991 ADAAG 4.16.5
Existing Condition: On center.	2004 ADAAG 604.6; Advisory 604.6
	2007 CBC 1115B.4.1(5); Fig. 11B-1A
	Other -

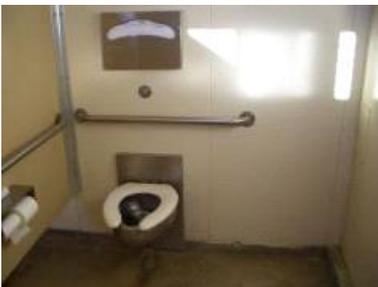
Location: Photo #
 Men's Restroom. 66

Field Condition	
16.49A - WC Flush Controls - Operation - Water closet flush controls are not automatic or operable with one hand. (Accessible controls shall be operable with one hand, and without tight grasping, pinching, or twisting of the wrist, and the force to operate the controls shall be no greater than 5 lbs.)	1991 ADAAG 4.16.5; 4.27.4
Existing Condition: 20 LBF.	2004 ADAAG 604.6; Advisory 604.6; 309.4
	2007 CBC 1115B.4.1(5); Fig. 11B-1A
	Other -

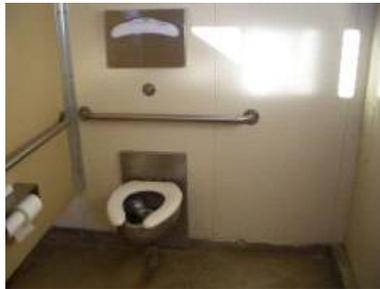
Location: Photo #
Men's Restroom. 66

Field Condition	
16.53 - SC Dispenser Height - Mounting height of seat cover dispenser's highest operable part exceeds 40" AFF.	1991 ADAAG 4.22.7; 4.27.3; 4.2.5; 4.2.6
Existing Condition: 51" high.	2004 ADAAG -
	2007 CBC 1115B.8.3
	Other -

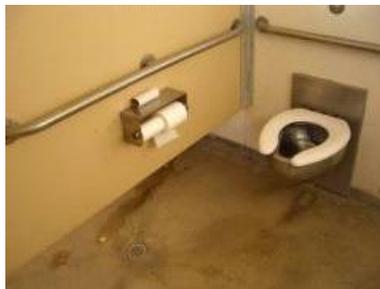
Location: Photo #
Men's Restroom. 69

Field Condition	
16.55A - Side Grab Bar Height - Side grab bar is not centered at 33" AFF. (ADA Standards require side grab bars to be centered from 33" to 36" AFF; CBC Standards require side grab bars to be centered at 33" AFF.)	1991 ADAAG 4.17.6; Figs. 29 & 30
Existing Condition: 33 1/2" high.	2004 ADAAG 604.5; Advisory 604.5; 604.5.2; Fig. 604.5.2; 609.4
	2007 CBC 1115B.4.1(3.1); Fig. 11B-1A
	Other -

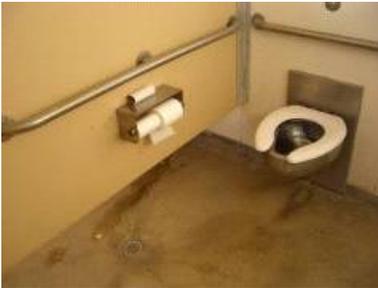
Location: Photo #
Men's Restroom. 69

Field Condition	
16.55B - Back Grab Bar Height - Non-Tank-Type WC - At non-tank-type WC, back grab bar is not centered at 33" AFF. (ADA Standards require back grab bars to be centered from 33" to 36" AFF; CBC Standards require back grab bars to be centered at 33" AFF.)	1991 ADAAG 4.17.6; Figs. 29 & 30
Existing Condition: 34 3/4" high.	2004 ADAAG 604.5; Advisory 604.5; 609.4
	2007 CBC 1115B.4.1(3.2); Fig. 11B-1A
	Other -

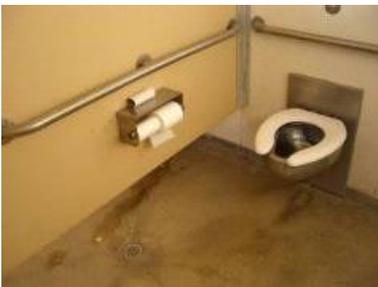
Location: Photo #
Men's Restroom. 69

Field Condition	
16.59 - Side Grab Bar - At WC providing front transfer, the side grab bar location is not compliant. (CBC Standards require the side grab bar to extend at least 54" min.. beyond the back wall while the other end is 12" max.. from the back wall. CBC also requires the grab bar's front end to be positioned 24" min.. in front of the WC.)	1991 ADAAG 4.17.6; Figs. 29 & 30
Existing Condition: 53" long.	2004 ADAAG Fig. 604.5.1
	2007 CBC 1115B.4.1(3.1); Fig. 11B-1A
	Other -

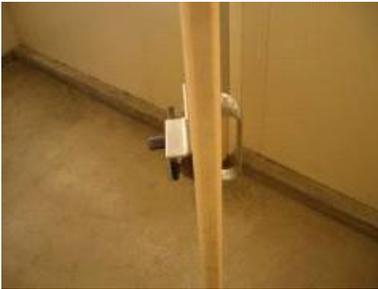
Keynote 72

Field Condition	
16.32A - U-Pulls at Stall Door - The stall door does not have U-pulls on both sides.	1991 ADAAG 4.13.9; 4.17.5
Existing Condition:	2004 ADAAG 309.4; 404.27; 604.8.1.2
	2007 CBC 1115B.3.1(4.4)
	Other -

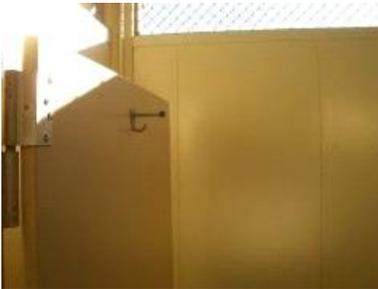
Location: Photo #
Men's Restroom. 74

Field Condition	
16.83 - Coat Hook - Height - Where a coat hook is provided In an accessible stall, height of coat hook exceeds 48" AFF.	1991 ADAAG 4.2.5
Existing Condition: 65 1/2" high.	2004 ADAAG 213.3.7; 308; 603.4
	2007 CBC 1117B.8
	Other -

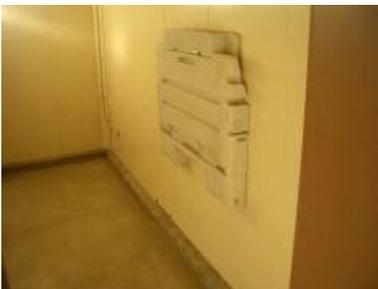
Location: Photo #
Men's Restroom. 75

Field Condition	
16.84F - Diaper Changing Table - Operating Height - Mounting height of diaper changing table's highest operable part exceeds 40" AFF. (Where provided, at least one shall be accessible.)	1991 ADAAG 4.27.3
Existing Condition: 43" high.	2004 ADAAG 308; 309
	2007 CBC -
	Other -

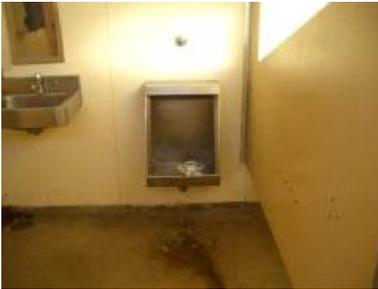
Location: Men's Restroom. Photo # 76

Field Condition	
16.65A - Wall-Hung Urinal - Rim Projection from Wall - The wall-hung urinal's elongated rim does not project 14" min.. to 17" max.. from the wall.	1991 ADAAG 4.18.2
Existing Condition: 12" deep.	2004 ADAAG 605.2; Fig. 605.2(a)
	2007 CBC 1115B.4.2(1)
	Other -

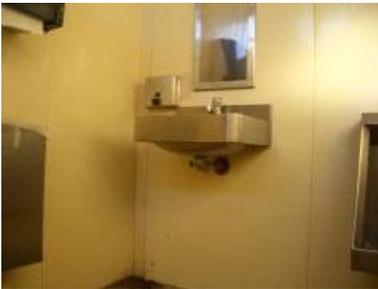
Keynote 77

Field Condition	
16.71 - Lavatory - Rim Height - Height of lavatory rim or counter surface exceeds 34" AFF.	1991 ADAAG 4.19.2; Fig. 31
Existing Condition: 34 3/8" high.	2004 ADAAG 606.3
	2007 CBC 1115B.4.3(2); Fig 11B-1D
	Other -

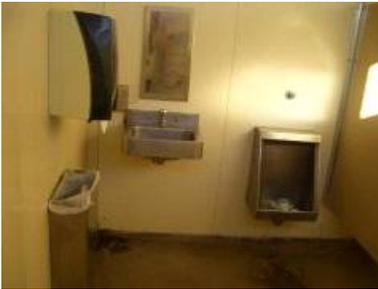
Location: Photo #
 Men's Restroom. 78

Field Condition	
16.75 - Clear Floor Space at Lavatory - There is no clear floor space at least 30" x 48" in front of the lavatory (extending a maximum of 19" underneath the lavatory) to allow a forward approach.	1991 ADAAG 4.19.3; 4.2.4
Existing Condition: PTD encroaches into lavatory clear floor space.	2004 ADAAG 606.2
	2007 CBC 1115B.4.3(3); Fig 11B-1D
	Other -

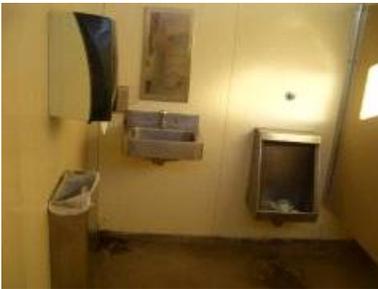
Keynote 79

Field Condition	
16.81 - Lavatory Faucet Operation - Min. 10 Second Standard - Self-closing valve remains open for less than 10 seconds.	1991 ADAAG 4.19.5
Existing Condition: 5 seconds.	2004 ADAAG 606.4
	2007 CBC 1115B.4.3(1)
	Other -

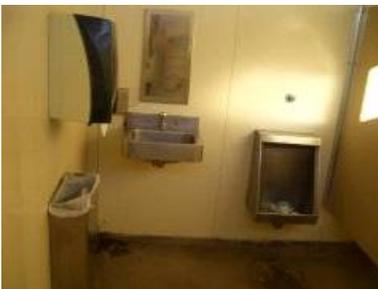
Location: Men's Restroom. Photo # 81

Field Condition	
16.78 - Pipe Insulation at Lavatory - Drainpipes and hot water pipes are not insulated to protect against contact.	1991 ADAAG 4.19.4 2004 ADAAG 606.5 2007 CBC 1115B.4.3(4) Other -
Existing Condition:

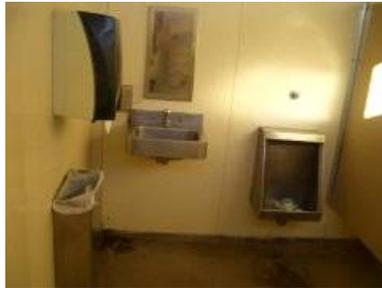
Keynote 82

Field Condition	
16.84A - Paper Towel Dispenser - Operating Height - Mounting height of paper towel dispenser's highest operable part exceeds 40" AFF. (Where provided, ADA Standards require at least one paper towel dispenser to be accessible with the highest operable part placed within at least one of the reach ranges specified in 4.2.5 and 4.2.6; where provided, CBC Standards require at least one paper towel dispenser to be accessible with the highest operable part no higher than 40" AFF.)	1991 ADAAG 4.22.7; 4.27.3; 4.2.5; 4.2.6 2004 ADAAG 308; 309 2007 CBC 1115B.8.3 Other -
Existing Condition: 46" high.

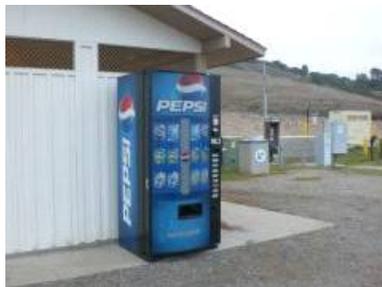
Location: N.E. of Concession Photo # 83

Field Condition	
06.02A - Clear Floor Space - The accessible telephone does not have a 30" x 48" clear floor space that adjoins or overlaps an accessible route of travel and that allows either a forward or parallel approach by wheelchair users.	1991 ADAAG 4.31.2; 4.2.4 2004 ADAAG 305; 704.2.1; Advisory 704.2.1 2007 CBC 1117B.2.2 Other -
Existing Condition: No P.O.T. to payphone.

Corrective Action	
006 - Concrete Walk - Remove non-compliant pavement and replace with new concrete (area as shown on the drawings). The walkway slope shall not exceed 5% along the POT and cross slope shall not exceed 2%.	
Additional Comments: Provide new walkway with curb to payphone.

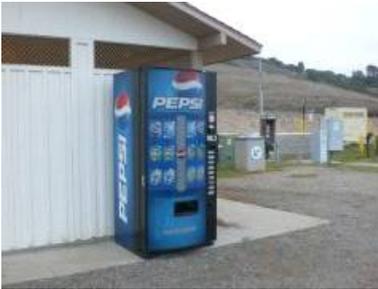
Keynote 84

Field Condition	
06.02B - ISA Sign - The wheelchair accessible telephone is not identified by the ISA.	1991 ADAAG 4.1.3(17)(b); 4.30.7(1)
Existing Condition:	2004 ADAAG 703.2.1; Fig. 703.2.1
	2007 CBC 1117B.5.8.1
	Other -

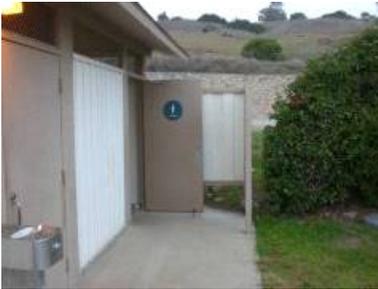
Keynote 86

Field Condition	
16.11A - Door Operating Effort - The force required to operate door exceeds 5 lbs. (Fire doors may have up to 15 lbs to achieve positive latching).	1991 ADAAG 4.13.11
Existing Condition: 8 LBF.	2004 ADAAG 404.2.9
	2007 CBC 1133B.2.5
	Other -

Corrective Action
072B - Replace Closer - Replace door closer.
Additional Comments:

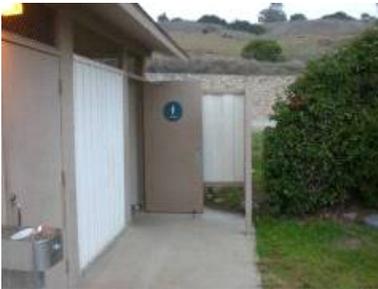
Keynote 87

Field Condition	
16.13B - Women's RR Geometric Symbol Signage - Circle - Doorway leading to a women's toilet room is not identified by a circle, 1/4" thick and 12" in diameter. OR Circle is provided, however it is accompanied by words in raised characters and Braille. (ADA and CBC Standards require a separate sign with raised characters and Braille mounted on the wall adjacent to the latch side of the door.)	1991 ADAAG -
Existing Condition: Bad Braille.	2004 ADAAG -
	2007 CBC 1115B.6
	Other -

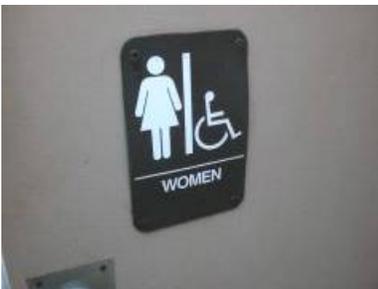
Keynote 89

Existing Condition: 50" high.

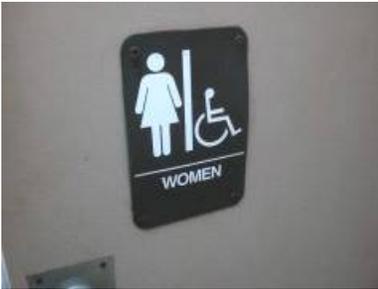
Keynote 90

Field Condition	
16.21A - Raised Characters and Braille (Visual/Tactile Signs) - The raised characters on this sign are not accompanied by California Grade 2 Braille (i.e., the dots within each cell are domed and spaced 1/10" o.c.)	1991 ADAAG 4.30.4
Existing Condition:	2004 ADAAG 703.2; 703.3
	2007 CBC 1117B.5.5 item 1, 1117B.5.6
	Other -

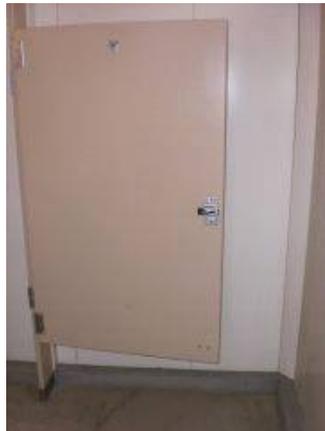
Location: Photo #
 Women's Restroom 92

Field Condition	
16.32A - U-Pulls at Stall Door - The stall door does not have U-pulls on both sides.	1991 ADAAG 4.13.9; 4.17.5
Existing Condition:	2004 ADAAG 309.4; 404.27; 604.8.1.2
	2007 CBC 1115B.3.1(4.4)
Other	-

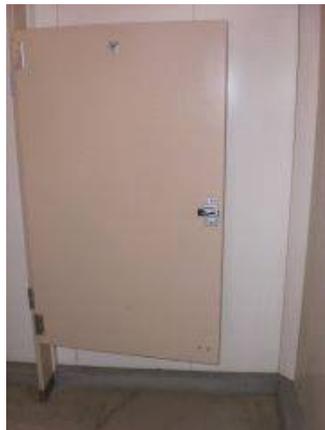
Keynote 93

Field Condition	
16.33 - Self-Closing Stall Door - The stall door is not self-closing.	1991 ADAAG 4.13.10
Existing Condition:	2004 ADAAG 604.8.1.2
	2007 CBC 1115B.3.1(4.4)
Other	-

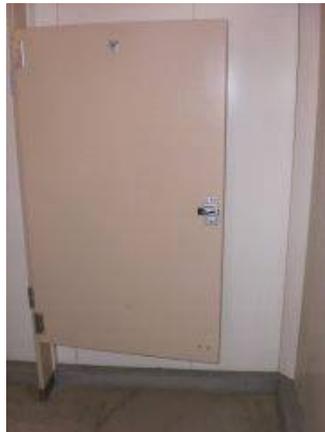
Keynote 94

Field Condition	
16.35C - Out-Swinging Stall Door - Approach - Where the stall door swings out, the aisle approaching the stall is less than 60" deep.	1991 ADAAG 4.17.5; 4.13.6; Fig. 25
Existing Condition: 45 1/2" deep landing.	2004 ADAAG 404.2.4.1; Fig. 404.2.4.1
	2007 CBC 1133B.2.4.2; Figs. 11B-26A and 11B-26B
	Other -

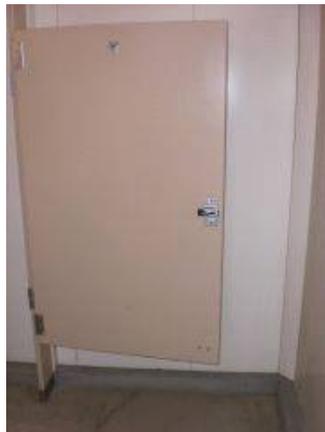
Keynote 95

Field Condition	
16.40 - Stall Door Location - End-Opening Stall - In an end-opening stall, the stall door is in front of the WC and not in front of the side transfer space. (ADA/CBC Standards require the door to be located in front of the side transfer space and diagonal to the WC, with a maximum stile width of 4".)	1991 ADAAG 4.17.3; Fig. 30(a)
Existing Condition: 9 1/2" stile.	2004 ADAAG 604.8.1.2; Fig. 604.8.1.2
	2007 CBC 1115B.3.1(4.3); Fig. 11B-1A
	Other -

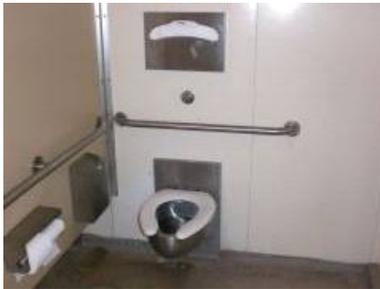
Location: Women's Restroom
Photo # 96

Existing Condition: 11 LBF.

322 - Sensor-Operated Water Closet Flushometer - Remove existing toilet flush valve, relocate water supply line per manufacturer's directions, and provide new sensor-operated flushometer. Patch and repair wall substrate and finishes, to match adjacent undisturbed surfaces.

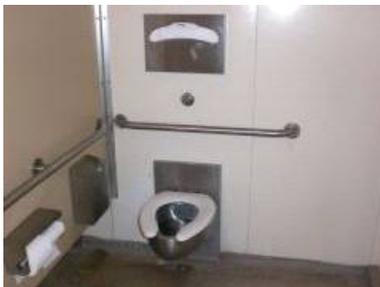
Keynote 97

Existing Condition: Center of W.C.

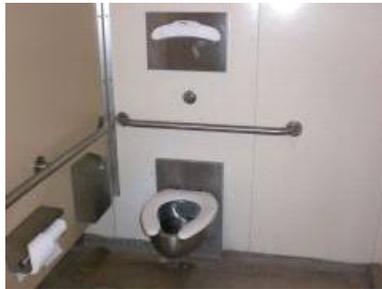
Keynote 98

Field Condition	
16.50 - TP Dispenser - Location - Pre-2007 CBC Facility - Location of the toilet paper dispenser does not comply with the Standard in effect at the time of construction. (The 2001 CBC required toilet tissue dispensers located on the wall within 12" of the front edge of the toilet seat, measured to the centerline of the dispenser; mounted below the grab bar; and centered at a min. height of 19" AFF.)	1991 ADAAG 4.16.6; Fig. 29(b)
Existing Condition: 17" from W.C.	2004 ADAAG 604.7; Advisory 604.7; Fig. 604.7
	2007 CBC -
	Other -

Corrective Action
325B - Replace Toilet Paper Dispenser - Remove existing toilet paper dispenser and provide a new dispenser 19" above finish floor and 12" from toilet face. The dispenser is recessed or projects no more than 3" from the wall. Patch and repair wall substrate and finishes, to match adjacent undist
Additional Comments:

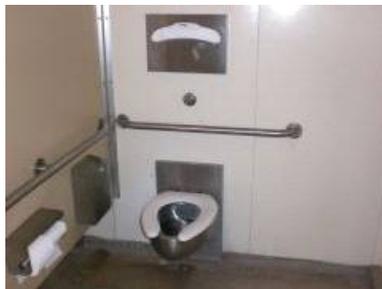
Keynote 99

Field Condition	
16.53 - SC Dispenser Height - Mounting height of seat cover dispenser's highest operable part exceeds 40" AFF.	1991 ADAAG 4.22.7; 4.27.3; 4.2.5; 4.2.6
Existing Condition: 50 1/2" high.	2004 ADAAG -
	2007 CBC 1115B.8.3
	Other -

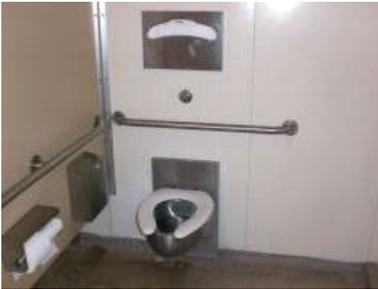
Keynote 100

Field Condition	
16.55A - Side Grab Bar Height - Side grab bar is not centered at 33" AFF. (ADA Standards require side grab bars to be centered from 33" to 36" AFF; CBC Standards require side grab bars to be centered at 33" AFF.)	1991 ADAAG 4.17.6; Figs. 29 & 30
Existing Condition: 33 1/2" high.	2004 ADAAG 604.5; Advisory 604.5; 604.5.2; Fig. 604.5.2; 609.4
	2007 CBC 1115B.4.1(3.1); Fig. 11B-1A
	Other -

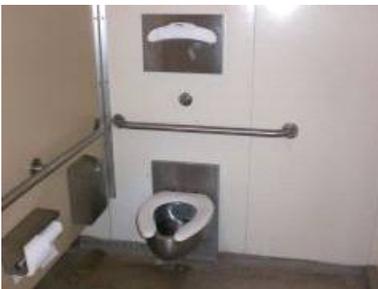
Keynote 101

Field Condition	
16.55B - Back Grab Bar Height - Non-Tank-Type WC - At non-tank-type WC, back grab bar is not centered at 33" AFF. (ADA Standards require back grab bars to be centered from 33" to 36" AFF; CBC Standards require back grab bars to be centered at 33" AFF.)	1991 ADAAG 4.17.6; Figs. 29 & 30
Existing Condition: 32 3/4" high.	2004 ADAAG 604.5; Advisory 604.5; 609.4
	2007 CBC 1115B.4.1(3.2); Fig. 11B-1A
	Other -

Corrective Action
326D - Replace Grab Bar(s) - Remove existing grab bars, if any. Provide new accessible grab bars 1 1/2" O.D. grab bar 42" long at 33" above the finished floor at both sides of the stall.
Additional Comments:

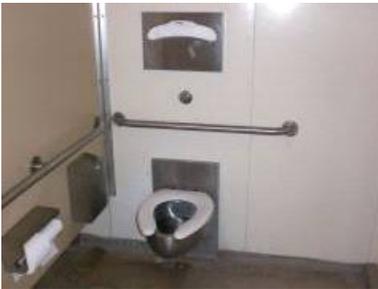
Keynote 102

Field Condition	
16.57 - Grab Bar Clearance - Dispenser is located so that it obstructs the use of the grab bar, i.e. less than 18" above or within 1-1/2" below the tangent point of the grab bar. (Exception: When dispenser is recessed, flush with wall, and has no sharp edges.)	1991 ADAAG 4.17.6, 4.26.2; Fig. 39
Existing Condition: 10 1/2" Clear from seat cover dispenser.	2004 ADAAG 609.4
	2007 CBC -
	Other -

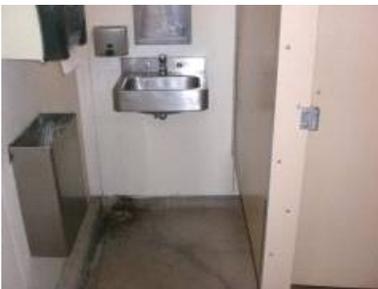
Location: Women's Restroom
 Photo # 103

Field Condition	
16.71 - Lavatory - Rim Height - Height of lavatory rim or counter surface exceeds 34" AFF.	1991 ADAAG 4.19.2; Fig. 31
Existing Condition: 34 1/2" high.	2004 ADAAG 606.3
	2007 CBC 1115B.4.3(2); Fig 11B-1D
	Other -

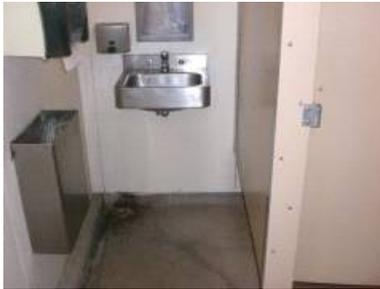
Keynote 106

Field Condition	
16.78 - Pipe Insulation at Lavatory - Drainpipes and hot water pipes are not insulated to protect against contact.	1991 ADAAG 4.19.4
Existing Condition:	2004 ADAAG 606.5
	2007 CBC 1115B.4.3(4)
	Other -

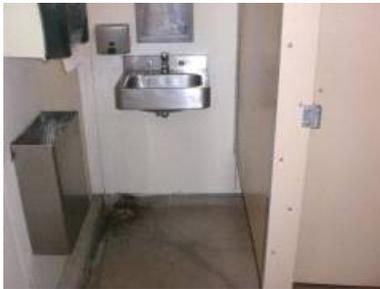
Keynote 107

Field Condition	
16.81 - Lavatory Faucet Operation - Min. 10 Second Standard - Self-closing valve remains open for less than 10 seconds.	1991 ADAAG 4.19.5
Existing Condition:	2004 ADAAG 606.4
	2007 CBC 1115B.4.3(1)
	Other -

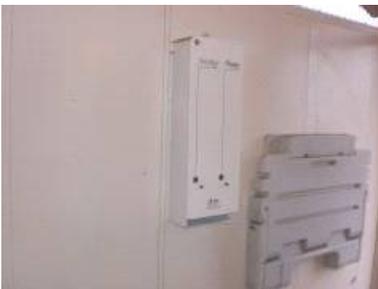
Location: Women's Restroom
Photo # 110

Field Condition	
16.88 - Other - Toilet Facilities - See Additional Comments	1991 ADAAG -
Existing Condition: Feminine dispenser protrudes 6" at 42" high.	2004 ADAAG -
	2007 CBC -
	Other -

Classification	
DOJ Location Type:	3
Use:	PV
Severity:	A
Level of Difficulty	Low to Moderate

Corrective Action	
292 - Relocate Sanitary Napkin/ Feminine Hygiene Dispenser - Women's Restroom - Relocate existing sanitary napkin/feminine hygiene dispenser so height of operating handles is no higher than 40" above finish floor. Patch and repair wall substrate and finishes, to match adjacent undisturbed surfaces.	
Additional Comments: Relocate & provide compliant type.

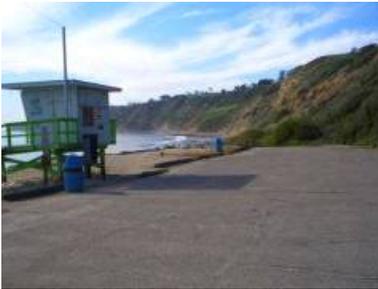
Photo #
112

01.02 - Number - Accessible Parking Spaces - Where parking spaces are provided for self-parking by employees or visitors or both, the required number of accessible parking spaces is not provided. (Note: All or some of the accessible parking spaces may be in a different location if equivalent or greater accessibility is ensured.) (Spaces required: (1 to 25 // 1) (26 to 50 // 2) (51 to 75 // 3) (76 to 100 // 4) (101 to 150 // 5) (151 to 200 // 6) (201 to 300 // 7) (301 to 400 // 8) (401 to 500 // 9) (501 to 1,000 // *) (1,000 and over // **) (**Twenty plus one for each 100, or fraction over 1,001.)

Existing Condition: No demarcated parking (7 cars allowed to park according to nursery school staff).

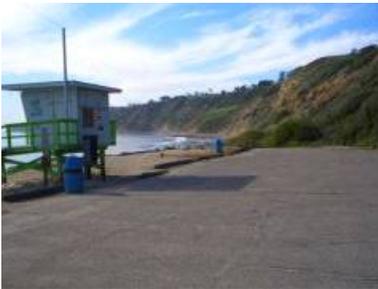
Location: Parking Lot at Nursery School
Photo # 112

Field Condition	
01.13 - Level Surface - The accessible parking spaces and access aisles are not level (slope is greater than 2%).	1991 ADAAG 4.6.3 2004 ADAAG 502.4; advisory 502.4 2007 CBC 1129B.3 items 3 & 4 Other
Existing Condition: Deteriorating surface, slope @ 4.7%

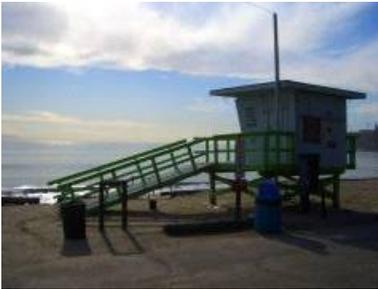
Location: Pay Phone North of Lifeguard Tower
Photo # 115

Field Condition	
06.02A - Clear Floor Space - The accessible telephone does not have a 30" x 48" clear floor space that adjoins or overlaps an accessible route of travel and that allows either a forward or parallel approach by wheelchair users.	1991 ADAAG 4.31.2; 4.2.4
Existing Condition: Bollards in front.	2004 ADAAG 305; 704.2.1; Advisory 704.2.1
	2007 CBC 1117B.2.2
	Other -

Corrective Action	
004A - Asphalt Paving - Remove non-compliant pavement and replace with new asphalt paving (area as shown on the drawings). The walkway slope shall not exceed 5% along the POT and cross slope shall not exceed 2%.	
Additional Comments: Provide new walkway with curb to payphone & remove existing bollard.

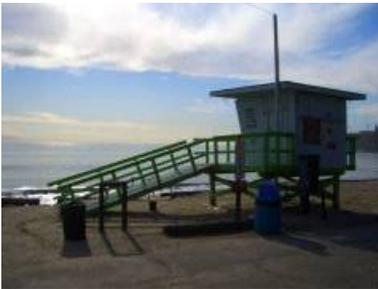
Location: Pay Phone North of Lifeguard Tower
Photo # 115

Field Condition	
06.02B - ISA Sign - The wheelchair accessible telephone is not identified by the ISA.	1991 ADAAG 4.1.3(17)(b); 4.30.7(1)
Existing Condition:	2004 ADAAG 703.2.1; Fig. 703.2.1
	2007 CBC 1117B.5.8.1
	Other -

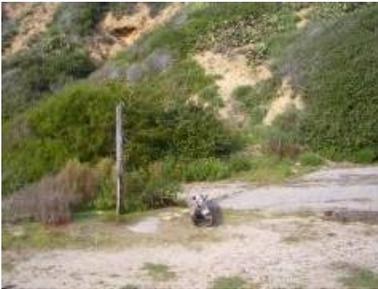
Location: Shower at Beach
Photo # 117

Field Condition	
17.01 - Accessible Bathing or Showering Facilities - Where facilities for bathing or showering are provided, less than 1% of these facilities are accessible.	1991 ADAAG 4.23.1; 4.23.8
Existing Condition: Twist type controls & no P.O.T.	2004 ADAAG 213.3.6
	2007 CBC 1115B.2
	Other -

Corrective Action	
004A - Asphalt Paving - Remove non-compliant pavement and replace with new asphalt paving (area as shown on the drawings). The walkway slope shall not exceed 5% along the POT and cross slope shall not exceed 2%.	
Additional Comments: Provide compliant shower.

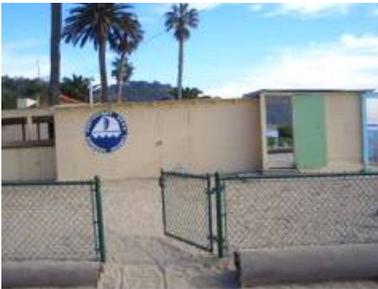
Location: West Gate at Nursery School
Photo # 118

Field Condition	
11.04 - Gates - Gate does not comply with all applicable ADAAG and CBC accessibility requirements for doors. (ADAAG and CBC accessibility requirements for doors apply to gates, including ticket gates.)	1991 ADAAG 4.13.3
Existing Condition:	2004 ADAAG 404.2; 404.3
	2007 CBC 1133B.1.1.1.4
	Other -

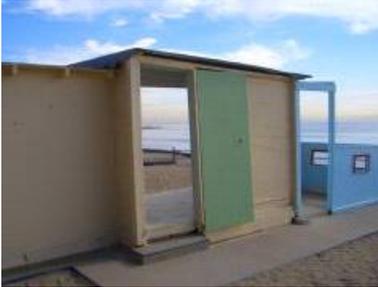
Location: Stage at Play Yard
Photo # 119

Field Condition	
11.11 - Single-Action Hardware - Handles, locks, and latches or other operative devices are not operable with one hand and without tight grasping, pinching, or twisting of the wrist. (U-shaped handles, levers, and push/pull type mechanisms are acceptable designs.)	1991 ADAAG 4.13.9
Existing Condition: Rope handle.	2004 ADAAG 309.4; 404.2.7; Advisory 404.2.7
	2007 CBC 1133B.2.5.2
	Other -

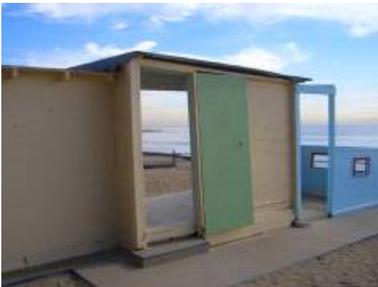
Location: Stage at Play Yard
Photo # 119

Field Condition	
11.10B - Threshold - Height - The threshold at doorway exceeds 1/2" in height.	1991 ADAAG 4.13.8
Existing Condition: 5" high & step condition.	2004 ADAAG 303.3; Advisory 303.3; Fig. 303.3
	2007 CBC 1133B.2.4.1
	Other -

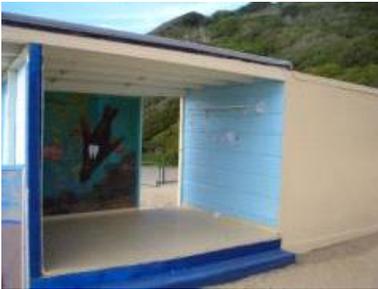
Location: Stage at Play Yard
Photo # 121

Field Condition	
14.31 - Head Room - Clear head room is at less than 80" within the pedestrian circulation area, including the accessible route of travel.	1991 ADAAG 4.4.2
Existing Condition: 7" at 67 1/2" AFF.	2004 ADAAG 307.2; Fig. 307.2
	2007 CBC 1133B.8.6.2
	Other -

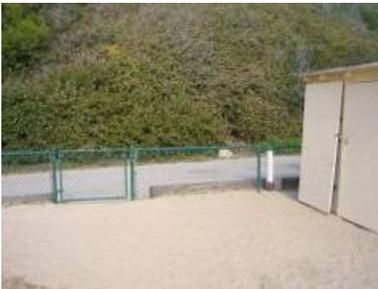
Location: North Gate at Nursery School
Photo # 122

Field Condition	
11.04 - Gates - Gate does not comply with all applicable ADAAG and CBC accessibility requirements for doors. (ADAAG and CBC accessibility requirements for doors apply to gates, including ticket gates.)	1991 ADAAG 4.13.3
Existing Condition:	2004 ADAAG 404.2; 404.3
	2007 CBC 1133B.1.1.1.4
	Other -

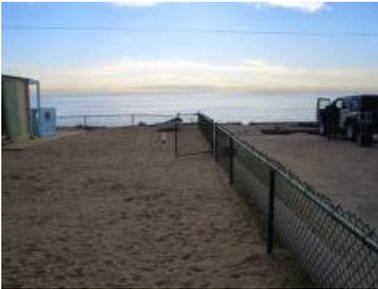
Location: Playground Photo # 123

Field Condition	
03B.03 - Facilities Connected - Accessible routes of travel do not connect all accessible buildings, facilities, elements and spaces on the same site with one another.	1991 ADAAG 4.1.2(2)(a)
Existing Condition: No P.O.T. from parking to play ground to nursery school.	2004 ADAAG 206.2.2; Advisory 206.2.2
	2007 CBC 1114B.1.2; 1127B.1
	Other -

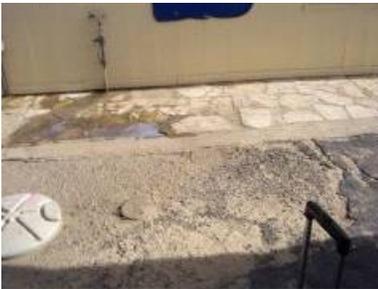
Location: East of Shade Structure Photo # 125

Field Condition	
03B.09 - Cross Slope - Cross slope of the accessible route of travel exceeds 1:50.	1991 ADAAG 4.3.7
Existing Condition: 9.5%	2004 ADAAG 403.3
	2007 CBC 1133B.7.1.3
	Other -

Corrective Action
004A - Asphalt Paving - Remove non-compliant pavement and replace with new asphalt paving (area as shown on the drawings). The walkway slope shall not exceed 5% along the POT and cross slope shall not exceed 2%.
Additional Comments: Replace utility cover to comply.

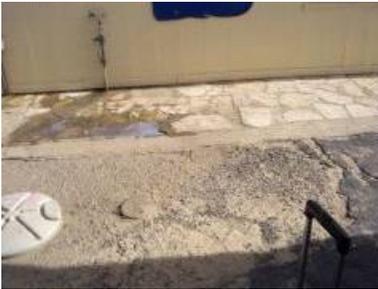
Location: East of Shade Structure
Photo # 125

Field Condition	
03B.15 - Surface - Accessible route surfaces are not stable, firm and slip-resistant.	1991 ADAAG 4.5.1
Existing Condition: Loose gravel.	
	2004 ADAAG 302.1; Advisory 302.1
	2007 CBC 1124B.1
	Other -

Classification	
DOJ Location Type:	1
Use:	GS
Severity:	A
Level of Difficulty	High

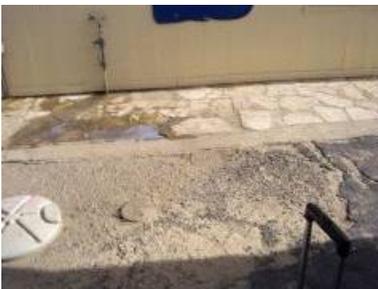
Location: East of Shade Structure
Photo # 125

Field Condition	
03B.13 - > 1/2" Changes in Level - Curb ramps, ramps, or elevators are not used for changes in level greater than 1/2 inch. (Lifts may only be used in certain limited situations.)	1991 ADAAG 4.5.2
Existing Condition: > 1/2" at utility cover.	
	2004 ADAAG 303.4
	2007 CBC 1124B.2
	Other -

Classification	
DOJ Location Type:	1
Use:	GS
Severity:	C
Level of Difficulty	High

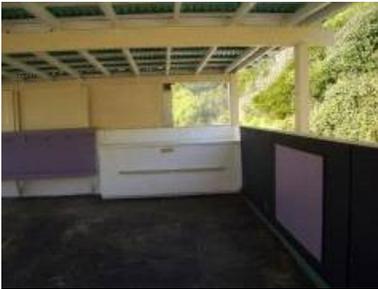
Location: Shade Structure
Photo # 127

Field Condition	
14.36A - Counter Height - Where provided in public or common use areas, countertops are not between 28" - 34" high. (Common use areas are those interior and exterior rooms, spaces, or elements that are made available for the use of a restricted group of people (for example, the occupants of an office building, or the guests of such occupants).	1991 ADAAG 4.32.4
Existing Condition: 38" A.F.F. counter.	2004 ADAAG 902.3
	2007 CBC 1122B.4
	Other -

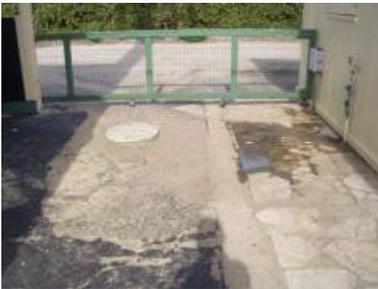
Location: North Gate at Nursery School
Photo # 128

Field Condition	
10.11A - Door Operating Effort - The force required to operate door exceeds 5 lbs. (Fire doors may have up to 15 lbs to achieve positive latching).	1991 ADAAG 4.13.11
Existing Condition: > than 30 LBF. sliding gate.	2004 ADAAG 404.2.9
	2007 CBC 1133B.2.5
	Other -

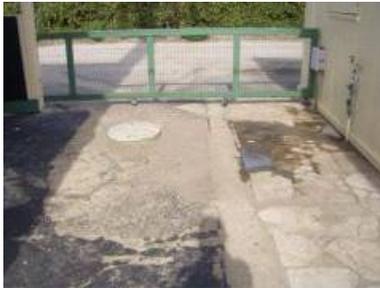
Location: North Gate at Nursery School
Photo #: 128

Field Condition	
11.04 - Gates - Gate does not comply with all applicable ADAAG and CBC accessibility requirements for doors. (ADAAG and CBC accessibility requirements for doors apply to gates, including ticket gates.)	1991 ADAAG 4.13.3 2004 ADAAG 404.2; 404.3 2007 CBC 1133B.1.1.1.4 Other -
Existing Condition: Sliding gate.

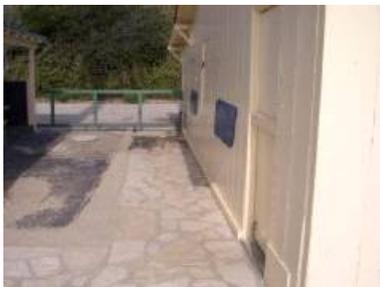
Location: West of Nursery School
Photo #: 130

Field Condition	
03B.09 - Cross Slope - Cross slope of the accessible route of travel exceeds 1:50.	1991 ADAAG 4.3.7 2004 ADAAG 403.3 2007 CBC 1133B.7.1.3 Other -
Existing Condition: 2.3%

Corrective Action
006 - Concrete Walk - Remove non-compliant pavement and replace with new concrete (area as shown on the drawings). The walkway slope shall not exceed 5% along the POT and cross slope shall not exceed 2%.
Additional Comments:

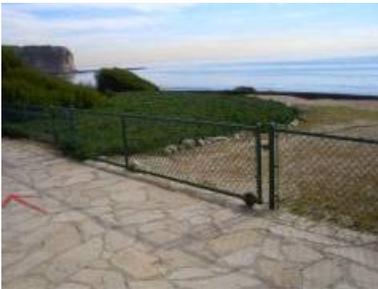
Location: South of Nursery School
 Photo # 131

Field Condition	
11.04 - Gates - Gate does not comply with all applicable ADAAG and CBC accessibility requirements for doors. (ADAAG and CBC accessibility requirements for doors apply to gates, including ticket gates.)	1991 ADAAG 4.13.3
	2004 ADAAG 404.2; 404.3
Existing Condition: > than 1/2" transition from playground to sand.	2007 CBC 1133B.1.1.1.4
	Other -

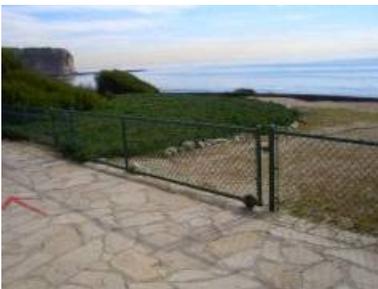
Location: South of Nursery School
 Photo # 131

Field Condition	
10.10 - Single-Action Hardware - Handles, locks, and latches or other operative devices are not operable with one hand and without tight grasping, pinching, or twisting of the wrist. (U-shaped handles, levers, and push/pull type mechanisms are acceptable designs.)	1991 ADAAG 4.13.9
	2004 ADAAG 309.4; 404.2.7; Advisory 404.2.7
Existing Condition:	2007 CBC 1133B.2.5.2
	Other -

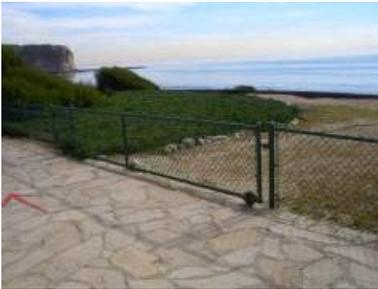
Location: South of Nursery School
Photo # 131

Field Condition	
10.11A - Door Operating Effort - The force required to operate door exceeds 5 lbs. (Fire doors may have up to 15 lbs to achieve positive latching).	1991 ADAAG 4.13.11
Existing Condition: 25 LBF.	2004 ADAAG 404.2.9
	2007 CBC 1133B.2.5
	Other -

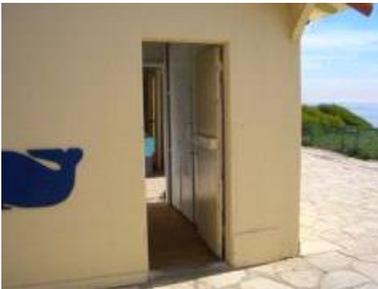
Location: All Purpose Room
Photo # 134

Field Condition	
10.02 - Entrance Sign - Accessible entrance is not identified by an ISA.	1991 ADAAG 28 CFR 35.163(b)1
Existing Condition:	2004 ADAAG 216.6
	2007 CBC 1117B.5.8.1.2
	Other -

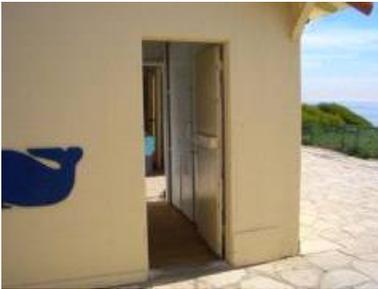
Photo #
134

Field Condition	
10.05 - Clear Door Opening - When the door is open 90 degrees, clear opening width is not at least 32" measured between the face of the door and the doorstep on the latch side.	1991 ADAAG 4.13.5
Existing Condition: 27" clear.	2004 ADAAG 404.2.3; Fig. 404.2.3
	2007 CBC 1133B.1.1.1.1; 1133B.2.2
	Other -

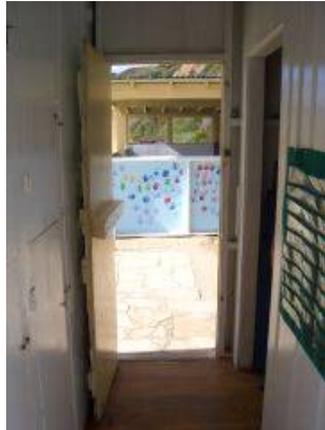
Location: All Purpose Room Photo # 136

Field Condition	
10.06A - Door Maneuvering Space - Door that is not automatic or power-assisted does not have compliant maneuvering space relative to the direction of approach as shown in CBC Fig. 11B-26. (Approach // Side // Width // Depth) (Front // Pull // D + 24" * // 60") (Front // Push // D + 0" ** // 48") (Latch // Pull // D + 24" // 60") (Latch // Push // D + 24" // 44" ***) (Hinge // Pull // D + 36" // 60") (Hinge // Push // 54" **** // 44" *****) (* D + 18" at interior doors.) (** D + 12" if door has both a latch and a closer.) (***) 48" if door has closer.) (**** Measured from latch toward hinge.) (***** 48" if door has both a latch and a closer.)	1991 ADAAG 4.13.6; Fig. 25 2004 ADAAG 404.2.4.1; Tab.404.2.4.1; Fig.404.2.4.1 2007 CBC 1133B.2.4.2; Fig. 11B-26 Other -
Existing Condition: 4" at pull side.

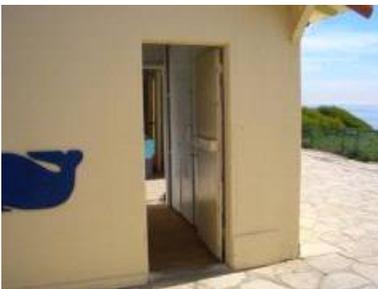
Location: All Purpose Room
 Photo # 134

Field Condition	
10.08 - Kick Plate - Bottom 10" of door does not have a smooth, uninterrupted surface on the push side to allow the door to be opened by a wheelchair footrest without creating a trap or hazardous condition. (This requirement does not apply to automatic and sliding doors.)	1991 ADAAG -
Existing Condition: Door stop.	2004 ADAAG 404.2.10
	2007 CBC 1133B.2.6
	Other -

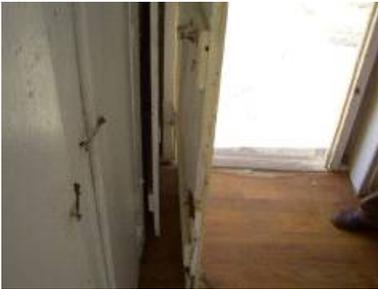
Location: All Purpose Room Photo # 139

Field Condition	
10.09B - Threshold - Height - The threshold at doorway exceeds 1/2" in height.	1991 ADAAG 4.13.8
Existing Condition: 1 3/4" high.	
	2004 ADAAG 303.3; Advisory 303.3; Fig. 303.3
	2007 CBC 1133B.2.4.1
	Other -

Classification	
DOJ Location Type:	1
Use:	GS
Severity:	C
Level of Difficulty	Low to Moderate

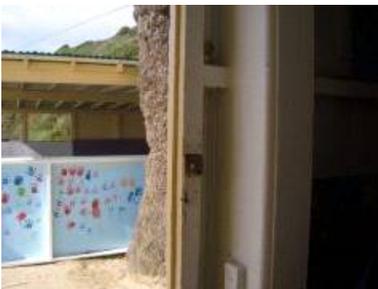
Field Condition	
10.10 - Single-Action Hardware - Handles, locks, and latches or other operative devices are not operable with one hand and without tight grasping, pinching, or twisting of the wrist. (U-shaped handles, levers, and push/pull type mechanisms are acceptable designs.)	1991 ADAAG 4.13.9
Existing Condition:	
	2004 ADAAG 309.4; 404.2.7; Advisory 404.2.7
	2007 CBC 1133B.2.5.2
	Other -

Classification	
DOJ Location Type:	1
Use:	GS
Severity:	B
Level of Difficulty	Low to Moderate

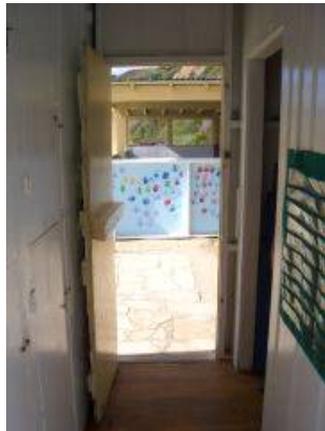
Location: All Purpose Room Photo # 136

Field Condition	
10.13A - Required Exit Door Sign - At grade level exterior exit door, there is no tactile and CA Braille exit sign with the word "EXIT" mounted on the wall adjacent to the latch side of the door.	1991 ADAAG 4.1.3(16); 4.30.1
Existing Condition:	2004 ADAAG 216.4; 703.2; 703.3; 703.4
	2007 CBC 1011.3 item 1
	Other -

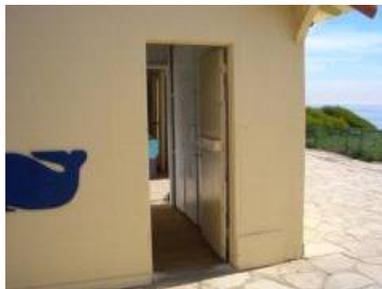
Location: All Purpose Room Photo # 142

Field Condition	
11.17A - Recommendation: Providing Room/Space ID Sign - A sign designating the permanent room or space has not been provided.	1991 ADAAG 4.1.2(7)
Existing Condition:	2004 ADAAG 216.2; 703.1; 703.2; 703.5
	2007 CBC 1117B.5.1 item 1
	Other -

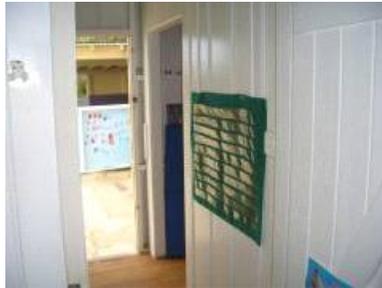
Location: Chair Storage
Photo # 143

Field Condition	
14.21B - 36" Width Standard - The accessible route of travel is not at least 36" wide where the occupancy load is < 10. (For a depth of 24" max., clear opening width may be reduced to 32" min..) (Doorways are compliant when the door, open 90 degrees, affords a clear opening width of at least 32".)	1991 ADAAG 4.3.3; Fig. 7(a)(b)
Existing Condition: 29 1/2" wide.	2004 ADAAG 403.5.1; Fig. 403.5.1
	2007 CBC 1133B.3.1
	Other -

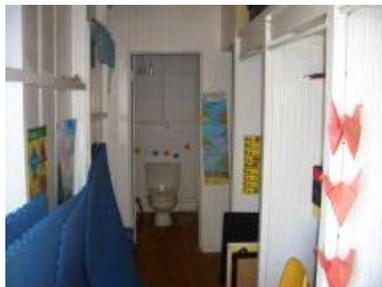
Location: Toilet Room
Photo # 144

Field Condition	
16.01 - Toilet Rooms - Toilet room does not comply with all applicable ADAAG and CBC accessibility requirements.	1991 ADAAG 4.1.2(6); 4.1.3(11); 4.22.1
Existing Condition: Non compliant, room too small 40"x56"	2004 ADAAG 213.2; Advisory 213.2
	2007 CBC 1115B.1
	Other -

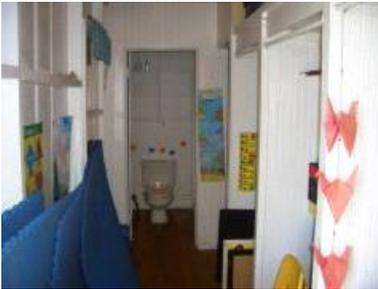
Location: Toilet Room
 Photo # 144

Field Condition	
16.07 - Clear Door Opening - When the door is open 90 degrees, clear opening width is less than 32" measured between the face of the door and the doorstep on the latch side.	1991 ADAAG 4.13.5
Existing Condition: 26 1/2"	2004 ADAAG 404.2.3
	2007 CBC 1133B.1.1.1.1; 1133B.2.2
	Other -

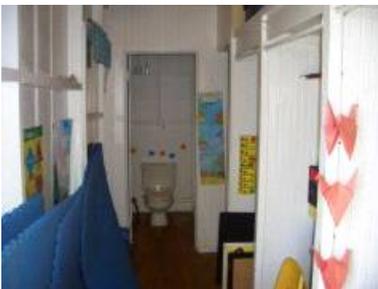
Location: Toilet Room
 Photo # 144

Field Condition	
16.13C - Unisex RR Geometric Symbol Signage - Circle/Triangle - Doorway leading to a unisex toilet room is not identified by a 12" circle, 1/4" with a 1/4" thick triangle superimposed and within the circle. OR Circle and triangle are provided, however they are accompanied by words in raised characters and Braille. (ADA and CBC Standards require a separate sign with raised characters and Braille mounted on the wall adjacent to the latch side of the door.)	1991 ADAAG -
Existing Condition:	2004 ADAAG -
	2007 CBC 1115B.6
	Other -

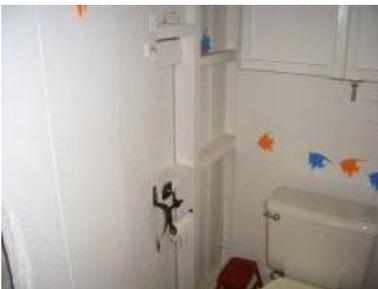
Location: Toilet Room Photo # 148

Field Condition	
16.47A - WC Location from Sidewall - The centerline of the WC is not 18" absolute from a wall or partition.	1991 ADAAG 4.22.4
Existing Condition: 20"	2004 ADAAG -
	2007 CBC 1115B.4.1(1)
	Other -

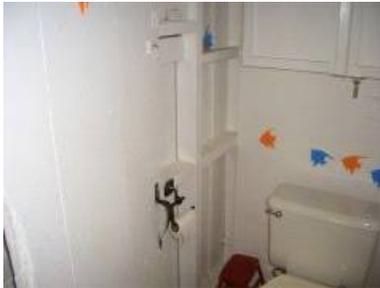
Location: Toilet Room Photo # 148

Field Condition	
16.49B - WC Flush Controls - Location - Flush controls are not located on the wide side of the WC where the clear floor space is provided.	1991 ADAAG 4.16.5
Existing Condition:	2004 ADAAG 604.6; Advisory 604.6
	2007 CBC 1115B.4.1(5); Fig. 11B-1A
	Other -

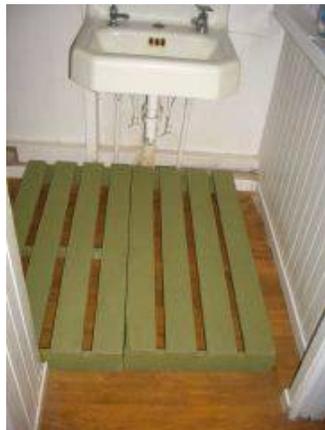
Location: Chair Storage Sink Photo # 150

Field Condition	
16.72 - Lavatory Apron Clearance - Lavatory does not provide accessible apron clearance (i.e. at least 29" clearance from the floor to the bottom of the apron).	1991 ADAAG 4.19.2; Fig. 31
Existing Condition: 25 7/8" high.	2004 ADAAG 606.3
	2007 CBC 1115B.4.3(2); Fig 11B-1D
	Other -

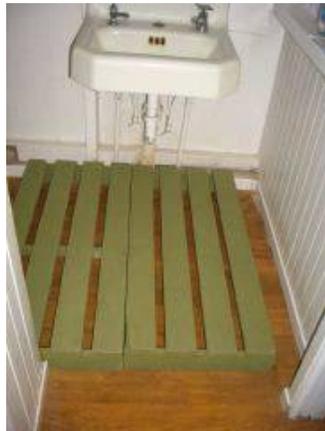
Location: Chair Storage Sink Photo # 150

Field Condition	
16.73 - Lavatory Knee Clearance - Lavatory does not provide accessible knee clearance (i.e. at least 27" clearance from the floor to the underside of the lavatory, extending 8" min.. measured from the front edge underneath the lavatory back towards the wall).	1991 ADAAG 4.19.2; Fig. 31
Existing Condition: 24 1/2"	2004 ADAAG 306.3; Fig. 306.3
	2007 CBC 1115B.4.3(2); Fig 11B-1D
	Other -

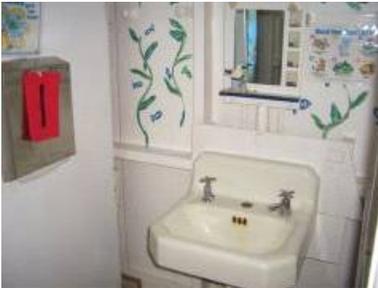
Location: Chair Storage Sink
 Photo # 153

Field Condition	
16.82A - Mirror Height - Max. 40" AFF Standard - Mirror above accessible lavatory or countertop is mounted so the bottom edge of the reflective surface is not 40" max.. AFF. (ADA Standards require at least one mirror to be accessible; CBC Standards prior to August 1, 2009 required all mirrors to be accessible. Effective August 1, 2009, amended CBC Standards require all mirrors above accessible lavatories or countertops to be accessible.)	1991 ADAAG 4.19.6; Fig. 31 2004 ADAAG 213.3.5; 603.3; Advisory 603.3 2007 CBC 1115B.8.1 Other -
Existing Condition: 47 1/2" high.

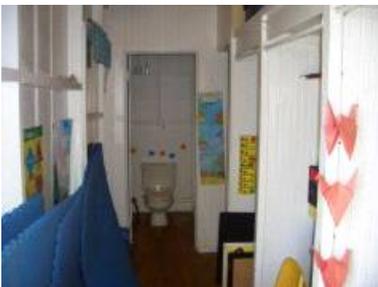
Location: Toilet Room
 Photo # 144

Field Condition	
16.48 - WC Seat Height - The top of the WC seat is not between 17" and 19" AFF.	1991 ADAAG 4.16.3; Fig. 29(b) 2004 ADAAG 604.4 2007 CBC 1115B.4.1(4); Fig. 11B-1A Other -
Existing Condition: 15 1/4"

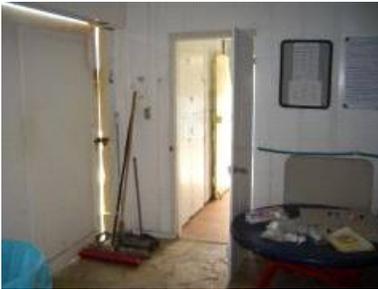
Location: Hall to All Purpose Room
Photo # 155

Field Condition	
11.05A - Clear Opening - Single-Leaf Door - When the door is open 90 degrees, clear opening width is not at least 32" measured between the face of the door and the doorstop on the latch side.	1991 ADAAG 4.13.5
Existing Condition: 30" clear.	2004 ADAAG 404.2.3
	2007 CBC 1133B.1.1.1.1; 1133B.2.2
	Other -

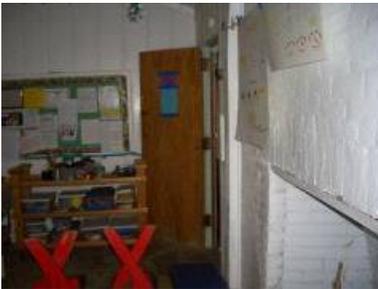
Location: Kitchen
Photo # 156

Field Condition	
11.05A - Clear Opening - Single-Leaf Door - When the door is open 90 degrees, clear opening width is not at least 32" measured between the face of the door and the doorstop on the latch side.	1991 ADAAG 4.13.5
Existing Condition: 29 1/2" clear.	2004 ADAAG 404.2.3
	2007 CBC 1133B.1.1.1.1; 1133B.2.2
	Other -

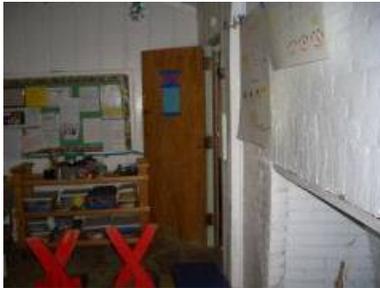
Location: Kitchen Photo # 156

Field Condition	
11.11 - Single-Action Hardware - Handles, locks, and latches or other operative devices are not operable with one hand and without tight grasping, pinching, or twisting of the wrist. (U-shaped handles, levers, and push/pull type mechanisms are acceptable designs.)	1991 ADAAG 4.13.9
Existing Condition: Lock.	2004 ADAAG 309.4; 404.2.7; Advisory 404.2.7
	2007 CBC 1133B.2.5.2
	Other -

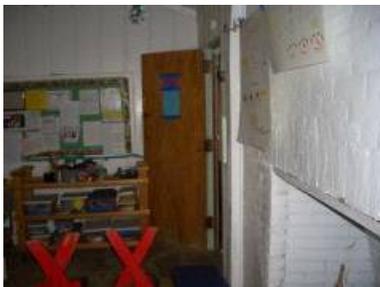
Location: Kitchen Photo # 156

Field Condition	
11.12 - Hardware Mounting Height - Mounting height of all operating hardware is not 30" min.. or 44" max., as measured to the highest operable part. (1994 ADA Standards permit a max.. height of 48"; CBC Standards permit a range of 30" min.. to 44" max..)	1991 ADAAG 4.13.9
Existing Condition: 57" high.	2004 ADAAG -
	2007 CBC 1133B.2.5.2
	Other -
