City of Rancho Palos Verdes
**Rancho Palos Verdes ADA Assessment
 Facility Report with Photos**

Facility ID: # 01 - Abalone Cove Shoreline Park

Author: Vaish, B

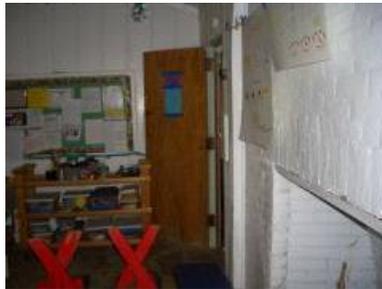
Location: Kitchen Photo # 156

Field Condition	
11.17A - Recommendation: Providing Room/Space ID Sign - A sign designating the permanent room or space has not been provided.	1991 ADAAG 4.1.2(7)
Existing Condition:	2004 ADAAG 216.2; 703.1; 703.2; 703.5
	2007 CBC 1117B.5.1 item 1
	Other -

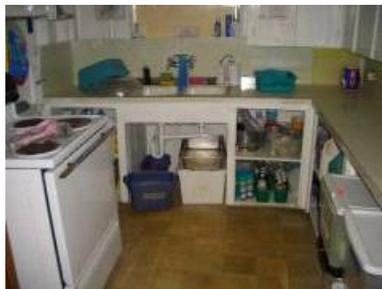
Location: Kitchen Photo # 160

Field Condition	
14.36B - Kitchen Counter/Sink Height - Where provided in public or common use areas, countertops and sinks are not mounted at 34" AFF. max..(Common use areas are those interior and exterior rooms, spaces, or elements that are made available for the use of a restricted group of people (for example, the occupants of an office building, or the guests of such occupants).	1991 ADAAG 4.24.2
Existing Condition: 35 1/2"	2004 ADAAG 212.3; 606.3
	2007 CBC 1115B.4.7(2); 1122B.4
	Other -

Corrective Action
480A - New Counter Top and Sink - Remove existing cabinetry, and provide new counter at 34" above the finished floor. Remove and replace sink and faucet with new accessible sink and faucet. Provide accessible knee clearance (i.e. at least 27" high, 30" wide, and 19" deep) under the sink.
Additional Comments:

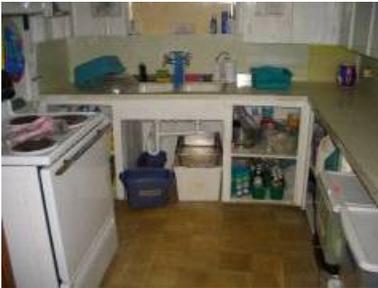
Location: Kitchen Photo # 160

Field Condition	
14.37 - Kitchen Sink - Sink does not provide accessible knee clearance (i.e. at least 27" high, 30" wide, and 19" deep).	1991 ADAAG 4.24.3
Existing Condition: Pipes encroach into knee space.	2004 ADAAG 305; 306; 606.2
	2007 CBC 1115B.4.7(2); 1122B.4
	Other -

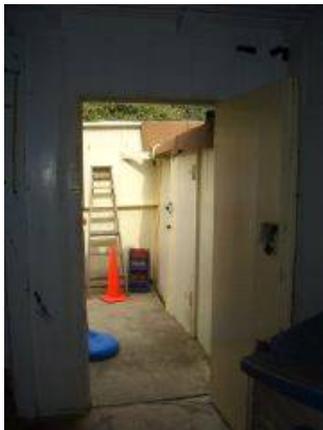
Location: North Exit Door Photo # 162

Field Condition	
10.09A - > 1/4" Changes in Level - Threshold - Where threshold is 1/4" min.. to 1/2" max.. in height, change in level is not beveled at 1:2 or less.	1991 ADAAG 4.13.8
Existing Condition: > 1/4" abrupt.	2004 ADAAG 303.3; Advisory 303.3; Fig. 303.3
	2007 CBC 1133B.2.4.1
	Other -

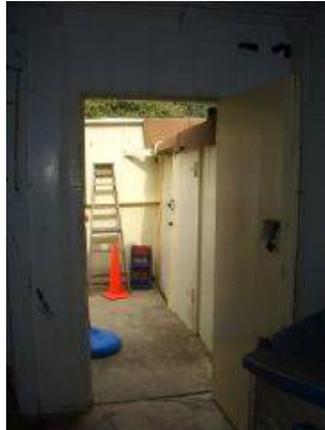
Location: North Exit Door Photo # 162

Field Condition	
10.10 - Single-Action Hardware - Handles, locks, and latches or other operative devices are not operable with one hand and without tight grasping, pinching, or twisting of the wrist. (U-shaped handles, levers, and push/pull type mechanisms are acceptable designs.)	1991 ADAAG 4.13.9
Existing Condition: Lock.	2004 ADAAG 309.4; 404.2.7; Advisory 404.2.7
	2007 CBC 1133B.2.5.2
	Other -

Corrective Action	
067B - Lever Hardware - Replace door hardware with lever-type handset.	
Additional Comments:

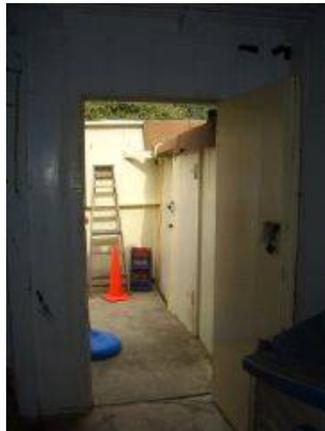
Location: North Exit Door Photo # 162

Field Condition	
10.13A - Required Exit Door Sign - At grade level exterior exit door, there is no tactile and CA Braille exit sign with the word "EXIT" mounted on the wall adjacent to the latch side of the door.	1991 ADAAG 4.1.3(16); 4.30.1
Existing Condition:	2004 ADAAG 216.4; 703.2; 703.3; 703.4
	2007 CBC 1011.3 item 1
	Other -

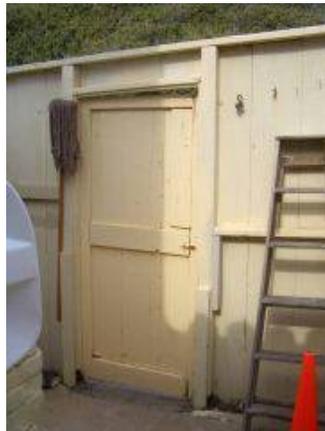
Location: Patio Door Photo # 165

Field Condition	
10.08 - Kick Plate - Bottom 10" of door does not have a smooth, uninterrupted surface on the push side to allow the door to be opened by a wheelchair footrest without creating a trap or hazardous condition. (This requirement does not apply to automatic and sliding doors.)	1991 ADAAG -
Existing Condition:	2004 ADAAG 404.2.10
	2007 CBC 1133B.2.6
	Other -

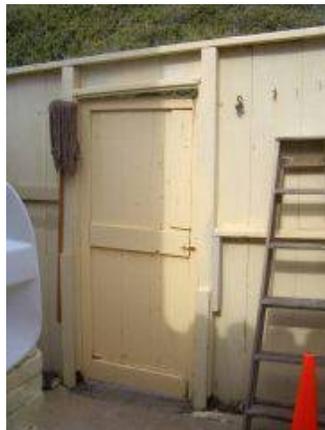
Location: Patio Door Photo # 165

Field Condition	
10.09A - > 1/4" Changes in Level - Threshold - Where threshold is 1/4" min.. to 1/2" max.. in height, change in level is not beveled at 1:2 or less.	1991 ADAAG 4.13.8
Existing Condition:	2004 ADAAG 303.3; Advisory 303.3; Fig. 303.3
	2007 CBC 1133B.2.4.1
	Other -

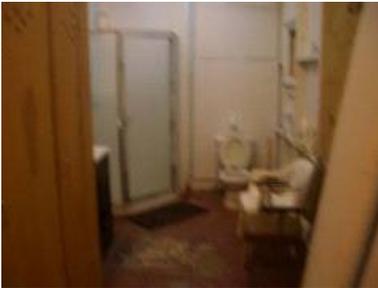
Location: Lifeguard Sanitary Room
 Photo # 169

Field Condition	
16.01 - Toilet Rooms - Toilet room does not comply with all applicable ADAAG and CBC accessibility requirements.	1991 ADAAG 4.1.2(6); 4.1.3(11); 4.22.1
Existing Condition:	2004 ADAAG 213.2; Advisory 213.2
	2007 CBC 1115B.1
	Other -

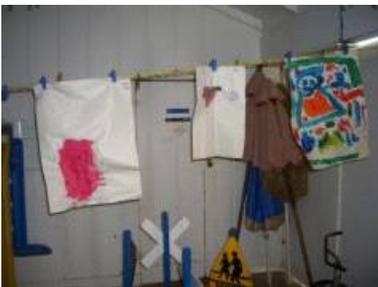
Location: Lifeguard Sanitary Room
 Photo # 170

Field Condition	
16.06 - Entry Doors - Entry door does not comply with all applicable ADAAG and CBC accessibility requirements.	1991 ADAAG 4.22.2
Existing Condition:	2004 ADAAG 404.1
	2007 CBC 1115B.5; 1133B.2
	Other -

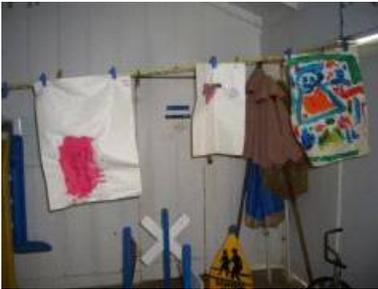
Location: Lifeguard Sanitary Room
Photo #: 170

Field Condition	
16.07 - Clear Door Opening - When the door is open 90 degrees, clear opening width is less than 32" measured between the face of the door and the doorstep on the latch side.	1991 ADAAG 4.13.5
Existing Condition:	2004 ADAAG 404.2.3
	2007 CBC 1133B.1.1.1.1; 1133B.2.2
	Other -

Corrective Action	
056 - Widen Door Opening - Remove existing door and replace with new door and door frame. Cut existing wall to widen door opening. Provide new accessible door hardware.	
Additional Comments:

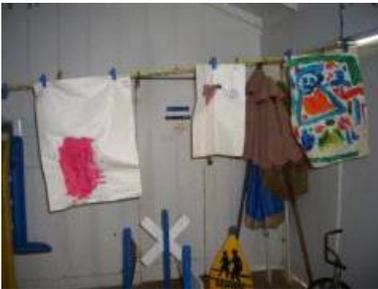
Location: Lifeguard Sanitary Room
Photo #: 170

Field Condition	
16.10 - Single-Action Hardware - Handles, locks, and latches or other operative devices are not operable with one hand. OR They are not operable without tight grasping, pinching, or twisting of the wrist. (U-shaped handles, levers, and push/pull type mechanisms are acceptable designs.)	1991 ADAAG 4.13.9
Existing Condition:	2004 ADAAG 309.4; 404.2.7; Advisory 404.2.7
	2007 CBC 1133B.2.5.2
	Other -

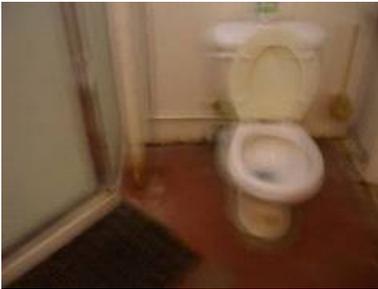
Location: Lifeguard Sanitary Room
 Photo # 175

Field Condition	
16.47A - WC Location from Sidewall - The centerline of the WC is not 18" absolute from a wall or partition.	1991 ADAAG 4.22.4
Existing Condition:	2004 ADAAG -
	2007 CBC 1115B.4.1(1)
	Other -

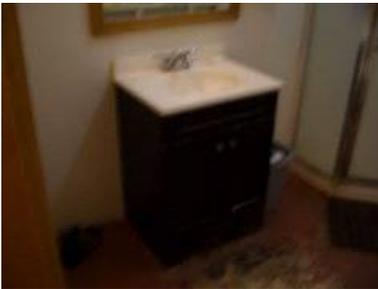
Location: Lifeguard Sanitary Room
 Photo # 176

Field Condition	
16.70 - Lavatories - Lavatory does not comply with ADAAG and CBC requirements. (ADA Standards require at least one lavatory to be accessible. CBC Standards prior to August 1, 2009 required all lavatories to be accessible. Effective August 1, 2009, amended CBC Standards require at least 5% of lavatories, but not less than one lavatory, to be accessible.)	1991 ADAAG 4.22.6
Existing Condition:	2004 ADAAG 213.3.4; 606.1
	2007 CBC 1115B.4.3
	Other -

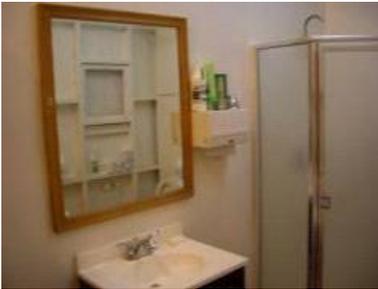
Field Condition	
16.82A - Mirror Height - Max. 40" AFF Standard - Mirror above accessible lavatory or countertop is mounted so the bottom edge of the reflective surface is not 40" max.. AFF. (ADA Standards require at least one mirror to be accessible; CBC Standards prior to August 1, 2009 required all mirrors to be accessible. Effective August 1, 2009, amended CBC Standards require all mirrors above accessible lavatories or countertops to be accessible.)	1991 ADAAG 4.19.6; Fig. 31 2004 ADAAG 213.3.5; 603.3; Advisory 603.3 2007 CBC 1115B.8.1 Other -
Existing Condition:

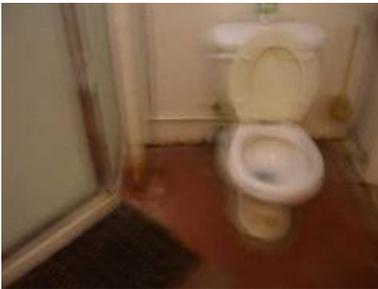
Keynote 178

Field Condition	
17.01 - Accessible Bathing or Showering Facilities - Where facilities for bathing or showering are provided, less than 1% of these facilities are accessible.	1991 ADAAG 4.23.1; 4.23.8 2004 ADAAG 213.3.6 2007 CBC 1115B.2 Other -
Existing Condition:

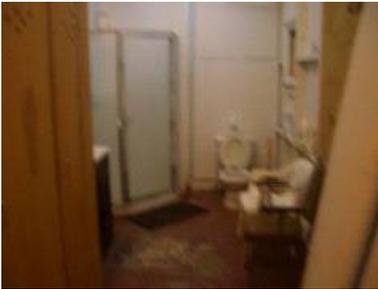
Keynote 179

Field Condition	
18.01 - Dressing, Fitting, and Locker Rooms - Dressing, fitting, or locker room does not comply with all applicable CBC and ADAAG accessibility requirements.	1991 ADAAG 4.1.3 (21); 4.35.1
Existing Condition:	2004 ADAAG 222.1
	2007 CBC 1117B.8
	Other -

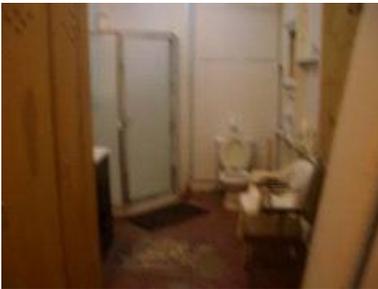
Keynote 180

Field Condition	
18.05A - Fixed Bench Requirement - Fixed bench is not provided.	1991 ADAAG 4.35.4
Existing Condition:	2004 ADAAG 803.4
	2007 CBC 1117B.8
	Other -

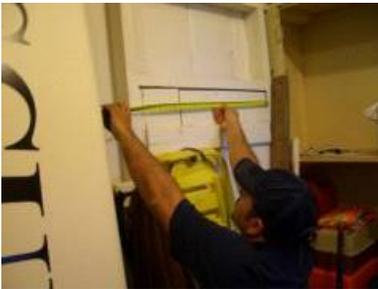
Keynote 181

Field Condition	
10.05 - Clear Door Opening - When the door is open 90 degrees, clear opening width is not at least 32" measured between the face of the door and the doorstep on the latch side.	1991 ADAAG 4.13.5
Existing Condition: 30" clear.	2004 ADAAG 404.2.3; Fig. 404.2.3
	2007 CBC 1133B.1.1.1.1; 1133B.2.2
	Other -

Corrective Action	
056 - Widen Door Opening - Remove existing door and replace with new door and door frame. Cut existing wall to widen door opening. Provide new accessible door hardware.	
Additional Comments:

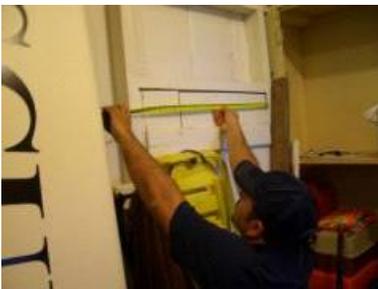
Keynote 182

Field Condition	
10.10 - Single-Action Hardware - Handles, locks, and latches or other operative devices are not operable with one hand and without tight grasping, pinching, or twisting of the wrist. (U-shaped handles, levers, and push/pull type mechanisms are acceptable designs.)	1991 ADAAG 4.13.9
Existing Condition:	2004 ADAAG 309.4; 404.2.7; Advisory 404.2.7
	2007 CBC 1133B.2.5.2
	Other -

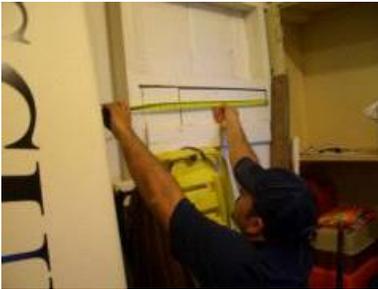
Keynote 183

Field Condition	
10.13A - Required Exit Door Sign - At grade level exterior exit door, there is no tactile and CA Braille exit sign with the word "EXIT" mounted on the wall adjacent to the latch side of the door.	1991 ADAAG 4.1.3(16); 4.30.1
Existing Condition:	2004 ADAAG 216.4; 703.2; 703.3; 703.4
	2007 CBC 1011.3 item 1
	Other -

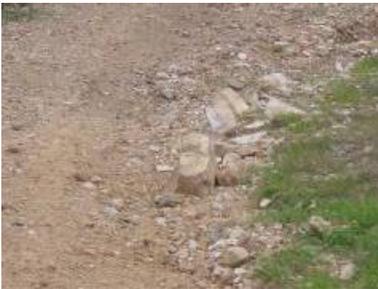
Keynote 184

Field Condition	
30.11E - Trails - Tread Obstacles - Tread obstacles such as roots or rocks are higher than 2". Exception: obstacles may be up to 3" high where the running slope and cross slope are 5% or less.	1991 ADAAG -
Existing Condition: 2" to 3" rocks.	2004 ADAAG -
	2007 CBC -
	Other 1999 ADAAG-16.2.5

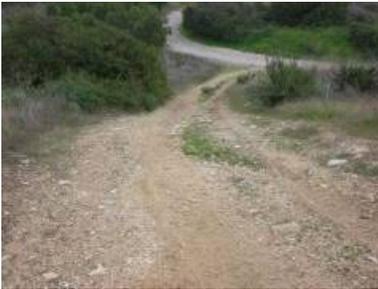
Keynote 185

Field Condition	
30.10A - Trail Segment - Running Slope - Running slope of trail segment in the direction of travel does not comply with the following: a. 5% or less for any distance. b. From 5.1% to 8.33% for 200' maximum. c. From 8.34% to 10% for 30' maximum. d. From 10% to 12% for 10' maximum.	1991 ADAAG -
Existing Condition: 15.1% to 27.2%.	2004 ADAAG -
	2007 CBC -
	Other 1999 ADAAG-16.2.7.2.1; 16.2.7.2.2; 16.2.7.2.3; 16.2.7.2.4

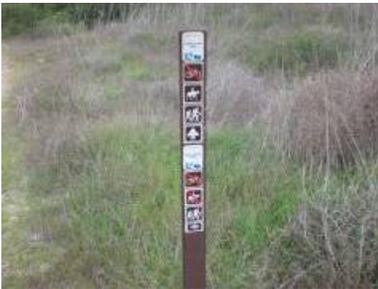
Keynote 187

Field Condition	
30.11H - Trails - Signs - Trail complying with 1999 ADAAG Section 16.2 is not designated with a symbol at the trailhead and at designated access points. OR Signage has been provided but does not indicate the total distance of the accessible segment and the location of the first point of departure from the Section 16.2 requirements.	1991 ADAAG -
Existing Condition:	2004 ADAAG -
	2007 CBC -
	Other 1999 ADAAG-16.2.10

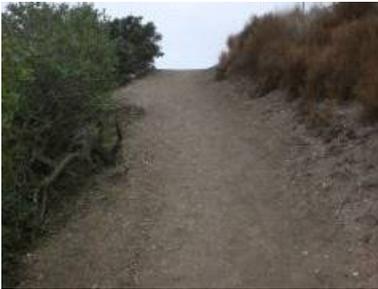
Keynote 189

Field Condition	
30.10A - Trail Segment - Running Slope - Running slope of trail segment in the direction of travel does not comply with the following: a. 5% or less for any distance. b. From 5.1% to 8.33% for 200' maximum. c. From 8.34% to 10% for 30' maximum. d. From 10% to 12% for 10' maximum.	1991 ADAAG -
Existing Condition: 14.9% to 23%..	2004 ADAAG -
	2007 CBC -
	Other 1999 ADAAG-16.2.7.2.1; 16.2.7.2.2; 16.2.7.2.3; 16.2.7.2.4

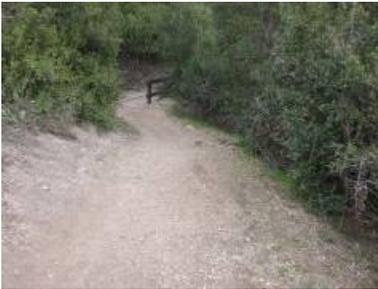
Keynote 190

30.10B - Trail Resting Space - Resting space does not comply with 1999 ADAAG Section 16.2.8 (Resting intervals shall be 60" min. in length, shall have a width at least as wide as the trail and have a slope of 5% or less in any direction. The installation of resting spaces is required as follows: Percent slope, maximum length, Rest interval: 0% to 5.0%, No restriction, No restriction; 5.1% to 8.33%, 200', Every 200'; 8.34% to 10%, 30', Every 30'; 10.1% to 12%, 10', Every 10'.)

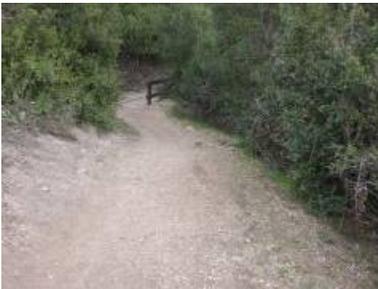
Keynote 191

30.10C - Trail Segment - Cross Slope - Cross slope of the trail segment exceeds 1:20.

Existing Condition: 9.6% to 15.8%

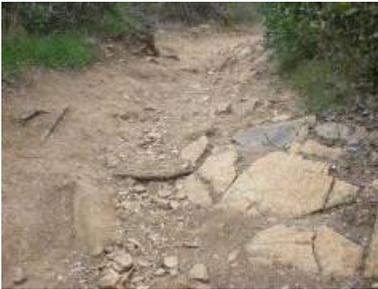
Keynote 192

Field Condition	
30.10E - Trail Surface - The surface of the trail is not firm or stable.	1991 ADAAG -
Existing Condition: Loose rocks, 2 1/2" high roots, pipes, & erosion.	2004 ADAAG -
	2007 CBC -
	Other 1999 ADAAG-16.2.1

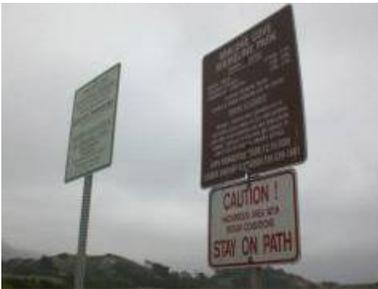
Keynote 193

Field Condition	
30.11H - Trails - Signs - Trail complying with 1999 ADAAG Section 16.2 is not designated with a symbol at the trailhead and at designated access points. OR Signage has been provided but does not indicate the total distance of the accessible segment and the location of the first point of departure from the Section 16.2 requirements.	1991 ADAAG -
Existing Condition:	2004 ADAAG -
	2007 CBC -
	Other 1999 ADAAG-16.2.10

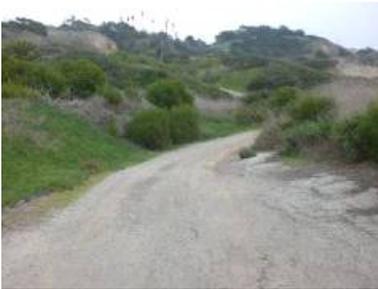
Keynote 195

Field Condition	
30.10A - Trail Segment - Running Slope - Running slope of trail segment in the direction of travel does not comply with the following: a. 5% or less for any distance. b. From 5.1% to 8.33% for 200' maximum. c. From 8.34% to 10% for 30' maximum. d. From 10% to 12% for 10' maximum.	1991 ADAAG -
Existing Condition: 18% to 51%.	2004 ADAAG -
	2007 CBC -
	Other 1999 ADAAG-16.2.7.2.1; 16.2.7.2.2; 16.2.7.2.3; 16.2.7.2.4

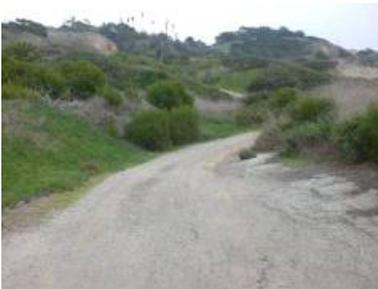
Keynote 197

Field Condition	
30.10E - Trail Surface - The surface of the trail is not firm or stable.	1991 ADAAG -
Existing Condition: Loose gravel, cracks.	2004 ADAAG -
	2007 CBC -
	Other 1999 ADAAG-16.2.1

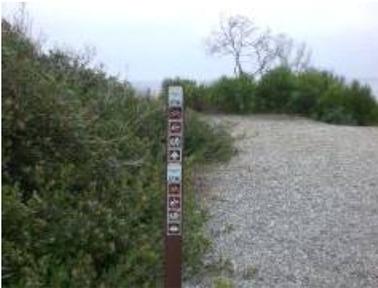
Keynote 198

Field Condition	
30.11H - Trails - Signs - Trail complying with 1999 ADAAG Section 16.2 is not designated with a symbol at the trailhead and at designated access points. OR Signage has been provided but does not indicate the total distance of the accessible segment and the location of the first point of departure from the Section 16.2 requirements.	1991 ADAAG -
Existing Condition:	2004 ADAAG -
	2007 CBC -
	Other 1999 ADAAG-16.2.10

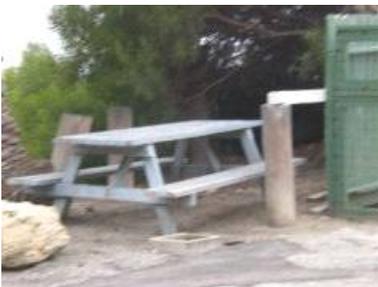
Keynote 199

Field Condition	
30.24 - Picnic Table - Accessible Route - Picnic table is not accessible. OR Picnic table is not connected to an outdoor recreation access route.	1991 ADAAG -
Existing Condition:	2004 ADAAG -
	2007 CBC 1127B.1; 1132B.2
	Other 1999 ADAAG-16.5.1.1

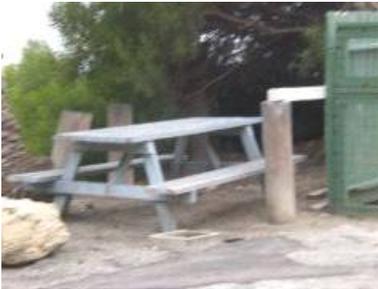
Keynote 200

Field Condition	
30.29 - Picnic Site Surface - Picnic tables and benches are not on a firm and stable surface.	1991 ADAAG -
Existing Condition: Big rock & meter near picnic table.	2004 ADAAG -
	2007 CBC -
	Other 1999 ADAAG-16.5.6

Corrective Action
004A - Asphalt Paving - Remove non-compliant pavement and replace with new asphalt paving (area as shown on the drawings). The walkway slope shall not exceed 5% along the POT and cross slope shall not exceed 2%.
Additional Comments: Relocate.
