City of Rancho Palos Verdes
Rancho Palos Verdes ADA Assessment
Facility Report with Photos

Facility ID: # 05 - Eastview Park

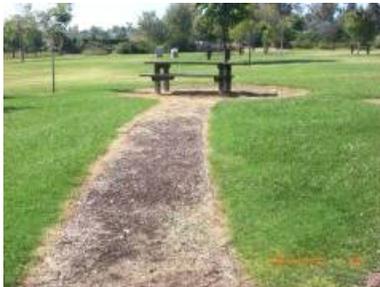
Keynote 42

Field Condition	
30.32 - 36" Aisle Width Standard - Around the picnic table, there is less than 36" clear space measured from the seat.	1991 ADAAG -
Existing Condition:	2004 ADAAG -
	2007 CBC -
	Other 1999 ADAAG-16.5.5

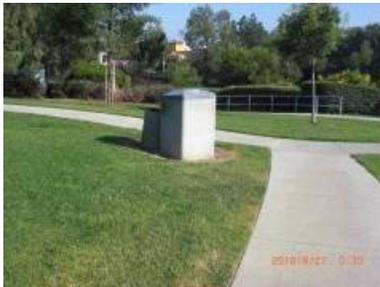
Keynote 48

Field Condition	
30.47 - Trash & Recycling Receptacles - Location - The picnic area does not provide a trash receptacle at the site or on an accessible route to the site.	1991 ADAAG -
Existing Condition: Accessible path of travel to trash and recycling bins not provided, at two locations.	2004 ADAAG -
	2007 CBC -
	Other 1999 ADAAG-16.8.1

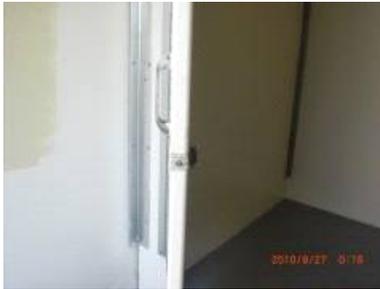
Keynote 65

16.32A - U-Pulls at Stall Door - The stall door does not have U-pulls on both sides.

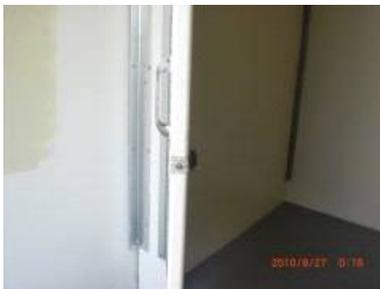
Keynote 66

16.32B - Single-Action Stall Door Hardware - The stall door's locking mechanism is not operable with one hand. OR It is not operable without tight grasping, pinching, or twisting of the wrist.

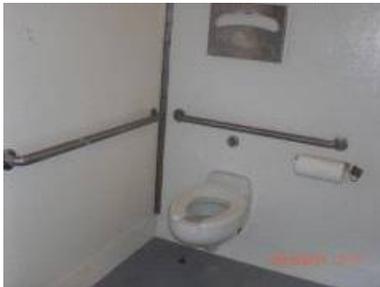
Keynote 74

16.56 - Grab Bar Wall Clearance - The space between the grab bar and the wall is not 1-1/2" absolute.

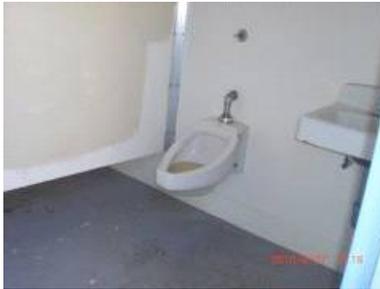
Keynote 79

Field Condition	
16.65A - Wall-Hung Urinal - Rim Projection from Wall - The wall-hung urinal's elongated rim does not project 14" min.. to 17" max.. from the wall.	1991 ADAAG 4.18.2
Existing Condition: 21" AFF.	2004 ADAAG 605.2; Fig. 605.2(a)
	2007 CBC 1115B.4.2(1)
	Other -

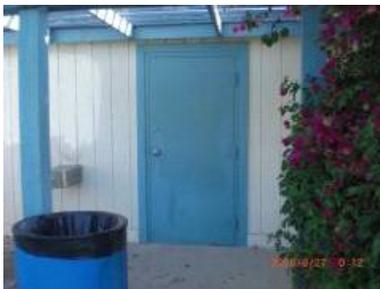
Keynote 80

Field Condition	
10.10 - Single-Action Hardware - Handles, locks, and latches or other operative devices are not operable with one hand and without tight grasping, pinching, or twisting of the wrist. (U-shaped handles, levers, and push/pull type mechanisms are acceptable designs.)	1991 ADAAG 4.13.9
Existing Condition: Door knob.	2004 ADAAG 309.4; 404.2.7; Advisory 404.2.7
	2007 CBC 1133B.2.5.2
	Other -

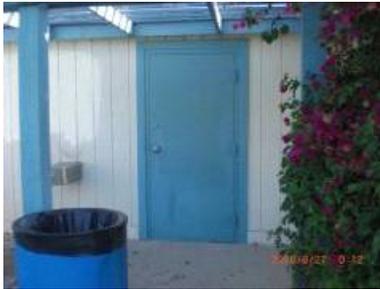
Keynote 81

Field Condition	
11.17A - Recommendation: Providing Room/Space ID Sign - A sign designating the permanent room or space has not been provided.	1991 ADAAG 4.1.2(7)
Existing Condition:	2004 ADAAG 216.2; 703.1; 703.2; 703.5
	2007 CBC 1117B.5.1 item 1
	Other -

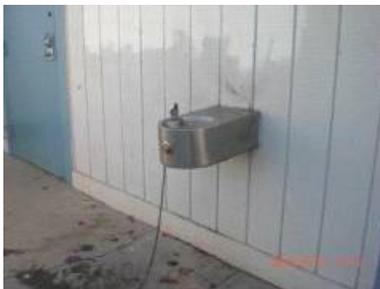
Keynote 82

Field Condition	
05.01A - "Hi" Drinking Fountain Requirement - Where there is only one drinking fountain area on a floor (e.g., an area with a drinking fountain or separate drinking fountains), it is accessible to wheelchair users and not to persons who have difficulty bending or stooping (i.e., the required accessibility for persons who have difficulty bending or stooping on each floor has not been provided).	1991 ADAAG 4.1.3(10)(a); 4.15.1
Existing Condition:	2004 ADAAG 211.1; 211.2
	2007 CBC 1115B.4.6 item 1
	Other -

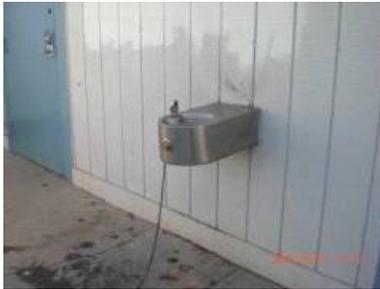
Keynote 83

Field Condition	
05.08A - Wall-Mounted Protruding Objects - Wall mounted drinking fountain with leading edges between 27" and 80" from the floor projects more than 4" into the circulation path.	1991 ADAAG 4.4.1
Existing Condition:	2004 ADAAG 204; 307.2; Advisory 307.2; Fig.
	2007 CBC 1133B.8.6.1
	Other -

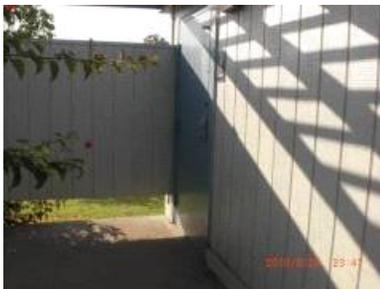
Keynote 84

Field Condition	
16.11A - Door Operating Effort - The force required to operate door exceeds 5 lbs. (Fire doors may have up to 15 lbs to achieve positive latching).	1991 ADAAG 4.13.11
Existing Condition: 10 LBF., (fire rated door).	2004 ADAAG 404.2.9
	2007 CBC 1133B.2.5
	Other -

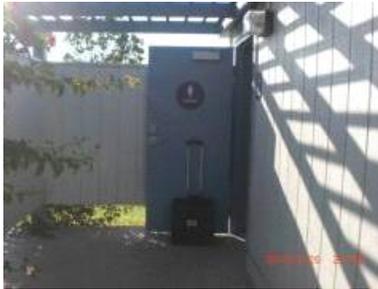
Keynote 85

Field Condition	
16.13B - Women's RR Geometric Symbol Signage - Circle - Doorway leading to a women's toilet room is not identified by a circle, 1/4" thick and 12" in diameter. OR Circle is provided, however it is accompanied by words in raised characters and Braille. (ADA and CBC Standards require a separate sign with raised characters and Braille mounted on the wall adjacent to the latch side of the door.)	1991 ADAAG -
Existing Condition: Geometric sign on wrong side of the door. Geometric sign has Braille.	2004 ADAAG -
	2007 CBC 1115B.6
	Other -

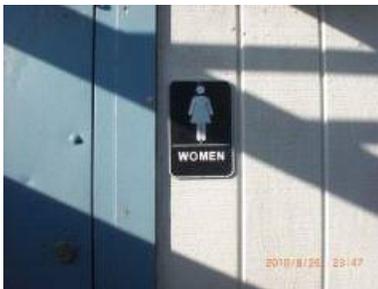
Keynote 86

Field Condition	
16.19A - Mounting Location (Visual/Tactile Signs) - Sign is not mounted on the wall adjacent to the latch side of the door. OR At double leaf doors, the sign is not placed on the nearest adjacent wall.	1991 ADAAG 4.30.6
Existing Condition: 62" high Wall Sign.	2004 ADAAG 703.4.2; Fig. 703.4.2
	2007 CBC 1117B.5.7
	Other -

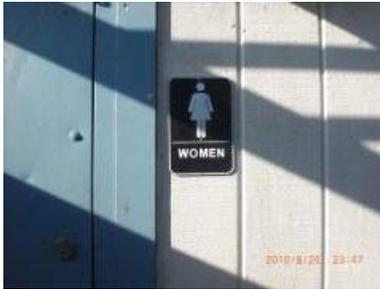
Keynote 89

03B.22 - Other - On-Site Accessible Path of Travel - See Additional Comments

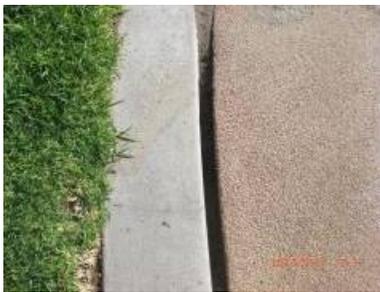
Keynote 90

16.26A - Cross Slope - Cross slope of the accessible route of travel exceeds 1:50.

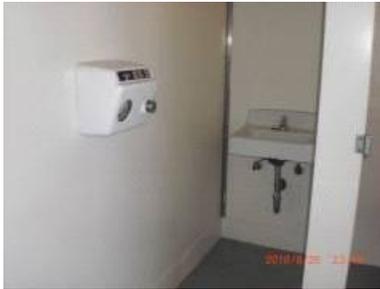
Keynote 91

Field Condition	
16.84B - Electric Hand Dryer - Operating Height - Mounting height of electric hand dryer's highest operable part exceeds 40" AFF. (Where provided, ADA Standards require at least one electric hand dryer to be accessible with the highest operable part placed within at least one of the reach ranges specified in 4.2.5 and 4.2.6; where provided, CBC Standards require at least one electric hand dryer to be accessible with the highest operable part no higher than 40" AFF.)	1991 ADAAG 4.22.7; 4.27.3; 4.2.5; 4.2.6 2004 ADAAG 308; 309 2007 CBC 1115B.8.3 Other -
Existing Condition: 43 1/2" AFF.

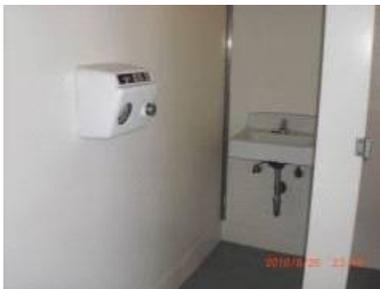
Keynote 92

Field Condition	
14.30A - Wall-Mounted Protruding Objects - Wall-mounted object(s) with leading edges between 27 and 80" from the floor project more than 4" into the pathway. (Wall mounted objects with leading edges at or below 27" may project any amount as long as the required clear width of an accessible route is not reduced.)	1991 ADAAG 4.4.1 2004 ADAAG 307.2; Fig. 307.2 2007 CBC 1133B.8.6.1 Other -
Existing Condition: Hand dryer protrudes 6 1/2" at 41" AFF.

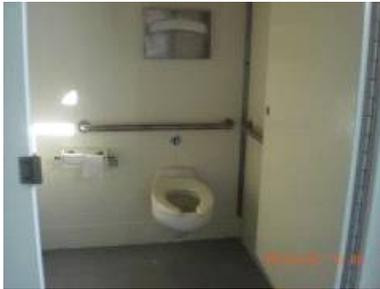
Keynote 97

Field Condition	
16.36A - Stall Width - The stall is less than 60" wide.	1991 ADAAG 4.17.3; Fig. 30(a)
Existing Condition: 58" wide.	2004 ADAAG 604.8.1.1; Advisory 604.8.1.1; Fig. 604.8.1.1
	2007 CBC 1115B.3.1(4.1)
	Other -

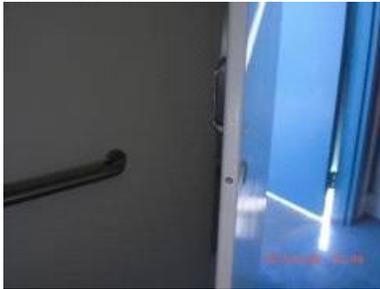
Keynote 99

Field Condition	
16.32A - U-Pulls at Stall Door - The stall door does not have U-pulls on both sides.	1991 ADAAG 4.13.9; 4.17.5
Existing Condition:	2004 ADAAG 309.4; 404.27; 604.8.1.2
	2007 CBC 1115B.3.1(4.4)
	Other -

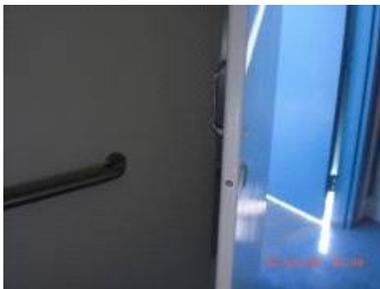
Keynote 100

Field Condition	
16.32B - Single-Action Stall Door Hardware - The stall door's locking mechanism is not operable with one hand. OR It is not operable without tight grasping, pinching, or twisting of the wrist.	1991 ADAAG 4.13.9; 4.17.5
Existing Condition:	2004 ADAAG 309.4; 404.2.7; Advisory 404.2.7
	2007 CBC 1117B.6(4)
	Other -

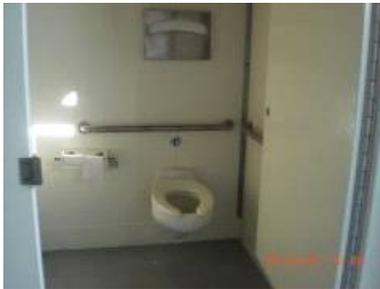
Keynote 102

Field Condition	
16.47A - WC Location from Sidewall - The centerline of the WC is not 18" absolute from a wall or partition.	1991 ADAAG 4.22.4
Existing Condition: 18 1/2" from side wall.	2004 ADAAG -
	2007 CBC 1115B.4.1(1)
	Other -

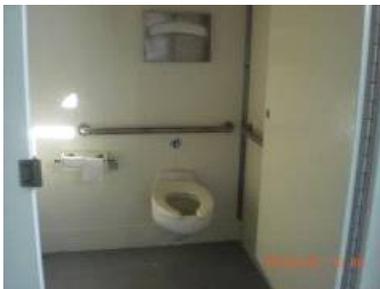
Keynote 104

16.49B - WC Flush Controls - Location - Flush controls are not located on the wide side of the WC where the clear floor space is provided.

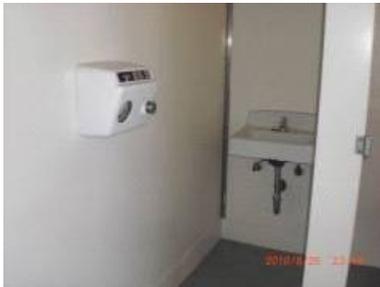
Keynote 112

Field Condition									
16.81 - Lavatory Faucet Operation - Min. 10 Second Standard - Self-closing valve remains open for less than 10 seconds.

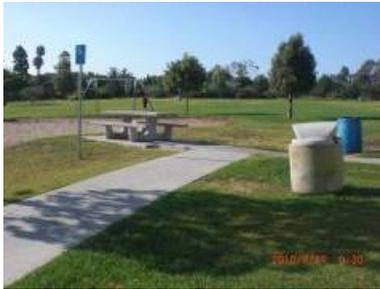
Keynote 113

Field Condition	
30.32 - 36" Aisle Width Standard - Around the picnic table, there is less than 36" clear space measured from the seat.	1991 ADAAG -
Existing Condition: 13" aisle around picnic table.	2004 ADAAG -
	2007 CBC -
	Other 1999 ADAAG-16.5.5

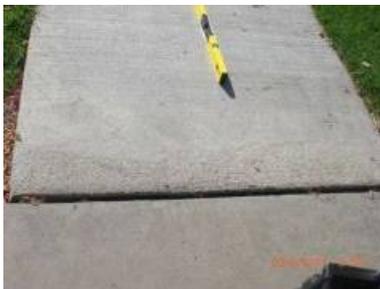
Keynote 114

Field Condition	
03B.22 - Other - On-Site Accessible Path of Travel - See Additional Comments	1991 ADAAG -
Existing Condition: 1" gap at 5 locations.	2004 ADAAG -
	2007 CBC -
	Other -

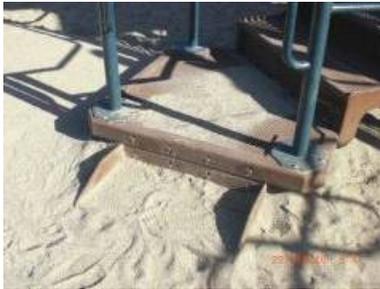
Keynote 117

Field Condition	
31.21 - Transfer Platforms - Height - Platforms surfaces are not 11" min. and 24" maximum from the clear ground or floor space.	1991 ADAAG -
Existing Condition: 4" high.	2004 ADAAG 1008.3.1.2
	2007 CBC -
	Other 2000 ADAAG-15.6.5.1.2

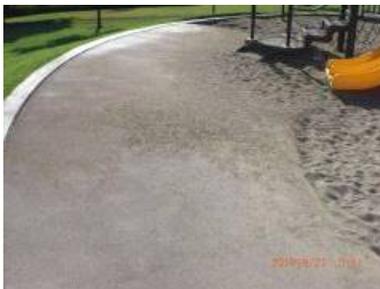
Keynote 118

Field Condition	
31.30B - Play Components - Clear Floor or Ground Space Slope - The clear floor or ground space has a slope greater than 2% in some or all directions.	1991 ADAAG -
Existing Condition: 2.3% to 4.3% slope.	2004 ADAAG 1008.4.2; 305.2; 305.3
	2007 CBC -
	Other 2000 ADAAG-15.6.6.2; PRC 5410-5411

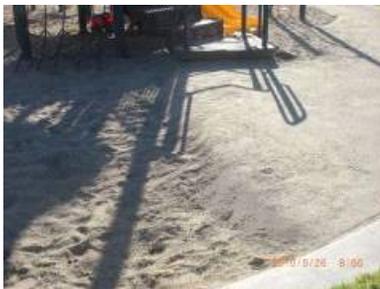
Keynote 120

Field Condition	
31.38 - Other - Play Areas - See Additional Comments	1991 ADAAG -
Existing Condition: 3" - 7" drop along playground area.	2004 ADAAG -
	2007 CBC -
	Other -
