## 1.0 Introduction

### 2.2 ~~System Evaluation~~Condition Assessment and Capacity Analysis Findings

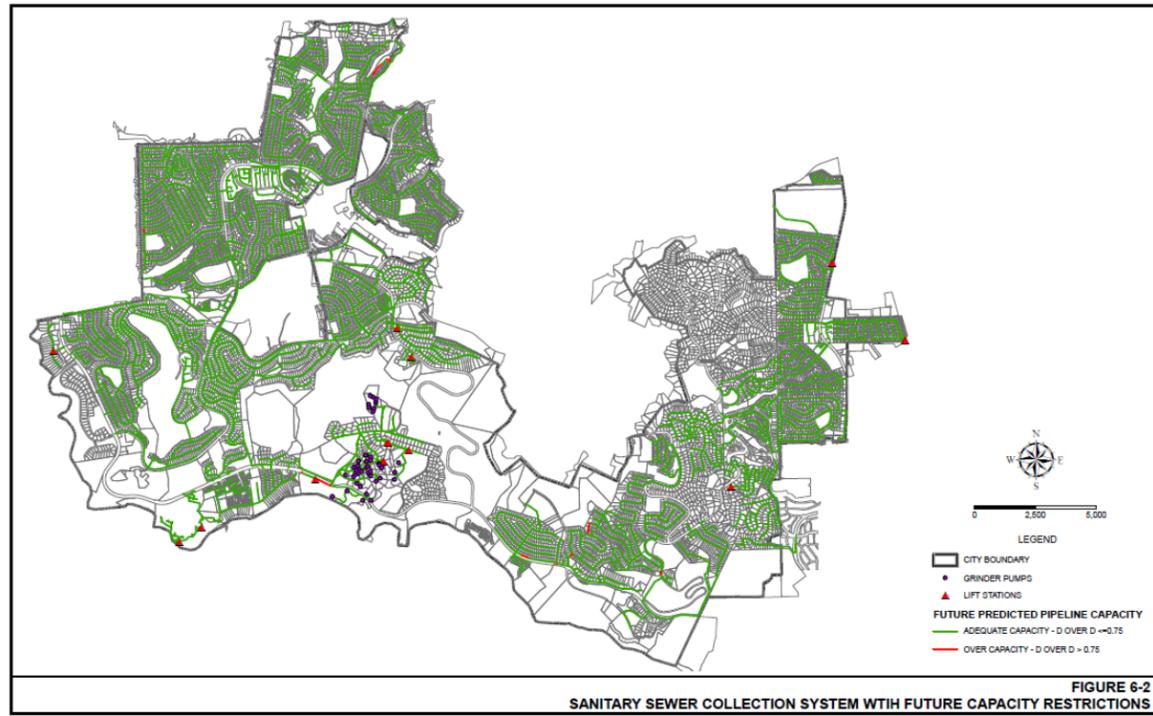
Figure 6-2 Future Capacity Restrictions

The model shows that 16 pipe segments out of 3,812 or 0.42% will be over capacity to accommodate the future population predictions. These pipe segments are graphically shown in Figure 6-2 and are included as part of the recommended CIP projects discussed in Chapter 7.

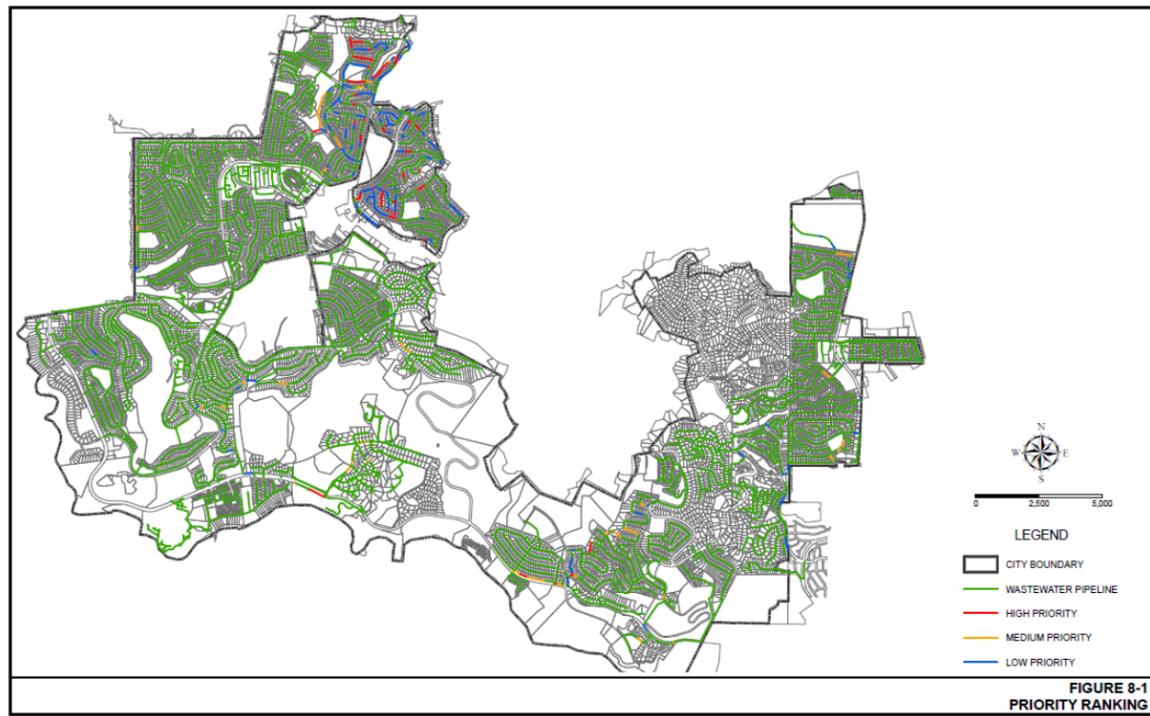
Figure 7-1 Priority Ranking

To develop the CIP project list, many factors were considered. The areas of CCTV pipeline were superimposed with the capacity related problems as determined by HYDRA. A priority level of high, medium, or low was assigned to each pipe segment based on their capacity and maintenance condition. Pipe segments showing capacity problems under the existing flow conditions and or a PACP rating of 4 or 5 were given a ranking of “high”. Pipe segments over capacity for the 2.5 factor of safety case and or a PACP rating of 3 were given a ranking of “medium”. Pipe segments that did not have a capacity problem and did not show any observed structural or maintenance problems (receiving a PACP ranking of 1) were not considered as a potential project. These rankings are shown in Figure 7-1.
