**Preliminary Geotechnical Study Report
for San Ramon Canyon Storm Drain System,
City of Rancho Palos Verdes, California**

**Prepared For
HARRIS & ASSOCIATES**

November 10, 2010

GMU Project No. 10-036-00

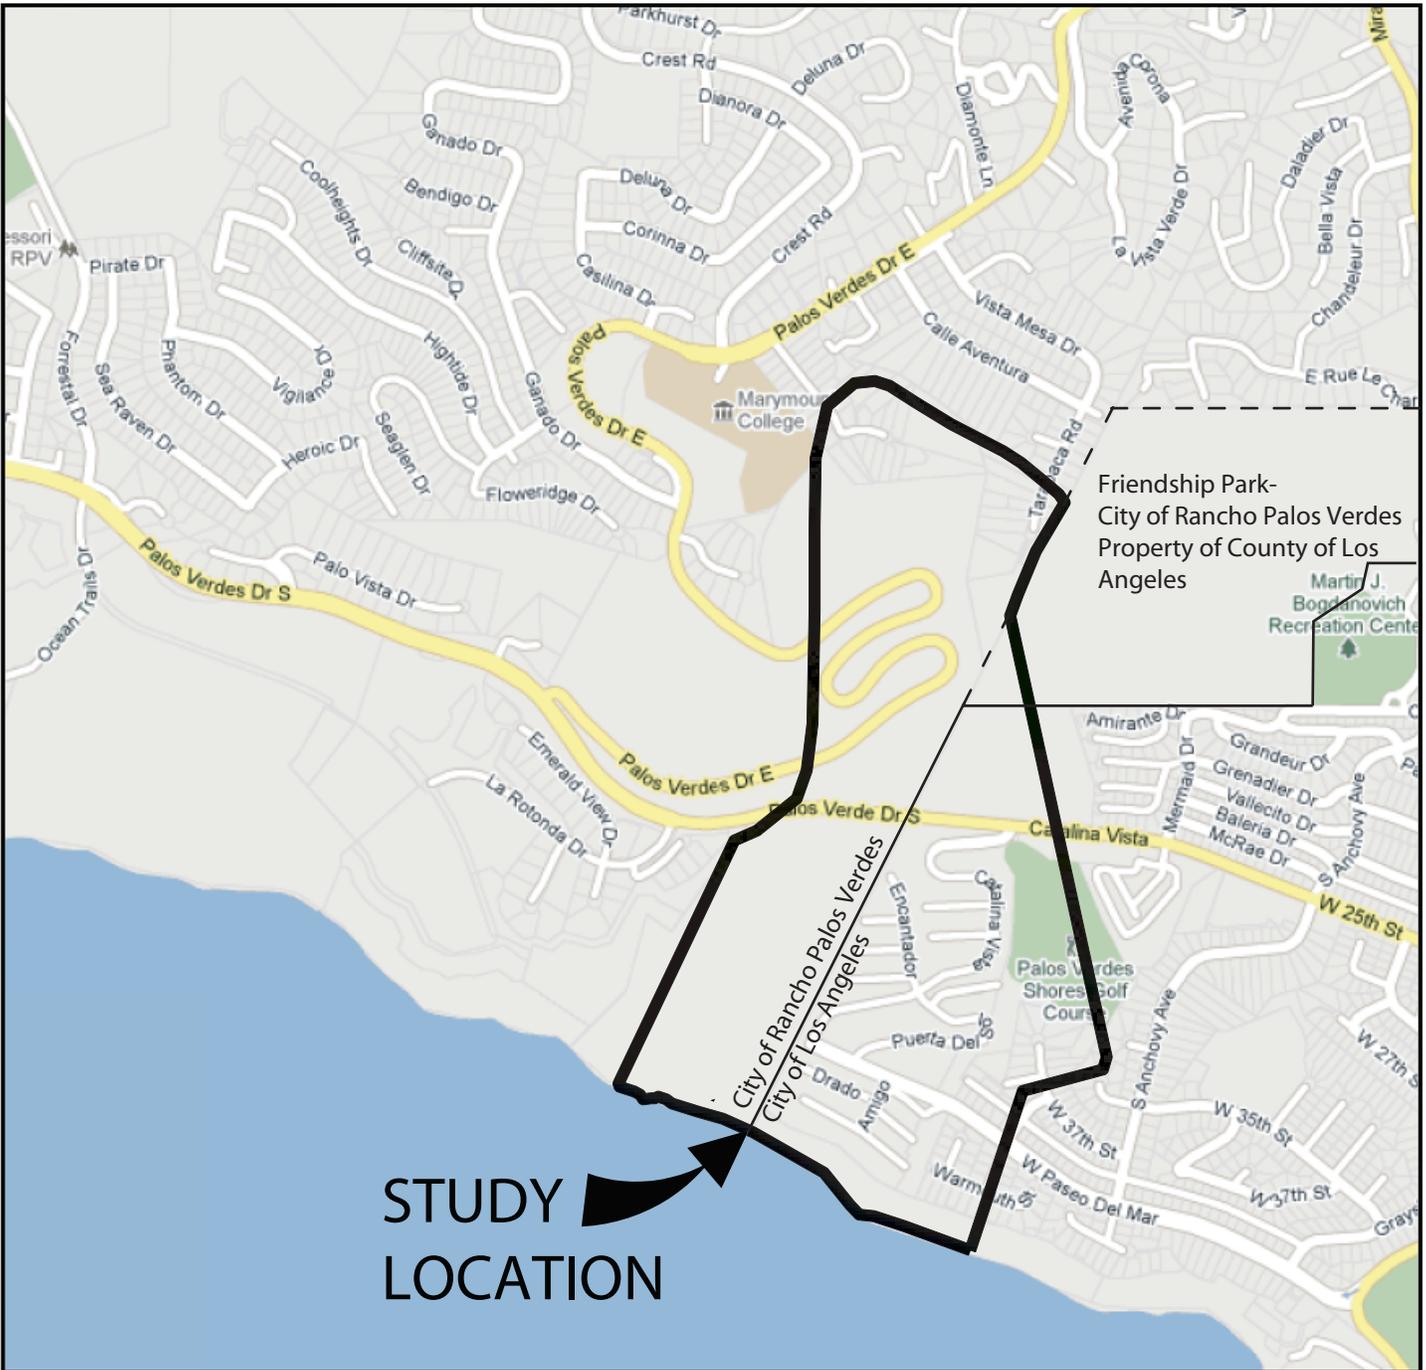
Plate
1

**STUDY
LOCATION**

The project site is located within the eastern portion of the City of Rancho Palos Verdes. In general, the site is bounded by Palos Verdes Drive East (PVDE) on the west, Calle Aventura and Tarapaca Road to the north, the City of Los Angeles boundary to the east, and the Pacific Ocean to the south. It should be noted that the site is bisected by Palos Verdes Drive South, which is named 25th Street within the City of LA. For the purposes of this report, this street is referred to as “25th Street”. A Location Map showing the specific limits of the project site is included in this report as Plate 1.

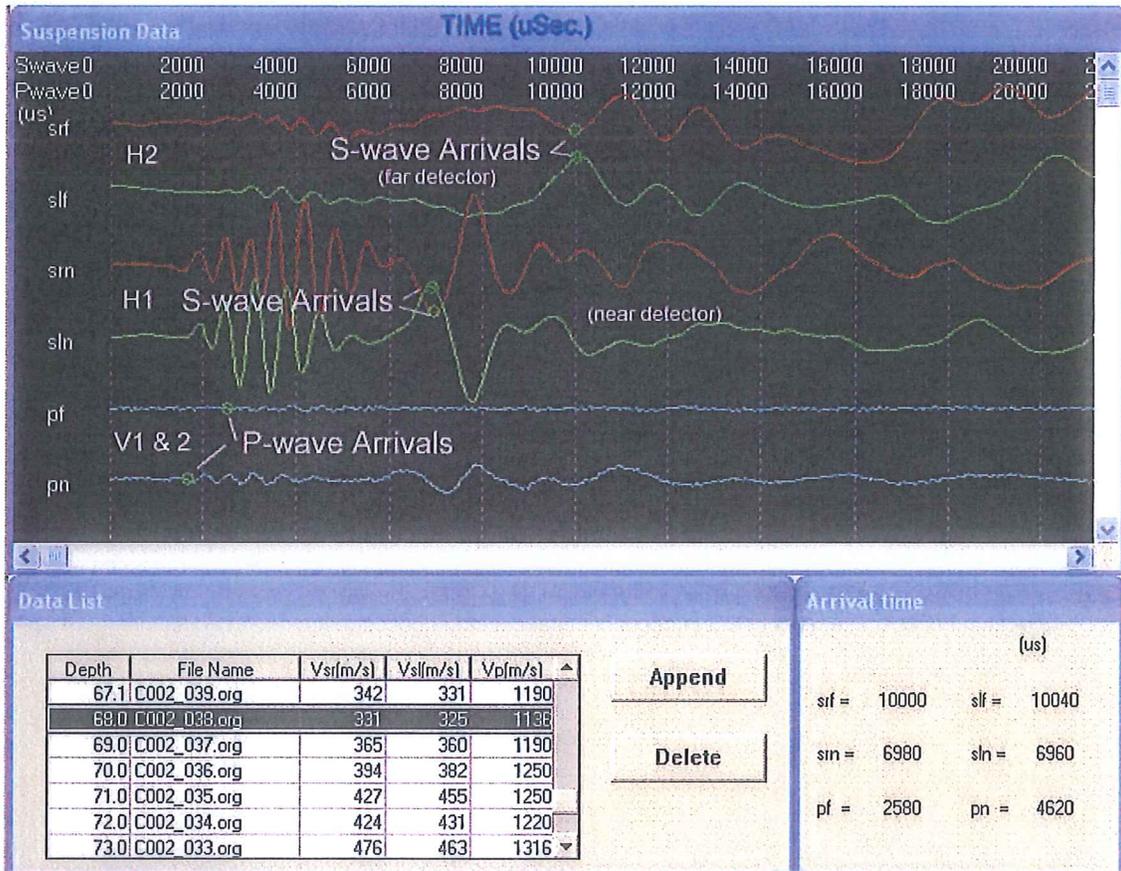
Example Suspension Waveform Record with Interpreted Arrival Times

Example Interpreted Waveform Record via GLOG-SUS Program CH-2

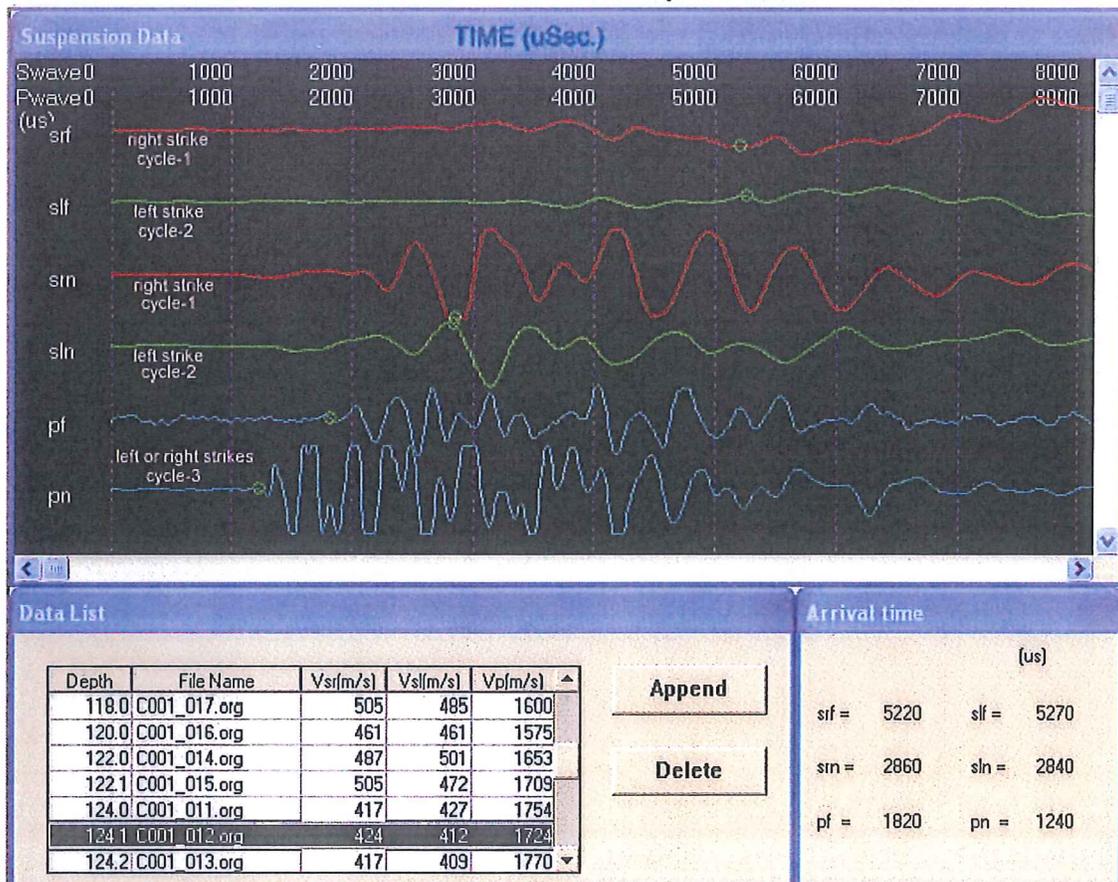
Example Waveform Record CH-1
