ABALONE COVE, PORTUGUESE BEND,  
KLONDIKE CANYON LANDSLIDES

# LANDSLIDE WORKSHOP

# KLONDIKE CANYON LANDSLIDE

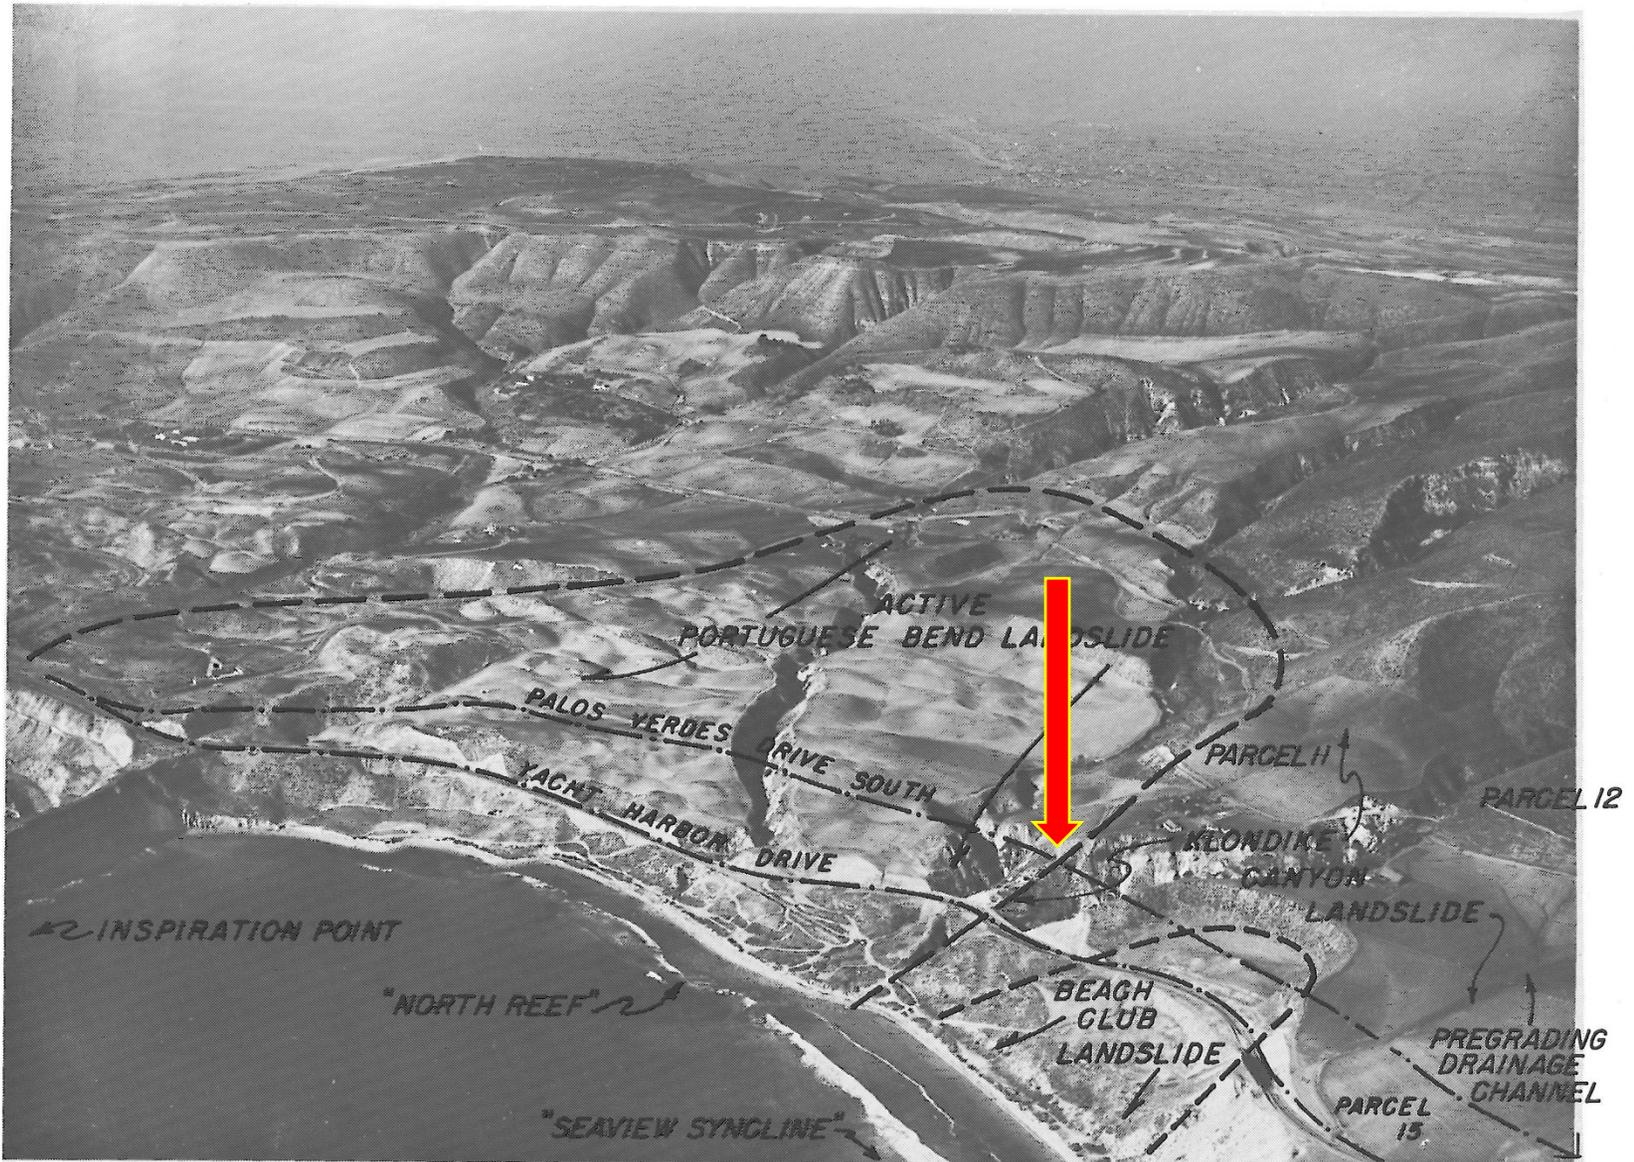
PLATE III

**PORTUGUESE BEND AREA — NOVEMBER 28, 1931**

*Approximate Extent of Klondike Canyon Landslide  
Photo courtesy of Spence Air Photo Collection - Dept. of Geography - U.C.L.A.*

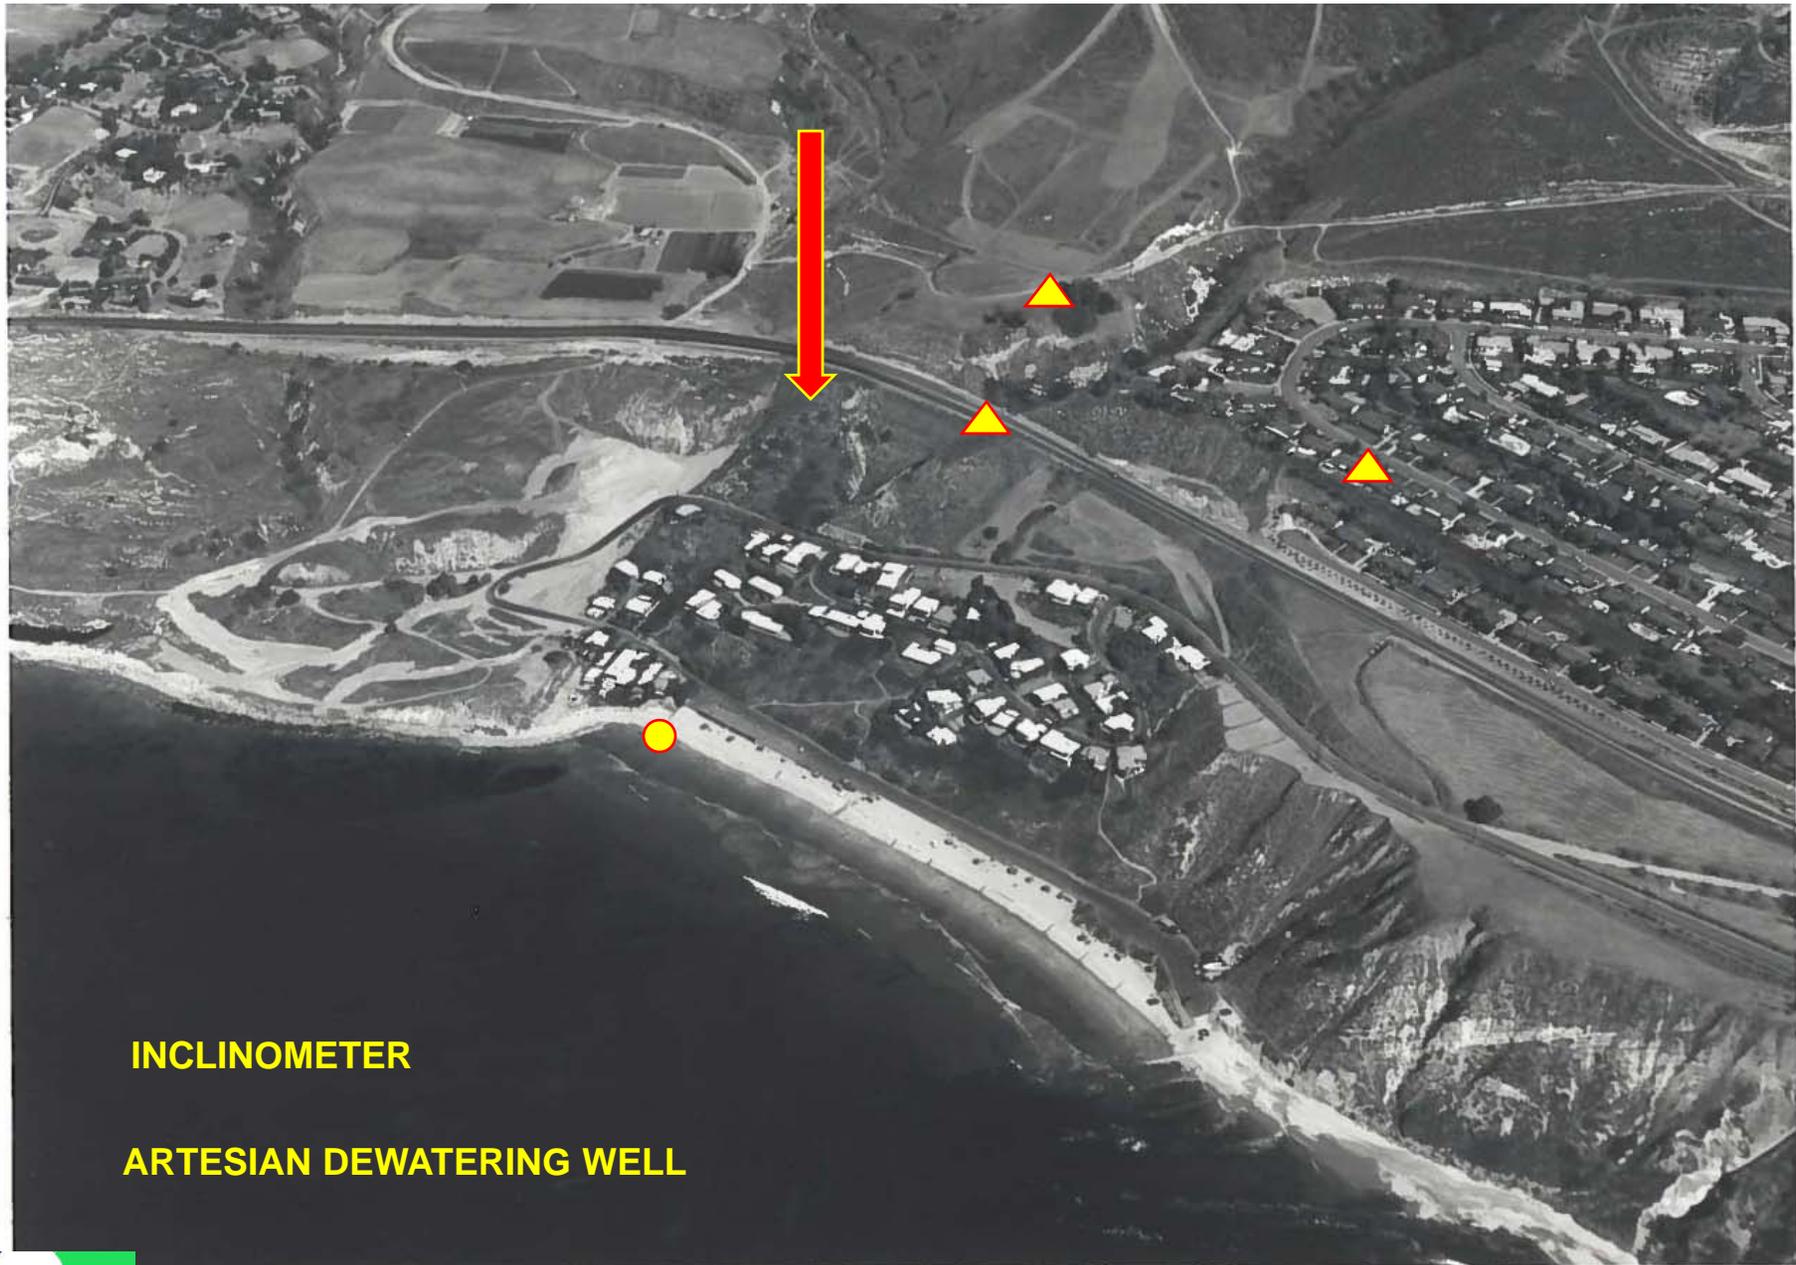
## **Inclinometer and Well Locations**

**INCLINOMETER**

**ARTESIAN DEWATERING WELL**

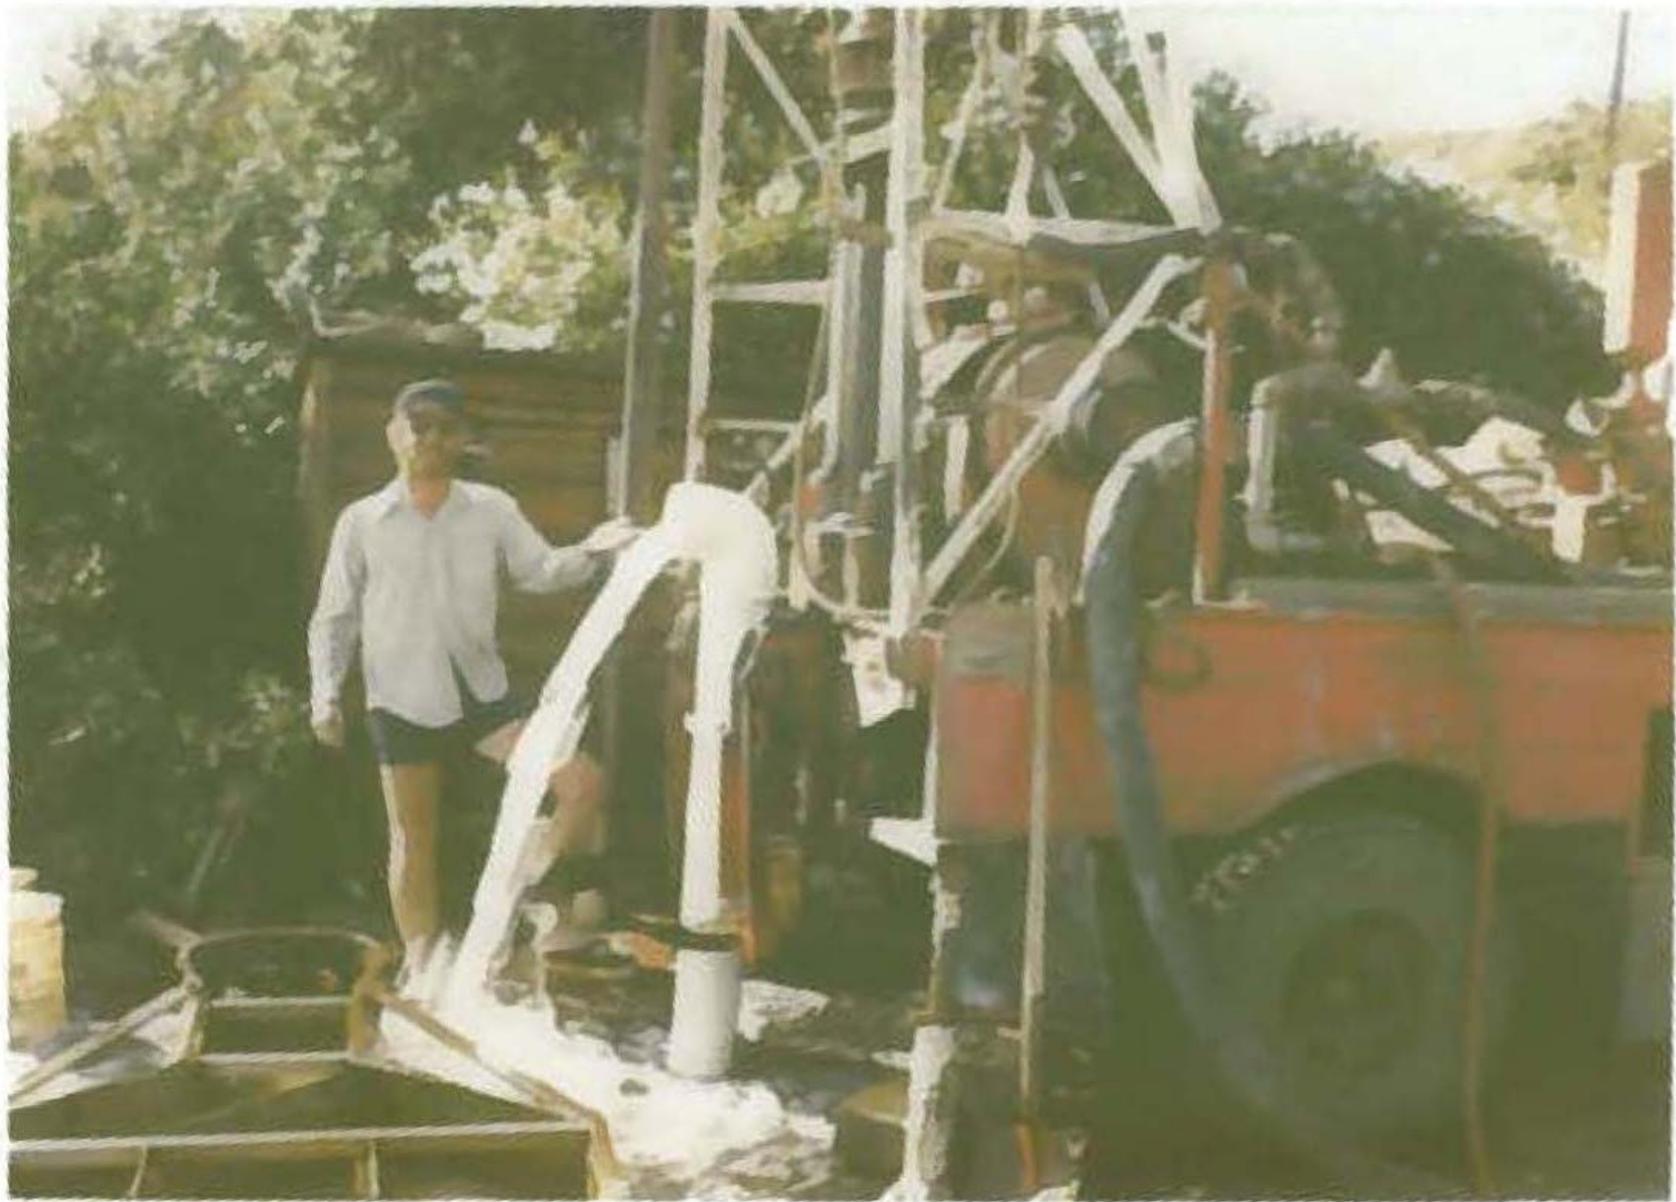
**Artesian Dewatering Well Established on the Beach Near the Mouth of  
Klondike Canyon – May 1981**

**Initial Flow Rate: 150 Gallons/Minute**

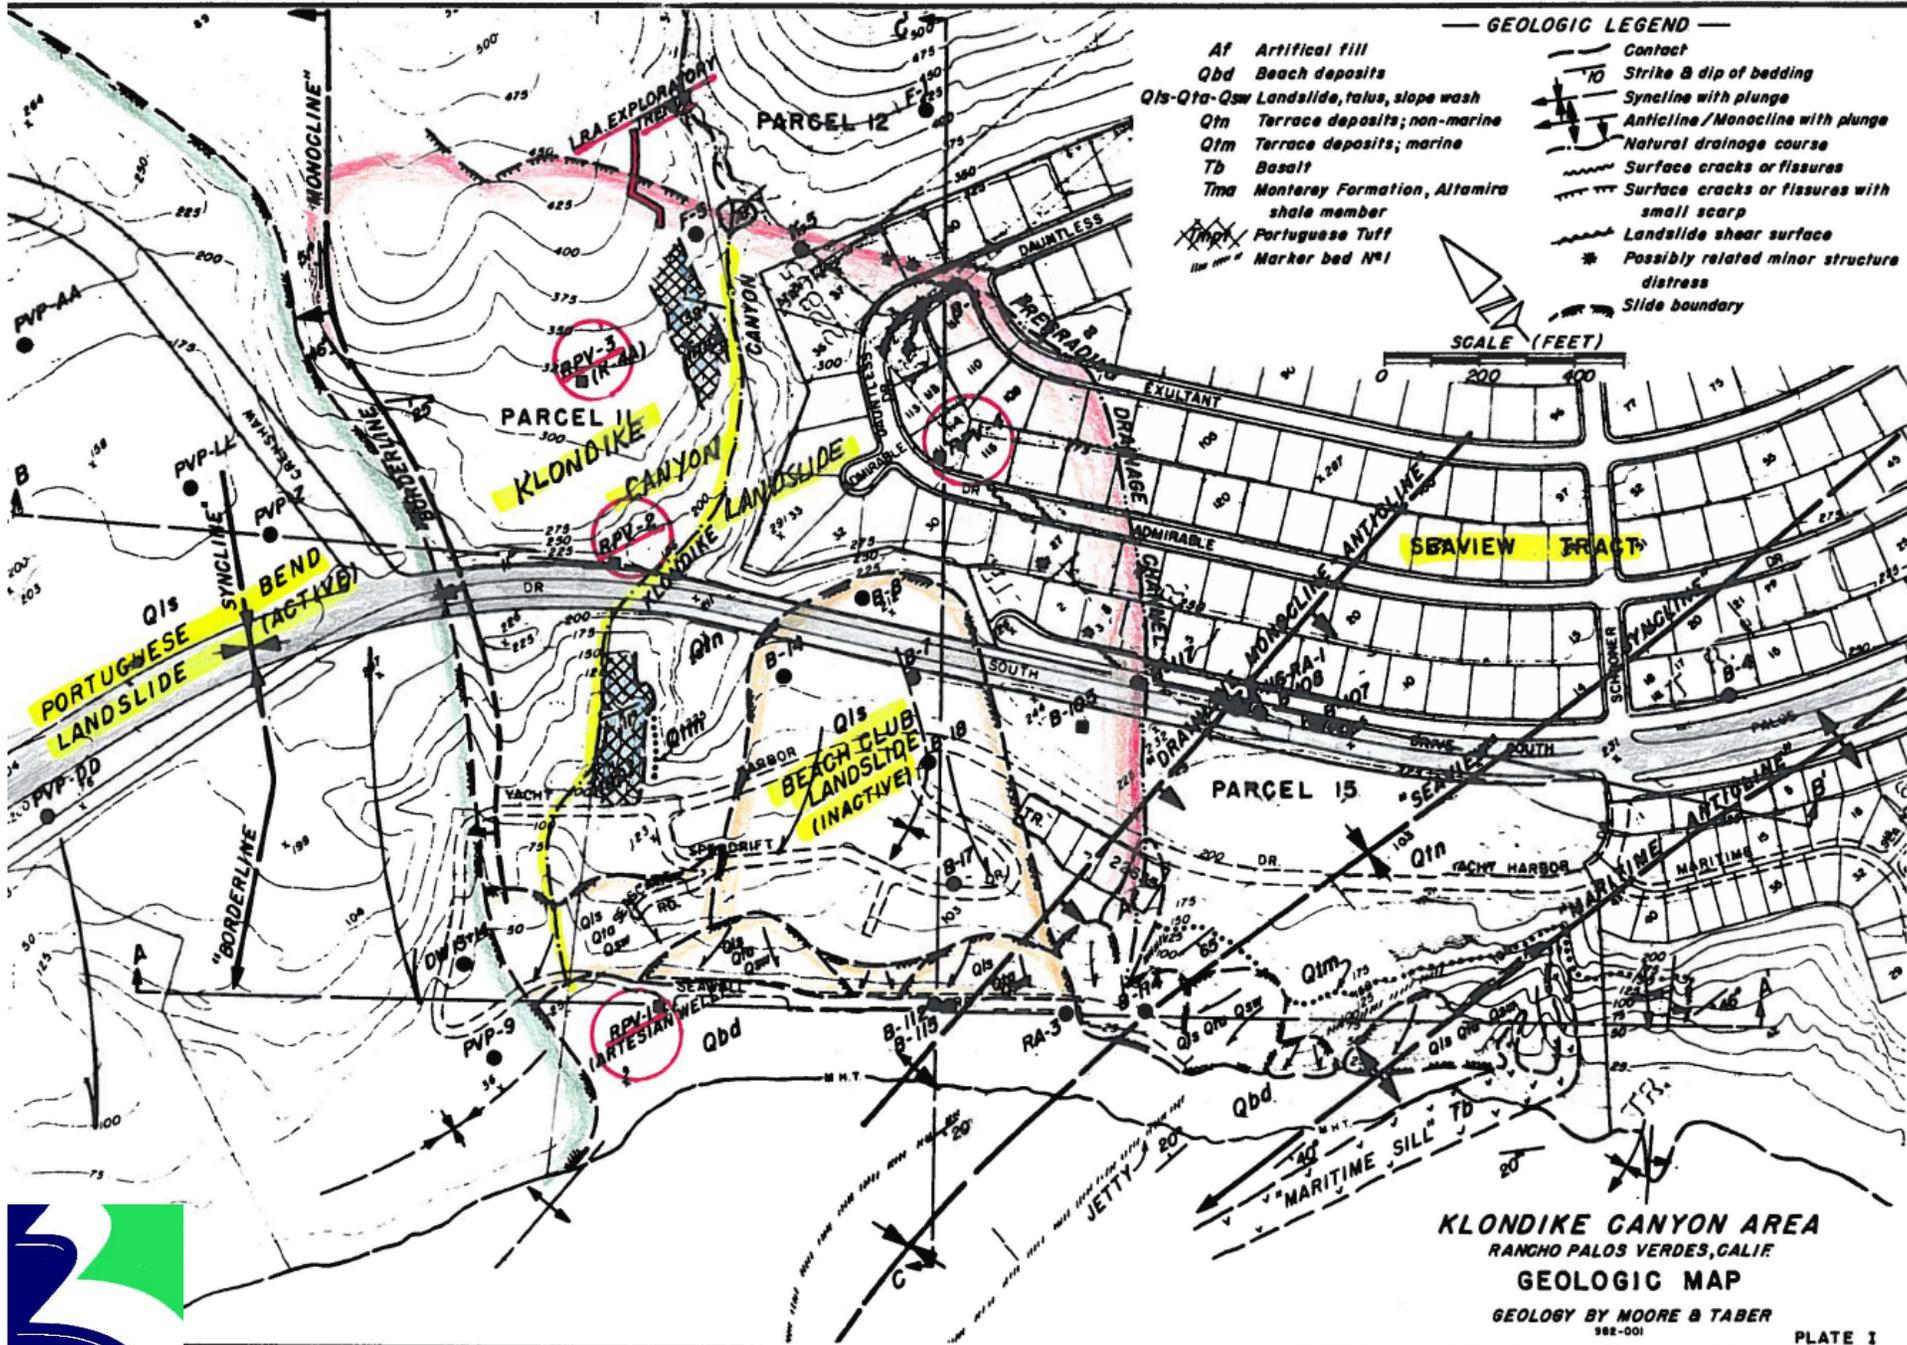
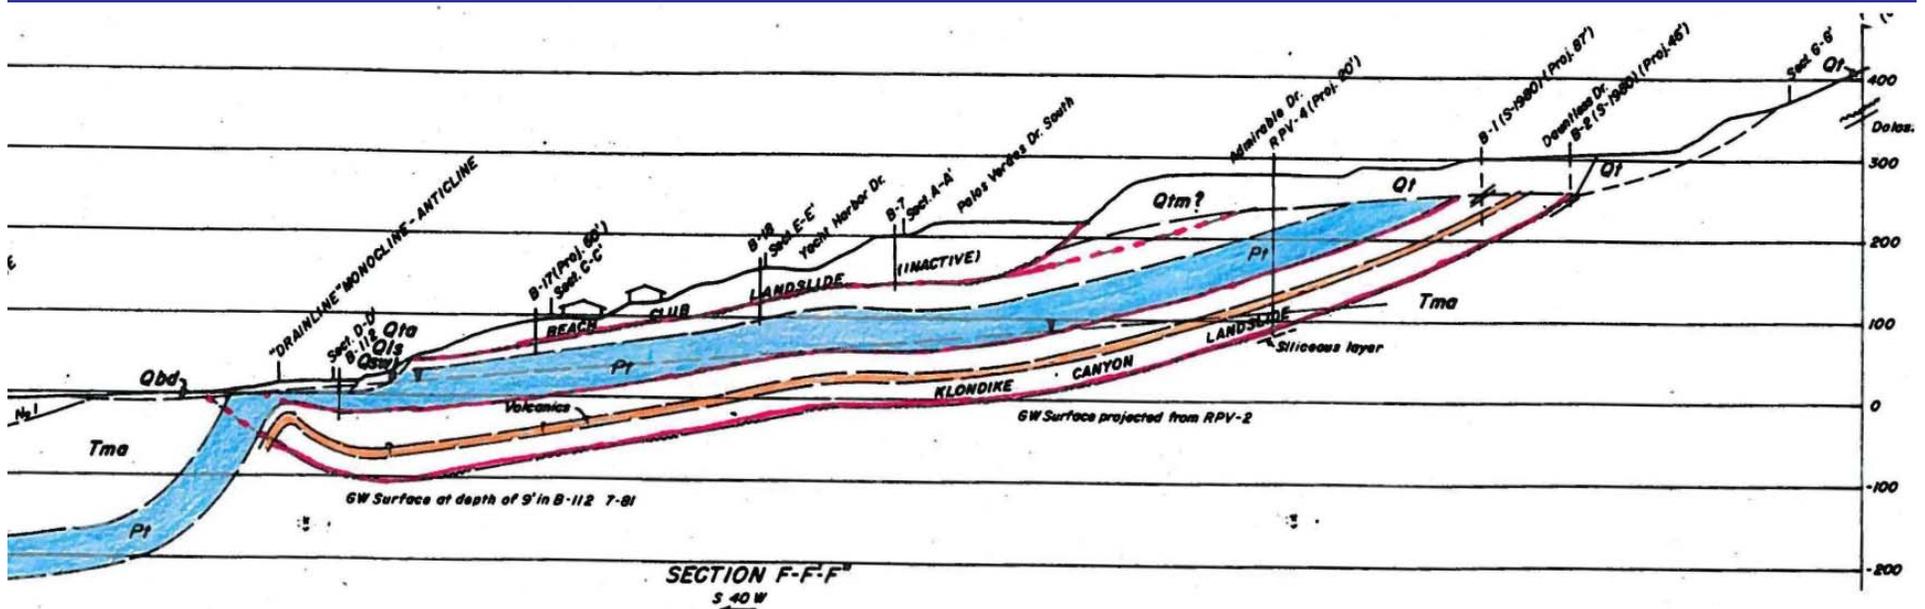
## Geologic Profile From the Back of the Seaview Tract Down Through Center of Beach Club Landslide

### 3 Landslide Surfaces:

1. 10 to 20 feet above Portuguese Tuff (Beach Club Landslide)
2. At the Base of the Portuguese Tuff (Klondike Canyon Landslide).
3. Approximately 65 Feet Below the Base of the Portuguese Tuff (Klondike Canyon Landslide)

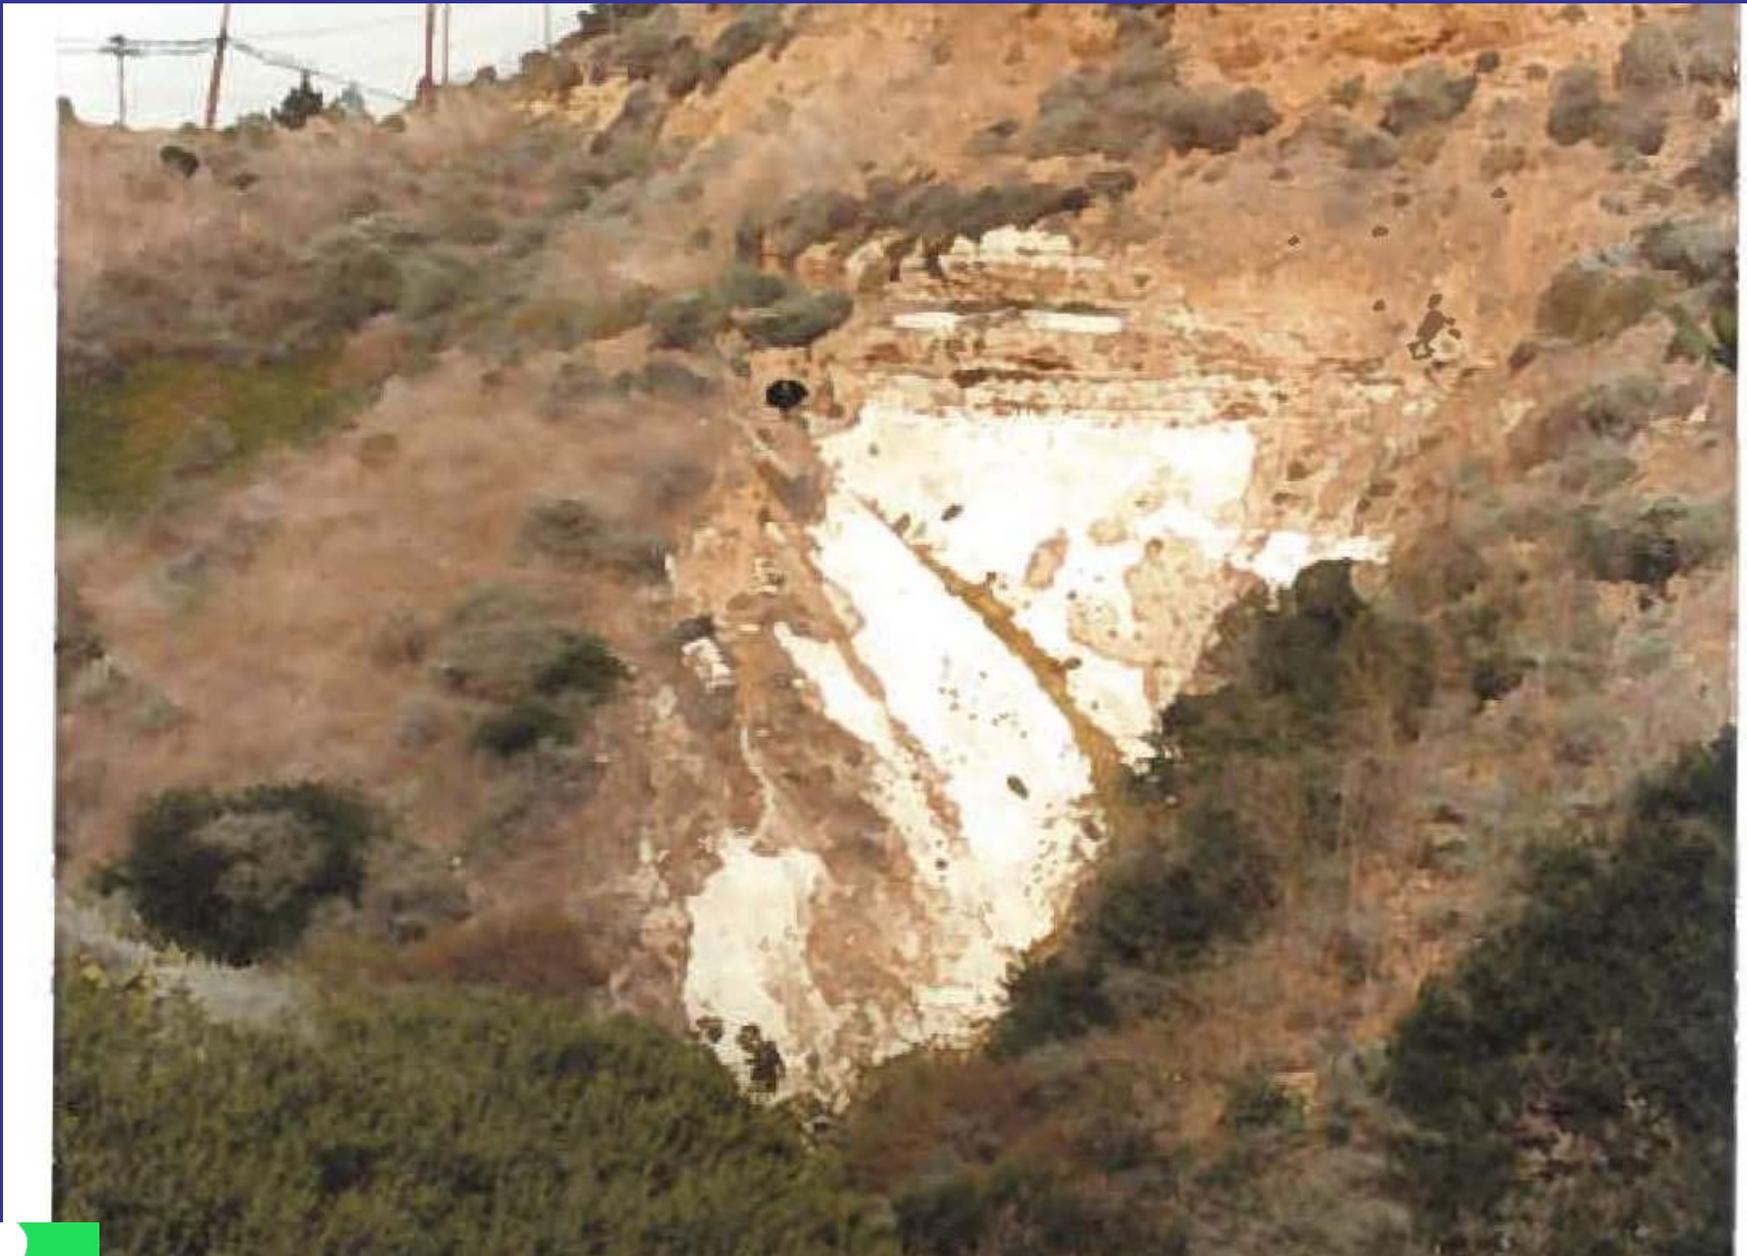
**Portuguese Tuff Exposure – Lower Klondike Canyon  
Downstream from PV Drive South**

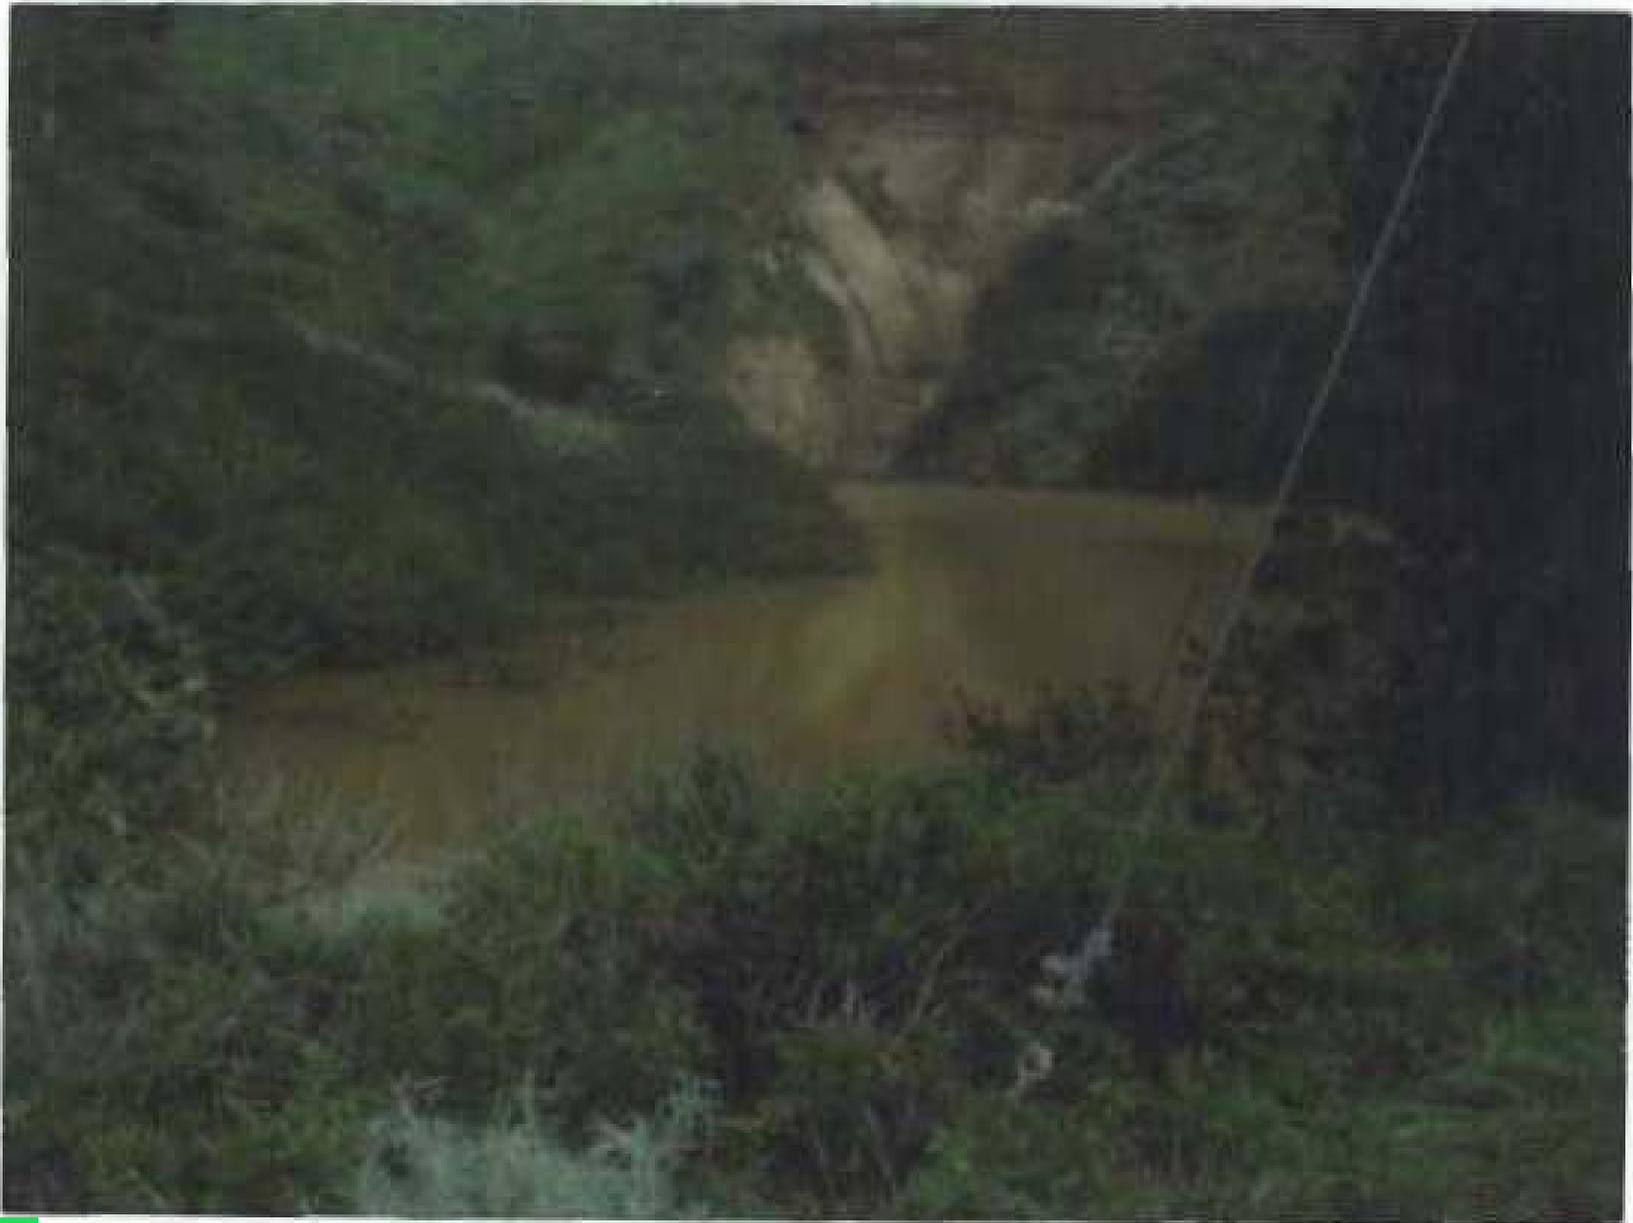
**Temporary Lake in Lower Klondike Canyon Behind Yacht Harbor  
Drive Road Fill - 1983**

- Total Displacement 50 to 60 Feet
- Surface Deformation Suggests Small Displacement
- Inclinometer Measurements Showed “Creep”
- Total Measured Displacement Less than 0.5-inch
- 1983- Heavy Rainfall Formed Temporary Lakes
- 1986- Land Surveys showed Seaward Shift of 1.5 over 30 Years
- Pavement Cracks Suggest Slow “Creep”
  - Minor Acceleration Likely During Heavy Rainfall Years.

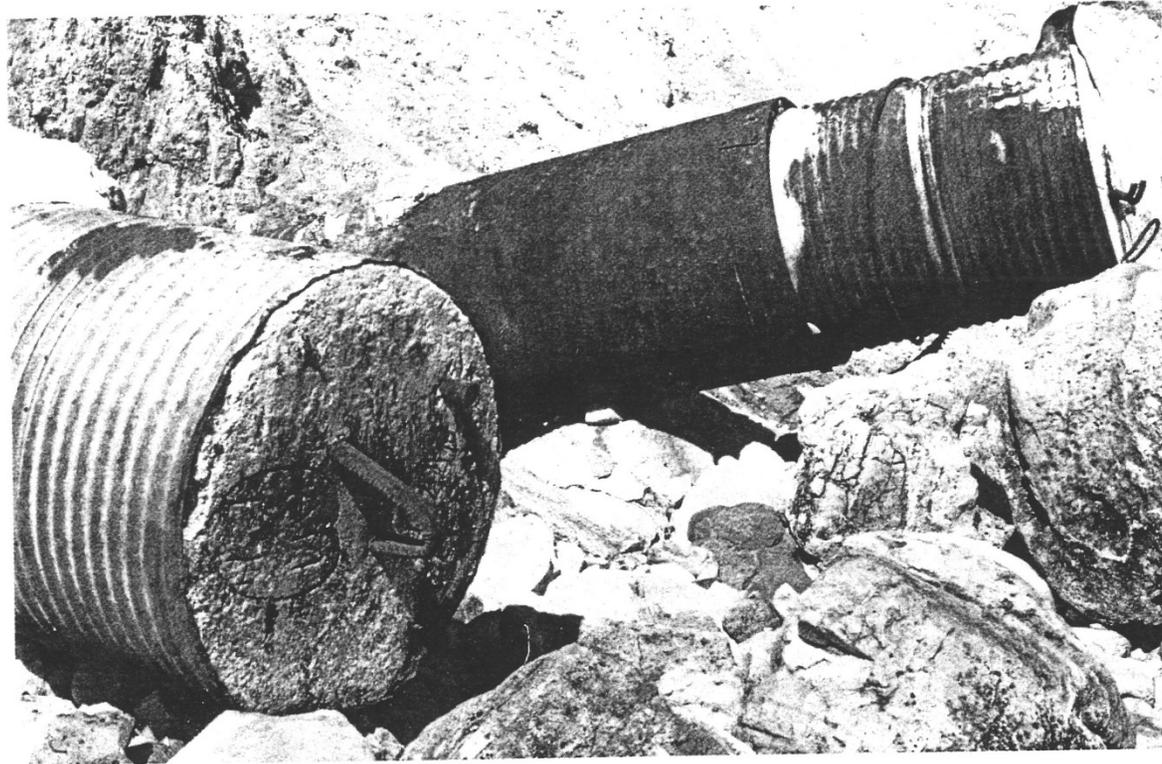
# Caisson In Surf Zone

Figure 2. Reinforced concrete caissons exposed by wave erosion at the toe of the Portuguese Bend landslide in 1981. Pins were installed through the base of the landslide with their midpoints 42 feet below sea level in 1957.

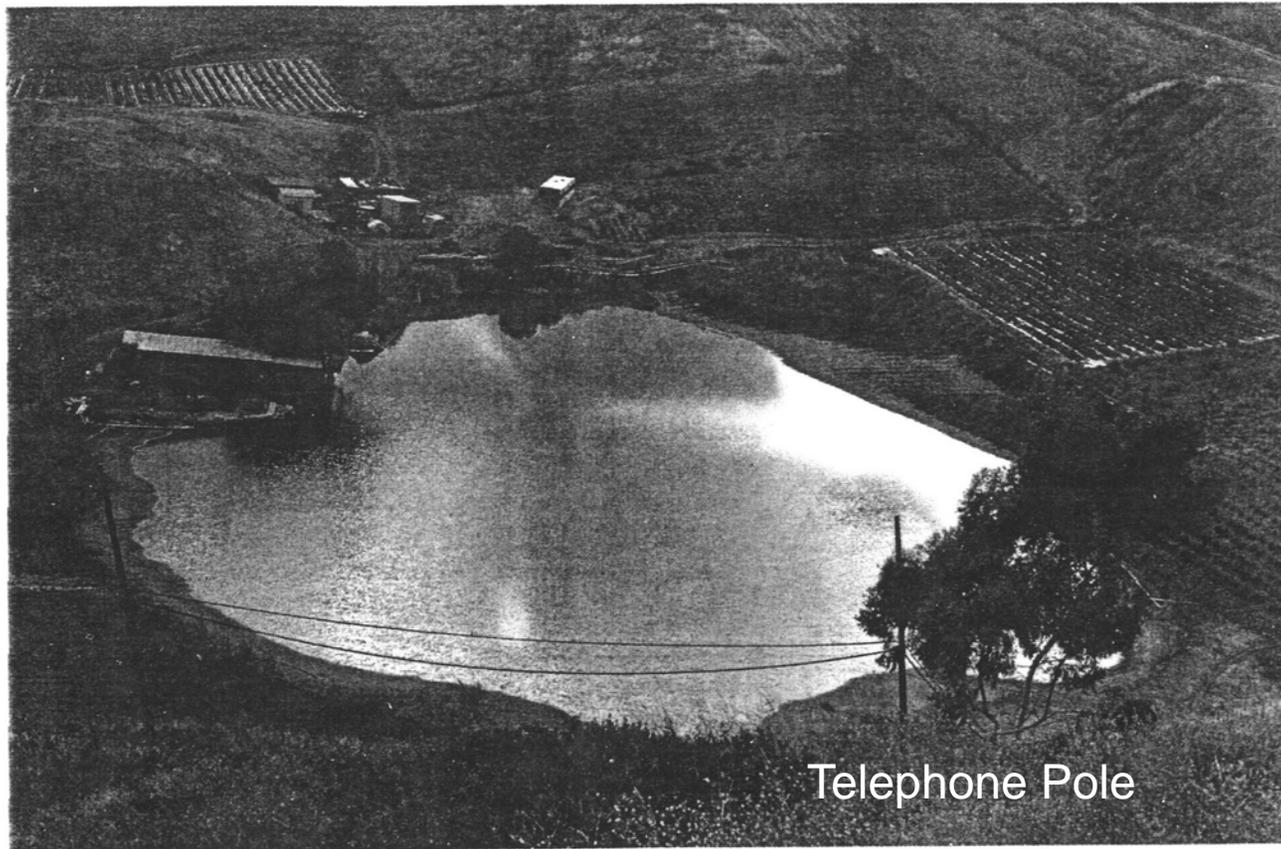
Lake Ishibashi – Pre 1986

Telephone Pole

- Lake Ishibashi Grading – 1986
- Two Phases of Grading totaling about 560,000 cubic yards
- Graded depression to drain
- Established existing alignment of PVDS

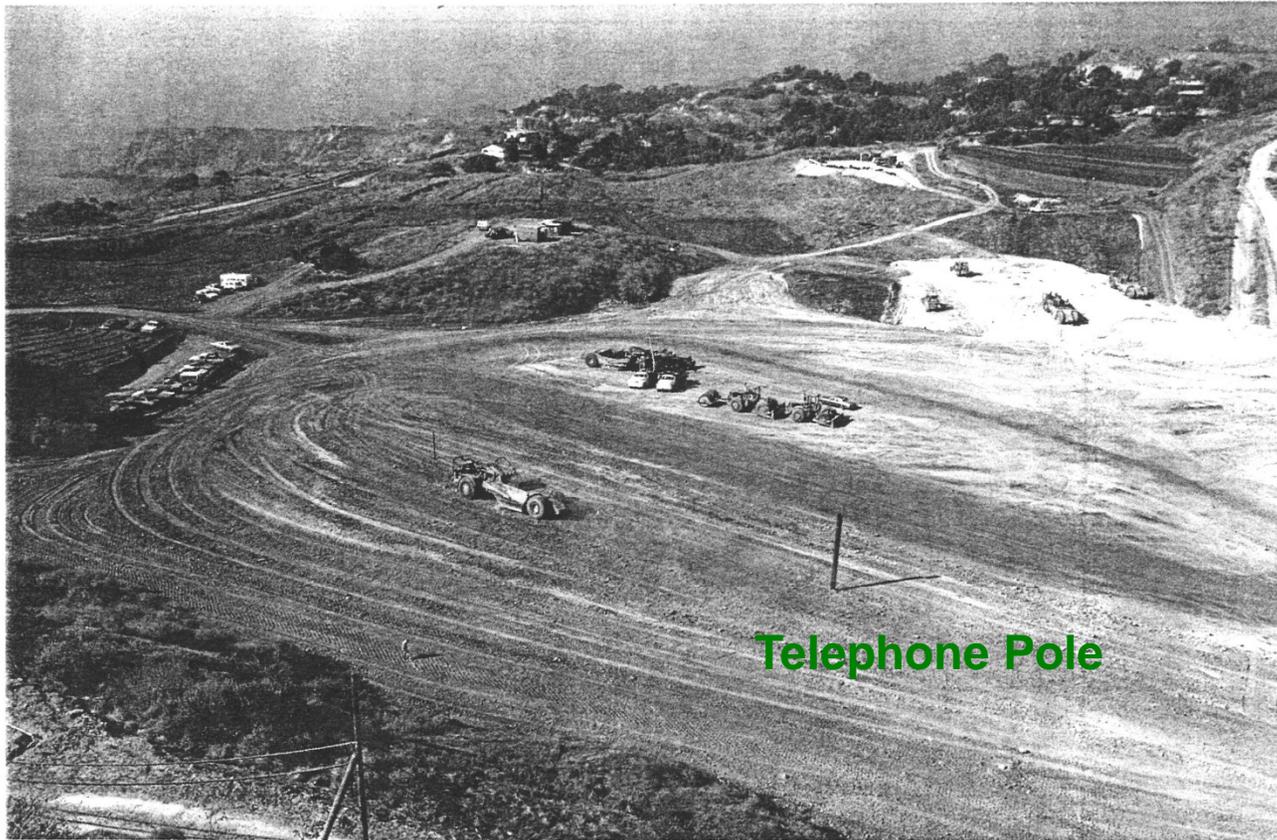
Lake Ishibashi – Late 1986 Graded Condition

Telephone Pole
