## 4.4 GEOLOGY

Crestridge Senior Housing Project EIR  
**Section 4.4 Geology**

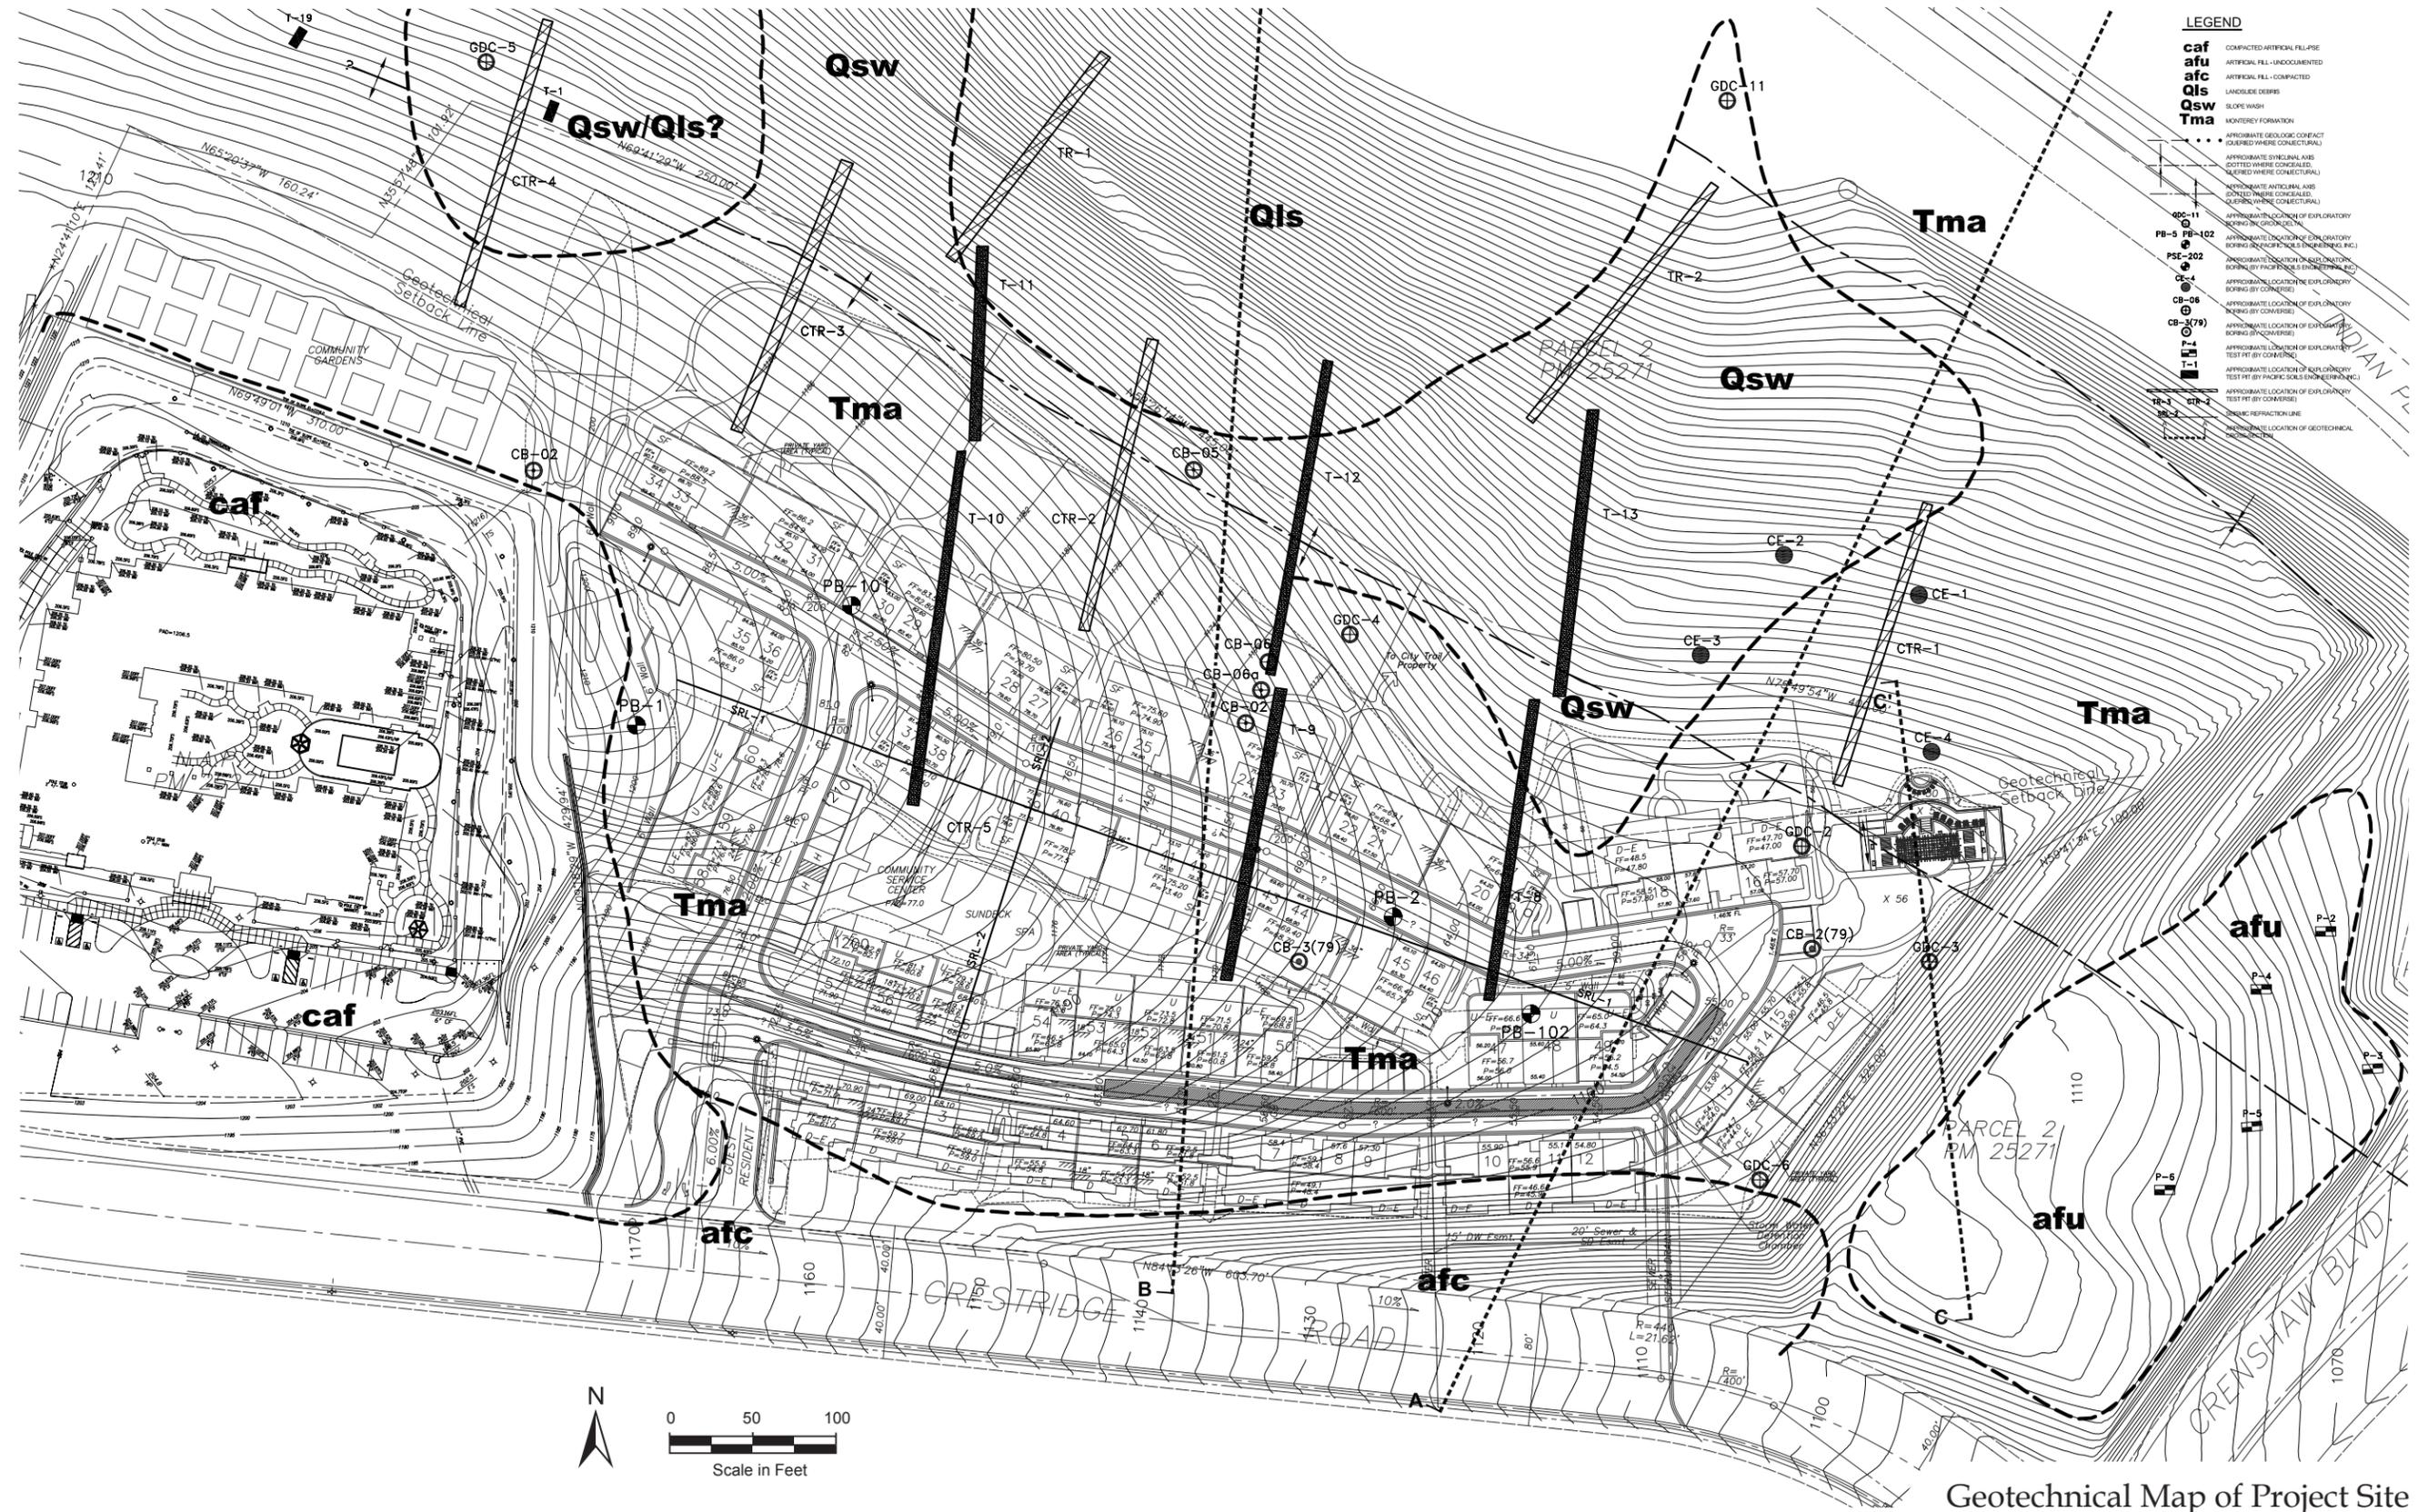
Geotechnical Map of Project Site

Source: Geotek, March 5, 2012.

**c. Geologic Structure.** The major structural feature on the site is a roughly east-west trending anticline that is located approximately 100 to 150 feet north of the axis of the ridgeline. The southern limb of this antiform dips at shallow to moderate angles (5-20°) to the south. The northern limb of the antiform coincides with the northerly descending natural slope. In general, this limb of the anticline forms a dip slope condition with bedding angles ranging from 5 to 25°. There is evidence that many small folds are located on the north limb, probably as a result of movement due to contemporaneous settlement during deposition, drag folding from tectonic deformation, gravity creep along bedding, and may also have possibly been affected by

movement of the ancient landslide when it was active. Bedrock joints are well developed along the ridge area of the site and trend in a general east-west and north-south direction, with dips ranging from 70 degrees to vertical. Minor "inactive" faults have previously been observed in trenches excavated on the northerly facing natural slope and on the cut slopes westerly of Crenshaw Boulevard (Group Delta Consultants, 2003). These faults are not interpreted as continuous features and are likely near-surface phenomena resulting from creep affected bedrock.

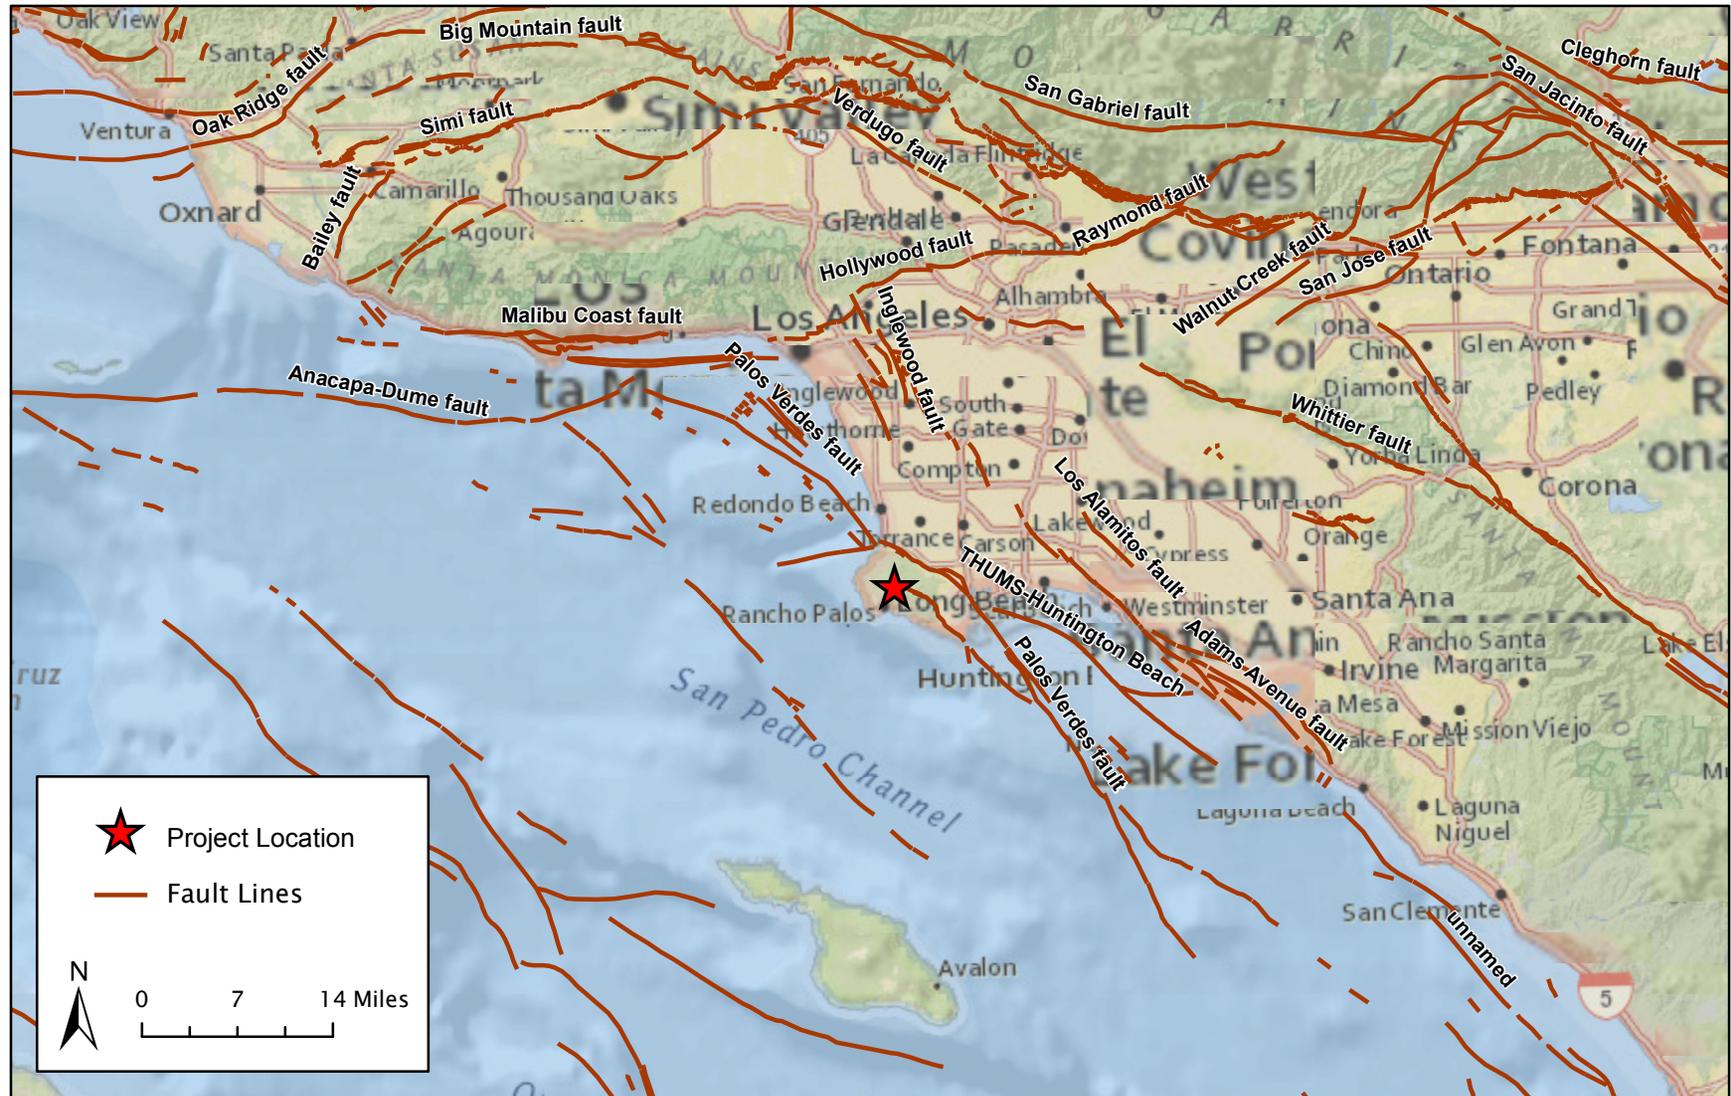
Regional Fault Map

Source: Bryant, W.A. (compiler), 2005, Digital Database of Quaternary and Younger Faults from the Fault Activity Map of California, version 2.0: California Geological Survey Web Page, <[http://www.consrv.ca.gov/CGS/information/publications/QuaternaryFaults\\_ver2.htm](http://www.consrv.ca.gov/CGS/information/publications/QuaternaryFaults_ver2.htm)>; (1/31/07). Note: information regarding site specific faults/concealed faults can be found on the Dibblee Map 1993. Imagery provided by National Geographic Society, ESRI and its licensors, 2012.

Other seismogenic faults capable of generating high ground motions at the site include the Los Angeles Basin segment of the Newport-Inglewood Fault Zone, located approximately 10 miles
