MOORE & TABER GEOTECHNICAL ENGINEERS AND GEOLOGISTS
4530 EAST LA PALMA AVENUE • ANAHEIM, CALIFORNIA 92807 • (714) 779-2591

Job No. 386-428

RESPONSE TO REVIEW OF GEOTECHNICAL REPORTS
EASTERLY PORTION OF PARCEL 15
PORTUGUESE BEND CLUB
RANCHO PALOS VERDES, CALIFORNIA

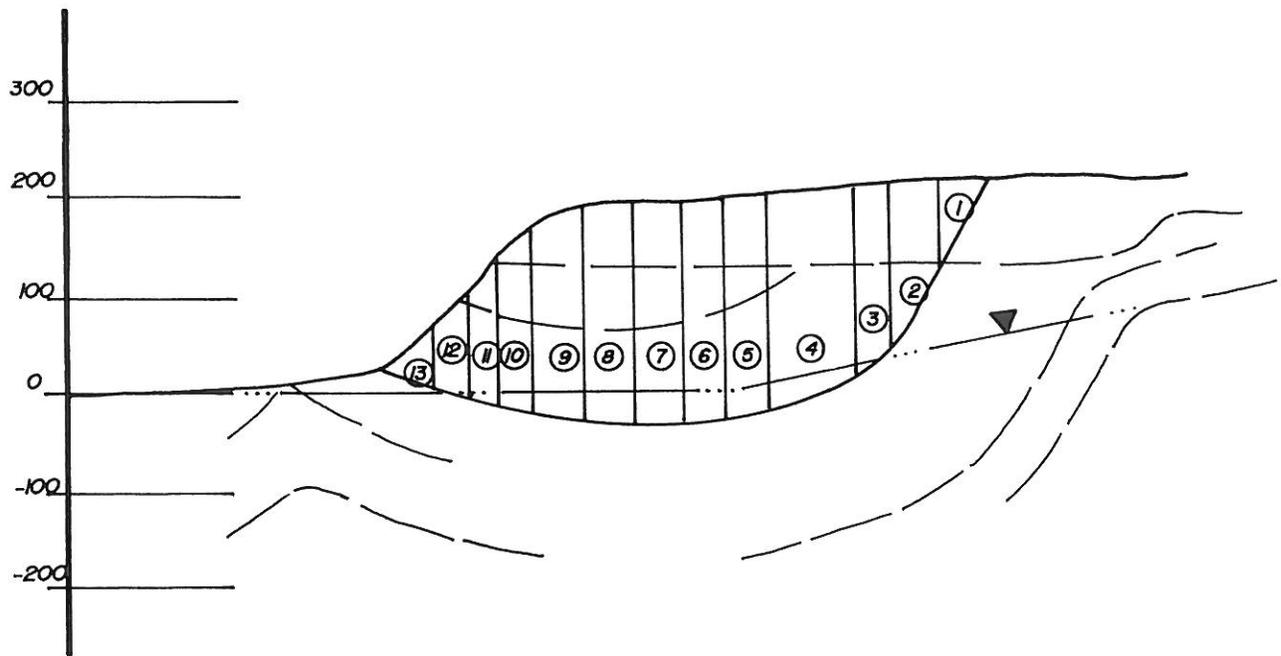
GROSS STABILITY SECTION G-G'

*horizontal acceleration = 0.15g
 no vertical acceleration*

SCALE 1" = 200'

Factors of safety of 2.01, 1.65, 1.81 and 1.55 were calculated for hypothetical failure(s) of the sea cliff along Stability Sections G-G', H-H', I-I' and J-J', respectively. Analyses for the pseudostatic case using a seismic coefficient of 0.15g determined factors of safety of 1.66, 1.46, 1.51 and 1.49, respectively. Summaries of the stability calculations are attached in Appendix C.

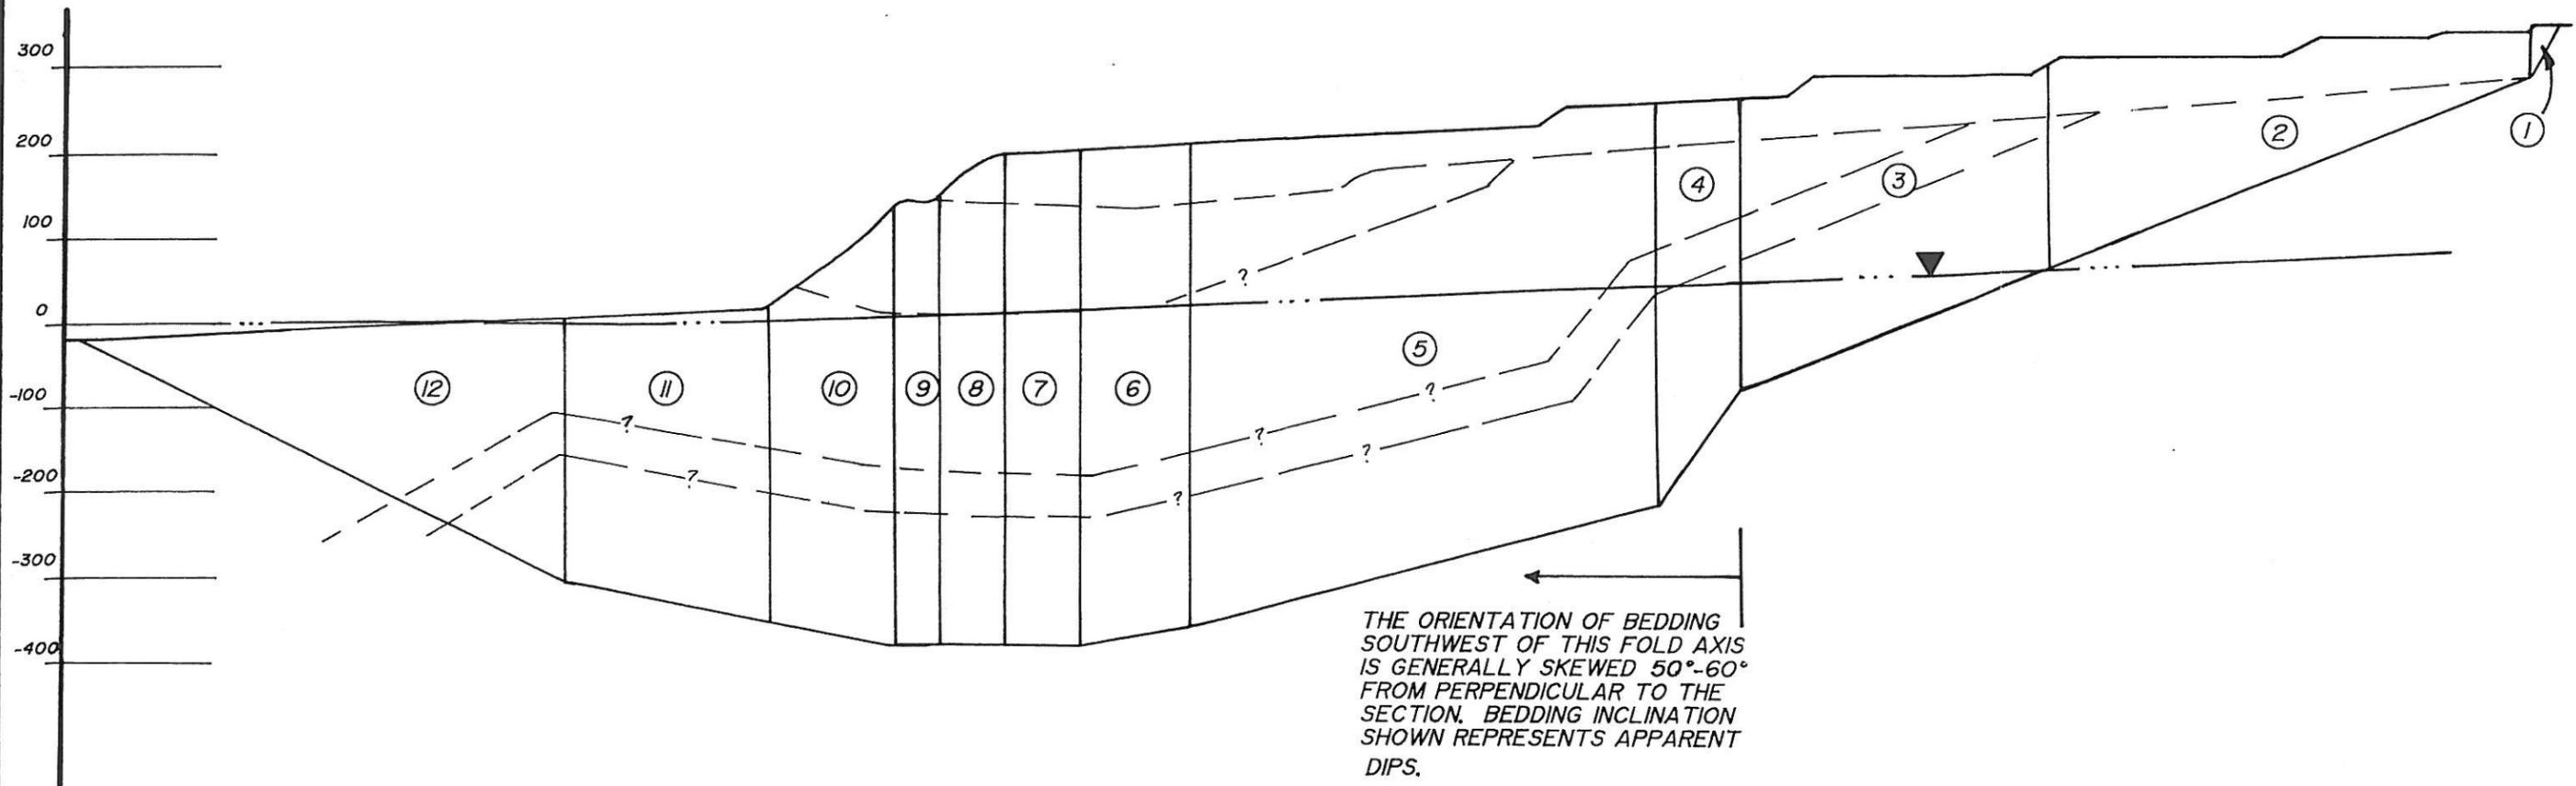
GROSS STABILITY SECTION I-I'

F.S. BY ORDINARY SLICES SUM (Fr)/SUM (Fd) = 1.77
 F.S. BY MODIFIED BISHOP SUM (Fb/Ma)/SUM (Fd) = 2.15

SCALE 1" ≈ 200'

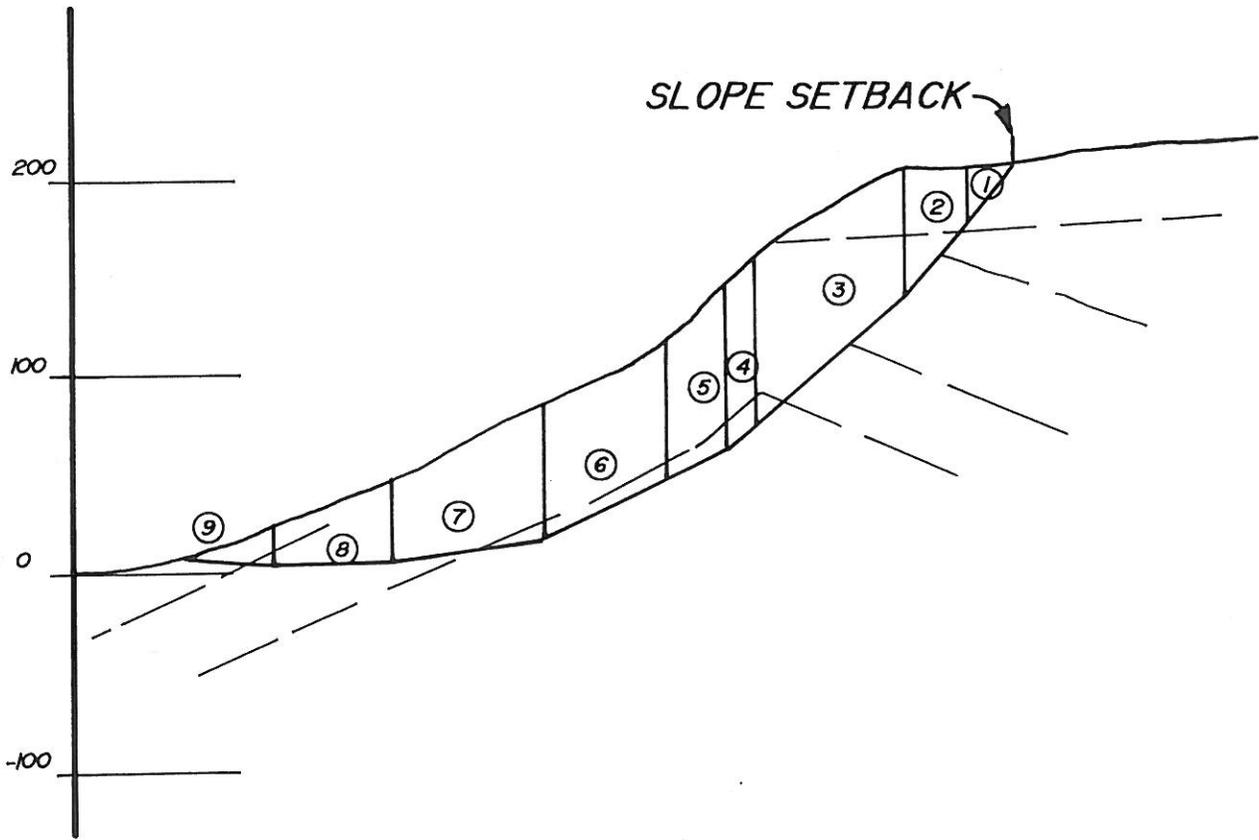
**BLUFF SLOPE STABILITY
SECTION J-J'**

2053.5 1377.2

F.S. BY ORDINARY SLICES SUM (Fr)/SUM (Fd) = 1.49
F.S. BY MODIFIED BISHOP SUM (Fb/Ma)/SUM (Fd) = 1.49

SCALE 1" ≈ 100'
S49W
