**CONSOLIDATED SEWER MAINTENANCE DISTRICT
CONDITION ASSESSMENT PROGRAM REPORT
PROJECT Y0TV0506F**

**CONDITION ASSESSMENT REPORT
COUNTY OF LOS ANGELES DEPARTMENT OF PUBLIC WORKS
CONSOLIDATED SEWER MAINTENANCE DISTRICT**

The Sewer Condition Assessment Program utilizes the Pipeline Assessment and Certification Program (PACP) Quick Rating methodology to rank the maintenance and structural ratings of your system based on industry standards.

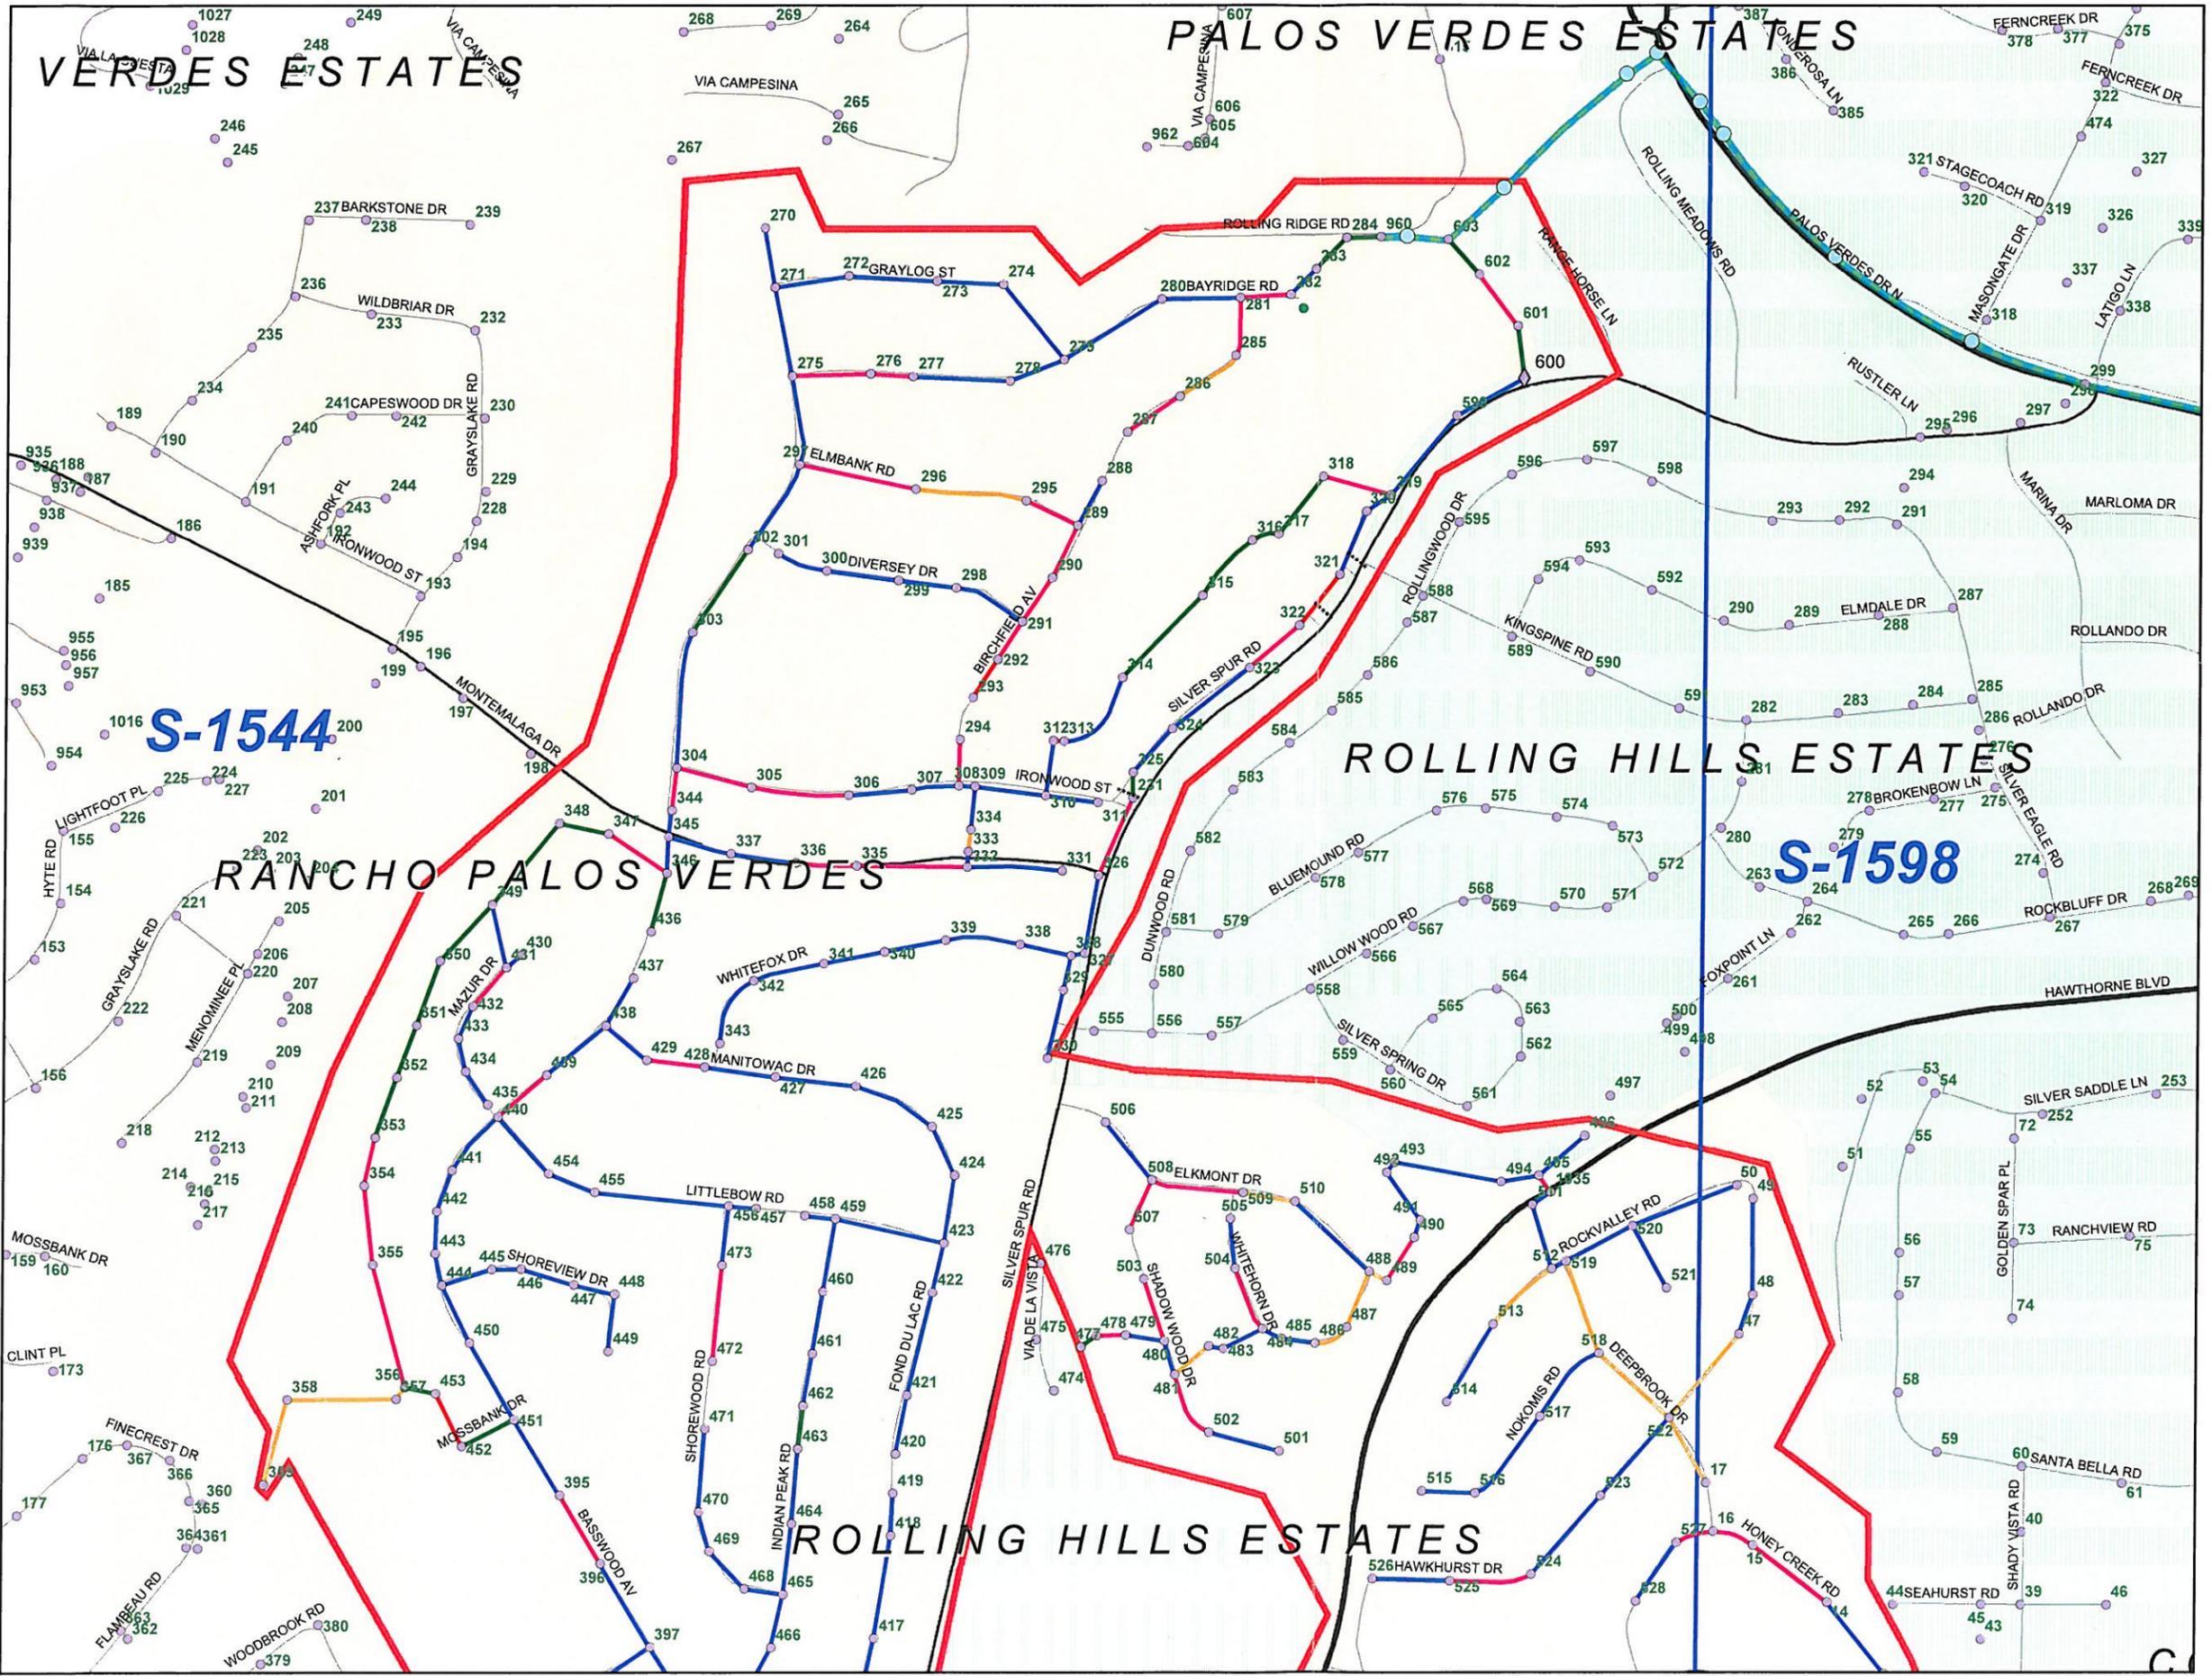
ENCLOSURE 2
CCTV PROJECT
YOTV0506F

Supervisorial District 4
 RANCHO PALOS VERDES

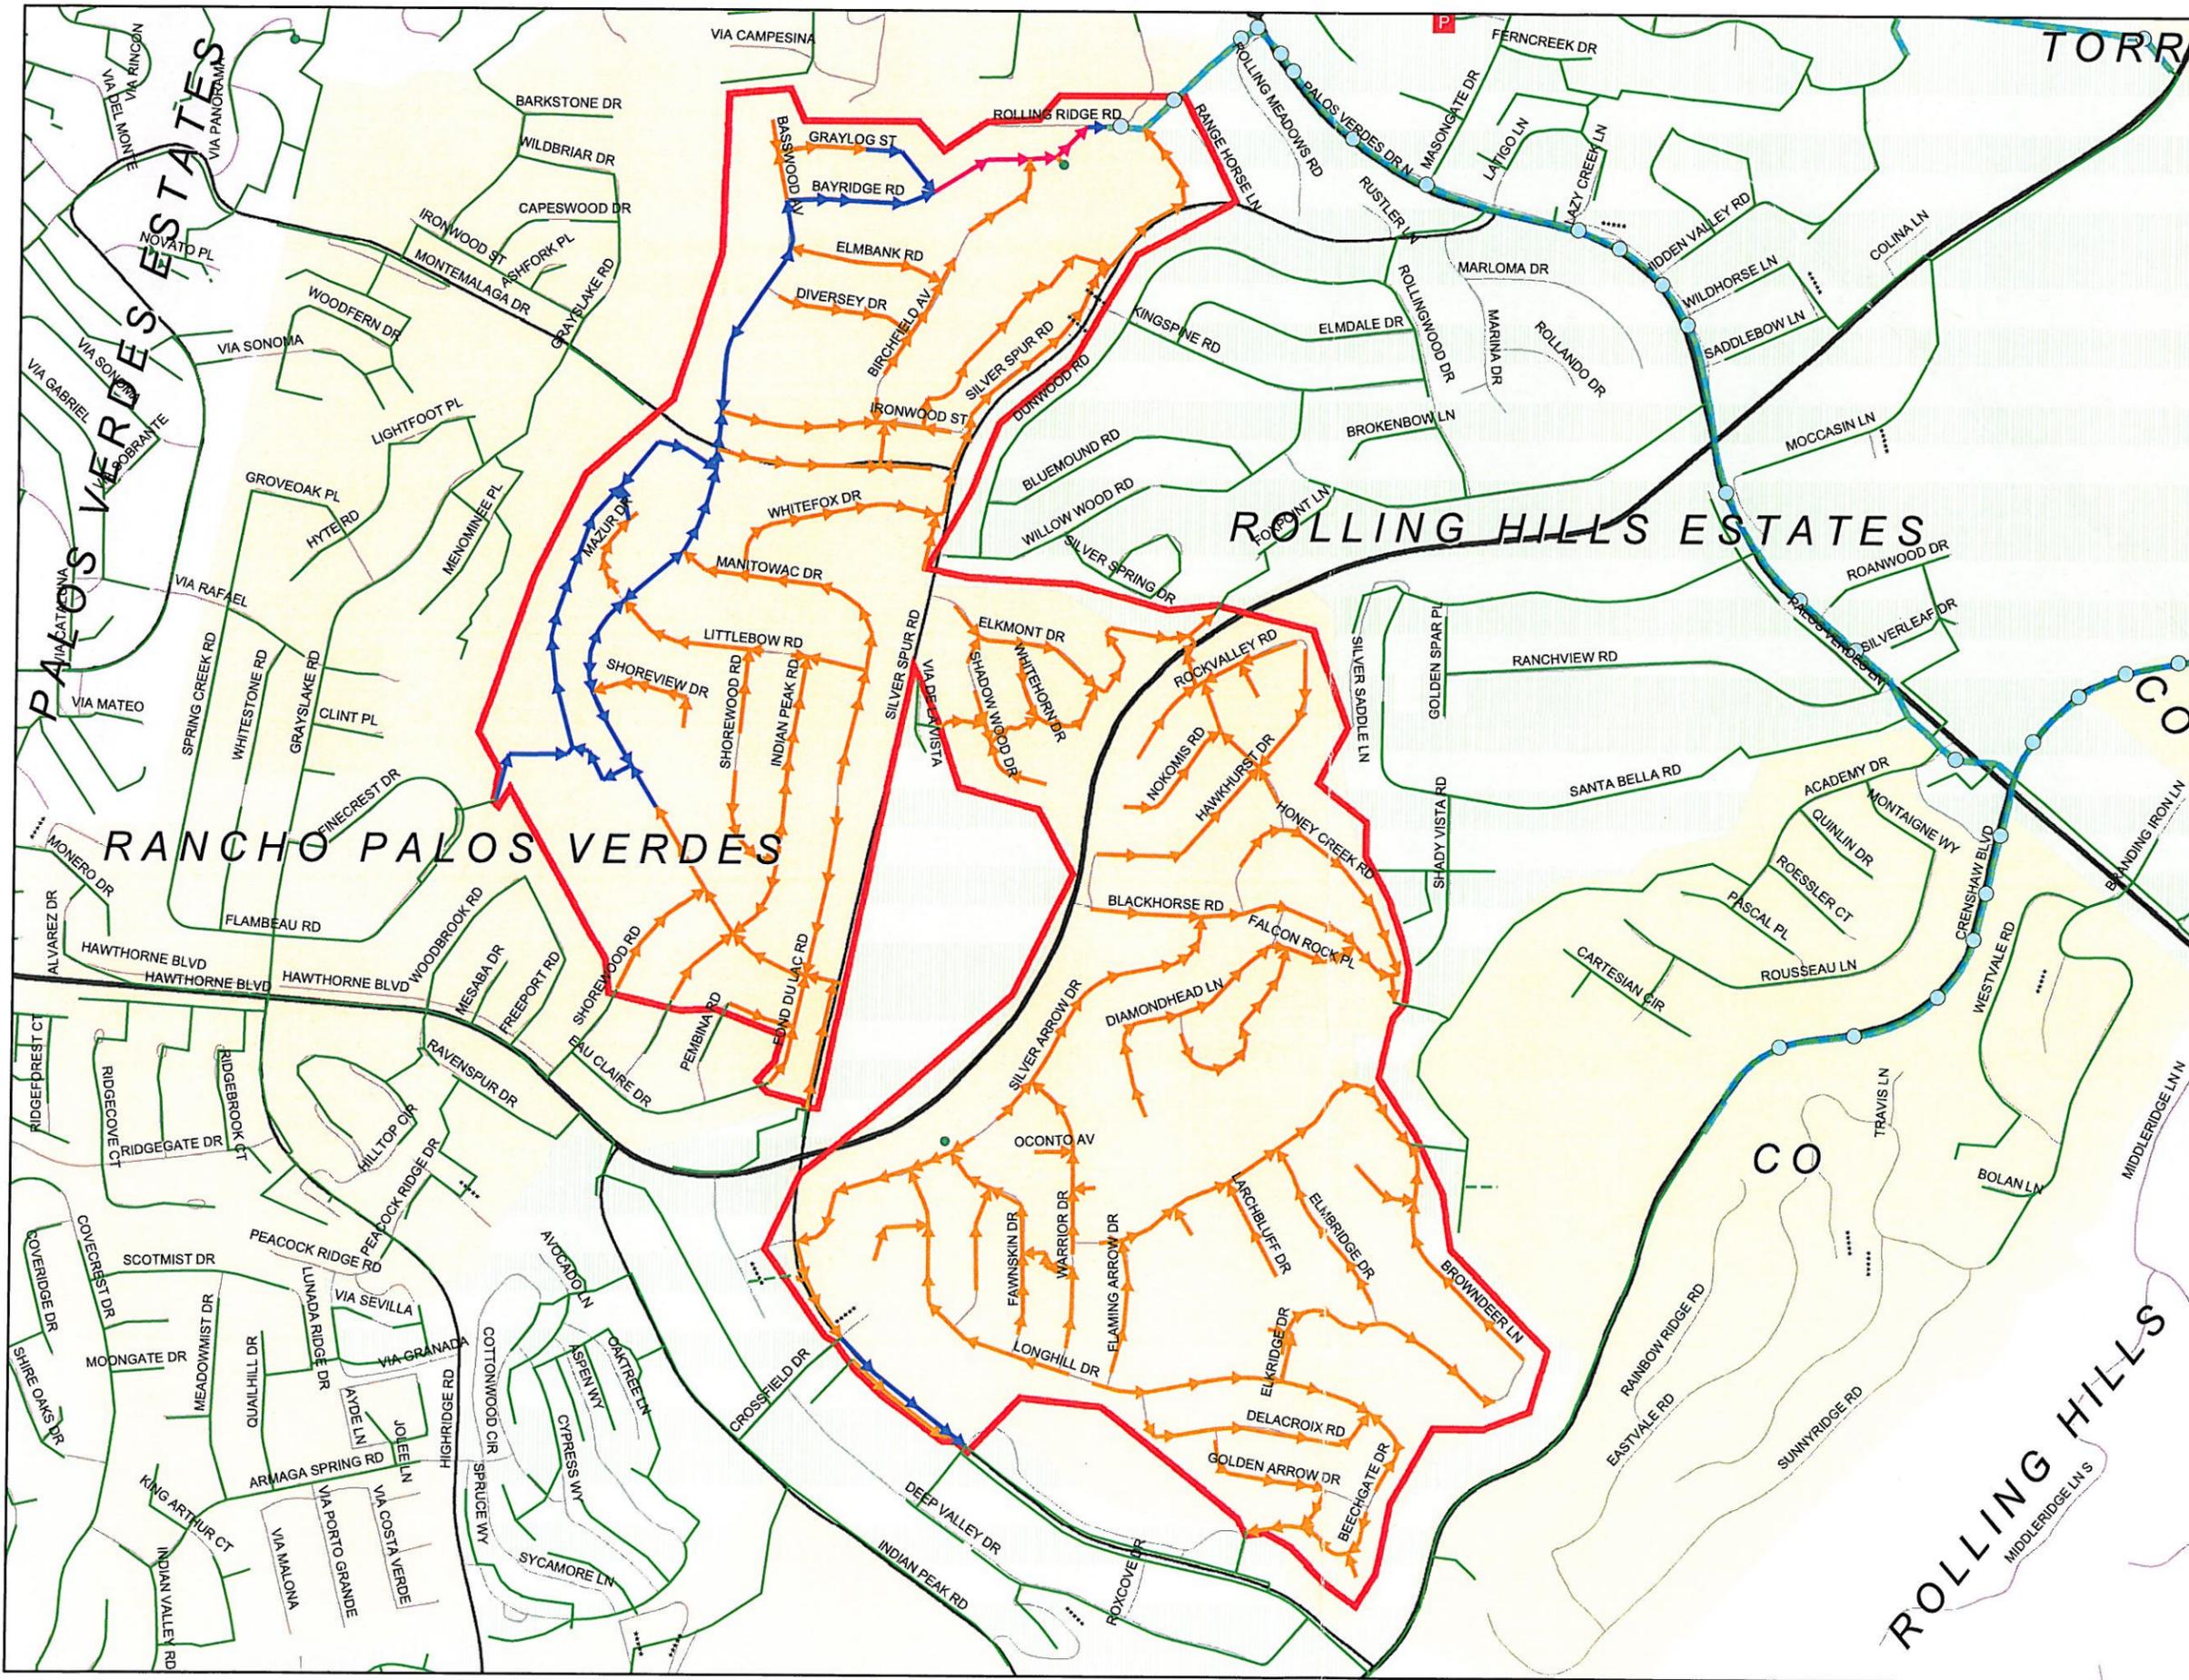
PROJECT OVERVIEW MAP

Project Overview Map

**CCTV PROJECT
YOTV0506F**

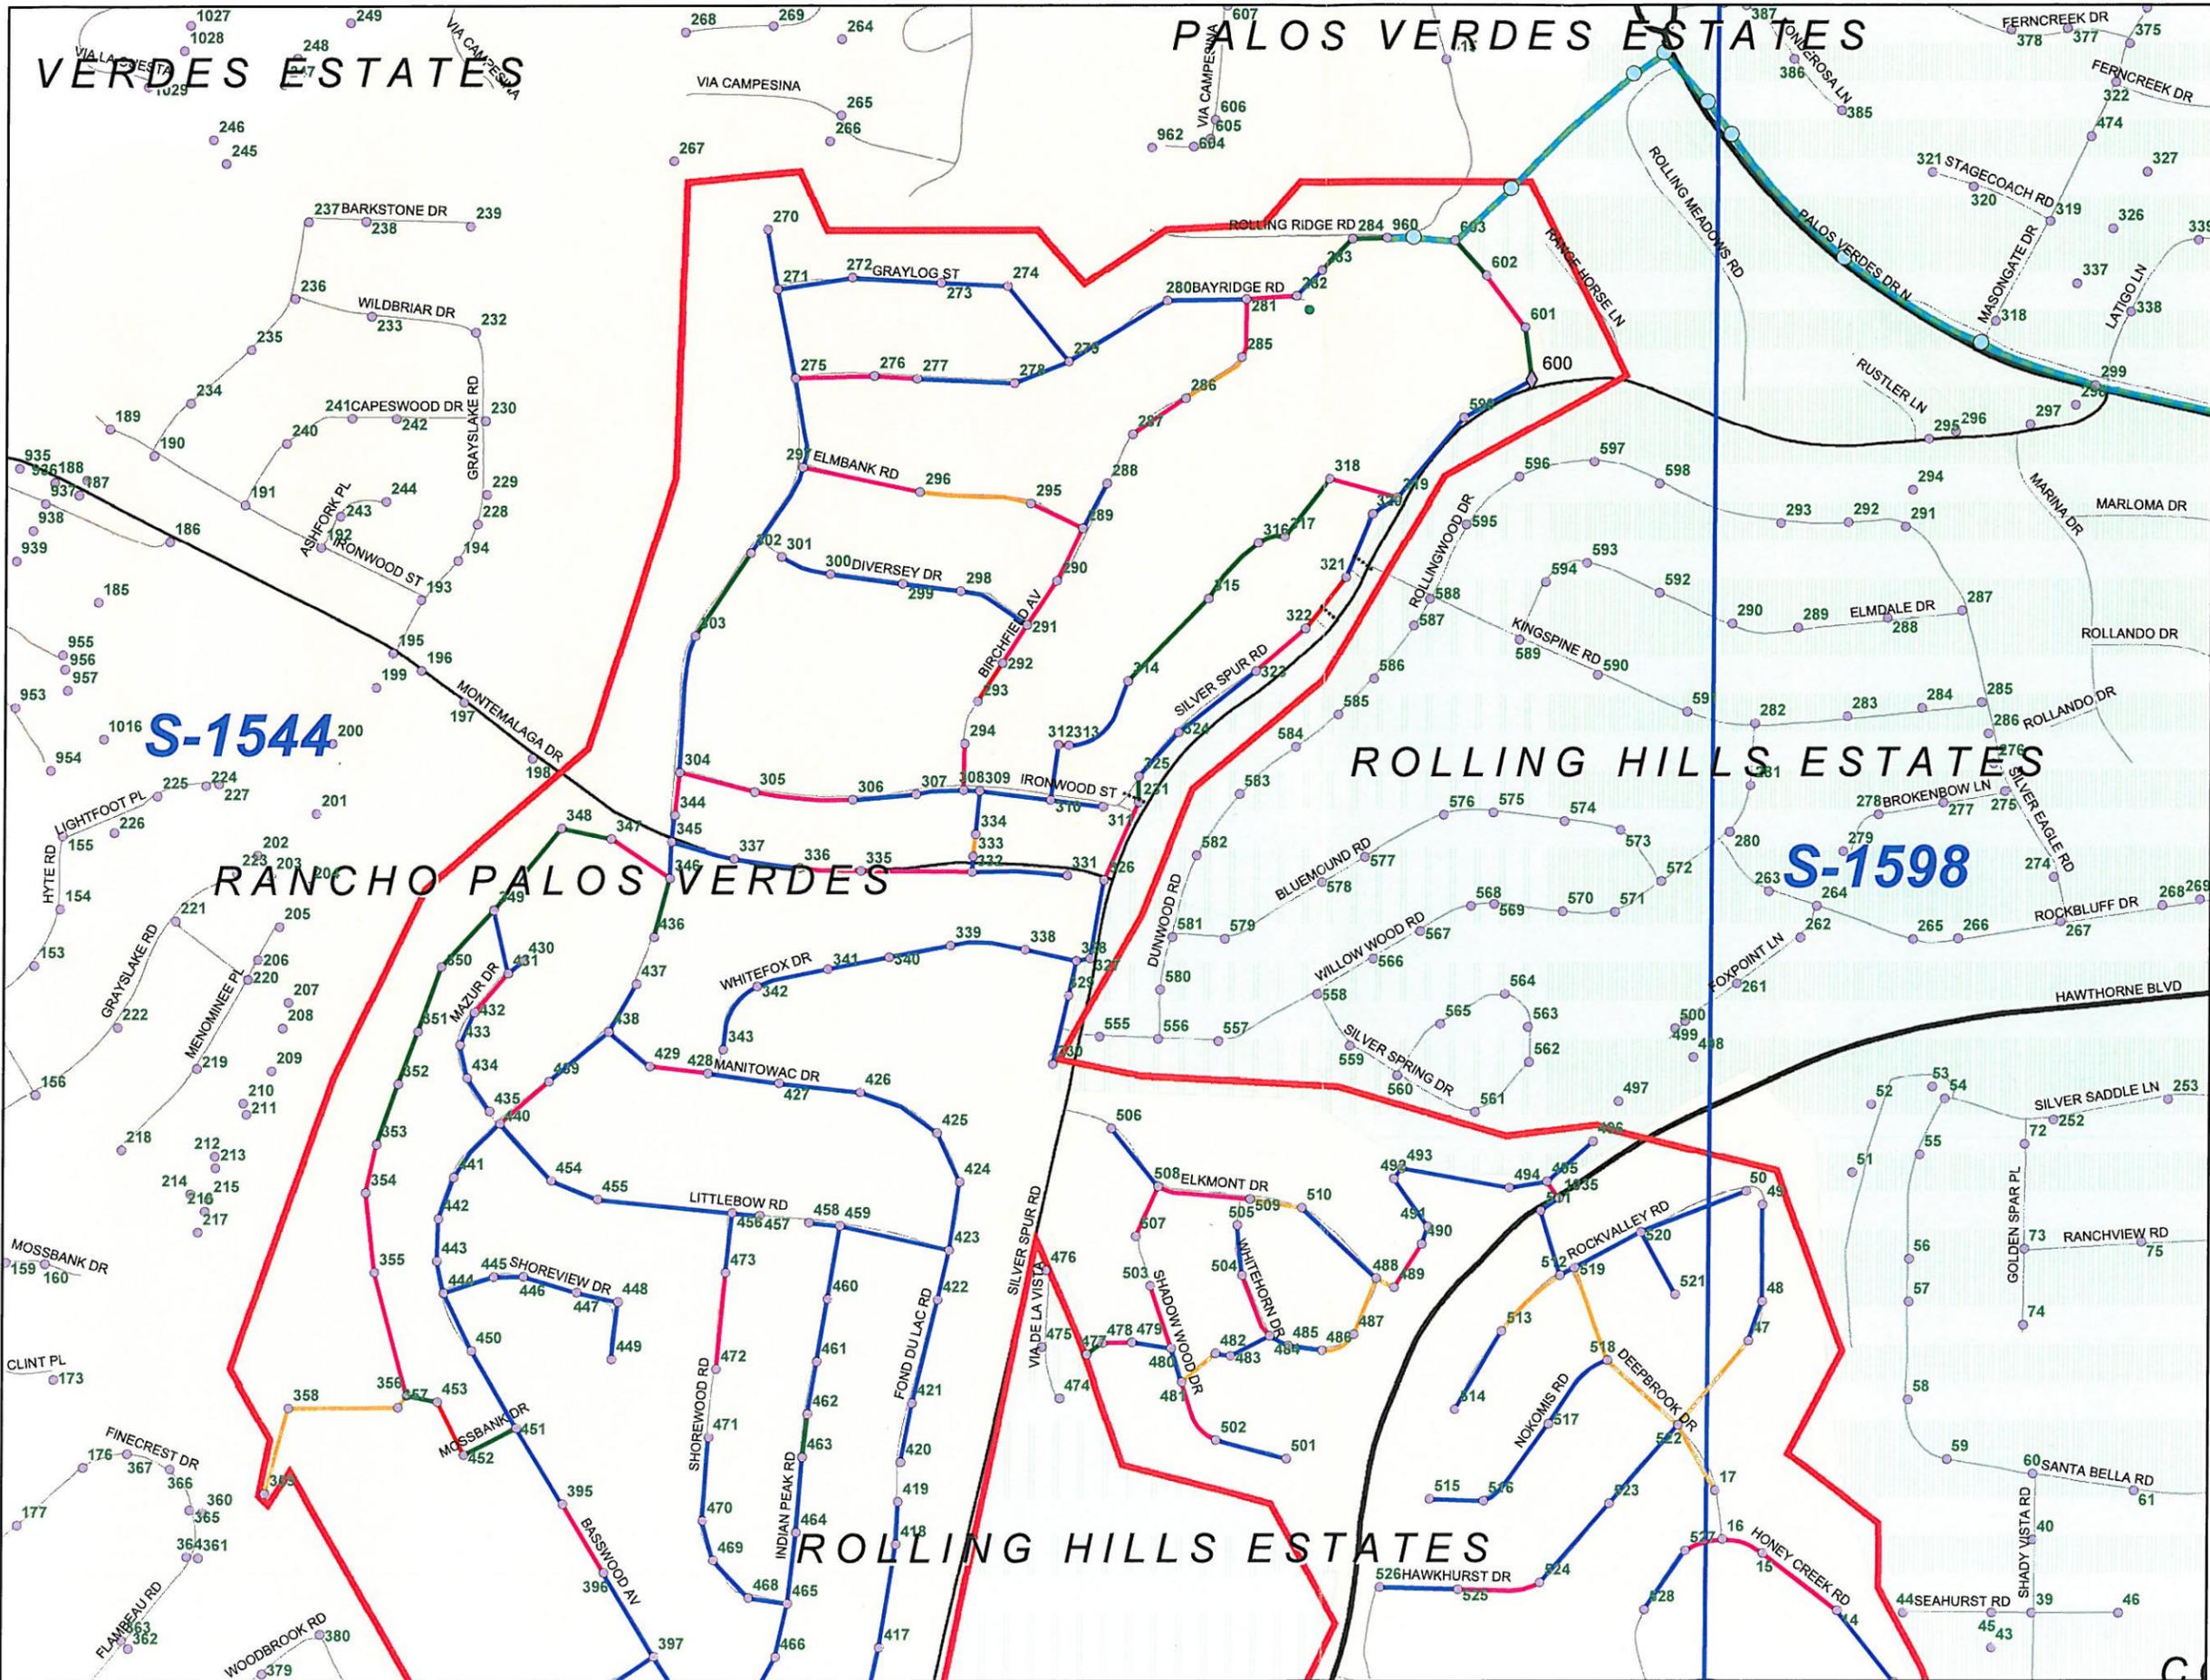
ENCLOSURE 2 CCTV PROJECT YOTV0506F

Supervisory District 4
RANCHO PALOS VERDES

Our inspection revealed that approximately 79.1 percent of the system televised was free of blockages or restrictions that would impede sewer flows. However, the remaining 20.9 percent of the inspected pipe segments within the City of Rancho Palos Verdes had a PACP maintenance grade of 4 or 5 as indicated in the Quick Maintenance Rating Table shown below. These segments have been incorporated into our routine cleaning schedule with corrective action taken as noted on the Quick Maintenance Rating Report Priority List (Enclosure 2). Also included is a color-coded map showing the quick maintenance rating for each pipe segment.

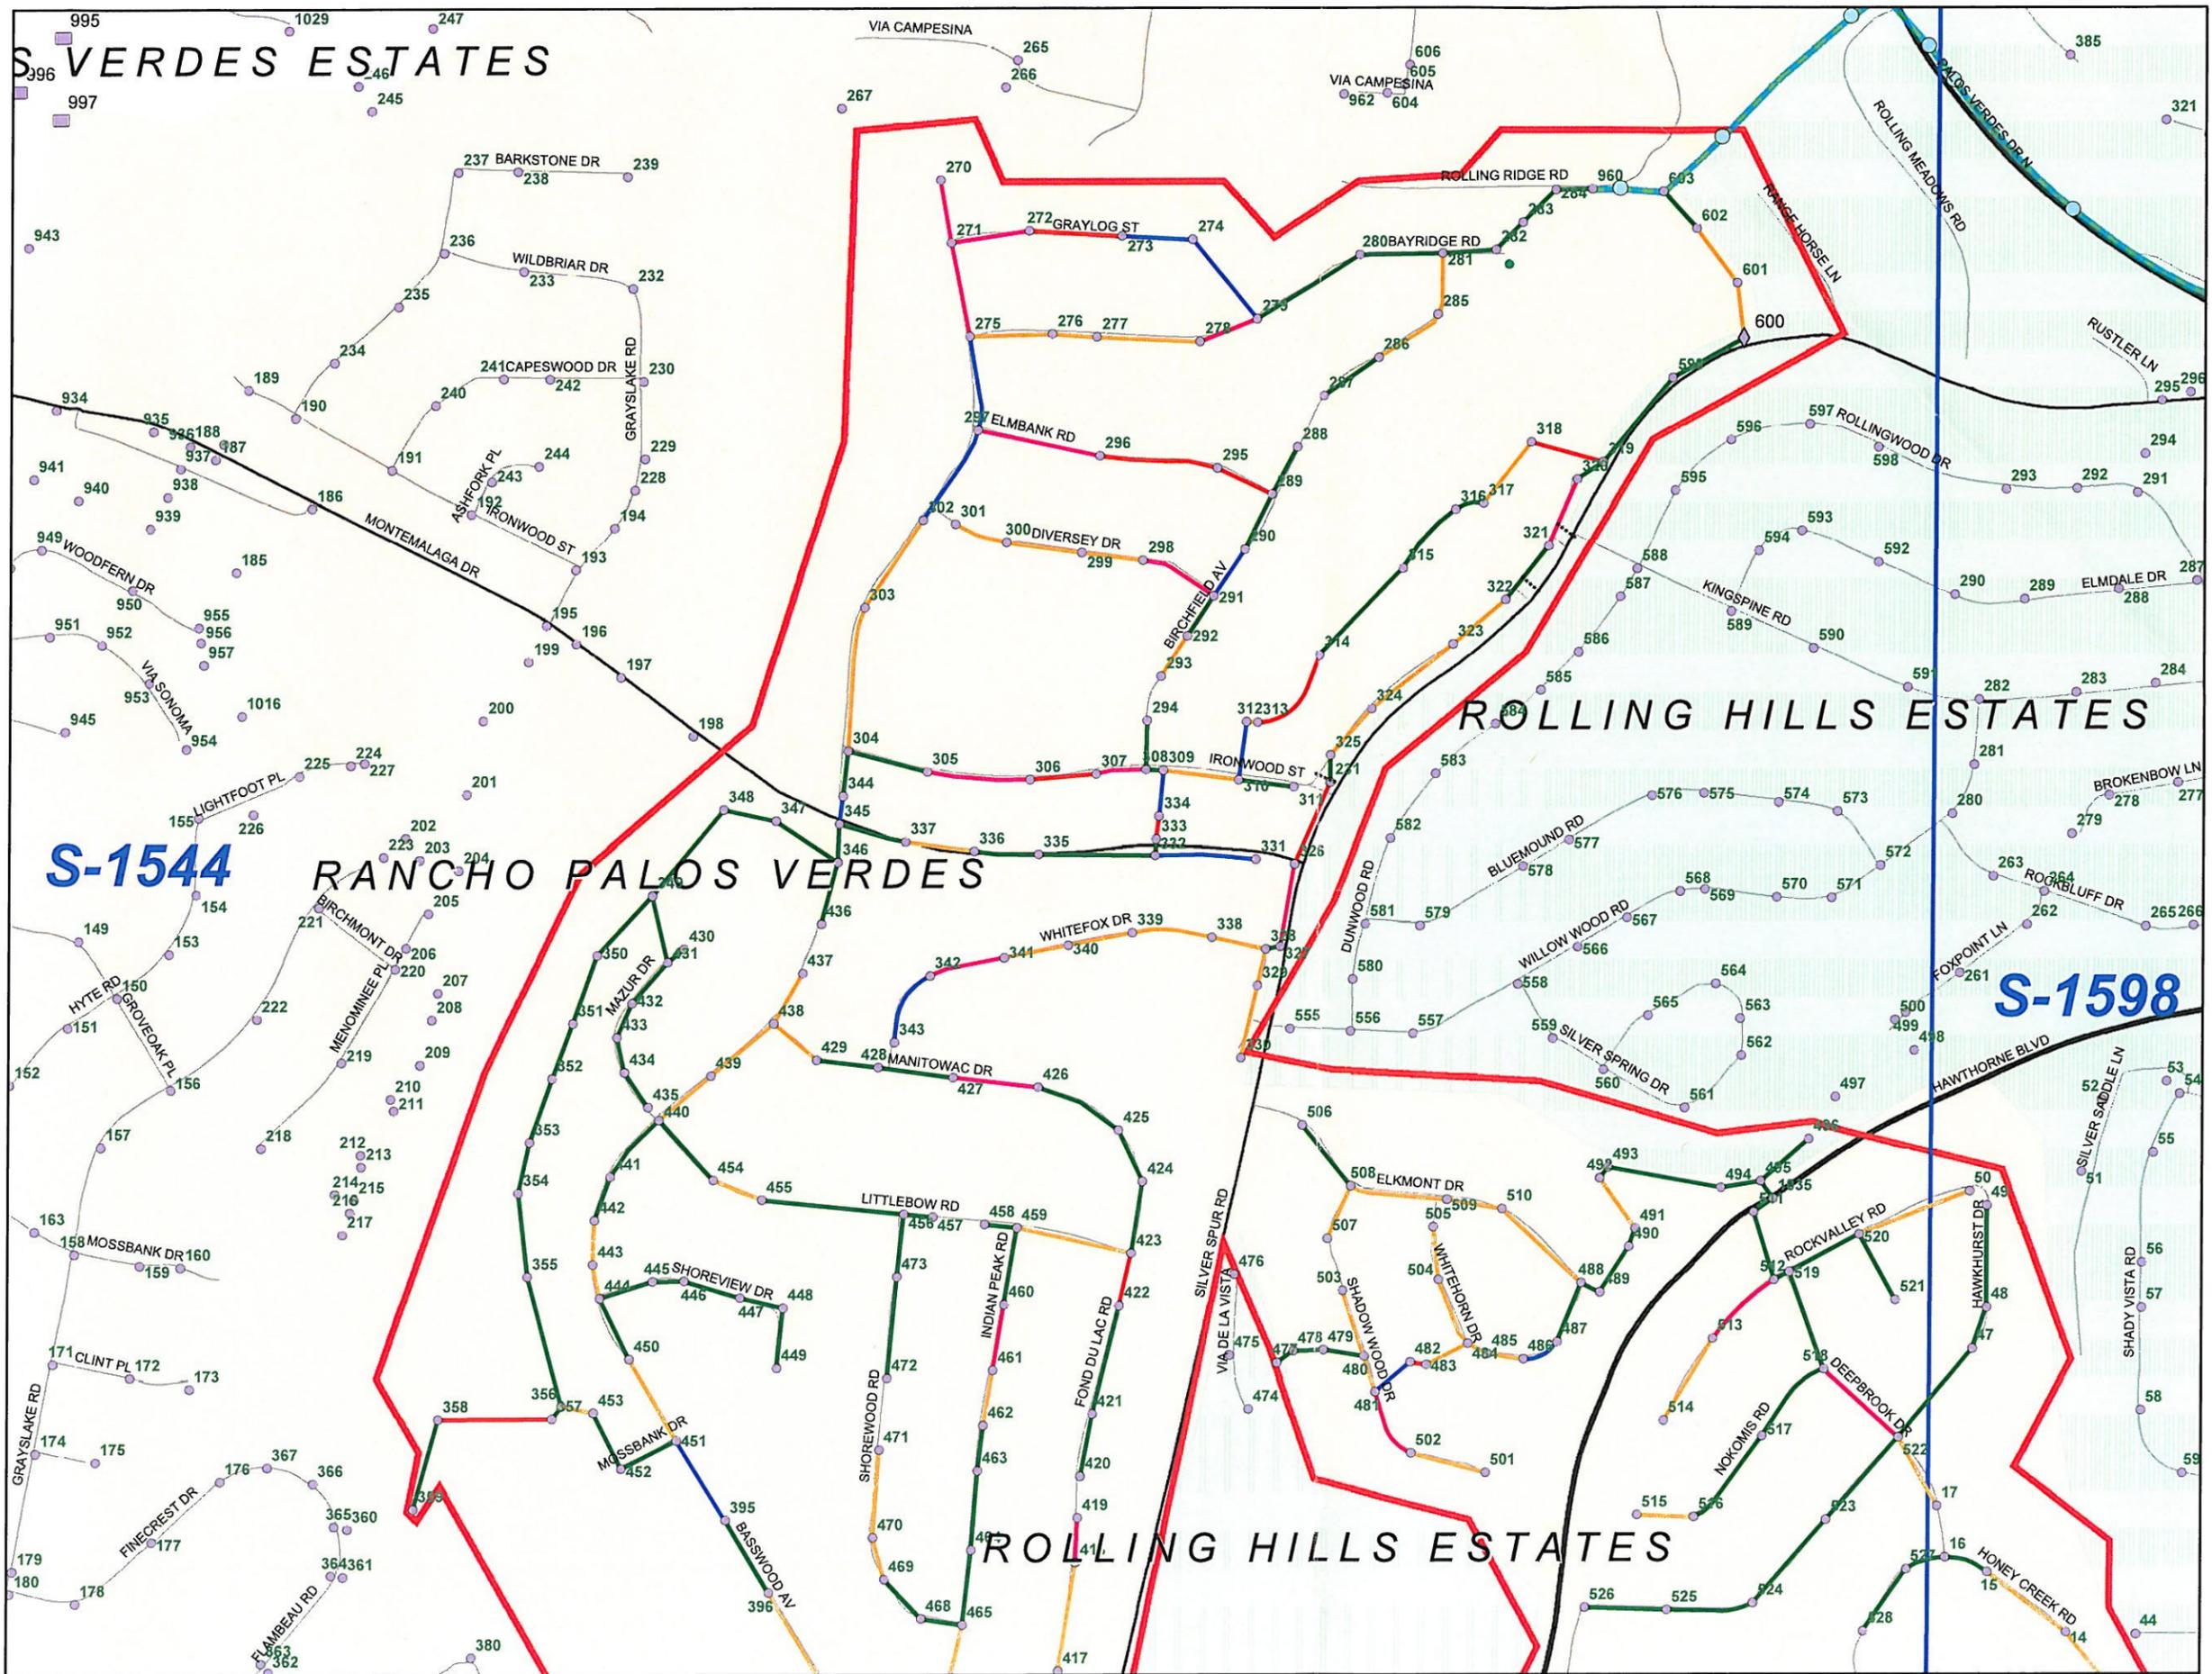
ENCLOSURE 3 CCTV PROJECT Y0TV0506F

Supervisorial District 4
RANCHO PALOS VERDES

Our inspection revealed that approximately 88.8 percent of the inspected pipe segments within the City of Rancho Palos Verdes were free of severe structural defects. However, the remaining 11.2 percent of the inspected pipe segments had a PACP structural grade of 4 or 5 as indicated in the Quick Structural Rating Table shown below. These segments have been placed on a priority list based on the severity and the need for action. For Items 1 through 42 in the Quick Structural Rating Report Priority List (Enclosure 3) which require a corrective action, the proposed corrective method will be scheduled in the next 24 months as part of the ongoing Accumulative Capital Outlay Project. A color-coded map showing the Quick Structural Rating for each pipe segment is located in Enclosure 3. Copies of the actual inspection reports for these 42 segments are included in Enclosure 4.

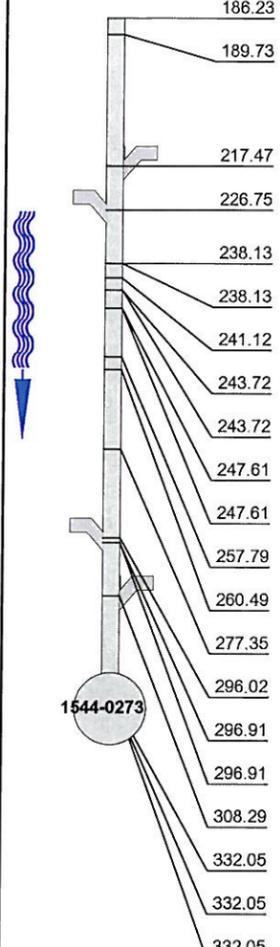
296.91	Roots Fine Joint, at 03 o'clock, within 8 inch: YES	00:19:34		
	308.29	Tap Factory Made Active, at 10 o'clock, 6", within 8 inch: YES, Remark: ROOTS	00:20:03	137a

332.05	General Observation, Remark: End of Segment	00:21:23		
	332.05	General Observation, Remark: Materials found- VCP	00:21:26		
	332.05	Manhole	00:21:39

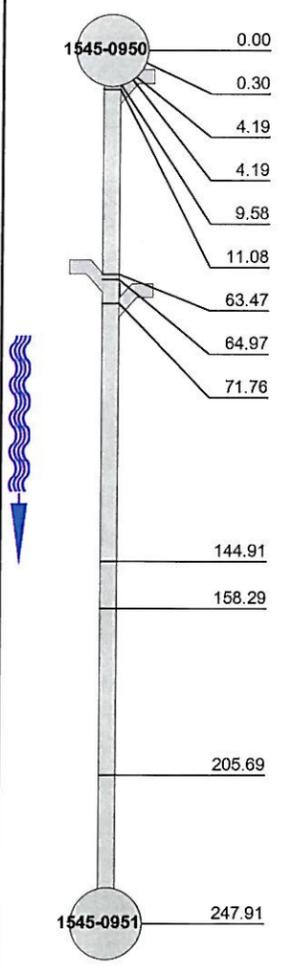
144.91	Roots Fine Joint, from 03 to 05 o'clock, within 8 inch: YES	00:07:10		
	158.29	Crack Spiral, from 09 to 12 o'clock, within 8 inch: YES	00:07:58	1258a

205.69	Crack Spiral, from 09 to 11 o'clock, within 8 inch: YES	00:09:27		
	247.91	Manhole, Remark: End of Segment Material found-VCP	00:11:22

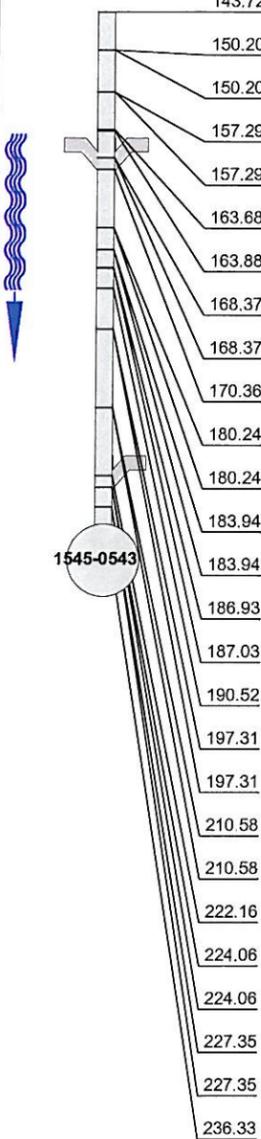
<u>180.24</u>	Crack Multiple, from 08 to 04 o'clock, within 8 inch: YES, Remark: Roots	00:18:05	2470a	
	<u>180.24</u>	Roots Fine Joint, from 08 to 04 o'clock, within 8 inch: YES	00:18:10		
	<u>183.94</u>	Crack Spiral, from 07 to 11 o'clock, within 8 inch: YES, Remark: Roots	00:18:27	2472a	
	<u>183.94</u>	Roots Fine Joint, from 07 to 10 o'clock, within 8 inch: YES	00:18:44		
	<u>186.93</u>	Crack Multiple, from 08 to 11 o'clock, within 8 inch: YES, Remark: Roots	00:19:00	2474a	
	<u>187.03</u>	Roots Fine Joint, from 08 to 04 o'clock, within 8 inch: YES	00:19:14		
	<u>190.52</u>	Crack Multiple, from 07 to 11 o'clock, within 8 inch: YES	00:19:30	2476a	
	<u>197.31</u>	Crack Multiple, from 09 to 03 o'clock, within 8 inch: YES, Remark: Roots	00:20:03	2477a	
	<u>197.31</u>	Roots Fine Joint, from 08 to 04 o'clock, within 8 inch: YES	00:20:10		
	<u>210.58</u>	Crack Multiple, from 08 to 04 o'clock, within 8 inch: YES, Remark: Roots	00:20:41

<u>210.58</u>	Roots Fine Joint, from 08 to 04 o'clock, within 8 inch: YES	00:20:46		
	<u>222.16</u>	Tap Factory Made Active, at 10 o'clock, 4", within 8 inch: YES	00:21:11		
	<u>224.06</u>	Crack Multiple, from 08 to 04 o'clock, within 8 inch: YES, Remark: Roots	00:21:25	2482a	
	<u>224.06</u>	Roots Fine Joint, from 10 to 02 o'clock, within 8 inch: YES	00:21:46		
	<u>227.35</u>	Crack Multiple, from 01 to 09 o'clock, within 8 inch: YES, Remark: Roots	00:22:24	2484a	
	<u>227.35</u>	Roots Fine Joint, from 10 to 02 o'clock, within 8 inch: YES	00:22:30		
	<u>236.33</u>	Manhole, Remark: End of Segment Material found-VCP	00:23:23
