3 OCEAN SOUTH SOUTH

3.1 Watershed Hydrology Analysis

Michael Baker
INTERNATIONAL
**Storm Water
Recommended
Improvements**

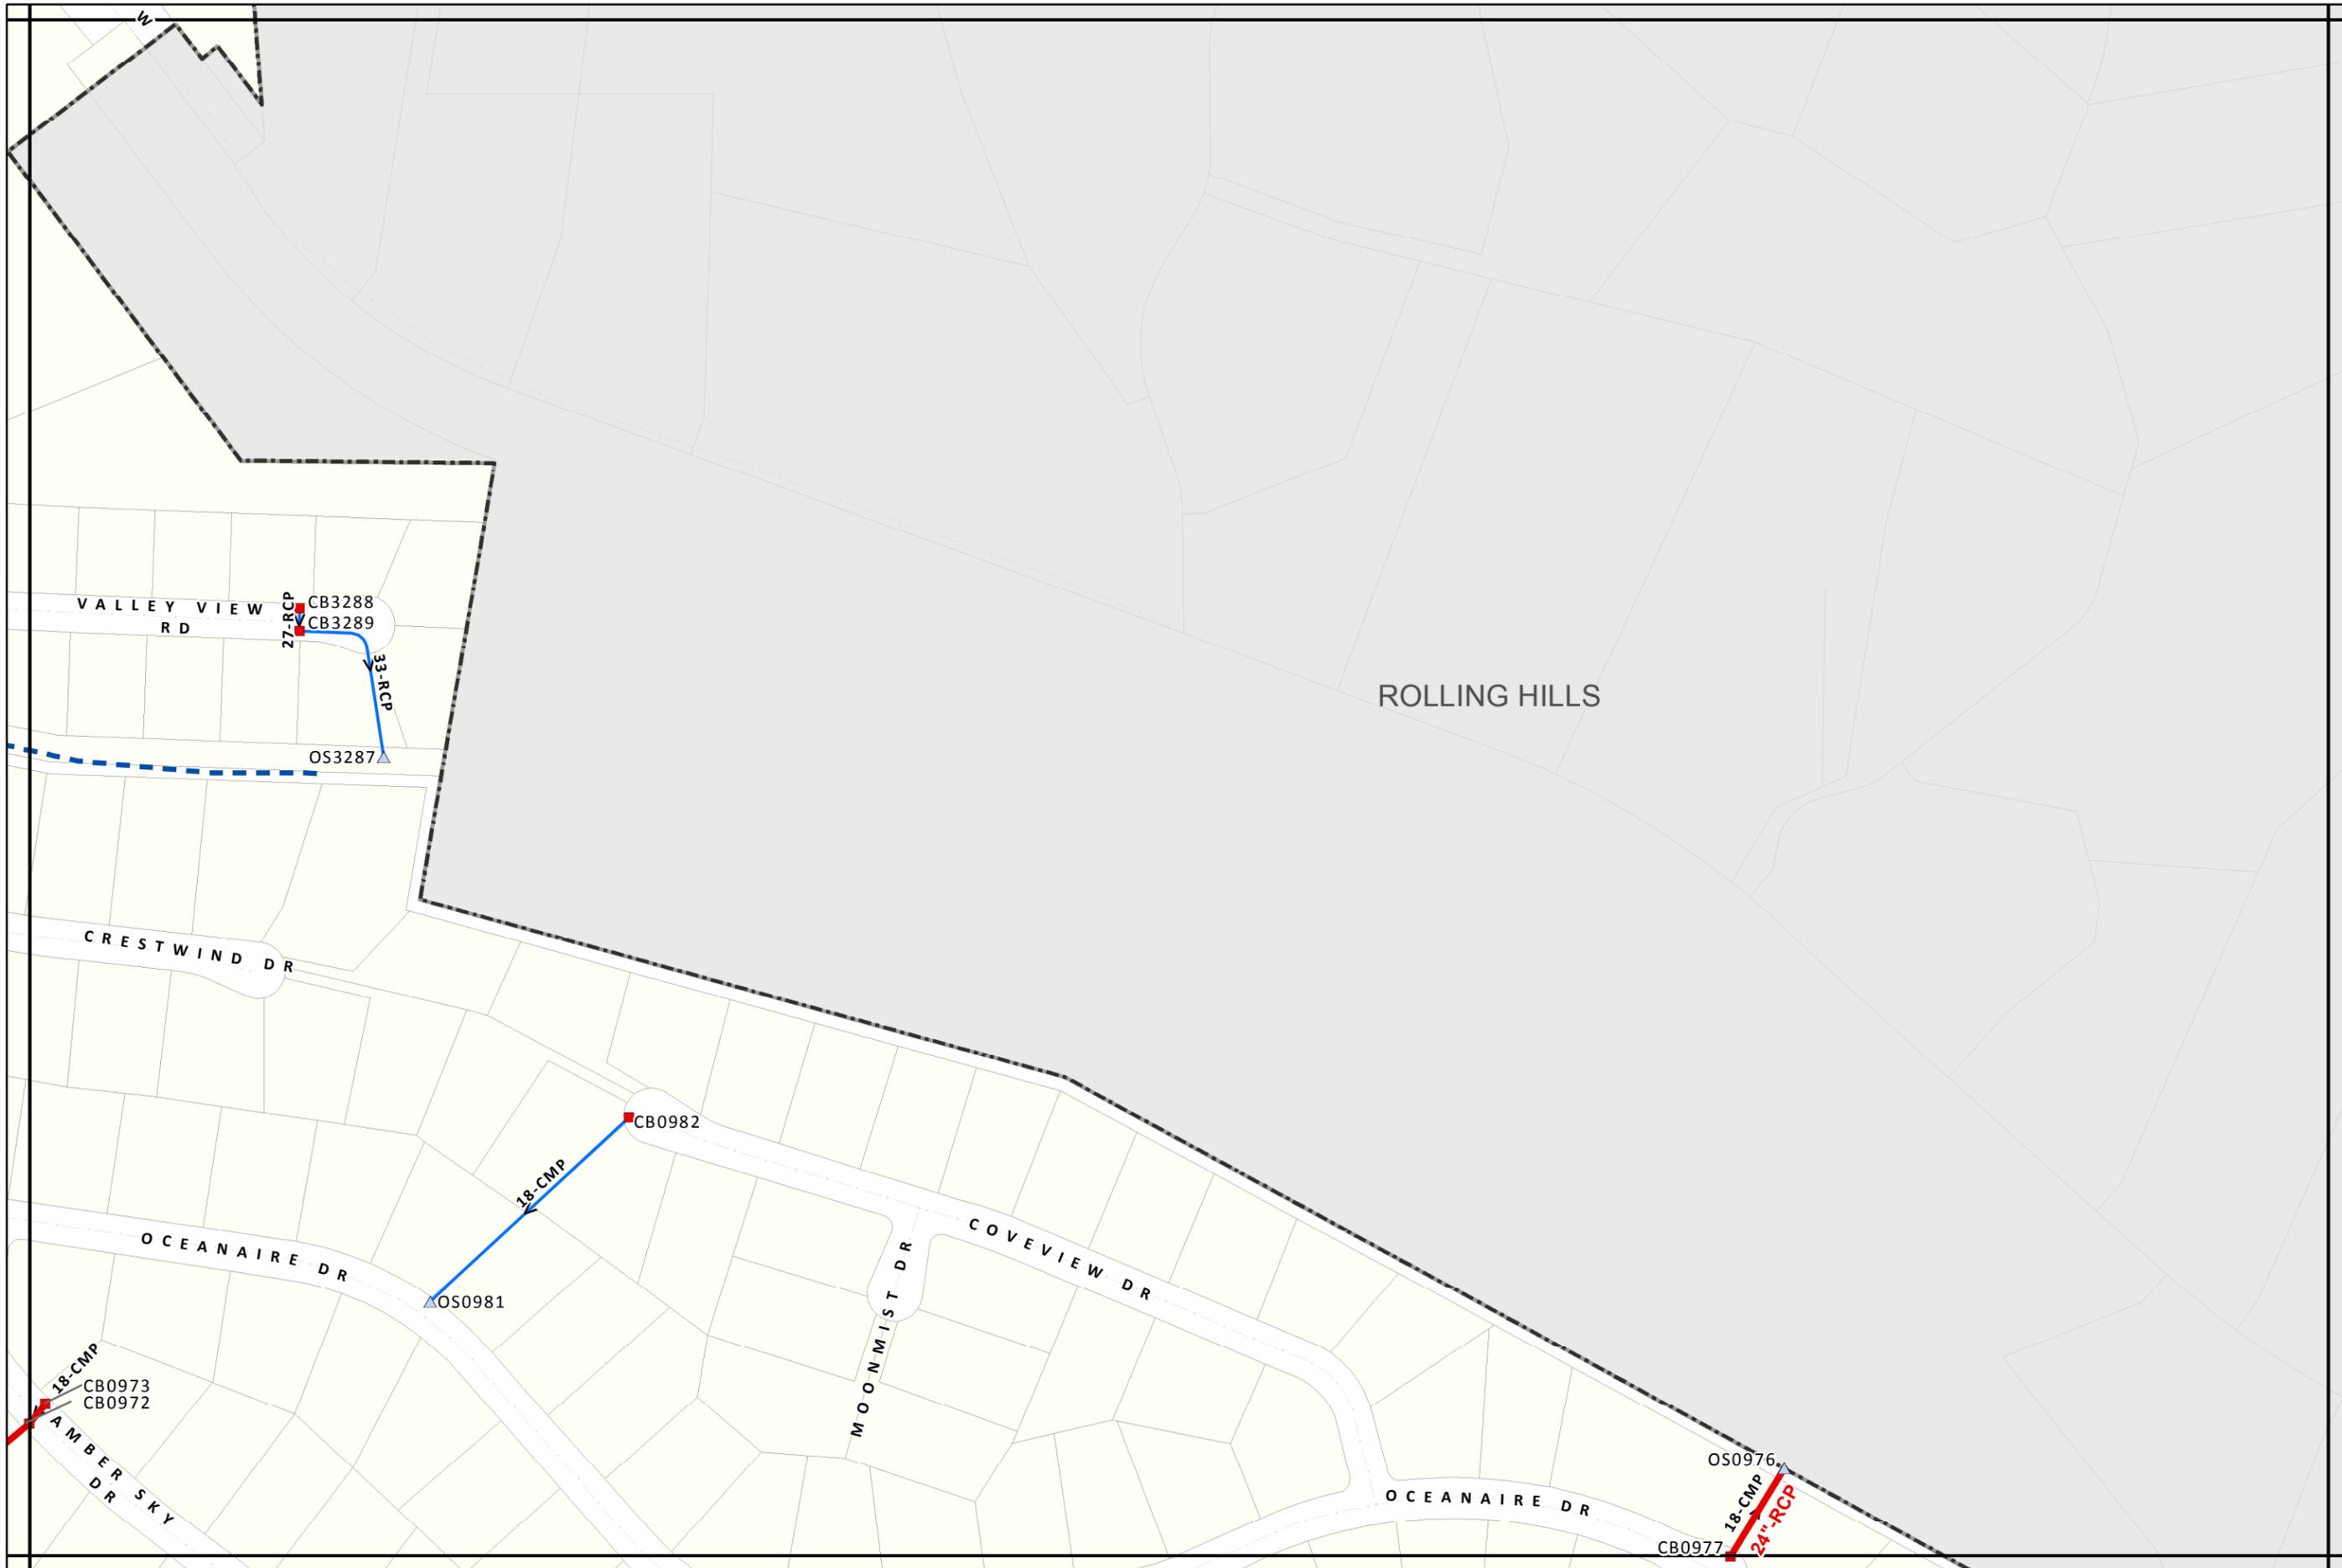
13A	13B	14A
13C	13D	14C
18A	18B	17A

**Storm Water
Recommended
Improvements**

Table 3-6: OSS Total Cost Estimate	
Atlas Map	Total Project Cost
13C	\$90,000
13D	\$68,000
24C	\$1,155,000
Total	\$1,313,000

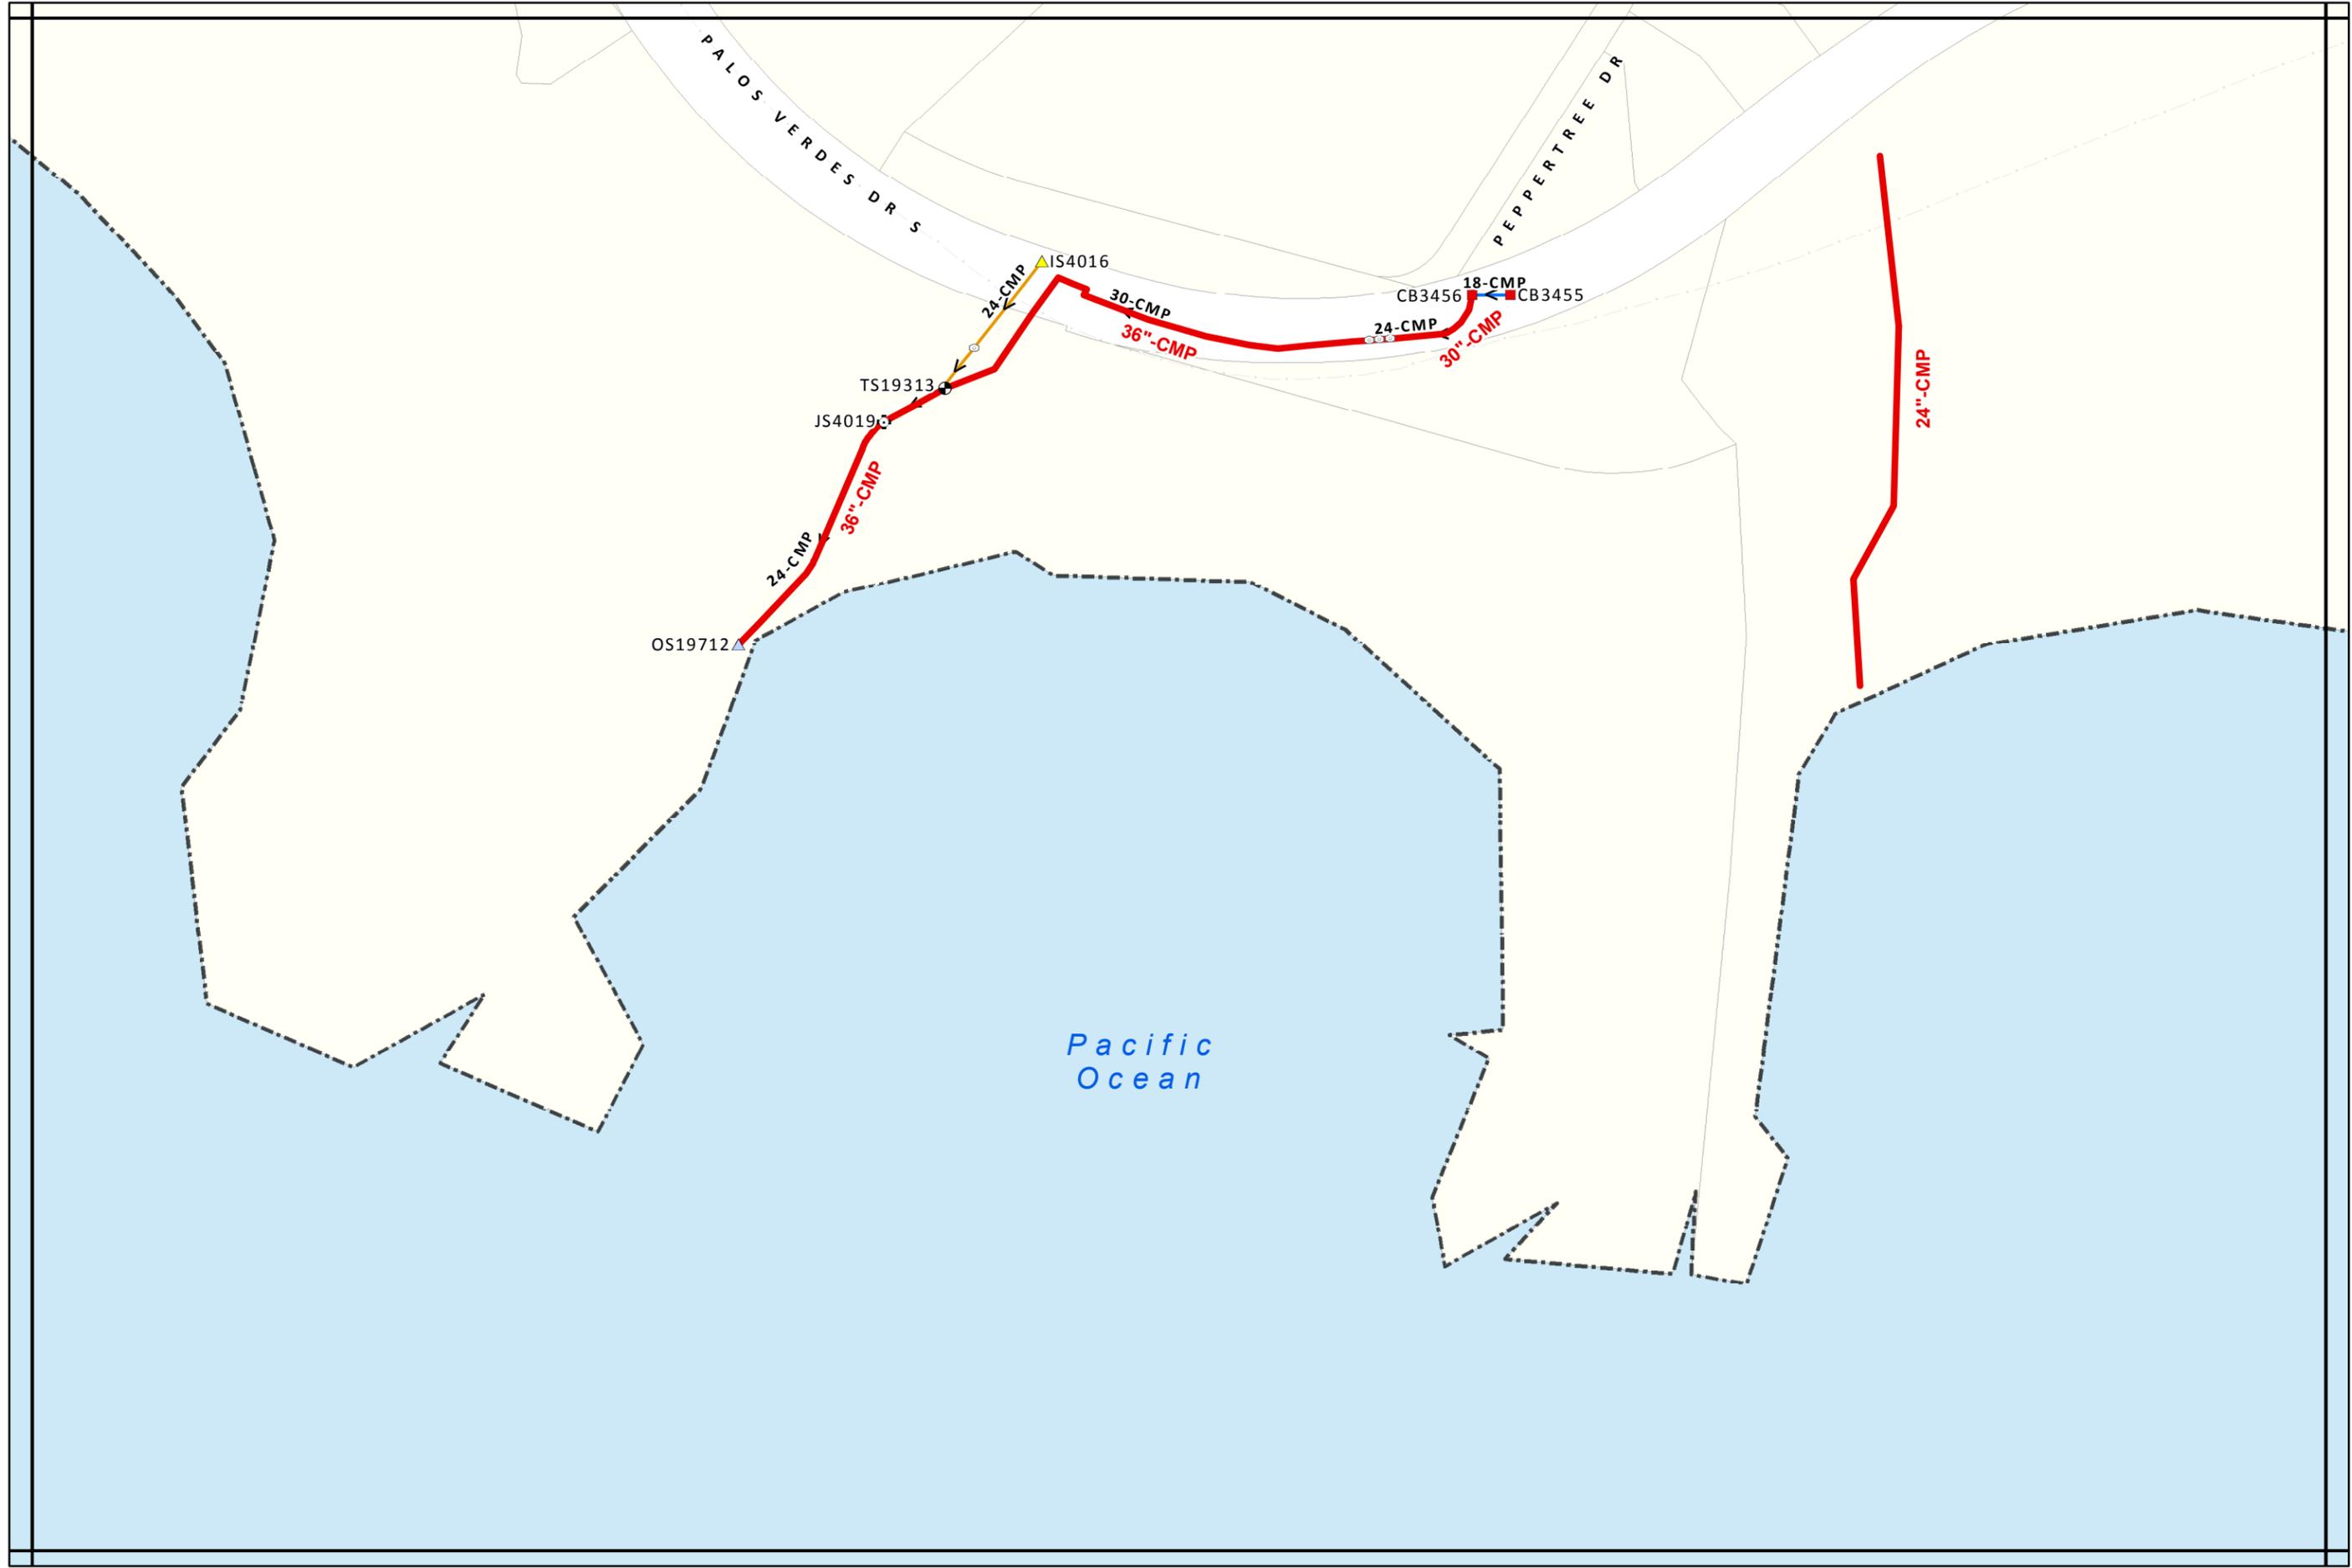
23B	24A	24B
23D	24C	24D
	29A	29B

**Storm Water
Recommended
Improvements**
