City of Rancho Palos Verdes
Rancho Palos Verdes ADA Assessment
Facility Report with Photos

Facility ID: # 04 - Del Cerro Park

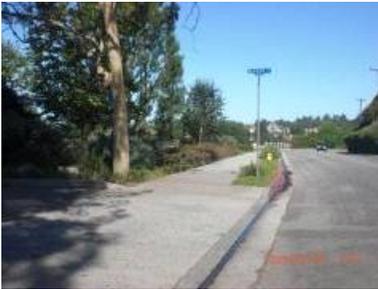
Location: Entry to Park
Photo # 1

Field Condition	
30.02 - On-site Accessible Route of Travel - There is no accessible route within the property line of the site linking accessible site elements with site arrival points serving the following, if provided: public transportation stops, accessible parking, passenger loading zones, and public sidewalks.	1991 ADAAG 4.1.2(1)
Existing Condition:	2004 ADAAG 202.2.1; Advisory 206.2.1
	2007 CBC 1114B.1.2; 1127B.1
	Other -

Corrective Action
001A - Accessible Route - Provide new accessible route.
Additional Comments:

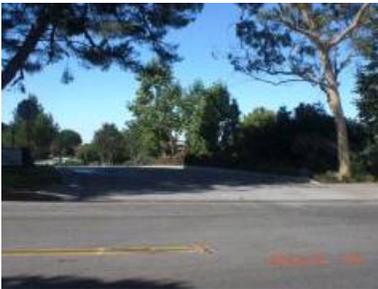
Location: Parking Lot
Photo # 2

Field Condition	
01.19B - Tow-away Sign - A California tow-away sign is not posted in a conspicuous place at each entrance to off-street parking lot, or immediately adjacent to and visible from each accessible stall.	1991 ADAAG -
Existing Condition: None provided.	2004 ADAAG -
	2007 CBC 1129B.4
	Other

Corrective Action
392 - Tow-away Sign - Provide pole-mounted California tow-away sign at a height of 80" above finish grade to bottom of sign.
Additional Comments:

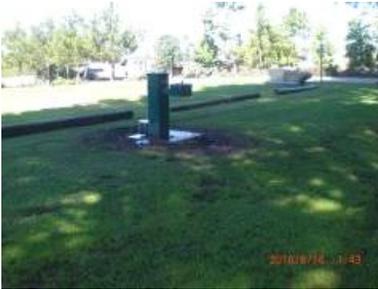
Location: North of Park
 Photo # 3

Field Condition		
05.03 - Accessible Route - The accessible drinking fountain is not located on an accessible route.	1991 ADAAG	4.1.3(10)(b)
Existing Condition:	2004 ADAAG	206.2.4
	2007 CBC	1115B.4.6 item 1
	Other	-

Corrective Action
001A - Accessible Route - Provide new accessible route.
Additional Comments: Provide accessible route to drinking fountain.

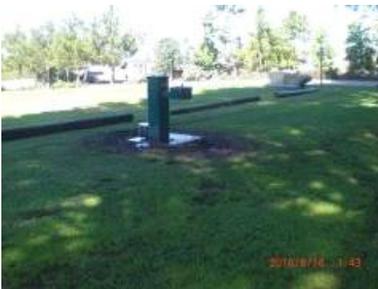
Location: North of Park
 Photo # 3

Field Condition		
05.05B - Knee Space Width - Drinking fountain provides less than 30" wide accessible knee clearance between the bottom of the apron and the floor.	1991 ADAAG	4.15.5(1); Figs. 27(a) and (b)
Existing Condition: Drinking fountain protrudes 17 1/4" at 27 1/2" high.	2004 ADAAG	306.3; Figs. 306.3
	2007 CBC	1115B.4.6 item 2
	Other	-

Corrective Action
289 - Drinking Fountain - Miscellaneous - See Additional Comments
Additional Comments: See Keynote 5 for corrective action.

Corrective Action	
275D - Double Hi-Low Drinking Fountain - Provide new hi-low drinking fountain. Additional Comments:

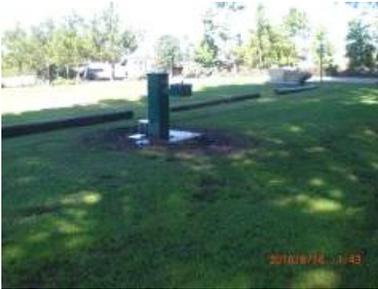
Location: North of Park Photo # 3

Field Condition	
05.04 - Depth - Drinking fountain is not 18" min.. to 19" max.. in depth. Existing Condition: 17 1/4" deep.	1991 ADAAG 4.15.5(1); Figs. 27(a) and (b) 2004 ADAAG - 2007 CBC 1115B.4.6 item 2 Other -

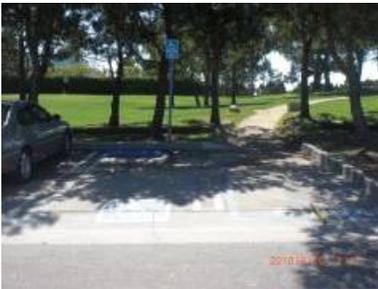
Location: Parking Lot Photo # 6

Field Condition	
01.04 - Van Accessible Spaces - Lot does not provides the required number of designated "van accessible" parking spaces (one in every eight accessible parking spaces; one in every six per 2004 ADAAG). Existing Condition: 17 parking spaces provided, 1 accessible (stall 8'-6" by 18', aisle 7'-1" by 18').	1991 ADAAG 4.1.2(5)(b); 4.6.4 2004 ADAAG 208.2.4 2007 CBC 1129B.3 item 2, 1129B.4 Other

Corrective Action	
193B - Re-stripe for Compliant Dimensions - Re-stripe to provide parking spaces with compliant dimensions. Additional Comments: Provide one compliant van-accessible parking stall.

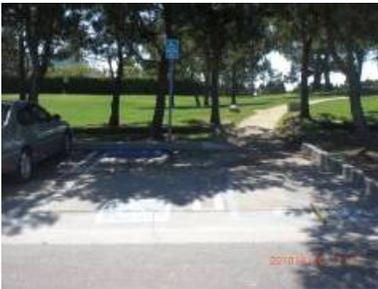
Location: Photo #
Parking Lot 6

Field Condition	
01.10A - Van Access Aisle - Dimensions - Where the parking space is designated as "van accessible," the adjacent access aisle is not at least 8' wide by 18' long. (Aisle width is measured from the center line of the stripe on one side to the center line of the stripe on the other.)	1991 ADAAG 4.1.2(5)(b)
Existing Condition:	2004 ADAAG -
	2007 CBC 1129B.3 item 2
	Other

Corrective Action
199 - Parking Spaces - Miscellaneous - See Additional Comments
Additional Comments: See Keynote 6 for corrective action.

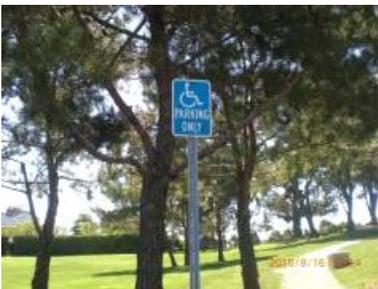
Location: Photo #
Parking Lot 8

Field Condition	
01.15C - Minimum Fine Sign - Accessible parking space has no sign stating "Minimum Fine \$250" below the ISA.	1991 ADAAG -
Existing Condition: No minimum fine sign.	2004 ADAAG -
	2007 CBC 1129B.4
	Other

Corrective Action
394D - Sign - Fine for Unauthorized Parking - Provide sign stating minimum fine for unauthorized parking.
Additional Comments:

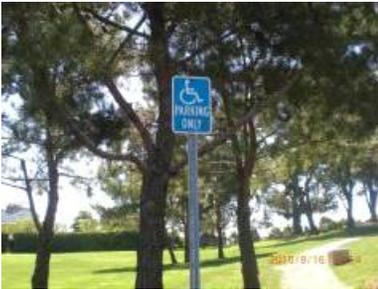
Location: Parking Lot
Photo # 8

Field Condition	
01.17 - Van Accessible Sign - Van accessible space has no sign stating "Van Accessible" below the ISA.	1991 ADAAG 4.6.4
Existing Condition: No van-accessible sign.	2004 ADAAG 502.6
	2007 CBC 1129B.4
	Other

Corrective Action	
398 - Van Accessible Parking Sign - Provide accessible parking sign with "Van Accessible" sign, pole-mounted to a height of 80" above finish grade measured to bottom of sign.	
Additional Comments:

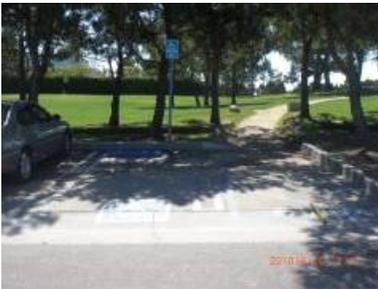
Location: Parking Lot
Photo # 6

Field Condition	
01.13 - Level Surface - The accessible parking spaces and access aisles are not level (slope is greater than 2%).	1991 ADAAG 4.6.3
Existing Condition: 3.5% - 3.7% CS & RS at disable parking, stall and access aisle vary from 2.3% - 11.2%.	2004 ADAAG 502.4; advisory 502.4
	2007 CBC 1129B.3 items 3 & 4
	Other

Corrective Action	
194 - Asphalt Paved Parking Stall and Access Aisle - Remove non-compliant pavement and replace with new asphalt paving. The parking space and access aisle slope shall not exceed 2% in any direction.	
Additional Comments: Re-route concrete swale away from accessible parking.

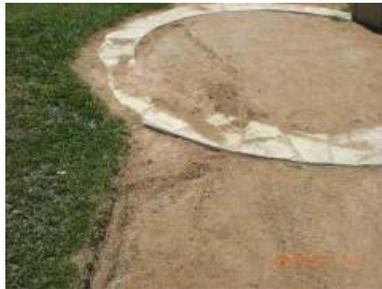
Location: DG Trail Photo # 11

Field Condition	
30.68 - Other - Parks - See Additional Comments	1991 ADAAG -
Existing Condition: Level change due to water erosion.	2004 ADAAG -
	2007 CBC -
	Other -

Corrective Action
015C - Decomposed Granite Trail - New decomposed granite outdoor recreation access route (area as shown on the drawings). Slope along the POT shall conform to the following: PercentSlope//MaximumLength//RestInterval ; 0% - 5.0% // No Restriction // No Restriction ; 5.1% - 8.33% //
Additional Comments:

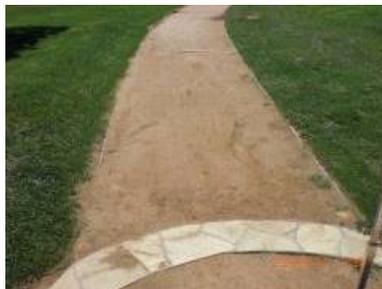
Location: DG Trail Photo # 12

Field Condition	
30.10E - Trail Surface - The surface of the trail is not firm or stable.	1991 ADAAG -
Existing Condition: 1/2" level change from decomposed granite to concrete.	2004 ADAAG -
	2007 CBC -
	Other 1999 ADAAG-16.2.1

Corrective Action
027 - Site Work - Miscellaneous - See Additional Comments
Additional Comments: See Keynote 11 for corrective action.

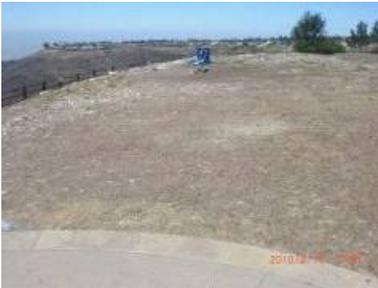
Location: Photo #
 Center Point of View 24

Field Condition	
30.04 - Accessible Route - Facilities Connected - Accessible routes of travel do not connect all accessible buildings, facilities, elements and spaces on the same site with one another.	1991 ADAAG 4.1.2(2)(a)
Existing Condition: No accessible path of travel connects to bench.	2004 ADAAG 206.2.2; Advisory 206.2.2
	2007 CBC 1114B.1.2; 1127B.1
	Other -

Corrective Action
015C - Decomposed Granite Trail - New decomposed granite outdoor recreation access route (area as shown on the drawings). Slope along the POT shall conform to the following: PercentSlope//MaximumLength//RestInterval ; 0% - 5.0% // No Restriction // No Restriction ; 5.1% - 8.33% //
Additional Comments:

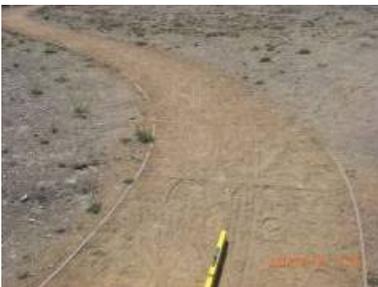
Location: Photo #
 DG Trail 14

Field Condition	
30.10E - Trail Surface - The surface of the trail is not firm or stable.	1991 ADAAG -
Existing Condition: Loose surface.	2004 ADAAG -
	2007 CBC -
	Other 1999 ADAAG-16.2.1

Corrective Action
015C - Decomposed Granite Trail - New decomposed granite outdoor recreation access route (area as shown on the drawings). Slope along the POT shall conform to the following: PercentSlope//MaximumLength//RestInterval ; 0% - 5.0% // No Restriction // No Restriction ; 5.1% - 8.33% //
Additional Comments:

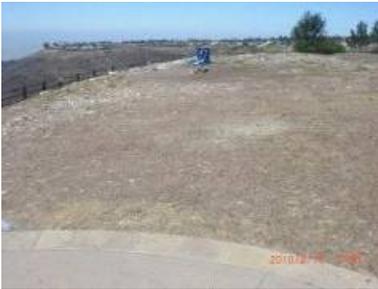
Location: Photo #
 Center Point of View 24

Field Condition	
30.12 - Fixed Bench - Fixed bench is not accessible for users with various types of disabilities.	1991 ADAAG -
Existing Condition: No accessible bench.	2004 ADAAG 903.1
	2007 CBC -
	Other 1999 ADAAG-16.12.2.1

Corrective Action	
027 - Site Work - Miscellaneous - See Additional Comments	
Additional Comments: Provide compliant bench with clear WC seating space.

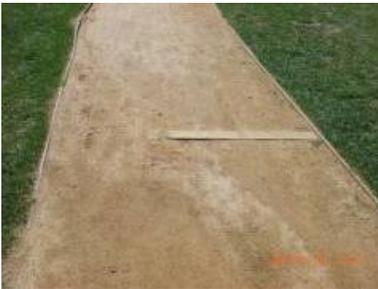
Location: Photo #
 DG Trail 16

Field Condition	
30.08 - Maintenance of Accessible Trail - Title II Entity - Accessible trail is not in operable working condition. (28 CFR 35.133)	1991 ADAAG -
Existing Condition: Level change due to water erosion.	2004 ADAAG -
	2007 CBC 1101B.3
	Other 28 CFR 35.133

Corrective Action	
027 - Site Work - Miscellaneous - See Additional Comments	
Additional Comments: See Keynote 14 for corrective action.

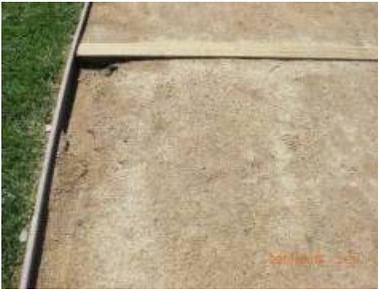
Location: DG Trail Photo # 17

30.08 - Maintenance of Accessible Trail - Title II Entity - Accessible trail is not in operable working condition. (28 CFR 35.133)

Existing Condition: Level change.

Additional Comments: See Keynote 14 for corrective action.

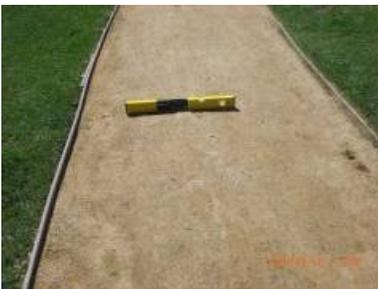
Location: DG Trail Photo # 18

30.10C - Trail Segment - Cross Slope - Cross slope of the trail segment exceeds 1:20.

Existing Condition: 6.6% CS.

Additional Comments: See Keynote 14 for corrective action.

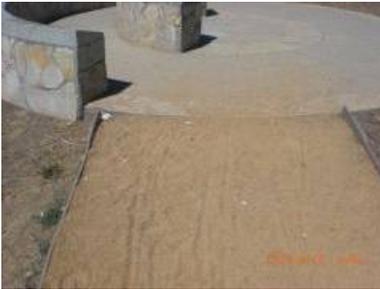
Location: South Point of View
 Photo # 21

Field Condition	
30.68 - Other - Parks - See Additional Comments	1991 ADAAG -
Existing Condition: Level change from decomposed granite to concrete is > than 1/2".	2004 ADAAG -
	2007 CBC -
	Other -

Corrective Action
027 - Site Work - Miscellaneous - See Additional Comments
Additional Comments: See Keynote 14 for corrective action.
