# **FINAL FEASIBILITY STUDY**

**PORTUGUESE BEND LANDSLIDE COMPLEX  
RANCHO PALOS VERDES**

**Feasibility Study Update**  
**Portuguese Bend Landslide Complex**  
**Rancho Palos Verdes, California**

**Prepared for City of Rancho Palos Verdes, California**

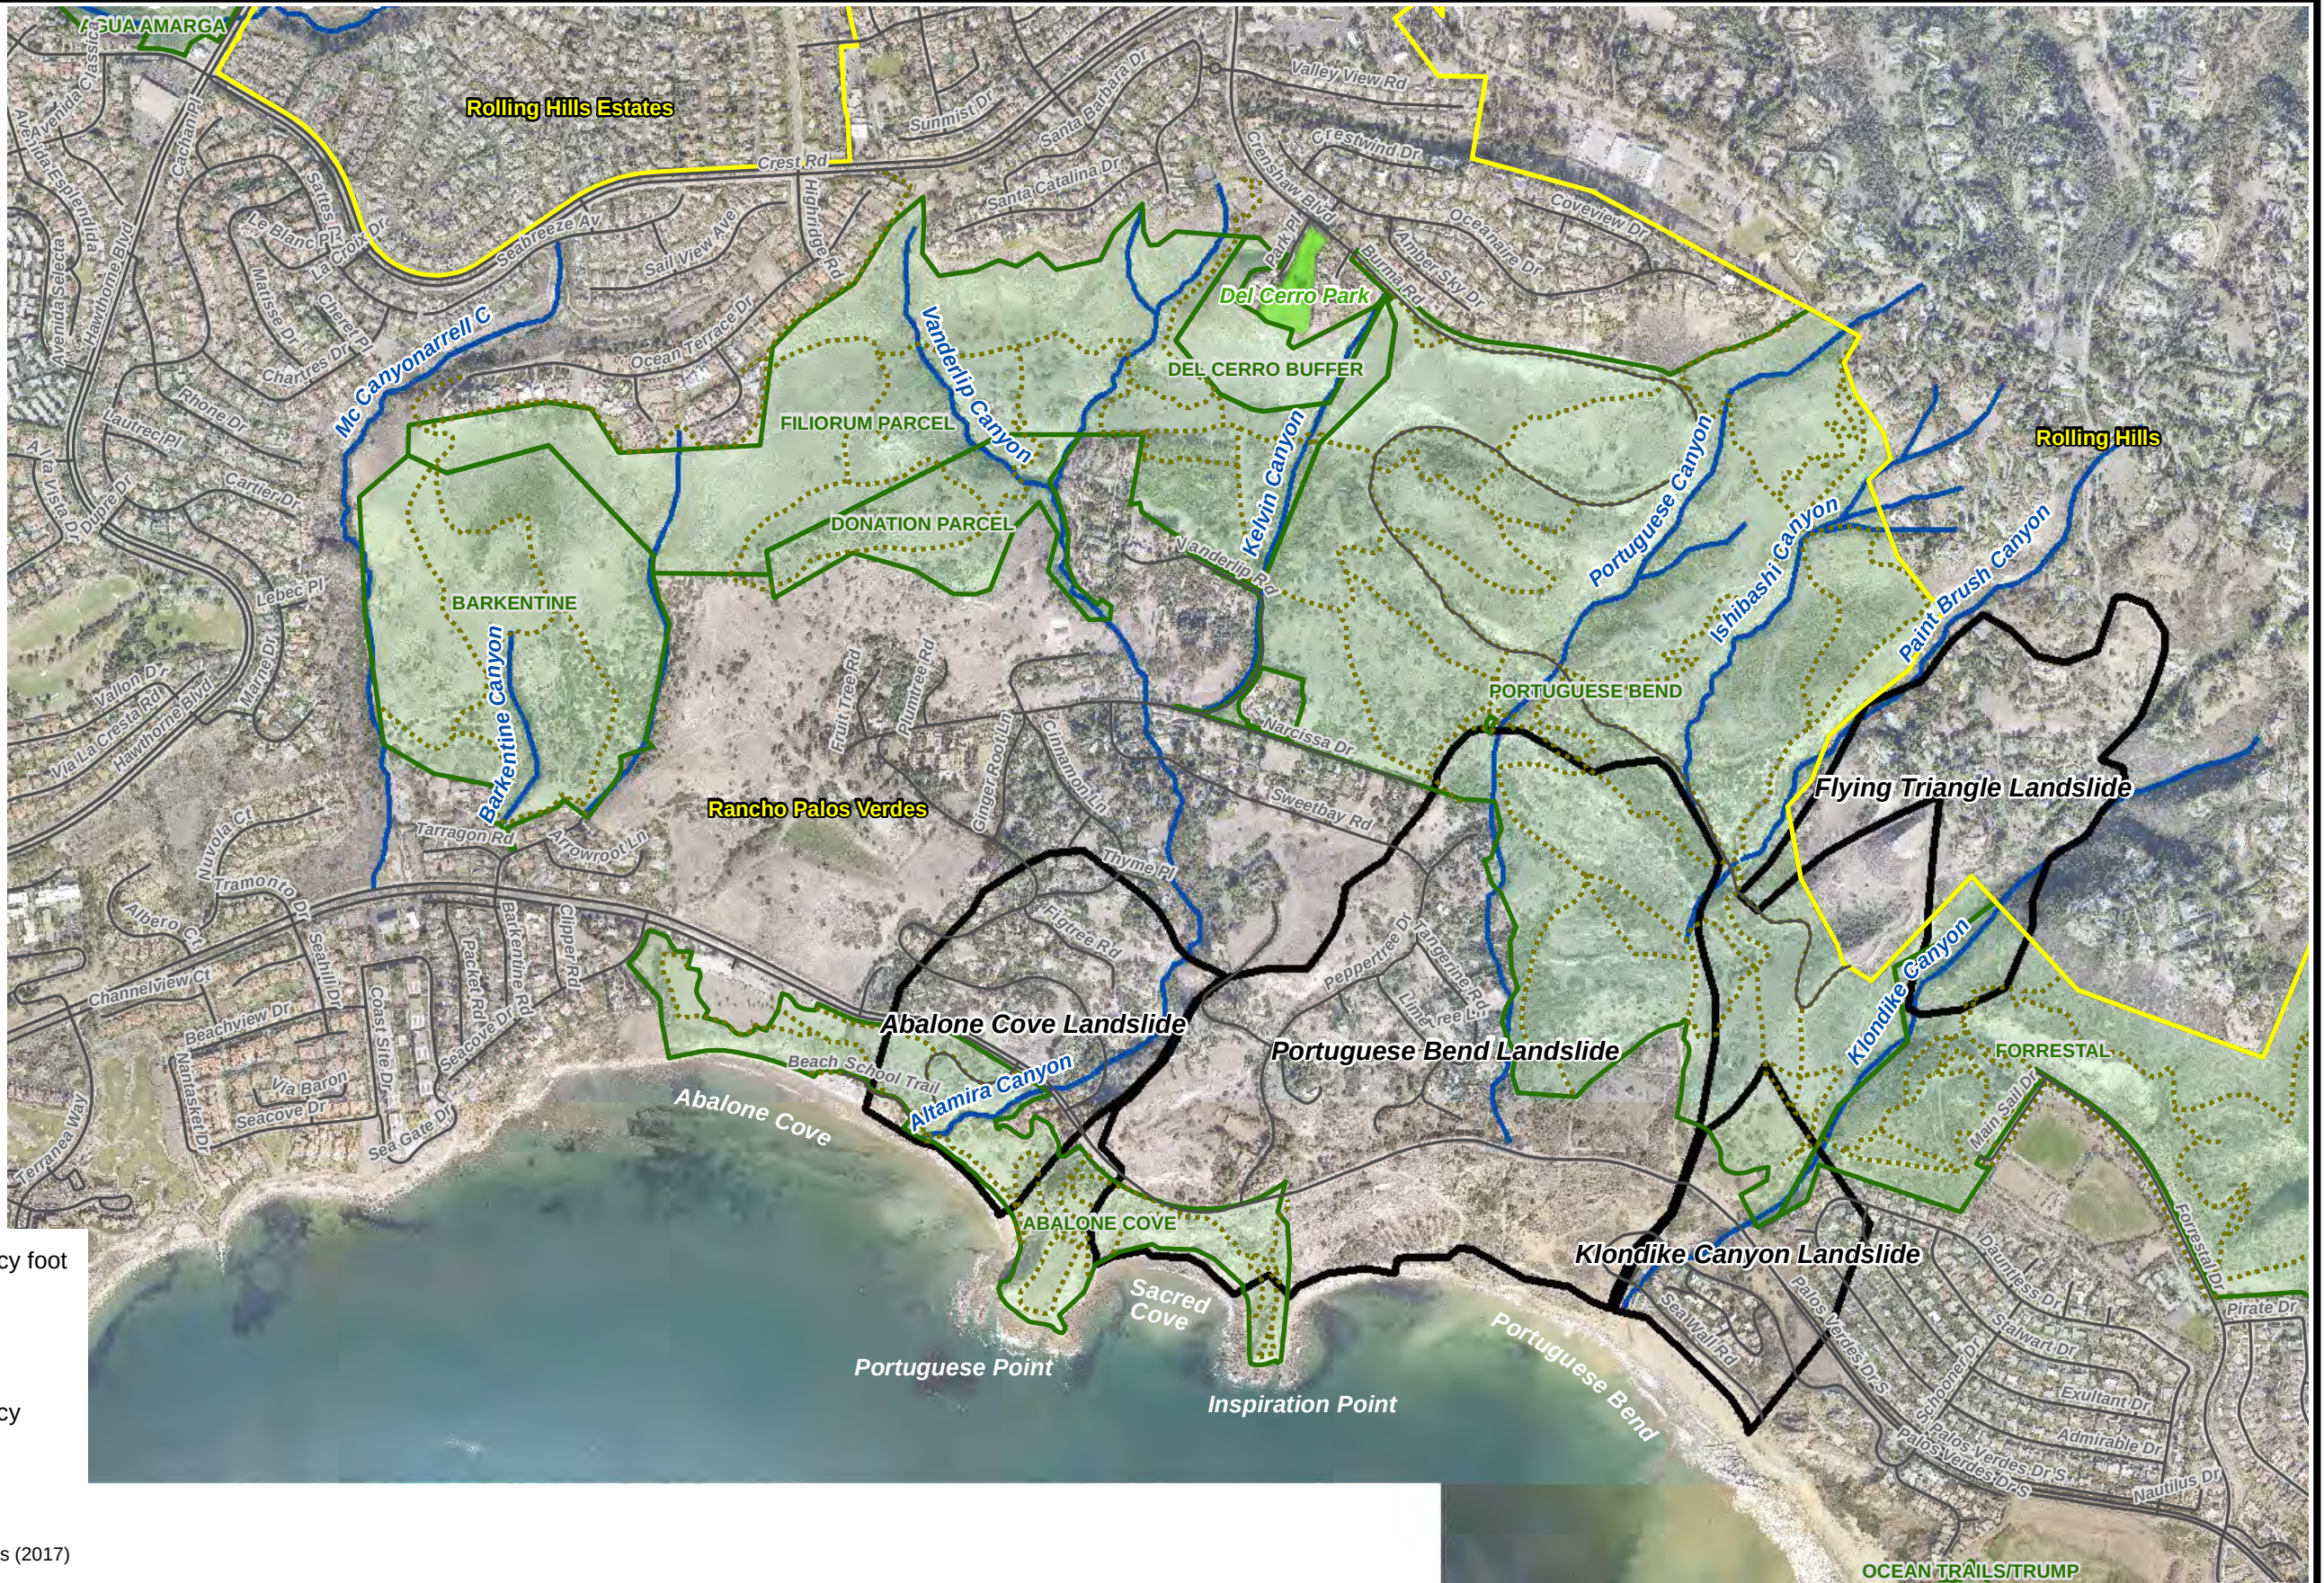
CITY OF RANCHO PALOS VERDES  
**Aerial Photograph with Geographic Features**

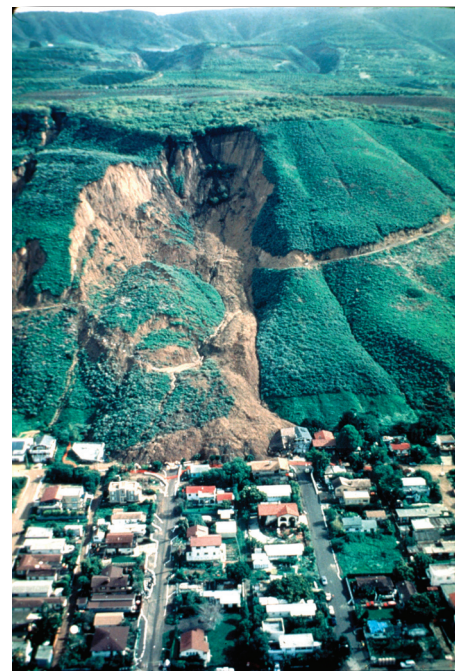
La Conchita, coastal area of southern California. This landslide and earthflow occurred in the spring of 1995. People were evacuated and the houses nearest the slide were completely destroyed. This is a typical type of landslide.
