# Portuguese Bend Land Movement Monitoring Survey

October 10, 2023 (M38) through April 17, 2024 (M41)

## Survey Report

### City of Rancho Palos Verdes

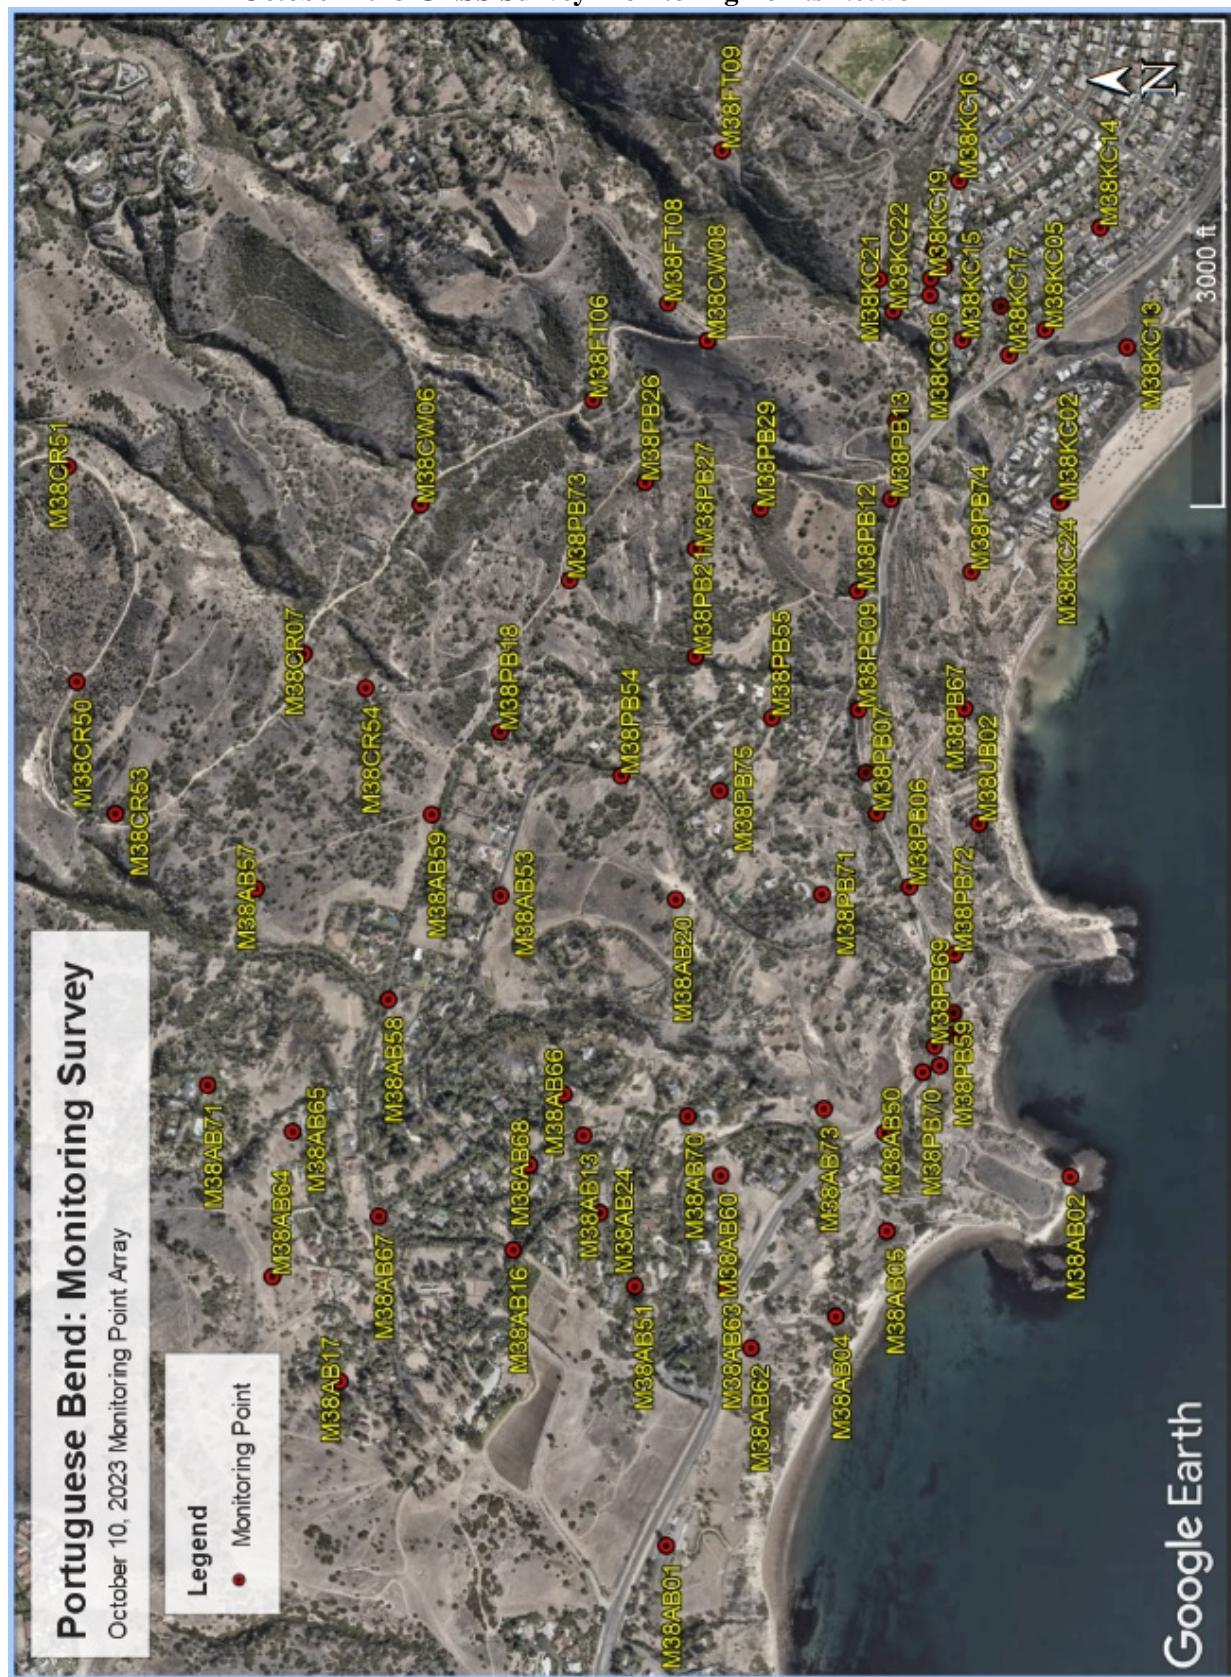
October 2023 GNSS Survey Monitoring Points Network

The monitoring points names were established in early surveys. Points are named for the slide they fall within and given a number. For example, AB01, PB01, KC01, CR01 and FT01. The number is increased as new points are established to replace abandoned or destroyed points or expand the network. Many of the original points are lost or no longer monitored. For data management purposes the point names are also prefixed with a sequential monitoring number to distinguish subsequent surveys. For example, for the occupation of AB02 on the 16<sup>th</sup> monitoring survey, AB02 is called M16AB02 where M16 indicates the sequence number since the first Monitoring Survey “M01” in September 2007. The prefix is stripped in these Reports.

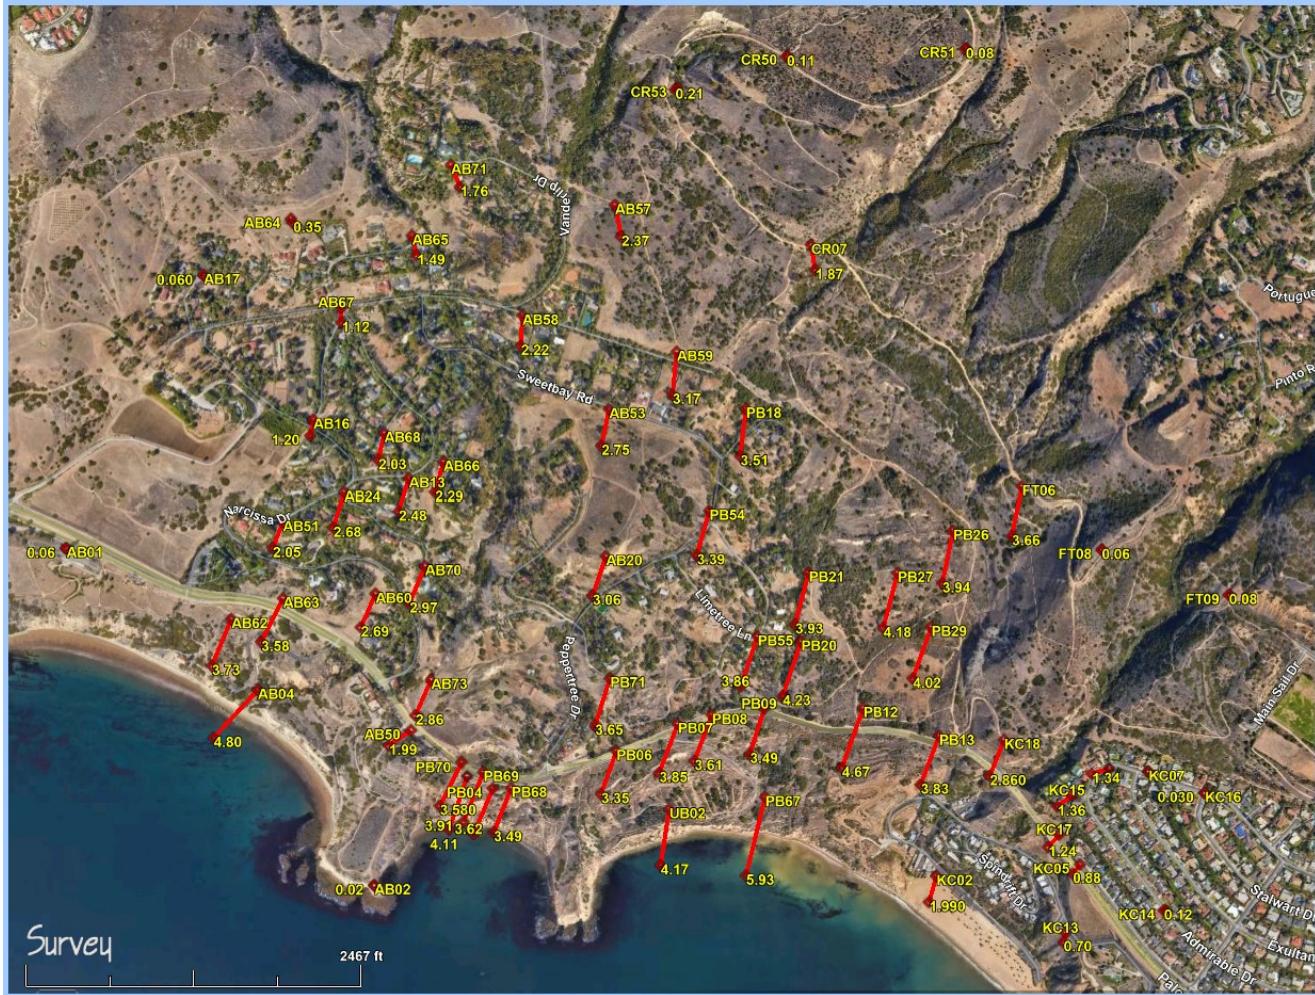
**October 10, 2022 to October 10, 2023 Movement Distances (Feet) & Directions as Indicated**

Listed below are the movement Azimuths (directions clockwise from North) in degrees, the two-dimensional horizontal movements, and the vertical (elevation) changes during the period in US Survey Feet. See the attached spreadsheet “PB MOVEMENT DATA POSTING.....xlsx”. Note: The horizontal measured movement confidence is estimated at +/-0.02' (1/4"); therefore, movements of less than 0.03' are statistically indeterminate. The estimated vertical measured movement confidence is +/-0.05'.

*Note: Distances are exaggerated x 100 for viewing*

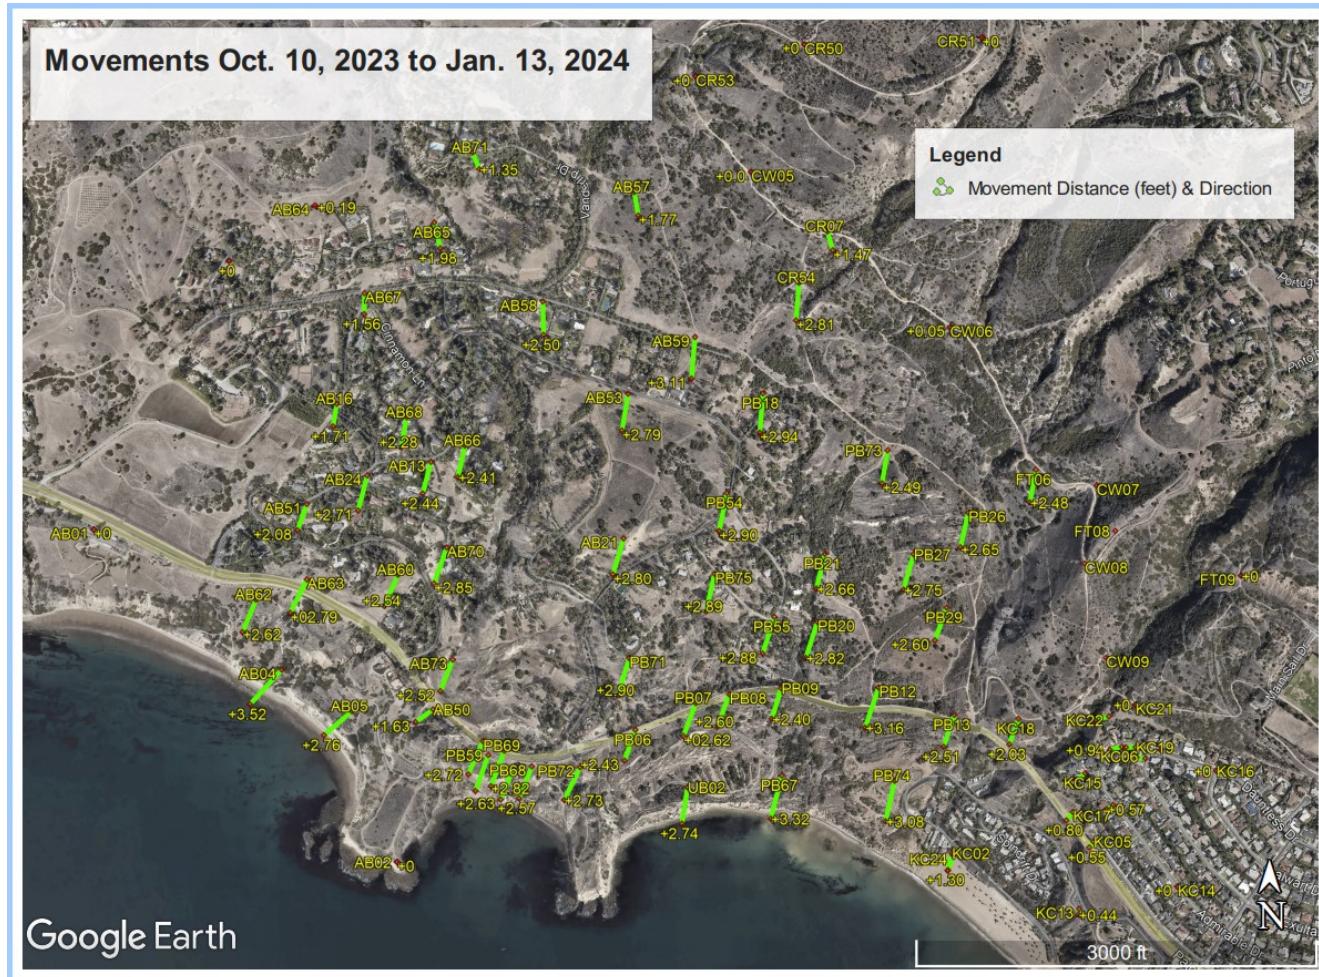
**October 10, 2023 to January 13, 2024 Movement Distances (Feet) & Directions as Indicated**

Listed below are the movement Azimuths (directions clockwise from North) in degrees, the two-dimensional horizontal movements, and the vertical (elevation) changes during the period in US Survey Feet. See the attached spreadsheet “PB MOVEMENT DATA POSTING (Revised 012224) 2007-Jan2024.xlsx”. Note: The horizontal measured movement confidence is estimated at +/-0.04’ (1/2”); therefore, indicated movements of less than 0.05’ are statistically indeterminate. The estimated vertical measured movement confidence is +/-0.08’.  
\* = Control Point for Recovery of the Reference Frame.

*Note: Distances are exaggerated x 100 for viewing*
