# Portuguese Bend Land Movement Monitoring Survey

October 10, 2023 (M38) through July 1, 2024 (M43)

## Survey Report

### City of Rancho Palos Verdes

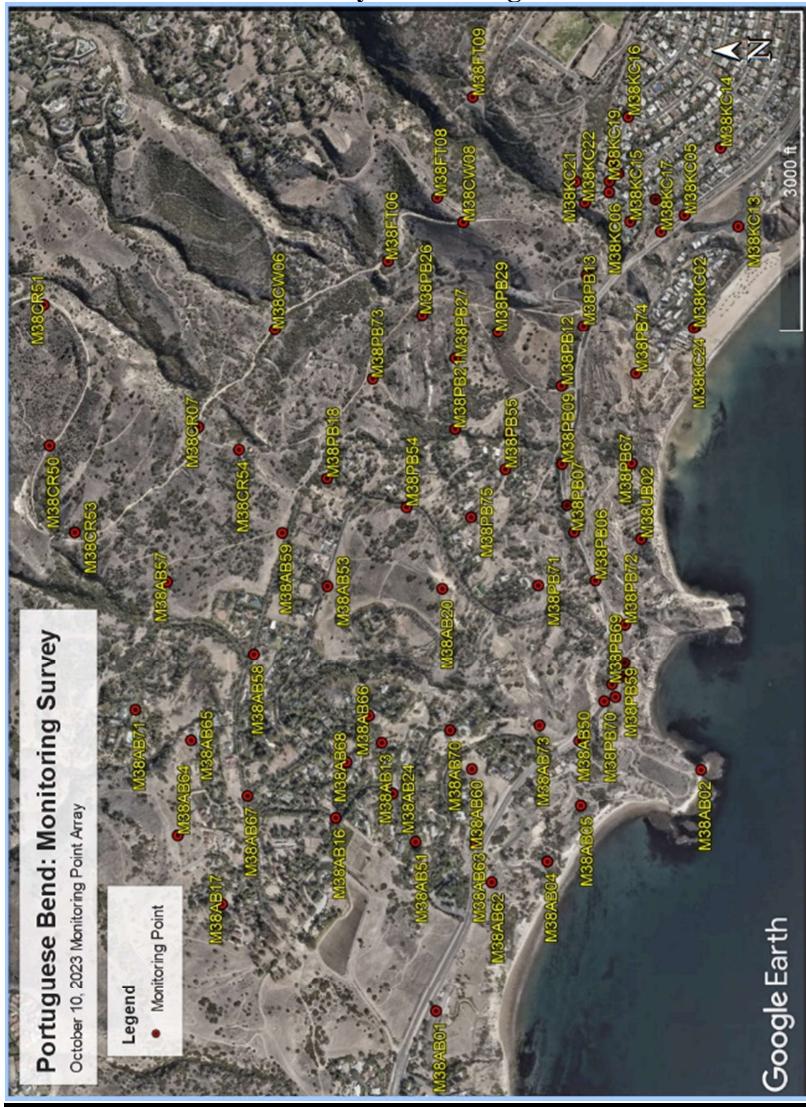
### October 2023 GNSS Survey Monitoring Points Network

The monitoring points names were established in the early surveys. The points are named for the slide they fall within and given a number. For example, AB01, PB01, KC01, CR01 and FT01. The number is increased as new points are established to replace abandoned or destroyed points or expand the network. Many of the original points are lost or no longer monitored. For data management purposes the point names are also prefixed with a sequential monitoring number to distinguish subsequent surveys. For example, for the occupation of AB02 on the 16<sup>th</sup> monitoring survey, AB02 is called M16AB02 where M16 indicates the sequence number since the first Monitoring Survey “M01” in September 2007. The prefix is stripped in these Reports.

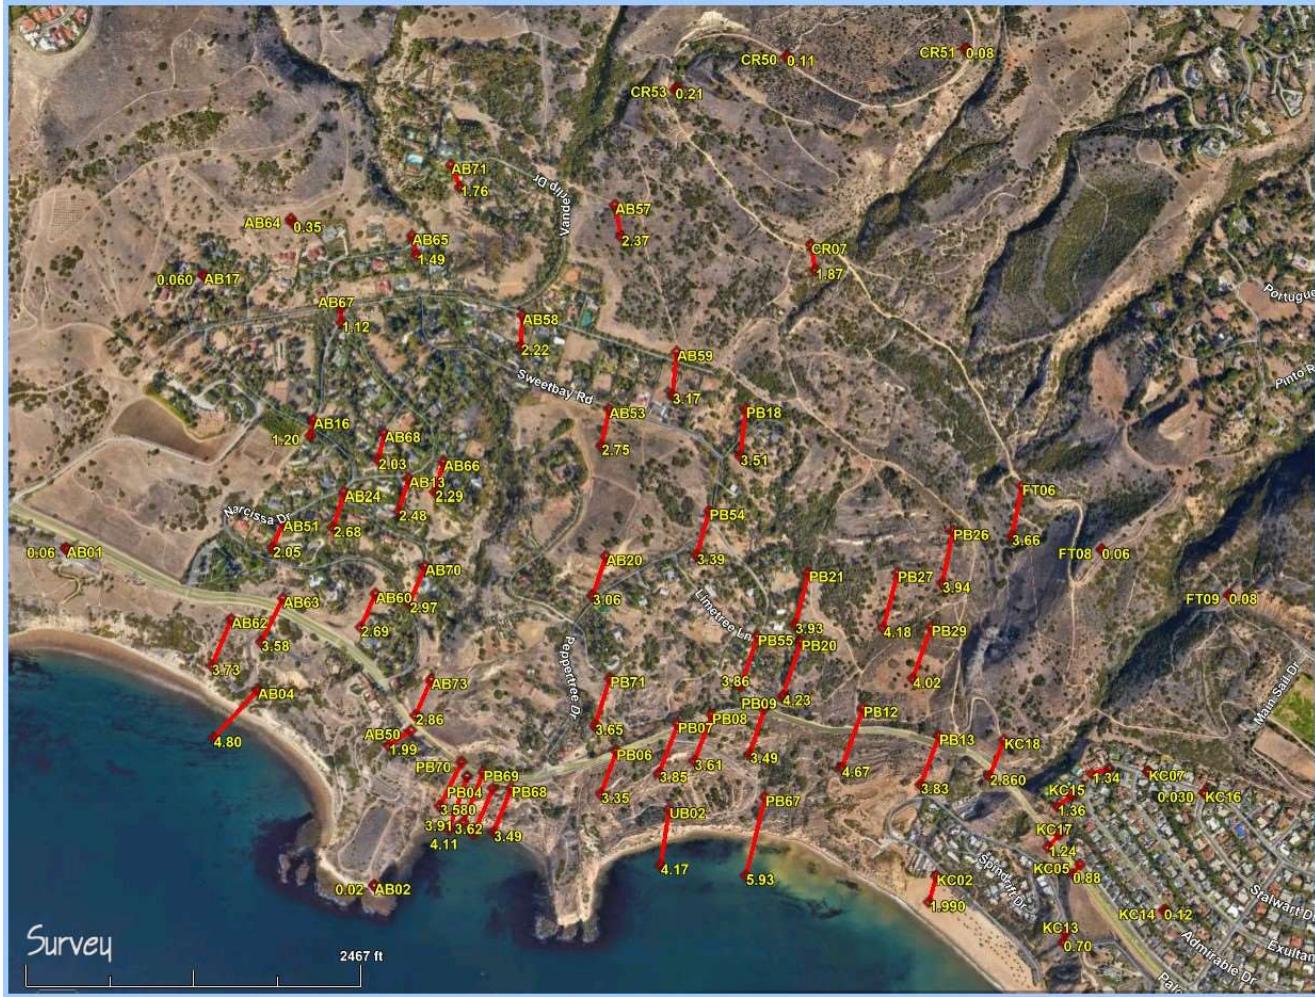
**October 10, 2022 to October 10, 2023 Movement Distances (Feet) & Directions as Indicated**

Listed below are the movement Azimuths (directions clockwise from North) in degrees, the two-dimensional horizontal movements, and the vertical (elevation) changes during the period in US Survey Feet. See the attached spreadsheet “PB MOVEMENT DATA POSTING.....xlsx”. Note: The horizontal measured movement confidence is estimated at +/- 0.02' (1/4"); therefore, movements of less than 0.03' are statistically indeterminate. The estimated vertical measured movement confidence is +/- 0.05'.

*Note: Distances are exaggerated x 100 for viewing*

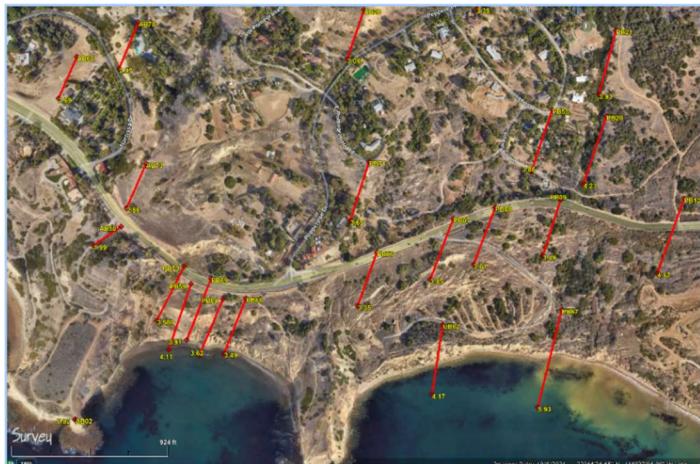
## Enlargement (PVDS)

PVDS respectively. The separation between AB73 and AB50 is diminishing at the rate of about one foot per month in April 2024 resulting in a steeper slope on the north side of PVDS which may be de-stabilizing.
