# Portuguese Bend Land Movement Monitoring Survey

## October 10, 2023 (M38) through October 13, 2024 (M49)

### Survey Report

for the  
**City of Rancho Palos Verdes**

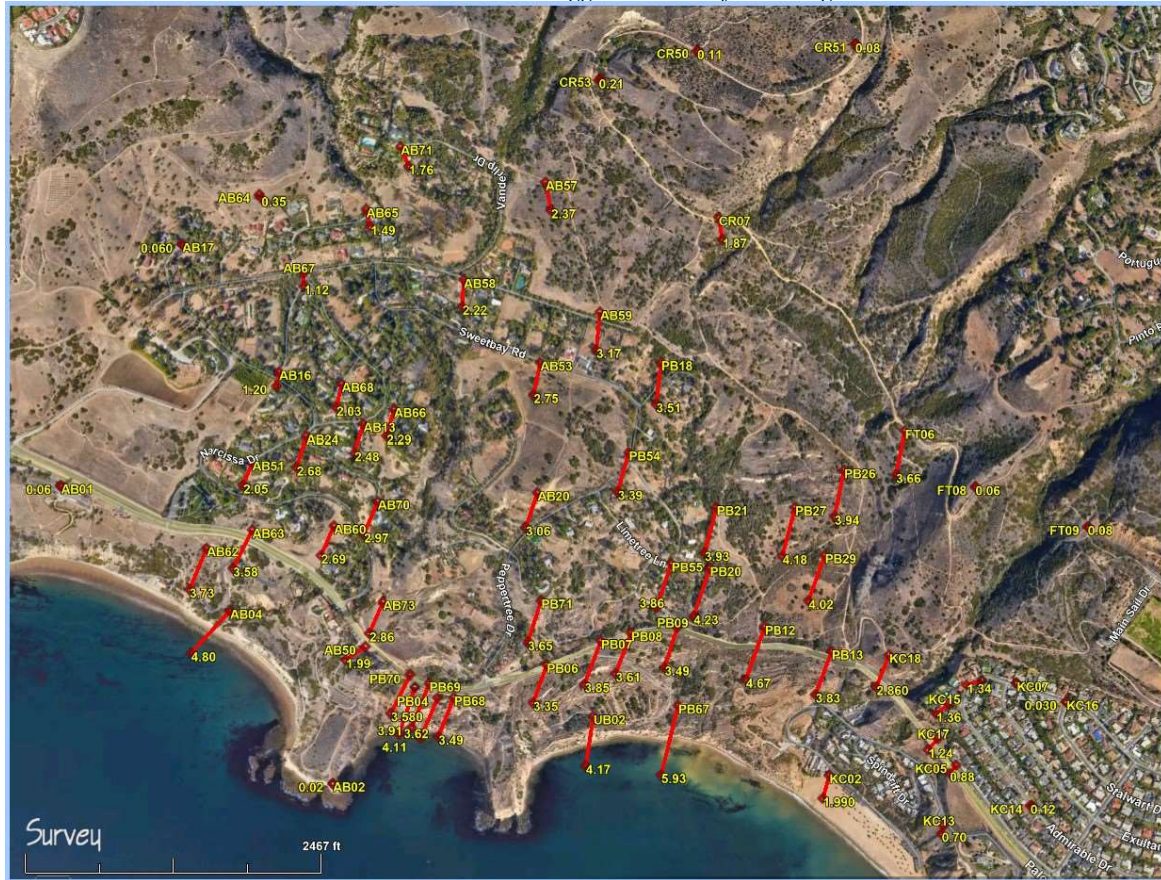
**October 10, 2022 to October 10, 2023 Movement Distances (Feet) & Directions as Indicated**

*Note: Distances are exaggerated x 100 for viewing*
