City of Rancho Palos Verdes
Rancho Palos Verdes ADA Assessment
Facility Report with Photos

Facility ID: # 02B - City Hall Buildings

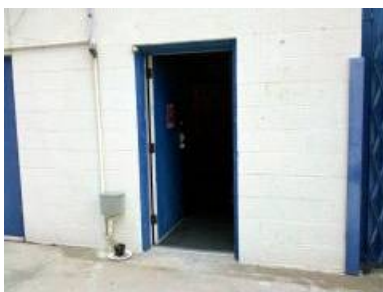
Photo #
1

10.02 - Entrance Sign - Accessible entrance is not identified by an ISA.

1991 ADAAG 28 CFR 35.163(b)1

2004 ADAAG 216.6

2007 CBC 1117B.5.8.1.2

404 - Entrance Sign - Provide compliant entrance sign with ISA.

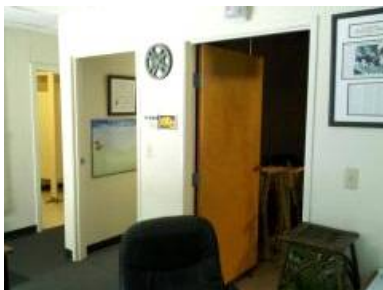
Location: Photo #
Ch. 33 - Office 9

Existing Condition: Security alarm at 57 1/4" AFF.

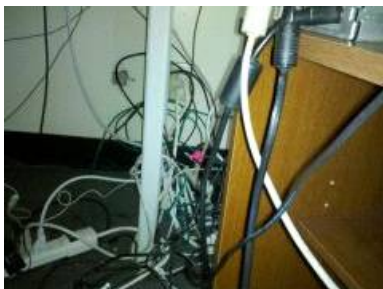
Location: Photo #
Ch. 33 - Office 10

Existing Condition: 3 power outlets and 1 data port at 12" AFF.

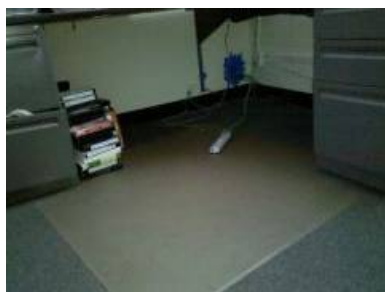
Photo #
13

Existing Condition: Mat.

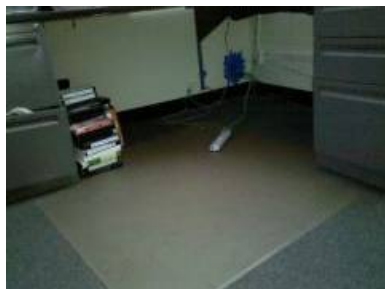
Photo #
13

Existing Condition: 3 power outlets and 1 data port at 11" AFF.

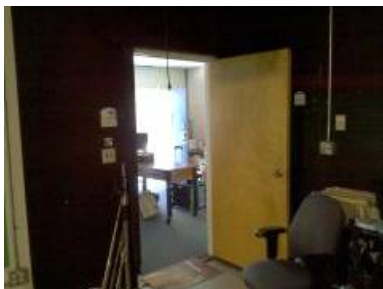
Photo #
18

Existing Condition: 5/8" change in level.

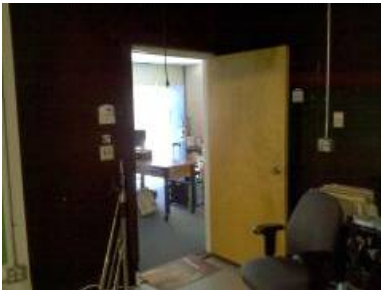
Location: Photo #
Ch. 33 - Sound Stage 18

Existing Condition: Door jamb at 79 1/2" AFF.

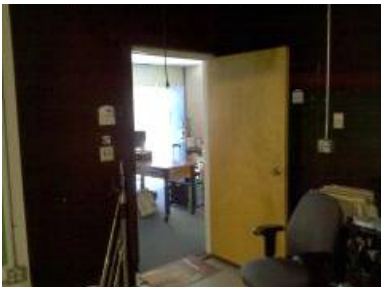
Location: Photo #
Ch. 33 - Sound Stage 18

Existing Condition: Thermostat at 62 1/2" AFF.

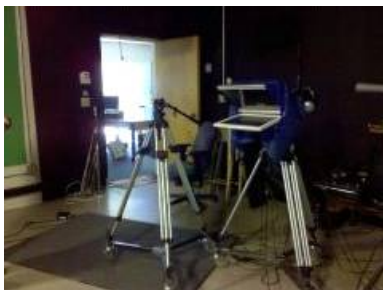
Location: Photo #
Ch. 33 - Sound Stage 21

Existing Condition: Floor mat.

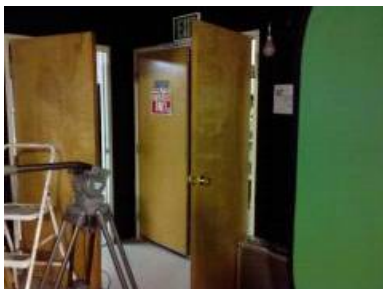
Location: Photo #
Ch. 33 - Sound Stage 22

Existing Condition: 27 1/2" clear opening.

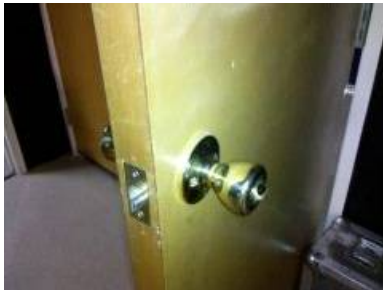
Photo #
23

Existing Condition: Door knob.

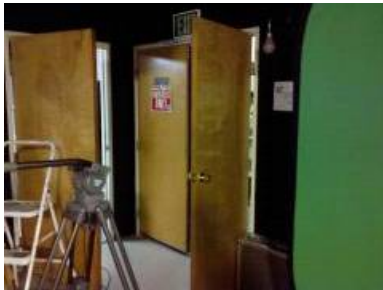
24

11.21A - Required Exit Route Sign - At exit access door from an interior room or area that is required to have a visual exit sign, there is no tactile and CA Braille exit sign with the words "EXIT ROUTE" mounted on the wall adjacent to the latch side of the door. (Visual exit signs are required when two or more exits are required. Generally, all occupants shall have access to two exits from a floor (CBC Table 1019.1). Exceptions: a) Single story building with maximum occupant load of 49 and less than 75 ft travel distance to exit (CBC Table 1019.2), and b) Two story building with maximum occupant load of 30 occupants per floor and maximum travel distance of 75 ft to exit. (CBC Table 1019.2). Two exit access doors are required from an office tenant space when the occupant load exceeds 49.)

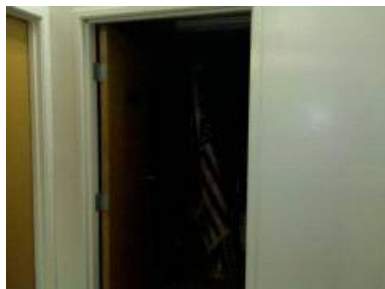
Location: Photo #
Ch. 33 - Storage 30

Existing Condition: Door jamb at 79 7/8" AFF.

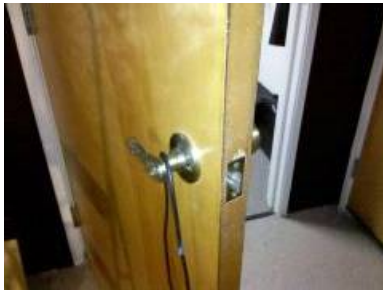
Photo #
31

Existing Condition: Door knob & twist-type locking mechanism.

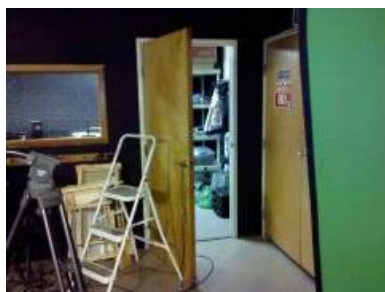
Photo #
32

Existing Condition: 12 1/2" pull side.

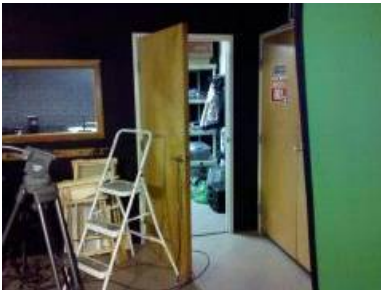
Keynote 33

Existing Condition: Door jamb at 79 1/4" AFF.

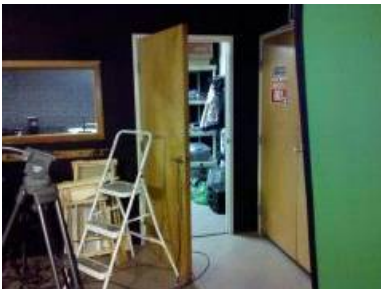
Keynote 34

11.17A - Recommendation: Providing Room/Space ID Sign - A sign designating the permanent room or space has not been provided.

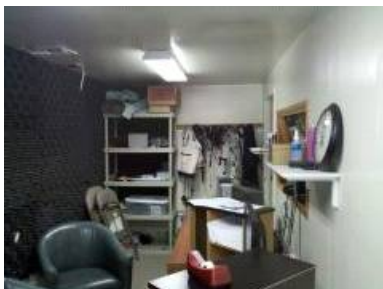
Location: Photo #
Ch. 33 - Control Room 36

Existing Condition: 24" clearance due to non-fixed furniture.

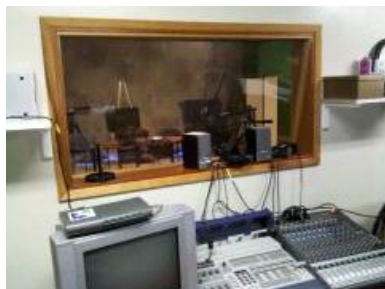
Location: Photo #
Ch. 33 - Control Room 38

Existing Condition: Observation window sill at 46 1/2" AFF.

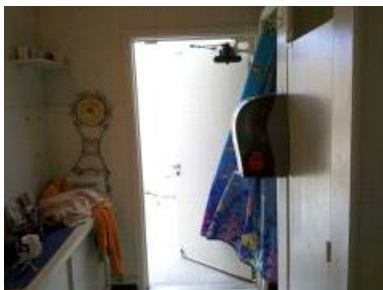
Photo #
44

Existing Condition: 9" to counter at pull side.

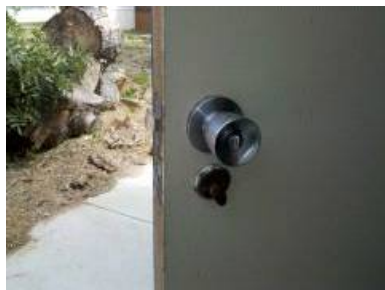
Photo #
45

Existing Condition: Door knob & twist-type locking mechanisms.

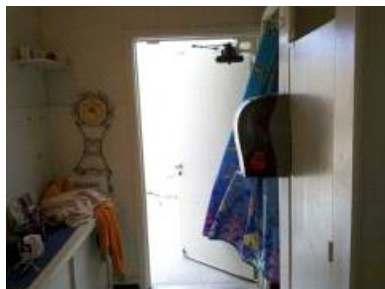
46

Existing Condition: 22 LBF.

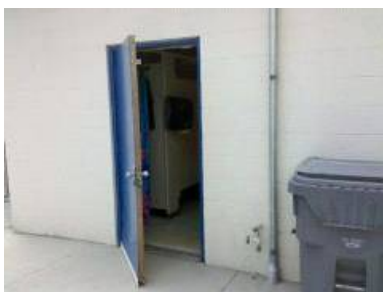
Keynote 49

Existing Condition: 2004 ADAAG 216.2; 703.1; 703.2; 703.5
2007 CBC 1117B.5.1(1)
Other -

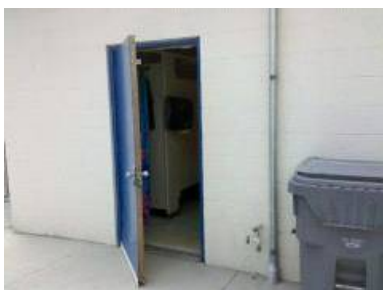
Keynote 50

Existing Condition: 2004 ADAAG 216.8
2007 CBC 1117B.5.1(3)
Other -

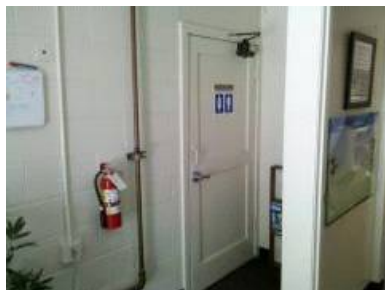
Location:
Ch. 33 - Restroom

Existing Condition: 35 1/2" landing at latch approach, pull side.

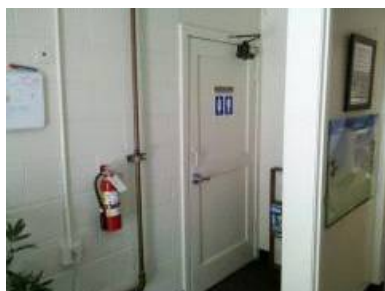
Location: Ch. 33 - Restroom
Photo # 61

Existing Condition: Door cannot open 90 degrees.

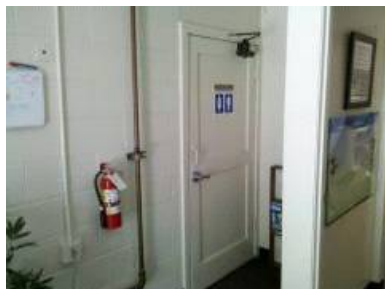
Ch. 33 - Restroom

16.13C - Unisex RR Geometric Symbol Signage - Circle/Triangle - Doorway leading to a unisex toilet room is not identified by a 12" circle, 1/4" with a 1/4" thick triangle superimposed and within the circle. OR Circle and triangle are provided, however they are accompanied by words in raised characters and Braille. (ADA and CBC Standards require a separate sign with raised characters and Braille mounted on the wall adjacent to the latch side of the door.)

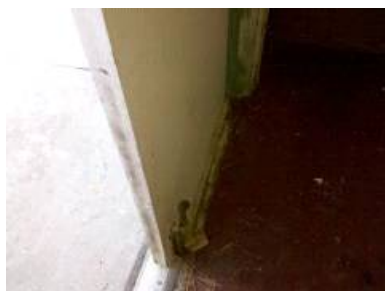
Location: Photo #
Ch. 33 - Storage 69

10.08 - Kick Plate - Bottom 10" of door does not have a smooth, uninterrupted surface on the push side to allow the door to be opened by a wheelchair footrest without creating a trap or hazardous condition. (This requirement does not apply to automatic and sliding doors.)

Existing Condition: Door stops and latch at kick plate area.

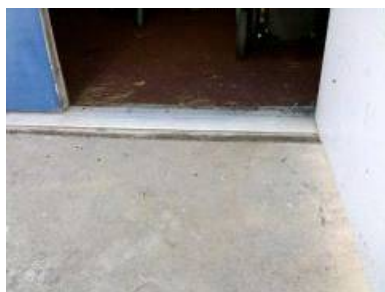
Location:
Ch. 33 - Storage

Existing Condition: 1" change in level.

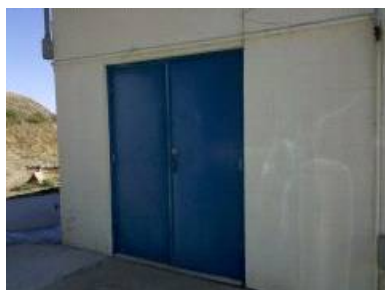
Location:
Ch. 33 - Storage

Existing Condition: Door jamb at 78 1/2" AFF.

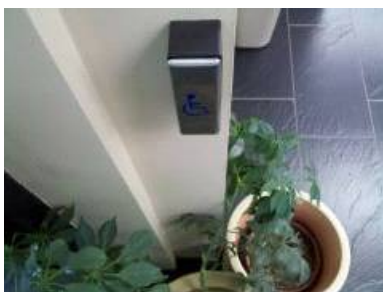
Location:
Comm. Dev. - Vestibule

Existing Condition: Motorized door actuator not functioning.

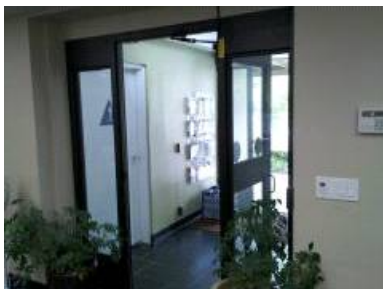
Location:
Comm. Dev. - Vestibule

Existing Condition: 6 LBF.

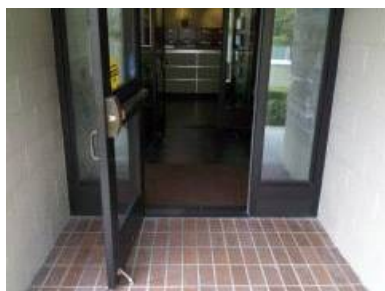
Location: Photo #
Comm. Dev. - Vestibule 77

10.08 - Kick Plate - Bottom 10" of door does not have a smooth, uninterrupted surface on the push side to allow the door to be opened by a wheelchair footrest without creating a trap or hazardous condition. (This requirement does not apply to automatic and sliding doors.)

Existing Condition: Door stop.

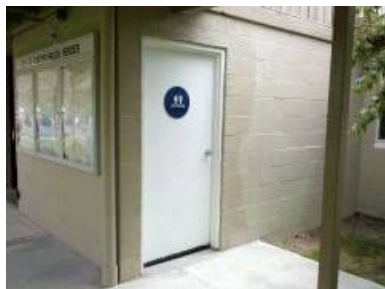
Location: Photo #
Comm. Dev. - Public Restroom 79

Existing Condition: 11 LBF.

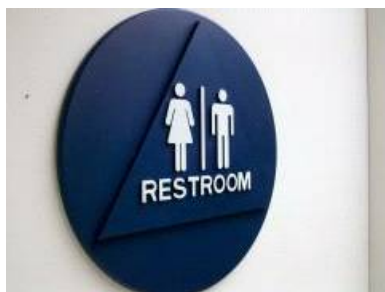
Location:
Comm. Dev. - Public Restroom

Existing Condition: Braille on door sign.

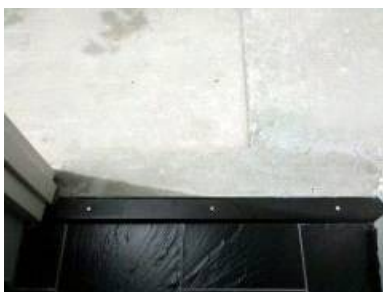
Location: Photo #
Comm. Dev. - Public Restroom 84

Existing Condition: Threshold.

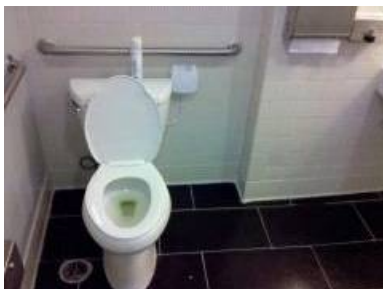
Location: Photo #
Comm. Dev. - Public Restroom 83

Existing Condition: 17 1/4" clear.

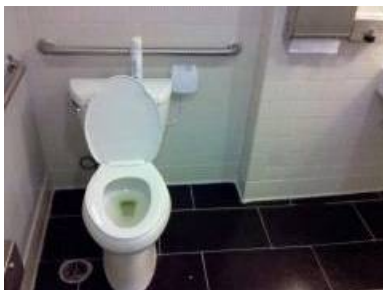
Location: Photo #
Comm. Dev. - Public Restroom 83

Existing Condition: Not on wide side.

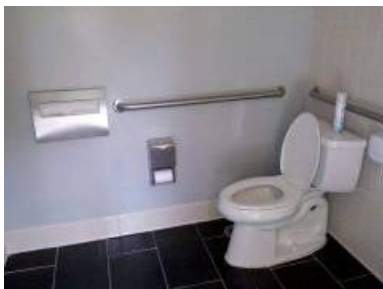
Location: Photo #
Comm. Dev. - Public Restroom 87

Existing Condition: 44 1/2" from back wall.

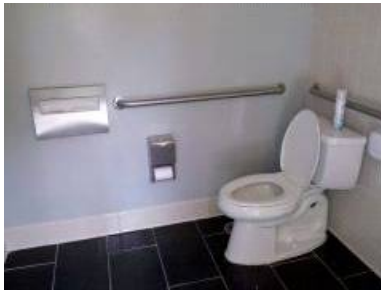
Location: Photo #
Comm. Dev. - Public Restroom 87

Existing Condition: 35" AFF.

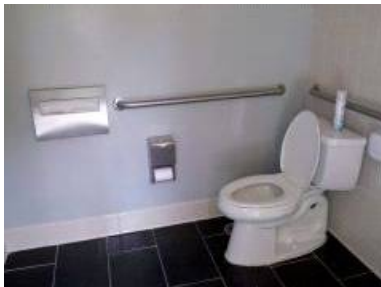
Location: Photo #
Comm. Dev. - Public Restroom 87

Existing Condition: 1 5/8" clear.

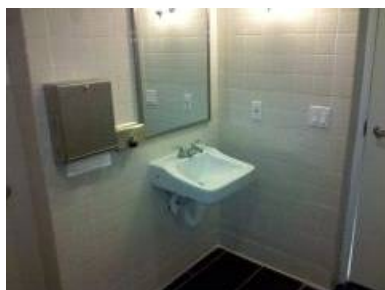
Location: Photo #
Comm. Dev. - Public Restroom 78

Existing Condition: 28 1/2" clear.

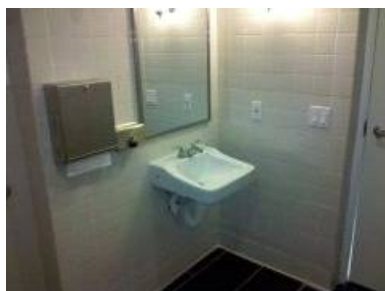
Location: Photo #
Comm. Dev. - Public Restroom 78

Existing Condition: 16" from side wall.

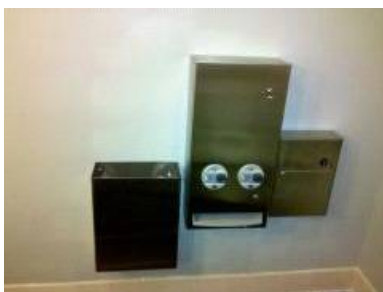
16.84D - Sanitary Napkin/Feminine Hygiene Dispenser - Operating Height - Mounting height of sanitary napkin/feminine hygiene dispenser's highest operable part exceeds 40" AFF. (Where provided, ADA Standards require at least one sanitary napkin/feminine hygiene dispenser to be accessible with the highest operable part placed within at least one of the reach ranges specified in 4.2.5 and 4.2.6; where provided, CBC Standards require at least one sanitary napkin/feminine hygiene dispenser to be accessible with the highest operable part no higher than 40" AFF.)

Existing Condition: 46" AFF.

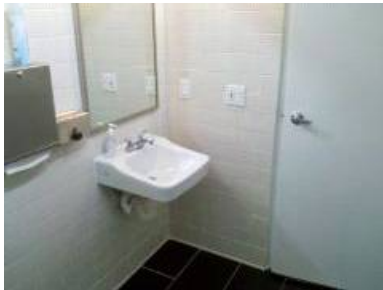
Location: Photo #
Comm. Dev. - Men's Staff Restroom 100

Existing Condition: 13" pull side, lavatory.

053 - Reverse Door Swing - Remove existing door and frame and replace with new frame. Reinstall existing door (reverse door swing). Provide new accessible door hardware.

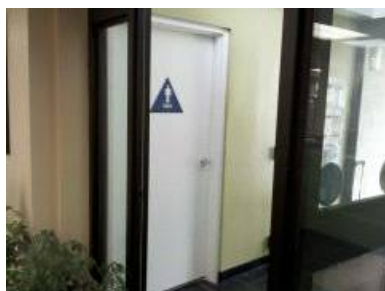
Location: Photo #
Comm. Dev. - Men's Staff Restroom 101

Existing Condition: Braille on sign.

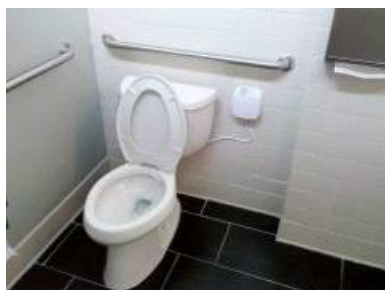
Location: Photo #
Comm. Dev. - Men's Staff Restroom 106

Existing Condition: 16" to wall.

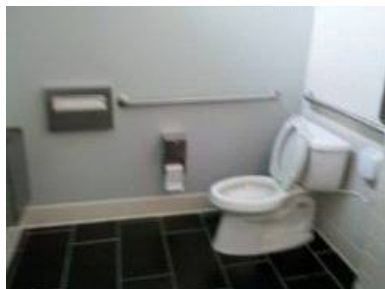
Location: Photo #
Comm. Dev. - Men's Staff Restroom 105

Existing Condition: 41" from back wall.

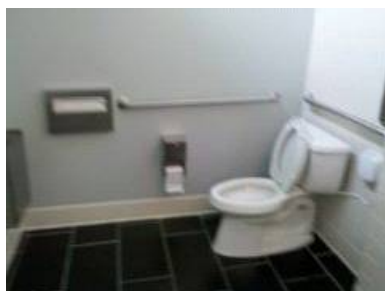
Location: Photo #
Comm. Dev. - Men's Staff Restroom 105

Existing Condition: 1 3/4" clear.

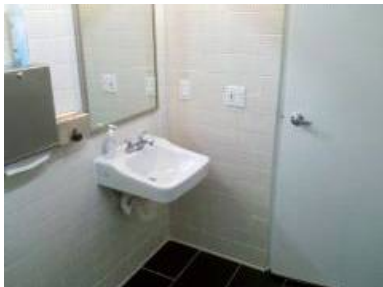
Location: Photo #
Comm. Dev. - Men's Staff Restroom 100

Existing Condition: 25 1/2" clear.

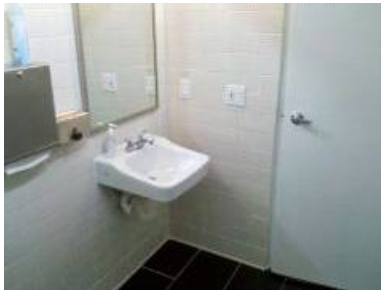
Location: Photo #
Comm. Dev. - Men's Staff Restroom 100

Existing Condition: Door swing encroaches clear floor space.

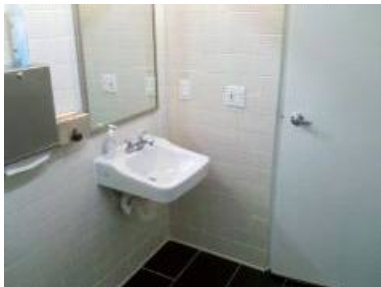
Location: Photo #
Comm. Dev. - Men's Staff Restroom 100

Existing Condition: 17" from side wall.

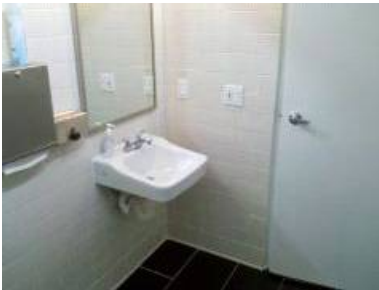
Location: Photo #
Comm. Dev. - Men's Staff Restroom 100

Existing Condition: 40 1/4" AFF.

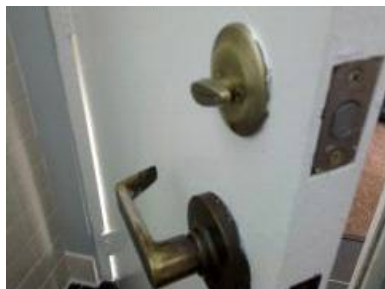
Field Condition

1991 ADAAG 4.13.9

Corrective Action

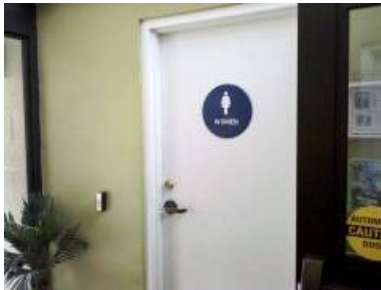
Author: Vaish, B

16.11A - Door Operating Effort - The force required to operate door exceeds 5 lbs. (Fire doors may have up to 15 lbs to achieve positive latching).

Corrective Action

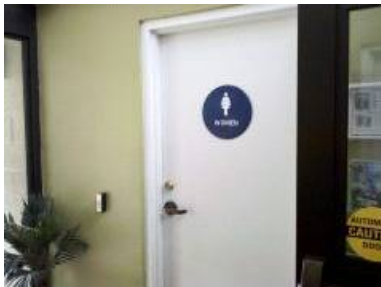
Reported By

16.13B - Women's RR Geometric Symbol Signage - Circle - Doorway leading to a women's toilet room is not identified by a circle, 1/4" thick and 12" in diameter. OR Circle is provided, however it is accompanied by words in raised characters and Braille. (ADA and CBC Standards require a separate sign with raised characters and Braille mounted on the wall adjacent to the latch side of the door.)

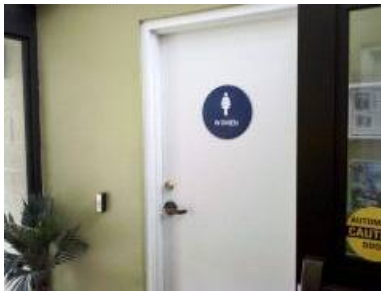
Author: Vaish, B

16.14A - Mounting Height - Geometric Symbol Signage - The geometric symbol is not centered on the door leaf. OR The symbol is not mounted at a height of 60" AFF.

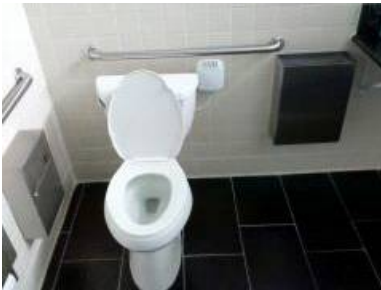
Author: Vaish, B

16.47A - WC Location from Sidewall - The centerline of the WC is not 18" absolute from a wall or partition.

Corrective Action

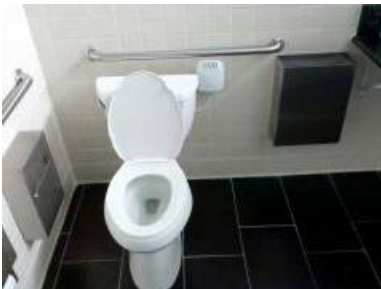
Reported By

16.49B - WC Flush Controls - Location - Flush controls are not located on the wide side of the WC where the clear floor space is provided.

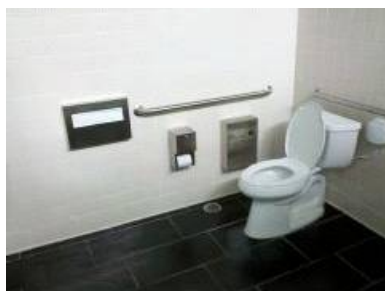
Plan Nbr:	DBB
Priority:	
Planned Completion	6/30/2019
Status Not Complete As of	05/09/2013
Reported By

16.56 - Grab Bar Wall Clearance - The space between the grab bar and the wall is not 1-1/2" absolute.

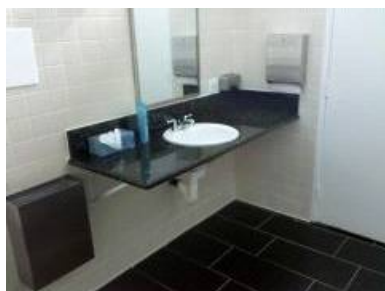
Plan Nbr:	DBB
Priority:	
Planned Completion	6/30/2019
Status	Not Complete As of 05/09/2013
Reported By

16.71 - Lavatory - Rim Height - Height of lavatory rim or counter surface exceeds 34" AFF.

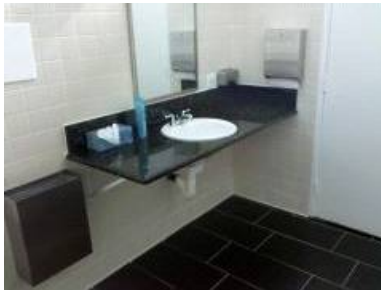
Author: Vaish, B

16.82A - Mirror Height - Max. 40" AFF Standard - Mirror above accessible lavatory or countertop is mounted so the bottom edge of the reflective surface is not 40" max.. AFF. (ADA Standards require at least one mirror to be accessible; CBC Standards prior to August 1, 2009 required all mirrors to be accessible. Effective August 1, 2009, amended CBC Standards require all mirrors above accessible lavatories or countertops to be accessible.)

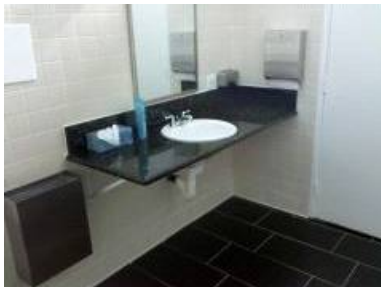
Plan Nbr:	DBB
Priority:	
Planned Completion	6/30/2019
Status Not Complete As of	05/09/2013
Reported By

16.84C - Soap Dispenser - Operating Height - Mounting height of soap dispenser's highest operable part exceeds 40" AFF. (Where provided, ADA Standards require at least one soap dispenser to be accessible with the highest operable part placed within at least one of the reach ranges specified in 4.2.5 and 4.2.6; where provided, CBC Standards require at least one soap dispenser to be accessible with the highest operable part no higher than 40" AFF.)

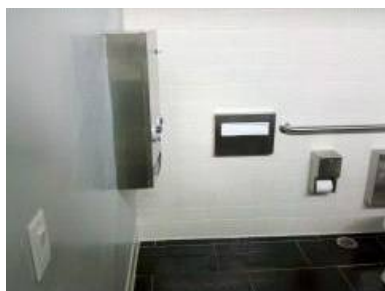
Plan Nbr:	DBB
Priority:	
Planned Completion	6/30/2019
Status Not Complete As of	05/09/2013
Reported By

14.30A - Wall-Mounted Protruding Objects - Wall-mounted object(s) with leading edges between 27 and 80" from the floor project more than 4" into the pathway. (Wall mounted objects with leading edges at or below 27" may project any amount as long as the required clear width of an accessible route is not reduced.)

Corrective Action

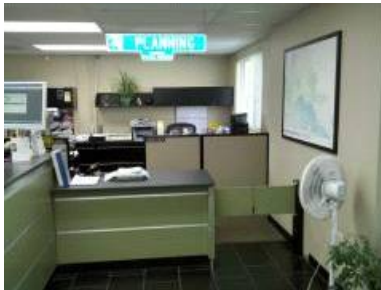
Author: Vaish, B

12B.11C - Counter - Knee Space Depth - Where seating for persons in wheelchairs is provided at table or counter, knee space is not at least 19" deep.

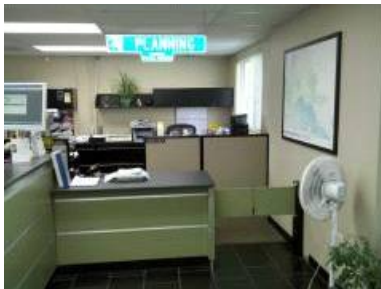
Reported By

11.04 - Gates - Gate does not comply with all applicable ADAAG and CBC accessibility requirements for doors. (ADAAG and CBC accessibility requirements for doors apply to gates, including ticket gates.)

079 - Doors - Miscellaneous - See Additional Comments

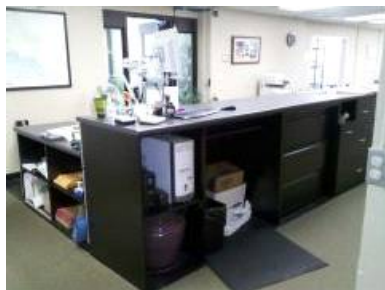
Author: Vaish, B

14.29C - Counter - Knee Space Depth - Where seating for persons in wheelchairs is provided at table or counter, knee space is less than 19" deep.

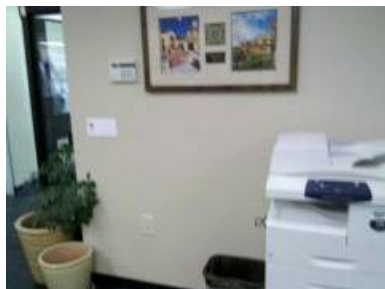
Plan Nbr: DBB
Priority:
Planned Completion: 6/30/2019
Status: Not Complete As of 05/09/2013
Reported By

14.32A - Reach Range - Controls - Controls, dispensers, and similar devices are not between 9" and 54" AFF when the clear floor space allows a parallel approach. OR They are not between 15" and 48" AFF when the clear floor space allows only a forward approach.

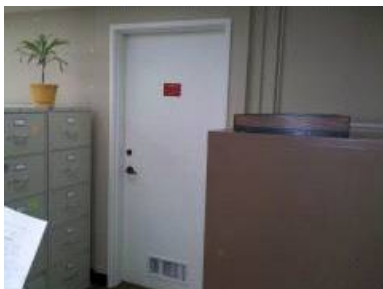
Plan Nbr: DBB
Priority:
Planned Completion 6/30/2019
Status Not Complete As of 05/09/2013
Reported By

Field Condition

11.15A - Kick Plate - Bottom 10" of door does not have a smooth, uninterrupted surface on the push side to allow the door to be opened by a wheelchair footrest without creating a trap or hazardous condition. (This requirement does not apply to automatic and sliding doors.)

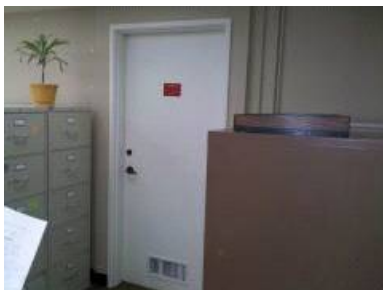
Author: Vaish, B

11.12 - Hardware Mounting Height - Mounting height of all operating hardware is not 30" min.. or 44" max., as measured to the highest operable part. (1994 ADA Standards permit a max.. height of 48"; CBC Standards permit a range of 30" min.. to 44" max..)

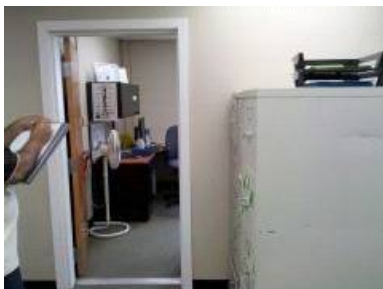
Reported By

14.31 - Head Room - Clear head room is at less than 80" within the pedestrian circulation area, including the accessible route of travel.

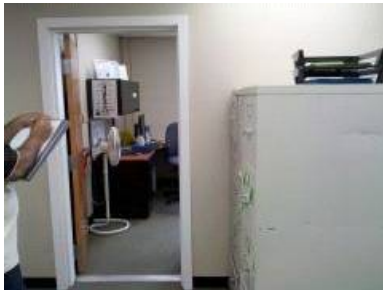
Author: Vaish, B

Field Condition

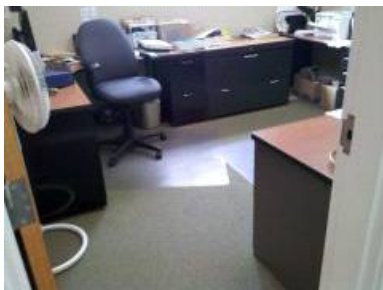
Author: Vaish, B

11.06A - Door Maneuvering Space - Door that is not automatic or power-assisted does not have compliant maneuvering space relative to the direction of approach as shown in CBC Fig. 11B-26. (Approach // Side // Width // Depth) (Front // Pull // D + 24" * // 60") (Front // Push // D + 0" ** // 48") (Latch // Pull // D + 24" // 60") (Latch // Push // D + 24" // 44" *** (Hinge // Pull // D + 36" // 60") (Hinge // Push // 54" **** // 44" *****) (* D + 18" at interior doors.) (** D + 12" if door has both a latch and a closer.) (***) 48" if door has closer.) (**** Measured from latch toward hinge.) (***** 48" if door has both a latch and a closer.)

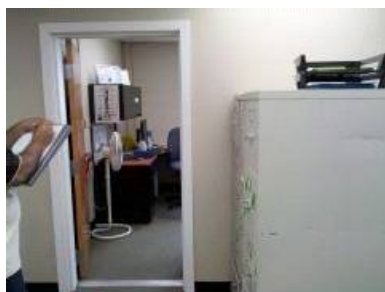
Author: Vaish, B

Field Condition

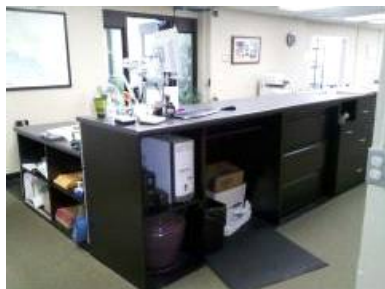
Reported By

1991 ADAAG 4.32.3

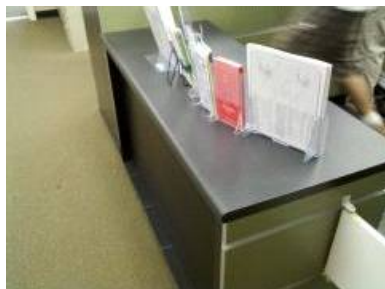
Reported By

14.29C - Counter - Knee Space Depth - Where seating for persons in wheelchairs is provided at table or counter, knee space is less than 19" deep.

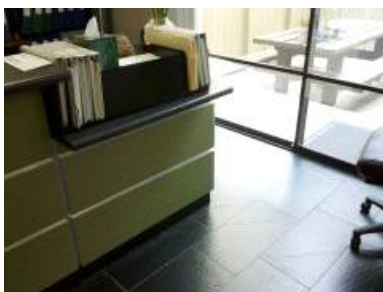
Location:
Comm. Dev. - Cashier

12B.11C - Counter - Knee Space Depth - Where seating for persons in wheelchairs is provided at table or counter, knee space is not at least 19" deep.

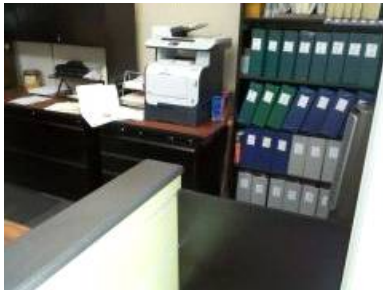
Location:
Comm. Dev. - Cashier

11.06A - Door Maneuvering Space - Door that is not automatic or power-assisted does not have compliant maneuvering space relative to the direction of approach as shown in CBC Fig. 11B-26. (Approach // Side // Width // Depth) (Front // Pull // D + 24" * // 60") (Front // Push // D + 0" ** // 48") (Latch // Pull // D + 24" // 60") (Latch // Push // D + 24" // 44" *** (Hinge // Pull // D + 36" // 60") (Hinge // Push // 54" **** // 44" *****) (* D + 18" at interior doors.) (** D + 12" if door has both a latch and a closer.) (***) 48" if door has closer.) (**** Measured from latch toward hinge.) (***** 48" if door has both a latch and a closer.)

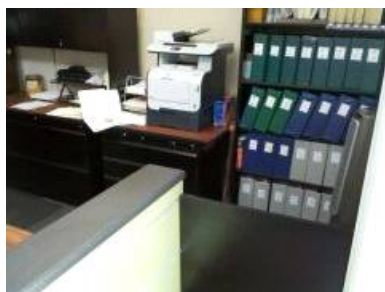
Author: Vaish, B

12A.03 - U-Turn - Where the accessible route of travel makes a U-turn around an obstacle which is less than 48" wide, the pathway width does not increase to at least 42" on the approaches or 48" in the turn.

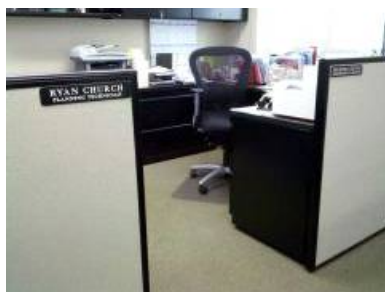
Author: Vaish, B

14.23B - Floor Surface - Accessible route surfaces are not stable, firm and slip-resistant.

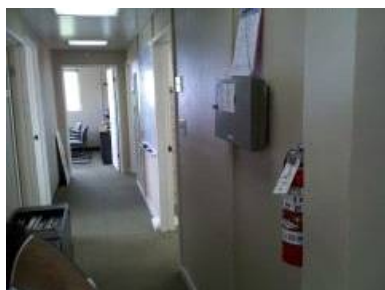
Reported By

14.32A - Reach Range - Controls - Controls, dispensers, and similar devices are not between 9" and 54" AFF when the clear floor space allows a parallel approach. OR They are not between 15" and 48" AFF when the clear floor space allows only a forward approach.

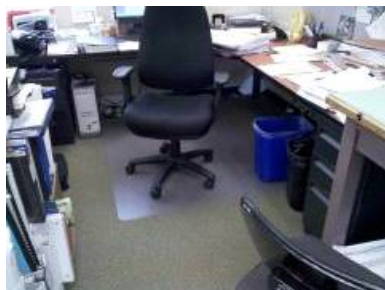
Author: Vaish, B

14.23B - Floor Surface - Accessible route surfaces are not stable, firm and slip-resistant.

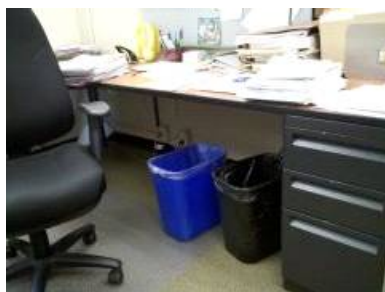
Photo #
170

Existing Condition: Power outlets at less than 15" AFF.

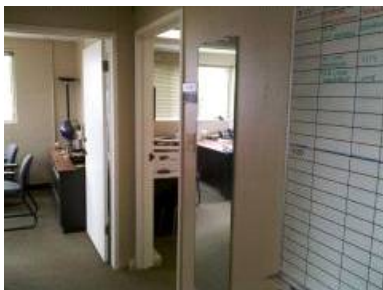
Keynote 172

Existing Condition: Door jamb at 79 3/4" AFF.

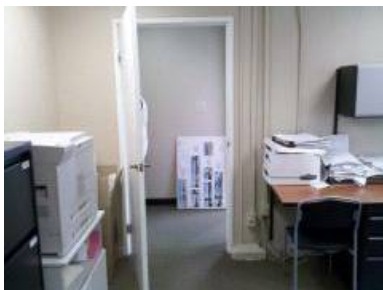
Keynote 173

11.06A - Door Maneuvering Space - Door that is not automatic or power-assisted does not have compliant maneuvering space relative to the direction of approach as shown in CBC Fig. 11B-26. (Approach // Side // Width // Depth) (Front // Pull // D + 24" * // 60") (Front // Push // D + 0" ** // 48") (Latch // Pull // D + 24" // 60") (Latch // Push // D + 24" // 44" *** (Hinge // Pull // D + 36" // 60") (Hinge // Push // 54" **** // 44" *****) (* D + 18" at interior doors.) (** D + 12" if door has both a latch and a closer.) (***) 48" if door has closer.) (**** Measured from latch toward hinge.) (***** 48" if door has both a latch and a closer.)

Existing Condition: 12" pull side, non-fixed furniture.

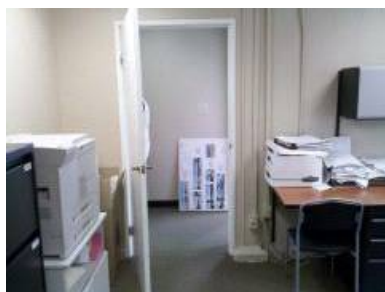
Keynote 174

Existing Condition: Coat hook at 67" AFF.

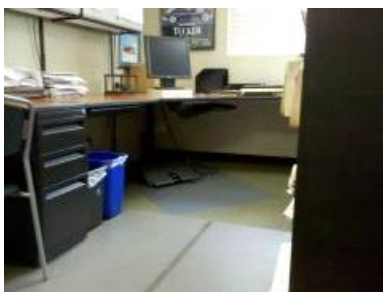
Photo #
176

Existing Condition: Floor mat.

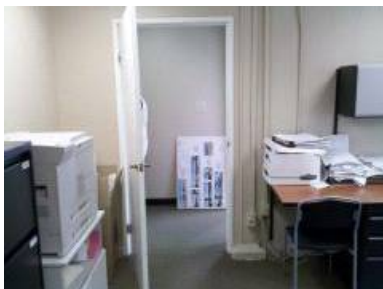
Keynote 177

Existing Condition: 4 power outlets and 1 data port between 12" & 14" AFF.

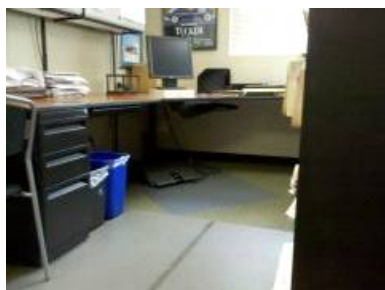
Keynote 179

Existing Condition: Knee space at 26 3/4".

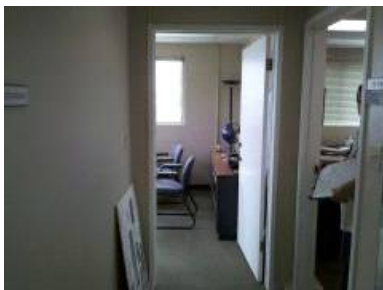
Photo #
180

11.17A - Recommendation: Providing Room/Space ID Sign - A sign designating the permanent room or space has not been provided.

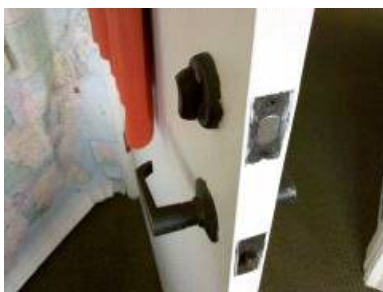
Location: Photo #
Comm. Dev. - Office 182

Existing Condition: Twist-type lock.

031B - Replace Control - Replace control. Repair/refinish as required.

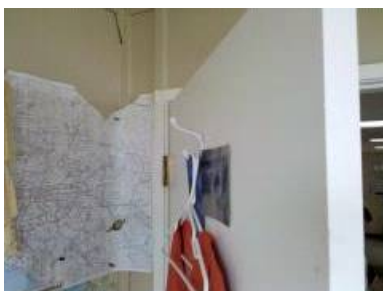
Location: Photo #
Comm. Dev. - Office 183

Existing Condition: Coat hook at 72" AFF.

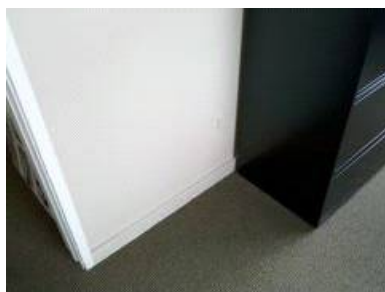
Photo #
184

Existing Condition: Power outlet at 13 1/2" AFF.

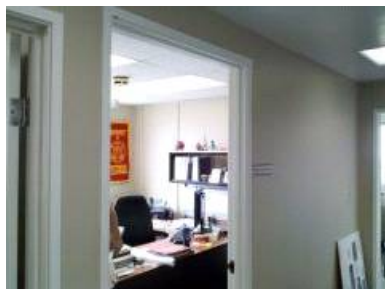
Photo #
185

11.17A - Recommendation: Providing Room/Space ID Sign - A sign designating the permanent room or space has not been provided.

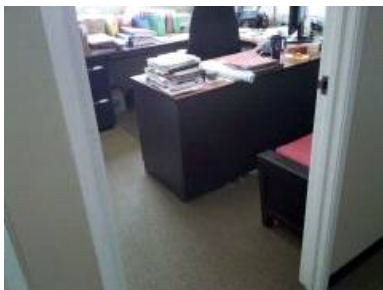
Keynote 186

11.06A - Door Maneuvering Space - Door that is not automatic or power-assisted does not have compliant maneuvering space relative to the direction of approach as shown in CBC Fig. 11B-26. (Approach // Side // Width // Depth) (Front // Pull // D + 24" * // 60") (Front // Push // D + 0" ** // 48") (Latch // Pull // D + 24" // 60") (Latch // Push // D + 24" // 44" *** (Hinge // Pull // D + 36" // 60") (Hinge // Push // 54" **** // 44" *****) (* D + 18" at interior doors.) (** D + 12" if door has both a latch and a closer.) (***) 48" if door has closer.) (**** Measured from latch toward hinge.) (***** 48" if door has both a latch and a closer.)

Existing Condition: Non-fixed furniture encroaches door landing at pull side.

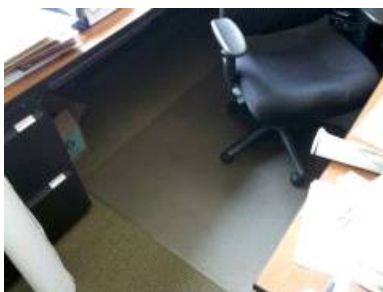
Photo #
187

Existing Condition: Floor mat.

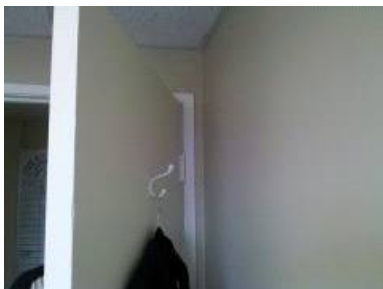
Photo #
188

Existing Condition: Coat hook at 69 1/2" AFF.

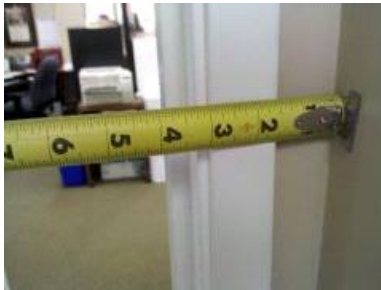
Keynote 190

11.06A - Door Maneuvering Space - Door that is not automatic or power-assisted does not have compliant maneuvering space relative to the direction of approach as shown in CBC Fig. 11B-26. (Approach // Side // Width // Depth) (Front // Pull // D + 24" * // 60") (Front // Push // D + 0" ** // 48") (Latch // Pull // D + 24" // 60") (Latch // Push // D + 24" // 44" ***) (Hinge // Pull // D + 36" // 60") (Hinge // Push // 54" **** // 44" *****) (* D + 18" at interior doors.) (** D + 12" if door has both a latch and a closer.) (***) 48" if door has closer.) (**** Measured from latch toward hinge.) (***** 48" if door has both a latch and a closer.)

Existing Condition: 3" maneuvering space at pull side, wall.

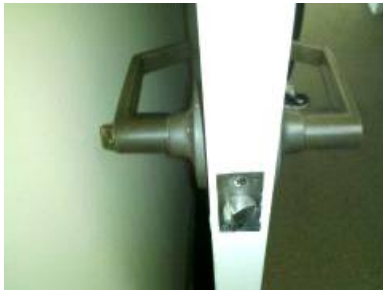
Photo #
191

Existing Condition: Twist-type lock.

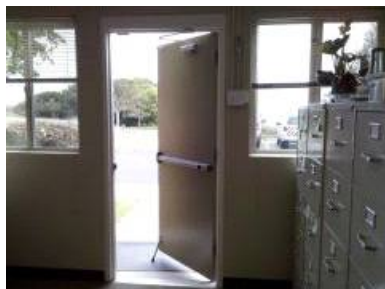
Keynote 196

Existing Condition: 7 LBF.

072B - Replace Closer - Replace door closer.

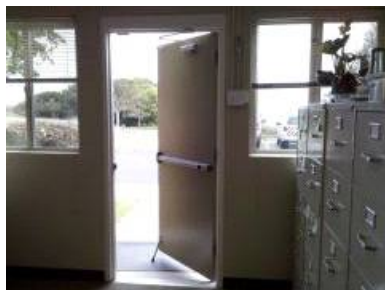
Keynote 199

10.08 - Kick Plate - Bottom 10" of door does not have a smooth, uninterrupted surface on the push side to allow the door to be opened by a wheelchair footrest without creating a trap or hazardous condition. (This requirement does not apply to automatic and sliding doors.)

Existing Condition: Door stop.

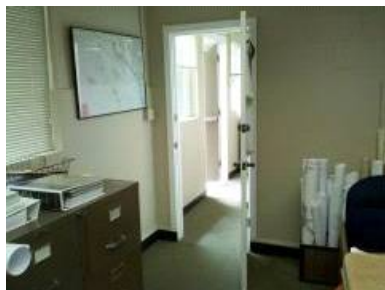
Photo #
203

Existing Condition: Door jamb at 76 3/4" AFF.

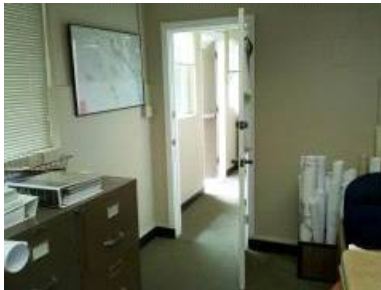
Keynote 204

11.06A - Door Maneuvering Space - Door that is not automatic or power-assisted does not have compliant maneuvering space relative to the direction of approach as shown in CBC Fig. 11B-26. (Approach // Side // Width // Depth) (Front // Pull // D + 24" * // 60") (Front // Push // D + 0" ** // 48") (Latch // Pull // D + 24" // 60") (Latch // Push // D + 24" // 44" *** (Hinge // Pull // D + 36" // 60") (Hinge // Push // 54" **** // 44" *****) (* D + 18" at interior doors.) (** D + 12" if door has both a latch and a closer.) (***) 48" if door has closer.) (**** Measured from latch toward hinge.) (***** 48" if door has both a latch and a closer.)

Existing Condition: 9 1/4" pull side, CMU wall.

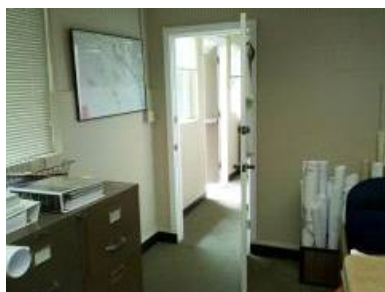
Keynote 205

Existing Condition: 26" clear.

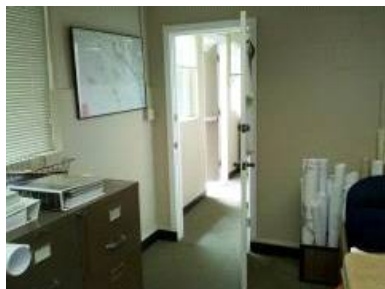
Keynote 206

11.15A - Kick Plate - Bottom 10" of door does not have a smooth, uninterrupted surface on the push side to allow the door to be opened by a wheelchair footrest without creating a trap or hazardous condition. (This requirement does not apply to automatic and sliding doors.)

Existing Condition: 8 1/2".

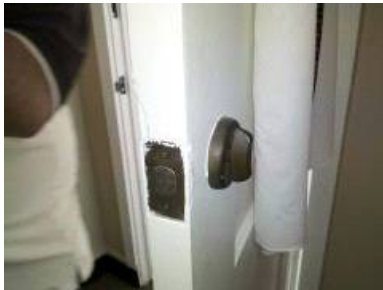
Location: Photo #
Comm. Dev. - Office 207

Existing Condition: Twist-type lock.

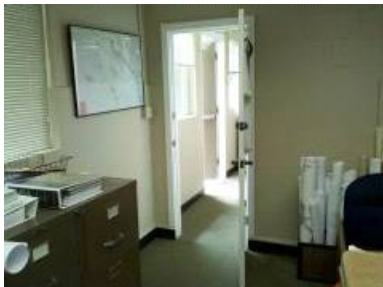
Keynote 208

Existing Condition: Twist-type lock at 48" AFF.

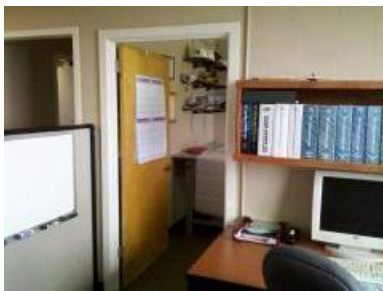
Photo #
213

Existing Condition: Door jamb at 77 1/4" AFF.

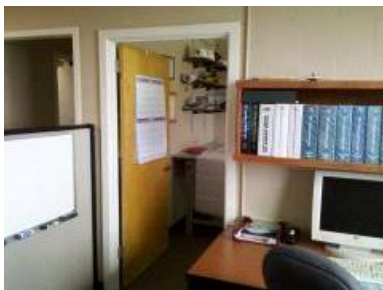
Keynote 214

Existing Condition: 51" door landing at pull side, non-fixed furniture.

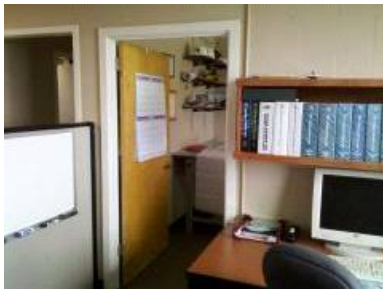
Keynote 216

11.17A - Recommendation: Providing Room/Space ID Sign - A sign designating the permanent room or space has not been provided.

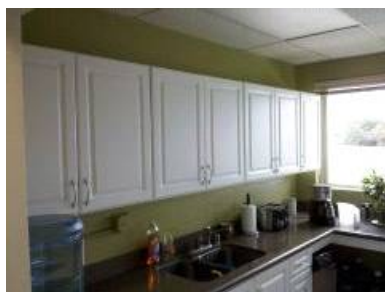
Location: Photo #
Comm. Dev. - Break Room 217

Existing Condition:

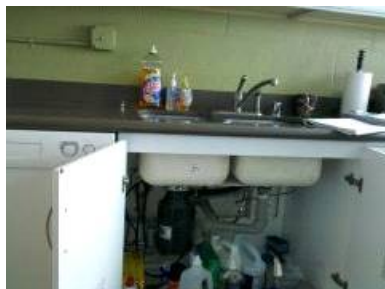
Location: Photo #
Comm. Dev. - Break Room 218

Existing Condition:

480A - New Counter Top and Sink - Remove existing cabinetry, and provide new counter at 34" above the finished floor. Remove and replace sink and faucet with new accessible sink and faucet. Provide accessible knee clearance (i.e. at least 27" high, 30" wide, and 19" deep) under the sink.

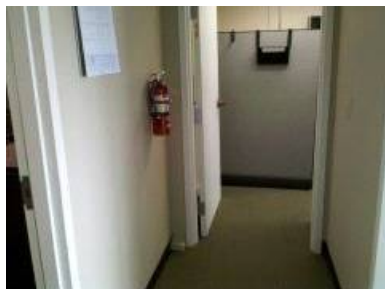
Location:
Comm. Dev. - Hallway

20.16B - Surface-Mounted Fire Extinguisher - Mounting Height - Where fire extinguishers are surface-mounted, mounting height of the extinguisher is not compliant. (Compliant surface-mounted extinguisher is 48" AFF maximum, as measured to the highest operable part, or in existing buildings, when the extinguisher is 54" AFF and parallel approach is provided)

Existing Condition: 52" AFF.

388D - Relocate Fire Extinguisher - Relocate existing fire extinguisher. Repair and refinish.

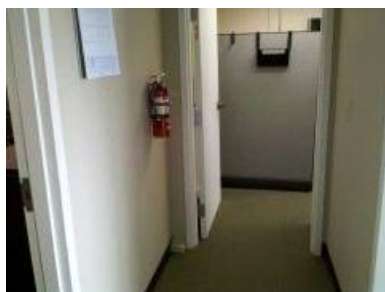
Location: Photo #
Comm. Dev. - Hallway 220

Existing Condition: Fire extinguisher protrudes 4 3/4" at 39 1/4" AFF.

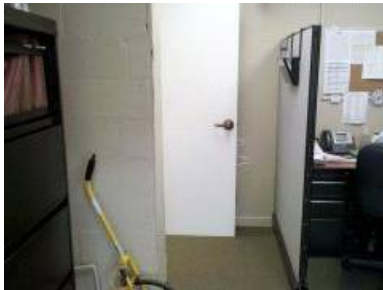
Photo #
223

Existing Condition: Non-fixed furniture encroaches door landing at pull side.

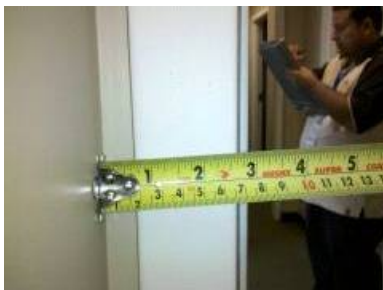
11.06A - Door Maneuvering Space - Door that is not automatic or power-assisted does not have compliant maneuvering space relative to the direction of approach as shown in CBC Fig. 11B-26. (Approach // Side // Width // Depth) (Front // Pull // D + 24" * // 60") (Front // Push // D + 0" ** // 48") (Latch // Pull // D + 24" // 60") (Latch // Push // D + 24" // 44" ***) (Hinge // Pull // D + 36" // 60") (Hinge // Push // 54" **** // 44" *****) (* D + 18" at interior doors.) (** D + 12" if door has both a latch and a closer.) (***) 48" if door has closer.) (**** Measured from latch toward hinge.) (***** 48" if door has both a latch and a closer.)

Existing Condition: 2 3/4" maneuvering space at pull side.

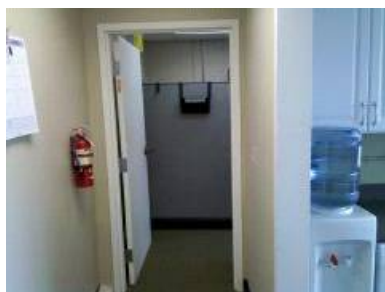
Photo #
225

Existing Condition: Door jamb at 79" AFF.

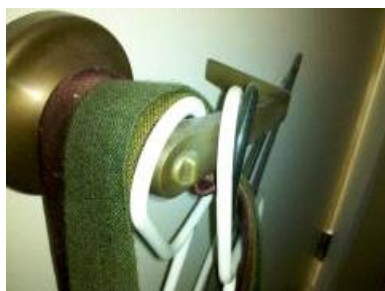
Photo #
226

Existing Condition: Twist-type lock.

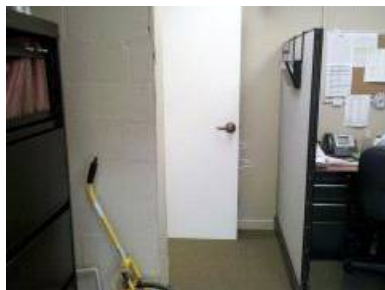
Photo #
223

Existing Condition: 33" clear.

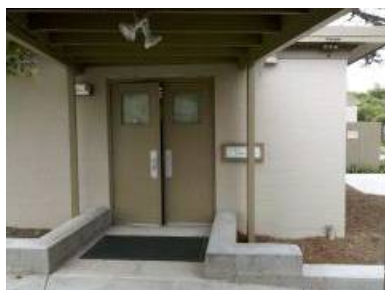
Location: Photo #
Comm. Dev. - Conference Rm 230

Existing Condition: 28" clear.

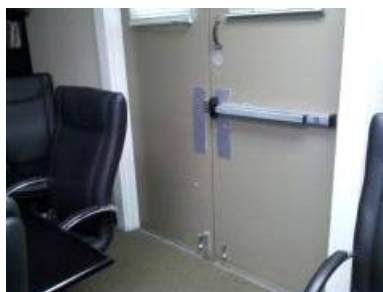
Location: Photo #
Comm. Dev. - Conference Rm 233

10.08 - Kick Plate - Bottom 10" of door does not have a smooth, uninterrupted surface on the push side to allow the door to be opened by a wheelchair footrest without creating a trap or hazardous condition. (This requirement does not apply to automatic and sliding doors.)

Existing Condition: Door stop.

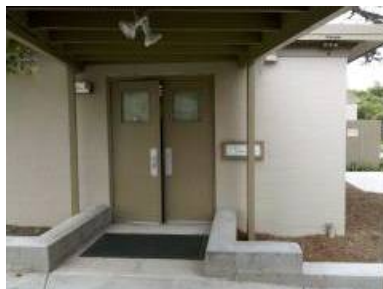
Location: Photo #
Comm. Dev. - Conference Rm 230

Existing Condition: 60" AFF.

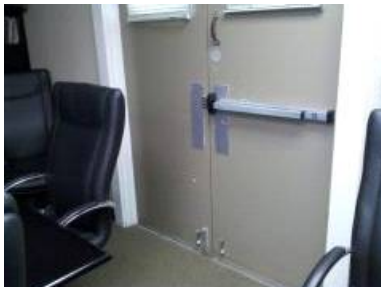
Location: Photo #
Comm. Dev. - Conference Rm 233

10.08 - Kick Plate - Bottom 10" of door does not have a smooth, uninterrupted surface on the push side to allow the door to be opened by a wheelchair footrest without creating a trap or hazardous condition. (This requirement does not apply to automatic and sliding doors.)

Existing Condition: Latch.

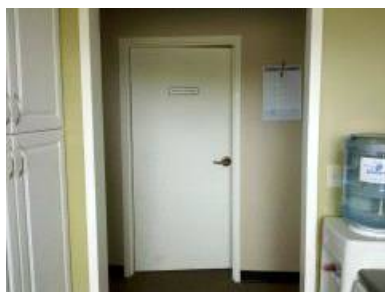
Location: Photo #
Comm. Dev. - Conference Rm 238

11.17A - Recommendation: Providing Room/Space ID Sign - A sign designating the permanent room or space has not been provided.

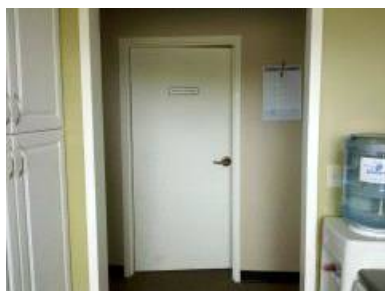
Location: Photo #
Comm. Dev. - Conference Rm 238

Existing Condition: Door jamb at 79" AFF.

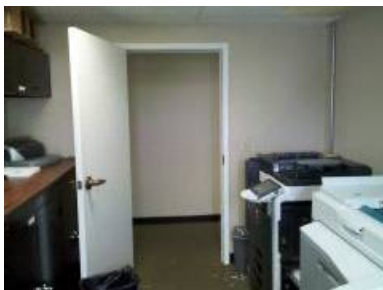
Photo #
243

Existing Condition: Door jamb at 79 1/8" AFF.

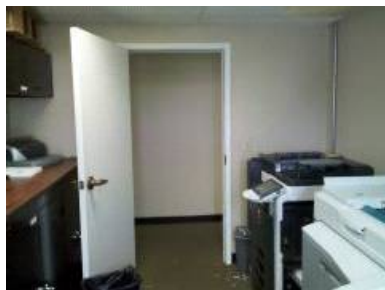
11.06A - Door Maneuvering Space - Door that is not automatic or power-assisted does not have compliant maneuvering space relative to the direction of approach as shown in CBC Fig. 11B-26. (Approach // Side // Width // Depth) (Front // Pull // D + 24" * // 60") (Front // Push // D + 0" ** // 48") (Latch // Pull // D + 24" // 60") (Latch // Push // D + 24" // 44" *** (Hinge // Pull // D + 36" // 60") (Hinge // Push // 54" **** // 44" *****) (* D + 18" at interior doors.) (** D + 12" if door has both a latch and a closer.) (***) 48" if door has closer.) (**** Measured from latch toward hinge.) (***** 48" if door has both a latch and a closer.)

Existing Condition: 0" maneuvering space at pull side, copy machine.

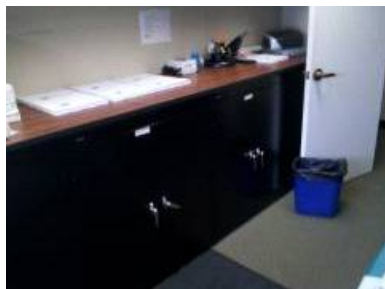
Location:
Comm. Dev. - Copy Rm

14.28 - Fixed/Built-in Seating, Tables or Counters - At fixed or built-in seating, tables, or counters in public or common employee areas, less than 5% of the provided seating spaces are wheelchair accessible and have a 30" by 48" clear space which overlaps an accessible route of travel. (Wheelchair accessible seating spaces are between 28" - 34" high and with knee space measuring at least 27" high, 30" wide, and 19" deep.) (These elements include study carrels and student laboratory stations.)

Existing Condition: 42 1/2" to counter top, 0" knee space.

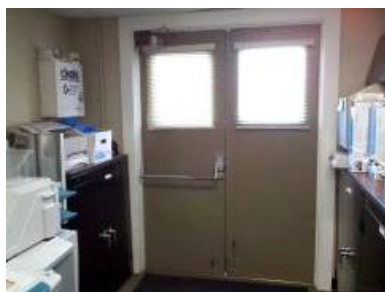
Location: Photo #
Comm. Dev. - Copy Rm 247

Existing Condition: First aid kit at 73" AFF.

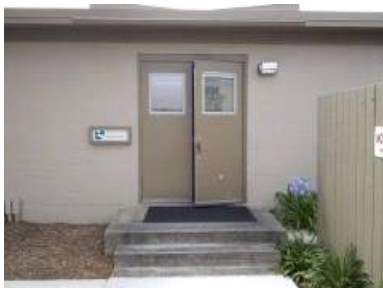
Location: Photo #
Comm. Dev. - Copy Rm 250

Existing Condition: 28" clear.

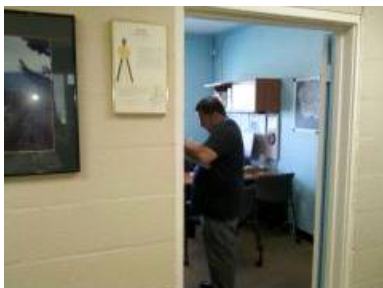
Location: Photo #
Admin. - Office 252

Existing Condition: 77 1/2" at door

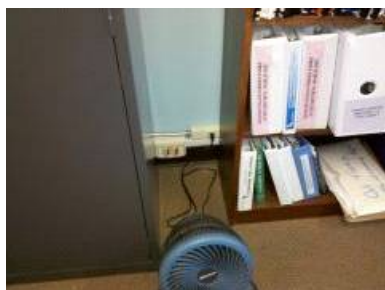
Location: Photo #
Admin. - Office 254

Existing Condition: 2 data, 1 power strip.

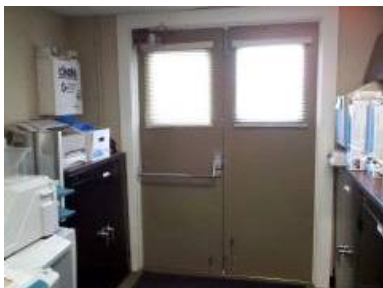
Location: Photo #
Comm. Dev. - Copy Rm 247

Existing Condition: 6 LBF.

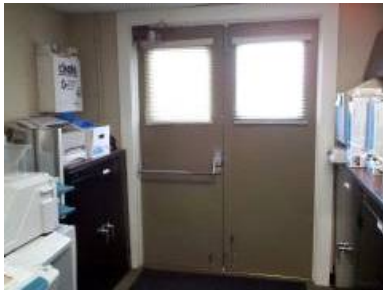
Location: Photo #
Comm. Dev. - Copy Rm 247

Existing Condition: 9 LBF.

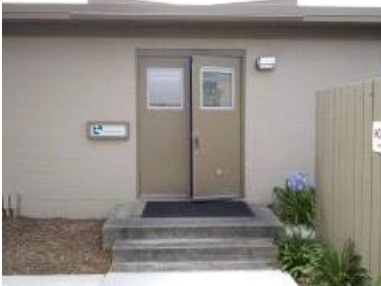
Location: Photo #
Comm. Dev. - Copy Rm 250

Existing Condition: 54" AFF.

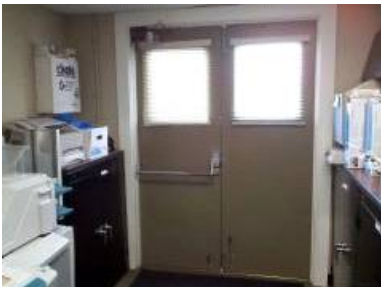
Location: Photo #
Comm. Dev. - Copy Rm 247

Existing Condition: Pinching latch lock.

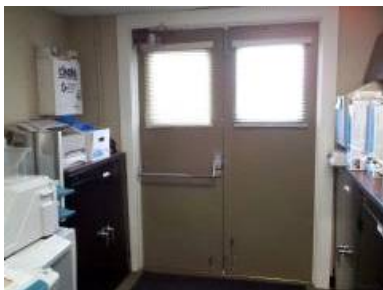
Location: Photo #
Comm. Dev. - Copy Rm 247

Existing Condition: Latch lock at 75" AFF.

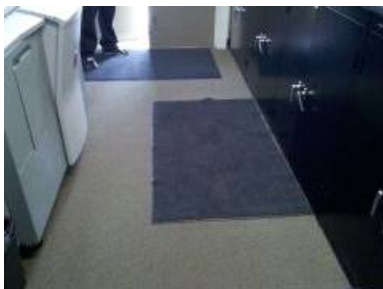
Location: Photo #
Comm. Dev. - Copy Rm 262

Existing Condition: Floor mat.

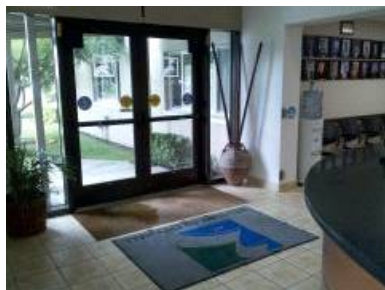
Location: Admin. - Reception
Photo # 263

Existing Condition: 2 floor mats

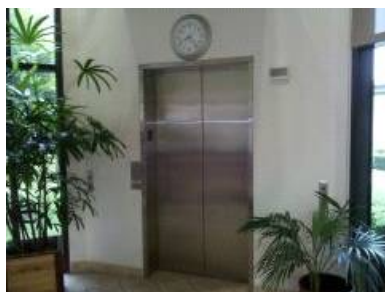
Location: Admin. - Elevator
Photo # 267

Existing Condition: 42 1/4" high at 1st flr. & 41 1/2" at 2nd flr.

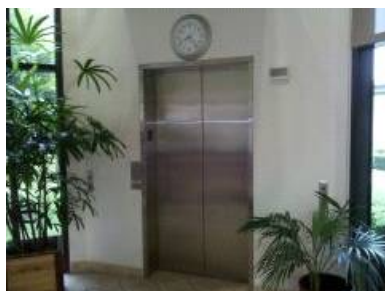
Location: Admin. - Elevator
Photo # 267

Existing Condition: illuminated w/ red light
