City of Rancho Palos Verdes
Rancho Palos Verdes ADA Assessment
Facility Report with Photos

Facility ID: # 02B - City Hall Buildings

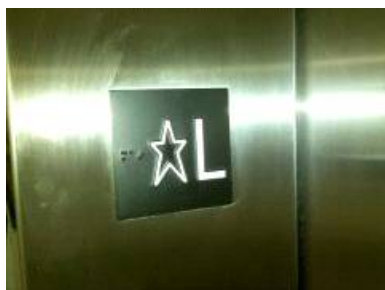
Location: Admin. - Elevator
Photo # 270

Existing Condition: Braille space to wide at 1st & 2nd floor

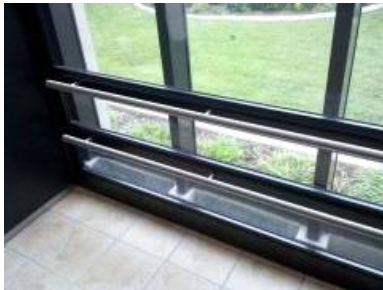
Photo #
271

Existing Condition: 31" AFF.

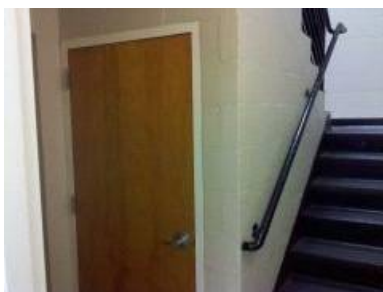
11.06A - Door Maneuvering Space - Door that is not automatic or power-assisted does not have compliant maneuvering space relative to the direction of approach as shown in CBC Fig. 11B-26. (Approach // Side // Width // Depth) (Front // Pull // D + 24" * // 60") (Front // Push // D + 0" ** // 48") (Latch // Pull // D + 24" // 60") (Latch // Push // D + 24" // 44" ****) (Hinge // Pull // D + 36" // 60") (Hinge // Push // 54" **** // 44" *****) (* D + 18" at interior doors.) (** D + 12" if door has both a latch and a closer.) (*** 48" if door has closer.) (**** Measured from latch toward hinge.) (***** 48" if door has both a latch and a closer.)

Existing Condition: 42 1/2" deep landing at pull side

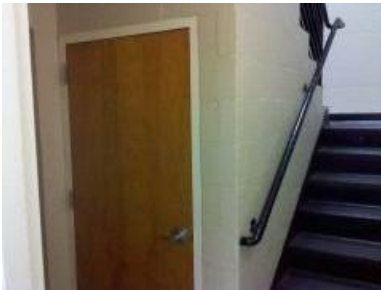
Location: Admin. - Central Stairwell
Photo # 273

Existing Condition: 78 1/2" at door

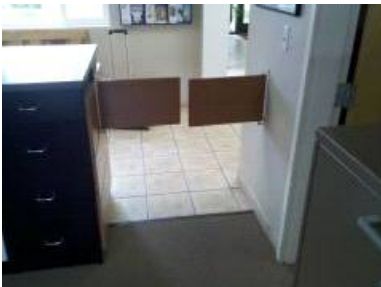
Location: Admin. - Open Office
Photo # 274

Existing Condition: 18" wide gate & 26 3/4" toe space.

054A - Replace Door - Remove existing door and replace with new door and door frame. Provide new accessible door hardware.

Additional Comments: replace with one compliant gate.

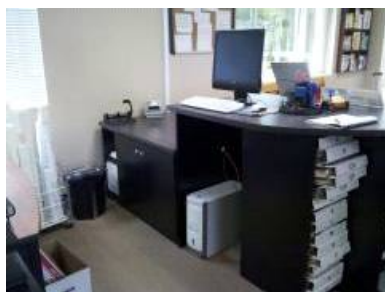
Location: Admin. - Open Office
Photo # 276

Existing Condition: 20" wide

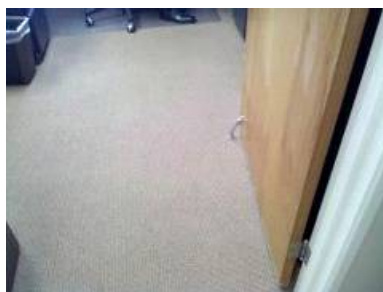
Location: Admin. - Office
Photo # 299

11.15A - Kick Plate - Bottom 10" of door does not have a smooth, uninterrupted surface on the push side to allow the door to be opened by a wheelchair footrest without creating a trap or hazardous condition. (This requirement does not apply to automatic and sliding doors.)

Existing Condition: Door stop

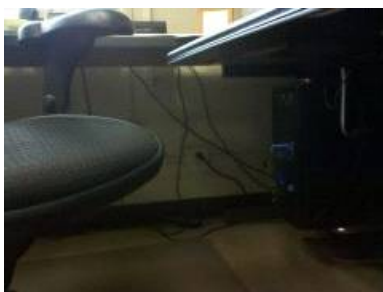
Location: Admin. - Office
Photo # 303

Existing Condition: 3 outlets

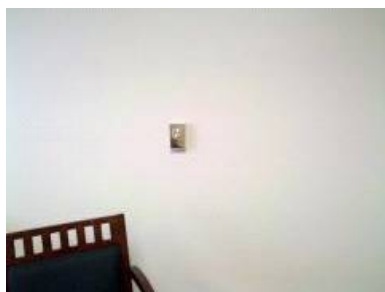
Location: Admin. - Office
Photo # 307

Existing Condition: 3 outlet & 3 Data, 1 thermostat

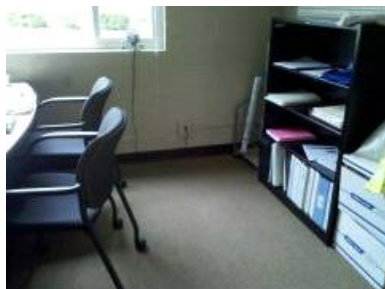
Location: Admin. - Office
Photo # 312

Existing Condition: 3 outlet & 3 data

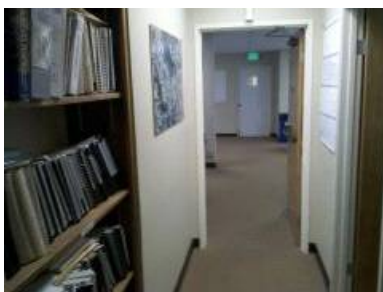
Location: Admin. - Conf.
Photo # 314

Existing Condition: 4" push side

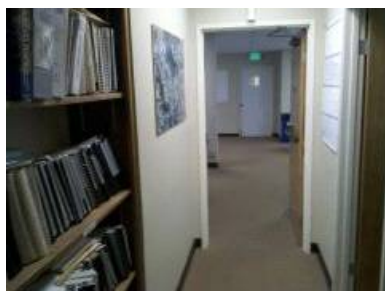
Keynote 316

Existing Condition:

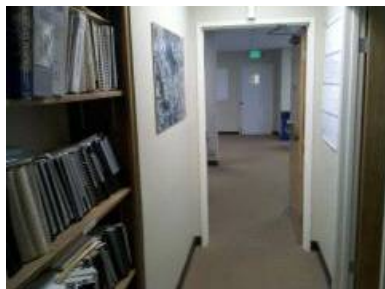
Keynote 318

11.15A - Kick Plate - Bottom 10" of door does not have a smooth, uninterrupted surface on the push side to allow the door to be opened by a wheelchair footrest without creating a trap or hazardous condition. (This requirement does not apply to automatic and sliding doors.)

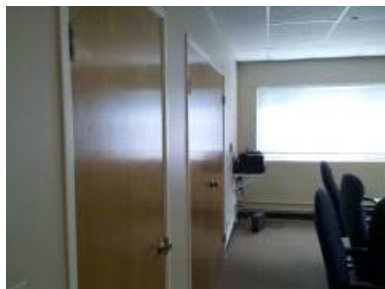
Keynote 320

Existing Condition:

067A - Replace Knob(s) with Lever Hardware - Remove knobs and existing latch and lock set. Provide new levers with new latch and lock sets.

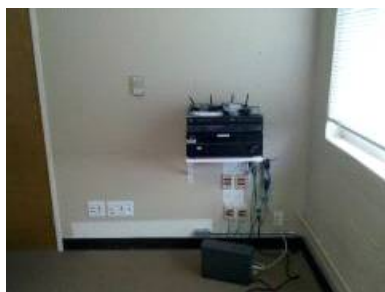
Keynote 321

Existing Condition: 16" deep at 31" high audio equipment

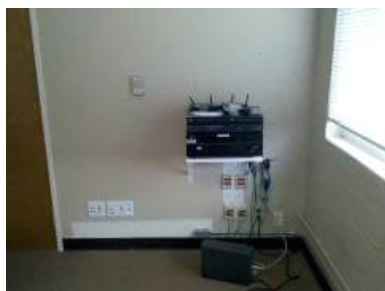
Keynote 322

Existing Condition: 5 outlets, 4 data, 3 audio

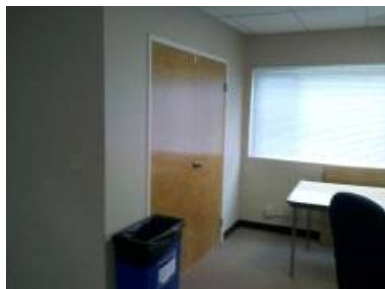
Keynote 324

Existing Condition:

067A - Replace Knob(s) with Lever Hardware - Remove knobs and existing latch and lock set. Provide new levers with new latch and lock sets.

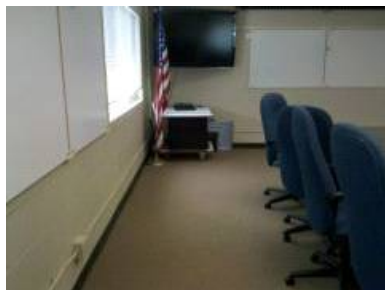
Keynote 326

Existing Condition: 4" at 53" high LCD screen

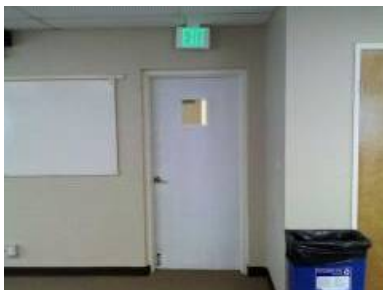
Keynote 328

Existing Condition: 7 lb.

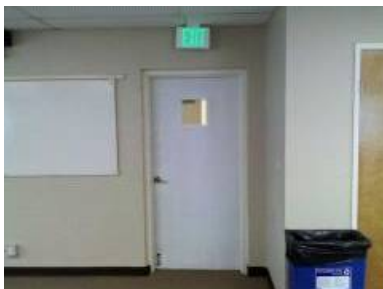
Keynote 329

11.15A - Kick Plate - Bottom 10" of door does not have a smooth, uninterrupted surface on the push side to allow the door to be opened by a wheelchair footrest without creating a trap or hazardous condition. (This requirement does not apply to automatic and sliding doors.)

Existing Condition: Door stop

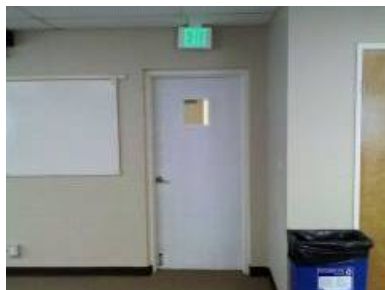
Keynote 330

Existing Condition: 59 3/4" high

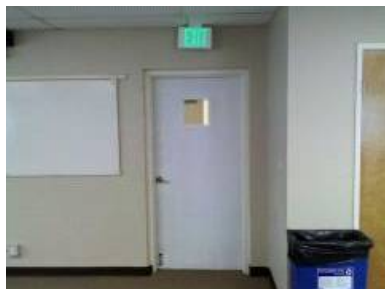
Keynote 333

Existing Condition: 79" at door

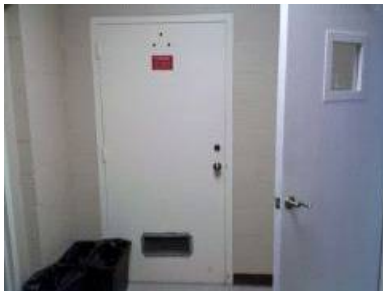
Keynote 334

Existing Condition: 78 1/2" at door

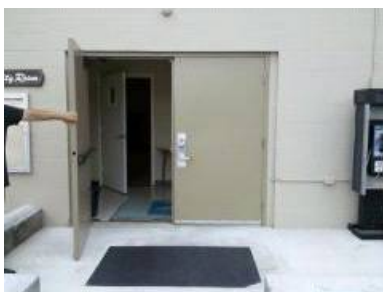
Keynote 336

10.02 - Entrance Sign - Accessible entrance is not identified by an ISA. 1991 ADAAG 28 CFR 35.163(b)1
Existing Condition: 2004 ADAAG 216.6
2007 CBC 1117B.5.8.1.2
Other -

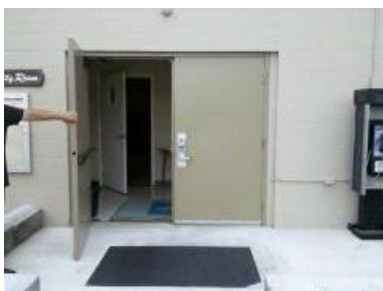
Keynote 337

10.07A - Landing - Level and Clear - Floor is not level (slope is greater than 2% in some or all directions). OR Floor is not clear within the required maneuvering space. 1991 ADAAG 4.13.6; Fig. 25
Existing Condition: 3.0% @ threshold & 2.7% at landing 2004 ADAAG 305; 404.2.4.4
2007 CBC 1133B.2.4
Other -

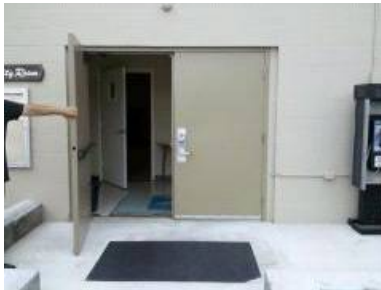
Keynote 338

Existing Condition: 10 lbs.

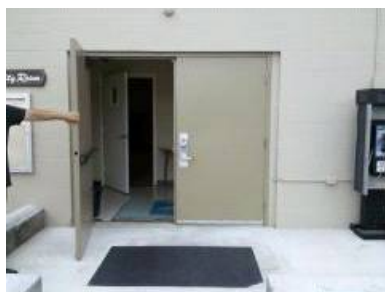
Keynote 340

Existing Condition: 2.5 secs.

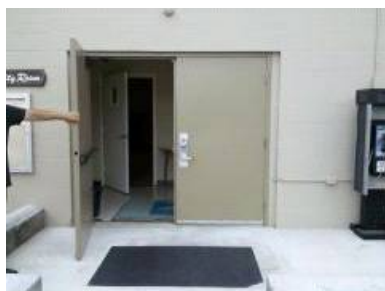
Keynote 341

Existing Condition: 2 floor mats

075B - Surface-Mounted Walk-Off Mat - Remove existing walk-off mat and replace with new surface-mounted walk-off mat. Permanently attach mat to floor. Edges of mat shall be beveled with a slope no greater than 1:2 or shall not exceed 1/4" in height.

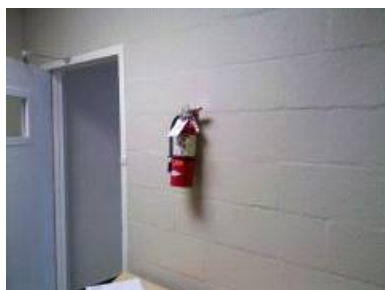
Keynote 343

Existing Condition: 64" high

388D - Relocate Fire Extinguisher - Relocate existing fire extinguisher. Repair and refinish.

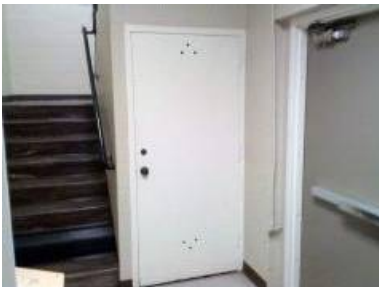
Keynote 345

Existing Condition: 78 1/2" at door

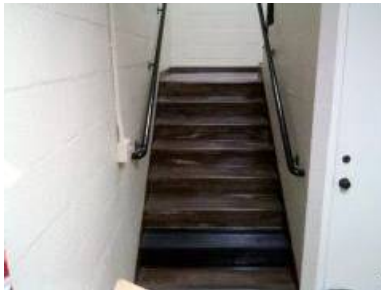
Keynote 346

Existing Condition: 43" x 4

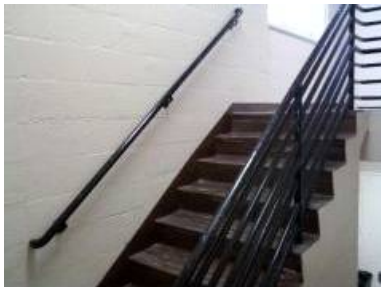
Keynote 347

08.09A - Handrail Extensions - Top Landing - At ends of handrails, less than 12" of handrail extends beyond the top nosing. (Top and bottom handrail extensions are important safety features for persons with balance problems and must extend in the direction of the stair run to permit the intended use.) (Per ADA/CBC Standards, in existing buildings and facilities, full extension of handrails at stairs shall not be required in alterations where such extensions would be hazardous or impossible due to plan configuration.)

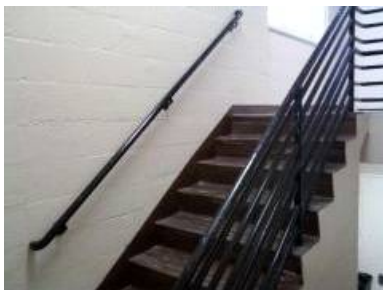
Keynote 348

08.09B - Handrail Extensions - Bottom Landing - At ends of handrails, less than 12" plus the tread width extends beyond the bottom nosing. (Top and bottom handrail extensions are important safety features for persons with balance problems and must extend in the direction of the stair run to permit the intended use.) (Per ADA/CBC Standards, in existing buildings and facilities, full extension of handrails at stairs shall not be required in alterations where such extensions would be hazardous or impossible due to plan configuration.)

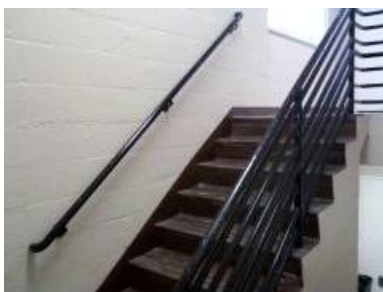
Keynote 349

08.09E - Handrails - Height above Stair Nosings - The tops of handrails are not between 34" and 38" above the stair nosings.

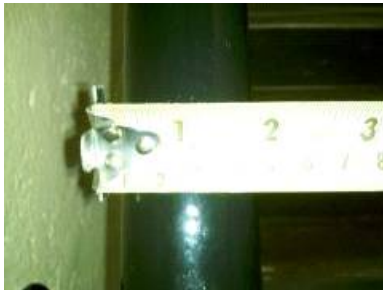
Keynote 350

Existing Condition: 2" dia.

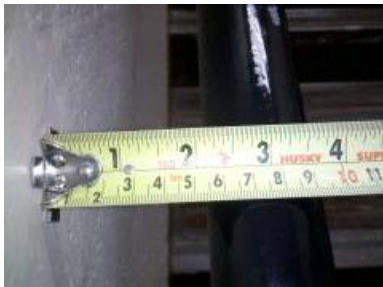
Keynote 351

Existing Condition: 2" clr.

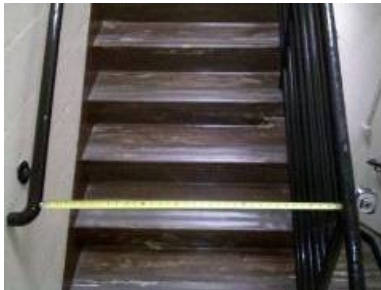
Keynote 352

Existing Condition: 35" wide.

257A - Replace Stairs - Replace stairs to comply with rise/run requirements.

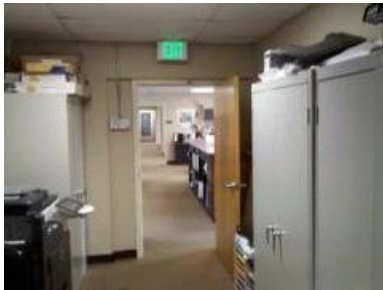
Keynote 354

Existing Condition: 12 LBF.

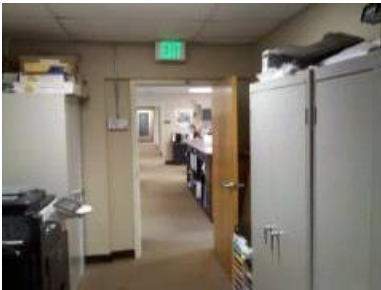
Keynote 355

11.21A - Required Exit Route Sign - At exit access door from an interior room or area that is required to have a visual exit sign, there is no tactile and CA Braille exit sign with the words "EXIT ROUTE" mounted on the wall adjacent to the latch side of the door. (Visual exit signs are required when two or more exits are required. Generally, all occupants shall have access to two exits from a floor (CBC Table 1019.1). Exceptions: a) Single story building with maximum occupant load of 49 and less than 75 ft travel distance to exit (CBC Table 1019.2), and b) Two story building with maximum occupant load of 30 occupants per floor and maximum travel distance of 75 ft to exit. (CBC Table 1019.2). Two exit access doors are required from an office tenant space when the occupant load exceeds 49.)

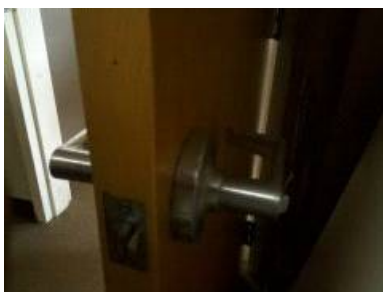
Keynote 356

Existing Condition: Twist-type locking mechanism.

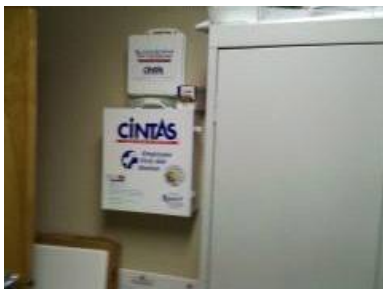
Keynote 357

Existing Condition: First aid kit at 65" AFF & infection control kit at 78" AFF.

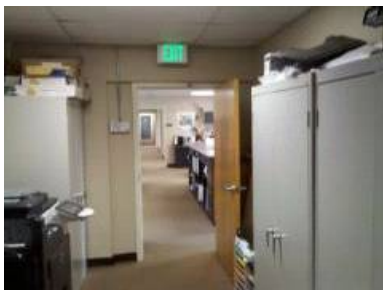
Keynote 358

Existing Condition: Security pad at 61 1/2" AFF.

031B - Replace Control - Replace control. Repair/refinish as required.

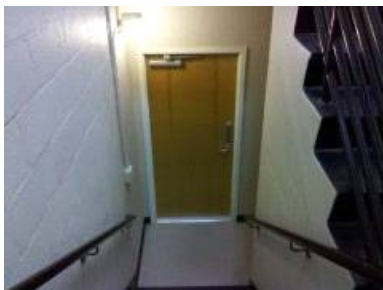
Keynote 359

11.06A - Door Maneuvering Space - Door that is not automatic or power-assisted does not have compliant maneuvering space relative to the direction of approach as shown in CBC Fig. 11B-26. (Approach // Side // Width // Depth) (Front // Pull // D + 24" * // 60") (Front // Push // D + 0" ** // 48") (Latch // Pull // D + 24" // 60") (Latch // Push // D + 24" // 44" *** (Hinge // Pull // D + 36" // 60") (Hinge // Push // 54" **** // 44" *****) (* D + 18" at interior doors.) (** D + 12" if door has both a latch and a closer.) (***) 48" if door has closer.) (**** Measured from latch toward hinge.) (***** 48" if door has both a latch and a closer.)

Existing Condition: 42 1/2" landing at push side, 51 1/2" landing at pull side.

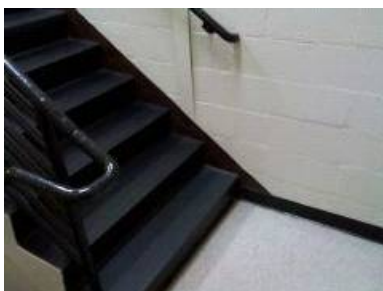
Keynote 363

Existing Condition: 46" X 4.

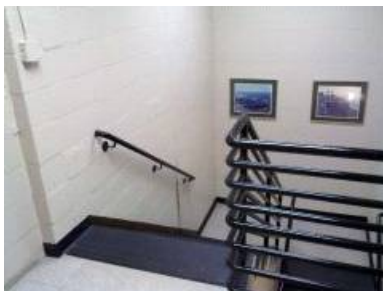
Keynote 364

08.09A - Handrail Extensions - Top Landing - At ends of handrails, less than 12" of handrail extends beyond the top nosing. (Top and bottom handrail extensions are important safety features for persons with balance problems and must extend in the direction of the stair run to permit the intended use.) (Per ADA/CBC Standards, in existing buildings and facilities, full extension of handrails at stairs shall not be required in alterations where such extensions would be hazardous or impossible due to plan configuration.)

Existing Condition: Extensions not provided.

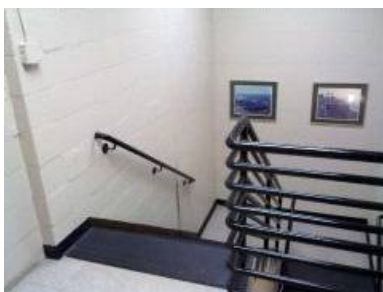
Keynote 366

08.10A - Profile of Handrails - The diameter of the handrail is not between 1-1/4" and 1-1/2" in cross-sectional nominal dimension. OR The shape does not provide an equivalent gripping surface (equivalent gripping surfaces are 4" to 6-1/4" in perimeter, and 2-1/4" max. in any direction). (Note: Standard pipe sizes designated by the industry as 1-1/4" to 1-1/2" are acceptable).

Existing Condition: 1 3/4" diameter.

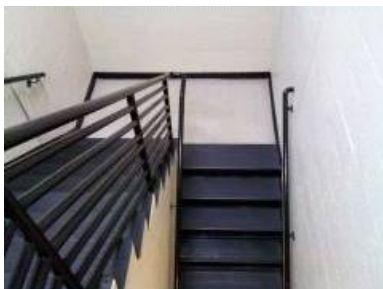
Keynote 368

Existing Condition: 39 3/4" clear.

257A - Replace Stairs - Replace stairs to comply with rise/run requirements.

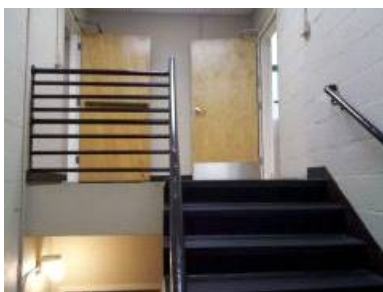
Keynote 369

Existing Condition: Not provided.

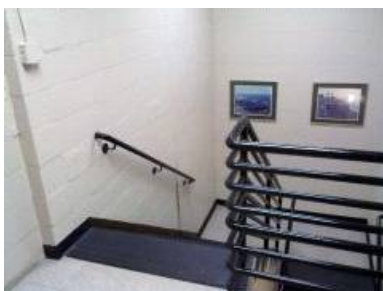
Keynote 370

Existing Condition: 32" above nosing.

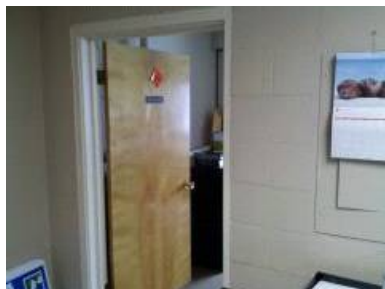
Keynote 372

Existing Condition: Door jamb at 77 1/2" AFF.

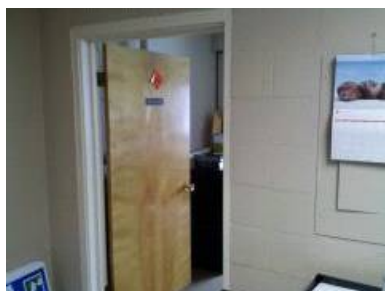
Keynote 374

Existing Condition: On door.

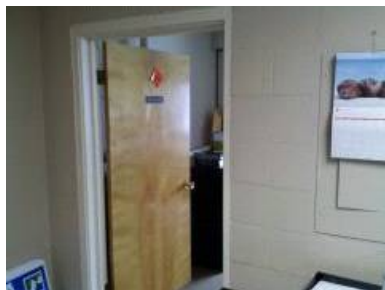
Keynote 375

Existing Condition: Door knob.

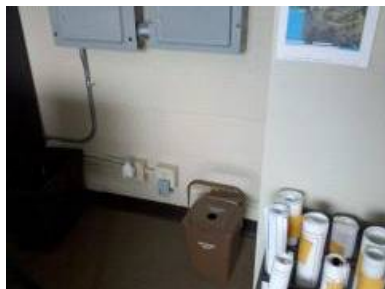
Keynote 376

Existing Condition: 5 power outlets.

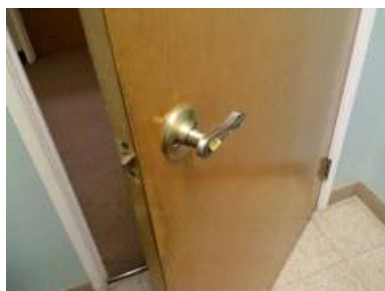
Keynote 378

Existing Condition: Twist-type locking mechanism.

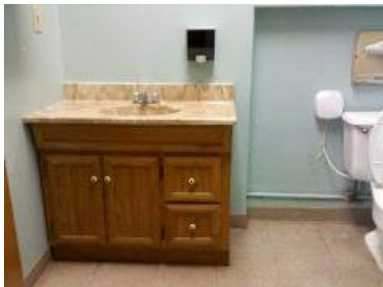
Keynote 382

Existing Condition: 51" diameter.

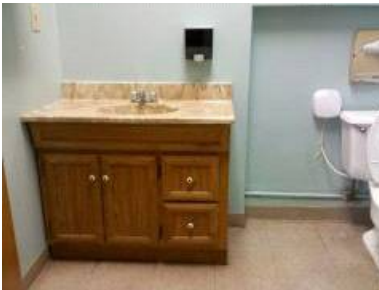
Keynote 383

Existing Condition: 25" clear.

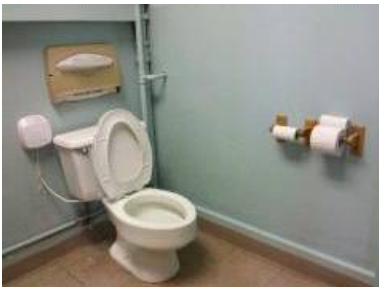
Keynote 384

Existing Condition: 17 1/2" from side wall.

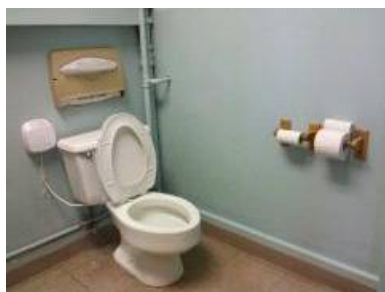
Keynote 385

16.48 - WC Seat Height - The top of the WC seat is not between 17" and 19" AFF. 1991 ADAAG 4.16.3; Fig. 29(b)
Existing Condition: 15" AFF.
2004 ADAAG 604.4
2007 CBC 1115B.4.1(4); Fig. 11B-1A
Other -

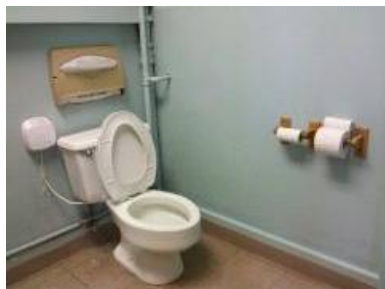
Keynote 386

16.53 - SC Dispenser Height - Mounting height of seat cover dispenser's highest operable part exceeds 40" AFF. 1991 ADAAG 4.22.7; 4.27.3; 4.2.5; 4.2.6
Existing Condition: 43" AFF.
2004 ADAAG -
2007 CBC 1115B.8.3
Other -

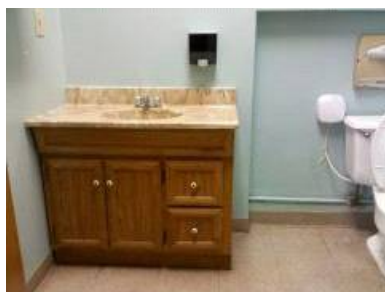
Keynote 389

Existing Condition: Knee space not provided.

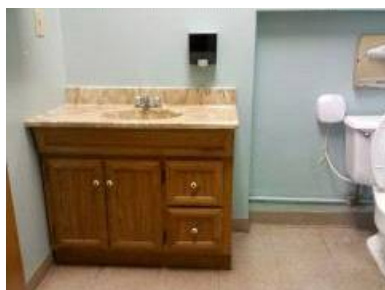
Keynote 390

Existing Condition: Twist-type faucet control.

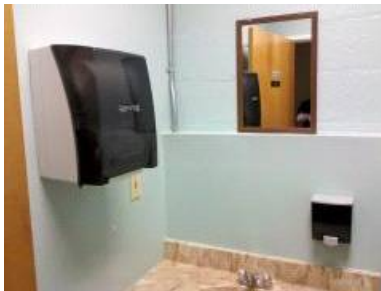
Keynote 391

Existing Condition: 56 1/2" AFF.

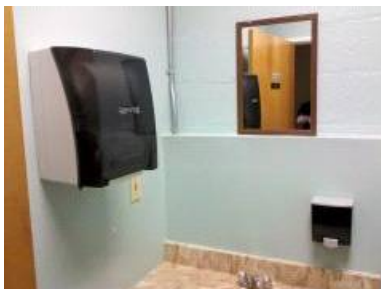
Keynote 392

Existing Condition: 53" AFF.

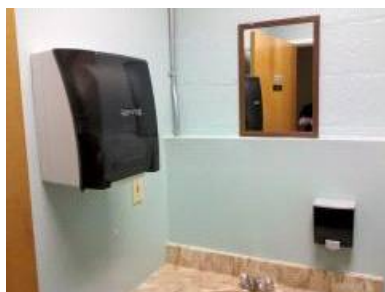
Keynote 393

Existing Condition: P.T.D. protrudes 5"

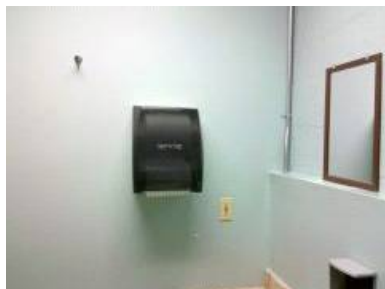
Keynote 394

Existing Condition: 75" AFF.

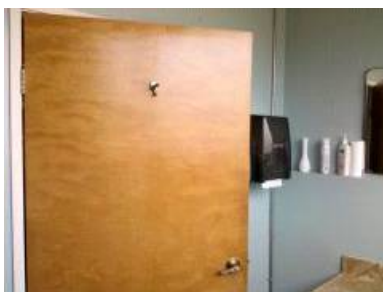
Keynote 397

Existing Condition: Twist-type locking mechanism.

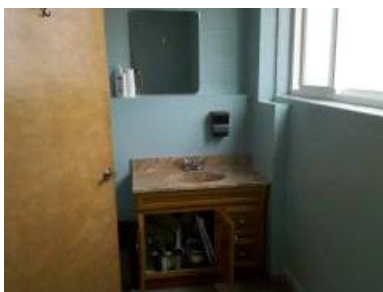
Keynote 401

16.09A - Door Maneuvering Space - Door that is not automatic or power-assisted does not have compliant maneuvering space relative to the direction of approach as shown in CBC Fig. 11B-26. (Approach // Side // Width // Depth) (Front // Pull // D + 24" * // 60") (Front // Push // D + 0" ** // 48") (Latch // Pull // D + 24" // 60") (Latch // Push // D + 24" // 44" ***) (Hinge // Pull // D + 36" // 60") (Hinge // Push // 54" **** // 44" *****) (* D + 18" at interior doors.) (** D + 12" if door has both a latch and a closer.) (***) 48" if door has closer.) (**** Measured from latch toward hinge.) (***** 48" if door has both a latch and a closer.)

Existing Condition: 8" to lavatory, pull side.

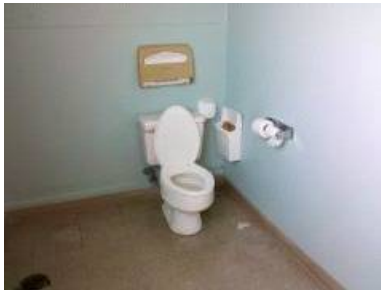
Keynote 402

Existing Condition: 20" from side wall.

319C - Water Closet - New Location - Replace existing water closet with compliant model in new location.

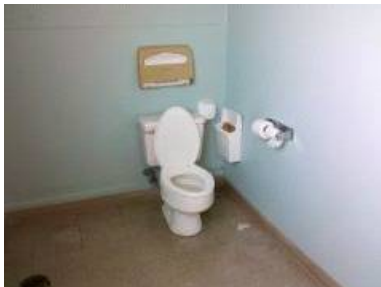
Keynote 403

Existing Condition: 15 1/2" AFF.

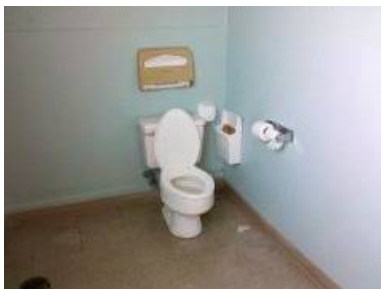
Location: Admin. - Women's Restroom
Photo # 402

Existing Condition:

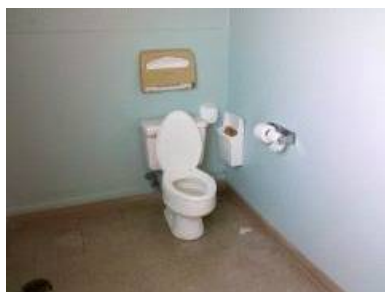
Location: Admin. - Women's Restroom
Photo # 402

Existing Condition: 37" from back wall.

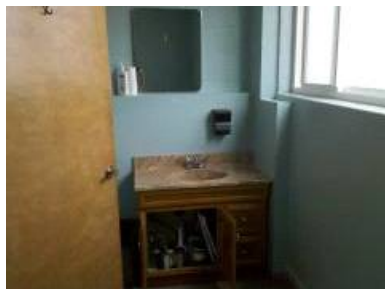
Location: Admin. - Women's Restroom
Photo # 401

Existing Condition: Knee space not provided.

300C - Replace Lavatory - Replace existing lavatory with new compliant model.

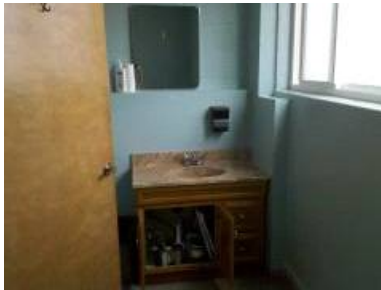
Location: Admin. - Women's Restroom
Photo # 401

Existing Condition: 54" AFF.

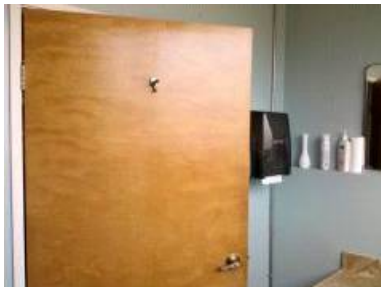
Location: Admin. - Women's Restroom
Photo # 397

Existing Condition: 52" AFF.

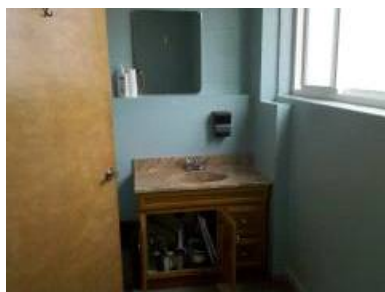
Location: Admin. - Women's Restroom
Photo # 401

Existing Condition: 41" AFF.

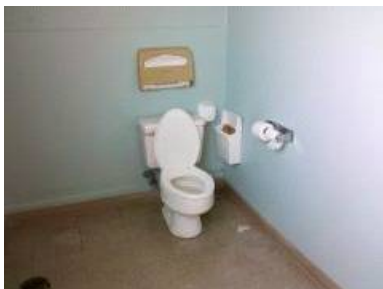
Location: Admin. - Women's Restroom
Photo # 402

Existing Condition: 3/4" change in level,

858A - Slip-Resistant Floor - Replace existing flooring with slip-resistant flooring.

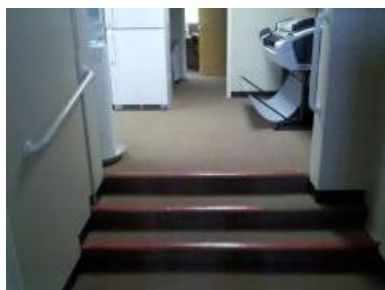
Location: Admin. - Stairs
Photo # 415

Existing Condition:

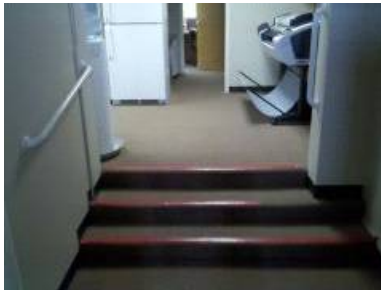
Location: Admin. - Stairs
Photo # 415

Existing Condition: Not provided on both sides.

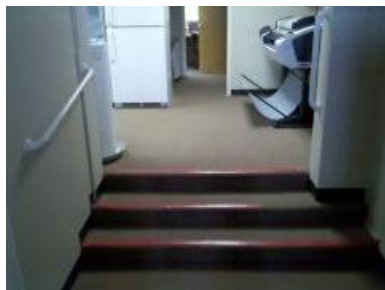
08.09B - Handrail Extensions - Bottom Landing - At ends of handrails, less than 12" plus the tread width extends beyond the bottom nosing. (Top and bottom handrail extensions are important safety features for persons with balance problems and must extend in the direction of the stair run to permit the intended use.) (Per ADA/CBC Standards, in existing buildings and facilities, full extension of handrails at stairs shall not be required in alterations where such extensions would be hazardous or impossible due to plan configuration.)

Existing Condition: Not provided.

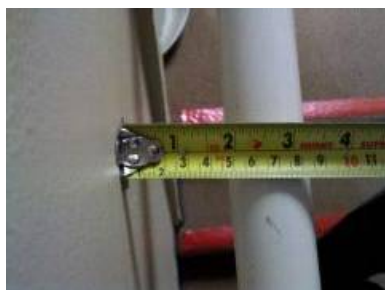
Existing Condition: 1 3/4" clear.

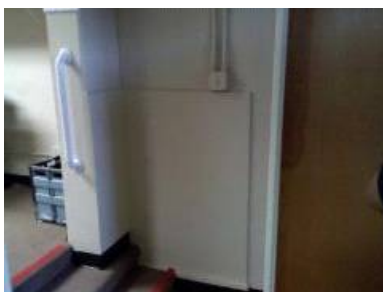
Location: Admin. - Hallway
Photo # 420

Existing Condition:

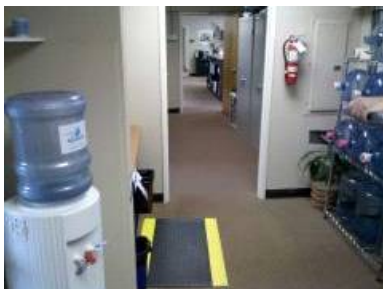
Location: Admin. - Hallway
Photo # 421

Existing Condition: Floor mat.

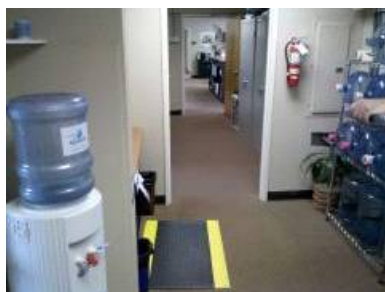
Location: Admin. - Hallway
Photo # 421

Existing Condition: 61" AFF.

388D - Relocate Fire Extinguisher - Relocate existing fire extinguisher. Repair and refinish.

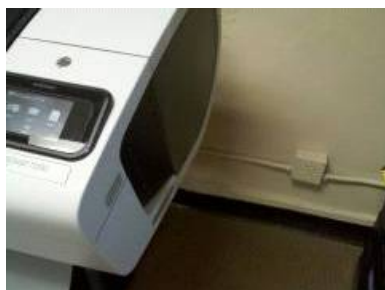
Location: Admin. - Hallway
Photo # 423

Existing Condition: 4 power outlets at 13" AFF.

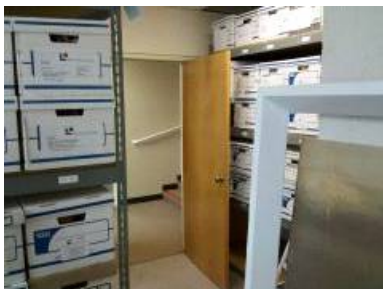
Location: Admin. - Storage
Photo # 425

Existing Condition: Door knob.

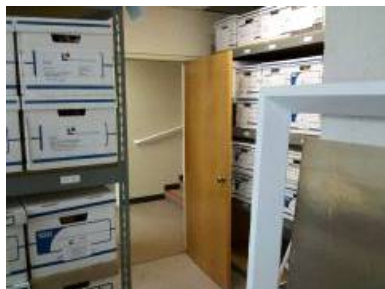
Photo #
425

Existing Condition: Door jamb at 77 1/4" AFF.

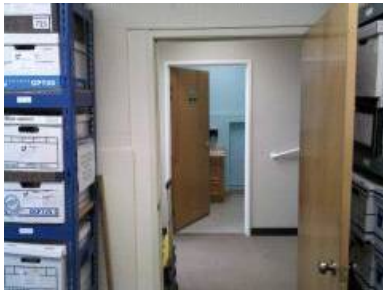
11.06A - Door Maneuvering Space - Door that is not automatic or power-assisted does not have compliant maneuvering space relative to the direction of approach as shown in CBC Fig. 11B-26. (Approach // Side // Width // Depth) (Front // Pull // D + 24" * // 60") (Front // Push // D + 0" ** // 48") (Latch // Pull // D + 24" // 60") (Latch // Push // D + 24" // 44" ***) (Hinge // Pull // D + 36" // 60") (Hinge // Push // 54" **** // 44" *****) (* D + 18" at interior doors.) (** D + 12" if door has both a latch and a closer.) (***) 48" if door has closer.) (**** Measured from latch toward hinge.) (***** 48" if door has both a latch and a closer.)

Existing Condition: 14" to non-fixed shelving, pull side.

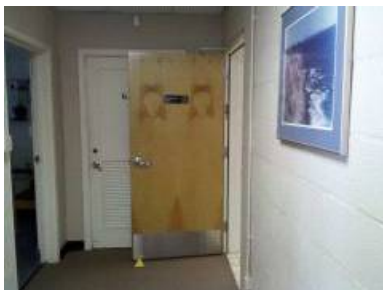
11.06A - Door Maneuvering Space - Door that is not automatic or power-assisted does not have compliant maneuvering space relative to the direction of approach as shown in CBC Fig. 11B-26. (Approach // Side // Width // Depth) (Front // Pull // D + 24" * // 60") (Front // Push // D + 0" ** // 48") (Latch // Pull // D + 24" // 60") (Latch // Push // D + 24" // 44" ***) (Hinge // Pull // D + 36" // 60") (Hinge // Push // 54" **** // 44" *****) (* D + 18" at interior doors.) (** D + 12" if door has both a latch and a closer.) (*** 48" if door has closer.) (**** Measured from latch toward hinge.) (***** 48" if door has both a latch and a closer.)

Existing Condition: 9 3/4" pull side

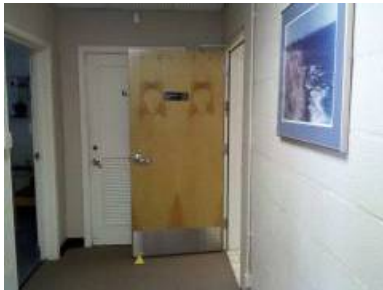
Photo #
453

Existing Condition: 77 1/2" at door

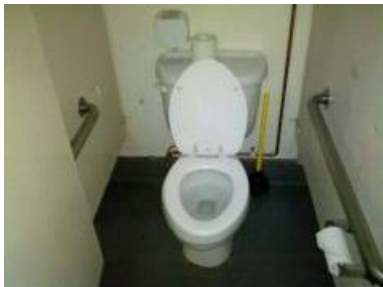
Photo #
431

Existing Condition: No accessible stall.

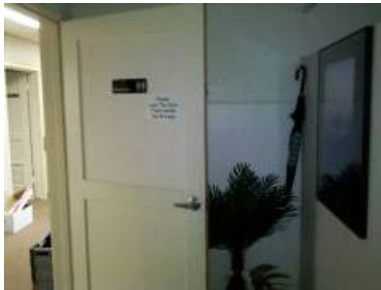
16.09A - Door Maneuvering Space - Door that is not automatic or power-assisted does not have compliant maneuvering space relative to the direction of approach as shown in CBC Fig. 11B-26. (Approach // Side // Width // Depth) (Front // Pull // D + 24" * // 60") (Front // Push // D + 0" ** // 48") (Latch // Pull // D + 24" // 60") (Latch // Push // D + 24" // 44" ****) (Hinge // Pull // D + 36" // 60") (Hinge // Push // 54" **** // 44" *****) (* D + 18" at interior doors.) (** D + 12" if door has both a latch and a closer.) (*** 48" if door has closer.) (**** Measured from latch toward hinge.) (***** 48" if door has both a latch and a closer.)

Existing Condition: 53 1/2" Latch pull side

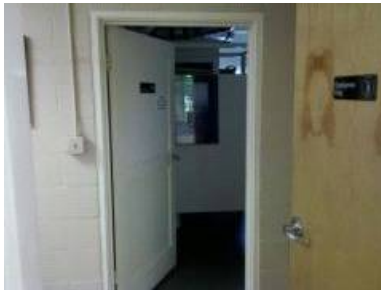
Location: Photo #
Admin. - Unisex Restrm. 433

Existing Condition:

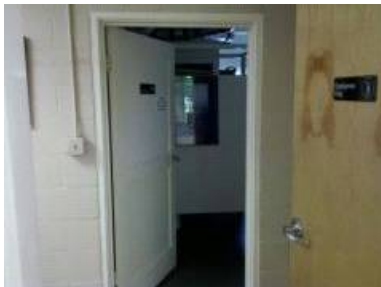
Location: Photo #
Admin. - Unisex Restrm. 433

Existing Condition:

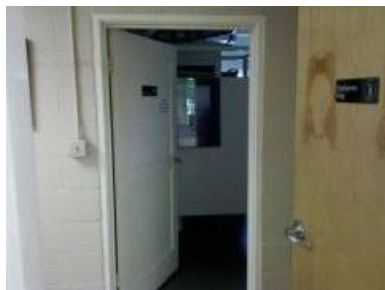
Location: Admin. - Unisex Restrm.
Photo # 433

Existing Condition:

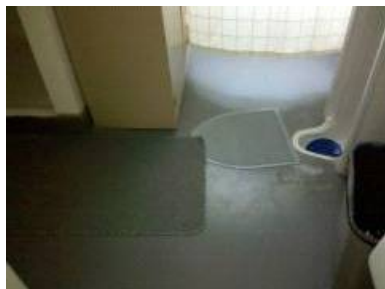
Location: Admin. - Unisex Restrm.
Photo # 436

Existing Condition:

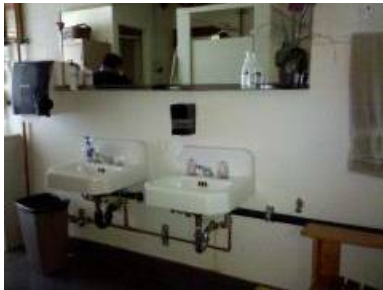
Location: Photo #
Admin. - Unisex Restrm. 437

Existing Condition: 27 1/2" high

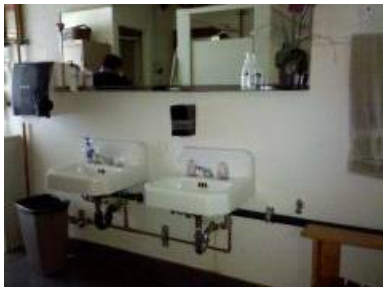
Location: Photo #
Admin. - Unisex Restrm. 437

Existing Condition: 25 1/4" high

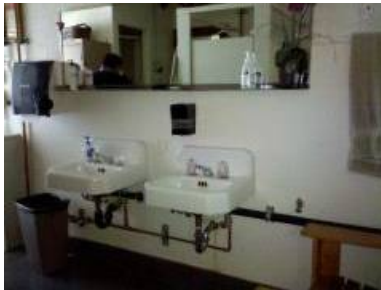
Location: Photo #
Admin. - Unisex Restrm. 437

Existing Condition:

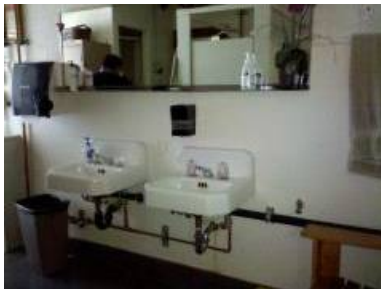
Location: Photo #
Admin. - Unisex Restrm. 437

Existing Condition:

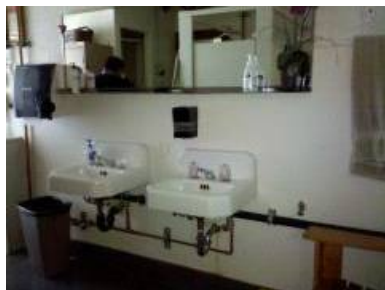
Location: Photo #
Admin. - Unisex Restrm. 437

Existing Condition: 52 1/2" high

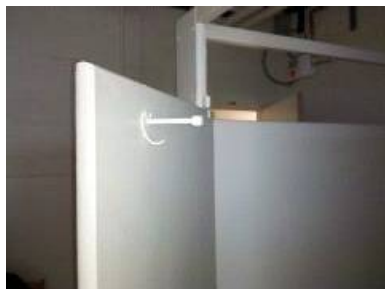
Location: Photo #
Admin. - Unisex Restrm. 442

Existing Condition: 57" high

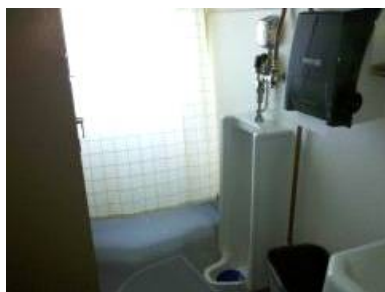
Location: Photo #
Admin. - Unisex Restrm. 443

Existing Condition: 44" high

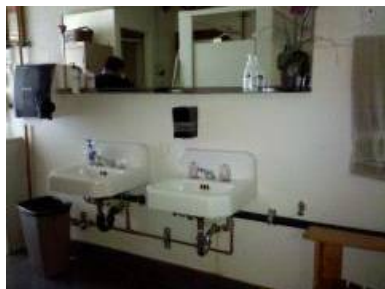
Location: Photo #
Admin. - Unisex Restrm. 437

Existing Condition: 41" high

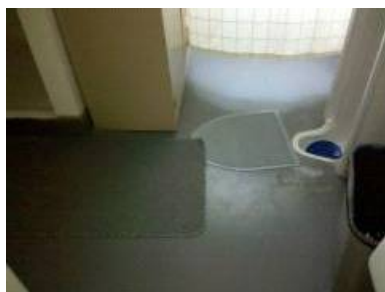
Location: Photo #
Admin. - Unisex Restrm. 436

Existing Condition: 43" deep clr floor space

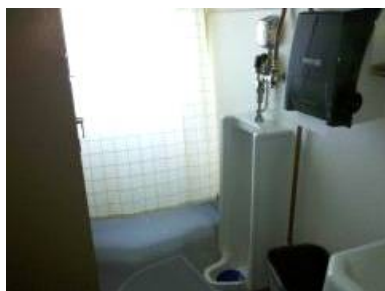
Location: Photo #
Admin. - Unisex Restrm. 443

Existing Condition: 52" high

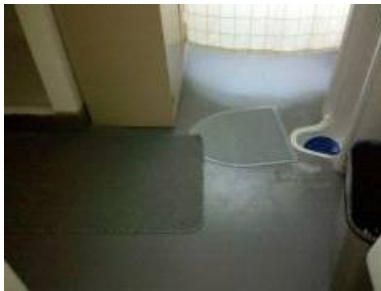
Location: Photo #
Admin. - Unisex Restrm. 436

Existing Condition: 2 mats

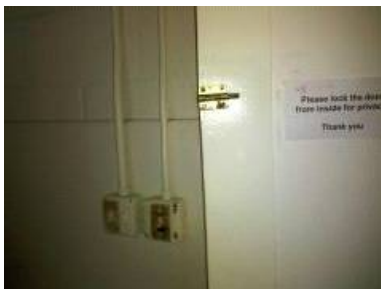
Location: Photo #
Admin. - Unisex Restrm. 448

Existing Condition: 53" high power switch

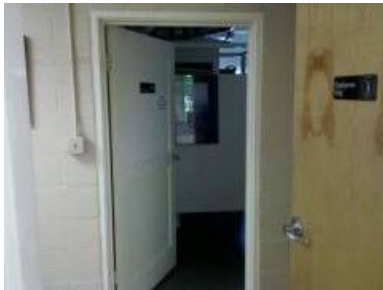
Keynote 451

Existing Condition: 77 1/2" at door

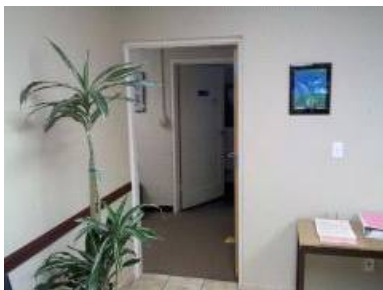
Keynote 452

Existing Condition: 6" at push side

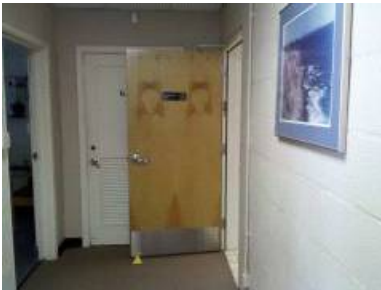
Keynote 453

Existing Condition: Lock on lever.

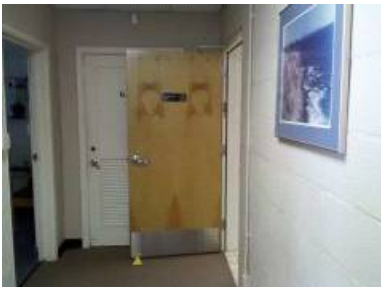
Keynote 454

Existing Condition: 9 Lb

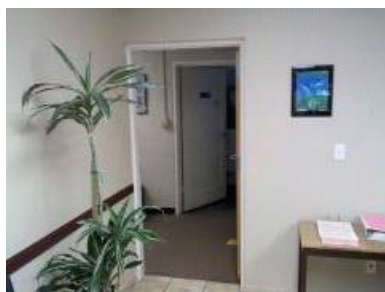
Keynote 455

Existing Condition: 77 1/2" at door

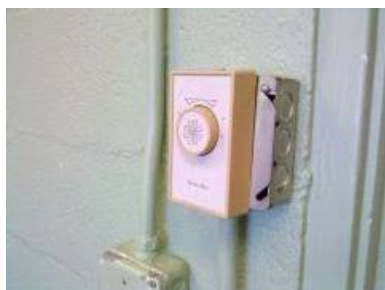
Keynote 460

Existing Condition: 1 outlet, 1 power strip, & 57" high thermostat.

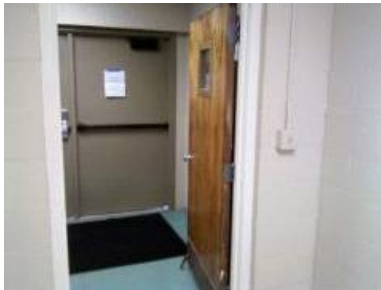
Keynote 463

Existing Condition: knob

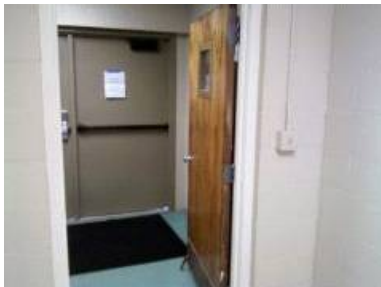
Keynote 464

Existing Condition: 6 Lb

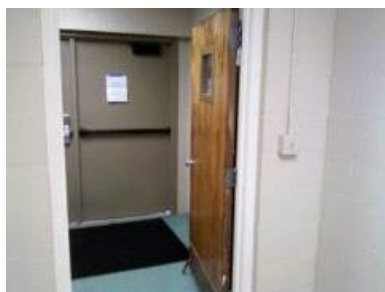
Keynote 465

Existing Condition: 2 sec.

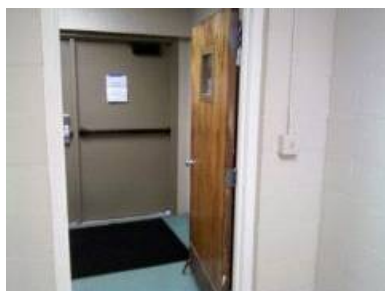
Keynote 466

11.15A - Kick Plate - Bottom 10" of door does not have a smooth, uninterrupted surface on the push side to allow the door to be opened by a wheelchair footrest without creating a trap or hazardous condition. (This requirement does not apply to automatic and sliding doors.)

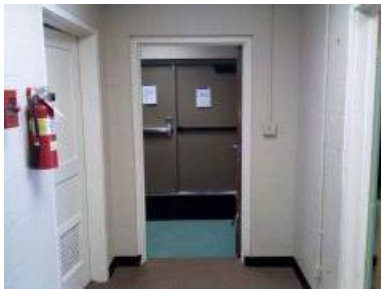
Keynote 468

Existing Condition: 77 1/2" high

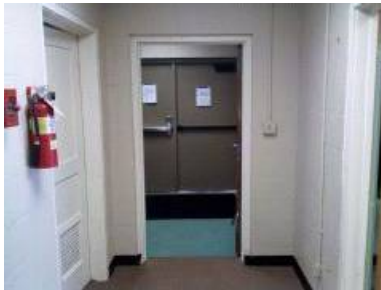
Keynote 469

Existing Condition: 3/4" high

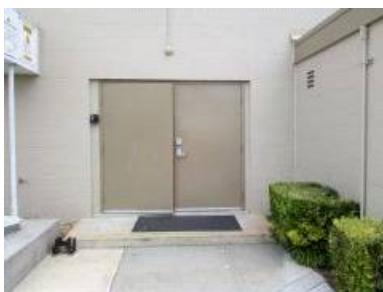
Keynote 471

Existing Condition: 65 3/4" high Security Pad.

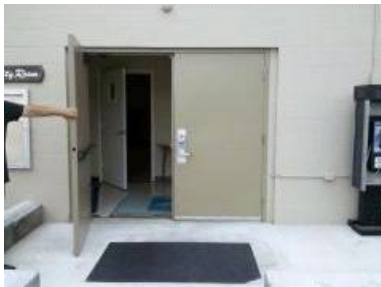
Keynote 474

Existing Condition: 78 1/4" at door

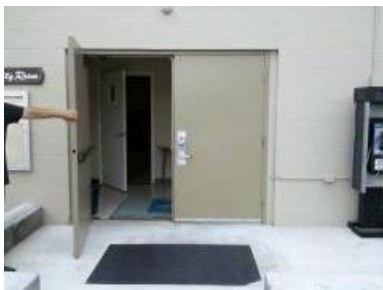
Keynote 475

Existing Condition: 1 1/2" high

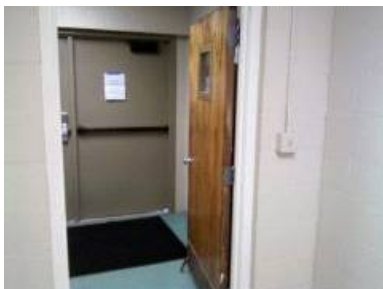
Keynote 476

Existing Condition: 8 Lb. x2

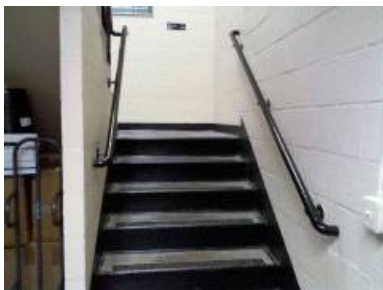
Keynote 483

08.09A - Handrail Extensions - Top Landing - At ends of handrails, less than 12" of handrail extends beyond the top nosing. (Top and bottom handrail extensions are important safety features for persons with balance problems and must extend in the direction of the stair run to permit the intended use.) (Per ADA/CBC Standards, in existing buildings and facilities, full extension of handrails at stairs shall not be required in alterations where such extensions would be hazardous or impossible due to plan configuration.)

Existing Condition: None provided

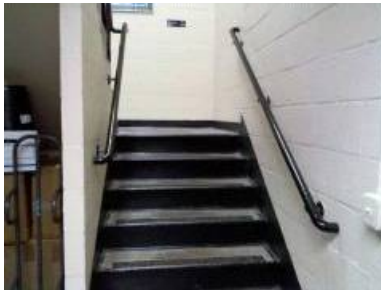
Keynote 484

08.09B - Handrail Extensions - Bottom Landing - At ends of handrails, less than 12" plus the tread width extends beyond the bottom nosing. (Top and bottom handrail extensions are important safety features for persons with balance problems and must extend in the direction of the stair run to permit the intended use.) (Per ADA/CBC Standards, in existing buildings and facilities, full extension of handrails at stairs shall not be required in alterations where such extensions would be hazardous or impossible due to plan configuration.)

Existing Condition: None provided

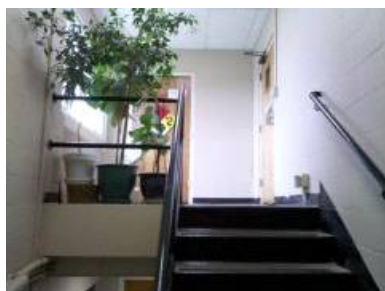
Keynote 489

Existing Condition: 29 1/2" high

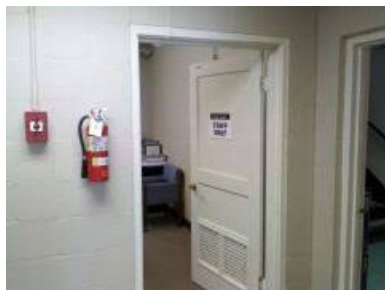
Keynote 490

11.15A - Kick Plate - Bottom 10" of door does not have a smooth, uninterrupted surface on the push side to allow the door to be opened by a wheelchair footrest without creating a trap or hazardous condition. (This requirement does not apply to automatic and sliding doors.)

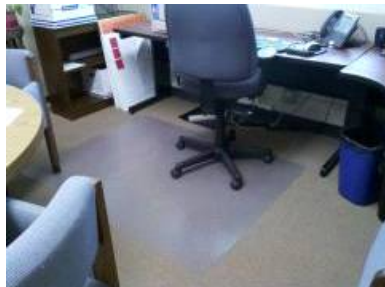
Keynote 491

Existing Condition: Floor mat

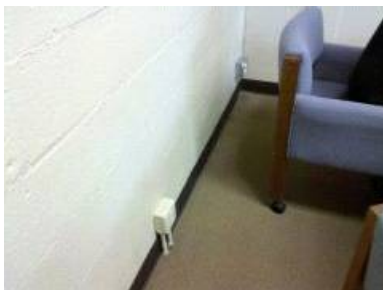
492

Existing Condition: 4 outlets

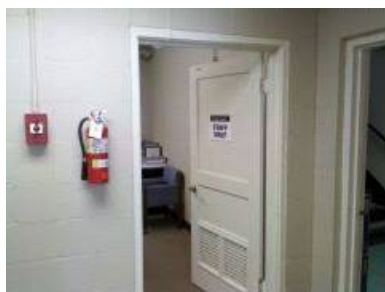
Keynote 494

11.17A - Recommendation: Providing Room/Space ID Sign - A sign designating the permanent room or space has not been provided.

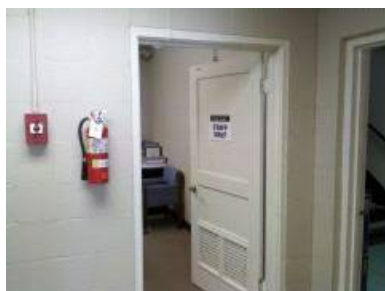
Keynote 495

Existing Condition: 77 1/2" at door

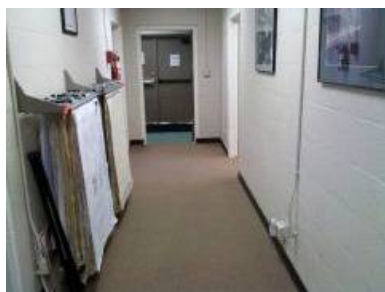
Keynote 496

Existing Condition: 11 1/4" at 47 1/2" high Blueprint hanger

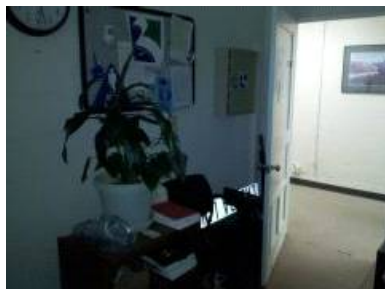
Keynote 497

Existing Condition: Thermostat twist type.

031B - Replace Control - Replace control. Repair/refinish as required.

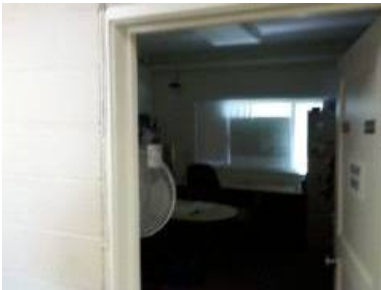
Keynote 498

Location: Admin. Office
Photo # 498

Existing Condition:

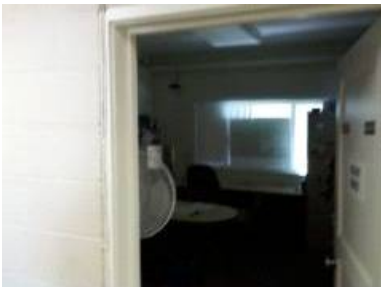
Keynote 499

Location: Admin. Office
Photo # 498

Existing Condition:

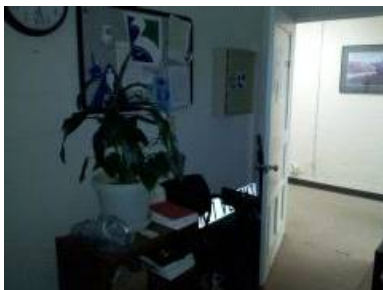
Keynote 500

Location: Admin. Office
Photo # 497

Existing Condition: knob

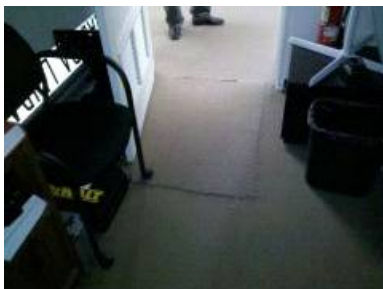
Keynote 501

Location: Admin. Office
Photo # 501

Existing Condition: 3 floor mats

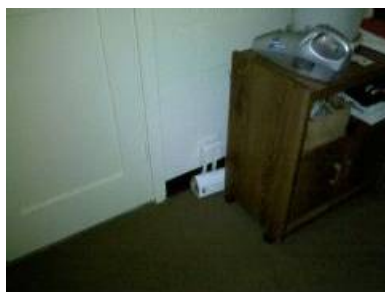
Keynote 502

Location: Admin. Office
Photo # 502

Existing Condition: 3 outlets

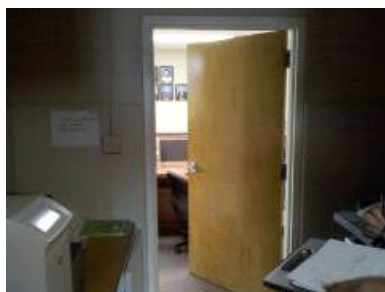
Keynote 504

Location: Admin. Receptionist
Photo # 504

Existing Condition: 77 1/2" at door

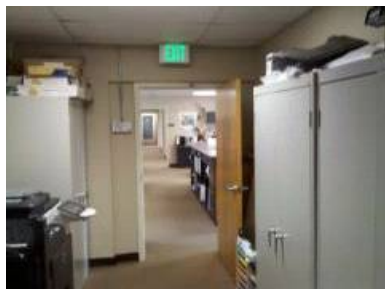
Keynote 505

Location: Admin. - Hallway
Photo # 354

Existing Condition: Door jamb at 77 1/2" AFF.

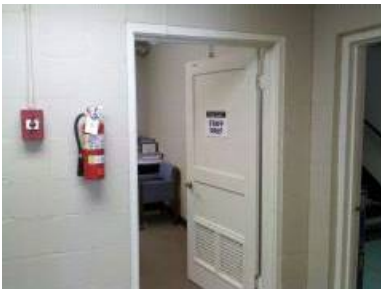
Keynote 507

20.16B - Surface-Mounted Fire Extinguisher - Mounting Height - Where fire extinguishers are surface-mounted, mounting height of the extinguisher is not compliant. (Compliant surface-mounted extinguisher is 48" AFF maximum, as measured to the highest operable part, or in existing buildings, when the extinguisher is 54" AFF and parallel approach is provided)

Existing Condition: 61" high.

388D - Relocate Fire Extinguisher - Relocate existing fire extinguisher. Repair and refinish.

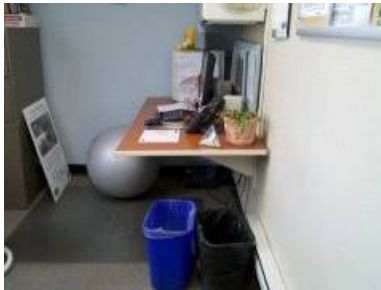
Keynote 508

Location: Admin. - Office
Photo # 753

Existing Condition: Shelf-type desk protrudes 31" at 29 1/2" AFF.

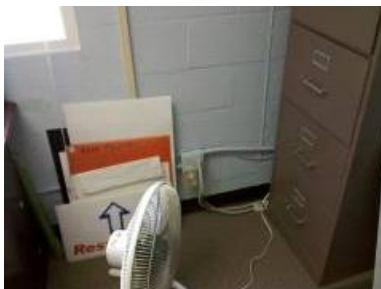
Keynote 509

Location: Admin. - Office
Photo # 755

Existing Condition: 1 power outlet at 13 1/2" AFF.

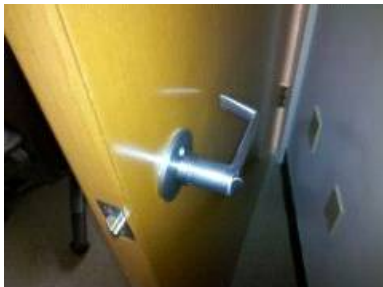
Keynote 511

Location: Admin. - Conference Room
Photo # 757

Existing Condition: Twist-type locking mechanism.

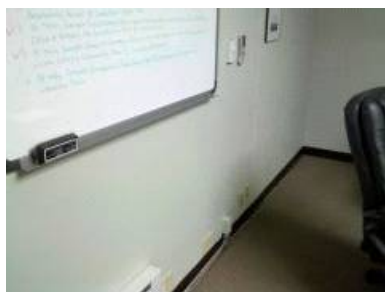
Keynote 512

Location: Admin. - Conference Room
Photo # 758

Existing Condition: 1 power outlet, 2 data ports.

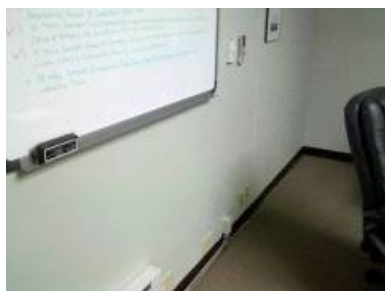
Keynote 513

Location: Admin. - Conference Room
Photo # 758

Existing Condition: Twist-type thermostat.

031B - Replace Control - Replace control. Repair/refinish as required.

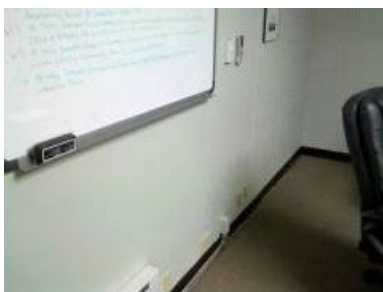
Keynote 516

Location: Admin. - Conference Room
Photo # 758

Existing Condition: 21", 22", 27 1/2", & 30 1/2" clear.

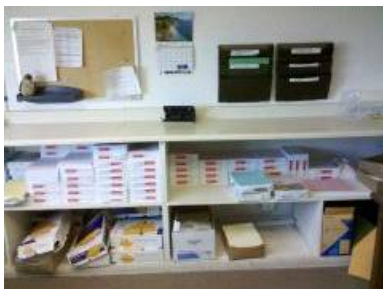
Keynote 517

Location: Admin. - Copy Room
Photo # 763

Existing Condition: Counter top at 38" AFF.

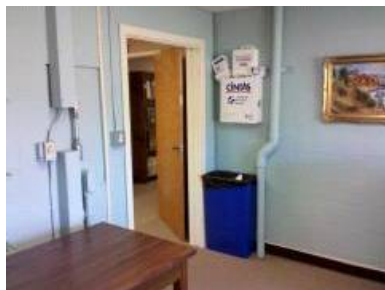
Keynote 518

Location: Admin. - Copy Room
Photo # 647

Existing Condition: Twist-type thermostat.

031B - Replace Control - Replace control. Repair/refinish as required.

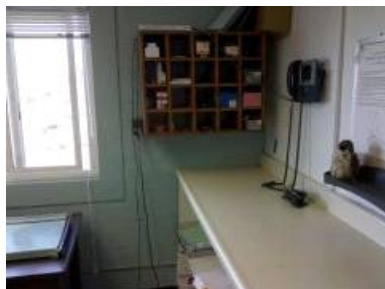
Keynote 519

Location: Admin. - Copy Room
Photo # 765

Existing Condition: Storage box at 67" AFF & mail bin at 60" AFF.
