City of Rancho Palos Verdes
Rancho Palos Verdes ADA Assessment
Facility Report with Photos

Facility ID: # 02B - City Hall Buildings

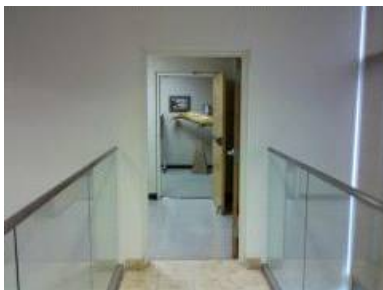
Keynote 520

Location: Admin. - Elevator Platform
Photo # 520

Existing Condition: 10" maneuvering space, guard rail.

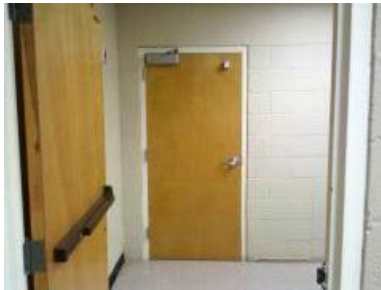
Keynote 521

Location: Admin. - Elevator Platform
Photo # 521

Existing Condition: 10 LBF.

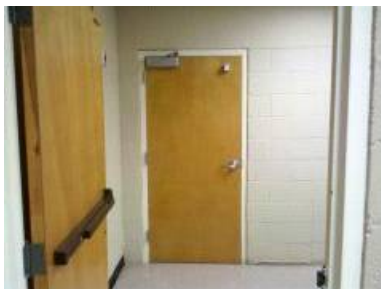
Keynote 522

Location: Admin. - Elevator Platform
Photo # 521

Existing Condition: 1.8 second closer.

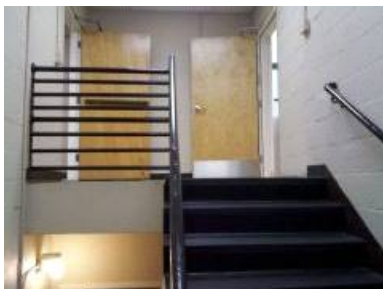
Keynote 524

Location: Admin. - Elevator Platform
Photo # 369

Existing Condition: 22 1/2" between doors opening toward one another.

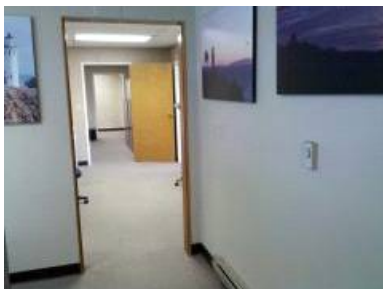
Keynote 526

Location:
Admin. - Open Office

Existing Condition: Twist-type thermostat.

031B - Replace Control - Replace control. Repair/refinish as required.

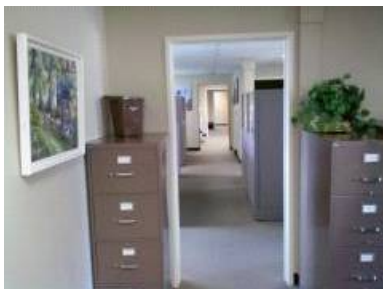
Keynote 528

Location:
Admin. - Open Office

Existing Condition: Door jamb at 79" AFF.

Additional Comments: Remove door jamb, patch and repair to match existing.

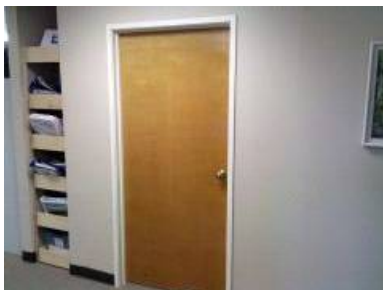
Keynote 529

Location:
Admin. - Open OfficePhoto #
529**Field Condition**

11.11 - Single-Action Hardware - Handles, locks, and latches or other operative devices are not operable with one hand and without tight grasping, pinching, or twisting of the wrist. (U-shaped handles, levers, and push/pull type mechanisms are acceptable designs.)

Existing Condition: Door knob.

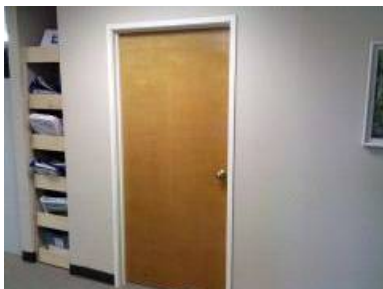
Keynote 530

Location:
Admin. - Open OfficePhoto #
529**Field Condition**

14.31 - Head Room - Clear head room is at less than 80" within the pedestrian circulation area, including the accessible route of travel.

Existing Condition: Door jamb at 79" AFF.

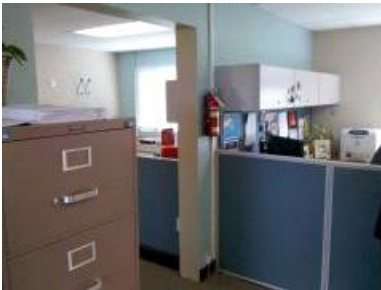
Keynote 531

Location: Admin. - Open Office
Photo # 531

Existing Condition: 60" AFF.

388D - Relocate Fire Extinguisher - Relocate existing fire extinguisher. Repair and refinish.

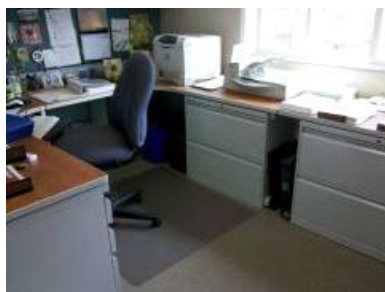
Keynote 533

Location: Admin. - Open Office
Photo # 533

Existing Condition: Floor mat.

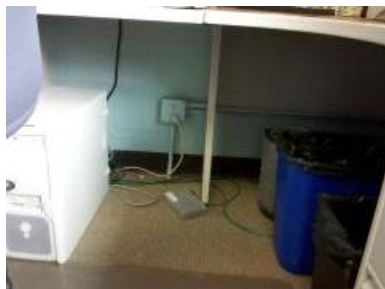
Keynote 534

Location: Admin. - Open Office
Photo # 534

Existing Condition: 5 power outlets at less than 15" AFF.

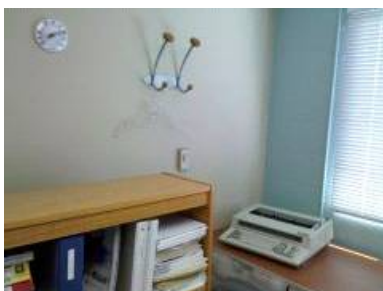
Keynote 536

Location: Admin. - Open Office
Photo # 535

Existing Condition: Coat hook above required reach range limit.

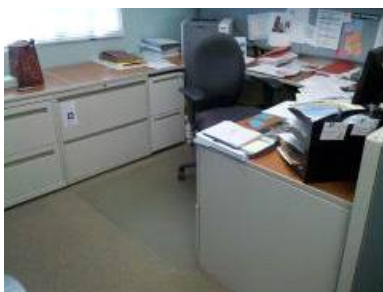
Keynote 537

Location: Admin. - Open Office
Photo # 537

Existing Condition: Floor mat.

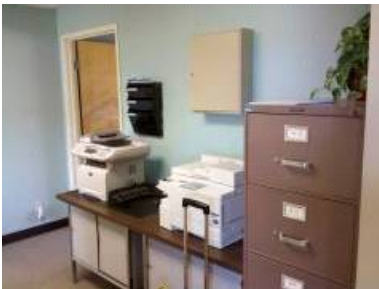
Keynote 542

Location:
Admin. - Hallway

Existing Condition: Key lock box at 64" AFF, mail box at 62" AFF.

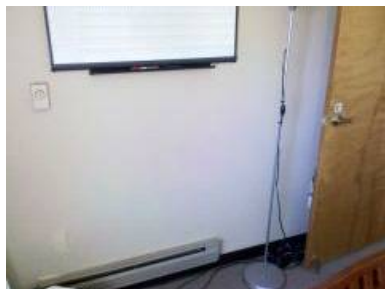
Keynote 544

Location:
Admin. - Office

Existing Condition: Twist-type thermostat.

031B - Replace Control - Replace control. Repair/refinish as required.

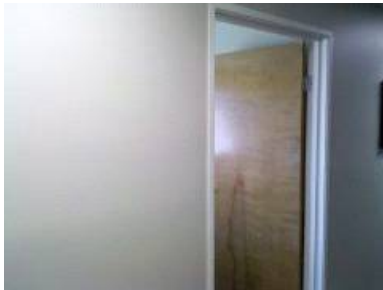
Keynote 545

Location:
Admin. - Office

Existing Condition: Door jamb at 79 1/2" AFF.

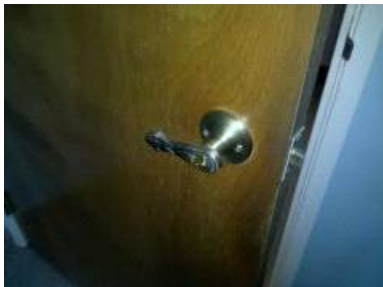
Keynote 546

Location:
Admin. - Men's Restroom

Existing Condition: Twist-type locking mechanism.

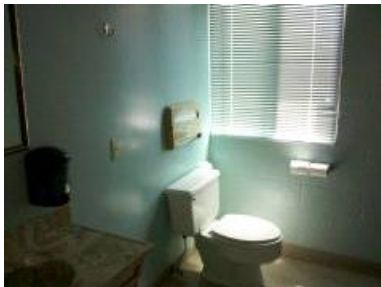
Location: Admin. - Men's Restroom
Photo # 550

Existing Condition: 19 3/4" from side wall.

319C - Water Closet - New Location - Replace existing water closet with compliant model in new location.

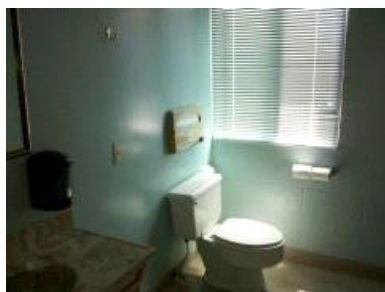
Location: Admin. - Men's Restroom
Photo # 550

16.48 - WC Seat Height - The top of the WC seat is not between 17" and 19" AFF. 1991 ADAAG 4.16.3; Fig. 29(b)
Existing Condition: 15 1/2" AFF.
2004 ADAAG 604.4
2007 CBC 1115B.4.1(4); Fig. 11B-1A
Other -

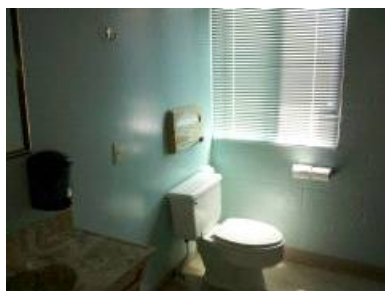
Location: Admin. - Men's Restroom
Photo # 550

16.53 - SC Dispenser Height - Mounting height of seat cover dispenser's highest operable part exceeds 40" AFF. 1991 ADAAG 4.22.7; 4.27.3; 4.2.5; 4.2.6
Existing Condition: 46" AFF.
2004 ADAAG -
2007 CBC 1115B.8.3
Other -

294C - Relocate Dispenser - Relocate existing dispenser on an accessible route. Patch and repair wall substrate and finishes, to match adjacent undisturbed surfaces.

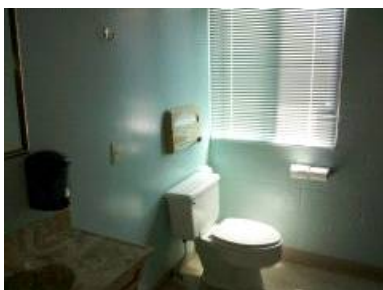
Location: Admin. - Men's Restroom
Photo # 550

Existing Condition: 39" from back wall.

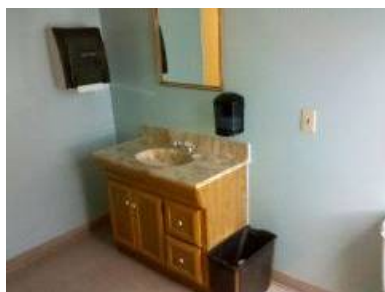
Photo #
555

Existing Condition: Knee space not provided.

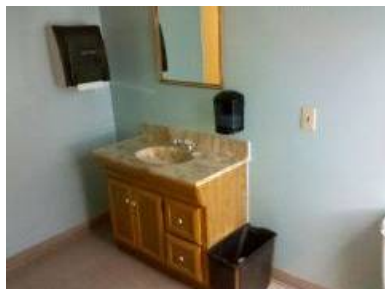
Photo #
555

Existing Condition: Twist-type faucet controls.

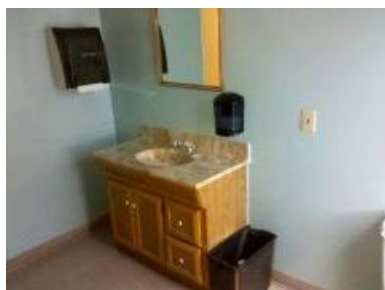
Location: Admin. - Men's Restroom
Photo # 555

Existing Condition: 49" AFF.

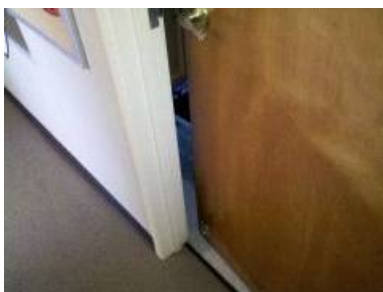
Location: Admin. - Men's Restroom
Photo # 559

11.15A - Kick Plate - Bottom 10" of door does not have a smooth, uninterrupted surface on the push side to allow the door to be opened by a wheelchair footrest without creating a trap or hazardous condition. (This requirement does not apply to automatic and sliding doors.)

Existing Condition: Door stop.

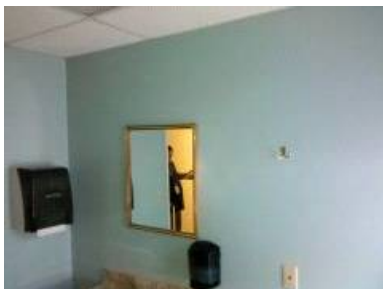
Location: Admin. - Men's Restroom
Photo # 560

Existing Condition: Coat hook at 65" AFF.

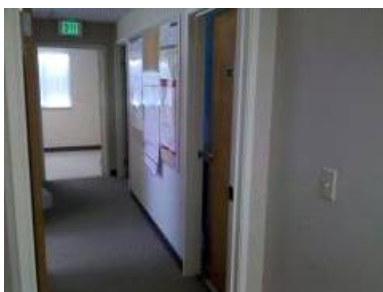
Location: Admin. - Men's Restroom
Photo # 547

Existing Condition: Door jamb at 79 1/2" AFF.

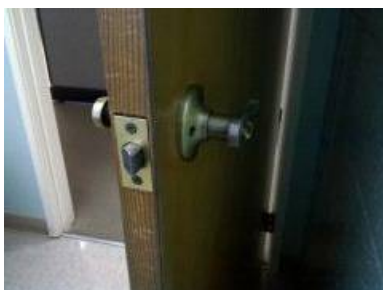
Location: Admin. - Women's Restroom
Photo # 562

Existing Condition: Twist-type locking mechanism.

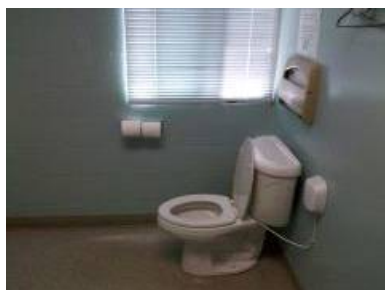
Location: Admin. - Women's Restroom
Photo # 566

Existing Condition: 19" from side wall.

319C - Water Closet - New Location - Replace existing water closet with compliant model in new location.

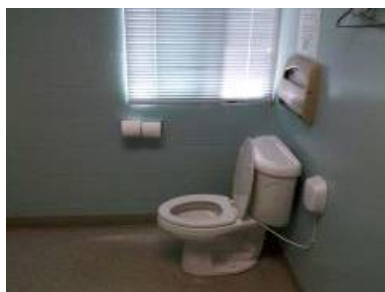
Location: Admin. - Women's Restroom
Photo # 566

16.48 - WC Seat Height - The top of the WC seat is not between 17" and 19" AFF. 1991 ADAAG 4.16.3; Fig. 29(b)
Existing Condition: 15 1/2" AFF.
2004 ADAAG 604.4
2007 CBC 1115B.4.1(4); Fig. 11B-1A
Other -

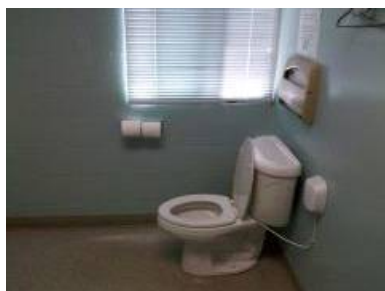
Location: Admin. - Women's Restroom
Photo # 566

16.53 - SC Dispenser Height - Mounting height of seat cover dispenser's highest operable part exceeds 40" AFF. 1991 ADAAG 4.22.7; 4.27.3; 4.2.5; 4.2.6
Existing Condition: 46" AFF.
2004 ADAAG -
2007 CBC 1115B.8.3
Other -

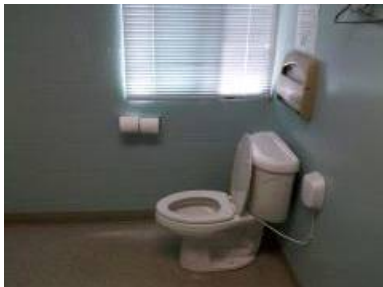
Location: Admin. - Women's Restroom
Photo # 566

Existing Condition: Flush valve not on wide side.

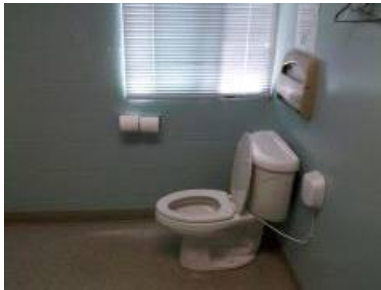
Location: Admin. - Women's Restroom
Photo # 566

Existing Condition: 39" from back wall.

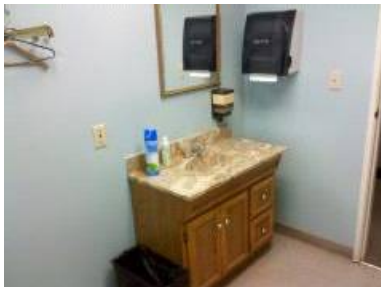
Location: Admin. - Women's Restroom
Photo # 572

Existing Condition: Knee space not provided.

300C - Replace Lavatory - Replace existing lavatory with new compliant model.

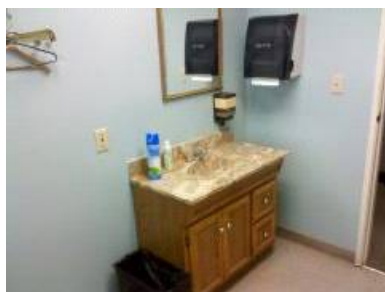
Location: Admin. - Women's Restroom
Photo # 572

Existing Condition: Twist-type faucet controls.

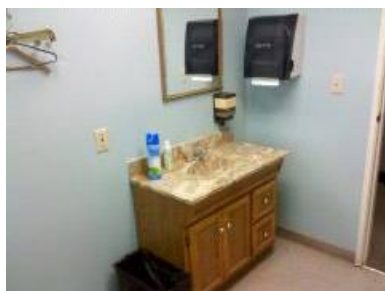
Location: Admin. - Women's Restroom
Photo # 572

Existing Condition: 46" AFF.

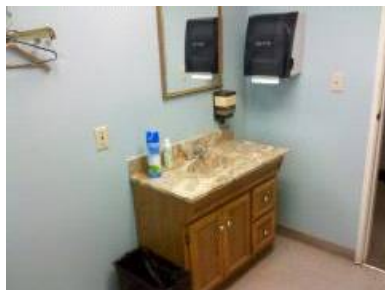
Location: Admin. - Women's Restroom
Photo # 572

Existing Condition: 49" AFF.

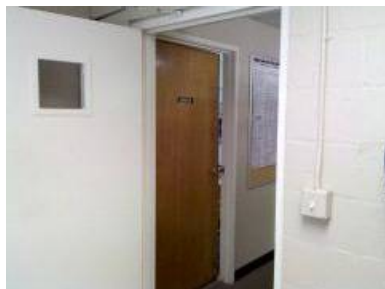
Location: Admin. - Women's Restroom
Photo # 563

11.15A - Kick Plate - Bottom 10" of door does not have a smooth, uninterrupted surface on the push side to allow the door to be opened by a wheelchair footrest without creating a trap or hazardous condition. (This requirement does not apply to automatic and sliding doors.)

Existing Condition: Door stop.

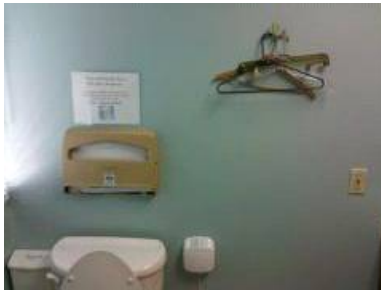
Location: Admin. - Women's Restroom
Photo # 577

Existing Condition: 65" AFF.

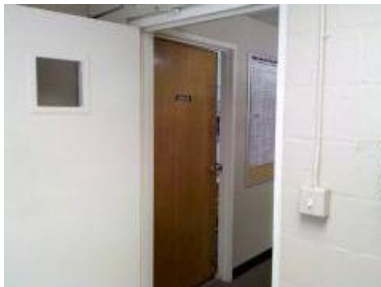
Location: Admin. - Women's Restroom
Photo # 563

Existing Condition: Door jamb at 79 1/2" AFF.

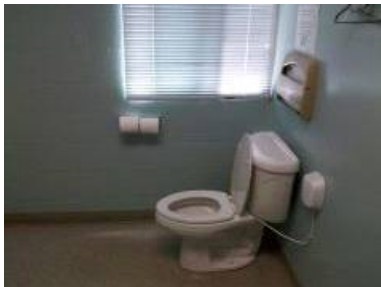
Location: Admin. - Women's Restroom
Photo # 566

Existing Condition: Approx. 40" diameter circle.

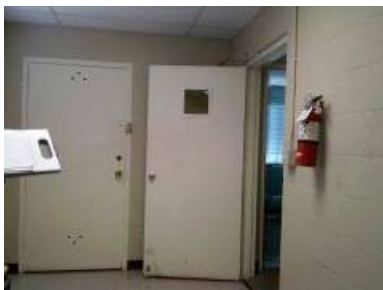
Photo #
581

Existing Condition: Door knob and lock.

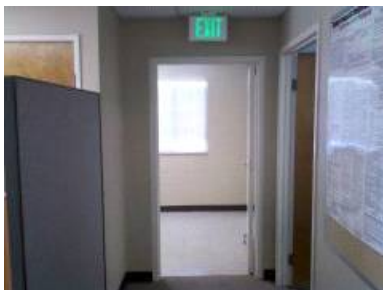
11.06A - Door Maneuvering Space - Door that is not automatic or power-assisted does not have compliant maneuvering space relative to the direction of approach as shown in CBC Fig. 11B-26. (Approach // Side // Width // Depth) (Front // Pull // D + 24" * // 60") (Front // Push // D + 0" ** // 48") (Latch // Pull // D + 24" // 60") (Latch // Push // D + 24" // 44" *** (Hinge // Pull // D + 36" // 60") (Hinge // Push // 54" **** // 44" *****) (* D + 18" at interior doors.) (** D + 12" if door has both a latch and a closer.) (***) 48" if door has closer.) (**** Measured from latch toward hinge.) (***** 48" if door has both a latch and a closer.)

Existing Condition: 11 1/2" push side, wall.

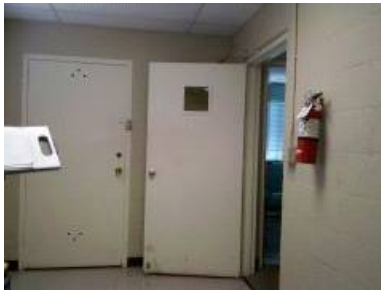
Location: Admin. - Stairwell
Photo # 581

Existing Condition: Door knob.

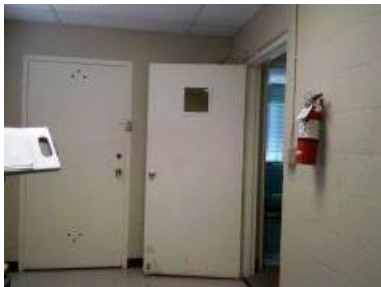
Location: Admin. - Stairwell
Photo # 581

11.15A - Kick Plate - Bottom 10" of door does not have a smooth, uninterrupted surface on the push side to allow the door to be opened by a wheelchair footrest without creating a trap or hazardous condition. (This requirement does not apply to automatic and sliding doors.)

Existing Condition: Door stop.

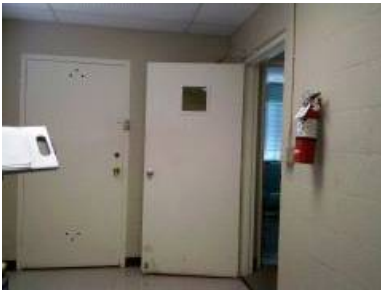
Location: Admin. - Stairwell
Photo # 581

Existing Condition: 61" AFF.

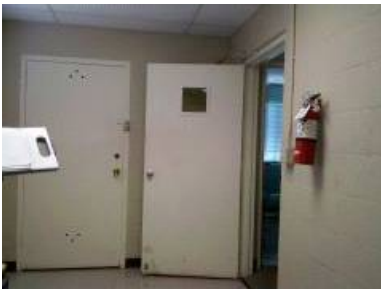
Location: Admin. - Stairwell
Photo # 581

Existing Condition: 6 LBF.

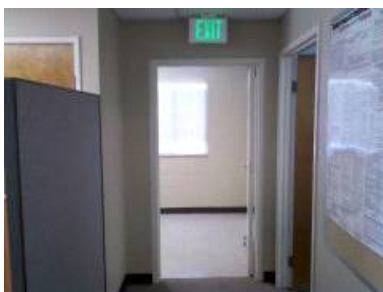
Photo #
582

Existing Condition: Door jamb at 78 1/2" AFF.

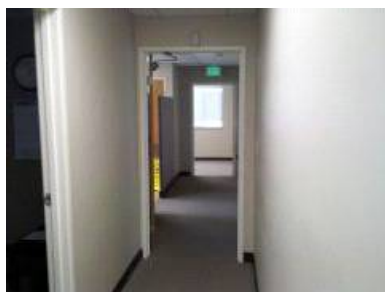
11.06A - Door Maneuvering Space - Door that is not automatic or power-assisted does not have compliant maneuvering space relative to the direction of approach as shown in CBC Fig. 11B-26. (Approach // Side // Width // Depth) (Front // Pull // D + 24" * // 60") (Front // Push // D + 0" ** // 48") (Latch // Pull // D + 24" // 60") (Latch // Push // D + 24" // 44" *** (Hinge // Pull // D + 36" // 60") (Hinge // Push // 54" **** // 44" *****) (* D + 18" at interior doors.) (** D + 12" if door has both a latch and a closer.) (***) 48" if door has closer.) (**** Measured from latch toward hinge.) (***** 48" if door has both a latch and a closer.)

Existing Condition: 5" at push and pull side.

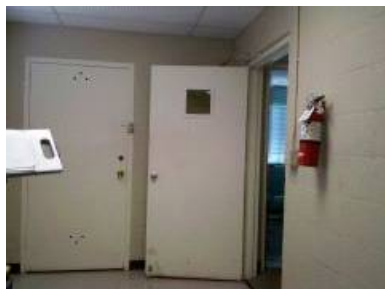
Keynote 594

Location: Admin. - Stair Well
Photo # 581

Existing Condition: 59" AFF.

388D - Relocate Fire Extinguisher - Relocate existing fire extinguisher. Repair and refinish.

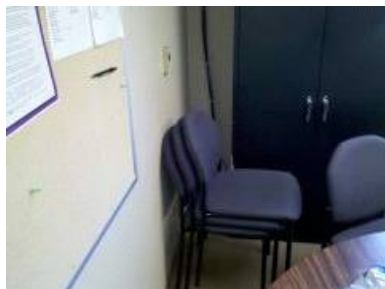
Keynote 596

14.35 - Controls - Operation - The controls are not accessible. (Accessible controls shall be operable with one hand, and without tight grasping, pinching, or twisting of the wrist, and the force to operate the controls shall be no greater than 5 lbs.)

Existing Condition: Twist-type thermostat.

031B - Replace Control - Replace control. Repair/refinish as required.

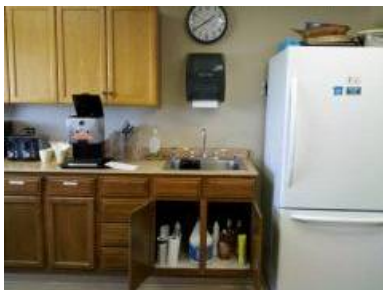
Keynote 597

Existing Condition: Knee space not provided.

480A - New Counter Top and Sink - Remove existing cabinetry, and provide new counter at 34" above the finished floor. Remove and replace sink and faucet with new accessible sink and faucet. Provide accessible knee clearance (i.e. at least 27" high, 30" wide, and 19" deep) under the sink.

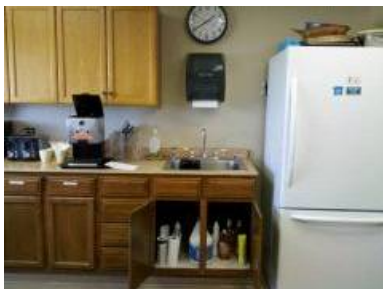
Keynote 598

Existing Condition: 54" AFF.

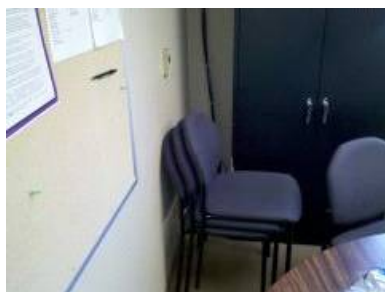
Keynote 599

Existing Condition: 2 power outlets, 1 data port at less than 15" AFF.

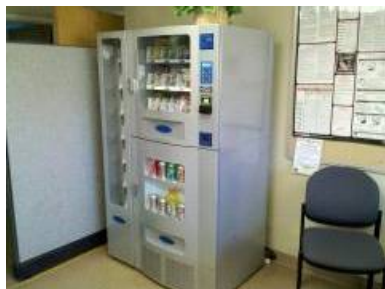
Keynote 600

Existing Condition: Vending machine coin slot at 67" AFF.

Additional Comments: Replace vending machine with new compliant model.

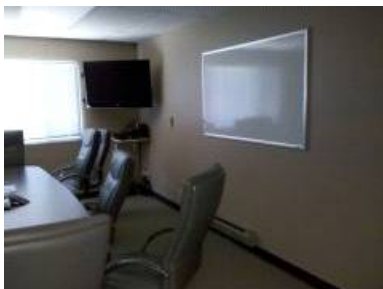
Keynote 604

Existing Condition: Flat screen TV protrudes at 54" AFF.

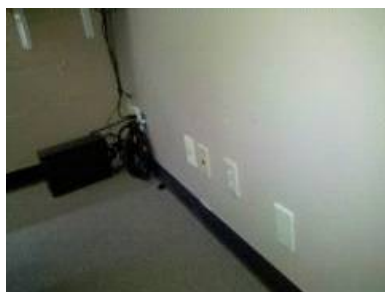
Keynote 606

Existing Condition: 6 power outlets, 3 data ports.

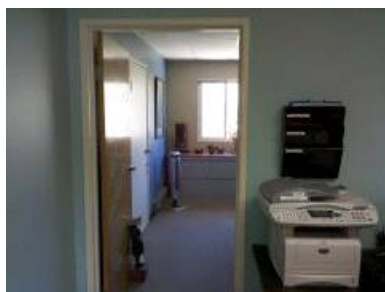
Keynote 608

Existing Condition: Door jamb at 79 1/2" AFF.

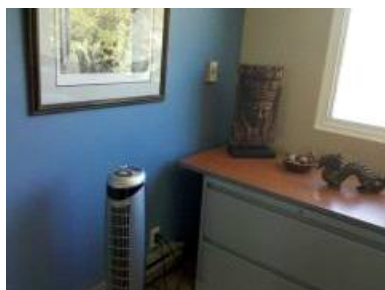
Keynote 609

Existing Condition: 1 power outlet, 2 data ports.

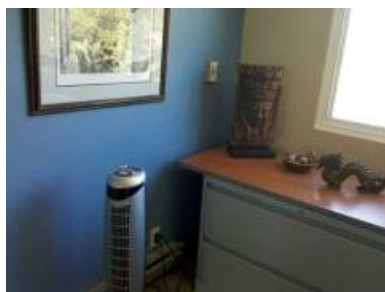
Keynote 610

Existing Condition: Twist-type thermostat.

031B - Replace Control - Replace control. Repair/refinish as required.

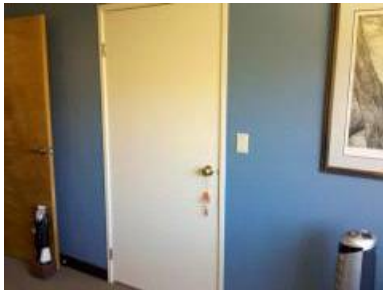
Keynote 612

Existing Condition: Door jamb at 79 1/4" AFF.

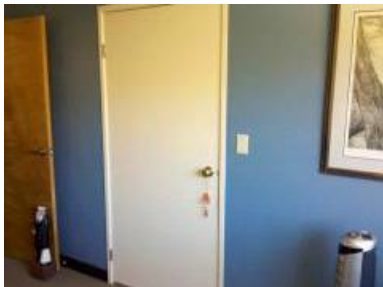
Keynote 613

Existing Condition: Door knob.

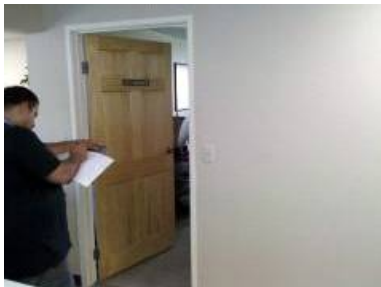
Keynote 615

Existing Condition: Mounted on door.

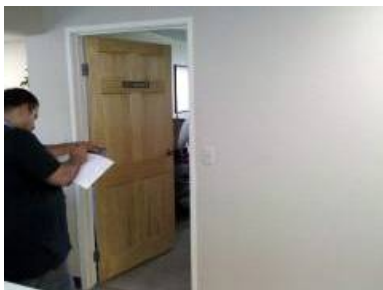
Keynote 616

14.31 - Head Room - Clear head room is at less than 80" within the pedestrian circulation area, including the accessible route of travel.

Existing Condition: Door jamb at 79 5/8" AFF.

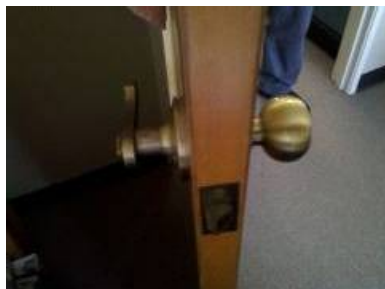
Keynote 623

11.11 - Single-Action Hardware - Handles, locks, and latches or other operative devices are not operable with one hand and without tight grasping, pinching, or twisting of the wrist. (U-shaped handles, levers, and push/pull type mechanisms are acceptable designs.)

Existing Condition: Door knob and twist-type locking mechanism.

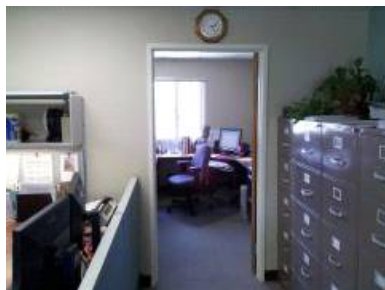
Keynote 624

11.17A - Recommendation: Providing Room/Space ID Sign - A sign designating the permanent room or space has not been provided.

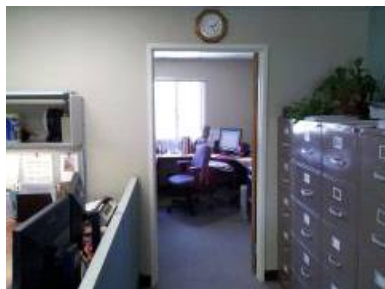
Keynote 625

Existing Condition: Door jamb at 79" AFF.

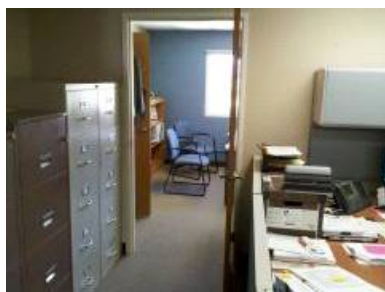
Keynote 626

11.17A - Recommendation: Providing Room/Space ID Sign - A sign designating the permanent room or space has not been provided.

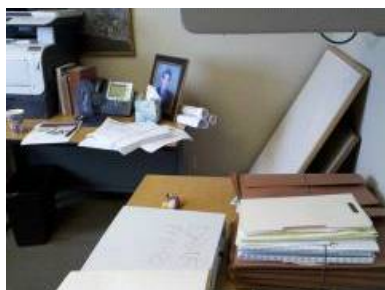
Keynote 627

Existing Condition: 2 power outlets, 1 data port.

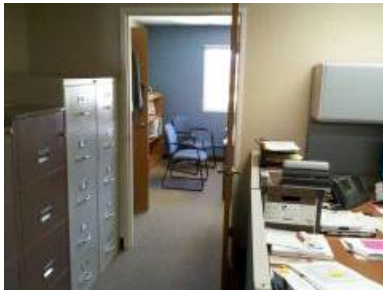
Keynote 628

Existing Condition: 2 1/2" pull side, non-fixed furniture.

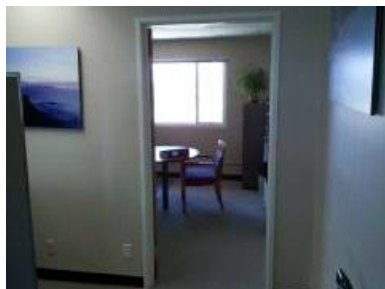
Keynote 630

11.17A - Recommendation: Providing Room/Space ID Sign - A sign designating the permanent room or space has not been provided.

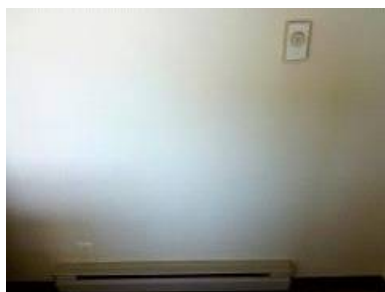
Keynote 631

Existing Condition: 3 power outlets.

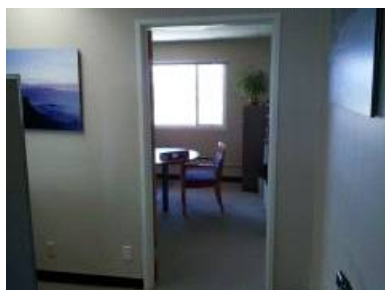
Keynote 632

Existing Condition: Door jamb at 79 1/4" AFF.

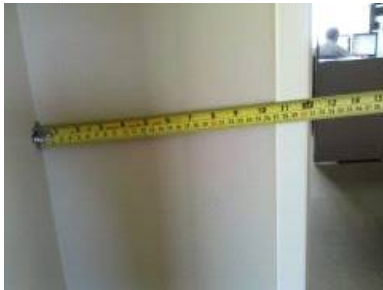
Keynote 633

11.06A - Door Maneuvering Space - Door that is not automatic or power-assisted does not have compliant maneuvering space relative to the direction of approach as shown in CBC Fig. 11B-26. (Approach // Side // Width // Depth) (Front // Pull // D + 24" * // 60") (Front // Push // D + 0" ** // 48") (Latch // Pull // D + 24" // 60") (Latch // Push // D + 24" // 44" *** (Hinge // Pull // D + 36" // 60") (Hinge // Push // 54" **** // 44" *****) (* D + 18" at interior doors.) (** D + 12" if door has both a latch and a closer.) (***) 48" if door has closer.) (**** Measured from latch toward hinge.) (***** 48" if door has both a latch and a closer.)

Existing Condition: 12" pull side, wall.

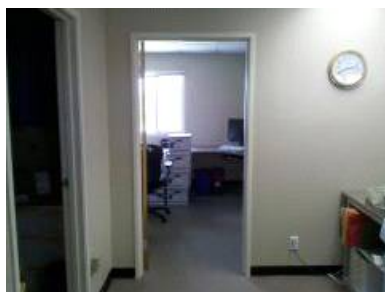
Keynote 640

Existing Condition: Door jamb at 79 1/4" AFF.

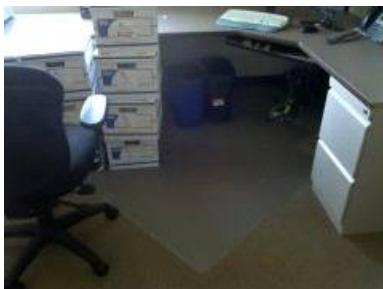
Location: Admin. - Office
Photo # 643

Existing Condition: Floor mat.

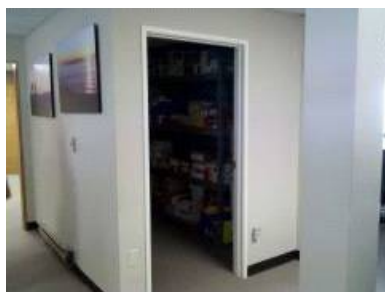
Location:
Admin. - Supply Room

11.17A - Recommendation: Providing Room/Space ID Sign - A sign designating the permanent room or space has not been provided.

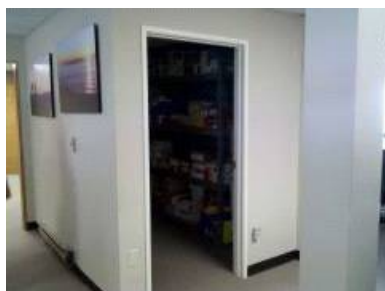
Location:
Admin. - Supply Room

Existing Condition: Door jamb at 79 1/4" AFF.

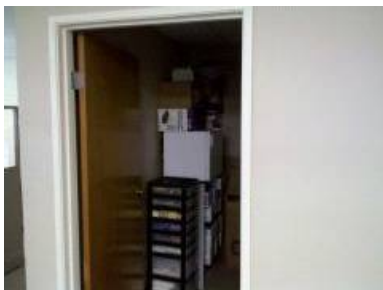
11.06A - Door Maneuvering Space - Door that is not automatic or power-assisted does not have compliant maneuvering space relative to the direction of approach as shown in CBC Fig. 11B-26. (Approach // Side // Width // Depth) (Front // Pull // D + 24" * // 60") (Front // Push // D + 0" ** // 48") (Latch // Pull // D + 24" // 60") (Latch // Push // D + 24" // 44" *** (Hinge // Pull // D + 36" // 60") (Hinge // Push // 54" **** // 44" *****) (* D + 18" at interior doors.) (** D + 12" if door has both a latch and a closer.) (***) 48" if door has closer.) (**** Measured from latch toward hinge.) (***** 48" if door has both a latch and a closer.)

Existing Condition: 40" deep landing at pull side, non-fixed furniture.

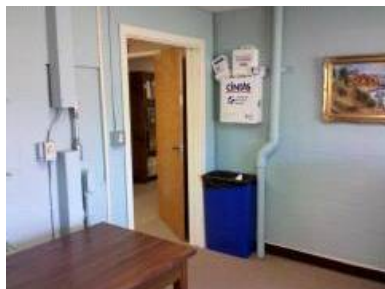
Location:
Admin. - Copy Room

Existing Condition: First aid kit at 66 1/2" AFF and infection control kit at 77 1/2" AFF.

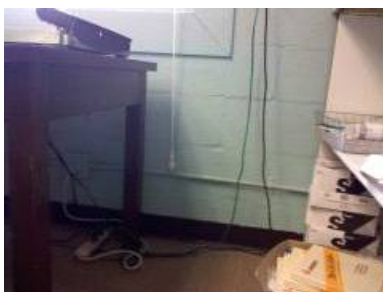
Location: Admin. - Copy Room
Photo # 649

Existing Condition: 2 power outlets at 11" AFF.

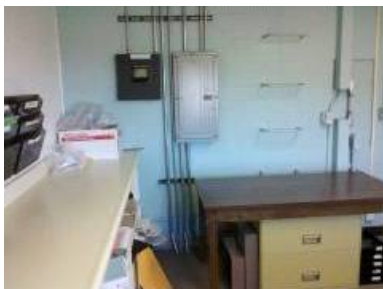
Location: Admin. - Copy Room
Photo # 650

Existing Condition: Phone at 61 1/2" AFF behind obstruction and alarm key pad at 64" AFF.

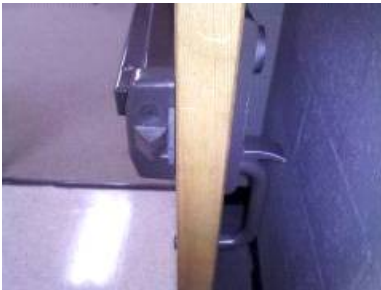
Location: Admin. - Stairwell
Photo # 654

Existing Condition: Thumb latch.

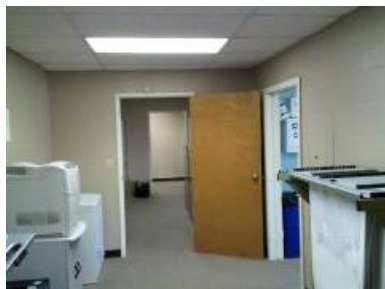
Location:
Admin. - Hallway

Existing Condition: Door knob.

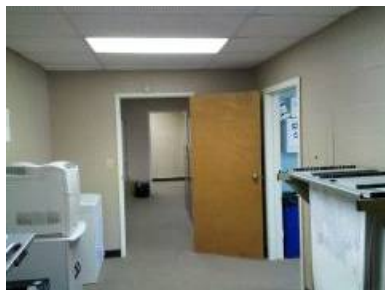
Location:
Admin. - Hallway

Existing Condition: Door jamb at 79" AFF.

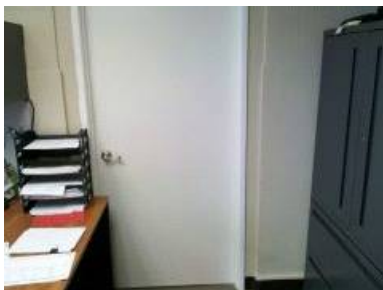
Location:
Admin. - Office

11.17A - Recommendation: Providing Room/Space ID Sign - A sign designating the permanent room or space has not been provided.

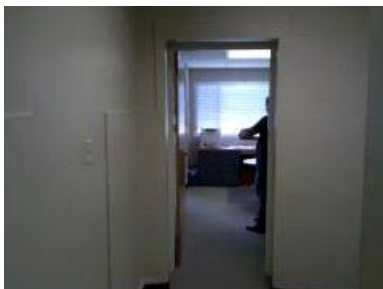
Location:
Admin. - Office

Existing Condition: Door jamb at 77" AFF.

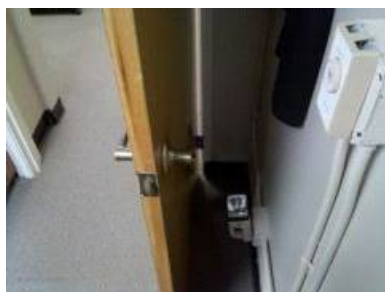
Location: Admin. - Office
Photo # 668

Existing Condition: Twist-type lock.

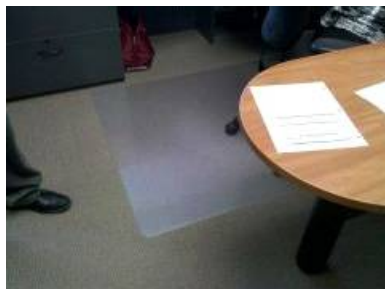
Location:
Admin. - Office

14.23B - Floor Surface - Accessible route surfaces are not stable, firm and slip-resistant.

Existing Condition: Floor mat.

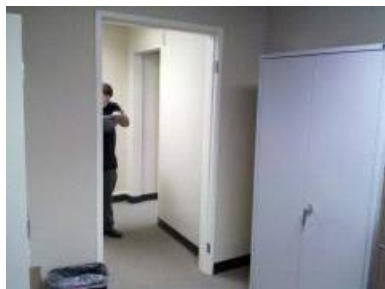
Admin. - Office

14.31 - Head Room - Clear head room is at less than 80" within the pedestrian circulation area, including the accessible route of travel.

Existing Condition: Door jamb at 79" AFF.

Additional Comments: Remove door jamb. Patch and repair to match existing.

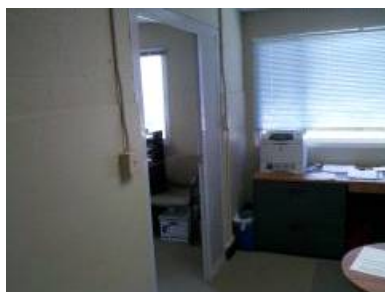
Location:
Admin. - Office

Existing Condition: Door jamb at 76 3/4" AFF.

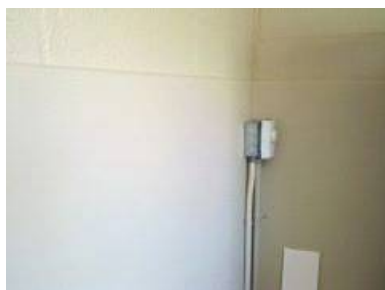
Location:
Admin. - Office

Existing Condition: Twist-type thermostat.

031B - Replace Control - Replace control. Repair/refinish as required.

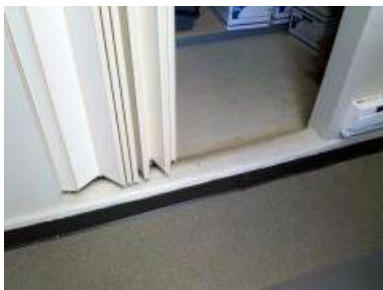
Location: Admin. - Office
Photo # 676

Existing Condition: 6" change in level between office and storage room.

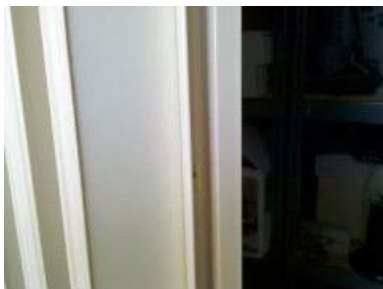
Location: Admin. - Office
Photo # 677

Existing Condition: Accessible hardware not provided.

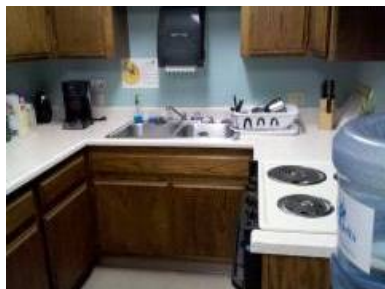
Admin. - Office

14.36B - Kitchen Counter/Sink Height - Where provided in public or common use areas, countertops and sinks are not mounted at 34" AFF. max..(Common use areas are those interior and exterior rooms, spaces, or elements that are made available for the use of a restricted group of people (for example, the occupants of an office building, or the guests of such occupants).

Existing Condition: Counter top at 36" AFF.

480B - New Lower Cabinet with Counter Top and Kitchen Sink - Remove portion of existing cabinetry, and provide new counter at 34" above the finished floor. Remove and replace sink and faucet with new accessible sink and faucet. Provide accessible knee clearance (i.e. at least 27" high, 30" wide, and 19" deep) under

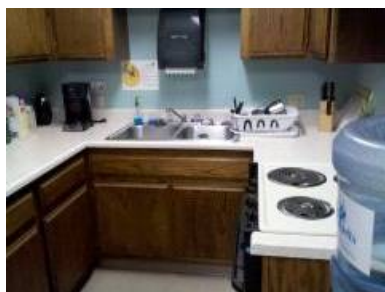
Location: Admin. - Break Room
Photo # 679

Existing Condition: Knee space not provided.

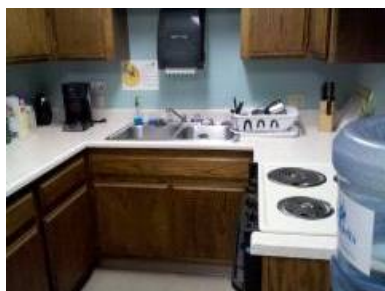
Location: Admin. - Break Room
Photo # 679

Existing Condition: Non-compliant faucet controls.

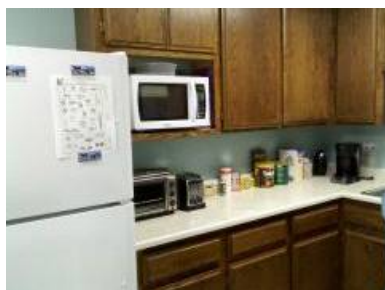
Location: Admin. - Break Room
Photo # 683

Existing Condition: Microwave at 64 1/2" AFF.

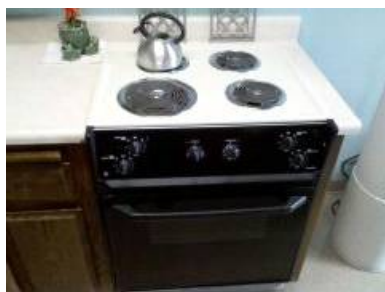
Location: Admin. - Break Room
Photo # 684

Existing Condition: Non-compliant controls at stove.

031B - Replace Control - Replace control. Repair/refinish as required.

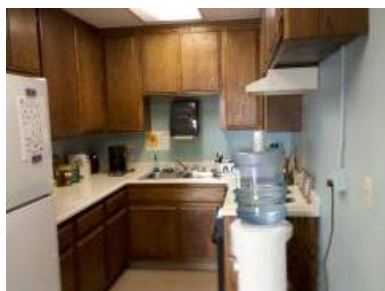
Location: Admin. - Break Room
Photo # 685

Existing Condition: Upper cabinets at 72" AFF.

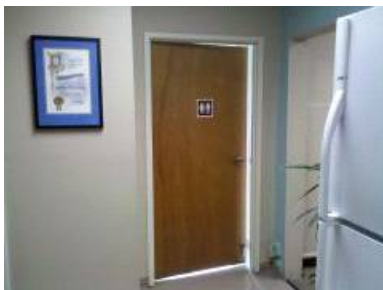
Location: Admin. - Unisex Restroom
Photo # 686

Existing Condition: Door jamb at 79 1/2" AFF.

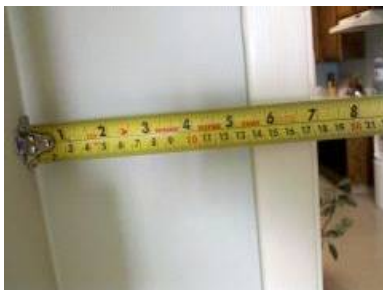
16.09A - Door Maneuvering Space - Door that is not automatic or power-assisted does not have compliant maneuvering space relative to the direction of approach as shown in CBC Fig. 11B-26. (Approach // Side // Width // Depth) (Front // Pull // D + 24" * // 60") (Front // Push // D + 0" ** // 48") (Latch // Pull // D + 24" // 60") (Latch // Push // D + 24" // 44" *** (Hinge // Pull // D + 36" // 60") (Hinge // Push // 54" **** // 44" *****) (* D + 18" at interior doors.) (** D + 12" if door has both a latch and a closer.) (***) 48" if door has closer.) (**** Measured from latch toward hinge.) (***** 48" if door has both a latch and a closer.)

Existing Condition: 7" to CMU wall at pull side, & 47" landing at pull side.

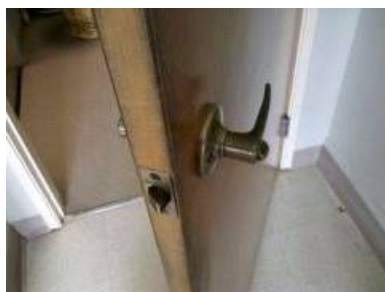
Location: Admin. - Unisex Restroom
Photo # 688

Existing Condition: Twist-type locking mechanism.

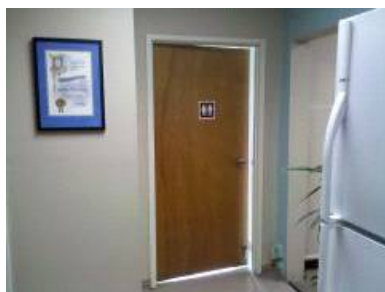
Keynote 690

Existing Condition: 2004 ADAAG 216.2; 703.1; 703.2; 703.5
2007 CBC 1117B.5.1(1)
Other -

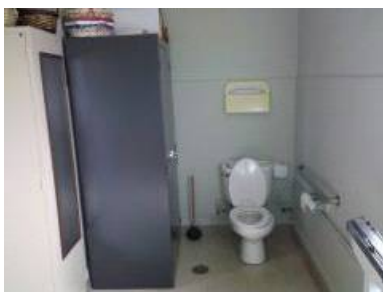
Keynote 692

Existing Condition: 18" to non-fixed furniture.

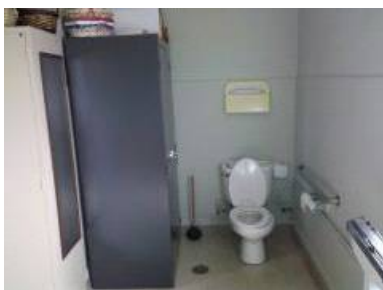
Keynote 693

Existing Condition: 16" AFF.

323A - Replace Toilet Seat - Remove existing toilet seat and retrofit a new toilet seat so that the top of the seat is 17" to 19" above finish floor.

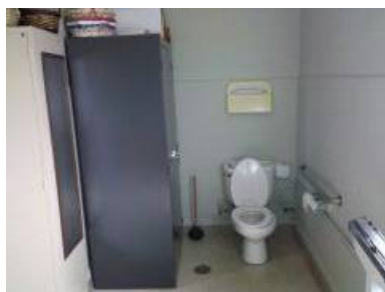
Keynote 694

Existing Condition: 40 1/2" from back wall.

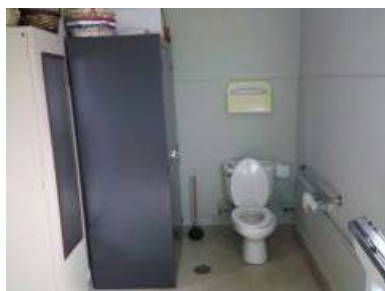
Keynote 695

Existing Condition: 56" AFF.

294C - Relocate Dispenser - Relocate existing dispenser on an accessible route. Patch and repair wall substrate and finishes, to match adjacent undisturbed surfaces.

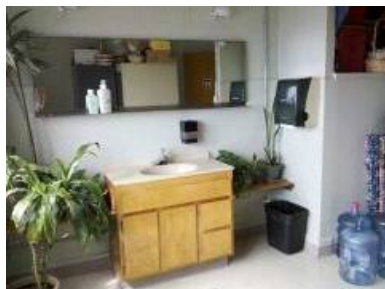
Keynote 701

Existing Condition: 52 1/2" AFF.

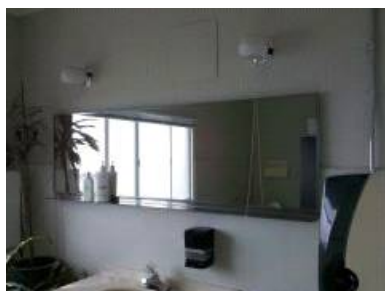
Keynote 703

Existing Condition: Lights above mirror require grasping to power on.

031B - Replace Control - Replace control. Repair/refinish as required.

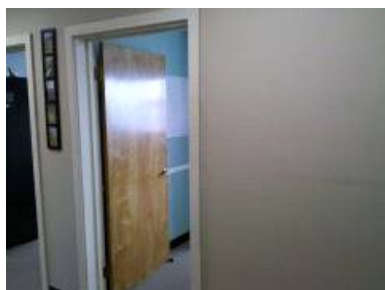
Keynote 707

11.17A - Recommendation: Providing Room/Space ID Sign - A sign designating the permanent room or space has not been provided.

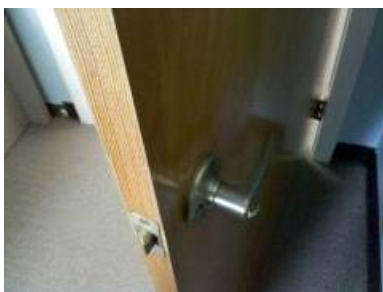
Keynote 708

Existing Condition: Twist-type locking mechanism.

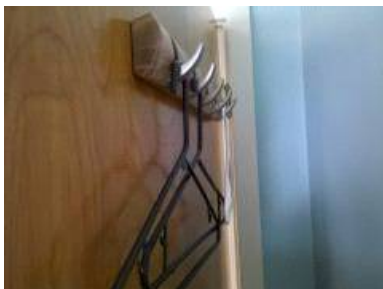
Keynote 709

Existing Condition: Coat hook at 67" AFF.

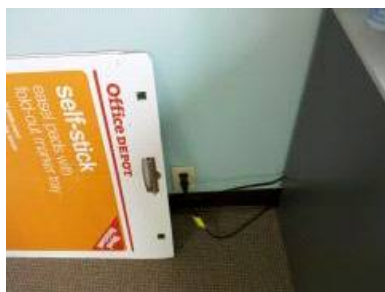
Keynote 711

Existing Condition: 2 power outlets.

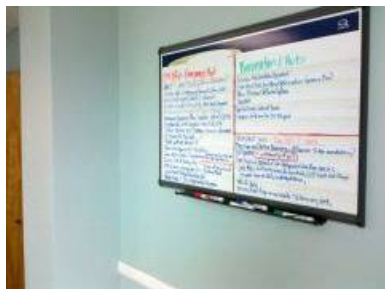
Keynote 712

Existing Condition: Dry erase board at 51 1/2" AFF.

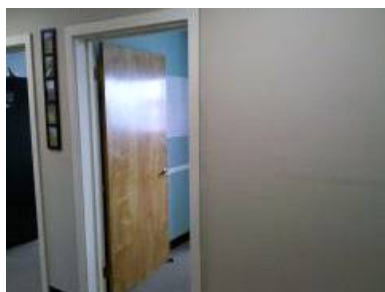
Keynote 713

Existing Condition: Door jamb at 76 3/4" AFF.

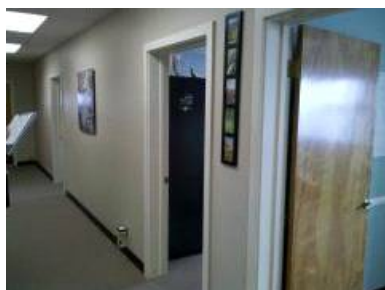
Keynote 714

11.17A - Recommendation: Providing Room/Space ID Sign - A sign designating the permanent room or space has not been provided.

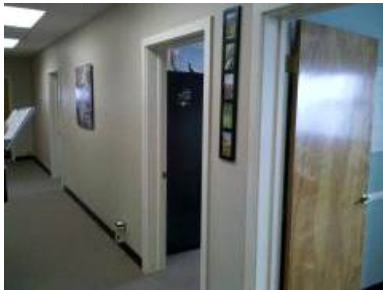
Keynote 715

Existing Condition: Door jamb at 77" AFF.

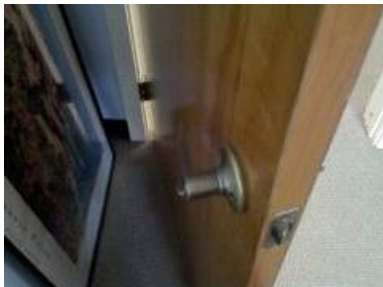
Keynote 716

Existing Condition: Twist-type locking mechanism.

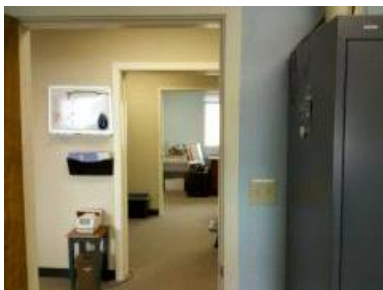
Keynote 717

11.06A - Door Maneuvering Space - Door that is not automatic or power-assisted does not have compliant maneuvering space relative to the direction of approach as shown in CBC Fig. 11B-26. (Approach // Side // Width // Depth) (Front // Pull // D + 24" * // 60") (Front // Push // D + 0" ** // 48") (Latch // Pull // D + 24" // 60") (Latch // Push // D + 24" // 44" ***) (Hinge // Pull // D + 36" // 60") (Hinge // Push // 54" **** // 44" *****) (* D + 18" at interior doors.) (** D + 12" if door has both a latch and a closer.) (***) 48" if door has closer.) (**** Measured from latch toward hinge.) (***** 48" if door has both a latch and a closer.)

Existing Condition: 11" to non-fixed furniture, pull side.

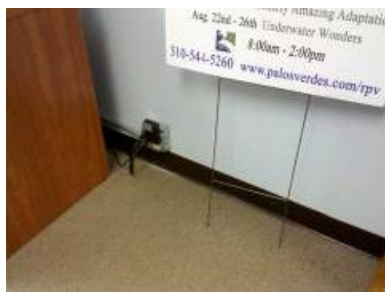
Keynote 718

Existing Condition: 1 power outlet at 6 1/2" AFF.

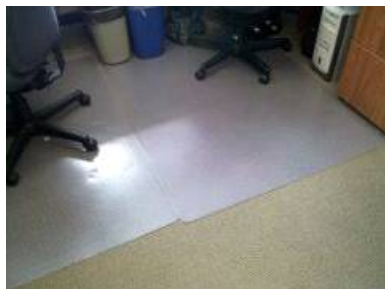
Keynote 719

Existing Condition: Floor mat.

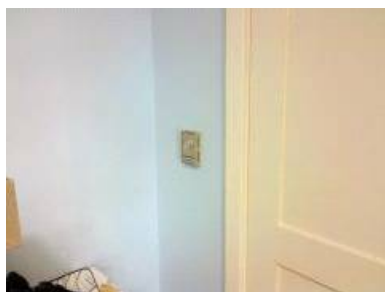
Keynote 720

Existing Condition: Twist-type thermostat.

031B - Replace Control - Replace control. Repair/refinish as required.

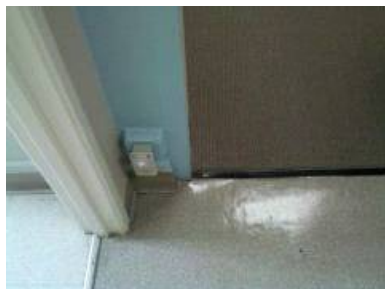
Keynote 721

Existing Condition: 3 power outlets at 9 1/2" AFF.

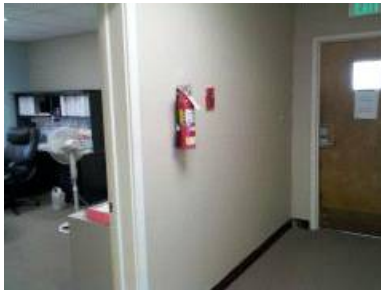
Keynote 722

Existing Condition: 59" AFF.

388D - Relocate Fire Extinguisher - Relocate existing fire extinguisher. Repair and refinish.

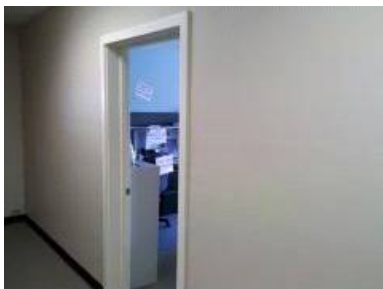
Keynote 725

Existing Condition: Door jamb at 76 3/4" AFF.

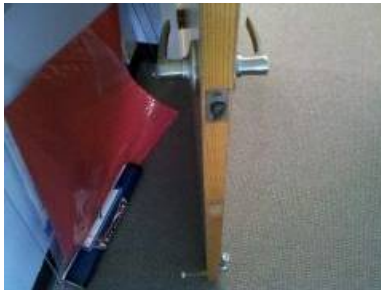
Keynote 726

Existing Condition: Twist-type locking mechanism.

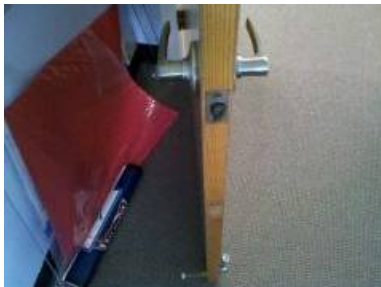
Keynote 727

11.15A - Kick Plate - Bottom 10" of door does not have a smooth, uninterrupted surface on the push side to allow the door to be opened by a wheelchair footrest without creating a trap or hazardous condition. (This requirement does not apply to automatic and sliding doors.)

Existing Condition: Door stop.

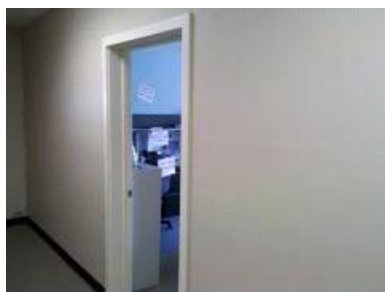
Keynote 728

11.17A - Recommendation: Providing Room/Space ID Sign - A sign designating the permanent room or space has not been provided.

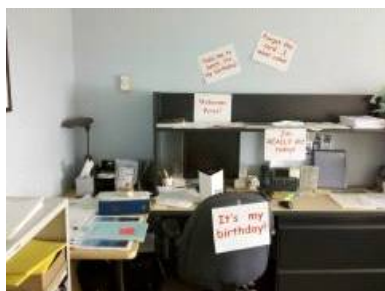
Keynote 729

Existing Condition: Twist-type thermostat.

031B - Replace Control - Replace control. Repair/refinish as required.

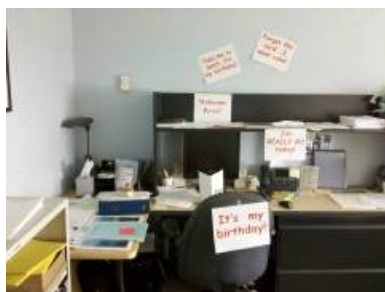
Keynote 730

Existing Condition: Thermostat at 58" AFF behind obstruction.

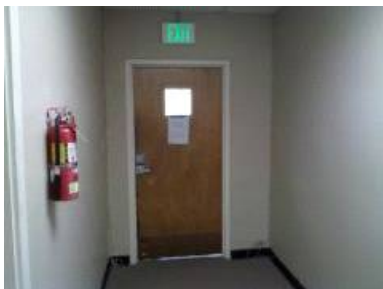
Keynote 733

Existing Condition: Door jamb at 77 1/4" AFF.

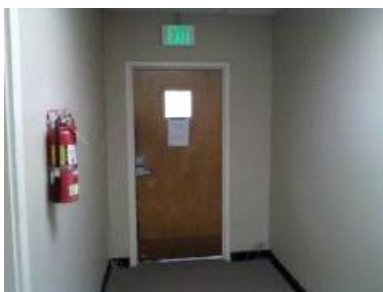
Keynote 734

11.15A - Kick Plate - Bottom 10" of door does not have a smooth, uninterrupted surface on the push side to allow the door to be opened by a wheelchair footrest without creating a trap or hazardous condition. (This requirement does not apply to automatic and sliding doors.)

Existing Condition: Door stop.

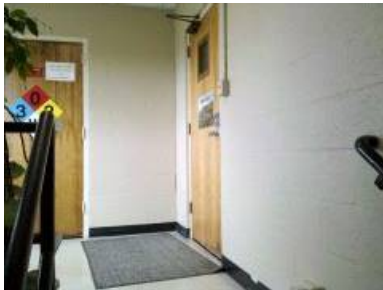
Keynote 736

Existing Condition: Floor mat.

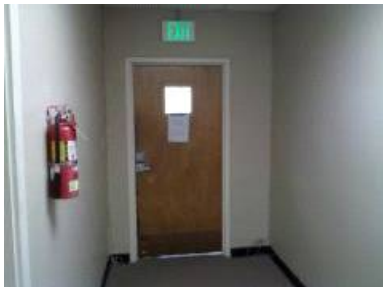
Keynote 737

Existing Condition: 12 LBF.

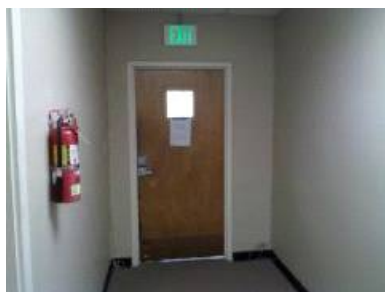
Keynote 738

Existing Condition: 59 3/4" AFF.

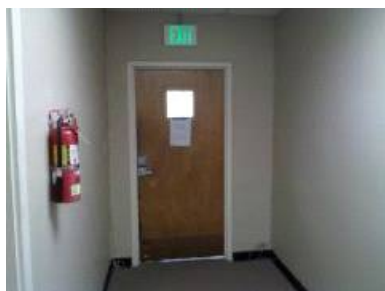
Keynote 739

Existing Condition:

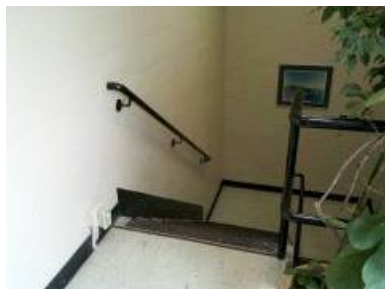
Keynote 741

Existing Condition: 1 power outlet at 7" AFF.

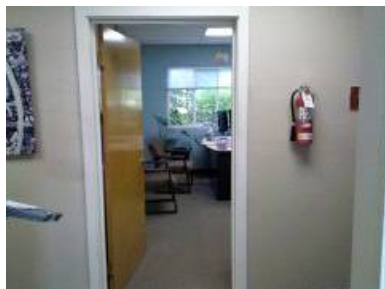
Keynote 743

11.17A - Recommendation: Providing Room/Space ID Sign - A sign designating the permanent room or space has not been provided.

Existing Condition:

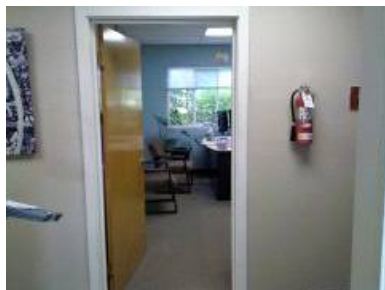
Keynote 744

14.31 - Head Room - Clear head room is at less than 80" within the pedestrian circulation area, including the accessible route of travel.

Existing Condition: Door jamb at 77" AFF.

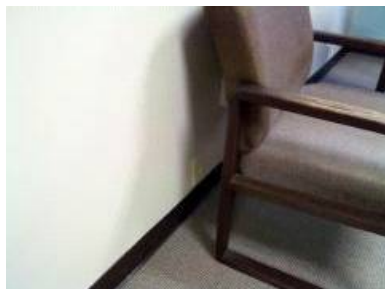
Keynote 745

14.32A - Reach Range - Controls - Controls, dispensers, and similar devices are not between 9" and 54" AFF when the clear floor space allows a parallel approach. OR They are not between 15" and 48" AFF when the clear floor space allows only a forward approach.

Existing Condition: 3 power outlets at 7" AFF.

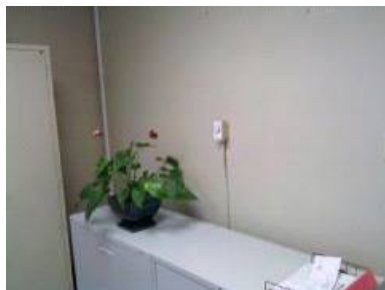
Keynote 746

Existing Condition: Twist-type thermostat.

031B - Replace Control - Replace control. Repair/refinish as required.

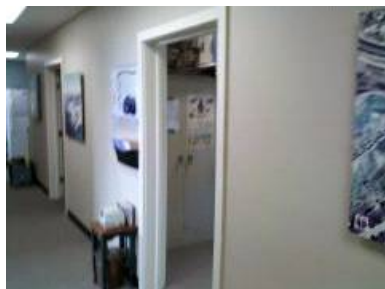
Keynote 747

Existing Condition: Door jamb at 76 1/2" AFF.

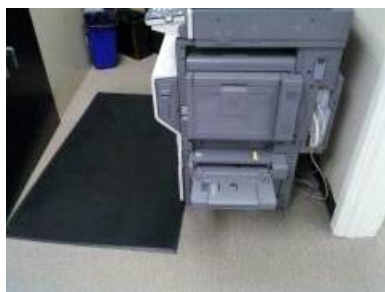
Keynote 748

Existing Condition: Floor mat.

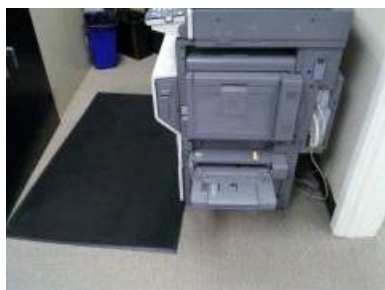
Keynote 749

Existing Condition: 3 power outlets, 1 data port at 9" AFF.

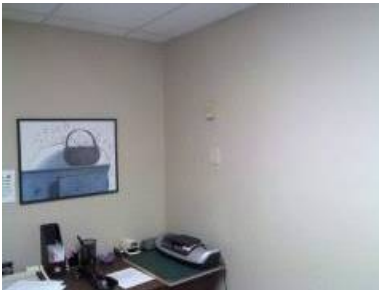
Keynote 750

Existing Condition: Twist-type thermostat.

031B - Replace Control - Replace control. Repair/refinish as required.

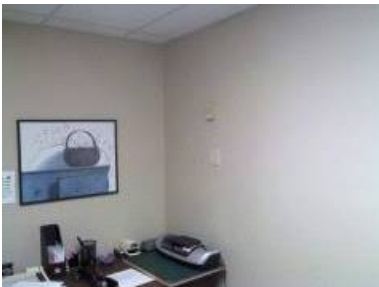
Keynote 751

Existing Condition: Thermostat at 60" AFF.

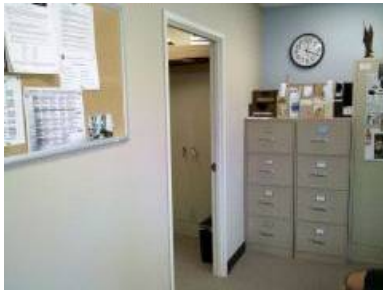
Keynote 752

Existing Condition: Door jamb at 76 1/2" AFF.
