City of Rancho Palos Verdes
Rancho Palos Verdes ADA Assessment
Facility Report with Photos

Facility ID: # 02B - City Hall Buildings

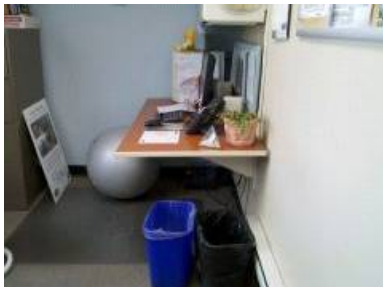
Keynote 753

Existing Condition: Floor mat.
